# **Environmental Impact Statement for the Proposed Development of 6012 Ottawa Street Area**

**October 9, 2025**

**Updated Report: Version 3**

Mike Green  
Tamarack Homes  
3187 Albion Road South  
Ottawa ON  
K1V 8Y3

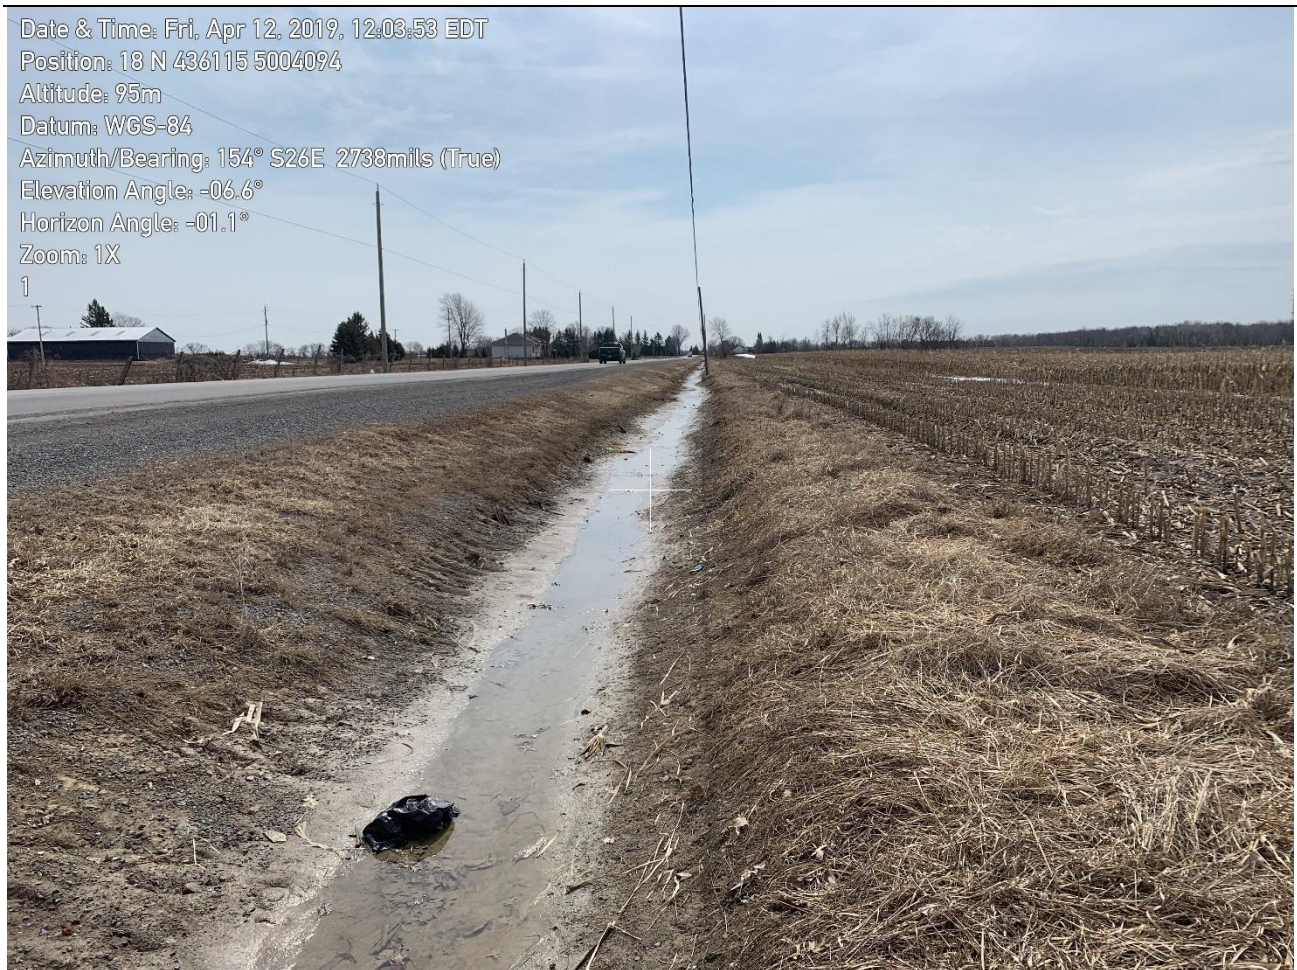
**Figure 5 Photo showing the roadside ditch along Eagleson Road taken on April 12, 2019**

A roadside ditch system stretches along Eagleson Road surrounding the corn field on Site and along Ottawa Street at the northeast corner of the Site. When originally assessed in the spring, there was no flow through most of the ditch length along the property. The water found along most of the ditches consisted of small, disconnected puddles; by late spring they had dried up completely. Only the portion nearest to Reach 1 (see below) held some standing water (i.e., the ditch was presumably draining into Reach 1, but with no detectable flow). The substrate consisted primarily of silt and sand, while the banks had grass along the shoulder of the road. Submergent vegetation was not present. No frogs or turtles were observed in the roadside ditches, but American Toads (*Anaxyrus americanus*), Spring Peepers (*Pseudacris crucifer*), and Green Frogs (*Rana clamitans*) could be heard calling from Marlborough Creek westward from the north end of the ditch down Ottawa Street (i.e., frogs were detected audibly from this ditch but were not observed directly in the ditch).

| Headwater<br>Drainage<br>Feature | Riparian Classification | | |
|---|---|---|---|
| Roadside<br>Ditches | No fish present, no SAR<br>present.<br>• Dry; no fishing effort. | <b>Contributing<br/>Functions</b> | No fish observed. The roadside ditches likely convey some water and allochthonous material to Reach 1 during the spring freshet. |

| <b>Headwater Drainage Feature</b> | <b>Description</b> | <b>Herpetofauna Observations</b> | <b>Terrestrial Classification</b> |
|---|---|---|---|
| Roadside Ditches | No adjacent wetland areas. With adjacent roadway and no adjacent vegetation, this feature would not provide corridor functionality. | No amphibians or reptiles were observed. | <b>Limited Functions</b> |

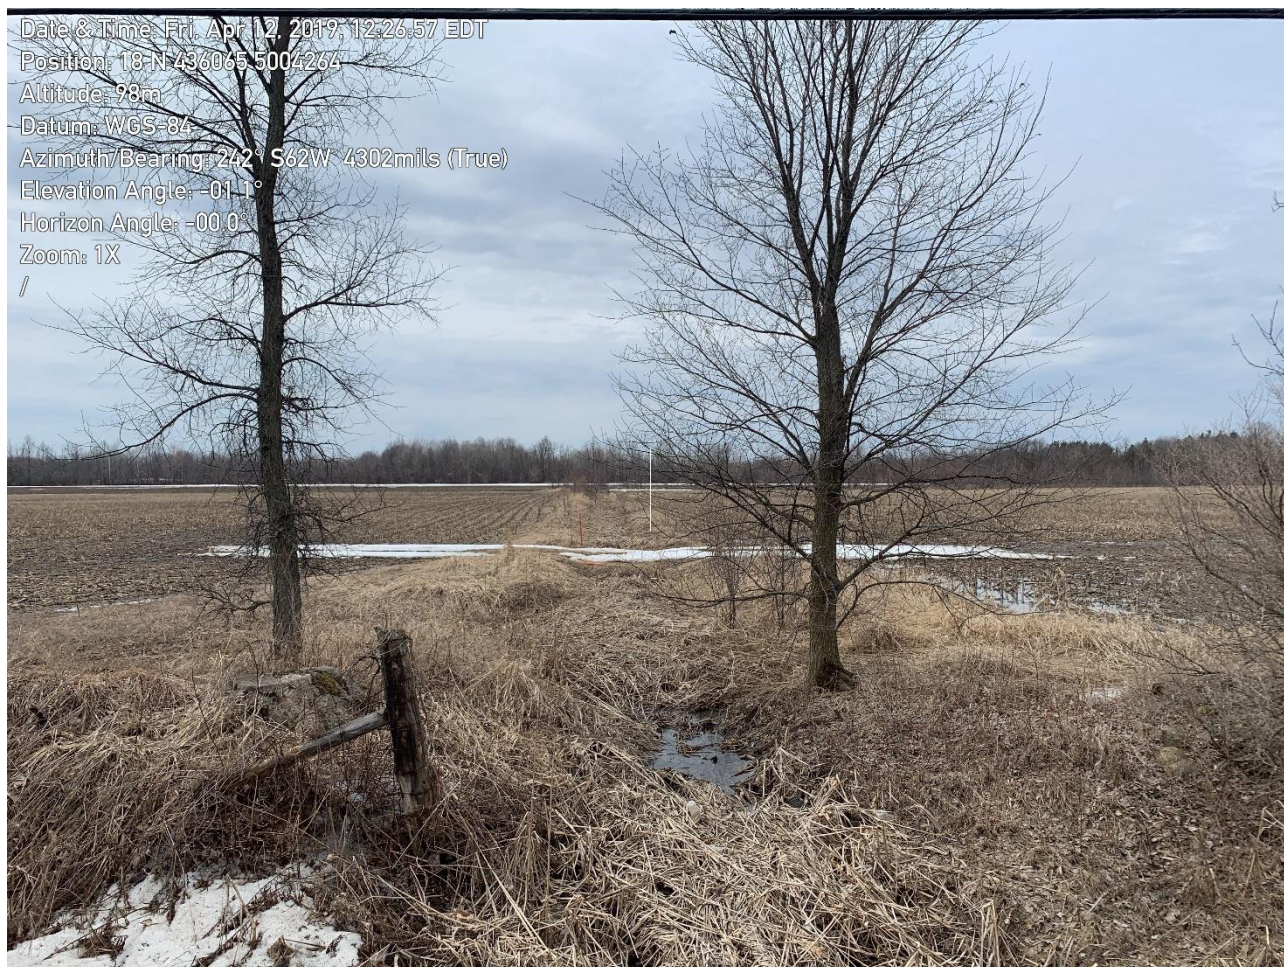
**Figure 6 Photo showing Reach 1 on Site taken on April 12, 2019**

Reach 1 runs 232 m from northeast to southwest of the Site between corn fields, starting at a culvert along the side of Eagleson Road, to a 90° bend northward into Reach 2. There was limited flow here in the initial visits in the early spring, and by mid-spring the area was dry. The feature has corn fields on either side and a few small trees along the banks. The substrate was mostly organic matter and cattails were found in the channel. Instream vegetation is otherwise limited, likely due to the buildup of organic matter. There is grass on either side of the banks, and cropped land (corn) at the edge of the grass. No frogs or turtles were observed in or along this feature.

| Headwater<br>Drainage<br>Feature | Riparian Classification | | |
|---|---|---|---|
| Reach 1 | No fish present, no SAR<br>present.<br>• Dry; no fishing effort. | <b>Contributing<br/>Functions</b> | No fish observed. Conveys water and allochthonous material to Reach 2 during the spring freshet. This reach may be accessible to fish during the spring freshet (e.g., may receive overflow from Marlborough Creek via Reach 2 and/or 3) but is dry by late spring. |

| <b>Headwater Drainage Feature</b> | <b>Description</b> | <b>Herpetofauna Observations</b> | <b>Terrestrial Classification</b> |
|---|---|---|---|
| Reach 1 | No adjacent wetland areas. This feature potentially connects a very small woodlot across Eagleson Rd to the Jock River corridor via Reach 2, but is not treed and has a maximum width of 6 m. As such, its potential as a wildlife corridor is very limited. | No amphibians or reptiles were observed. | <b>Limited Functions</b> |

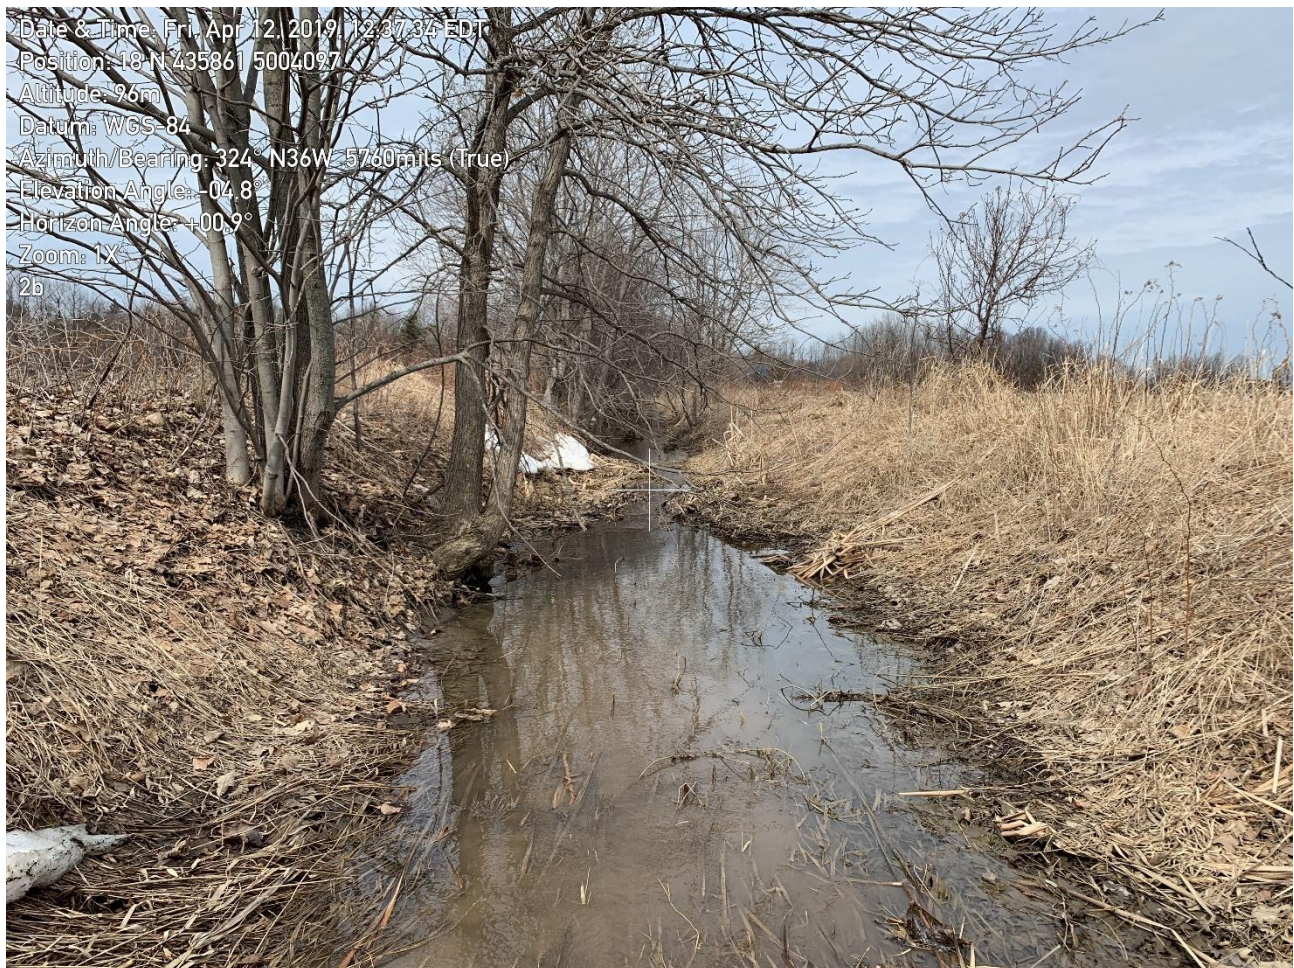
**Figure 7 Photo showing Reach 2 on Site taken on April 12, 2019**

Reach 2 runs 305 m southeast to northwest from the turn at the end of Reach 1 to Marlborough Creek on the northwestern side. The downstream-most end of the channel passes through the wooded riparian corridor of Marlborough Creek but most of the channel is situated between two corn fields. This reach appears to have been constructed as a drainage feature for the adjacent agricultural fields. Early spring flows in Reach 2 were somewhat more evident than in Reach 1, though grass and woody debris maintained pooled areas where flow was not apparent. The substrate consists of mostly organic matter. Like Reach 1, the banks of this feature are lined with grass, but some trees are present and the banks are much more defined. The trees and shrubs adjacent to Reach 2 include Common Buckthorn (*Rhamnus cathartica*), American Elm (*Ulmus americana*), Ash (*Fraxinus*), Willow (*Salix*), Raspberry (*Rubus*), Red Maple (*Acer rubrum*), Cedar (*Thuja*), and Red Osier Dogwood (*Cornus sericea*). This reach still held standing water in late spring (likely retained by minor debris jams) but it was generally very shallow (<5 cm) and there were no fish observed or caught in the channel. It was dry by early summer. No frogs or turtles were observed in this feature.

| Headwater<br>Drainage<br>Feature | Riparian Classification | | |
|---|---|---|---|
| Reach 2 | No fish present, no SAR<br>present.<br>• Dry; no fishing effort. | <b>Contributing<br/>Functions</b> | No fish observed. Conveys water and allochthonous material to Marlborough Creek during the spring freshet. This reach may be accessible to fish during the spring freshet (e.g., may receive overflow from Marlborough Creek) but only holds shallow standing water by late spring. |

| <b>Headwater Drainage Feature</b> | <b>Description</b> | <b>Herpetofauna Observations</b> | <b>Terrestrial Classification</b> |
|---|---|---|---|
| Reach 2 | No adjacent wetland areas. This feature connects only Reach 1 to the Jock River. Its potential as a wildlife corridor is very limited. | No amphibians or reptiles were observed. | <b>Limited Functions</b> |

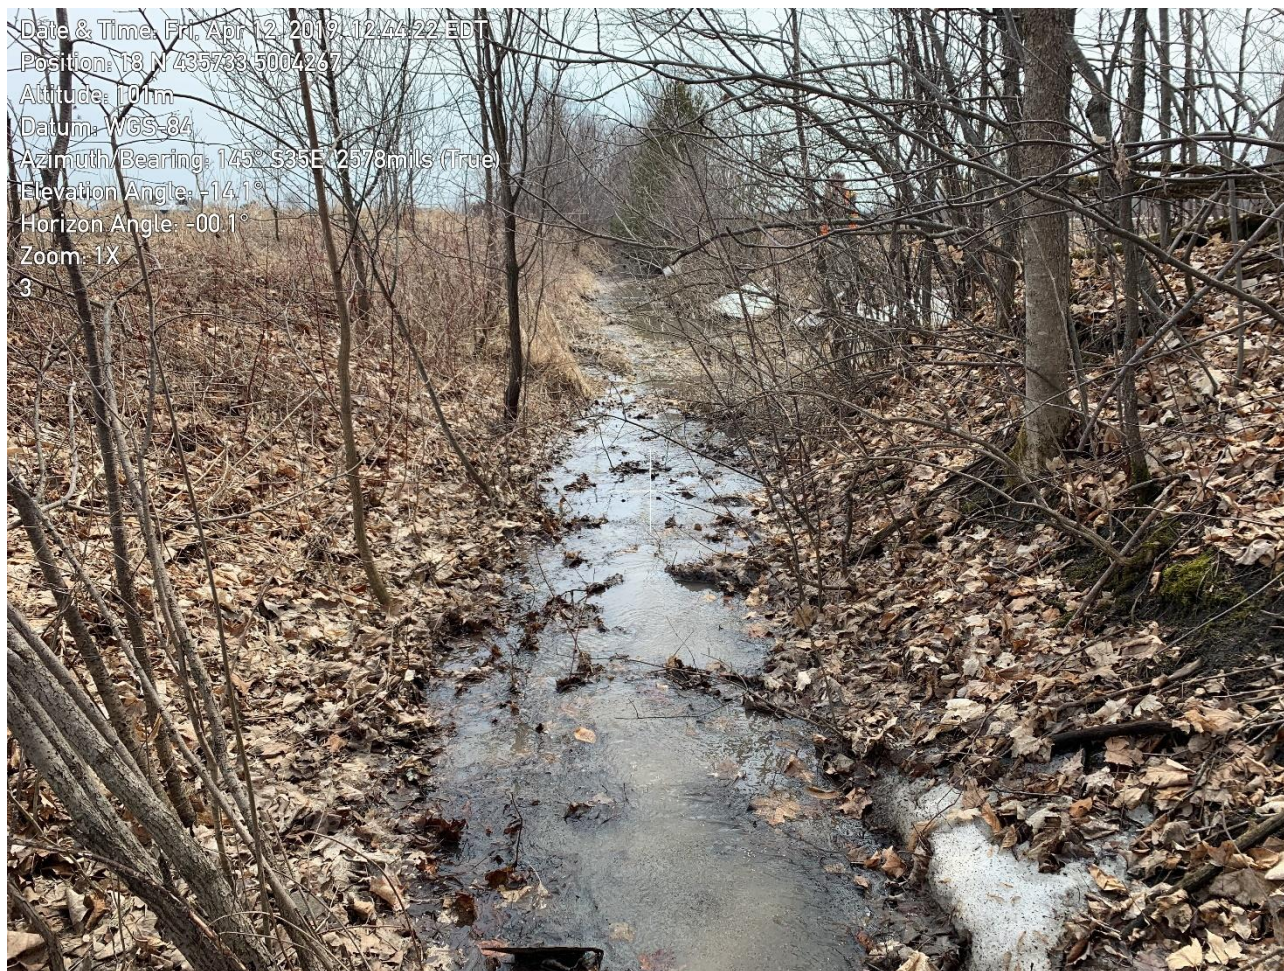
**Figure 8 Photo showing Reach 3 on Site taken on April 12, 2019**

Reach 3 is an 86 m channel along the northwestern edge of the eastern agricultural field. It conveys spring meltwater from the field to Reach 2 but runs dry after that. Consequently, no fish, frogs, or turtles were observed in this reach. There were a few frogs heard calling nearby during evening amphibian surveys, closer to Marlborough Creek. The substrate consisted mainly of organic matter and silt. The banks of this feature are grassy with trees present. These include Poplar (*Populus*), Pine (*Pinus*), and Ash (*Fraxinus*) trees.

| Headwater<br>Drainage<br>Feature | Riparian Classification | | |
|---|---|---|---|
| Reach 3 | No fish present, no SAR<br>present.<br>• Dry; no fishing effort. | <b>Contributing<br/>Functions</b> | No fish observed. Conveys water and allochthonous material to Marlborough Creek during the spring freshet. That wooded banks of Reach 3 further contribute to fish habitat in Marlborough Creek by moderating water temperature via shading. Reach 3 may be accessible to fish during the spring freshet (e.g., may receive overflow from Marlborough Creek) but dries immediately after the spring freshet. |

| <b>Headwater Drainage Feature</b> | <b>Description</b> | <b>Herpetofauna Observations</b> | <b>Terrestrial Classification</b> |
|---|---|---|---|
| Reach 3 | No adjacent wetland areas. This feature is a depression situated along the outer edge of (running parallel to) the riparian/forest corridor of Marlborough Creek. That forest habitat is significant to Marlborough Creek directly. Its relationship to this limited feature is not relevant from a herpetofauna perspective given that Reach 3 itself is adjacent to a farm field and dries immediately following the spring freshet. | No amphibians or reptiles were observed. | <b>Limited Functions</b> |

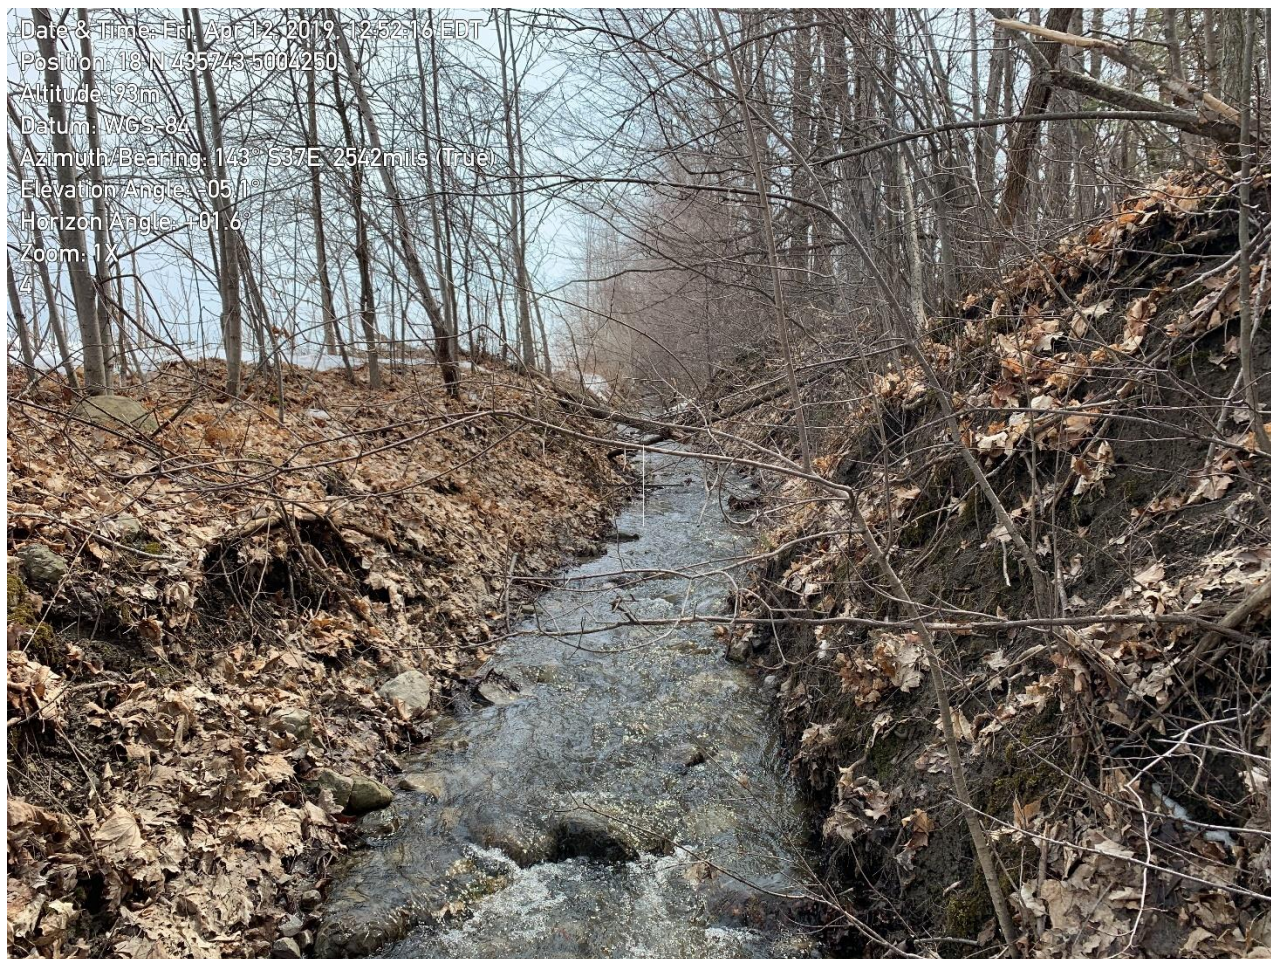
**Figure 9 Photo showing Reach 4 on Site taken on April 12, 2019**

Reach 4 is a linear, U-shaped channel with very well-defined banks and swift springtime flows that extend along the centre of the property, wrapping around to the southern and eastern sides of areas of successional regrowth towards the centre of the southern border of the property. This entire reach spans a distance of 795 m along the edge of active agricultural lands from a tile drain input and into Marlborough Creek. Older air photos suggest this feature previously received surface flows from a swale over the farm fields to the south, but that swale is no longer apparent. The tile drain is the main source of water in this reach. The presence of the tile drain resulted in steady flows through Reach 4 in late spring, and some standing water was still present in early summer. Given the substantial decrease of water depth by early July, and the lack of any apparent seeps, the feature was dry by late summer. This drainage ditch has a layer of cobble/gravel on the substrate. The west bank is lined with trees and continues up into a sparsely wooded area. There are some trees along the east bank, but the edge of the feature is generally contiguous with the adjacent corn/winter wheat fields. The steep banks and heavy flowing water in the spring did not make ideal habitat for turtles directly in the feature and none were noted here, but two Painted Turtles (*Chrysemys picta*) were observed in Marlborough Creek just beyond the end of Reach 4. There were no frogs observed in the area during any of the three evening frog surveys.

| Headwater<br>Drainage<br>Feature | Riparian Classification | | |
|---|---|---|---|
| Reach 4 | No fish present, no SAR<br>present.<br>• Electrofished along two<br>20-30 m transects<br>(shocking seconds: 141.8<br>for first reach, 182.9 for<br>second reach). | <b>Contributing<br/>Functions</b> | No fish observed despite fishing efforts. Leeches observed during shocking. Conveys water and allochthonous material to downstream fish habitat in Marlborough Creek throughout the spring and intermittently throughout the summer. Fish may be present in Reach 4 during the spring when water is still flowing (water is standing by summer). The wooded right upstream bank of Reach 4 further contributes to fish habitat in Marlborough Creek by moderating water temperature via shading. |

| <b>Headwater Drainage Feature</b> | <b>Description</b> | <b>Herpetofauna Observations</b> | <b>Terrestrial Classification</b> |
|---|---|---|---|
| Reach 4 | No adjacent wetland areas. This reach is on the edge of farm fields, adjacent to a dense hedgerow and re-naturalizing old fields with secondary tree growth. The west bank riparian zone may provide some potential corridor functionality. | No amphibians or reptiles were observed. | <b>Contributing Functions</b> |

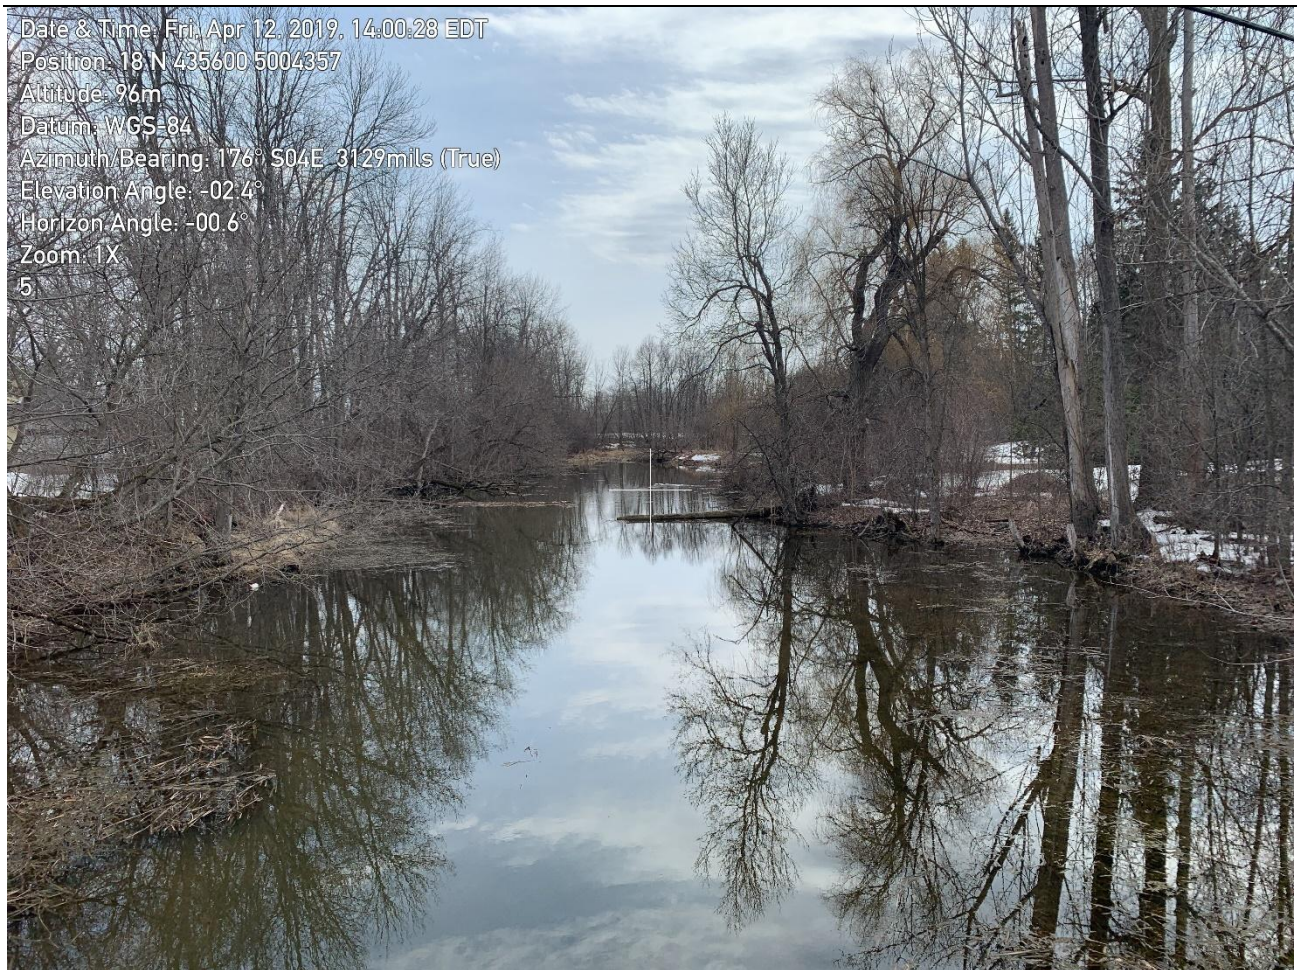
**Figure 10 Photo showing Marlborough Creek on Site taken on April 12, 2019**

Marlborough Creek, an important tributary of the Jock River with the confluence located immediately downstream of Eagleson Road, flows along the northern edge of the property. The permanent creek has fast and heavy spring flows and maintains a wetted width often over 15 m, even in mid-summer. According to the most recent Jock River Subwatershed Report by RVCA (2016), there were minimal anthropogenic alterations observed along the system, and 80% of Marlborough Creek remains “unaltered” with no anthropogenic alterations. The remaining 20% of Marlborough Creek was classified as natural with minor anthropogenic changes.

Average dissolved oxygen levels within Marlborough Creek in the Richmond catchment were found to be 7.68 mg/L, which is within the recommended levels for warm and cool water biota; the average conductivity was 964.41  $\mu\text{S}/\text{cm}$  (RVCA 2016). These levels would be considered higher than most systems in the Jock River watershed (based on measurements taken by the RVCA).

Marlborough Creek is dominated by invasive species. Sixty nine percent of the sections surveyed along the Jock River Richmond reach had invasive species, while 100% of Marlborough Creek had invasive species (RVCA, 2016). The invasive species observed in Marlborough Creek were European Frog-bit (*Hydrocharis morsus-ranae*), European/Black Alder (*Alnus glutinosa*), Purple Loosestrife (*Lythrum salicaria*), Poison/Wild Parsnip (*Pastinaca sativa*), Common/Glossy Buckthorn (*Rhamnus frangula*), Banded Mystery Snail (*Viviparus georgianus*), Garlic Mustard (*Alliaria petiolate*) and Manitoba Maple (*Acer negundo*). Along Marlborough Creek, 93% of the surrounding areas were characterized by forest, scrubland, meadow and wetland. Wetland was the most dominant habitat found along the creek at 44% relative cover. The remaining land use is made up of active agriculture, residential area, infrastructure, and industrial/commercial areas (RVCA, 2016). This creek generally had no undercut banks, except for a few sections in the upper reach with low to moderate levels. Marlborough Creek has high levels of stream shading along much of the system. The shading is assessed as the total coverage area in each section that is shaded by overhanging trees/grasses and tree canopy greater than 1m above the water surface (RVCA 2016). This contributes to the health of the stream by moderating its temperature, contributing to organic matter and aquatic forage, and helping with nutrient reduction.

Herptile surveys throughout the season noted two only Painted Turtles in the creek towards the western end of the Site, and small numbers (12 or fewer) of three different species of amphibians (American Toad, Spring Peeper, and Green Frog) along the length of the channel on Site.

| Headwater<br>Drainage<br>Feature | Riparian Classification | | |
|---|---|---|---|
| Marlborough<br>Creek | Fish present, no SAR<br>present.<br>• Not electrofished due to<br>readily available species<br>lists compiled by RVCA<br>(2016). | <b>Valued<br/>Functions</b> | <p>This creek provides suitable habitat for spawning/rearing, feeding, cover, refuge, and migration for several not-at-risk fish species and contributes to downstream habitat in the Jock River.</p> <p>Fish species presence is based on RVCA (2016) records for the creek from nearby sampling locations.</p> <p><b>Observed upstream of Site:</b> Blacknose Dace, Creek Chub, Fathead Minnow</p> <p><b>Observed downstream of Site:</b> Banded Killifish, Blackchin Shiner, Blacknose Shiner, Bluntnose Minnow, Central Mudminnow, Hybrid Minnow, Rock Bass</p> <p><b>Observed both up and downstream of the Site:</b> Bluegill, Brook Stickleback, Brown Bullhead, Common Shiner, Golden Shiner, Northern Pike, Northern Redbelly Dace, Pumpkinseed, White Sucker</p> |

| <b>Headwater Drainage Feature</b> | <b>Description</b> | <b>Herpetofauna Observations</b> | <b>Terrestrial Classification</b> |
|---|---|---|---|
| Marlborough Creek | The creek corridor does have some small areas of minor development along its north bank but is generally surrounded by a heavily treed riparian area 30 m or more in width. | Painted Turtles, Green Frogs, Spring Peepers, and American Toads were all noted in or adjacent to the creek, though only ever in small numbers. | <b>Important Functions</b> |

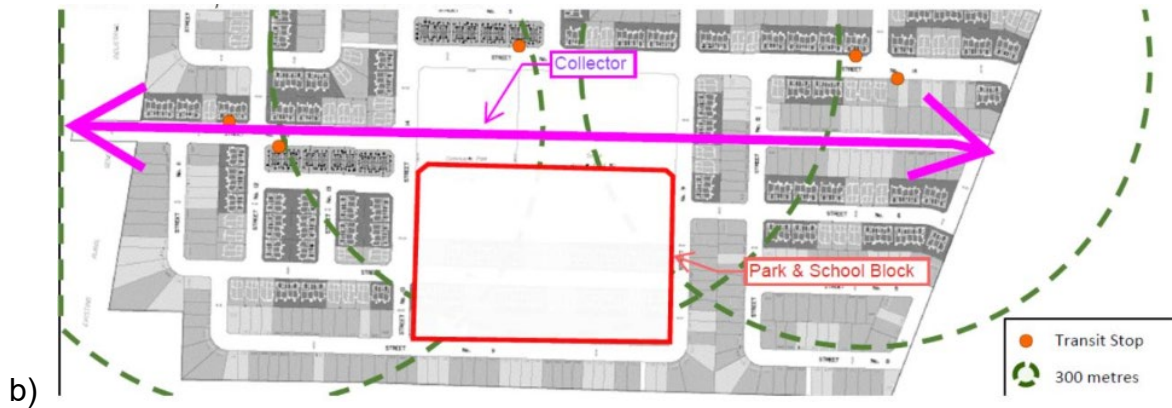
- a. Per previous comment: *“Justify the multiple 90-degree bents proposed for New Collector Road between McBean Street and Eagleson Road, particularly for the residential scenario concept plan. New Collector Road is envisioned as relatively straight in the Village of Richmond CDP and Map 8 of Annex B of the TMP (or Schedule G of the Official Plan), and the multiple bents proposed may prevent New Collector Road from fulfilling its function in the transportation network as envisioned by the CDP and TMP.”* Straighten the collector street alignment and shift the park and school block further south, as illustrated below:
