Phase I Environmental Site Assessment

Vacant Land – Eagleson Road
Ottawa (Richmond), Ontario

Taggart Group of Companies

Report: PE4079-1

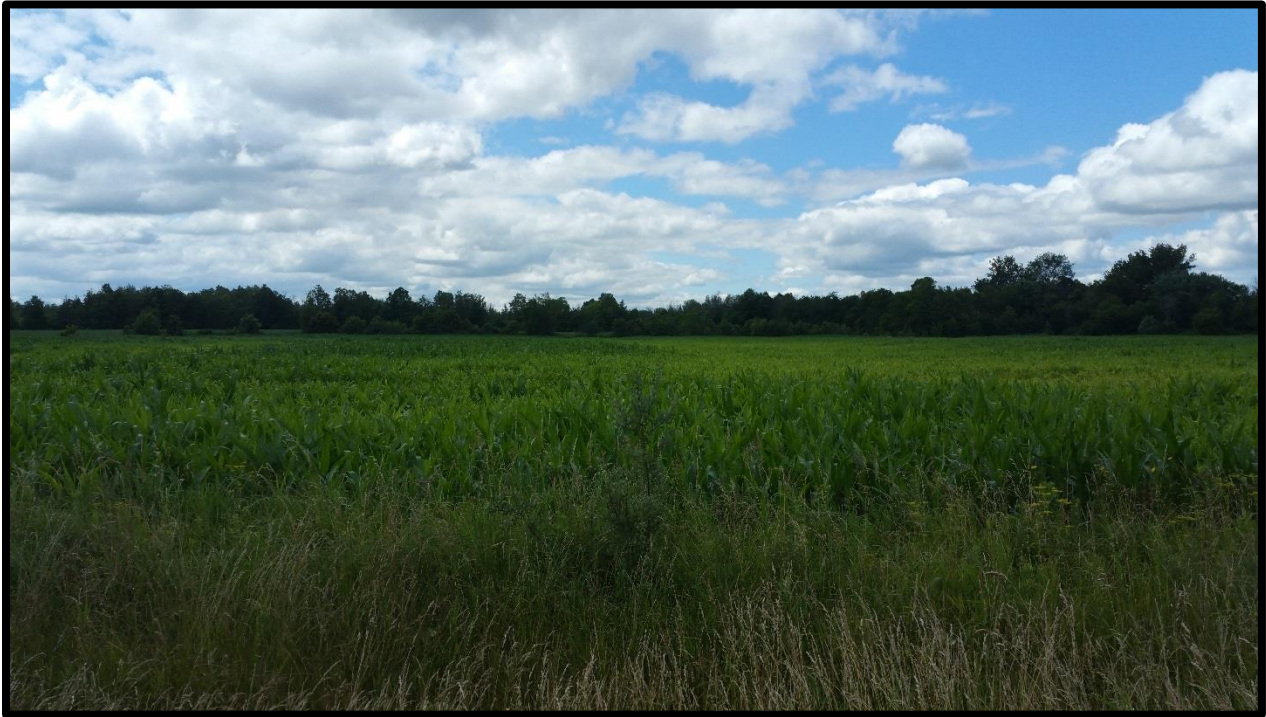
Photograph 1: View of the east side of the site, facing east. Photograph illustrates a corn field, the main land cover on the eastern portion of the site. No environmental concerns were identified.

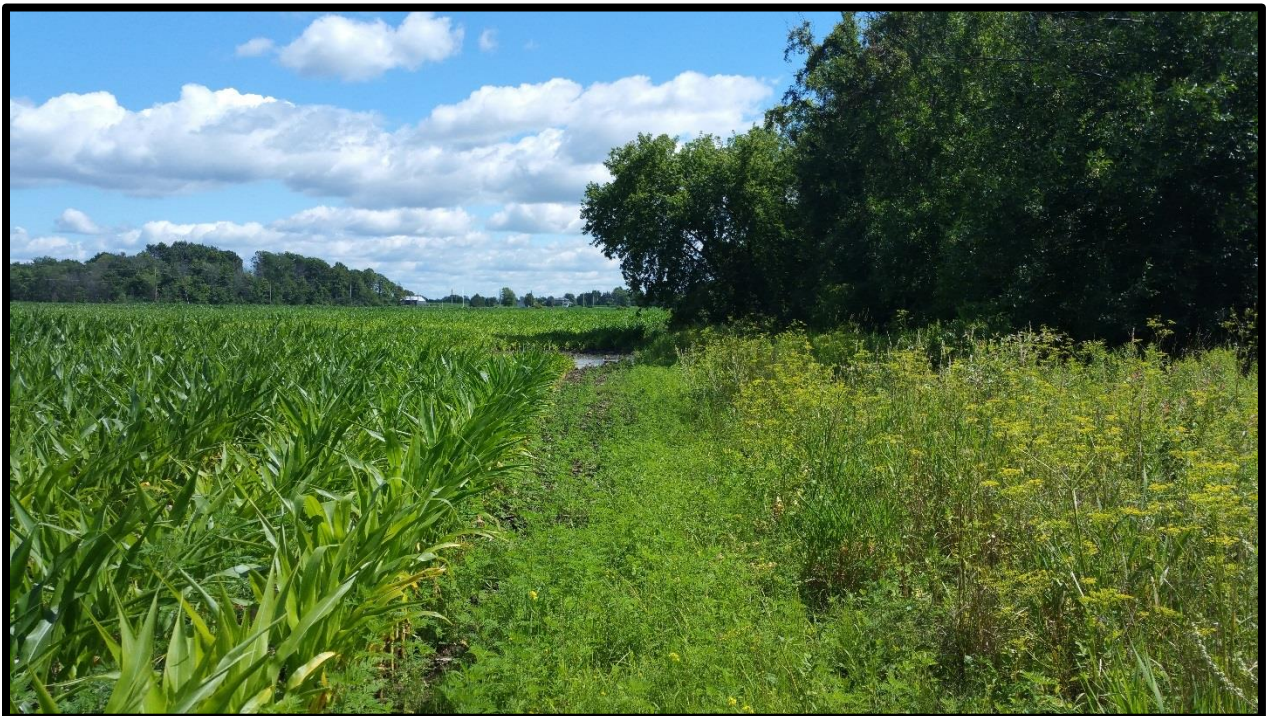
Photograph 2: View from the central portion of the subject site, facing south. Photograph illustrates corn, grass, small vegetation and trees. No environmental concerns were identified.

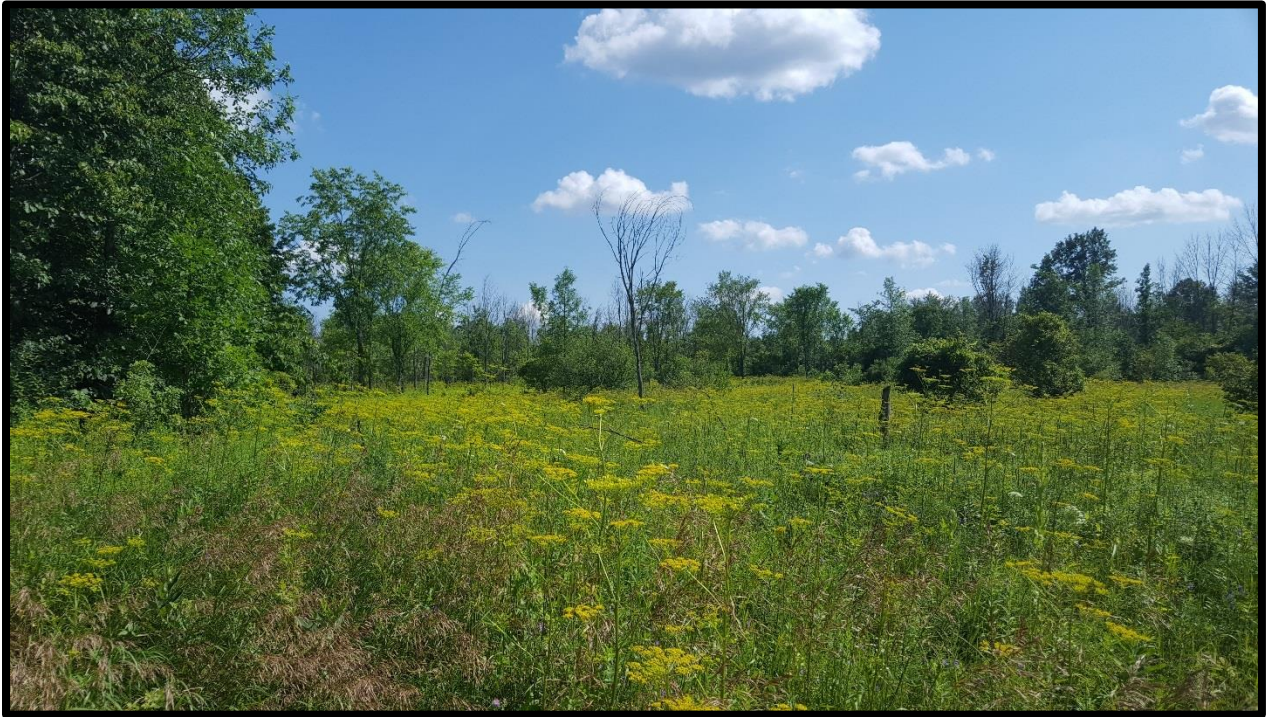
Photograph 3: View of trees and small vegetation, the main land cover on the western portion of the property. Photograph taken facing north. No environmental concerns were identified.

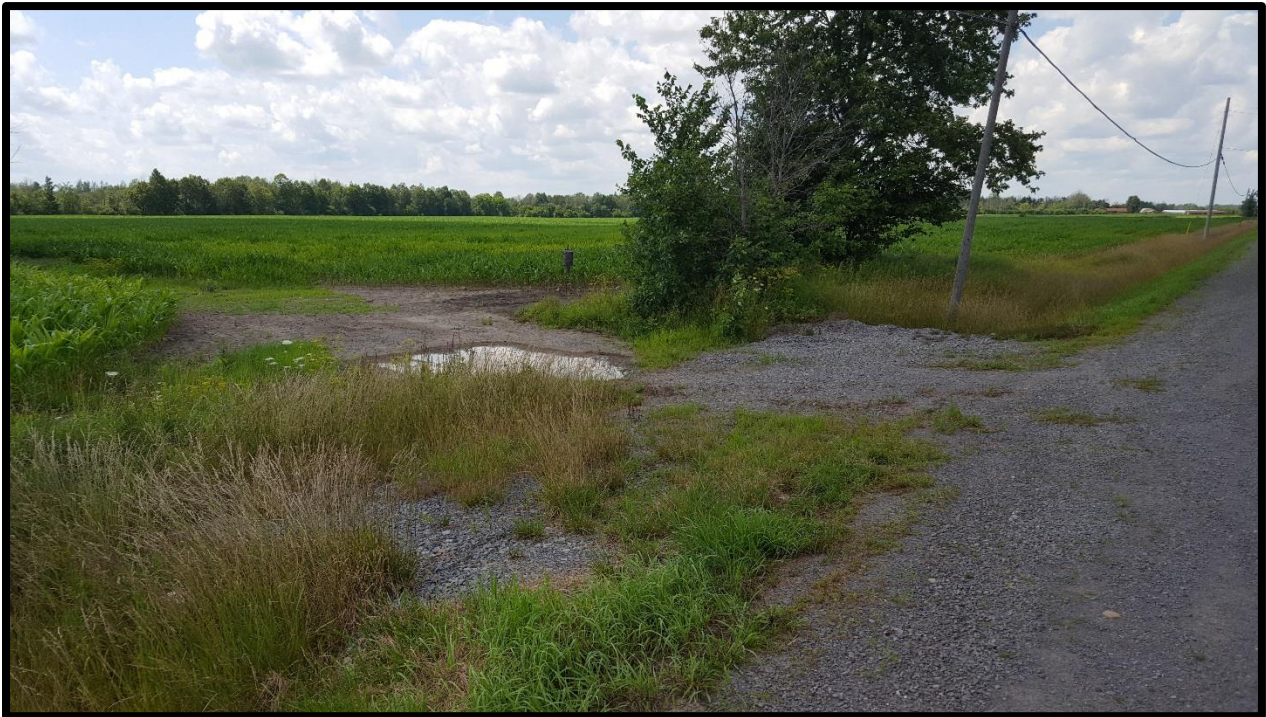
Photograph 4: View of the southeastern most portion of the subject site. Photograph depicts a corn field. Photograph taken facing northwest. No environmental concerns were identified.
