# **Environmental Impact Statement for the Proposed Development of 6012 Ottawa Street Area**

**December 6, 2024**

**Update of January 14, 2020  
Draft Report**

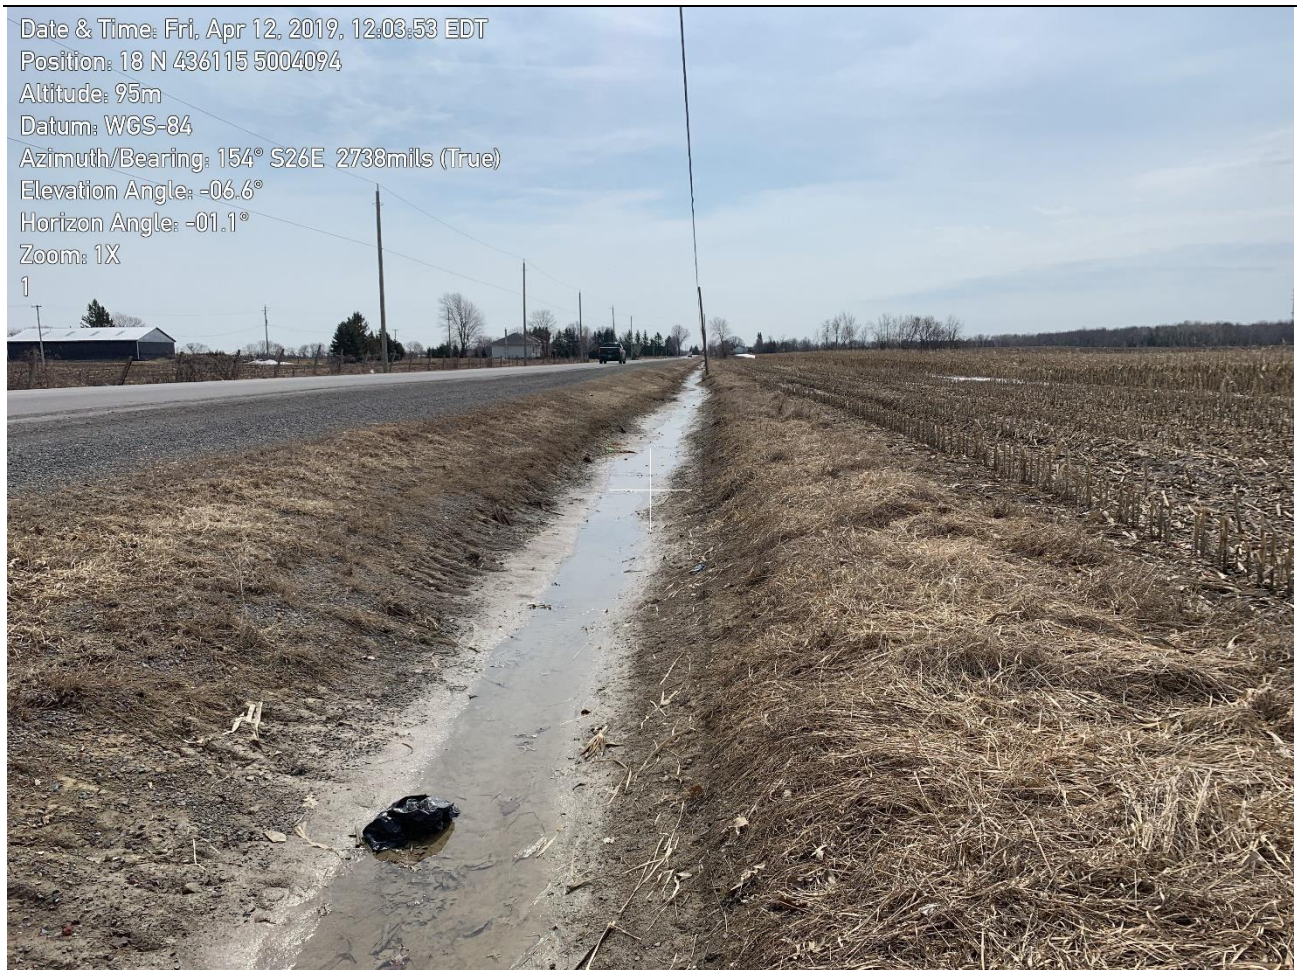
A roadside ditch system stretches along Eagleson Road surrounding the corn field on Site and along Ottawa Street at the northeast corner of the Site. When originally assessed in the spring, there was no flow through most of the ditch length along the property. The water found along most of the ditches consisted of small, disconnected puddles; by late spring they had dried up completely. Only the portion nearest to Reach 1 (see below) held some standing water (i.e., the ditch was presumably draining into Reach 1, but with no detectable flow). The substrate consisted primarily of silt and sand, while the banks had grass along the shoulder of the road. Submergent vegetation was not present. No frogs or turtles were observed in the roadside ditches, but American Toads (*Anaxyrus americanus*), Spring Peepers (*Pseudacris crucifer*), and Green Frogs (*Rana clamitans*) could be heard calling from Marlborough Creek westward from the north end of the ditch down Ottawa Street (i.e., frogs were detected audibly from this ditch but were not observed directly in the ditch).

**Figure 5 Photo showing the roadside ditch along Eagleson Road taken on April 12, 2019**

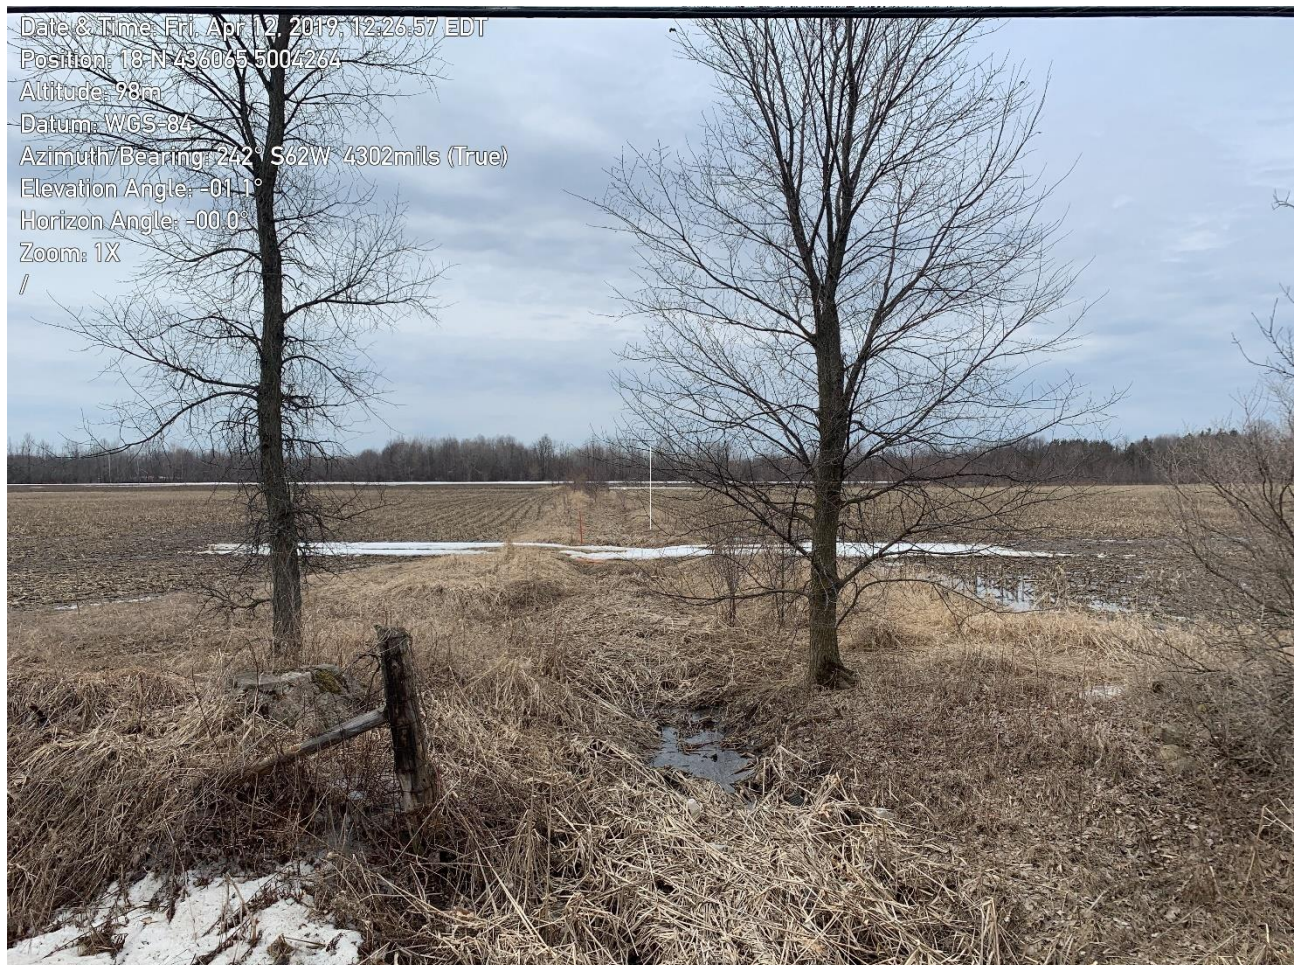
Reach 1 runs 232 m from northeast to southwest of the Site between corn fields, starting at a culvert along the side of Eagleson Road, to a 90° bend northward into Reach 2. There was limited flow here in the initial visits in the early spring, and by mid-spring the area was dry. The feature has corn fields on either side and a few small trees along the banks. The substrate was mostly organic matter and cattails were found in the channel. Instream vegetation is otherwise limited, likely due to the buildup of organic matter. There is grass on either side of the banks, and cropped land (corn) at the edge of the grass. No frogs or turtles were observed in or along this feature.

**Figure 6 Photo showing Reach 1 on Site taken on April 12, 2019**

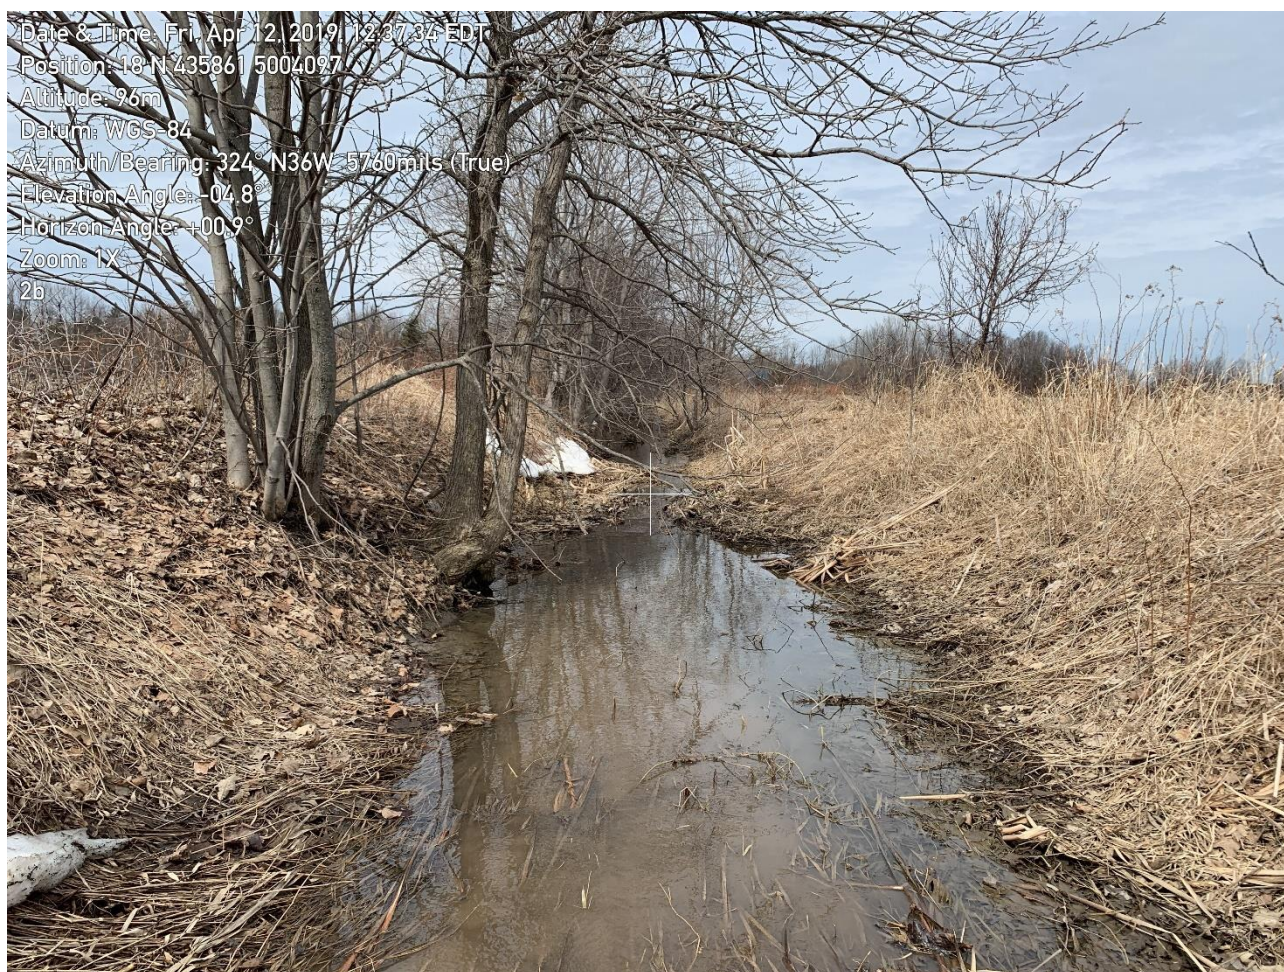
Reach 2 runs 305 m southeast to northwest from the turn at the end of Reach 1 to Marlborough Creek on the northwestern side. The downstream-most end of the channel passes through the wooded riparian corridor of Marlborough Creek but most of the channel is situated between two corn fields. This reach appears to have been constructed as a drainage feature for the adjacent agricultural fields. Early spring flows in Reach 2 were somewhat more evident than in Reach 1, though grass and woody debris maintained pooled areas where flow was not apparent. The substrate consists of mostly organic matter. Like Reach 1, the banks of this feature are lined with grass, but some trees are present and the banks are much more defined. The trees and shrubs adjacent to Reach 2 include Common Buckthorn (*Rhamnus cathartica*), American Elm (*Ulmus americana*), Ash (*Fraxinus*), Willow (*Salix*), Raspberry (*Rubus*), Red Maple (*Acer rubrum*), Cedar (*Thuja*), and Red Osier Dogwood (*Cornus sericea*). This reach still held standing water in late spring (likely retained by minor debris jams) but it was generally very shallow (<5 cm) and there were no fish observed or caught in the channel. It was dry by early summer. No frogs or turtles were observed in this feature.

**Figure 7 Photo showing Reach 2 on Site taken on April 12, 2019**

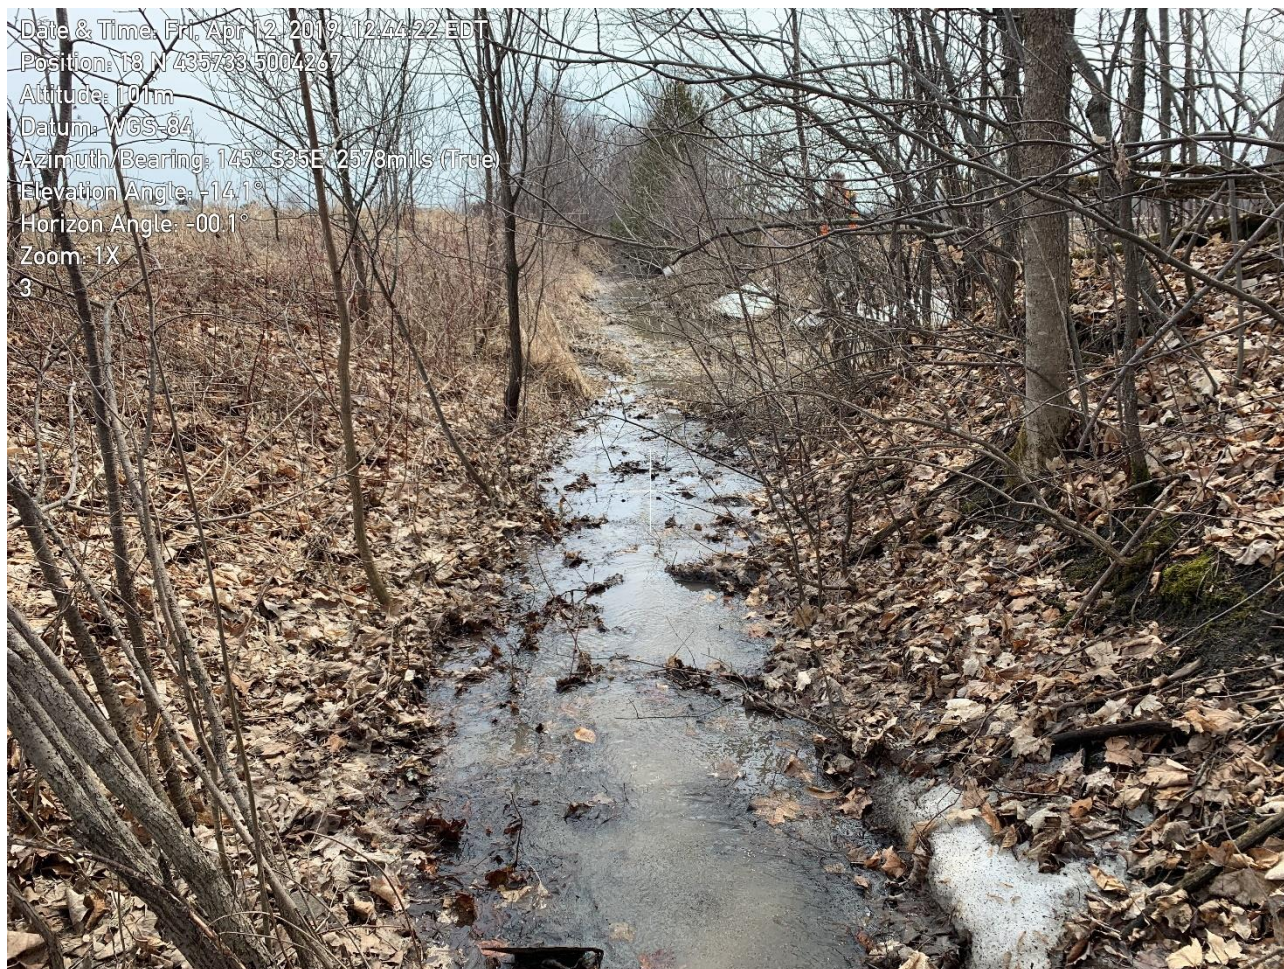
Reach 3 is an 86 m channel along the northwestern edge of the eastern agricultural field. It conveys spring meltwater from the field to Reach 2 but runs dry after that. Consequently, no fish, frogs, or turtles were observed in this reach. There were a few frogs heard calling nearby during evening amphibian surveys, closer to Marlborough Creek. The substrate consisted mainly of organic matter and silt. The banks of this feature are grassy with trees present. These include Poplar (*Populus*), Pine (*Pinus*), and Ash (*Fraxinus*) trees.

**Figure 8 Photo showing Reach 3 on Site taken on April 12, 2019**

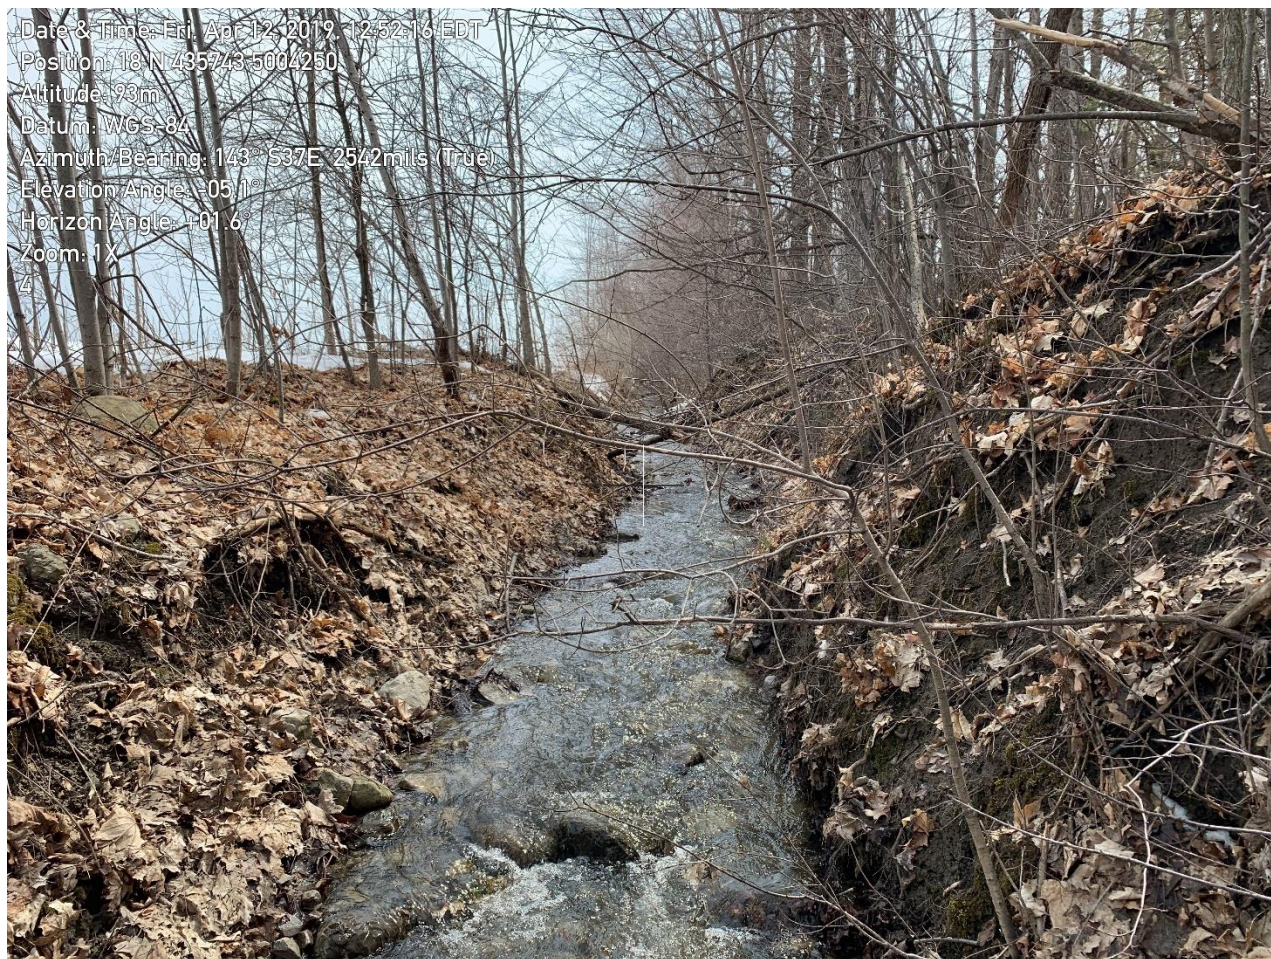
Reach 4 is a linear, U-shaped channel with very well-defined banks and swift springtime flows that extend along the centre of the property, wrapping around to the southern and eastern sides of areas of successional regrowth towards the centre of the southern border of the property. This entire reach spans a distance of 795 m along the edge of active agricultural lands from a tile drain input and into Marlborough Creek. Older air photos suggest this feature previously received surface flows from a swale over the farm fields to the south, but that swale is no longer apparent. The tile drain is the main source of water in this reach. The presence of the tile drain resulted in steady flows through Reach 4 in late spring, and some standing water was still present in early summer. Given the substantial decrease of water depth by early July, and the lack of any apparent seeps, the feature was dry by late summer. This drainage ditch has a layer of cobble/gravel on the substrate. The west bank is lined with trees and continues up into a sparsely wooded area. There are some trees along the east bank, but the edge of the feature is generally contiguous with the adjacent corn/winter wheat fields. The steep banks and heavy flowing water in the spring did not make ideal habitat for turtles directly in the feature and none were noted here, but two Painted Turtles (*Chrysemys picta*) were observed in Marlborough Creek just beyond the end of Reach 4. There were no frogs observed in the area during any of the three evening frog surveys.

**Figure 9 Photo showing Reach 4 on Site taken on April 12, 2019**

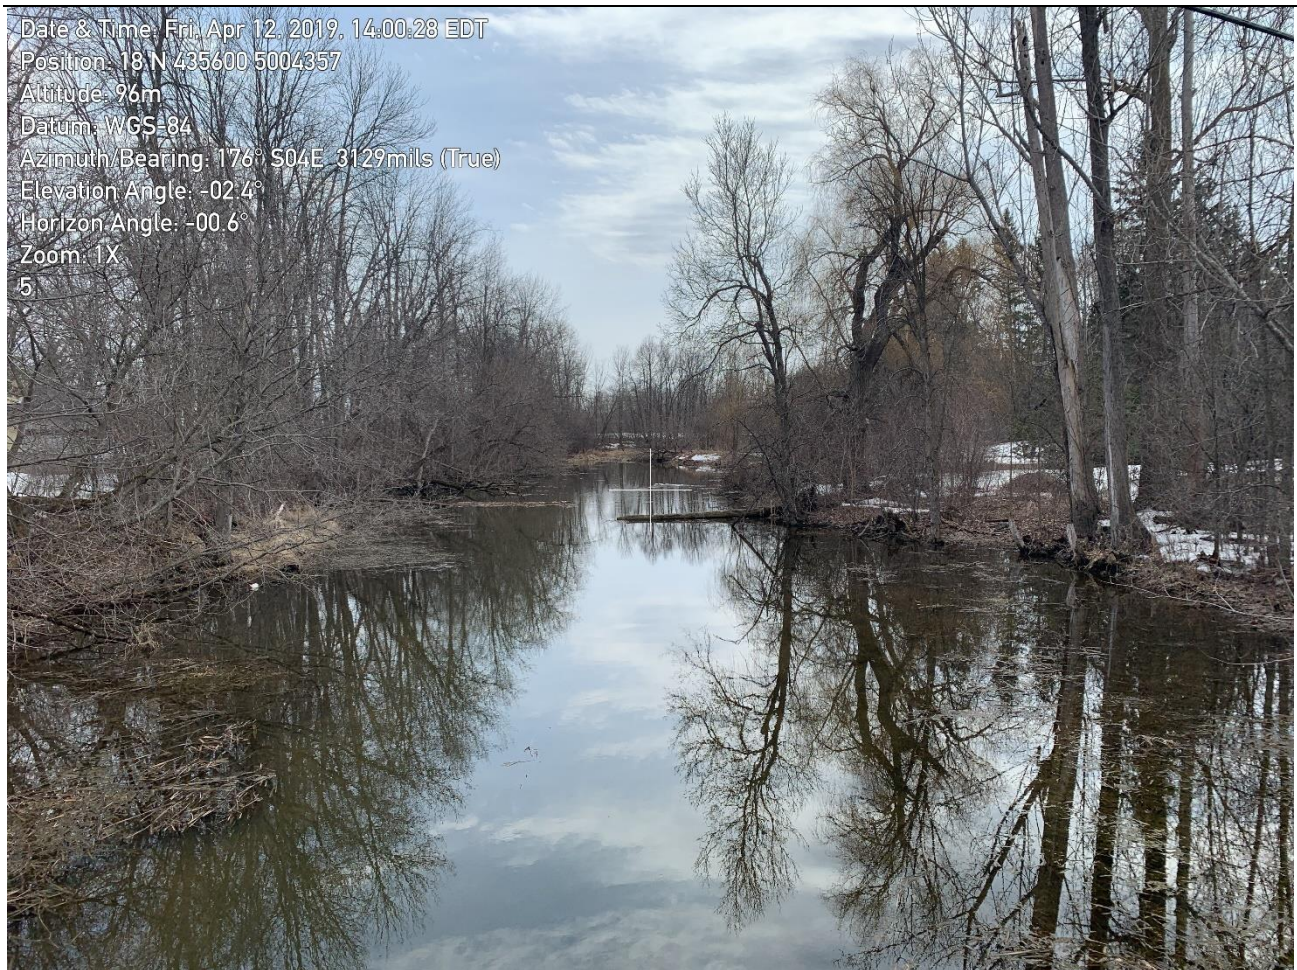
Marlborough Creek, an important tributary of the Jock River with the confluence located immediately downstream of Eagleson Road, flows along the northern edge of the property. The permanent creek has fast and heavy spring flows and maintains a wetted width often over 15 m, even in mid-summer. According to the most recent Jock River Subwatershed Report by RVCA (2016), there were minimal anthropogenic alterations observed along the system, and 80% of Marlborough Creek remains “unaltered” with no anthropogenic alterations. The remaining 20% of Marlborough Creek was classified as natural with minor anthropogenic changes.

**Figure 10 Photo showing Marlborough Creek on Site taken on April 12, 2019**
