February 26, 2021

**Re: Meander Belt Width Assessment
Marlborough Creek
City of Ottawa, Ontario
GEO Morphix Project No. 21012**

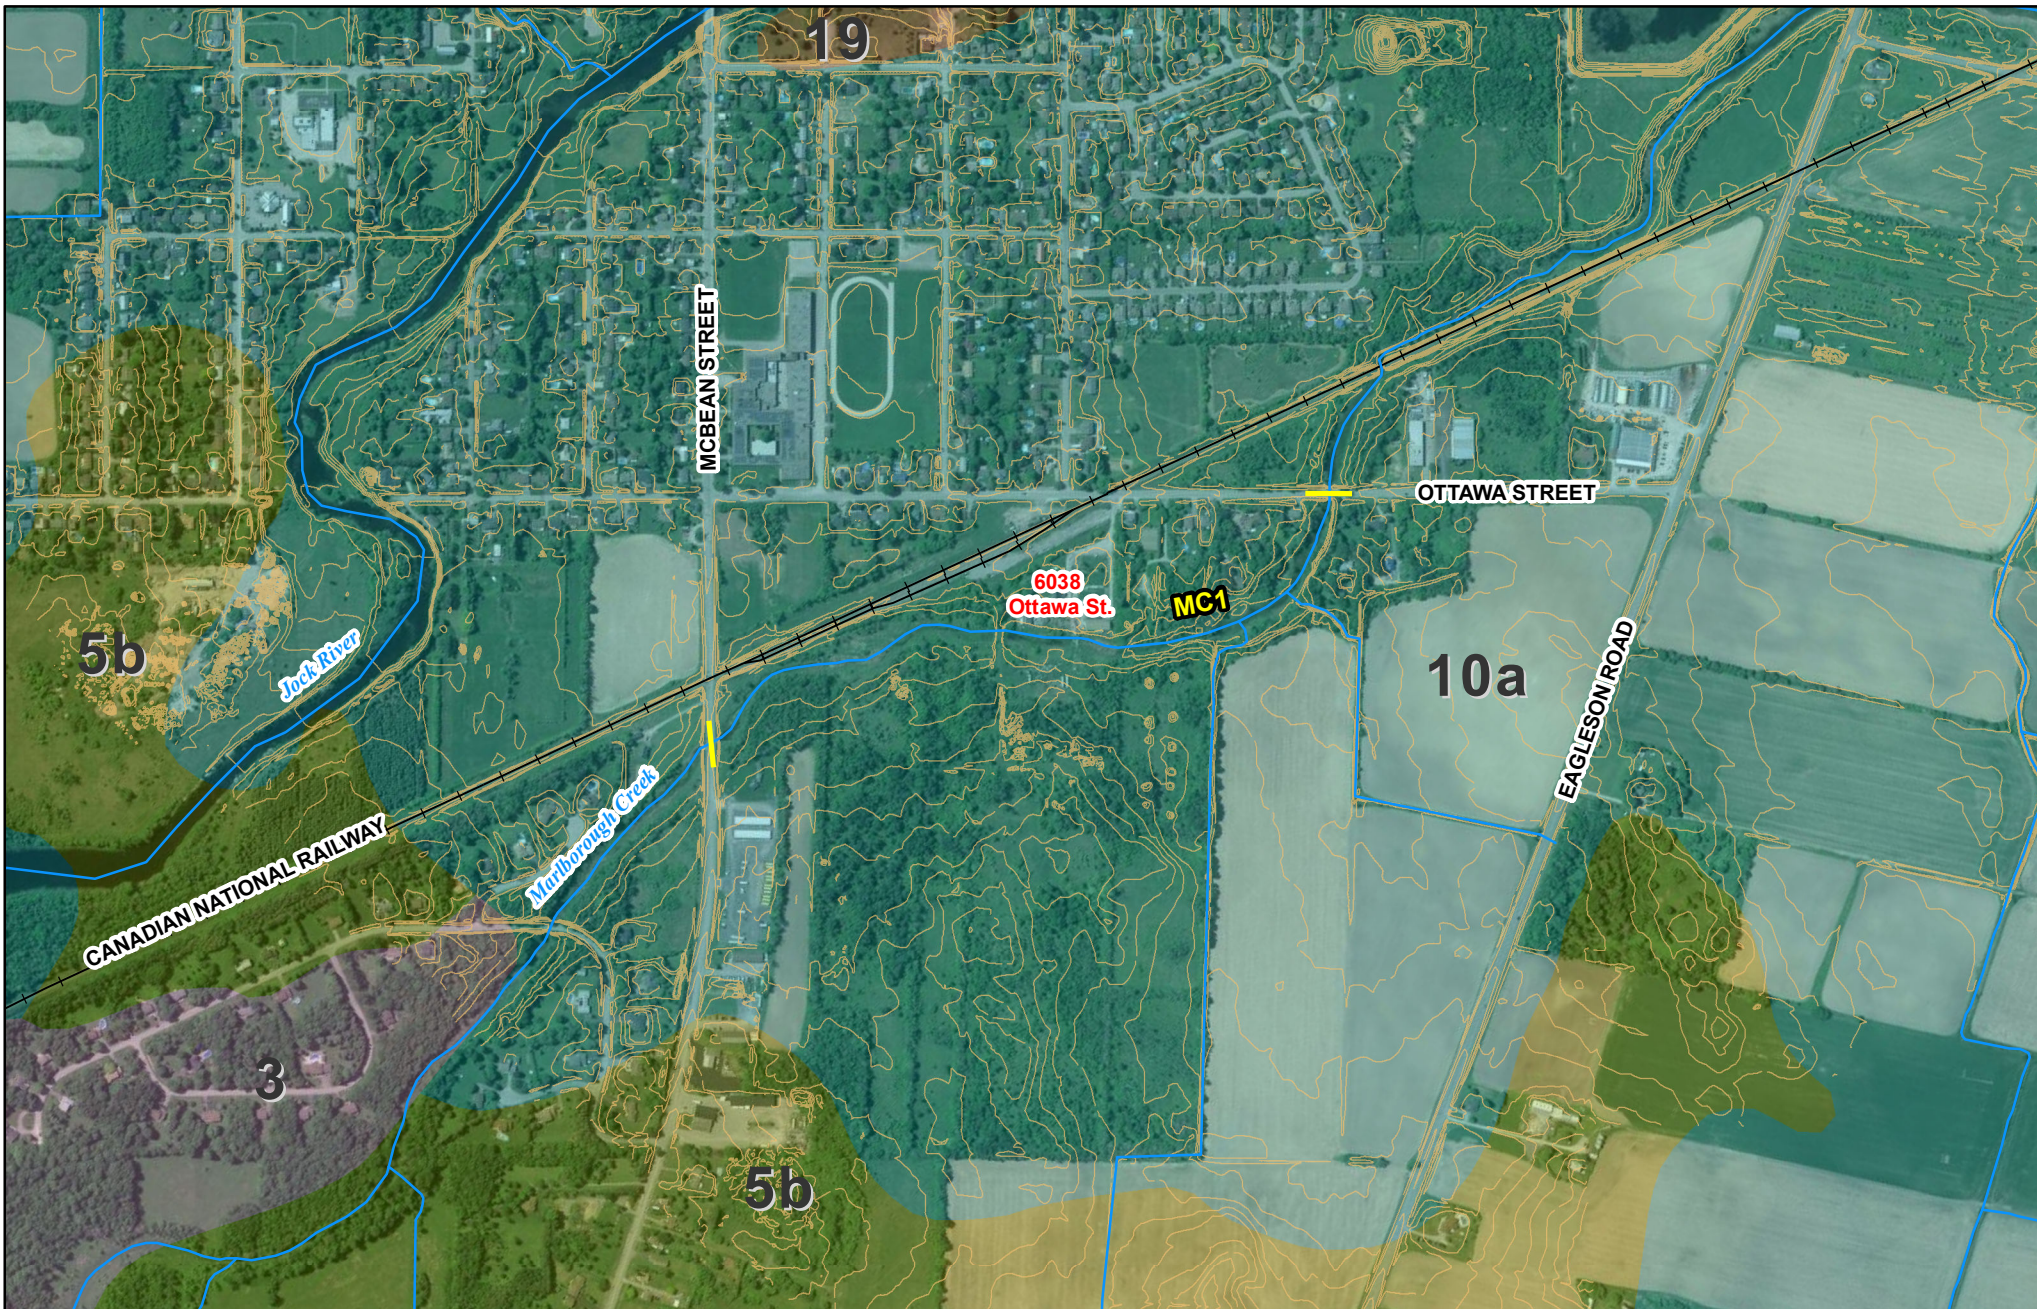
Surficial Geology

Within the subject property, Marlborough Creek is dominated by the Clay Plains physiographic region of Ontario (Chapman and Putnam, 2007). In terms of surficial geology, the subject lands are characterized by fine-textured glaciomarine deposits (OGS, 2010). Soils within these areas include silt and clay, minor sand, and gravel (OGS, 2010). Upstream, Marlborough Creek flows through lands characterized by Paleozoic bedrock and till (OGS, 2010). Local surficial geology is represented in **Appendix A**. Bedrock exposures are identified downstream from the subject property, and given the channel cuts through local geology, it is likely that bedrock exposures exist within the bed of the channel as well. The surficial geology associated with Marlborough Creek largely contributes to its planform and stability over time.

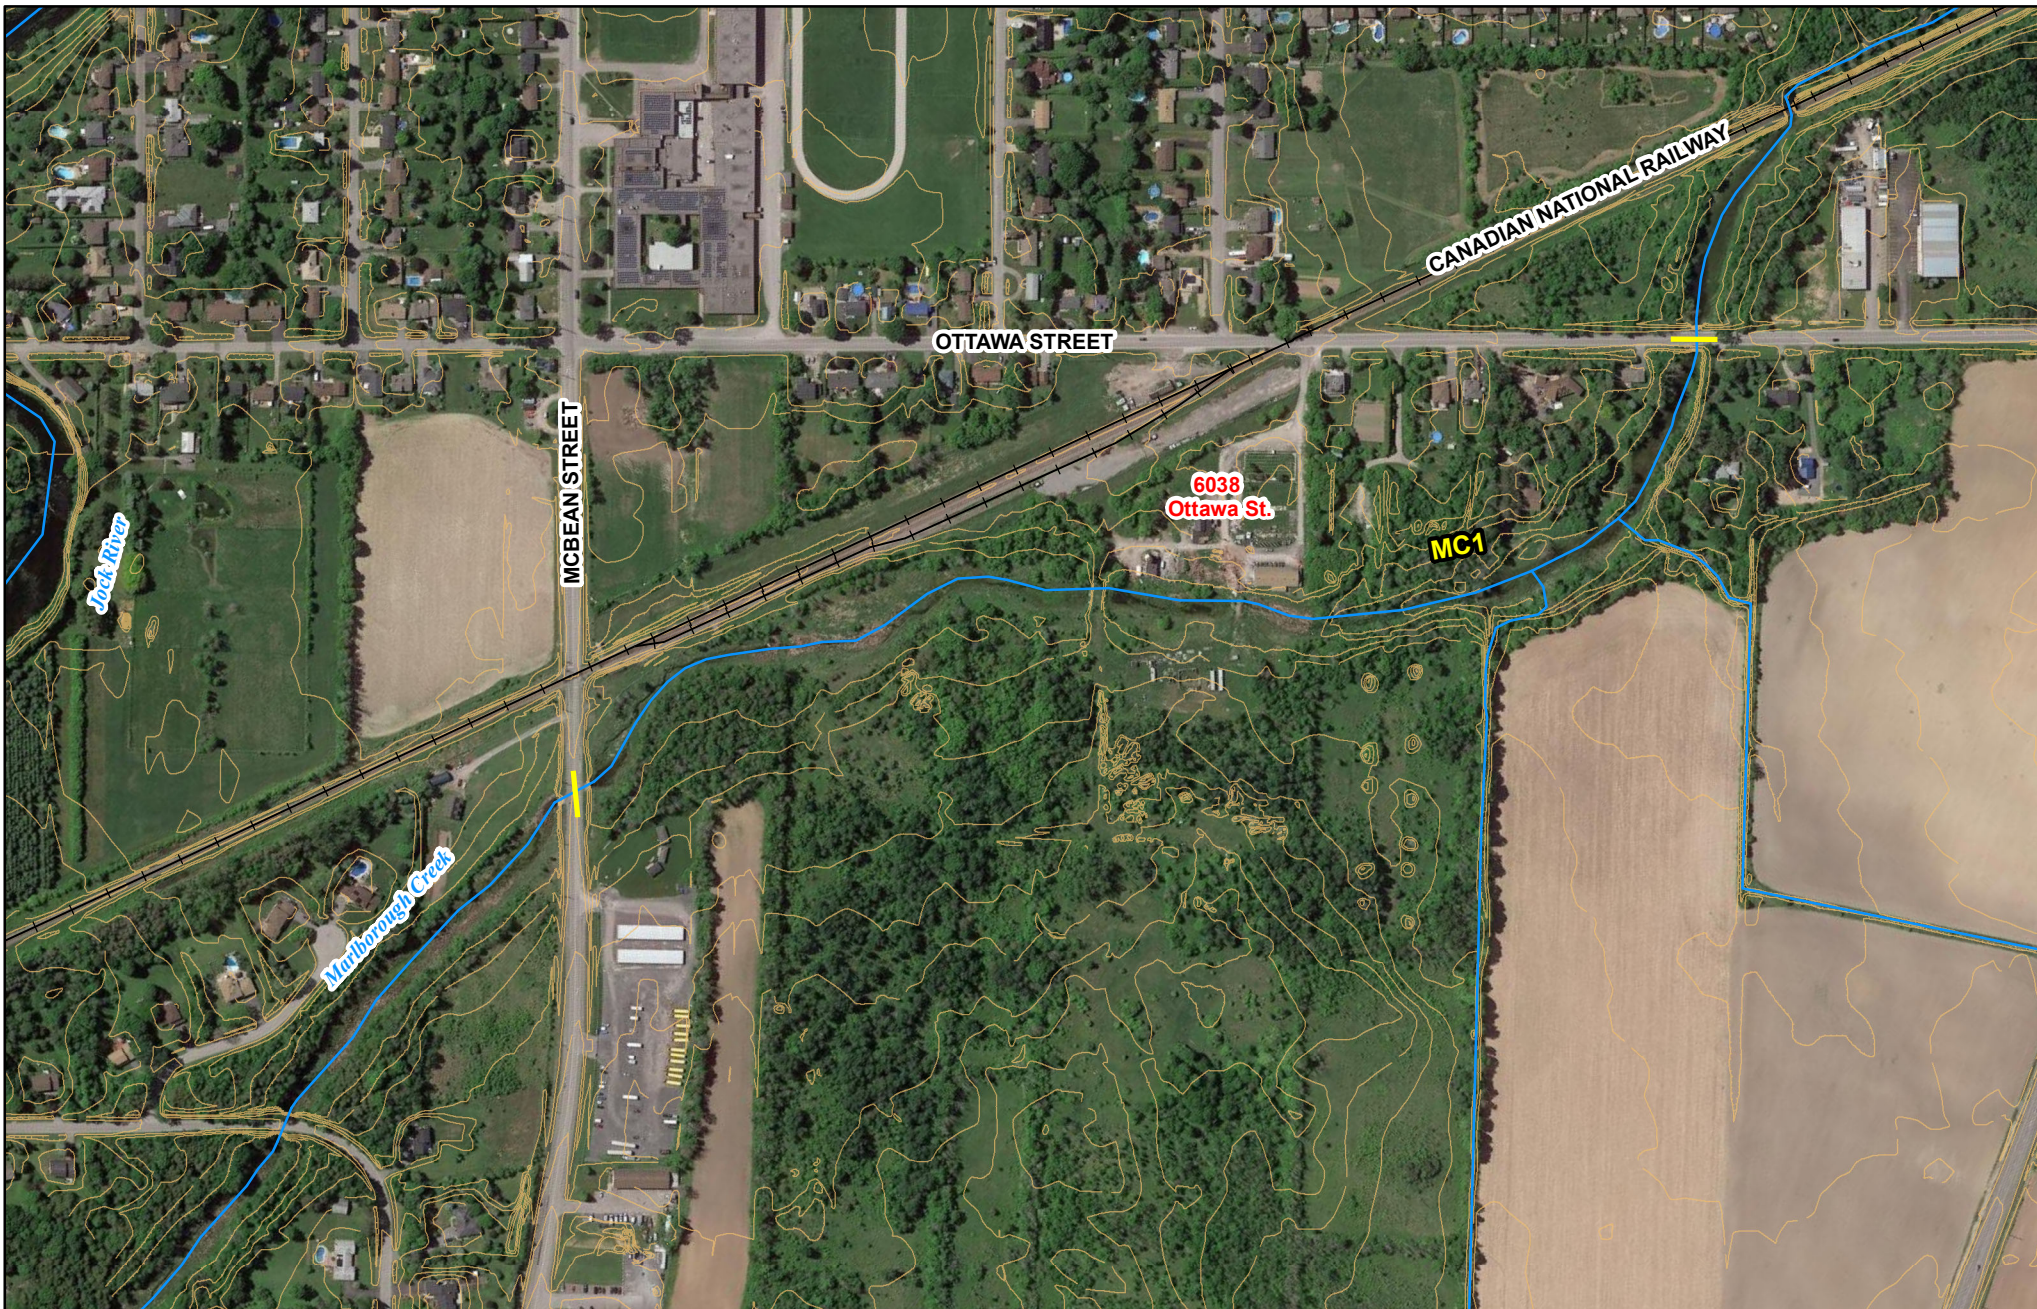
Study Site

Reach delineation follows scientifically defensible methodology proposed by Montgomery and Buffington (1997), Richards et al. (1997), and the Toronto and Region Conservation Authority (2004) as well as others. Based on a desktop assessment, there was limited change in channel geometry, planform, or riparian cover associated with Marlborough Creek within the subject property (between McBean Street and Ottawa Street). Additionally, there were no significant tributaries contributing flows to the system. As such, one (1) singular reach was delineated as **MC1**. It is important to note that there may be sub-reaches within **MC1**, which will be confirmed during field verification. Reach delineation is graphically defined in **Appendix B**.

Marlborough Creek flows through an unconfined valley system within the northwestern extent of the subject property and was delineated into one (1) reach for the purpose of a fluvial geomorphological assessment and meander belt width delineation. Due to seasonal conditions, a complete field investigation was not included. Rather, these preliminary findings are based on a desktop analysis of available information and a brief site visit. To confirm reach delineation and existing site conditions, finalize the geomorphic assessment, and inform the most suitable location for a stormwater outfall to accommodate stormwater management facilities, field reconnaissance will be completed in spring 2021.

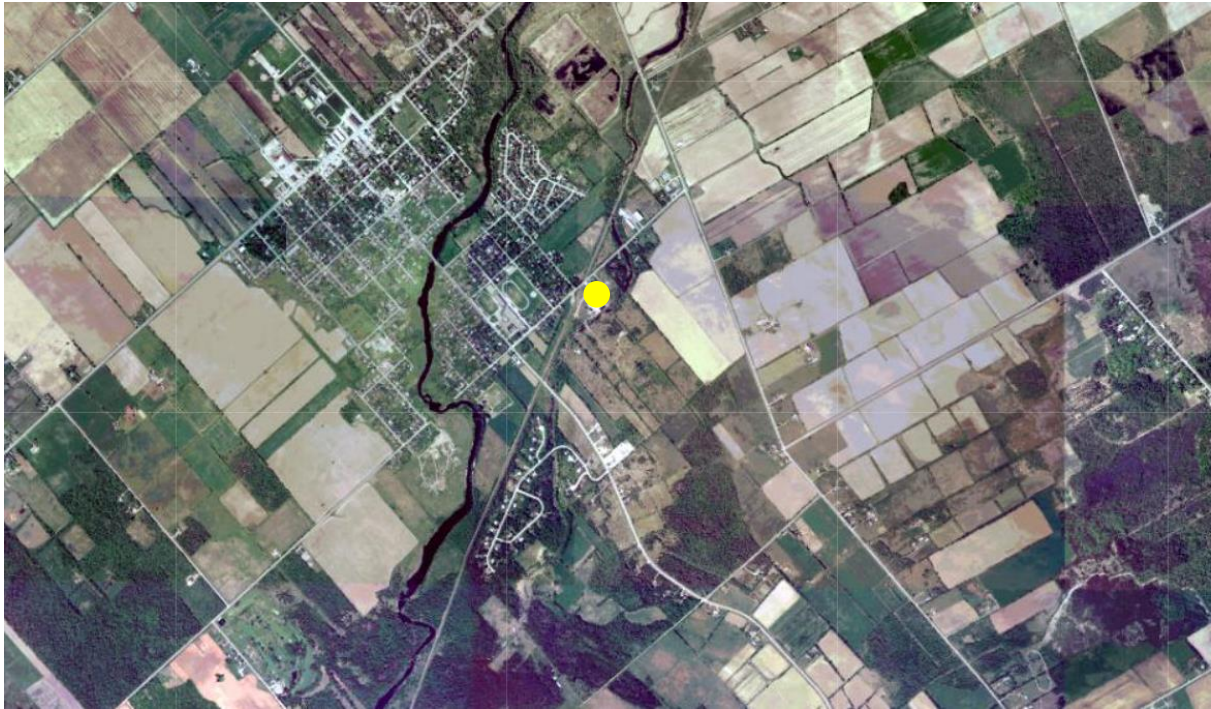
Location: 6038 Ottawa Street, Ottawa (Richmond), ON (yellow dot)
Year: 1999
Source: City of Ottawa

There were no changes in land use or channel planform by 1999. However, the development of geomorphic units and the fluctuation in channel geometry moving downstream became more evident. Particularly through the downstream extent of Marlborough Creek within the subject property, channel geometry was consistently widened. This may have been attributed to the time of year the photograph was taken (i.e., following snowmelt or a high rainfall event). The riparian buffer was more established through the system, with very few banks exposed with limited vegetation.

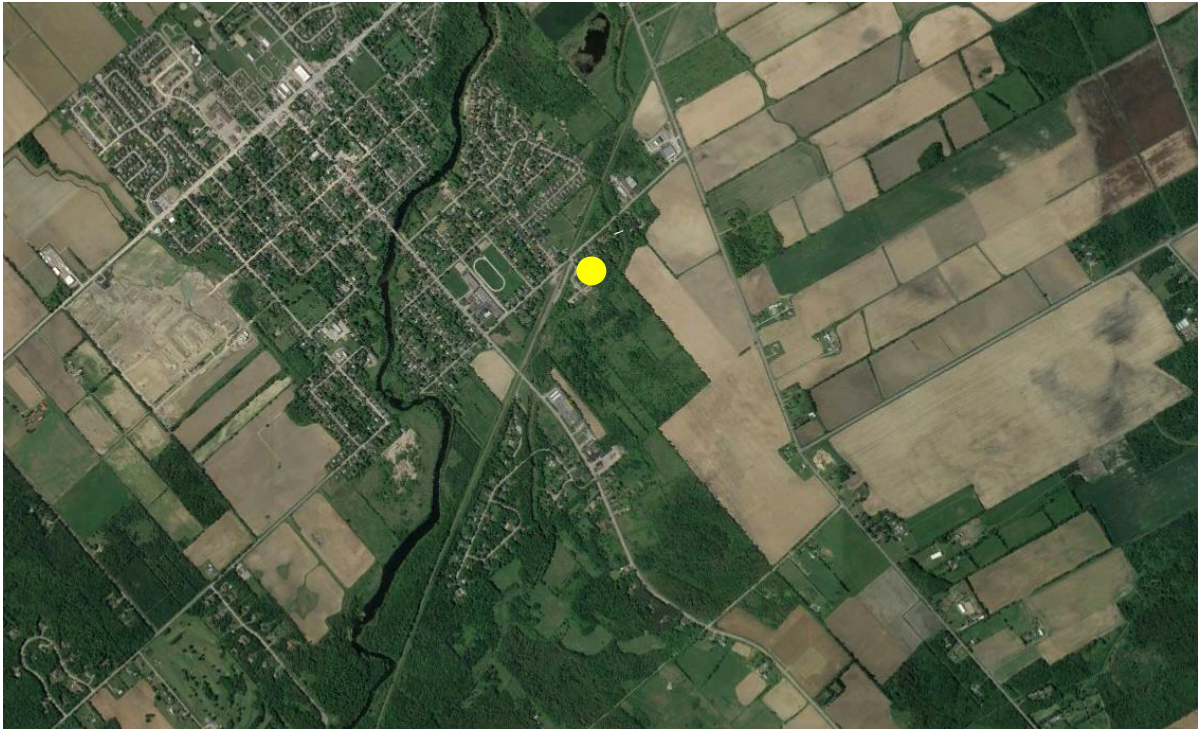
Location: 6038 Ottawa Street, Ottawa (Richmond), ON (yellow dot)
Year: 2017
Source: Google Earth Pro

In 2017, a similar sized crossing was constructed approximately 90 m downstream from the existing bridge. There were no changes in land use or channel planform, and riparian vegetation was more established. The sequence of geomorphic units (i.e., riffles and pools) was less defined, however, this may be due to the time of year the photograph was taken (summer).
