**Emerald Creek Phase 3 –  
Headwater Drainage Features  
Assessment**

FINAL REPORT

May 16, 2022

8298025 Canada Inc.

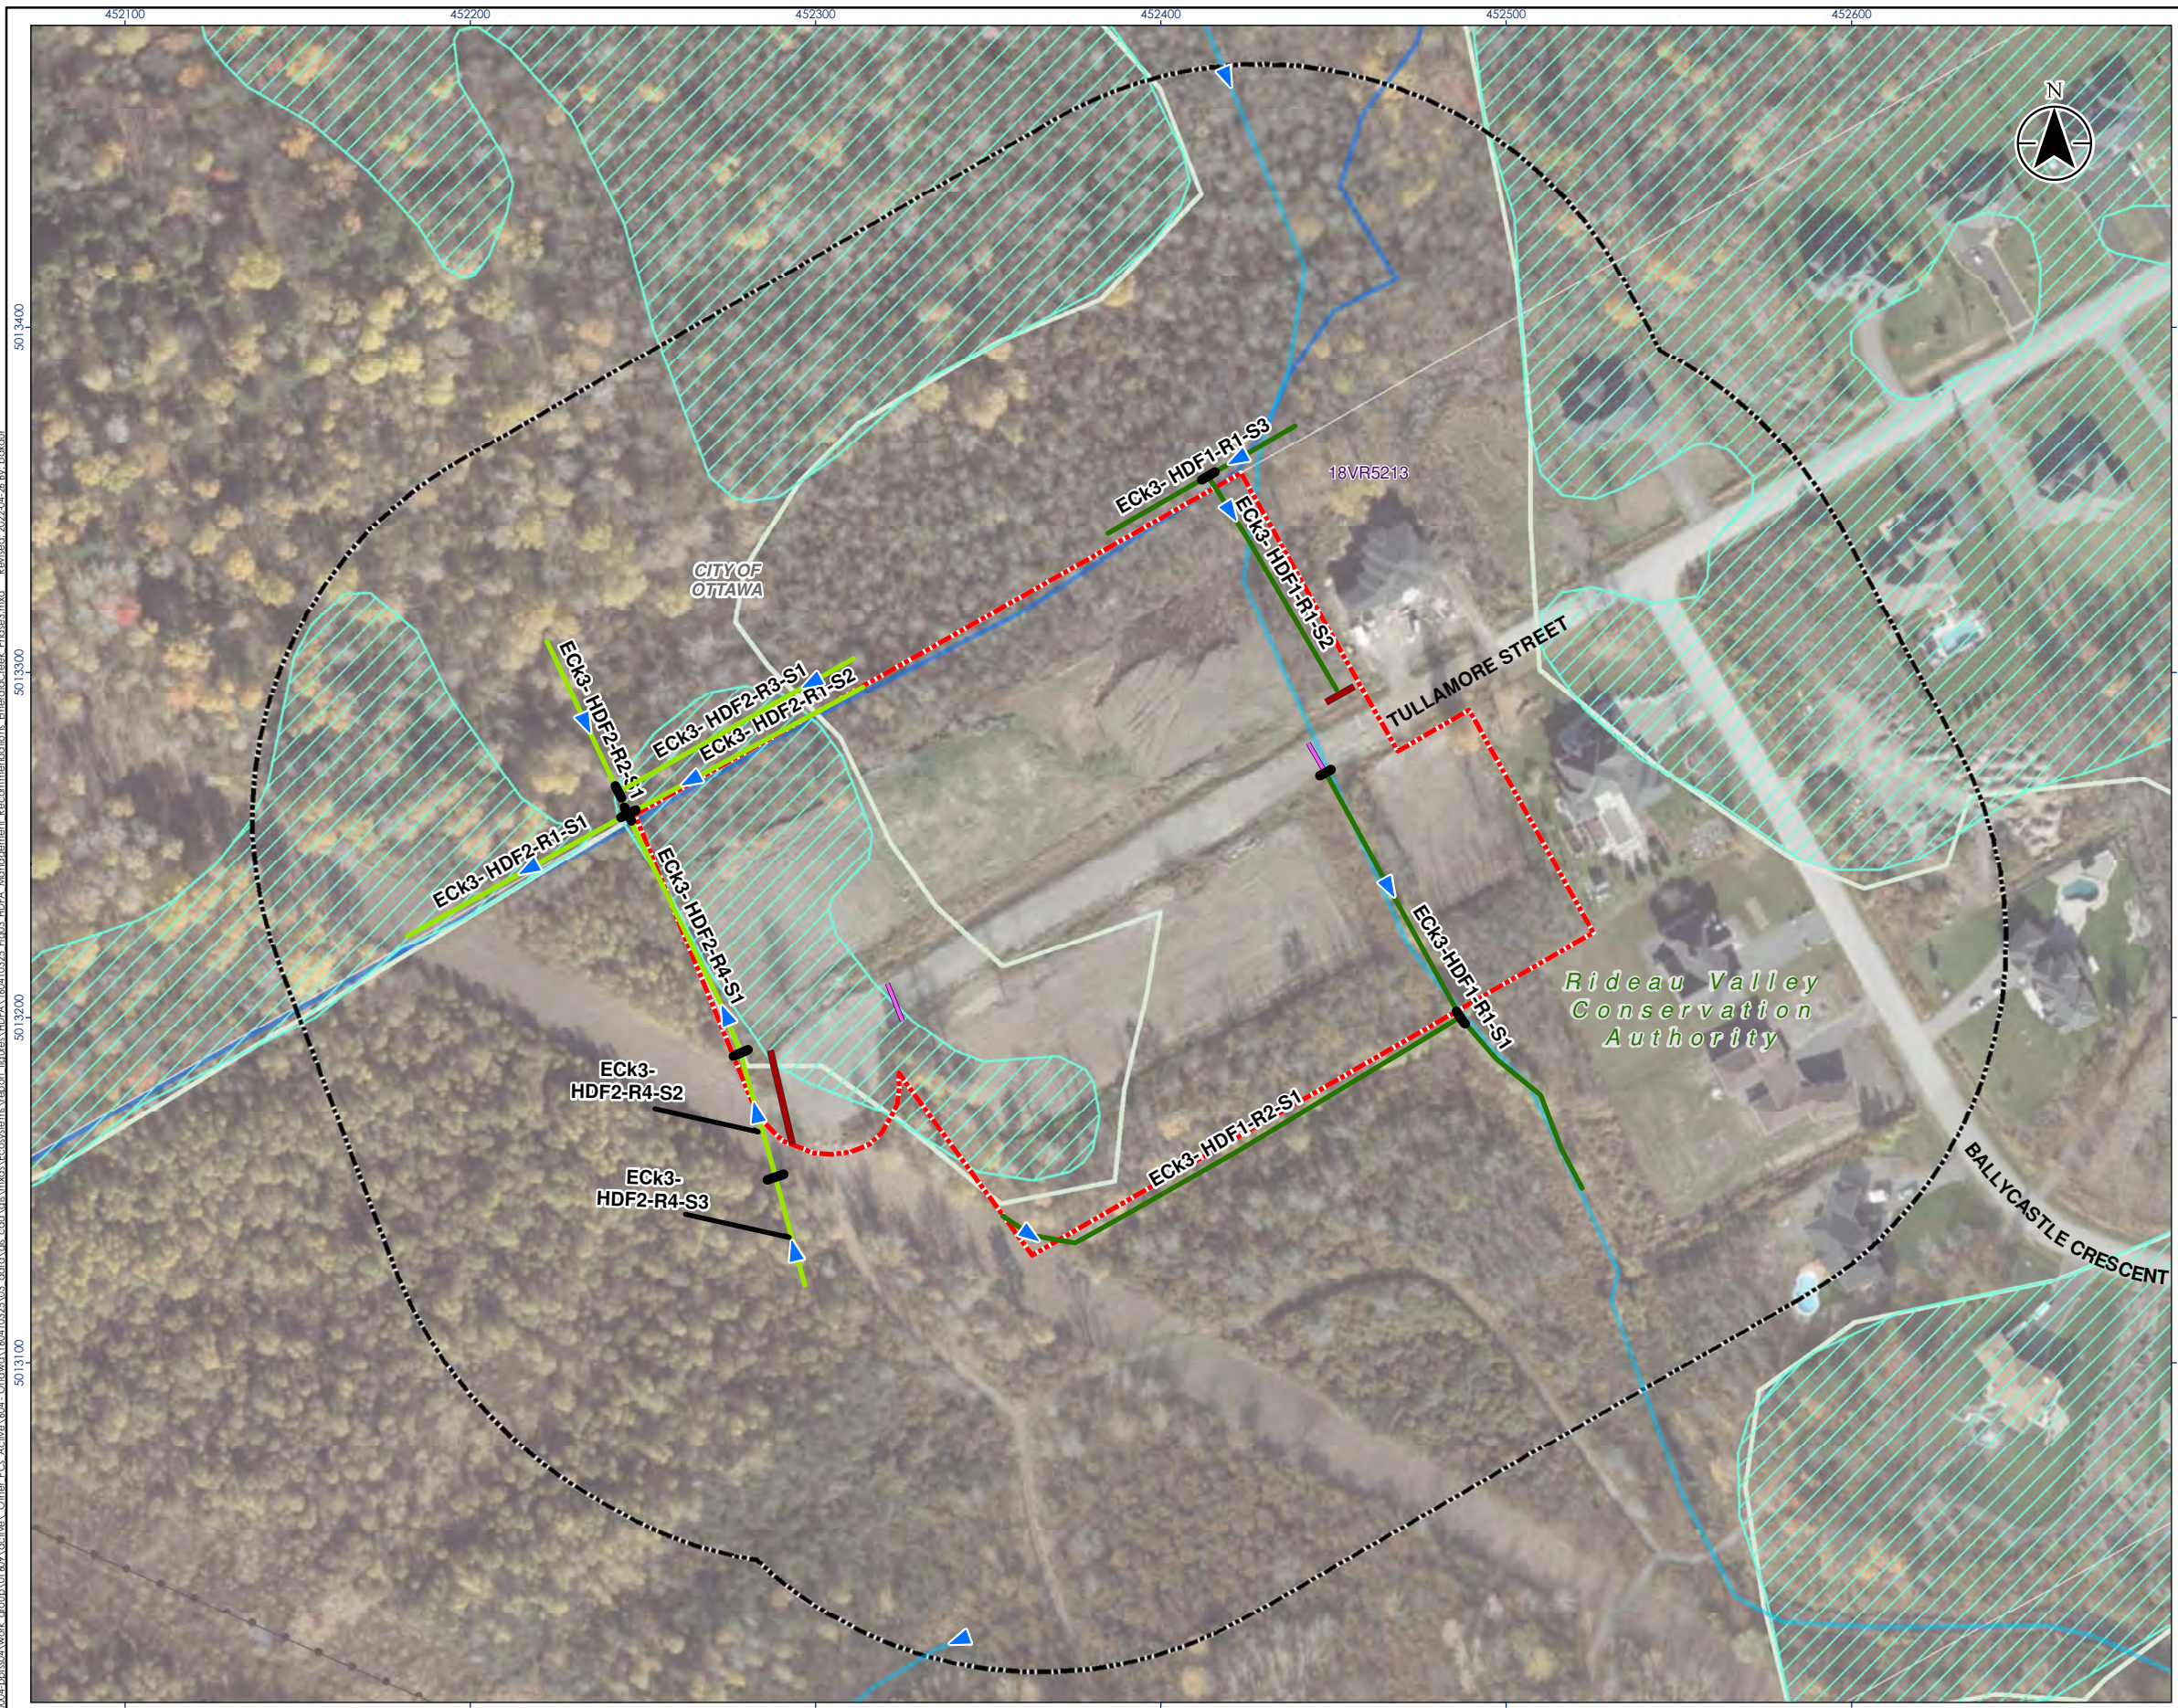
Figure No. **3**  
 Title: **Headwater Drainage Feature Management Recommendations**

This section compiles the information collected during Stantec’s 2021 reach characteristic and evaluation phase to classify hydrological, riparian, fish and fish habitat and terrestrial components to recommend management decisions for each feature or reach. As outlined in the Guidelines, management recommendations are based on flow characteristics and functions contributing to aquatic and terrestrial habitats (Table 4.1). The classification and management recommendation of each reach within the Site are summarized below in Table 4.2 and shown on Figure 3, Appendix A.

According to the Guidelines, all of the headwater drainage feature reaches on, and immediately adjacent to, the Site are considered to receive Protection or Conservation as a management recommendation.

Management recommendations for the Protection and Conservation of the functions of each reach should be considered and implemented through the subsequent design stages of the Project. One of the primary considerations to retain the function of all headwater drainage features on the Site should be to maintain downstream flows to the Spratt Creek municipal drain.

Where **Table 4.2** recommends Protection of a reach, the following measures from the Guidelines should be considered and incorporated into the design of the Project:

Where **Table 4.2** recommends Conservation of a reach, the following measures from the Guidelines should be considered and incorporated into the design of the Project:

- Maintain, relocate and/or enhance feature including the riparian vegetation surrounding the feature
- If upstream catchment area is proposed to be removed for development, restore lost functions through enhanced lot level controls (i.e., increase infiltration using permeable pavers), as feasible
- Maintain or replace flows using mitigation measures
- Maintain or replace external flows
- Use natural channel design techniques to maintain or enhance overall productivity of the reach

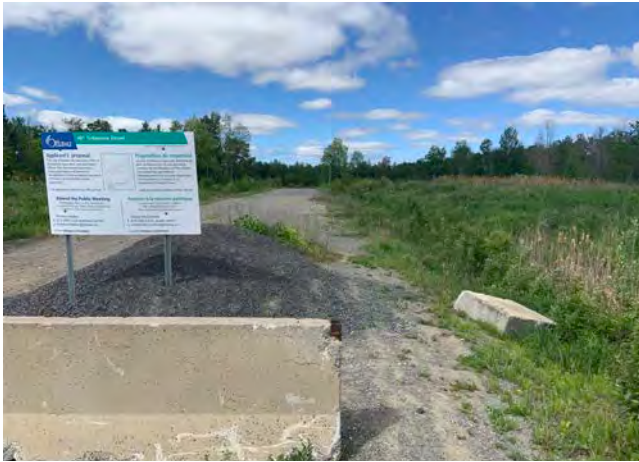
**Photo 1:** Existing conditions within the Site along the Tullamore Street extension (May 27). Looking west from the eastern Site boundary.

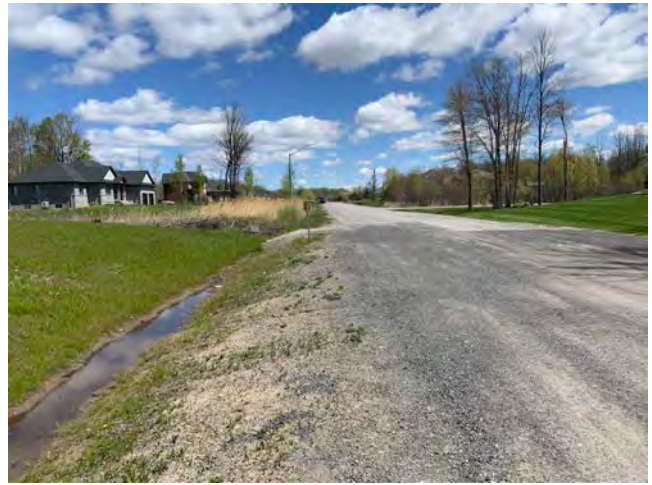
**Photo 2:** Existing conditions observed within the existing Emerald Creek subdivision along Tullamore Street immediately east of the Site (May 6).

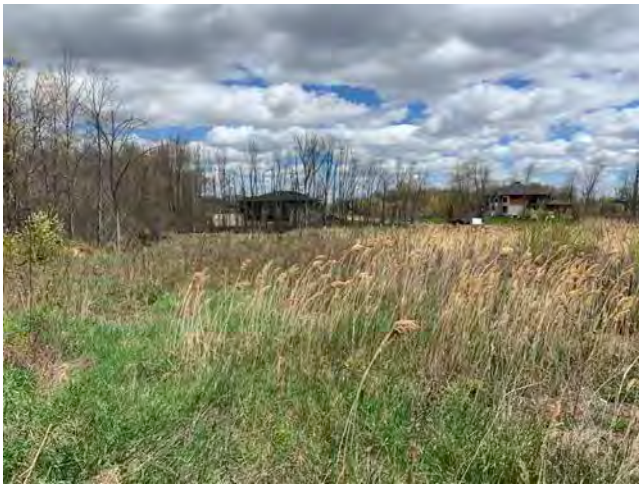
**Photo 3:** Existing conditions within the previously cleared areas of the Site north of Tullamore Street (May 6). Looking east.

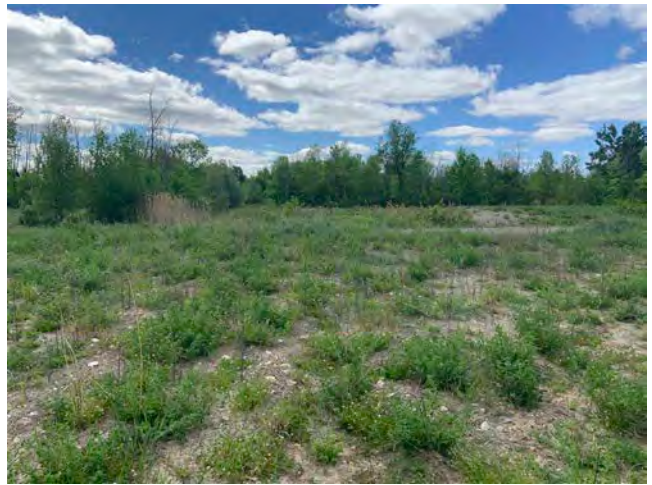
**Photo 4:** Existing conditions within the previously cleared areas of the Site south of Tullamore Street (May 27). Looking north.

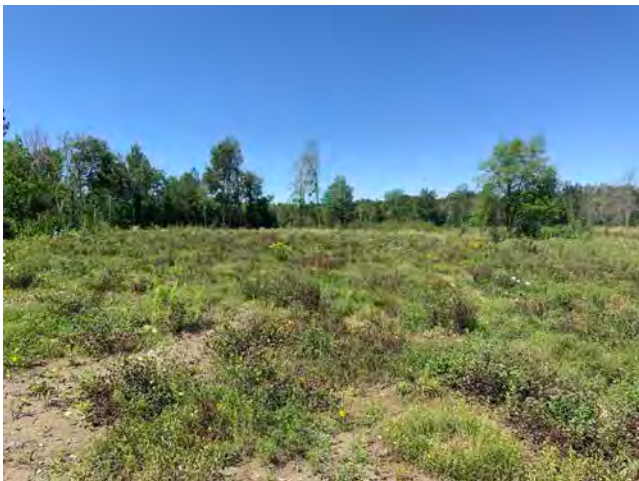
**Photo 5:** Existing conditions within the previously cleared areas of the Site south of Tullamore Street (July 30). Looking west.

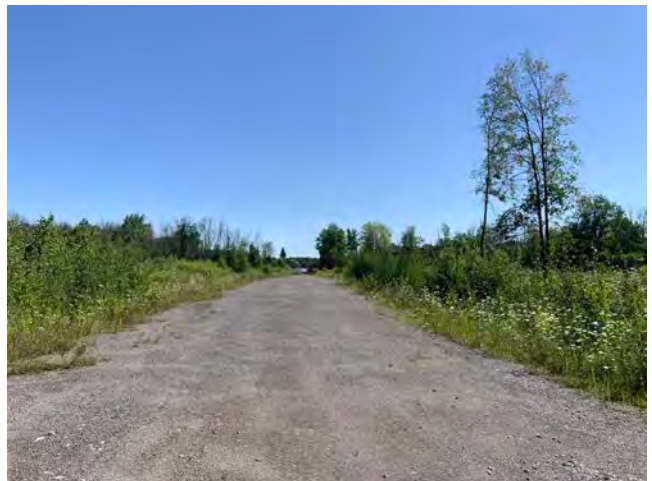
**Photo 6:** Existing conditions within the Site along the Tullamore Street extension (July 30). Looking east from the western Site boundary.

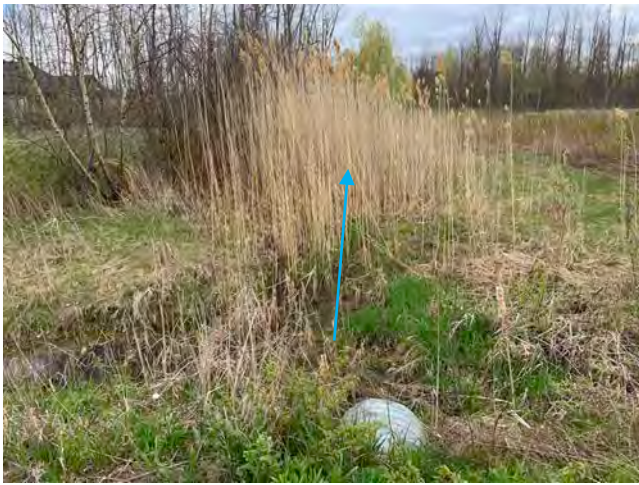
**Photo 7:** Existing conditions of Eck3-HDF1-R1-S1 looking south from the Tullamore Street extension (May 6).

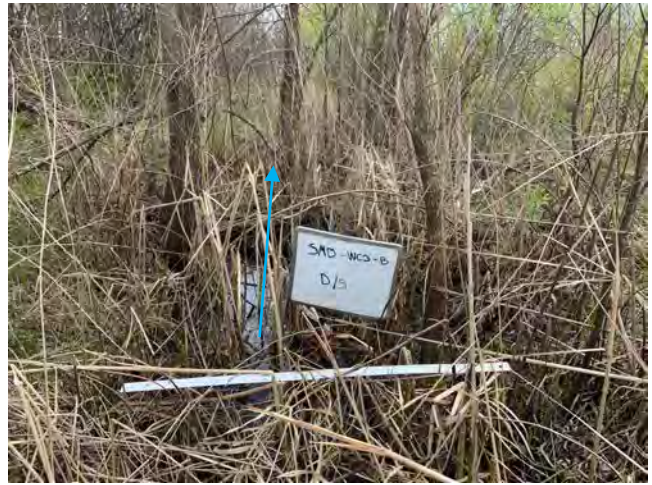
Headwater Drainage Feature Reach	Length Assessed (m)	Feature Type					Channel Dimensions		Early May 2021 Hydrology			Late May 2021 Hydrology			July 2021 Hydrology			Riparian Vegetation						Terrestrial Habitat			Fish Habitat				Headwater Drainage Feature Description		
		Defined Natural Channel	Channelized	No Defined Feature	Swale	Tiled Drainage	Wetland	Feature Width (m)	Bankfull Depth (m)	Water Present (Y/N)	Depth (mm)	Flow (Y/N)	Water Present (Y/N)	Depth (mm)	Flow (Y/N)	Water Present (Y/N)	Depth (mm)	Flow (Y/N)	None	Lawn	Cropped Land	Meadow	Scrubland	Forest	Wetland	Breeding Amphib. Wetlands	General Amphib. Habitat	Movement Corridors	No Habitat	Year Round		Seasonal	Contributing
Eck3-HDF1-R1-S1	82	-	✓	-	-	-	2.0	3.0	Y	16	Y	N	n/a	N	N	n/a	N	-	-	-	✓	✓	-	-	-	-	-	✓	-	-	-	✓	This channelized section is located south of the proposed Tullamore Street extension and flows south. It is not connected to Eck3-HDF1-R1-S2 via a culvert under Tullamore Street and is currently receiving flows from the existing roadside ditch south of Tullamore Street and Eck3-HDF1-R2-S1 during periods of high precipitation. The feature was observed to provide seasonal hydrology to downstream areas and may provide seasonal fish habitat, provided barriers to fish are not present further downstream. This section of the HDF is mapped by the NHIC (NDMNR 2021a), LIO (NDMNR 2021b), RVCA (2021) and OMAFRA (2020) and is also shown as a Ditch by geoOttawa (2020) (Photos 7 – 11, Appendix C).

**Photo 8:** Existing conditions observed within the middle of Eck3-HDF1-R1-S1 (May 6). Looking south and downstream.

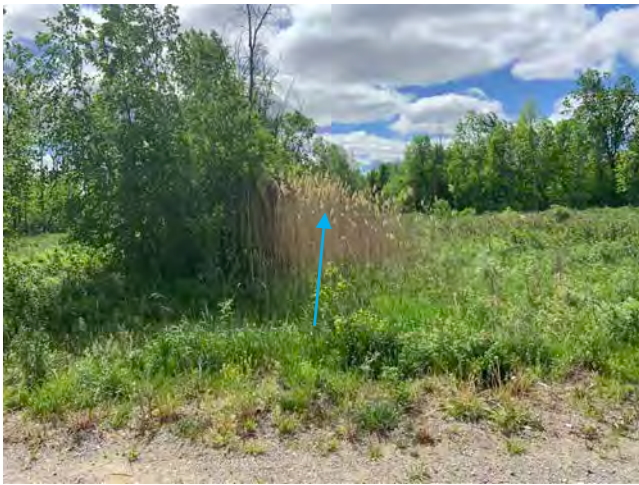
**Photo 9:** Existing conditions of Eck3-HDF1-R1-S1 looking south from the Tullamore Street extension (May 27).

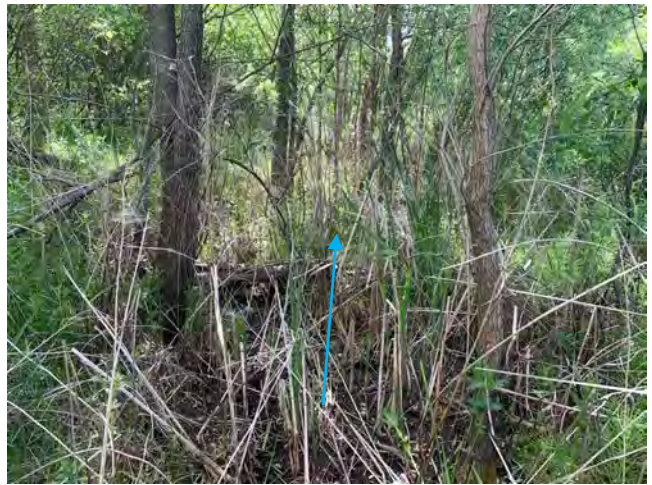
**Photo 10:** Existing conditions observed within the middle of Eck3-HDF1-R1-S1 (May 27). Looking south and downstream.

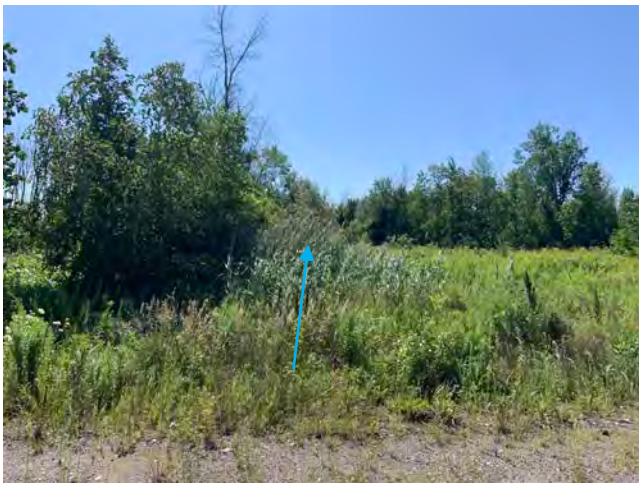
**Photo 11:** Existing conditions of Eck3-HDF1-R1-S1 looking south from the Tullamore Street extension (July 30).

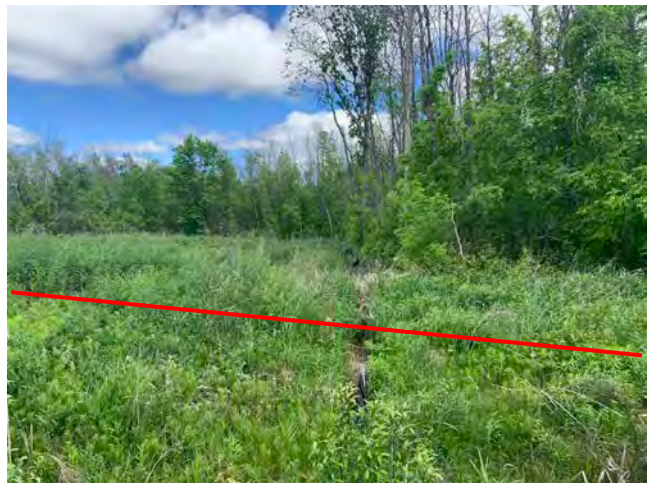
This isolated, wetland section is located north of the proposed Tullamore Street extension and flows south. The feature is located within the limits of the geoOttawa (2020) mapped unevaluated wetland. It is not connected to Eck3-HDF1-R1-S1 via a culvert under Tullamore Street and is currently receiving flows from Eck3-HDF1-R1-S3 and the unevaluated wetland north of the feature. This feature does not have a defined channel and was observed to be hydrologically connected to the unevaluated wetland, therefore, the amount of water in the feature is directly related to the seasonal water level of the wetland. The feature is not considered to provide fish habitat. This section of the HDF is mapped by the NHIC (NDMNRF 2021a), LIO (NDMNRF 2021b), RVCA (2021) and OMAFRA (2020) but is not shown by geoOttawa (2020) (Photos 12 – 17, 19, 22 Appendix C).

**Photo 12:** Looking towards Eck3-HDF1-R1-S2 north from the Tullamore Street extension (May 27). Note earthen berm (red line) isolates this reach from Eck3-HDF1-R1-S1 south of Tullamore Street.

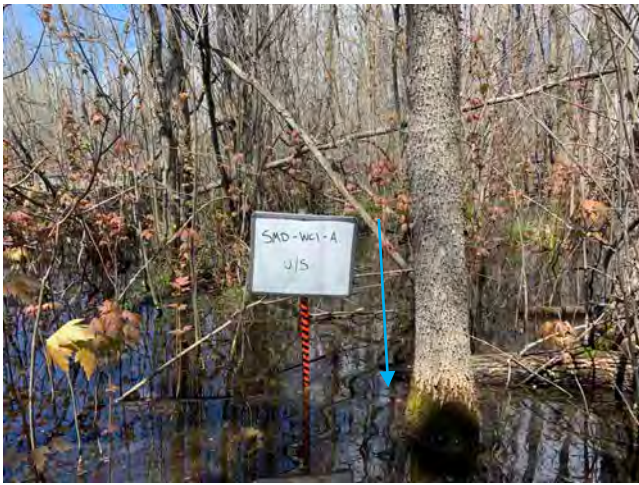
**Photo 13:** Existing conditions observed within the middle of ECK3-HDF1-R1-S2 (May 6). Looking north and upstream.

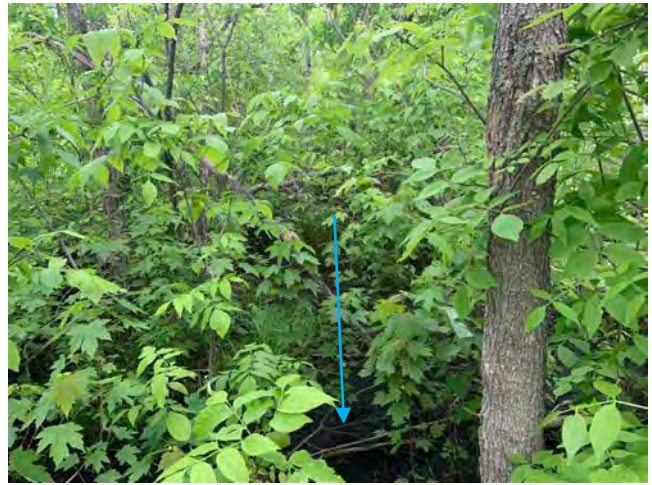
**Photo 14:** Existing conditions observed within the middle of ECK3-HDF1-R1-S2 (May 27). Looking north and upstream.

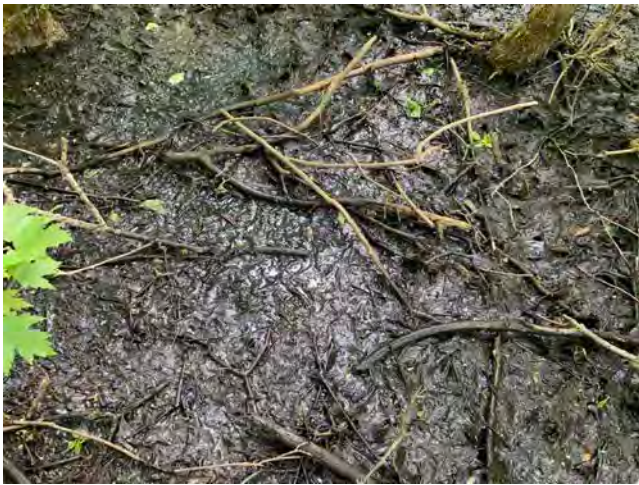
**Photo 15:** Water and substrate conditions observed within ECK3-HDF1-R1-S2 (May 27).

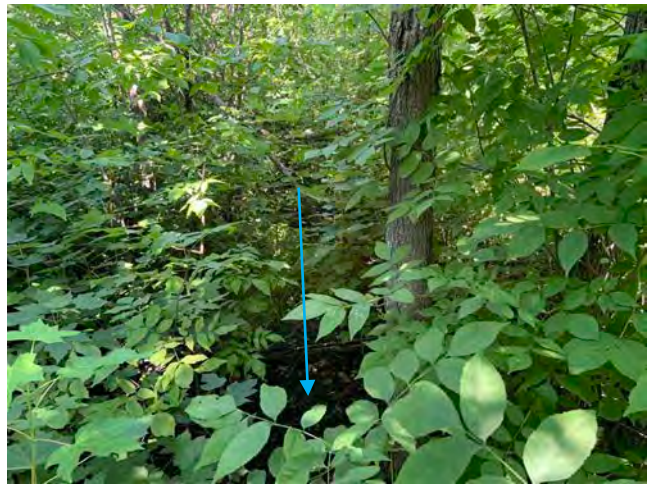
**Photo 16:** Existing conditions observed within the middle of ECK3-HDF1-R1-S2 (July 30). Looking north and upstream.

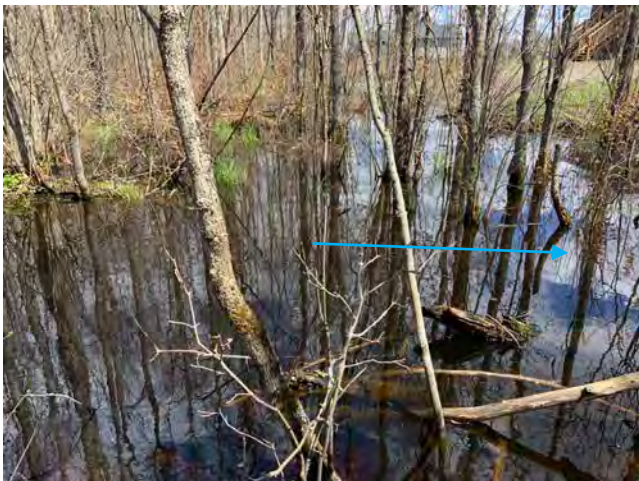
**Photo 17:** Existing conditions at the confluence of ECK3-HDF1-R1-S2 and ECK3-HDF1-R1-S3 (May 6). Looking east.

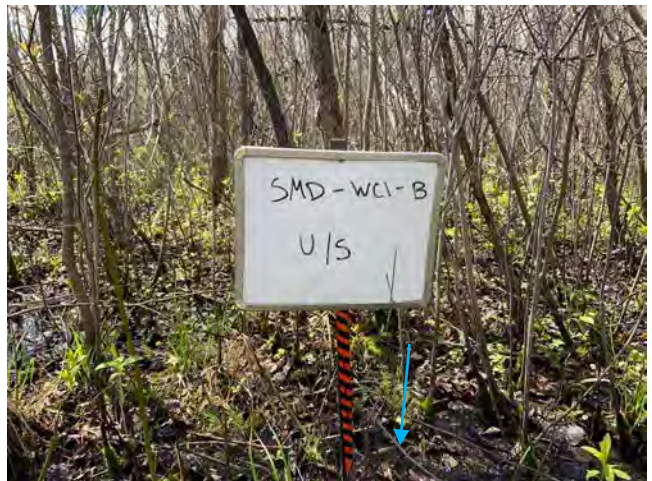
**Photo 18:** Existing conditions observed within the middle of ECK3-HDF1-R1-S3 west of ECK3-HDF1-R1-S2 (May 6). Looking west and upstream.

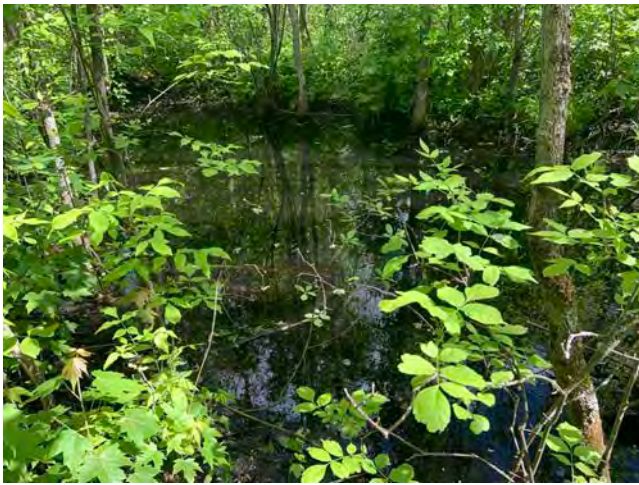
**Photo 19:** Existing conditions at the confluence of ECK3-HDF1-R1-S2 and ECK3-HDF1-R1-S3 (May 27). Looking northeast.

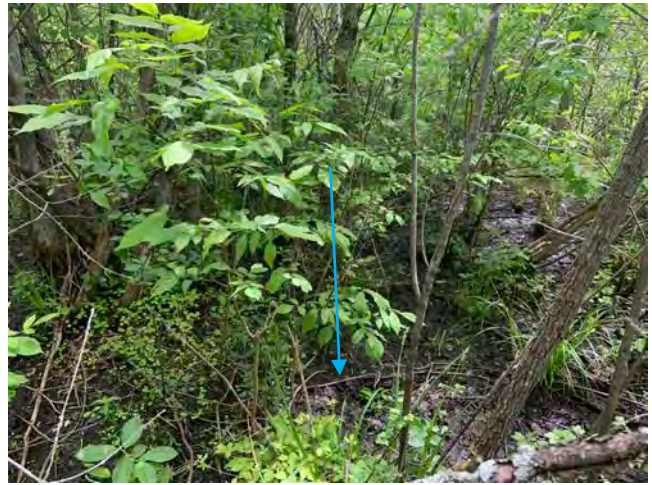
**Photo 20:** Existing conditions observed within the middle of ECK3-HDF1-R1-S3 west of ECK3-HDF1-R1-S2 (May 27). Looking west and upstream.

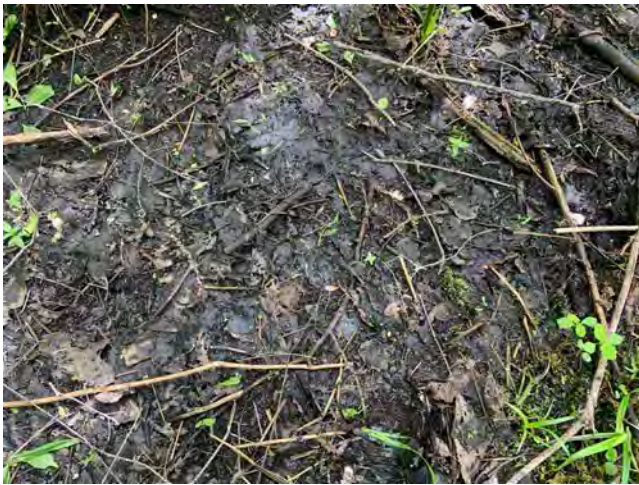
**Photo 21:** Water and substrate conditions observed within ECK3-HDF1-R1-S3 (May 27).

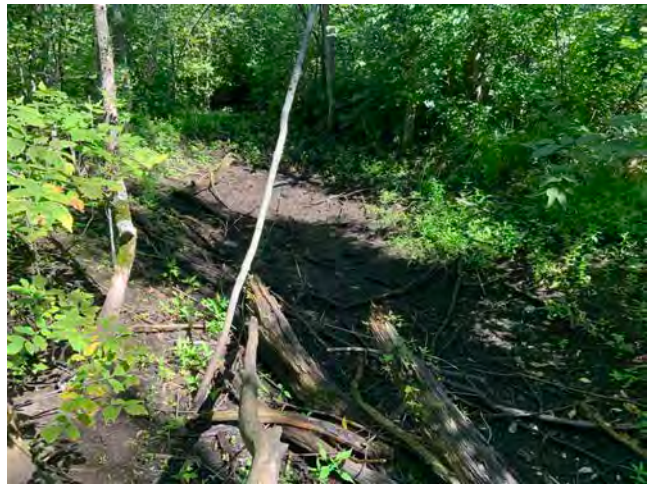
**Photo 22:** Existing conditions at the confluence of ECK3-HDF1-R1-S2 and ECK3-HDF1-R1-S3 (July 30). Looking northeast.

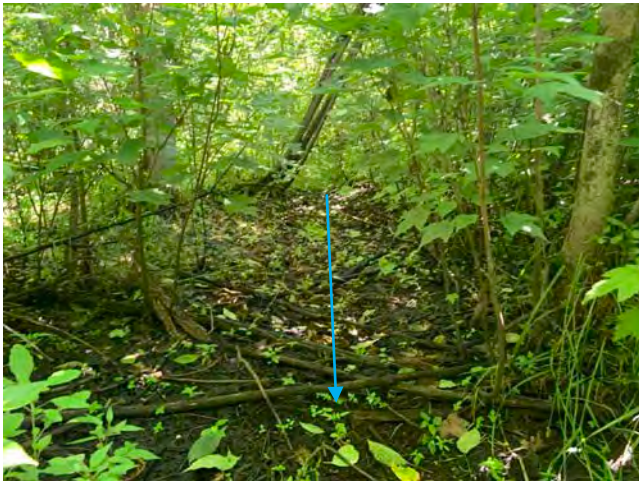
**Photo 23:** Existing conditions observed within the middle of ECK3-HDF1-R1-S3 west of ECK3-HDF1-R1-S2 (May 27). Looking west and upstream.

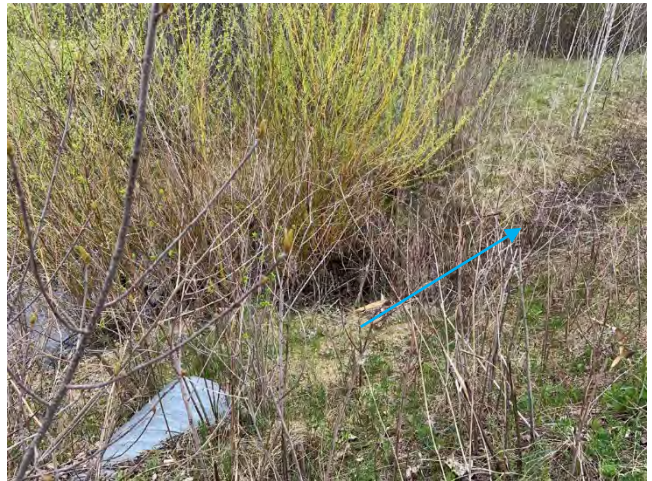
Headwater Drainage Feature Reach	Length Assessed (m)	Feature Type						Channel Dimensions		Early May 2021 Hydrology			Late May 2021 Hydrology			July 2021 Hydrology			Riparian Vegetation							Terrestrial Habitat			Fish Habitat				Headwater Drainage Feature Description	
		Defined Natural Channel	Channelized	No Defined Feature	Swale	Tiled Drainage	Wetland	Feature Width (m)	Bankfull Depth (m)	Water Present (Y/N)	Depth (mm)	Flow (Y/N)	Water Present (Y/N)	Depth (mm)	Flow (Y/N)	Water Present (Y/N)	Depth (mm)	Flow (Y/N)	None	Lawn	Cropped Land	Meadow	Scrubland	Forest	Wetland	Breeding Amphib. Wetlands	General Amphib. Habitat	Movement Corridors	No Habitat	Year Round	Seasonal	Contributing		
Eck3-HDF1-R2-S1	215	-	✓	-	-	-	-	1.0	0.1	Y	90	Y	N	n/a	N	N	n/a	N	-	-	-	✓	✓	-	-	-	-	-	✓	-	-	-	✓	This channelized feature observed along the southern boundary of the Site provides flows from the western area of the Site into Eck3-HDF1-R1-S1. The feature was observed to provide seasonal hydrology to downstream areas and may provide seasonal fish habitat, provided barriers to fish are not present further downstream. This section of the HDF is not shown by the NHIC (NDMNR 2021a), LIO (NDMNR 2021b), RVCA (2021) or OMAFRA (2020) and is shown as a Ditch in geoOttawa (2020) (Photos 24 – 27, Appendix C).

**Photo 24:** Existing conditions of ECK3-HDF1-R2-S1 south of the Tullamore Street extension (May 6). Looking south and downstream.

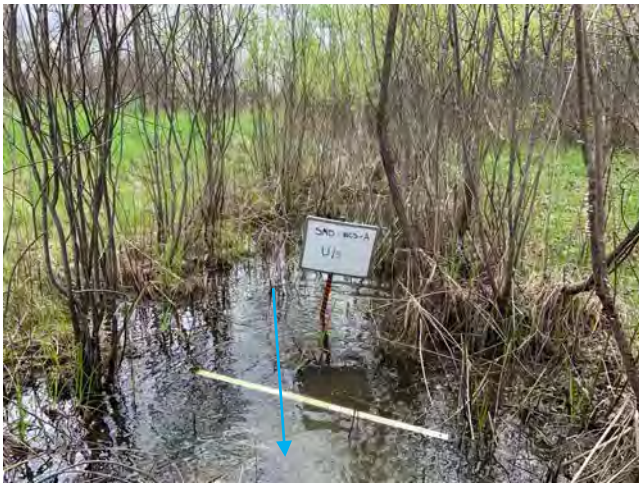
**Photo 25:** Existing conditions observed within the middle of ECK3-HDF1-R2-S1 (May 6). Looking west and upstream.

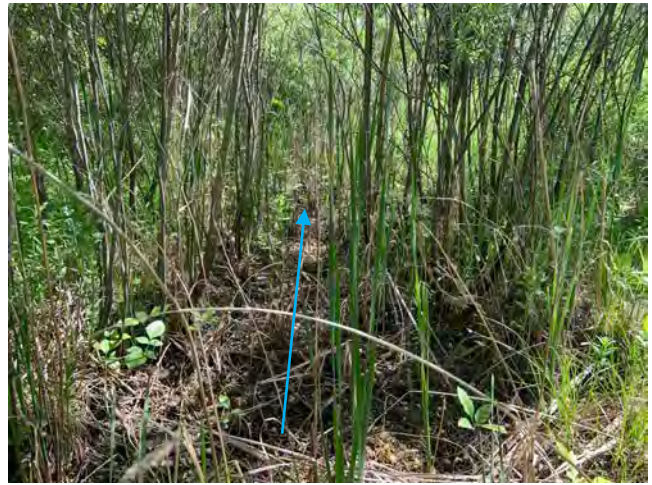
**Photo 26:** Existing conditions observed within the middle of ECK3-HDF1-R2-S1 (May 27). Looking east and downstream.

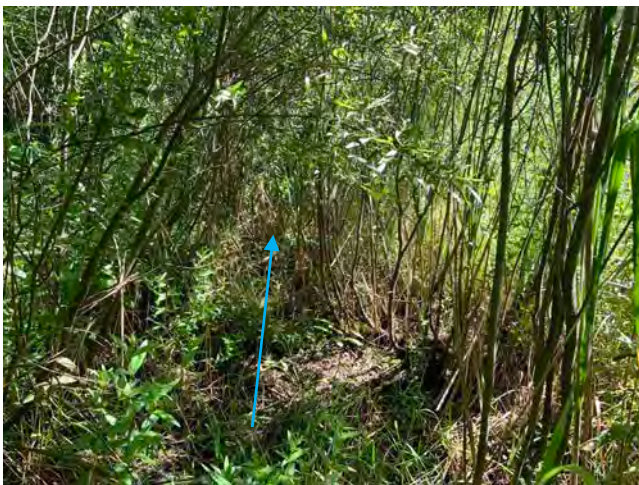
**Photo 27:** Existing conditions observed within the middle of ECK3-HDF1-R2-S1 (July 30). Looking east and downstream.

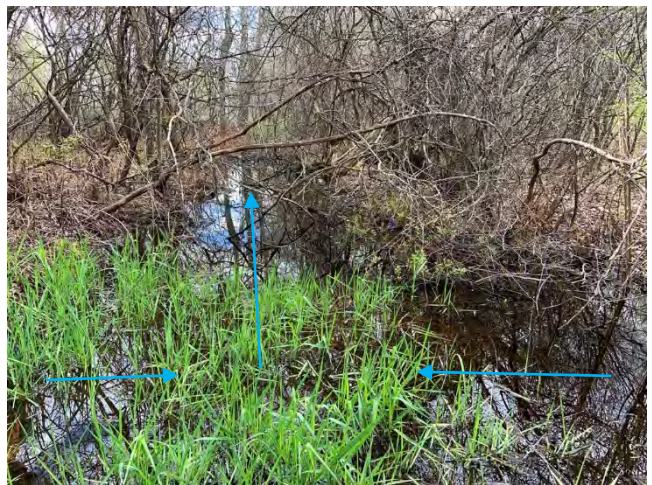
Headwater Drainage Feature Reach	Length Assessed (m)	Feature Type					Channel Dimensions		Early May 2021 Hydrology			Late May 2021 Hydrology			July 2021 Hydrology			Riparian Vegetation						Terrestrial Habitat			Fish Habitat				Headwater Drainage Feature Description		
		Defined Natural Channel	Channelized	No Defined Feature	Swale	Tiled Drainage	Wetland	Feature Width (m)	Bankfull Depth (m)	Water Present (Y/N)	Depth (mm)	Flow (Y/N)	Water Present (Y/N)	Depth (mm)	Flow (Y/N)	Water Present (Y/N)	Depth (mm)	Flow (Y/N)	None	Lawn	Cropped Land	Meadow	Scrubland	Forest	Wetland	Breeding Amphib. Wetlands	General Amphib. Habitat	Movement Corridors	No Habitat	Year Round		Seasonal	Contributing
Eck3-HDF2-R1-S1	0	-	✓	-	-	-	-	n/a	n/a	Y	n/a	Y	N	n/a	N	N	n/a	N	-	-	-	-	-	✓	✓	-	-	✓	-	-	-	✓	<p>This channelized feature, located west of the Site, was observed to receive all flows from all four reaches within Eck3-HDF2 and is shown by geoOttawa (2020) as a Ditch and Watercourse that directs flows into the Spratt Drain municipal drain ~650 m west of the Site. The feature was observed to provide seasonal hydrology to downstream areas and may provide seasonal fish habitat, provided barriers to fish are not present further downstream. This section of the HDF is not shown by the NHIC (NDMNR 2021a), LIO (NDMNR 2021b), RVCA (2021) or OMAFRA (2020). Access to this feature was not provided and was observed from the Site boundary only. As such, no data sheets for this section are provided (Photo 28, Appendix C).</p>

**Photo 28:** Existing conditions observed within ECK3-HDF2-R1-S1 along the western boundary of the Site (May 27). Looking west and downstream.

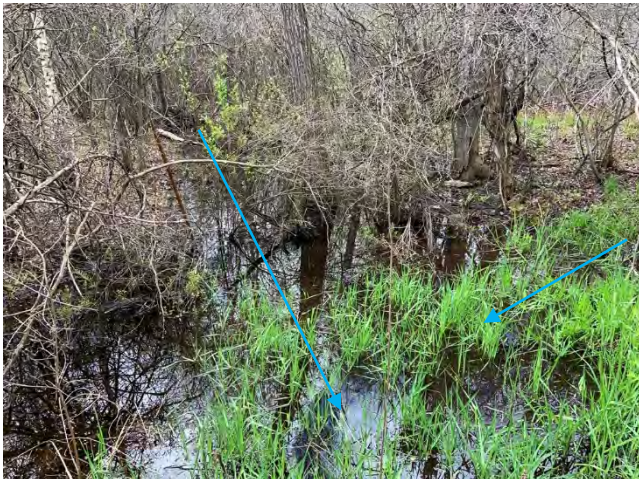
**Photo 29:** Existing conditions observed at the confluence of ECK3-HDF2-R2-S1 and ECK3-HDF2-R3-S1 (May 27) at the northwest corner of the Site. Looking north and upstream.

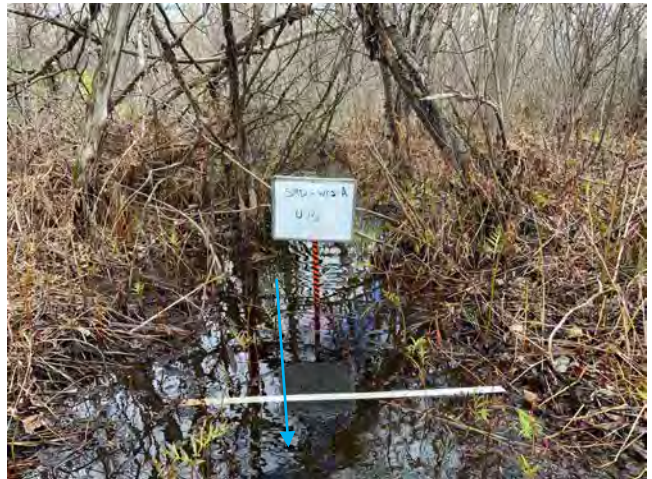
**Photo 30:** Existing conditions observed within the middle of ECK3-HDF2-R1-S2 (May 6). Looking east and upstream.

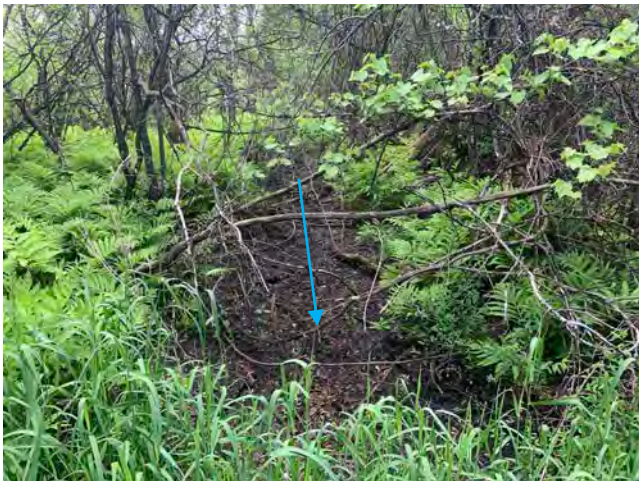
**Photo 31:** Existing conditions observed within the middle of ECK3-HDF2-R1-S2 (May 6). Looking east and upstream.

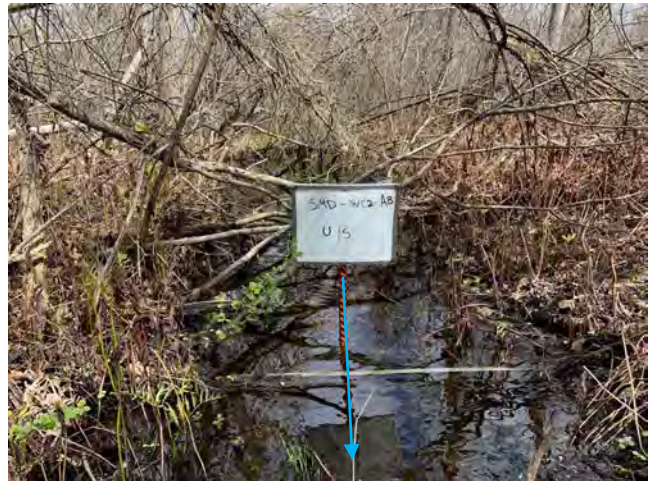
Headwater Drainage Feature Reach	Length Assessed (m)	Feature Type					Channel Dimensions		Early May 2021 Hydrology			Late May 2021 Hydrology			July 2021 Hydrology			Riparian Vegetation							Terrestrial Habitat			Fish Habitat				Headwater Drainage Feature Description	
		Defined Natural Channel	Channelized	No Defined Feature	Swale	Tiled Drainage	Wetland	Feature Width (m)	Bankfull Depth (m)	Water Present (Y/N)	Depth (mm)	Flow (Y/N)	Water Present (Y/N)	Depth (mm)	Flow (Y/N)	Water Present (Y/N)	Depth (mm)	Flow (Y/N)	None	Lawn	Cropped Land	Meadow	Scrubland	Forest	Wetland	Breeding Amphib. Wetlands	General Amphib. Habitat	Movement Corridors	No Habitat	Year Round	Seasonal		Contributing
Eck3-HDF2-R3-S1	100	-	✓	-	-	-	-	1.25	0.2	Y	90	Y	N	n/a	N	N	n/a	N	-	-	-	-	-	✓	✓	-	-	✓	-	-	-	✓	This small, channelized feature, shown as a Ditch and Watercourse by geoOttawa (2020), is located within the boundary of the unevaluated wetlands shown by the NHIC (NDMNR 2021a), LIO (NDMNR 2021b), RVCA (2021), OMAFRA (2020) and geoOttawa (2020) and flows into Eck3- HDF2-R3-S1. This feature runs parallel to Eck3-HDF2-R1-S2 and are ~10 m apart from each other. The feature was observed to provide seasonal hydrology to downstream areas and may provide seasonal fish habitat, provided barriers to fish are not present further downstream. This section of the HDF is not shown by any available mapping (Photos 32 – 33, Appendix C).

**Photo 32:** Existing conditions observed within the middle of ECK3-HDF2-R3-S1 (May 6). Looking east and upstream.

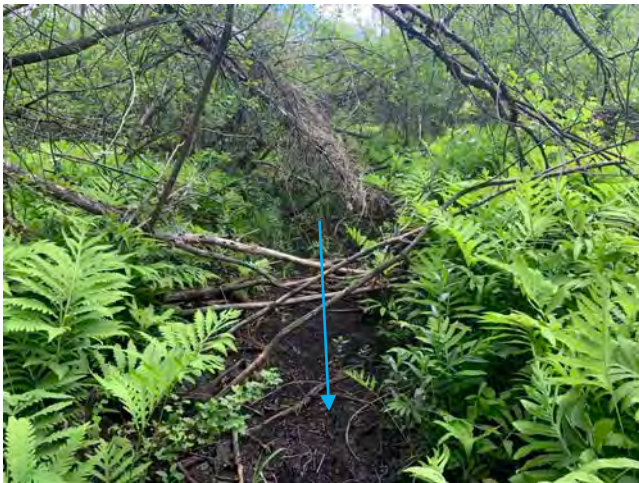
**Photo 33:** Existing conditions observed within the middle of ECK3-HDF2-R3-S1 (May 27). Looking east and upstream.

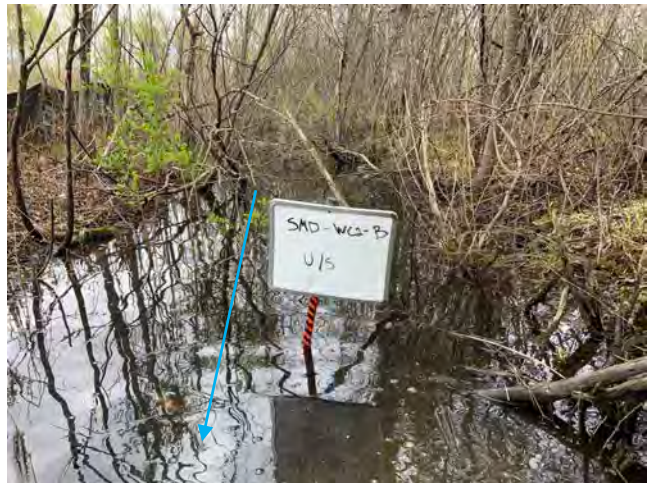
Headwater Drainage Feature Reach	Length Assessed (m)	Feature Type					Channel Dimensions		Early May 2021 Hydrology			Late May 2021 Hydrology			July 2021 Hydrology			Riparian Vegetation							Terrestrial Habitat			Fish Habitat				Headwater Drainage Feature Description	
		Defined Natural Channel	Channelized	No Defined Feature	Swale	Tiled Drainage	Wetland	Feature Width (m)	Bankfull Depth (m)	Water Present (Y/N)	Depth (mm)	Flow (Y/N)	Water Present (Y/N)	Depth (mm)	Flow (Y/N)	Water Present (Y/N)	Depth (mm)	Flow (Y/N)	None	Lawn	Cropped Land	Meadow	Scrubland	Forest	Wetland	Breeding Amphib. Wetlands	General Amphib. Habitat	Movement Corridors	No Habitat	Year Round	Seasonal		Contributing
Eck3-HDF2-R4-S1	75	—	✓	—	—	—	—	1.25	0.8	Y	15	Y	N	n/a	N	N	n/a	N	—	—	—	—	✓	✓	✓	—	—	✓	—	—	—	✓	<p>This medium, channelized feature, shown as a Ditch by geoOttawa (2020), is located along the western boundary of the Site. Located along the boundary of unevaluated wetlands shown by the NHIC (NDMNR 2021a), LIO (NDMNR 2021b), RVCA (2021), OMAFRA (2020) and geoOttawa (2020), the feature flows into Eck3-HDF2-R1-S1. The feature was observed to provide seasonal hydrology to downstream areas and may provide seasonal fish habitat, provided barriers to fish are not present further downstream. This section of the HDF is not shown by the NHIC (NDMNR 2021a), LIO (NDMNR 2021b), RVCA (2021) or OMAFRA (2020) (Photo 34 – 36, Appendix C).</p>

**Photo 34:** Existing conditions observed within the middle of ECK3-HDF2-R4-S1 (May 6). Looking south and upstream.

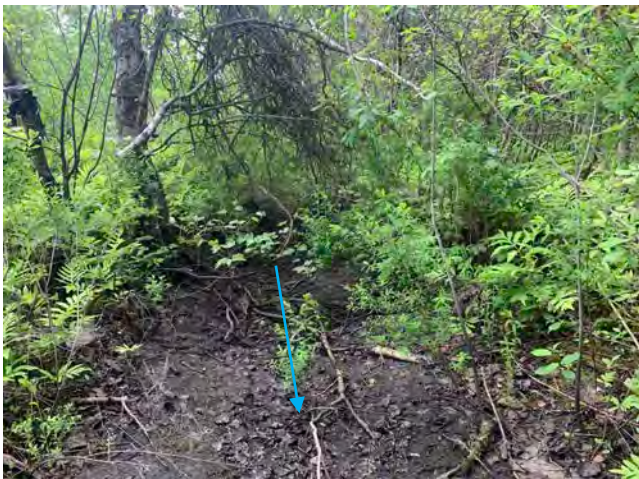
**Photo 35:** Existing conditions observed within the middle of ECK3-HDF2-R4-S1 (May 27). Looking south and upstream.

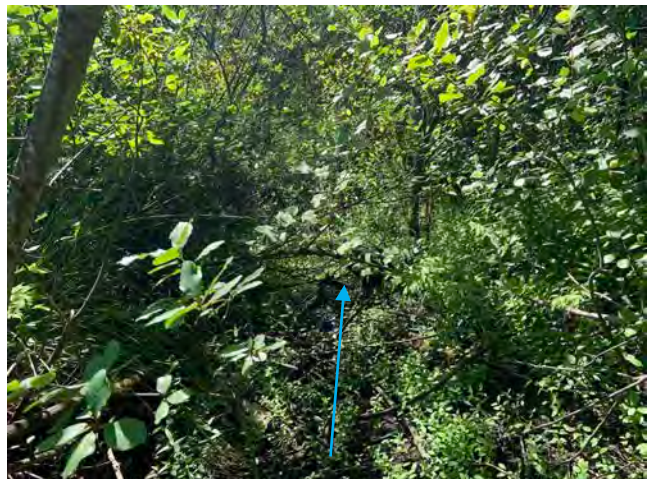
**Photo 36:** Existing conditions observed within the middle of ECK3-HDF2-R4-S1 (July 30). Looking north and downstream.

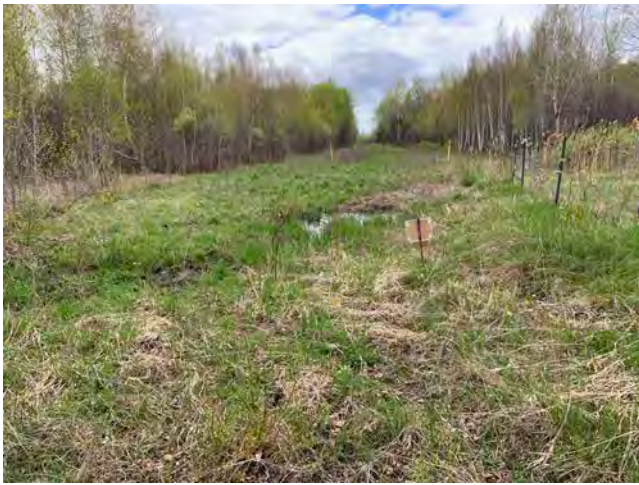
**Photo 37:** Existing conditions of the ECK3-HDF2-R4-S2 (May 6) within the Trans-Northern Pipelines Inc. right-of-way. Looking northwest.

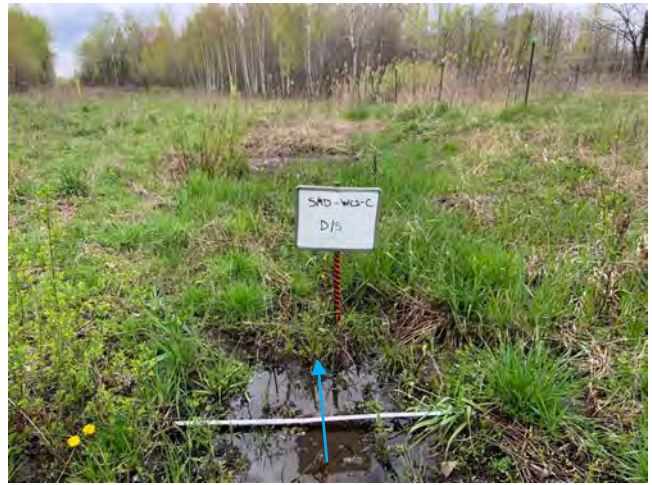
Headwater Drainage Feature Reach	Length Assessed (m)	Feature Type						Channel Dimensions		Early May 2021 Hydrology			Late May 2021 Hydrology			July 2021 Hydrology			Riparian Vegetation							Terrestrial Habitat			Fish Habitat				Headwater Drainage Feature Description	
		Defined Natural Channel	Channelized	No Defined Feature	Swale	Tiled Drainage	Wetland	Feature Width (m)	Bankfull Depth (m)	Water Present (Y/N)	Depth (mm)	Flow (Y/N)	Water Present (Y/N)	Depth (mm)	Flow (Y/N)	Water Present (Y/N)	Depth (mm)	Flow (Y/N)	None	Lawn	Cropped Land	Meadow	Scrubland	Forest	Wetland	Breeding Amphib. Wetlands	General Amphib. Habitat	Movement Corridors	No Habitat	Year Round	Seasonal	Contributing		
Eck3-HDF2-R4-S2	40	-	-	-	✓	-	-	2.0	1.0	Y	20	N	N	n/a	N	N	n/a	N	-	-	-	-	✓	-	-	-	-	-	✓	-	-	-	✓	This ill-defined section of Eck3-HDF2-R4, mapped as a Ditch by geoOttawa (2020), is located within the Trans-Northern Pipelines Inc. right-of-way that is dominated by wet meadow species. The feature was observed to provide seasonal hydrology to downstream areas and is not considered to provide fish habitat. This section of the HDF is not shown by the NHIC (NDMNRF 2021a), LIO (NDMNRF 2021b), RVCA (2021) or OMAFRA (2020) (Photo 37 – 40, Appendix C).

**Photo 38:** Existing conditions observed within the middle of ECK3-HDF2-R4-S2 (May 6). Looking northwest and downstream.

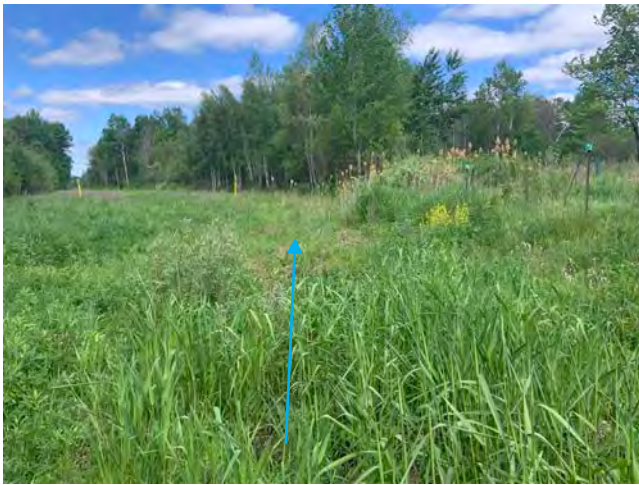
**Photo 39:** Existing conditions observed within the middle of ECK3-HDF2-R4-S2 (May 27). Looking northwest and downstream.

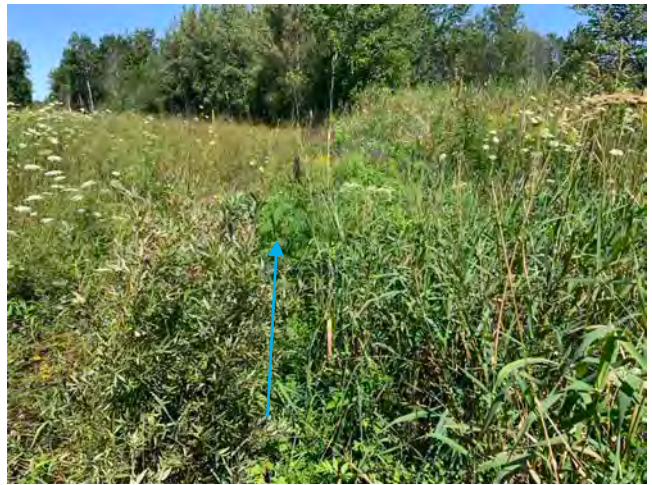
**Photo 40:** Existing conditions observed within the middle of ECK3-HDF2-R4-S2 (July 30). Looking northwest and downstream.

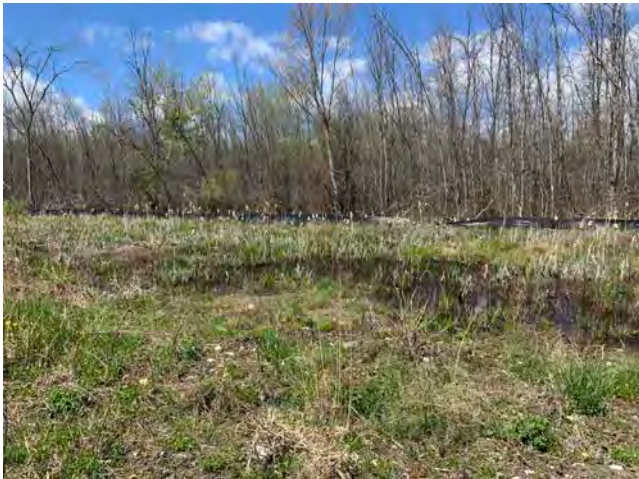
**Photo 41:** Existing conditions observed within the northeast corner of the Site that has not been filled and graded within the limits of the geoOttawa unevaluated wetland (May 6). Looking north towards ECK3-HDF1-R1-S3.

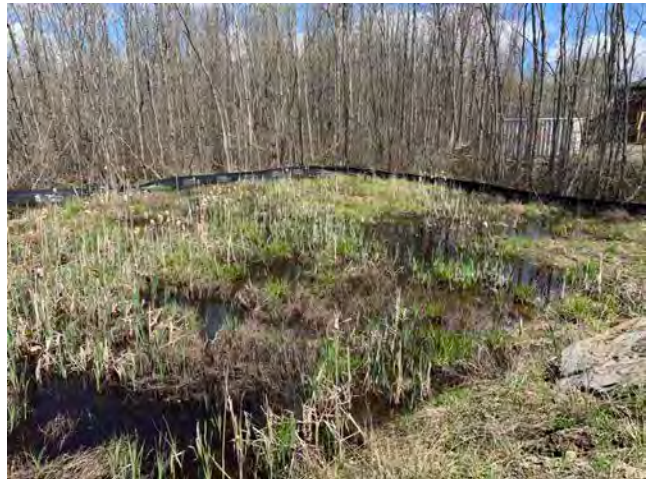
vegetation, predominantly *Carex* spp. and broad-leaved cattail (*Typha latifolia*) (**Photos 41 – 44, Appendix C**). An approximate 30 m strip of deciduous forest remains along both the northern and southern boundaries of the Site adjacent to the mapped headwater drainage features.

**Photo 42:** Existing conditions observed within the northeast corner of the Site that has not been filled and graded within the limits of the geoOttawa unevaluated wetland (May 6). Looking northeast towards ECK3-HDF1-R1-S2.

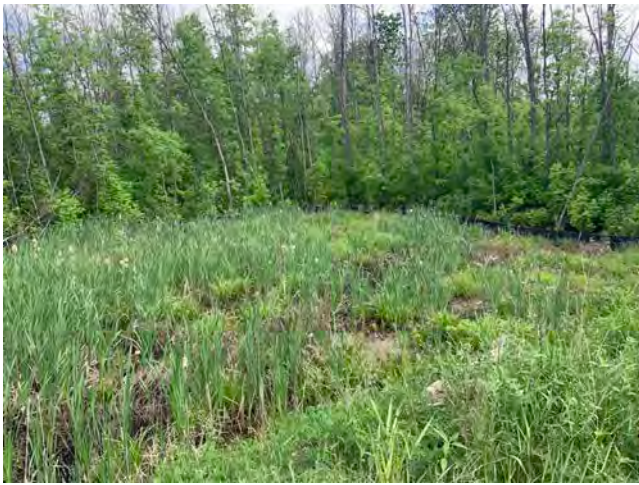
**Photo 43:** Existing conditions observed within the northeast corner of the Site that has not been filled and graded within the limits of the geoOttawa unevaluated wetland (May 27). Looking northeast towards ECK3-HDF1-R1-S2.

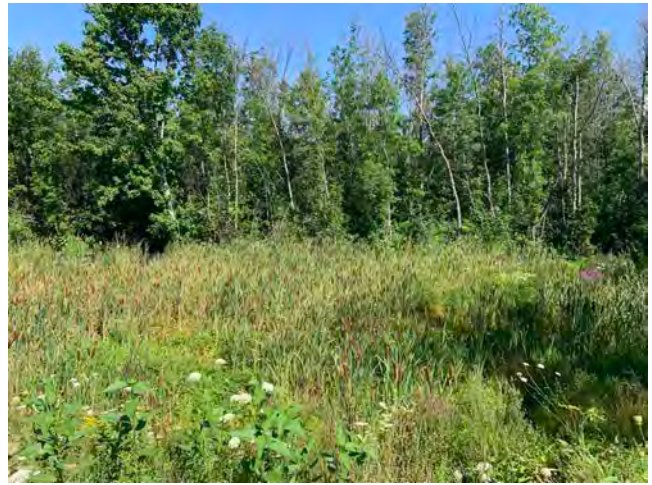
**Photo 44:** Existing conditions observed within the northeast corner of the Site that has not been filled and graded within the limits of the geoOttawa unevaluated wetland (July 30). Looking northeast towards ECK3-HDF1-R1-S2.
