McKINLEY
ENVIRONMENTAL
SOLUTIONS

Combined Environmental Impact Statement &
Tree Conservation Report
Brigil Kanata North Development

September 2020
Prepared for Brigil

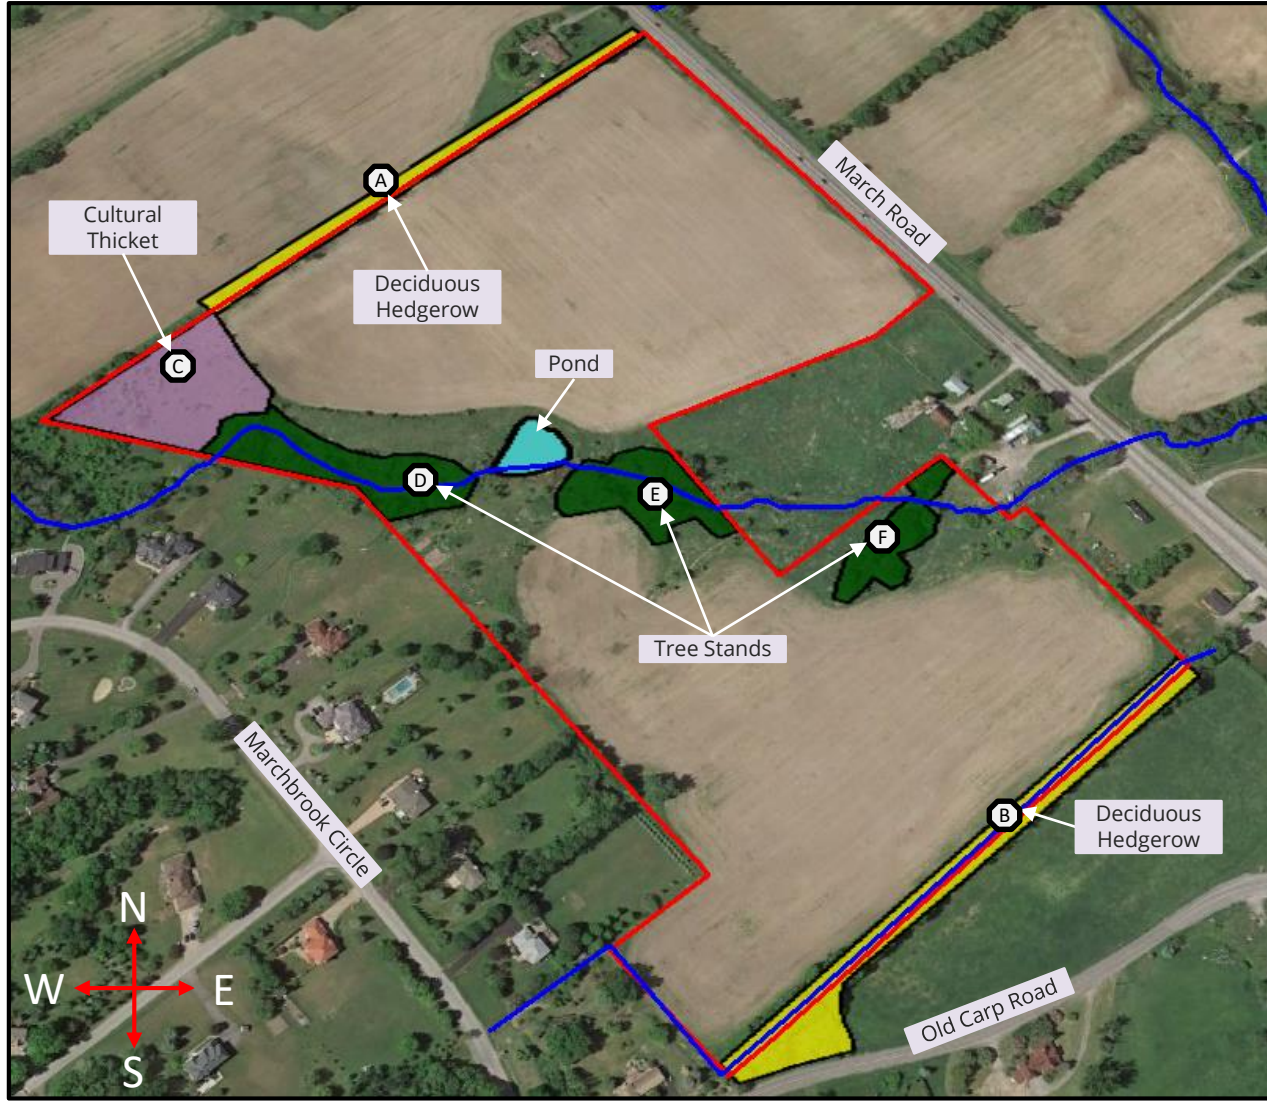
FIGURE 2: TREED HABITATS

— - Site Boundary
 — - Tributaries of Shirley's Brook
 (A) - Vegetation Feature Number

The extent of these vegetation communities is shown in Figures 2 & 3. Appendix A includes a list of plant species noted during the vegetation surveys. Each of the vegetation communities is described in greater detail below.

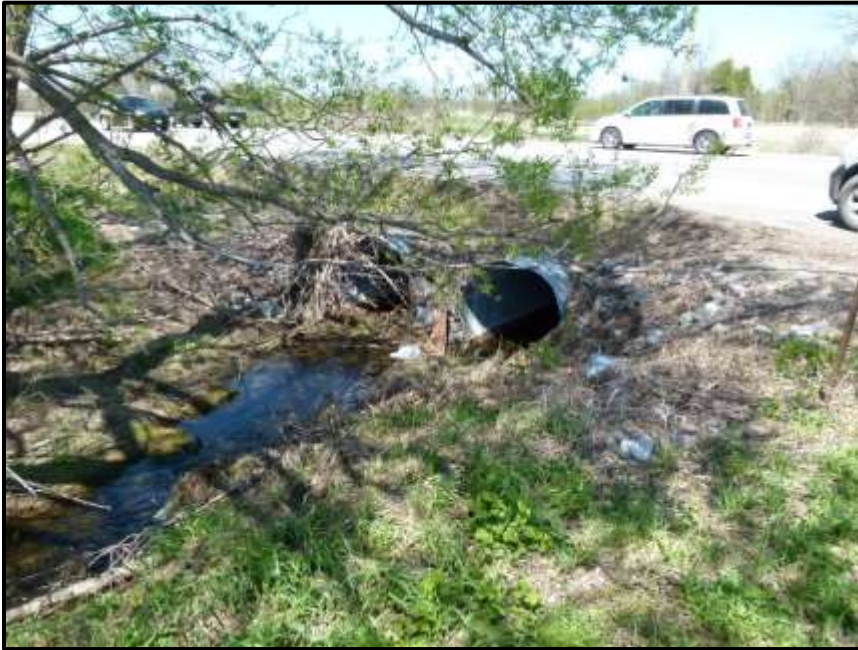
Photograph 10: Looking east along the North Branch. The culverts under March Road are shown (beyond the eastern limit of the Site) (May 12th, 2018).

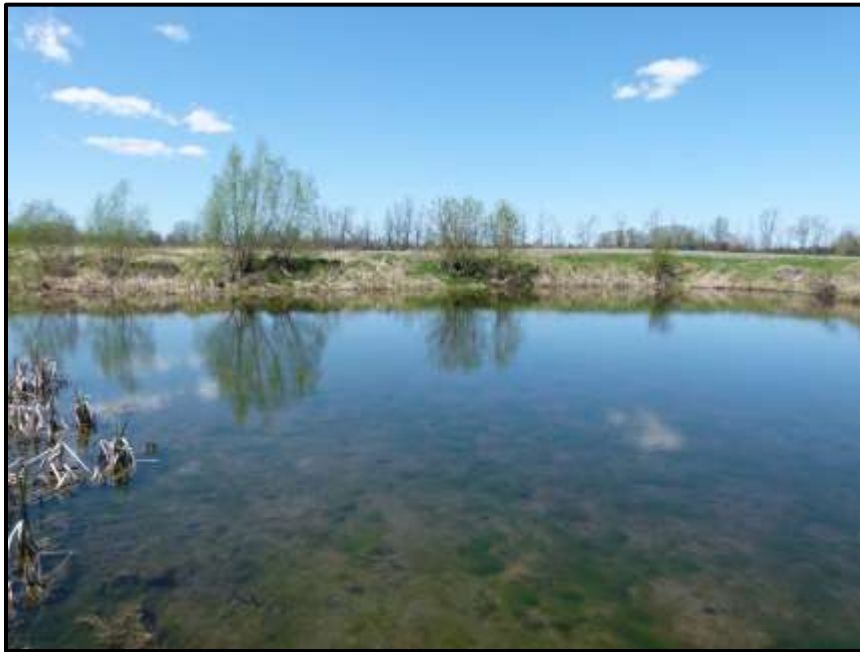
Photograph 12: Looking north at the inline pond. Note that the water level is relatively shallow (May 12th, 2018).

the spring of 2013. The inline pond was observed to contract significantly in the late summer, with the wetted area of the inline pond reduced by as much as 50% by July 2018. Notably, the northern approximately 50% of the inline pond was dry by July 2018, whereas the southern half of the inline pond remained hydrated. The southern half of the inline pond is likely to remain hydrated throughout the summer in most years.

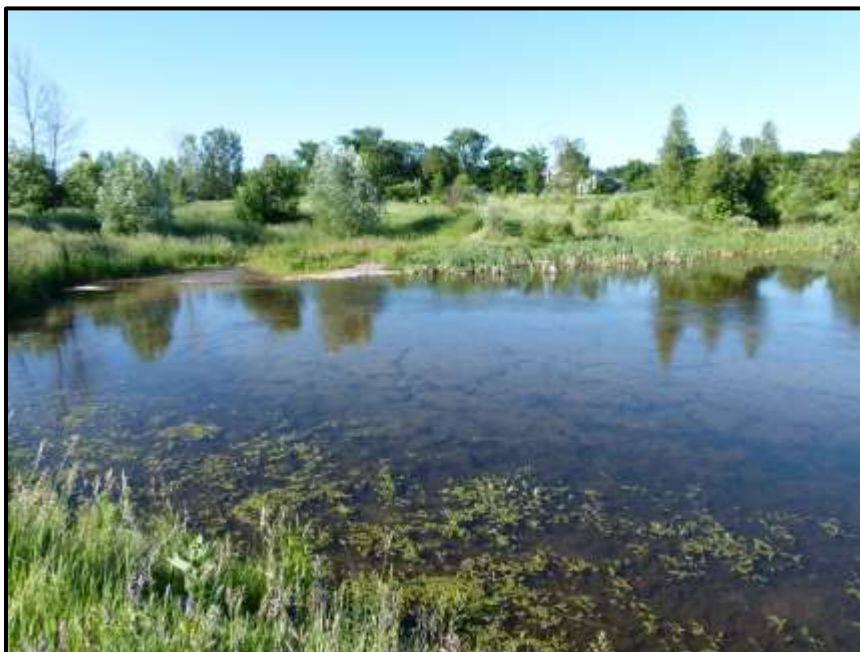
Photograph 13: Looking west at the inline pond. Note that the water level is relatively shallow (June 21st, 2018).

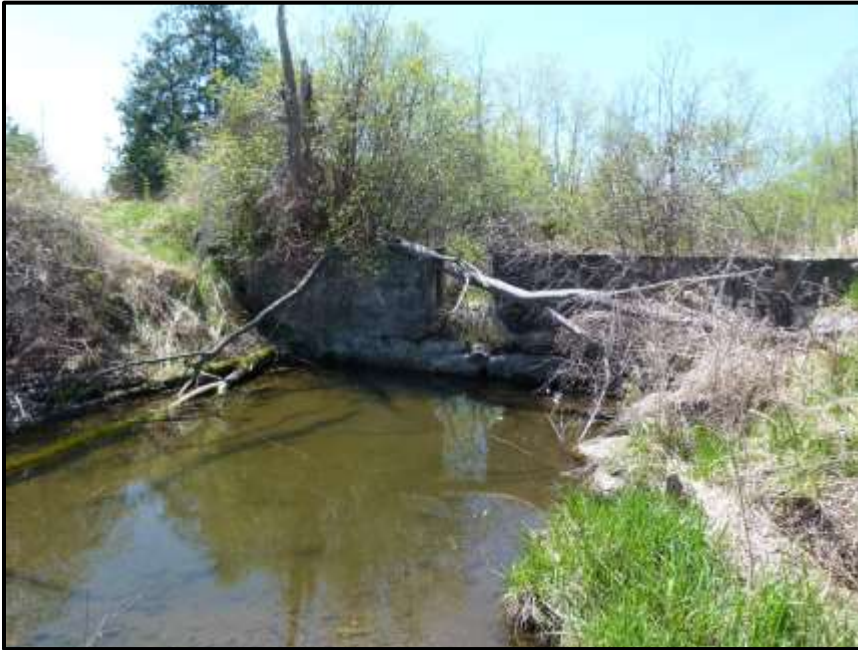
Photograph 14: Looking west at the concrete weir (west of the inline pond) (May 12th, 2018).

Three (3) concrete weirs occur along the North Branch, each of which creates pooling conditions. The largest weir has created an open water inline pond in the central part of the Site. The remaining two (2) weirs have created smaller pools, which are present at each weir. The inline pond is a relatively shallow feature, with much of its substrate consisting of bedrock. The presence of bedrock at the bottom of the inline pond likely limits its functionality as Blanding's Turtle habitat, as Blanding's Turtles require soft substrate that they can burrow into for overwintering (OMNRF 2014a). The inline pond has a generally flat profile with approximately 50 cm of water depth noted on May 12th, 2018. MEP (2016) noted that standing water depths in the inline pond reached 75 cm in

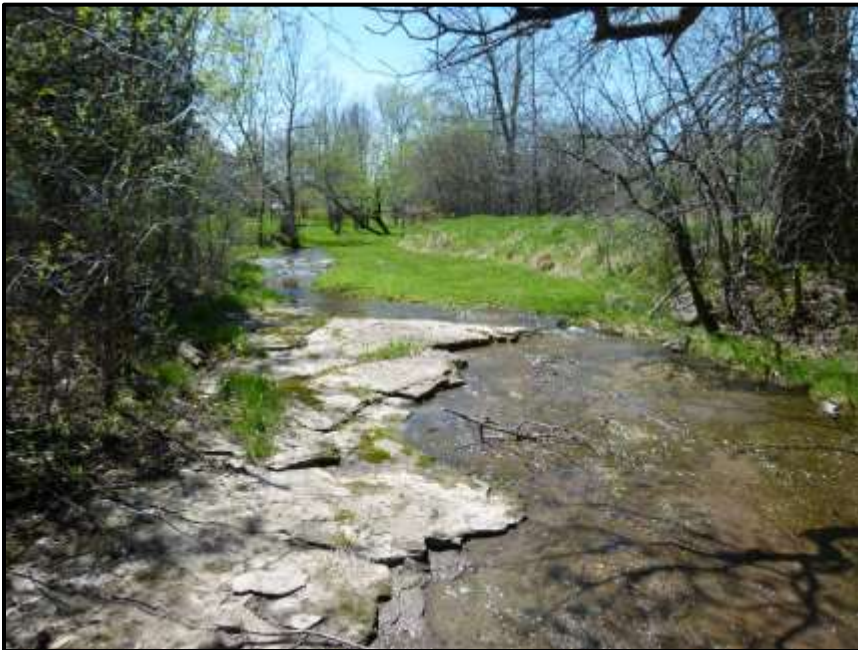
Photograph 15: Upstream section of the North Branch at the western limit of the Site. Note the exposed bedrock in the channel (May 12th, 2018).

Within the Site, the North Branch channel has well-defined banks. The substrate includes many areas of exposed bedrock within the channel bed, as well as areas with a silt and grass substrate. The channel width is approximately 1 m to 3 m in most areas, although the channel width broadens to 5 m in some areas. On May 12th, 2018, the North Branch was observed to be relatively fast flowing with shallow water depths throughout the system (<30 cm deep). The majority of the North Branch was observed to contain limited standing water with no flow on June 21st, 2018. MEP (2016) also noted that the North Branch had limited standing water in the summer of 2013. The North Branch conveys substantial flows in the spring, but is prone to drying out in late summer, when standing water and flow throughout the system may be very limited. Upstream connection and the bulk of water flow is contributed from the upstream areas of the North Branch. While overland flow from within the Site likely contributes to the North Branch hydrology, the bulk of water flow originates from upstream areas.

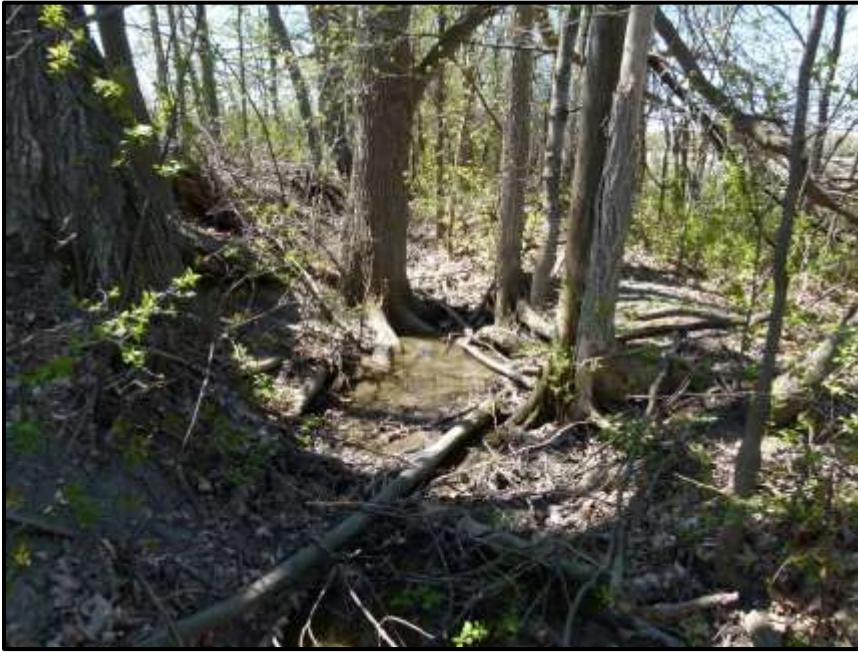
Photograph 16: Downstream (east) section of the Stormwater Swale (Tributary #4). The feature is found within Deciduous Hedgerow B (May 12th, 2018).

The Stormwater Swale does not include significant aquatic vegetation, and the feature's substrate is dominated by woody debris. The feature is fully shaded by Deciduous Hedgerow B (described above). The channel width is approximately 0.5 m to 1 m wide. MEP (2016) previously assessed the Stormwater Swale and determined that the feature is not ecologically significant. As such, a Headwaters Drainage Assessment (HDA) assessing the Stormwater Swale is not anticipated to be required. The Kanata North Urban Expansion Area (KNUEA) Environmental Management Plan (EMP) identified that the Stormwater Swale will be decommissioned, and flows that are currently conveyed by the feature will be rerouted to the North Branch via a new stormwater sewer (Novatech 2016b).

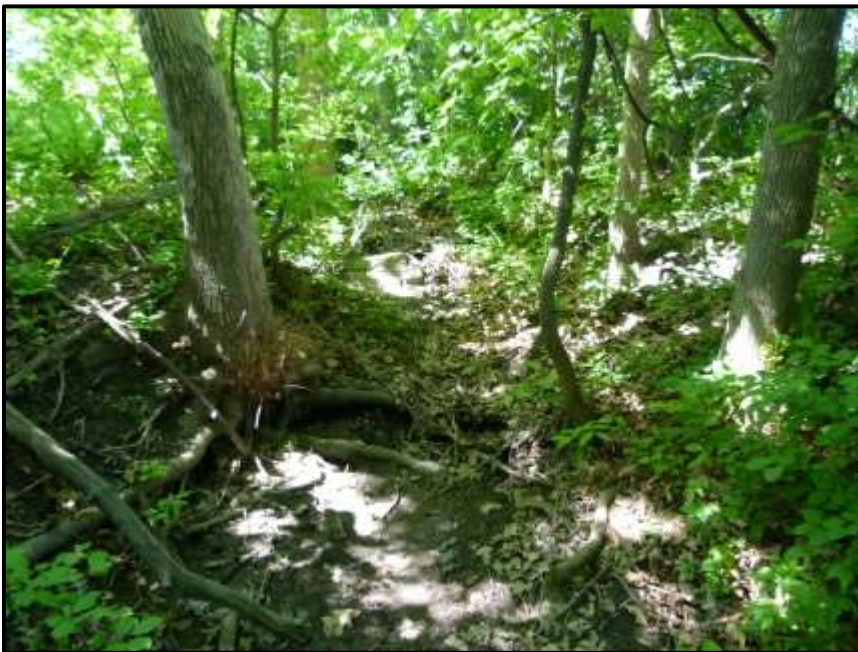
Photograph 17: Downstream (east) section of the Stormwater Swale (Tributary #4). The feature is found within Deciduous Hedgerow B. Note that the feature was completely dry by late May (May 29th, 2018).

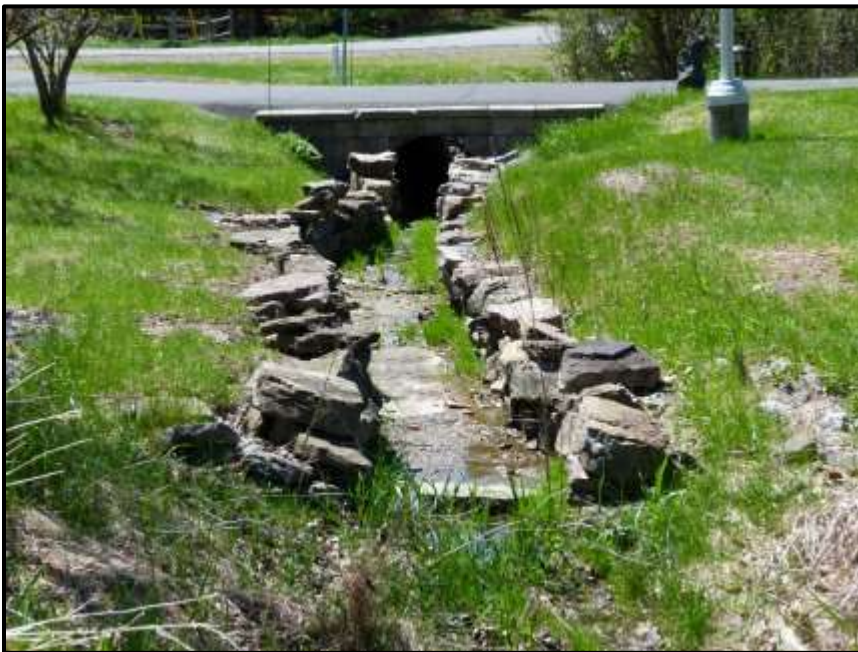
Photograph 19: Upstream (west) section of the Stormwater Swale (Tributary #4). Stormwater flows to the feature from the Marchbrook Circle subdivision and the roadside ditch along Old Carp Road (May 12th, 2018).

A Stormwater Swale (Tributary #4) flows through the Site in a southwest to northeast direction. The Stormwater Swale occurs within Deciduous Hedgerow B, and is fed by stormwater outflow from the adjacent Marchbrook Circle subdivision and the roadside ditch of Old Carp Road. The Stormwater Swale was observed to be predominantly dry with limited areas of standing water (<10 cm) and no flow on May 12th, 2018. The feature was observed to be entirely dry on May 29th, 2018. MEP (2016) also noted that the feature was predominantly dry in the spring and summer of 2013. The Stormwater Swale is likely only hydrated for limited periods immediately following the spring snow melt and after major storms. No fish were documented within the Stormwater Swale during the fish surveying (MEP 2016).

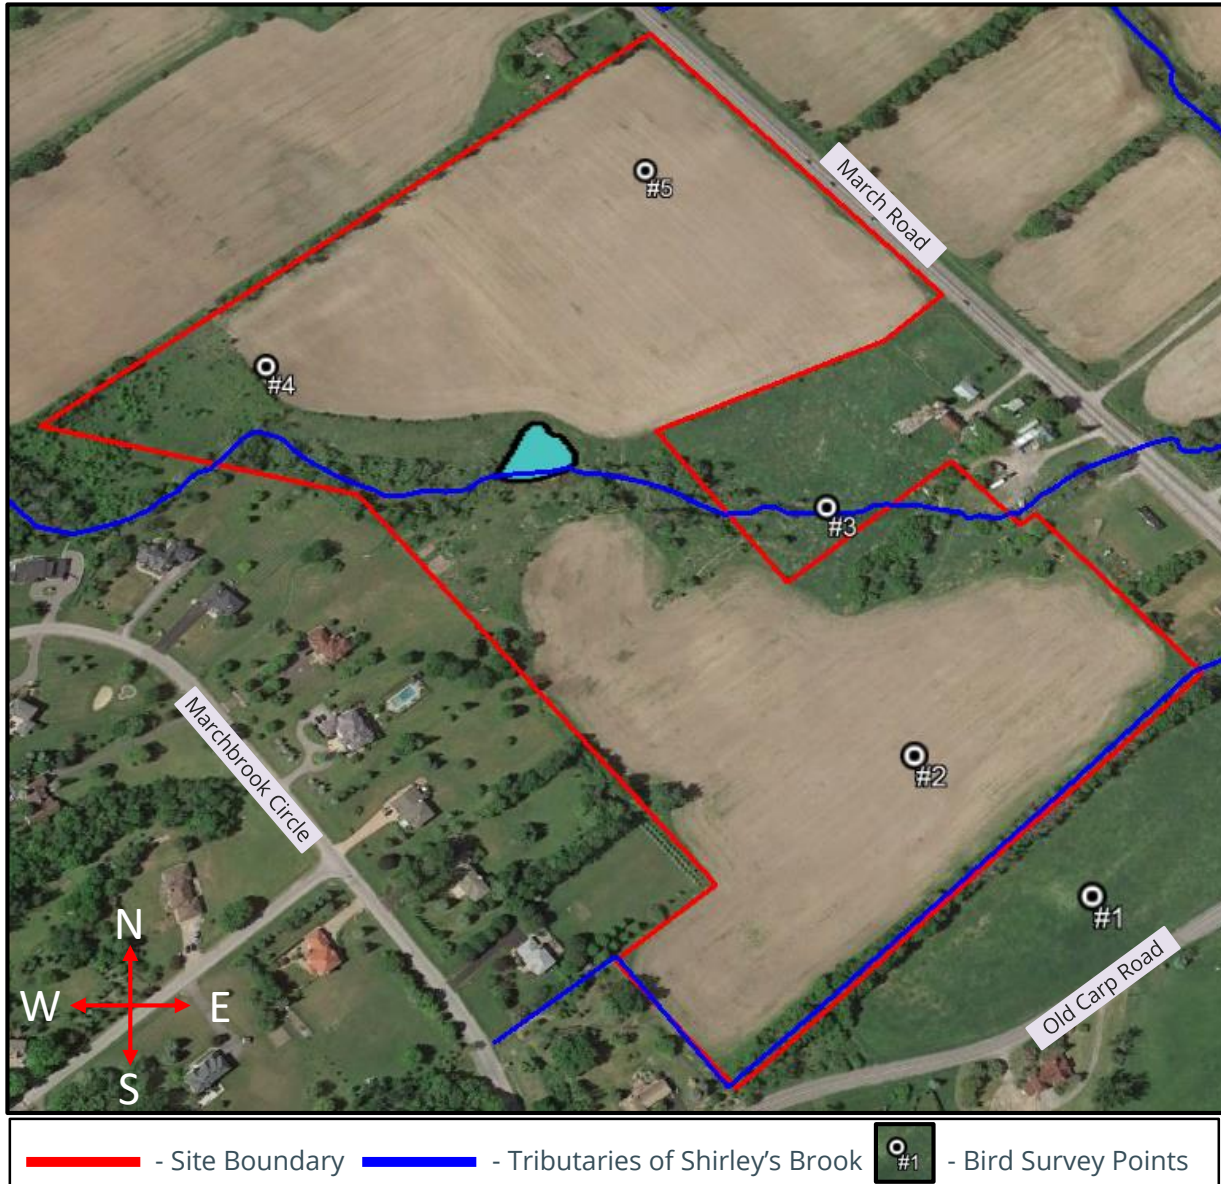
FIGURE 5: BIRD SURVEY POINTS

#1 - Bird Survey Points

Breeding bird survey points are shown below in Figure 5. A total of forty nine (49) bird species were noted within the Site. The majority of species are common migratory birds typically found in suburban and rural areas. Nesting Barn Swallows, non-breeding Bobolink, and foraging Chimney Swifts were also noted within the Site (discussed below). Other wildlife observed within the Site included Eastern Grey Squirrel, Red Squirrel, Eastern Chipmunk, White Tailed Deer, Common Raccoon, Groundhog, Coyote, Green Frog, Grey Tree Frog, Spring Peeper, Snapping Turtle (discussed below), and Common Garter Snake.

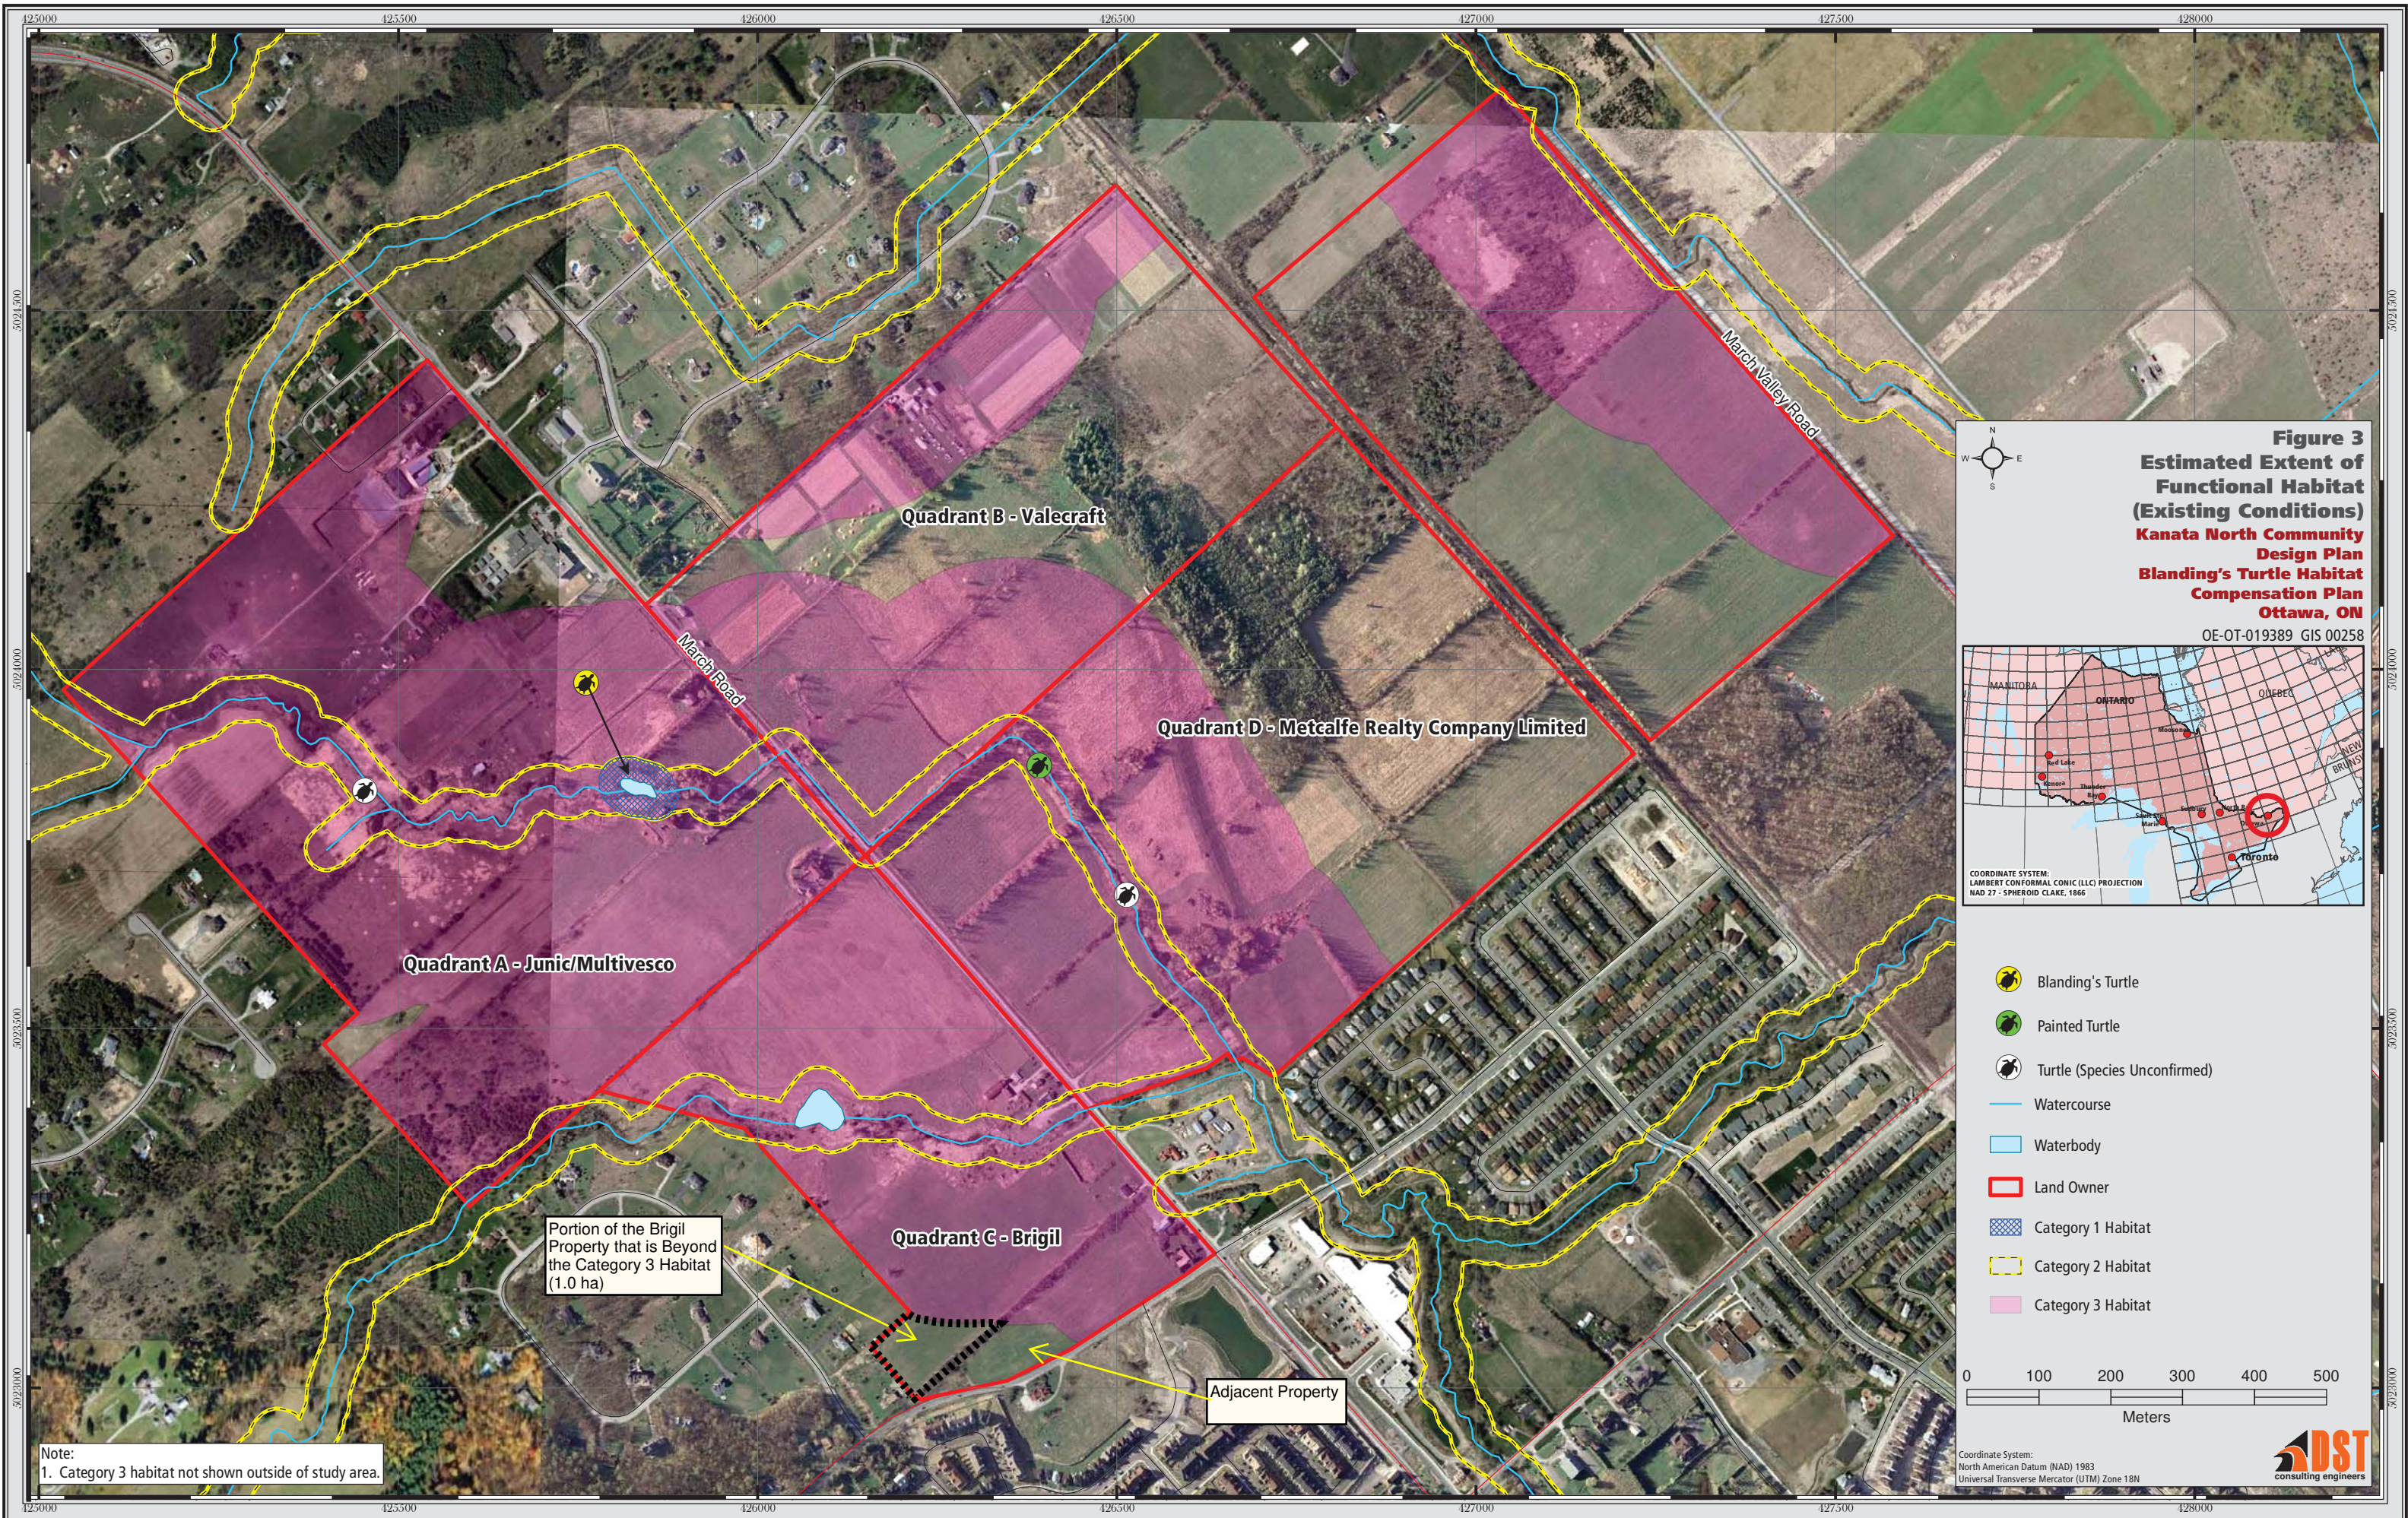
Figure 3
Estimated Extent of Functional Habitat (Existing Conditions)
Kanata North Community Design Plan
Blanding's Turtle Habitat Compensation Plan
Ottawa, ON

- Blanding's Turtle
- Painted Turtle
- Turtle (Species Unconfirmed)
- Watercourse
- Waterbody
- Land Owner
- Category 1 Habitat
- Category 2 Habitat
- Category 3 Habitat

- **Category 3 Habitat:** Category 3 habitat includes terrestrial areas extending up to 250 m from the edge of Category 2 wetlands and watercourses (e.g. an additional 220 m from the edge of the Category 2 habitat, which includes a 30 m buffer from the high-water mark). The main function of Category 3 habitat is to provide corridors that allow Blanding's Turtles to move overland between adjacent Category 1 and Category 2 habitat features (OMNRF 2014a). The portions of the Site that are within 250 m of the North Branch and the inline pond are shown as Category 3 habitat. ***As shown below, approximately 1.0 ha of the Site occurs beyond the limit of the Category 3 habitat (DST 2015). As noted above, approximately 2.88 ha of the Site falls within the definition of Category 2 habitat. The remaining approximately 16.1 ha of the Site qualifies as Category 3 habitat.***

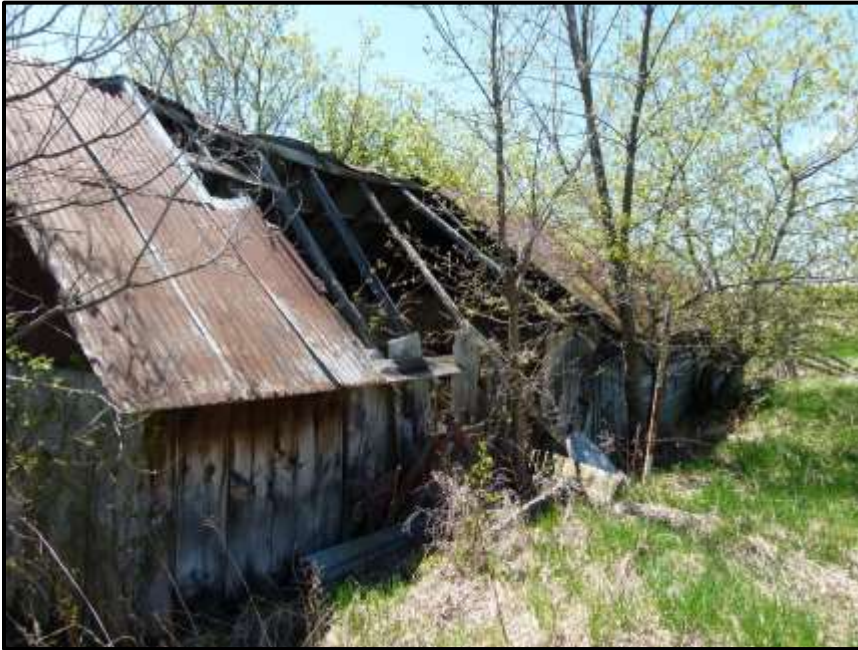
Photograph 22: Looking southeast at the collapsing barn. One (1) active and one (1) inactive Barn Swallow nest were observed within the collapsing barn (May 12th, 2018).

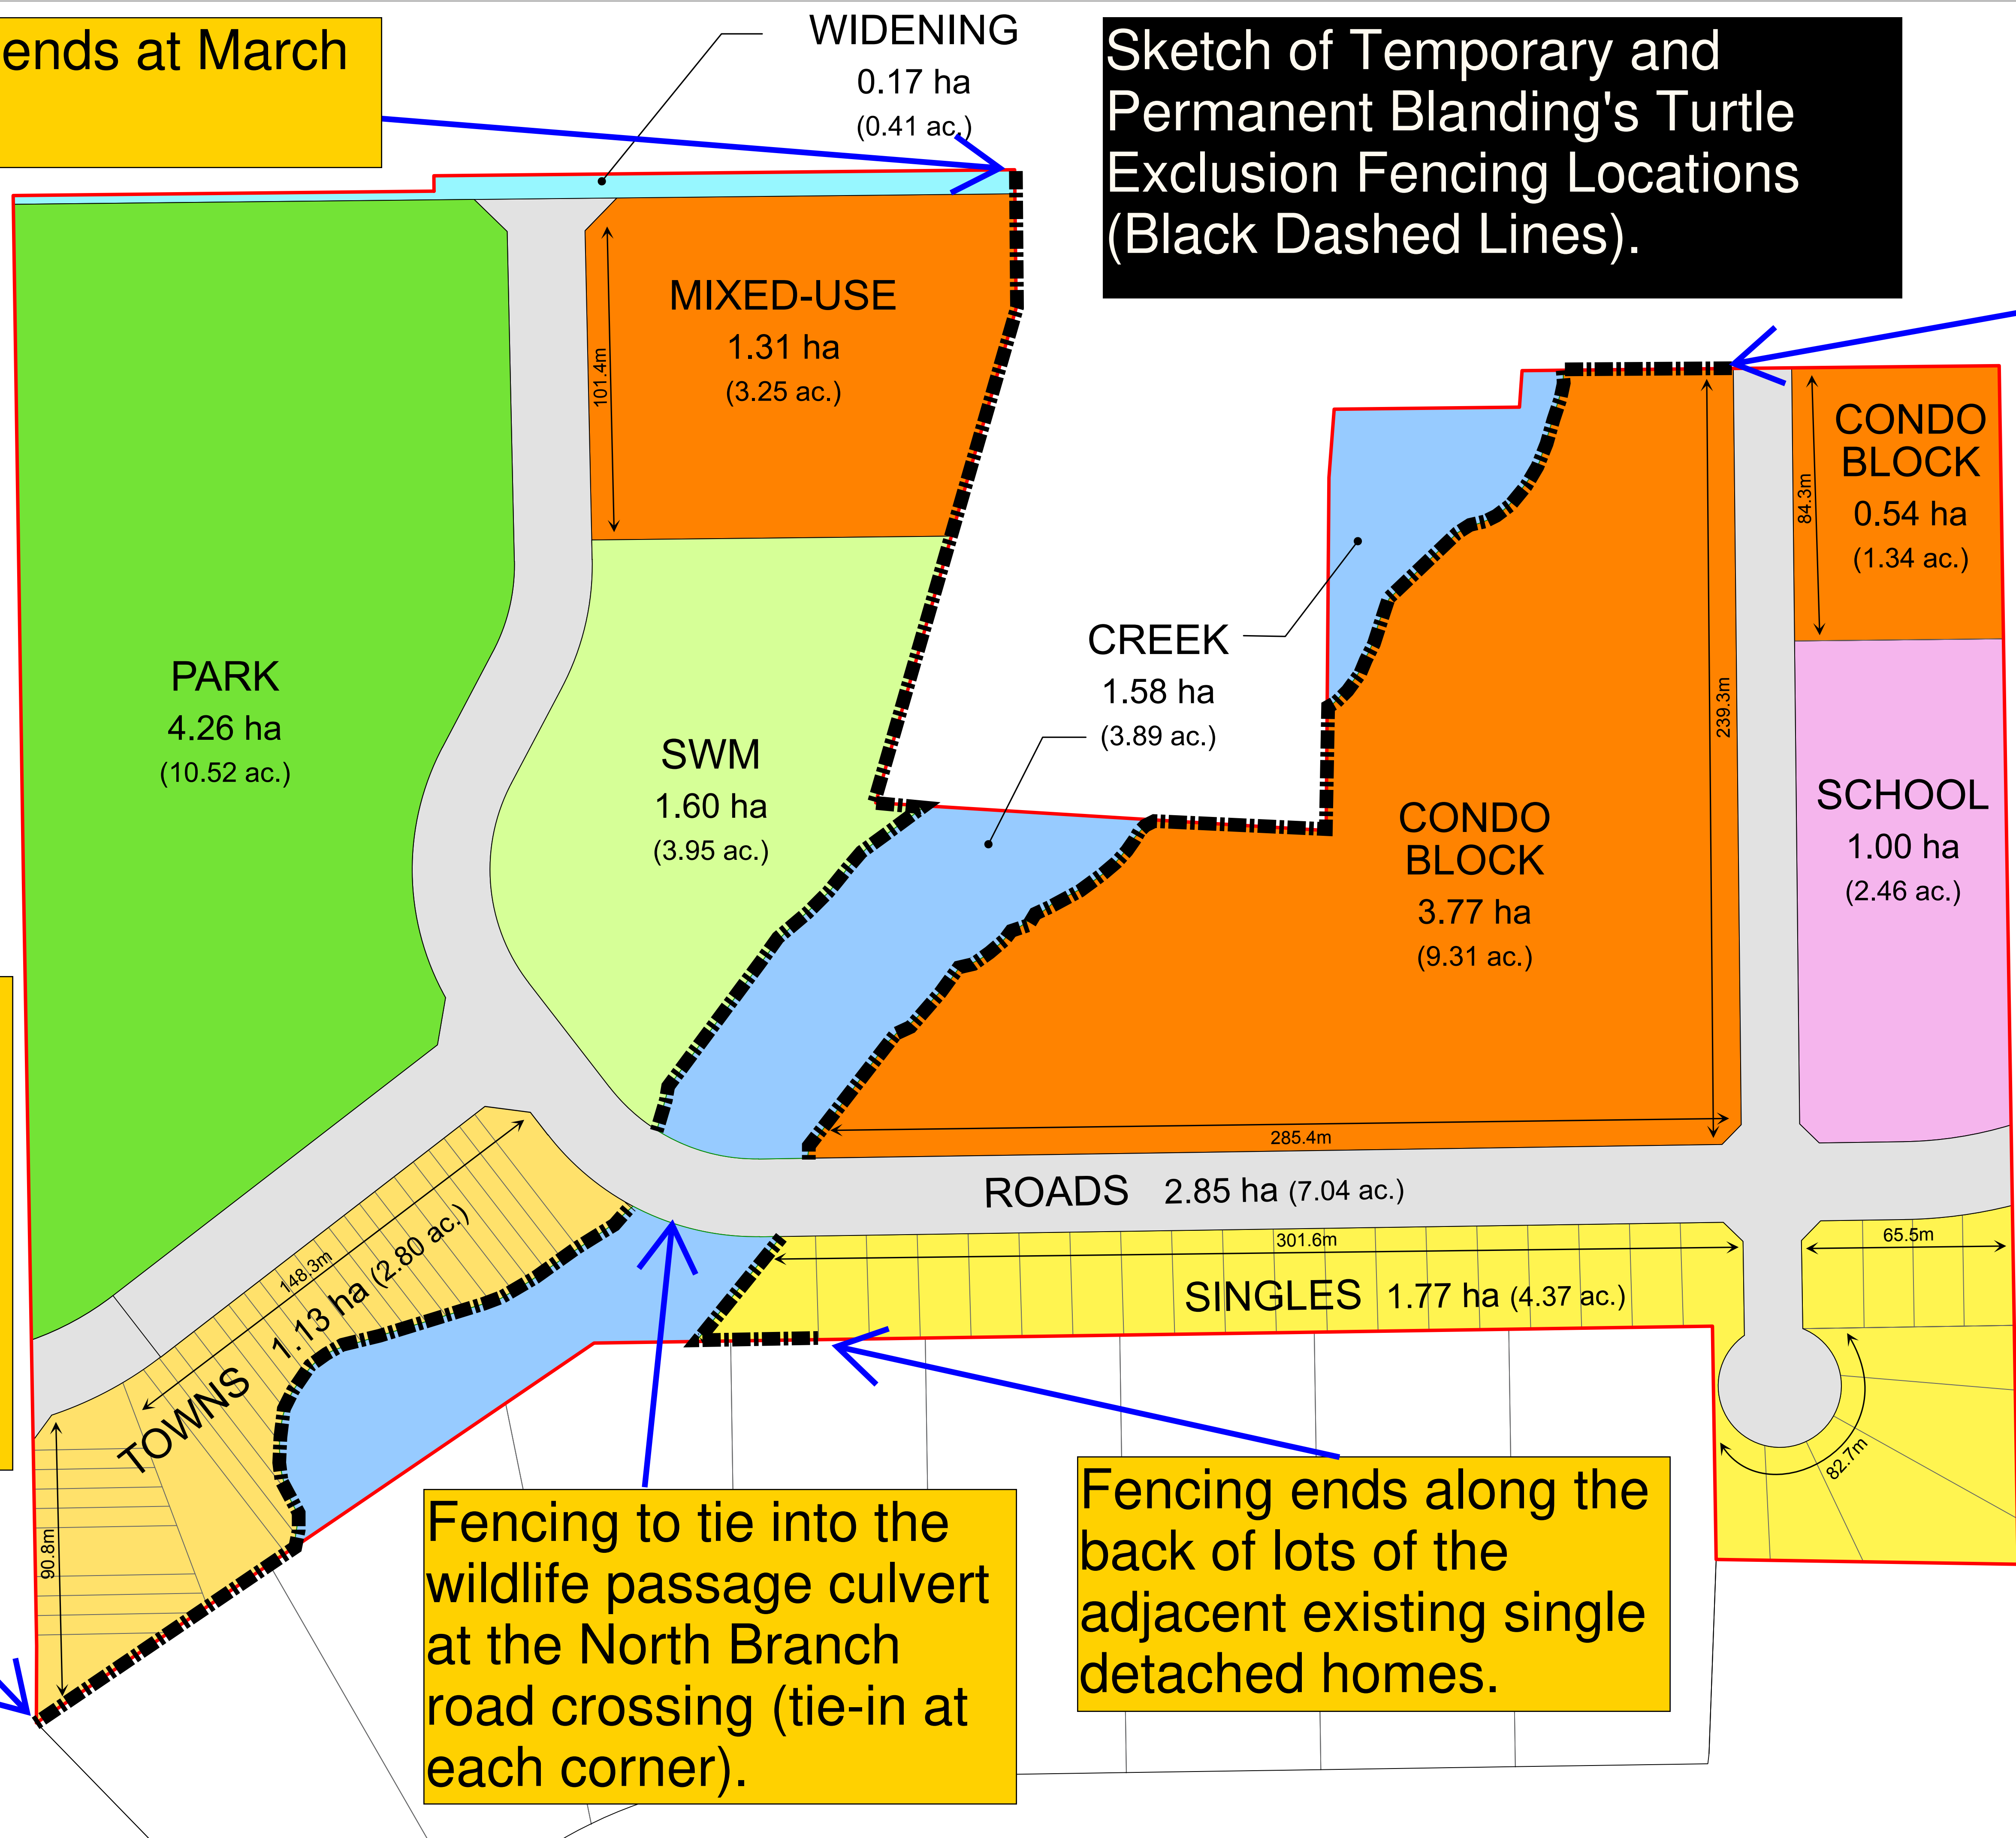
Fencing ends at March Road.

Sketch of Temporary and Permanent Blanding's Turtle Exclusion Fencing Locations (Black Dashed Lines).

Fencing ends along the back of the adjacent existing developed properties.

Fencing to tie into the adjacent 40 m wide corridor fencing in the KNUEA Northwest Quadrant.

Fencing to tie into the wildlife passage culvert at the North Branch road crossing (tie-in at each corner).

A sketch showing the approximate position of the fencing within the Site is included below. However, it should be noted that the final fencing configuration will be determined in consultation with the Ministry of Environment, Conservation, and Parks (MECP) as part of the Overall Benefit Permit process. The final fencing location and fencing materials will be confirmed at the detailed design stage. As shown in the fencing sketch, the fencing will be installed at the development edge adjacent to the open space blocks that will form the 40 m wide North Branch corridor. The fencing will be required to tie into the adjacent Blanding's Turtle exclusion fencing that is to be installed to the north within the KNUEA Northwest Quadrant. As described above in Section 4.2.5, the fencing will also be required to tie into the new wildlife passage culvert. The Blanding's Turtle exclusion fencing will be positioned between the edge of the minimum 40 m wide watercourse corridor and the 6 m wide recreational pathway, thereby separating the pathway from the watercourse corridor.

Temporary fencing will be required at the construction stage. The temporary fencing will be maintained and remain in place until the permanent fencing can be installed. Temporary fencing installed at the construction stage typically consists of wire re-enforced silt fencing that is buried at the bottom. Permanent fencing may consist of several different configurations, as described by the Ontario Ministry of Natural Resources and Forestry (OMNRF) guidance documents (Gunson et al. 2016). Generally, permanent Blanding's Turtle exclusion fencing must consist of a barrier a minimum of 60 cm tall that is buried into the ground and which is impassable to Blanding's Turtles of all sizes. The fencing material is typically required to be durable with little maintenance for a minimum of fifteen (15) years. Products typically used may include some combination of: A) Stone retaining walls or gabion baskets 60 cm tall; B) Chain link fencing with plastic inserts; or C) Purpose-built Blanding's Turtle exclusion fencing constructed from plastic sheeting or wire mesh.
