## Geotechnical - Existing Conditions Report

East Urban Community Mixed Use CDP  
Mer Bleue Road  
Ottawa - Ontario

Richcraft Group of Companies

Report: PG3130-2 Revision 2

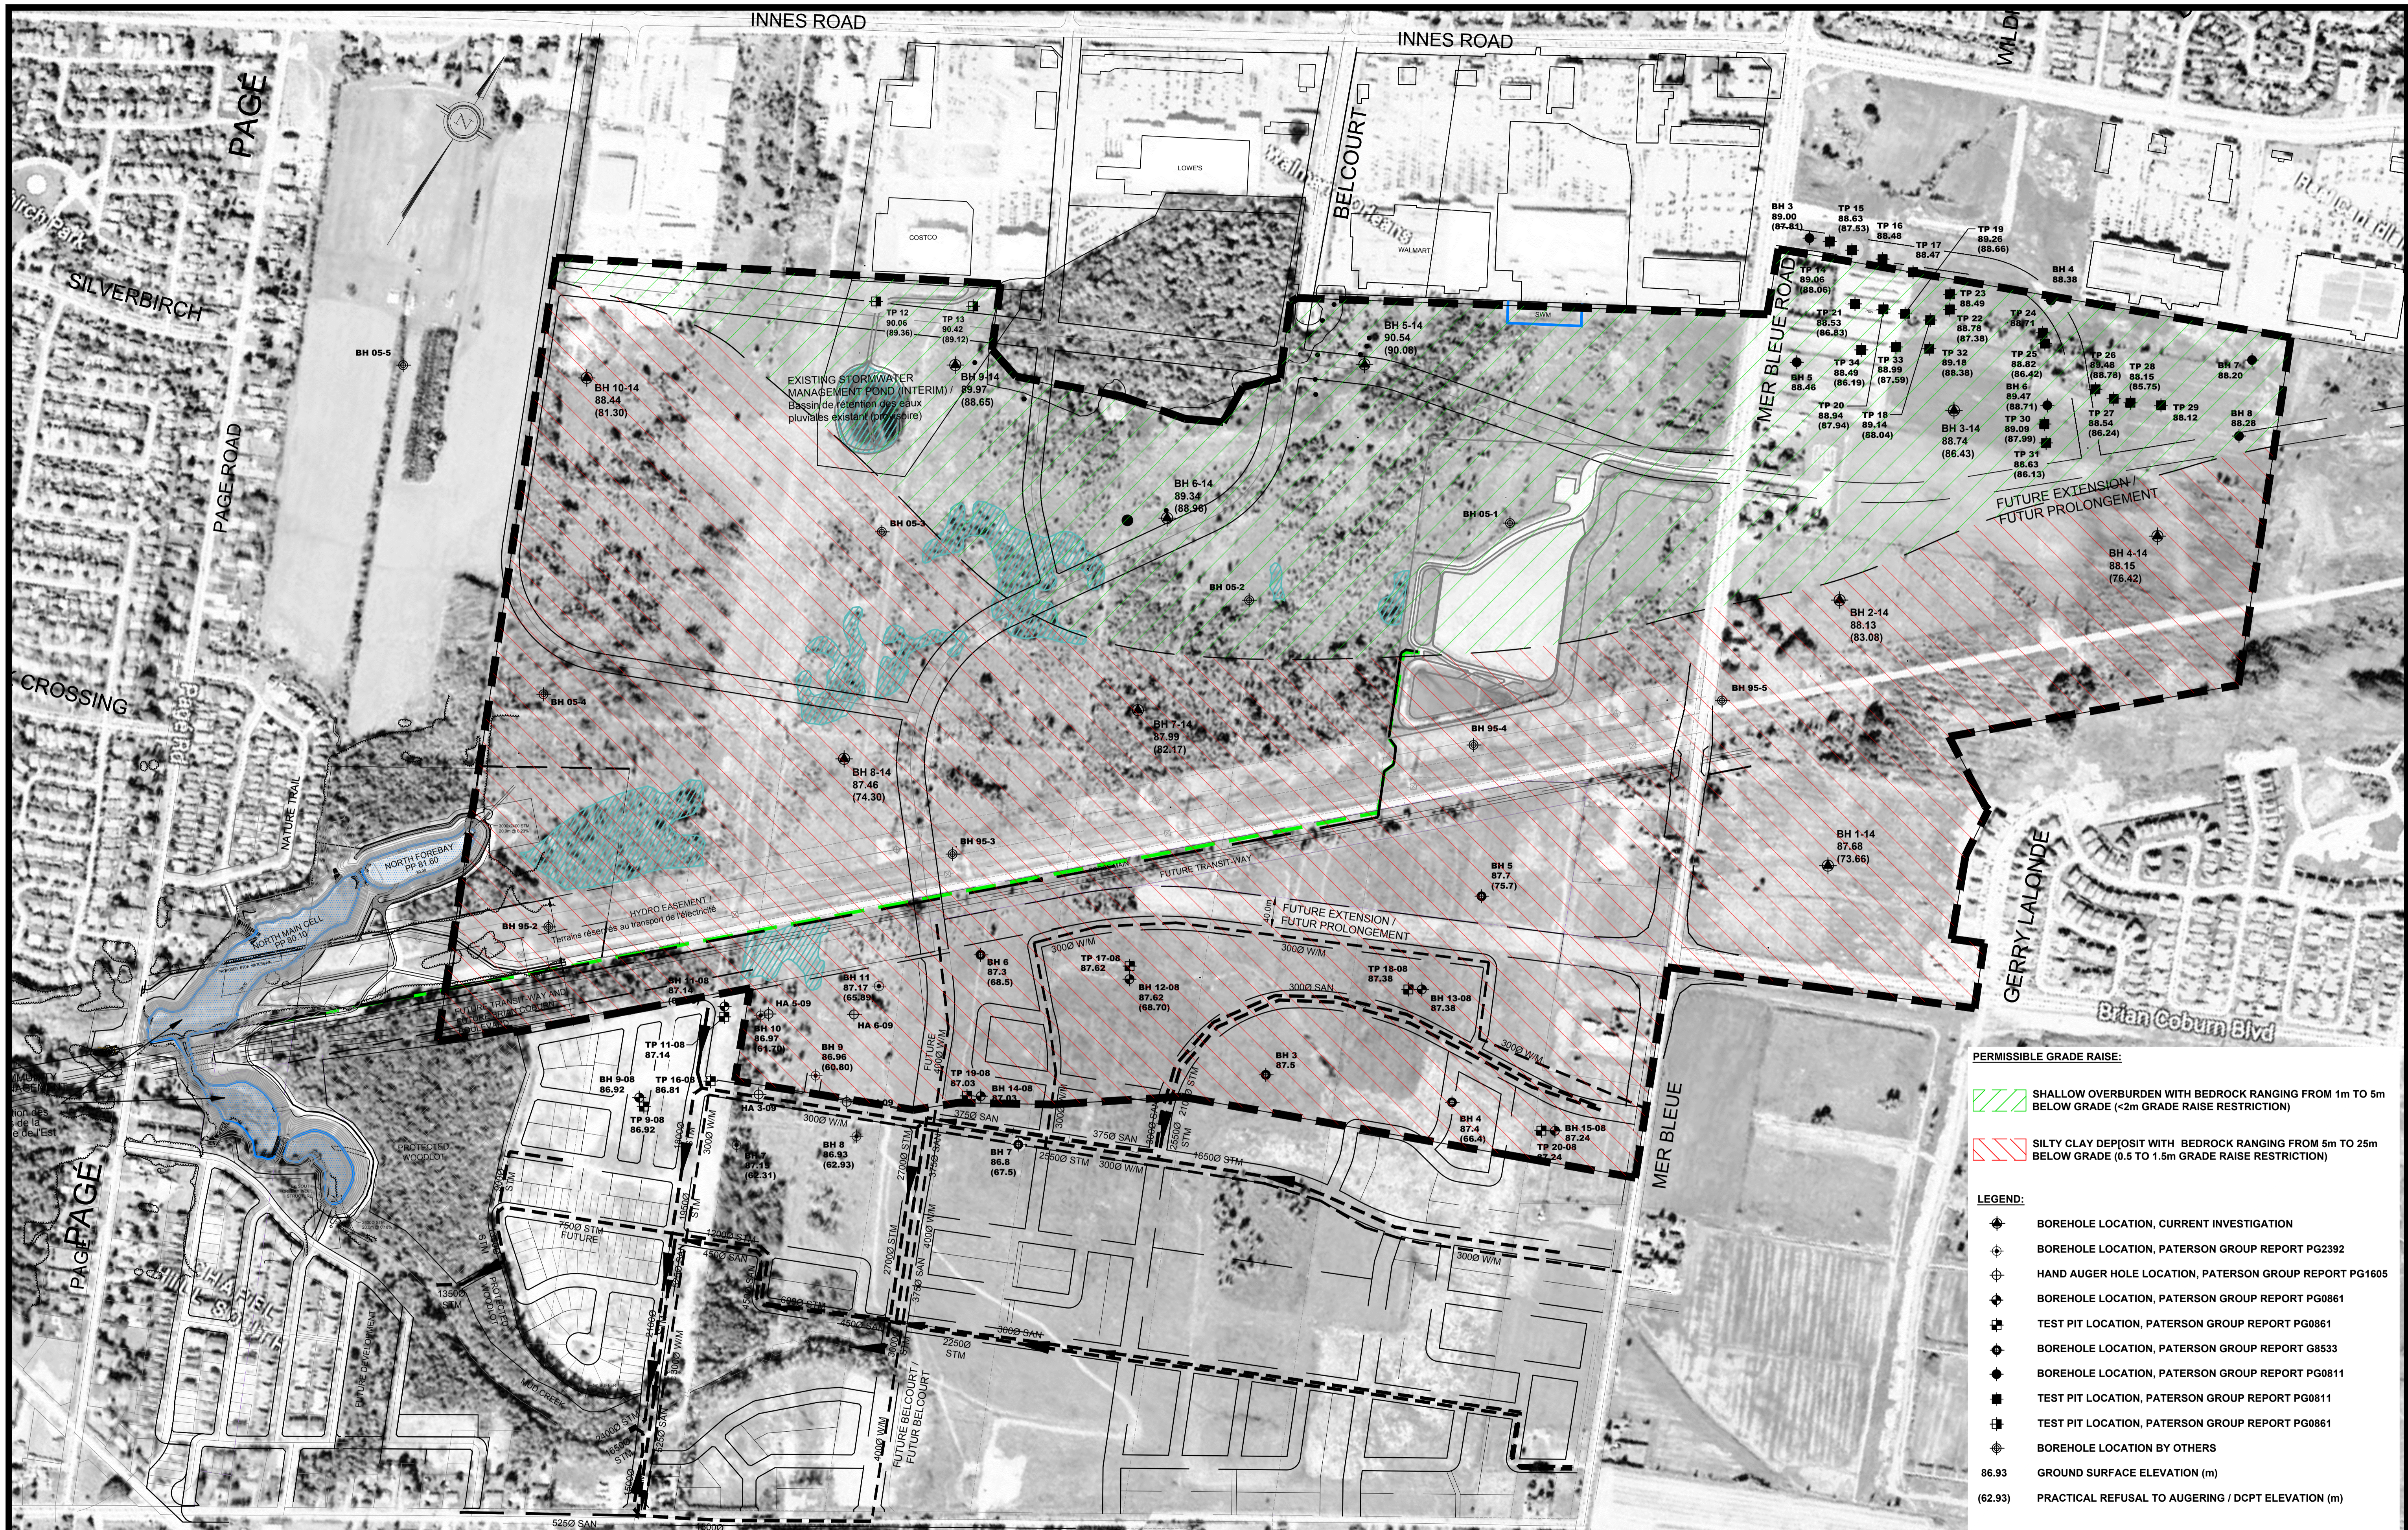
**DRAWING PG3130-7 - PERMISSIBLE GRADE RAISE PLAN**

Preliminary permissible grade raise recommendations have been designed based on the existing soils information. The recommended permissible grade raise areas are presented in Drawing PG3130-7 - Permissible Grade Raise Plan in Appendix 2. If higher than permissible grade raises are required, preloading with or without a surcharge, lightweight fill and/or other measures should be investigated to reduce the risks of unacceptable long-term post construction total and differential settlements.

The recommended permissible grade raise areas for buildings are defined in Drawing PG3130-7 - Permissible Grade Raise Plan in Appendix 2.

Where the grade raise is close to, but below, the maximum permissible grade raise, consideration should be given to using more reinforcement in the design of the foundation (footings and walls) to reduce the risks of cracking in the concrete foundation. The use of control joints within the brick work between the garage and basement area should also be considered.
