Niblett Environmental Associates Inc.

Project No. 13-093

East Urban Community, Mixed Use Center, Community Design Plan (EUC MUC CDP) RE:

Headwater Drainage Feature Assessment Summary

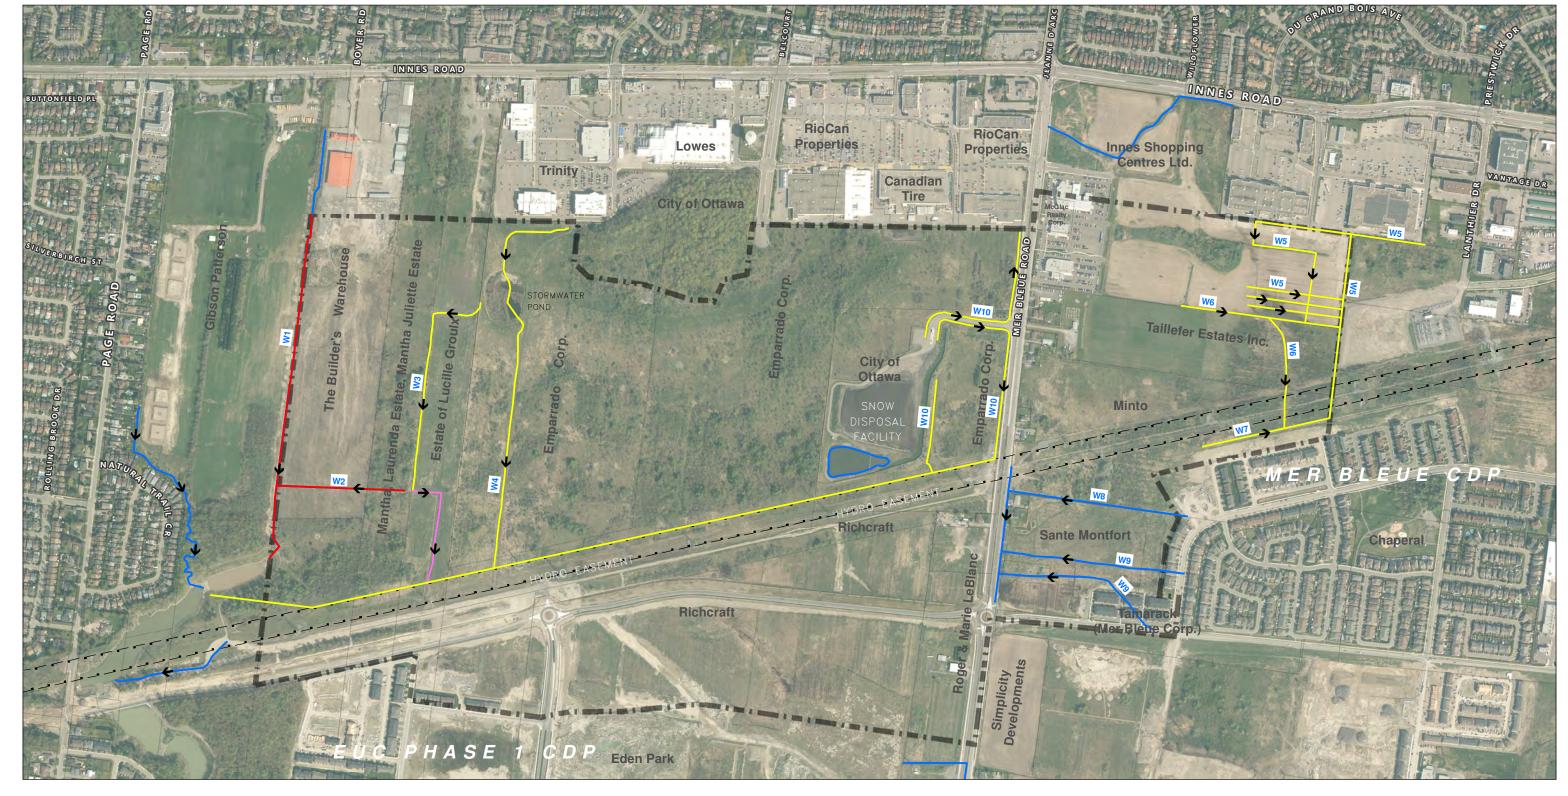
Attachment 1: Figure 1. Headwater Drainage Feature Management Recommendations for the CDP Lands (NEA, 2018).

FIGURE 1: HEADWATER DRAINAGE FEATURE MANAGEMENT RECOMMENDATIONS FOR CDP LANDS

- The feature was an agricultural ditch created to divert surface water flow and was disconnected from surrounding headwater features. Therefore, the feature was classified as No Management Required and verified during the RVCA March 14th, 2018 (Table 1 and Attachment 1). No additional surveys are recommended.
 - The downstream portion of the watercourse (south of the hydro easement) was included in Trails Edge Development DFO Authorization (10-HCAA-CA4-00350),

- The management recommendations were No Management Required (Table 1 and Attachment 1). Therefore, no additional surveys are recommended.
- The downstream portion of the watercourse (south of the hydro easement) was included in Trails Edge Development DFO Authorization (10-HCAA-CA4-00350), dated March 26th, 2013. The permitted works were completed and the feature has been infilled. This portion of the feature was labelled as Reach 4 in Trails Edge Development Plan (NEA, 2013)(Attachment 5). The upstream stormwater flows have been redirected into a drainage feature that runs east-west along the hydro easement and outlets into the stormwater pond.

• The features were created as surface water management ditches for the snow disposal facility and has been realigned to flow into a large stormwater pond directly west of the property. Therefore, the feature should not be managed as a natural headwater drainage feature and No Management is Required (Table 1 and Attachment 1). No additional surveys are recommended.

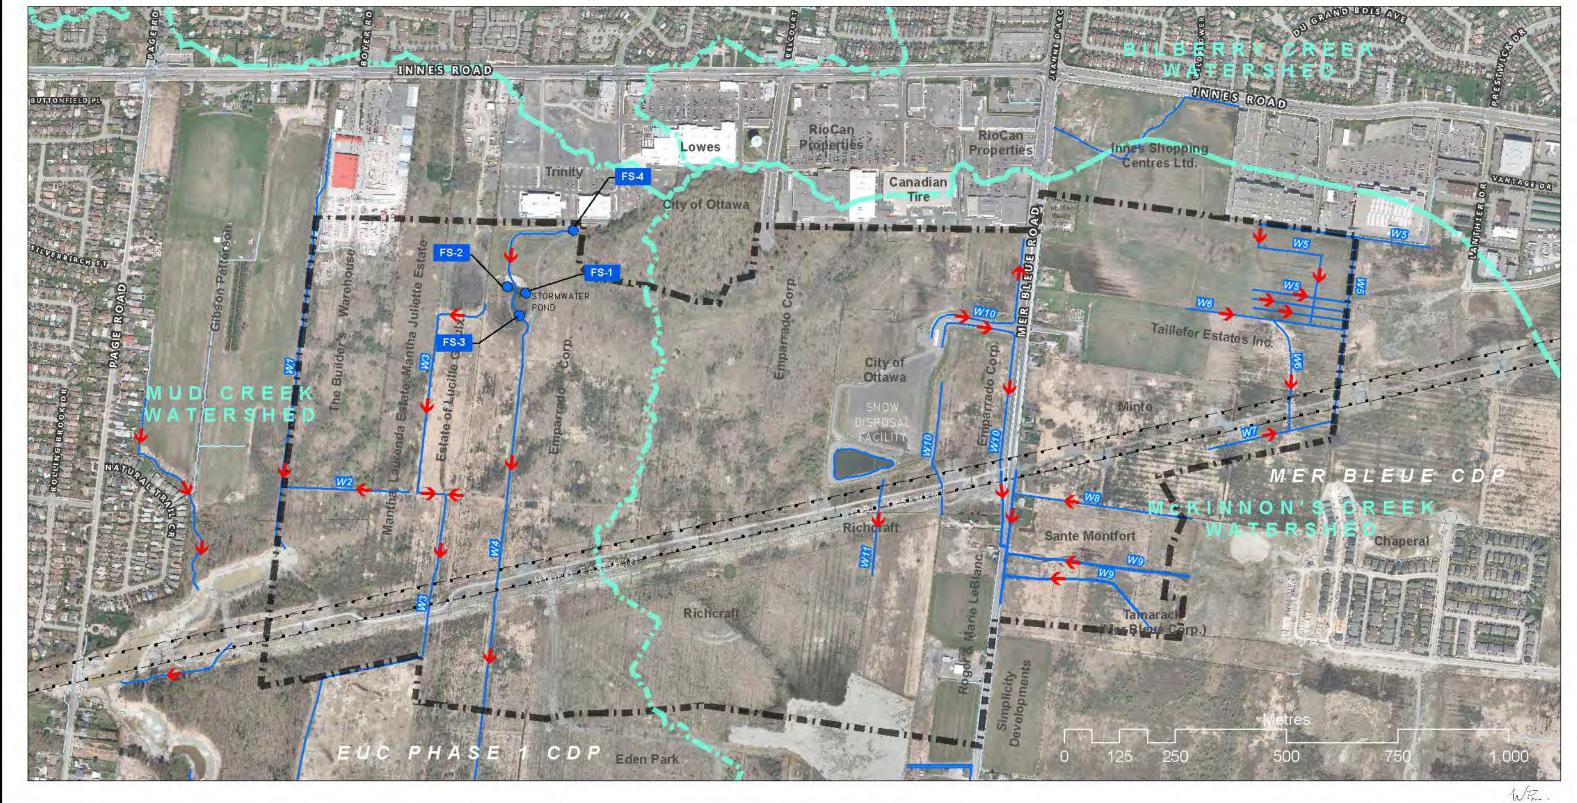
Attachment 2: Figure 2. Watercourse, Aquatic Stations and Flow Direction (NEA, 2015).

NEA conducted a rapid HDF assessment of the CDP watercourses in 2014 and provided the results in the Draft Existing Conditions Report (NEA, 2015). In 2014, 10 potential headwater features were identified within the CDP area (Attachment 2). Since then, several assessments have been conducted on CDP properties that contained watercourses.

FIGURE 2: WATERCOURSES, AQUATIC STATIONS & FLOW DIRECTION

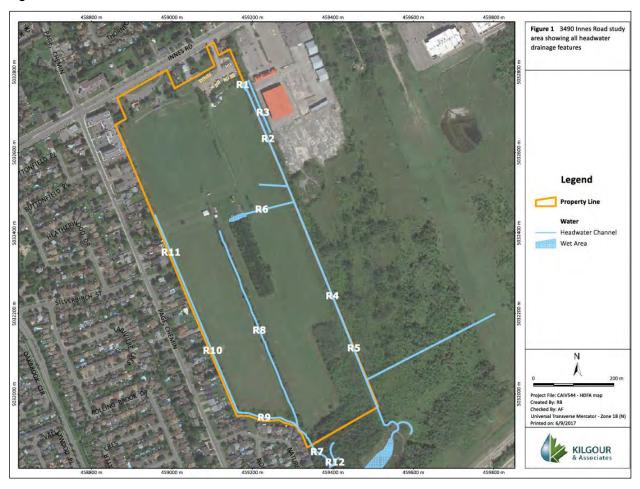
Attachment 3: Figure 1. HDF Reaches (Kilgour & Associates, 2017).

- The 2017 HDF assessments by Kilgour & Associates provide adequate surveys and management recommendations based on the HDF methods (Table 1). Therefore, no additional surveys are recommended.
- Kilgour & Associates conducted a standard HDF assessment on this watercourse in 2016 and classified the management recommendation as Mitigation. Details can be found in *Headwater Drainage Feature Assessment 3490 Innes Road Development* (Kilgour & Associates, 2017). The watercourse was divided into four reaches (Attachment 3).
- W1 is within Rideau Valley Conservation Authority jurisdiction.

Figure 1. HDF reaches

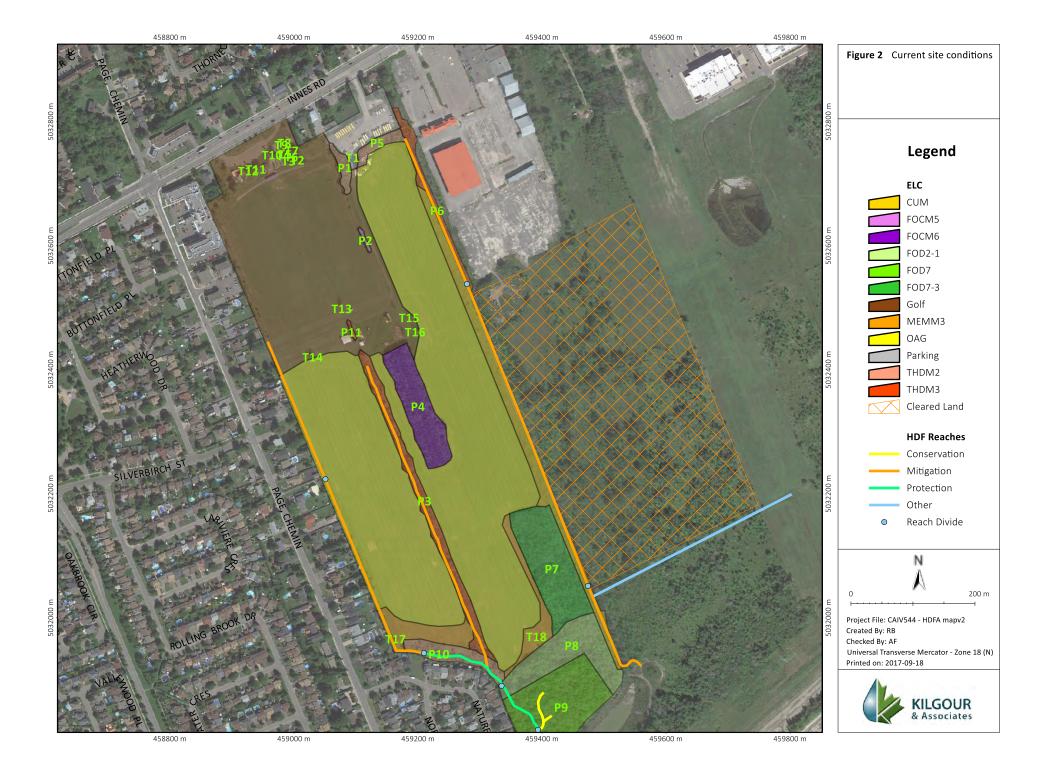
Attachment 4: Figure 2 Current Site Conditions (Kilgour & Associates, 2017).

Attachment 4: Figure 2 Current Site Conditions extracted from the Environmental Impact Statement for 3490 Innes Road, Orleans, Ontario (Kilgour & Associates, 2017).

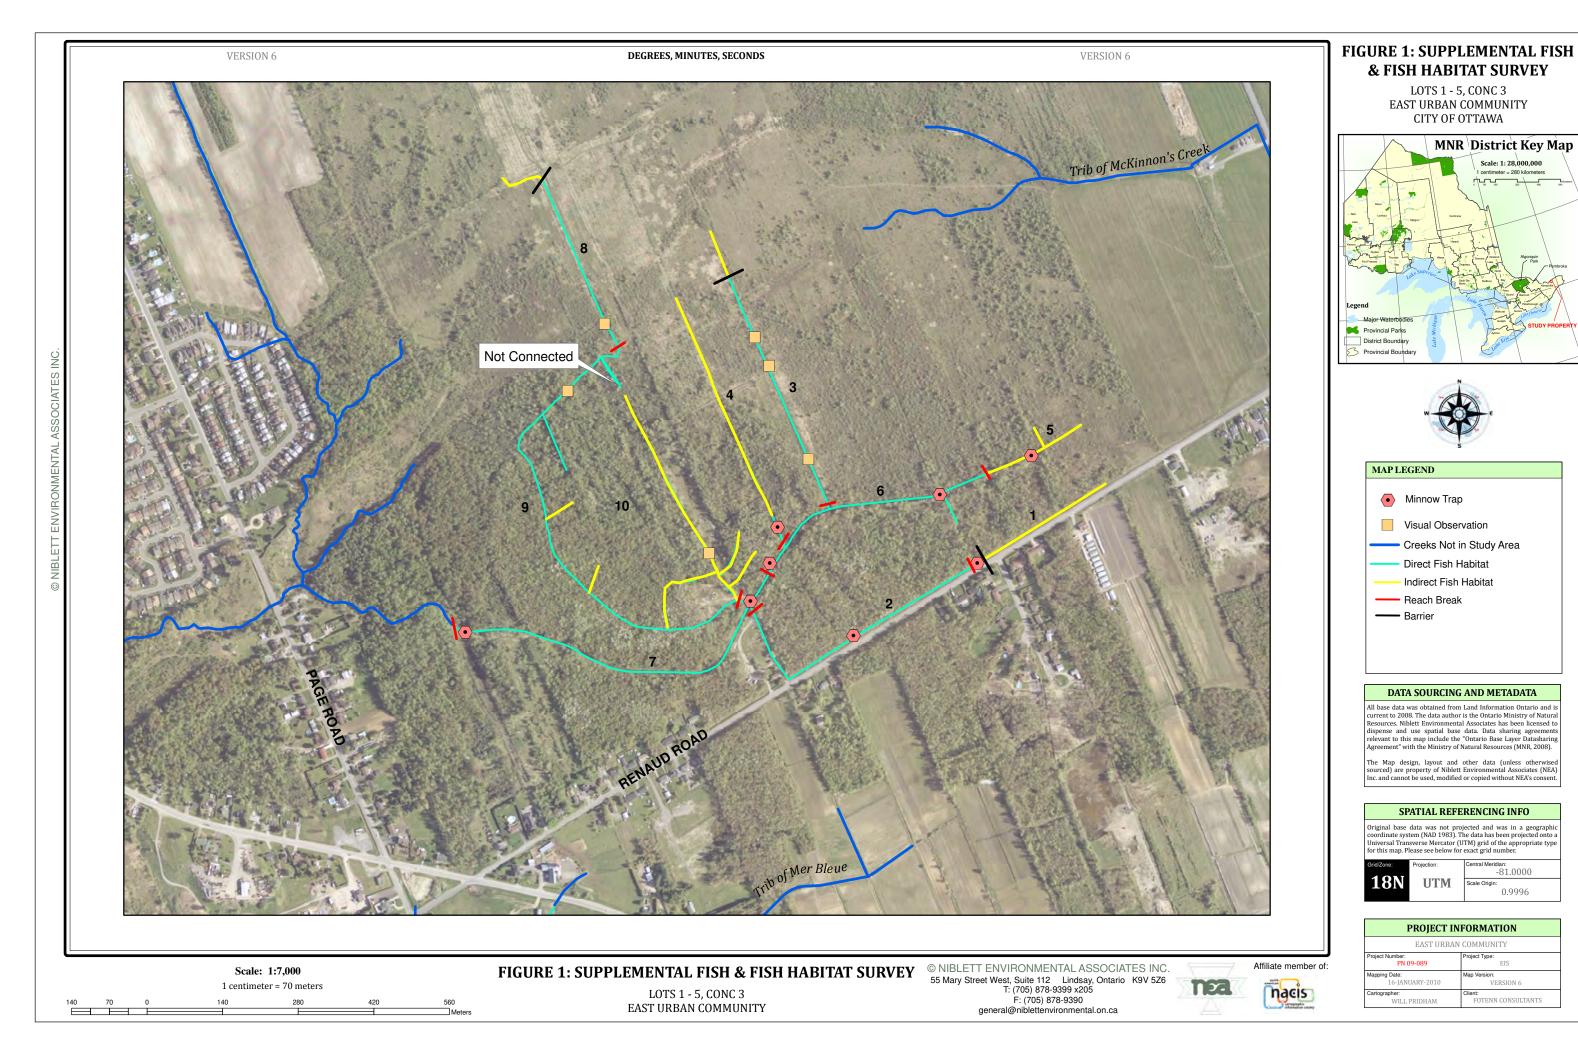
Attachment 5: Figure 1. Supplemental Fish and Fish Habitat Survey (NEA, 2013).

dated March 26th, 2013. The permitted works were completed and the feature has been infilled. This portion of the feature was labelled as Reach 8 in Trails Edge Development Plan (NEA, 2013), refer to Attachment 5. The upstream flows were redirected into a drainage feature that runs east-west along the hydro easement and outlets into the stormwater pond.

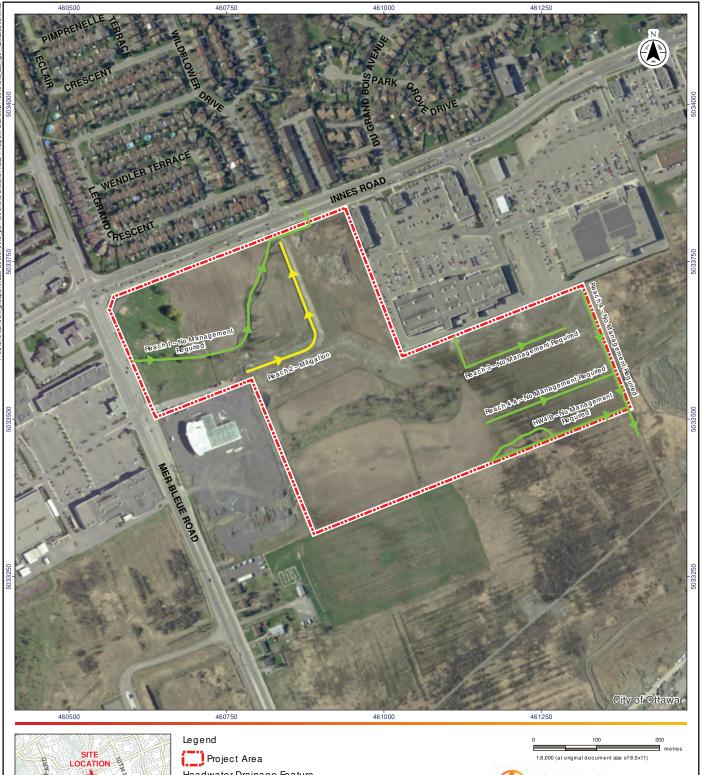
Attachment 6: Figure 3. Headwater Drainage Feature Management Recommendations (Stantec, 2016).

- Stantec conducted a standard HDF assessment on the watercourse in 2016. Details can be found in the *Environmental Impact Statement with Headwaters Assessment for 4100 Innes Road/2025 Mer Bleue Road* (Stantec, 2016).
 - The watercourse was divided into two reaches, HDF 3 and HF4. Refer to Attachment 6.
 - o The Management Recommendations were identified as follows:
 - HDF 3-No Management Required
 - HDF 4 (Reach 4-A)-No Management Required
- The 2016 HDF assessments by Stantec provides adequate management recommendation based on HDF methods (Table 1). Therefore, no additional surveys are recommended.
- W5 is within Rideau Valley and South Nation Conservation Authority jurisdiction.

• Stantec conducted a standard HDF assessment on the northern reach of this watercourse in 2016 (Attachment 6). Details can be found in the *Environmental Impact Statement with Headwaters Assessment for 4100 Innes Road/2025 Mer Bleue Road* (Stantec, 2016).

Headwater Drainage Feature Management Recommendations

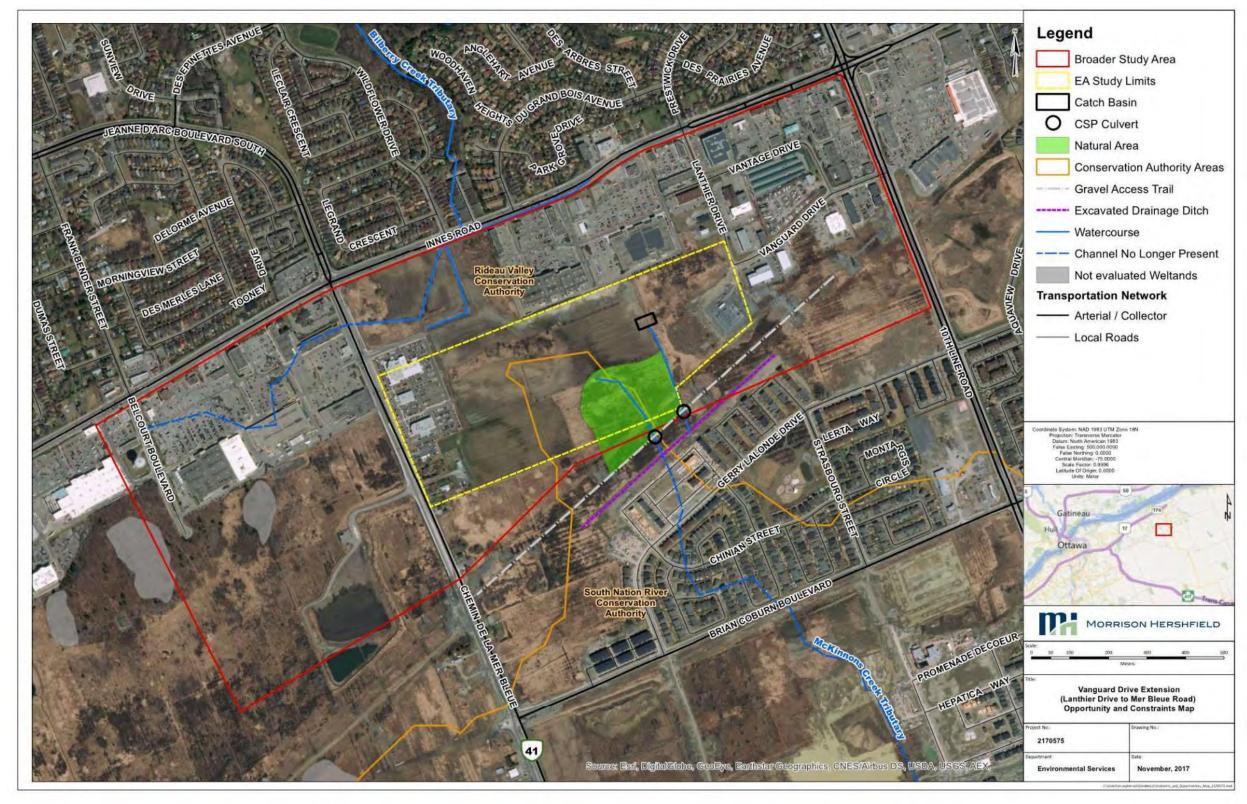
Attachment 7:

- The management recommendations were identified as follows; HDF 4 (Reach 4-B) - No management required.
- Morrison Hershfield confirmed a reach of the southern portion of W6 was no longer present in 2017 (Attachment 7). Details can be found in the *Vanguard Drive EA-Fisheries Existing Conditions Memo* (Morrison Hershfield, 2017).
- The southern reach was not included in the Stantec, 2016 report. However, all of the headwater features will be diverted north into the storm sewer at Wildflower and Innes Road (per the "Site Servicing and Stormwater Management Report Orleans II Development Rezoning" (Stantec, 2016); consequently, dehydrating the downstream feature. Therefore, no additional surveys are required and feature has been classified No Management Required (Table 1 and Attachment 1).
- W6 is within South Nation Conservation Authority.

Figure 1: Overview Map of Vanguard Drive Study Areas and Aquatic Habitat Values
