Environmental Impact Statement -Green Lands in Richmond Village

# **Revised Report**

August 31, 2022

Caivan (Richmond North) Ltd 2934 Baseline Road, Suite 302 Ottawa, ON K2H 1B2

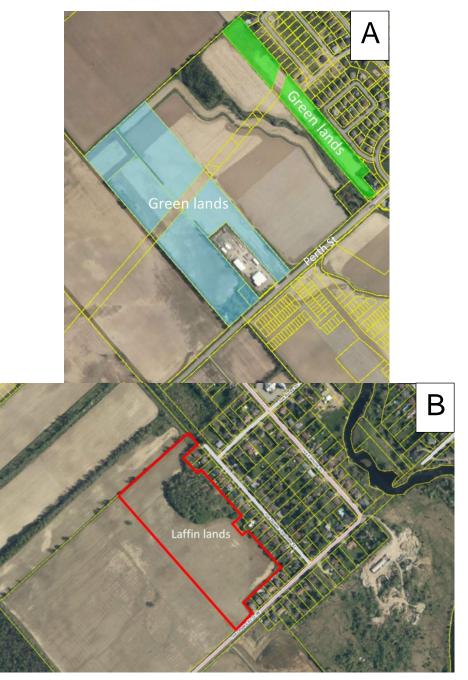
Figure 1 Map showing the locations of the Green lands (Panel A; blue and green parcels) and the Laffin lands (Panel B; outlined in red)

Current land use to the west of the more westerly Green lands parcel and to the north of both Green lands parcels is agricultural. Lands to the west and north of Laffin lands and between the two Green lands parcels are former agricultural fields that are currently undergoing regrading and preloading in preparation for site development. Lands to the east of both the Green and Laffin lands are village residential.

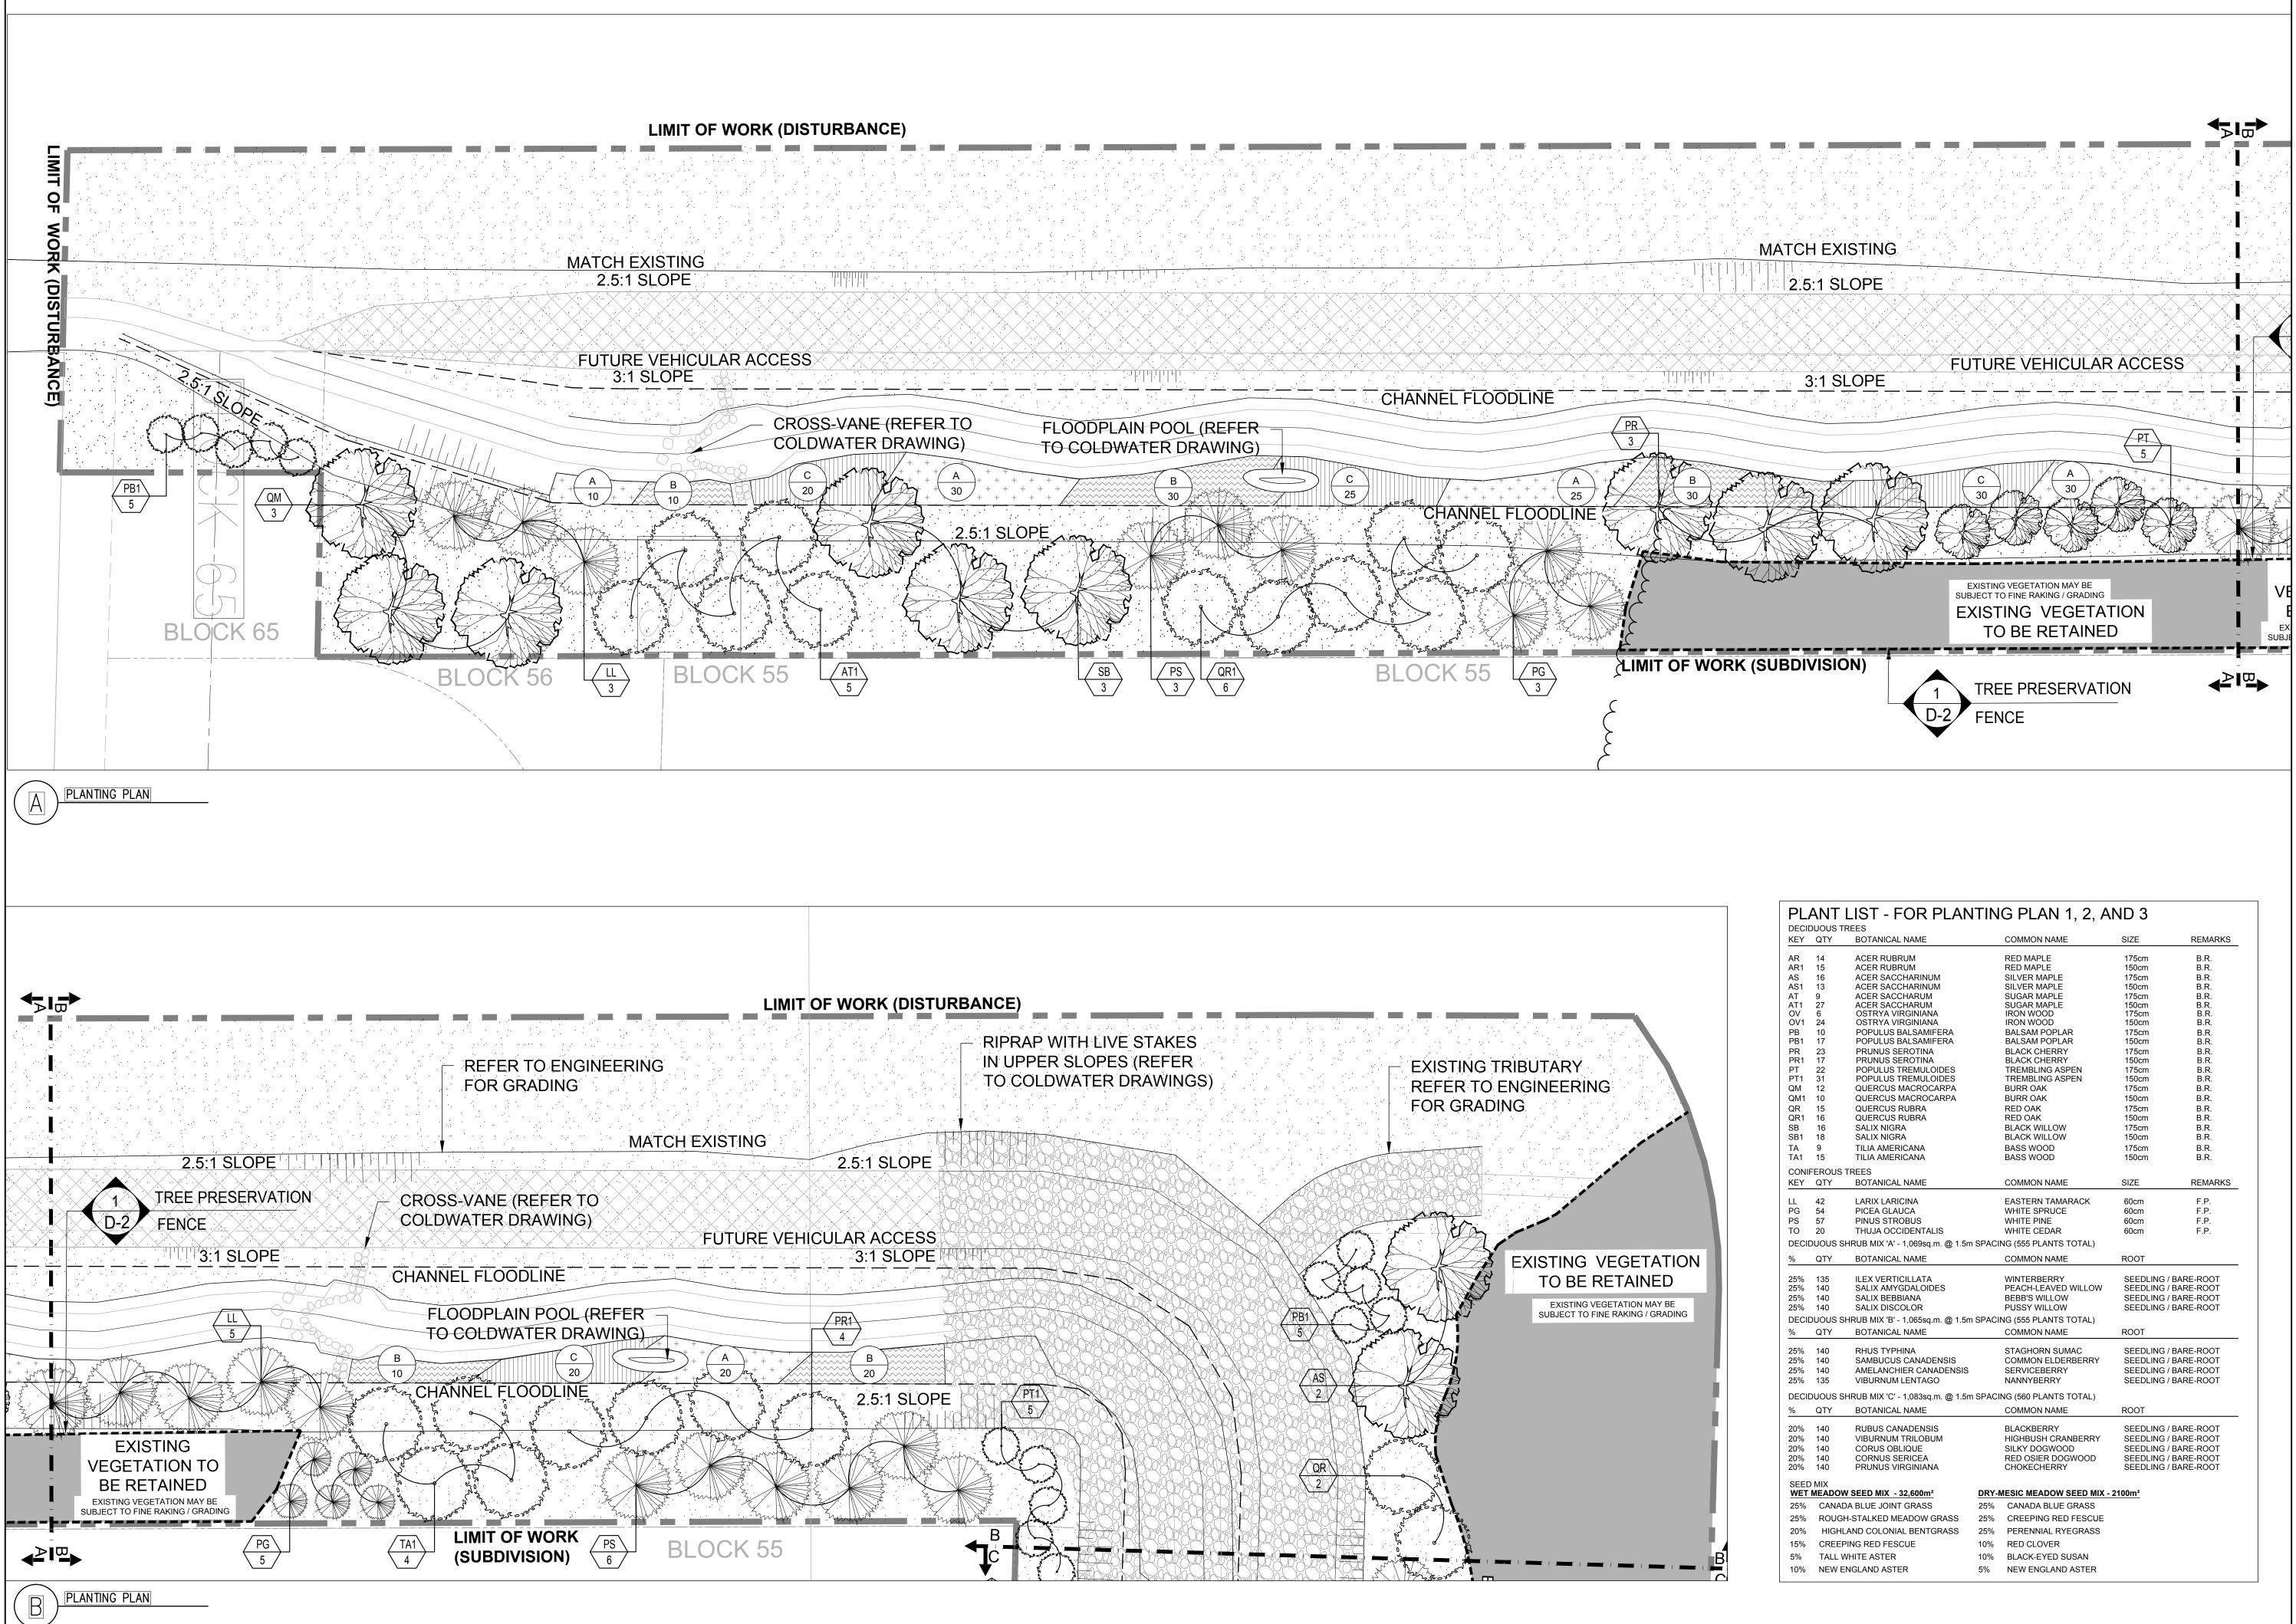
PLANTING PLAN I JANUARY 2015 Date Sheet Scale NTS Ρ1 Drawn AB Checked LM

BOTANICAL NAME		COMMON NAME	SIZE	REMARKS
	ACER RUBRUM		RED MAPLE	175cm	B.R.
	ACER RUBRUM		RED MAPLE	150cm	B.R.
	ACER SACCHARINUM ACER SACCHARINUM		SILVER MAPLE SILVER MAPLE	175cm 150cm	B.R. B.R.
	ACER SACCHARINOM		SUGAR MAPLE	175cm	B.R.
	ACER SACCHARUM		SUGAR MAPLE	150cm	B.R.
	OSTRYA VIRGINIANA		IRON WOOD	175cm	B.R.
	OSTRYA VIRGINIANA POPULUS BALSAMIFERA		IRON WOOD	150cm	B.R.
	POPULUS BALSAMIFERA		BALSAM POPLAR BALSAM POPLAR	175cm 150cm	B.R. B.R.
	PRUNUS SEROTINA		BLACK CHERRY	175cm	B.R.
	PRUNUS SEROTINA		BLACK CHERRY	150cm	B.R.
	POPULUS TREMULOIDES		TREMBLING ASPEN	175cm	B.R.
	POPULUS TREMULOIDES		TREMBLING ASPEN	150cm	B.R.
	QUERCUS MACROCARPA QUERCUS MACROCARPA		BURR OAK BURR OAK	175cm 150cm	B.R. B.R.
	QUERCUS MACROCARPA		RED OAK	175cm	B.R.
	QUERCUS RUBRA		RED OAK	150cm	B.R.
	SALIX NIGRA		BLACK WILLOW	175cm	B.R.
	SALIX NIGRA		BLACK WILLOW	150cm	B.R.
	TILIA AMERICANA		BASS WOOD	175cm	B.R.
_			BASS WOOD	150cm	B.R.

1	REES BOTANICAL NAME		COMMON NAME	SIZE	REMARKS
	LARIX LARICINA		EASTERN TAMARACK	60cm	F.P.
	PICEA GLAUCA		WHITE SPRUCE	60cm	F.P.
	PINUS STROBUS		WHITE PINE	60cm	F.P.
	THUJA OCCIDENTALIS		WHITE CEDAR	60cm	F.P.
зH	RUB MIX 'A' - 1,069sq.m. @ 1.5m	SPAC	NG (555 PLANTS TOTAL)		
	BOTANICAL NAME		COMMON NAME	ROOT	
	ILEX VERTICILLATA		WINTERBERRY	SEEDLING /	BARE-ROOT
	SALIX AMYGDALOIDES		PEACH-LEAVED WILLOW		BARE-ROOT
	SALIX BEBBIANA		BEBB'S WILLOW		BARE-ROOT
	SALIX DISCOLOR		PUSSY WILLOW	SEEDLING /	BARE-ROOT
Η	RUB MIX 'B' - 1,065sq.m. @ 1.5m	SPAC	(	DOOT	
	BOTANICAL NAME		COMMON NAME	ROOT	
	RHUS TYPHINA		STAGHORN SUMAC		BARE-ROOT
	SAMBUCUS CANADENSIS		COMMON ELDERBERRY		BARE-ROOT
	AMELANCHIER CANADENSIS VIBURNUM LENTAGO		SERVICEBERRY NANNYBERRY		BARE-ROOT
				SEEDLING /	DARE-RUUT
. 1	RUB MIX 'C' - 1,083sq.m. @ 1.5m BOTANICAL NAME	I SPAC	COMMON NAME	ROOT

-	RUBUS CANADENSIS				
	VIBURNUM TRILOBUM		BLACKBERRY HIGHBUSH CRANBERRY		' BARE-ROOT ' BARE-ROOT
	CORUS OBLIQUE		SILKY DOGWOOD		BARE-ROOT
	CORNUS SERICEA		RED OSIER DOGWOOD		BARE-ROOT
	PRUNUS VIRGINIANA		CHOKECHERRY	SEEDLING /	BARE-ROOT
v	SEED MIX - 32,600m <sup>2</sup>	DRY-	MESIC MEADOW SEED MIX -	2100m²	
	BLUE JOINT GRASS	25%	CANADA BLUE GRASS		
H-	STALKED MEADOW GRASS	25%	CREEPING RED FESCUE		
A	ND COLONIAL BENTGRASS	25%	PERENNIAL RYEGRASS		
	IG RED FESCUE	10%	RED CLOVER		
	ITE ASTER	10%	BLACK-EYED SUSAN		
	GLAND ASTER	10% 5%	NEW ENGLAND ASTER

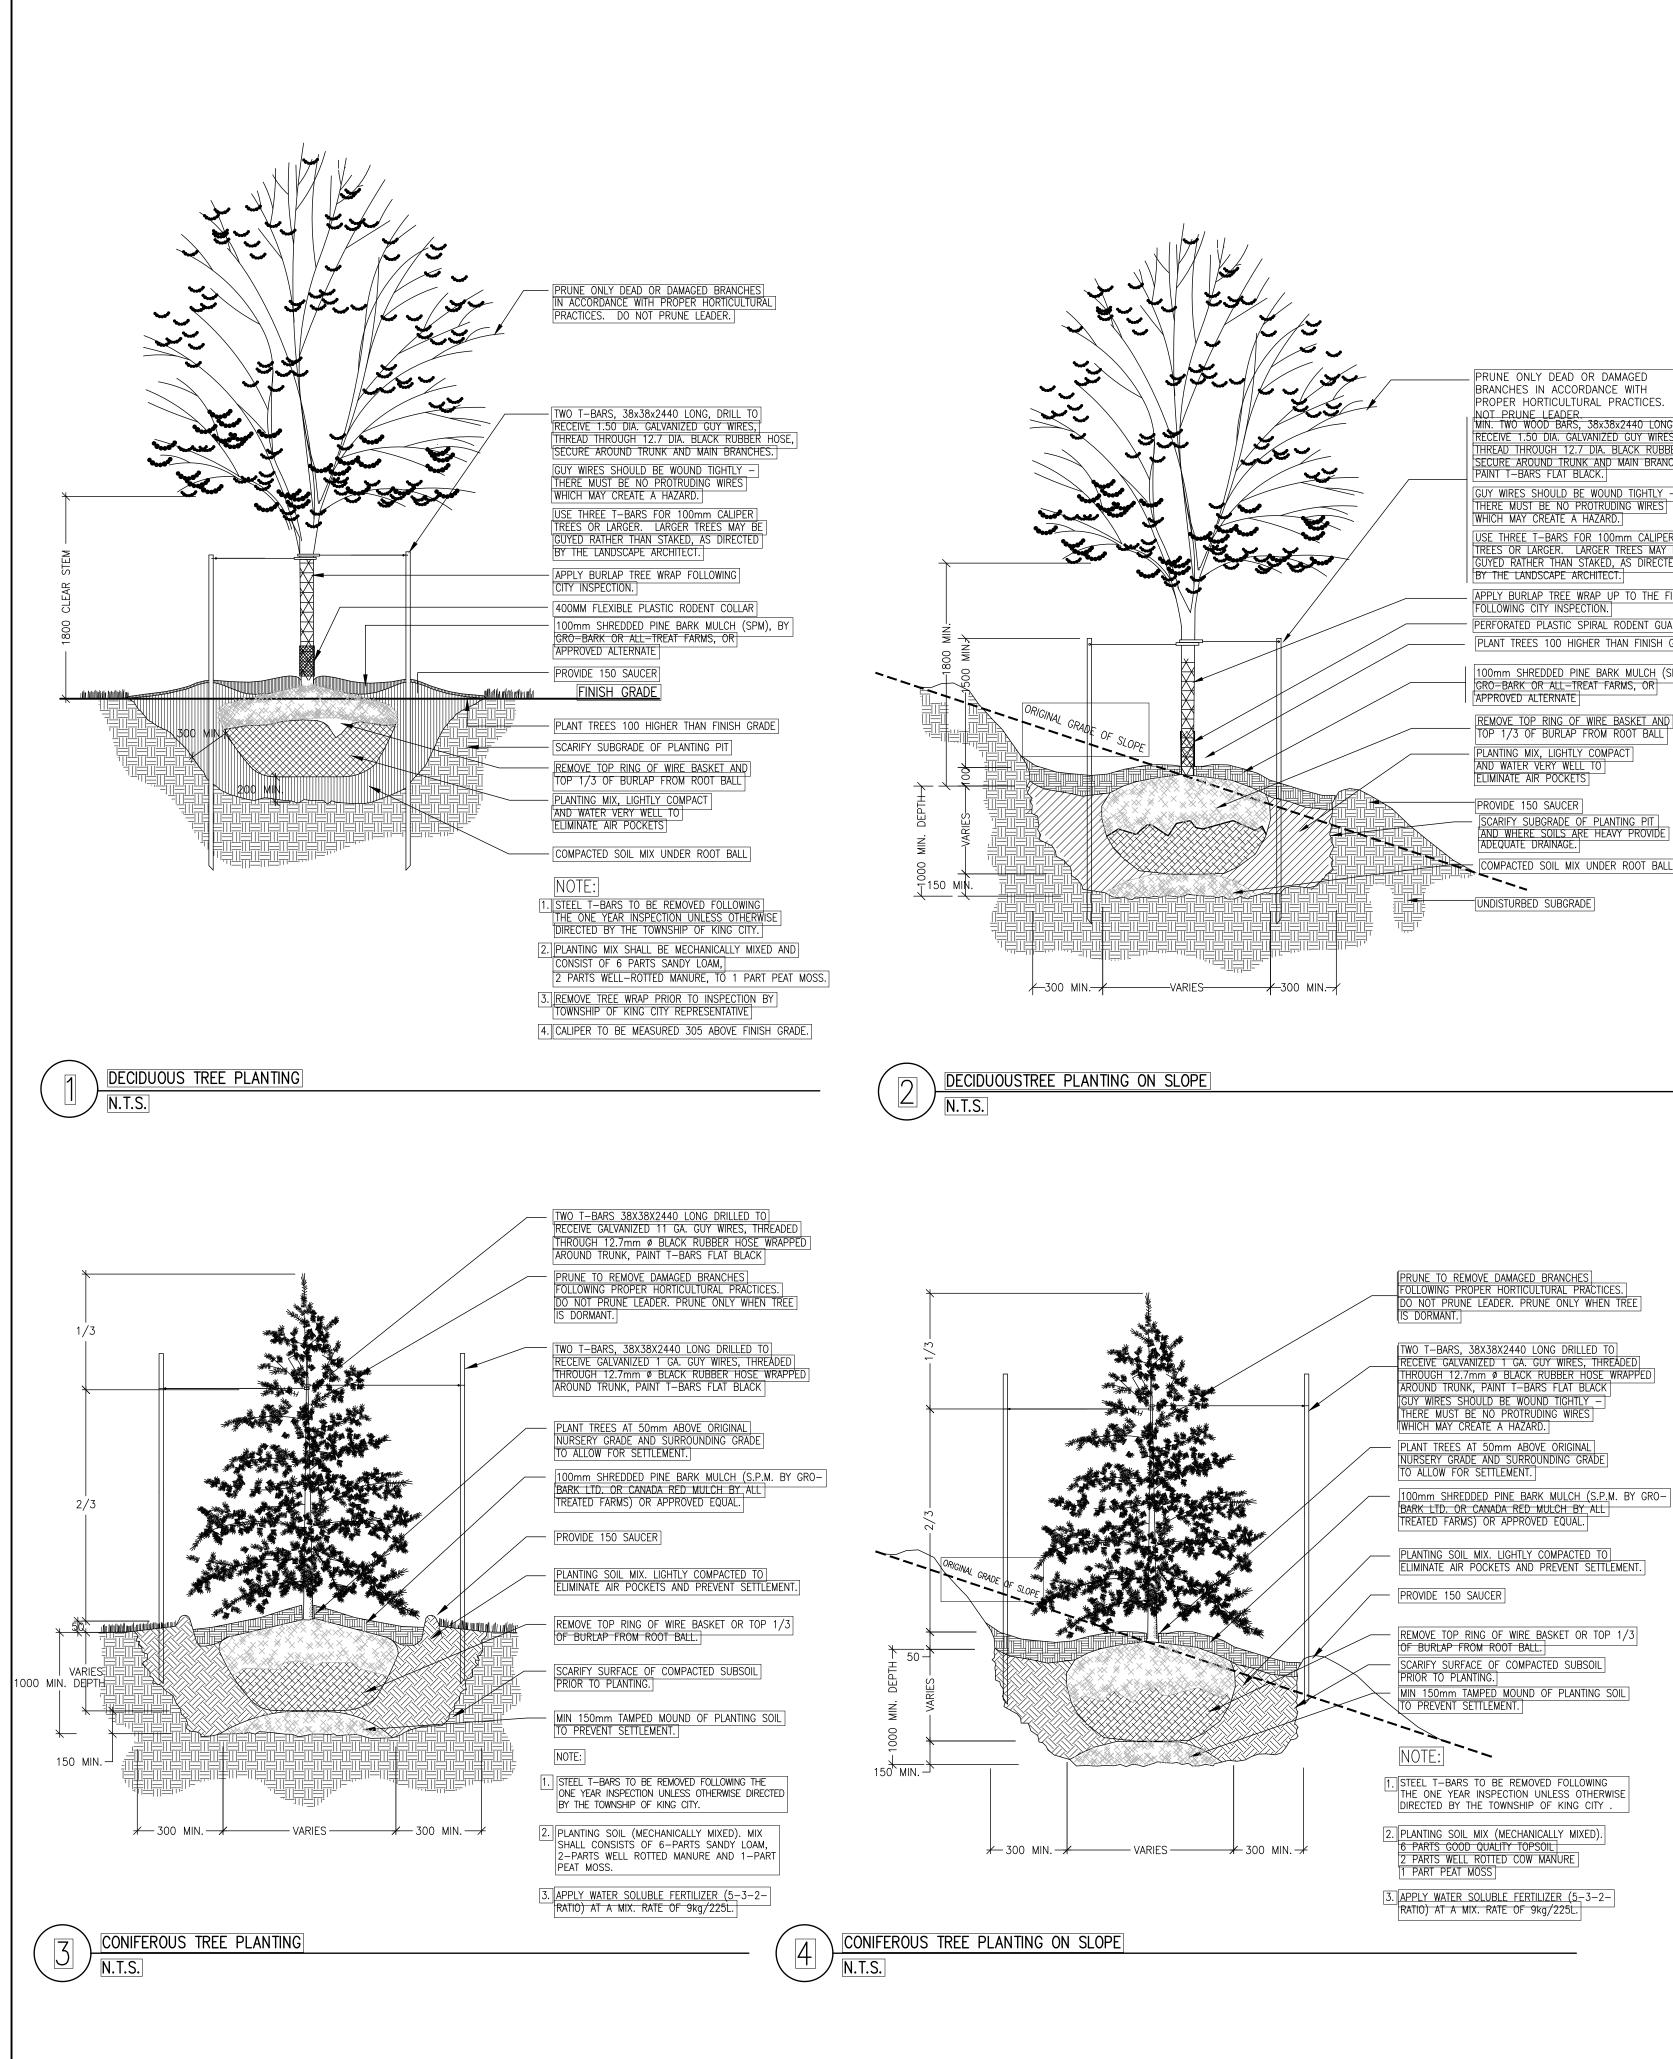
DETAIL SHEET

# PROPER HORTICULTURAL PRACTICES. DO NOT PRUNE LEADER. MIN. TWO WOOD BARS, 38x38x2440 LONG, DRILL TO RECEIVE 1.50 DIA. GALVANIZED GUY WIRES, THREAD THROUGH 12.7 DIA. BLACK RUBBER HOSE,

SECURE AROUND TRUNK AND MAIN BRANCHES. GUY WIRES SHOULD BE WOUND TIGHTLY THERE MUST BE NO PROTRUDING WIRES WHICH MAY CREATE A HAZARD. JSE THREE T–BARS FOR 100mm CALIPER IREES OR LARGER. LARGER TREES MAY BE GUYED RATHER THAN STAKED, AS DIRECTED BY THE LANDSCAPE ARCHITECT. APPLY BURLAP TREE WRAP UP TO THE FIRST BRANCH FOLLOWING CITY INSPECTION. PERFORATED PLASTIC SPIRAL RODENT GUARD PLANT TREES 100 HIGHER THAN FINISH GRADE 100mm SHREDDED PINE BARK MULCH (SPM), BY GRO-BARK OR ALL-TREAT FARMS, OR APPROVED ALTERNATE REMOVE TOP RING OF WIRE BASKET AND TOP 1/3 OF BURLAP FROM ROOT BALL PLANTING MIX, LIGHTLY COMPACT AND WATER VERY WELL TO ELIMINATE AIR POCKETS PROVIDE 150 SAUCER SCARIFY SUBGRADE OF PLANTING PIT AND WHERE SOILS ARE HEAVY PROVIDE ADEQUATE DRAINAGE. COMPACTED SOIL MIX UNDER ROOT BALL UNDISTURBED SUBGRADE

SHRUB PLANTING - SLOPES N.T.S. NOTES: ALL MEASUREMENTS AND DIMENSIONS ARE IN MILLIMETERS. BARE ROOT SHOULD BE PLANTED DURING THE DORMANT SEASON. PREFERABLY PLANT ON CLOUDY, COOL HUMID DAYS. PROTECT ROOTS FROM WIND AND SUN EXPOSURE. BARE ROOTS SHOULD BE KEPT MOIST AND PLANTED IMMEDIATELY. SOAK ROOTS COMPLETELY PRIOR TO PLANTING. UNHEALTHY PLANTS SHOULD NOT BE PLANTED. ORIGINAL (NATIVE) SOIL SHOULD BE GENTLY BACKFILLED AROUND THE ROOTS WHILE HOLDING THE PLANT IN PLACE. ENSURE THE PLANT IS VERTICAL AND ADEQUATELY SUPPORTED. ADD WATER TO THE BACKFILLED AREA UNTIL A SOUPY CONSISTENCY TO REMOVE AIR POCKETS. STAKES TO BE REMOVED AT COMPLETION OF THE TWO YEAR WARRANTY PERIOD. MONITOR WEEDS, SOIL MOISTURE AND GENERAL PLANT HEALTH. PROVIDE WEED MAINTENANCE, SUPPLEMENTAL IRRIGATION, AND PLANT CARE AS NEEDED OVER THE GROWING SEASON.

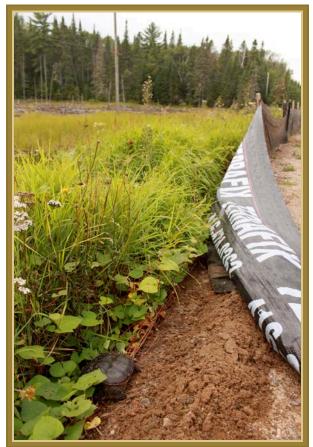
Plate 1. Light-duty geotextile fencing with preattached wooden stakes used to exclude turtles from a road as seen on a regular maintenance check (photo credit: Brad Steinberg).

Generally, light-duty geotextile fences are not effective if they exceed 1 metre in height unless purposely manufactured for greater height (e.g. stakes placed at closer intervals or cross braces). If greater height is required consider using heavy duty geotextile, hardware cloth or other fencing materials.

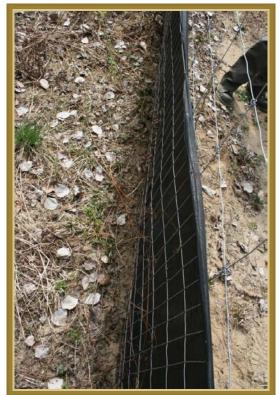
Plate 2. Example of a heavy-duty geotextile fencing used to exclude snake species (photo credit: Jeremy Rouse).

- The wire fence should be installed on the activity side to prevent animals from leveraging and climbing into the exclusion area while allowing the animal to escape if they find themselves on the wrong side (Figure 2).
- Geotextile fences across streams, ditches or waterways should have case-specific modifications.
- Contact your local MNR staff or experienced exclusion fencing contractor for advice.
- See light-duty geotextile section above and general best practices below for additional details.

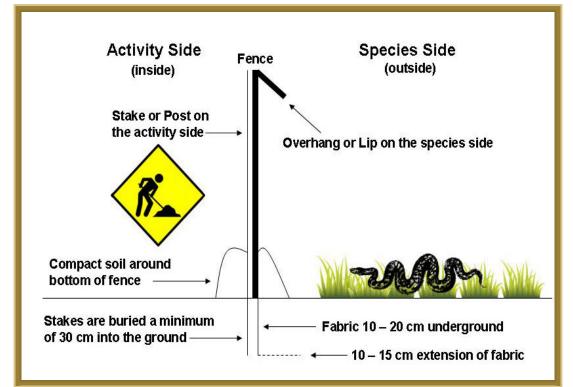
Figure 1. A side view of a basic exclusion fence including an overhang or flexible lip to deter animals from climbing or jumping over the fence. Placement of the stake on the Activity Side or on the inside of excluded area is also illustrated. This is particularly important for snake species which may use the stakes to maneuver over the fence.

- Fence posts should be closer together in undulating topography.
- Fences installed on slopes have a different effective height depending upon whether the animal will be approaching from the up or down slope. The fence height can be adjusted accordingly.
