March 28th, 2018

Project No. 13-093

**RE: East Urban Community, Mixed Use Center, Community Design Plan (EUC MUC CDP)
Part Lots 8 & 9, Concession 1,
Ottawa, Ontario**

Headwater Drainage Feature Assessment Summary

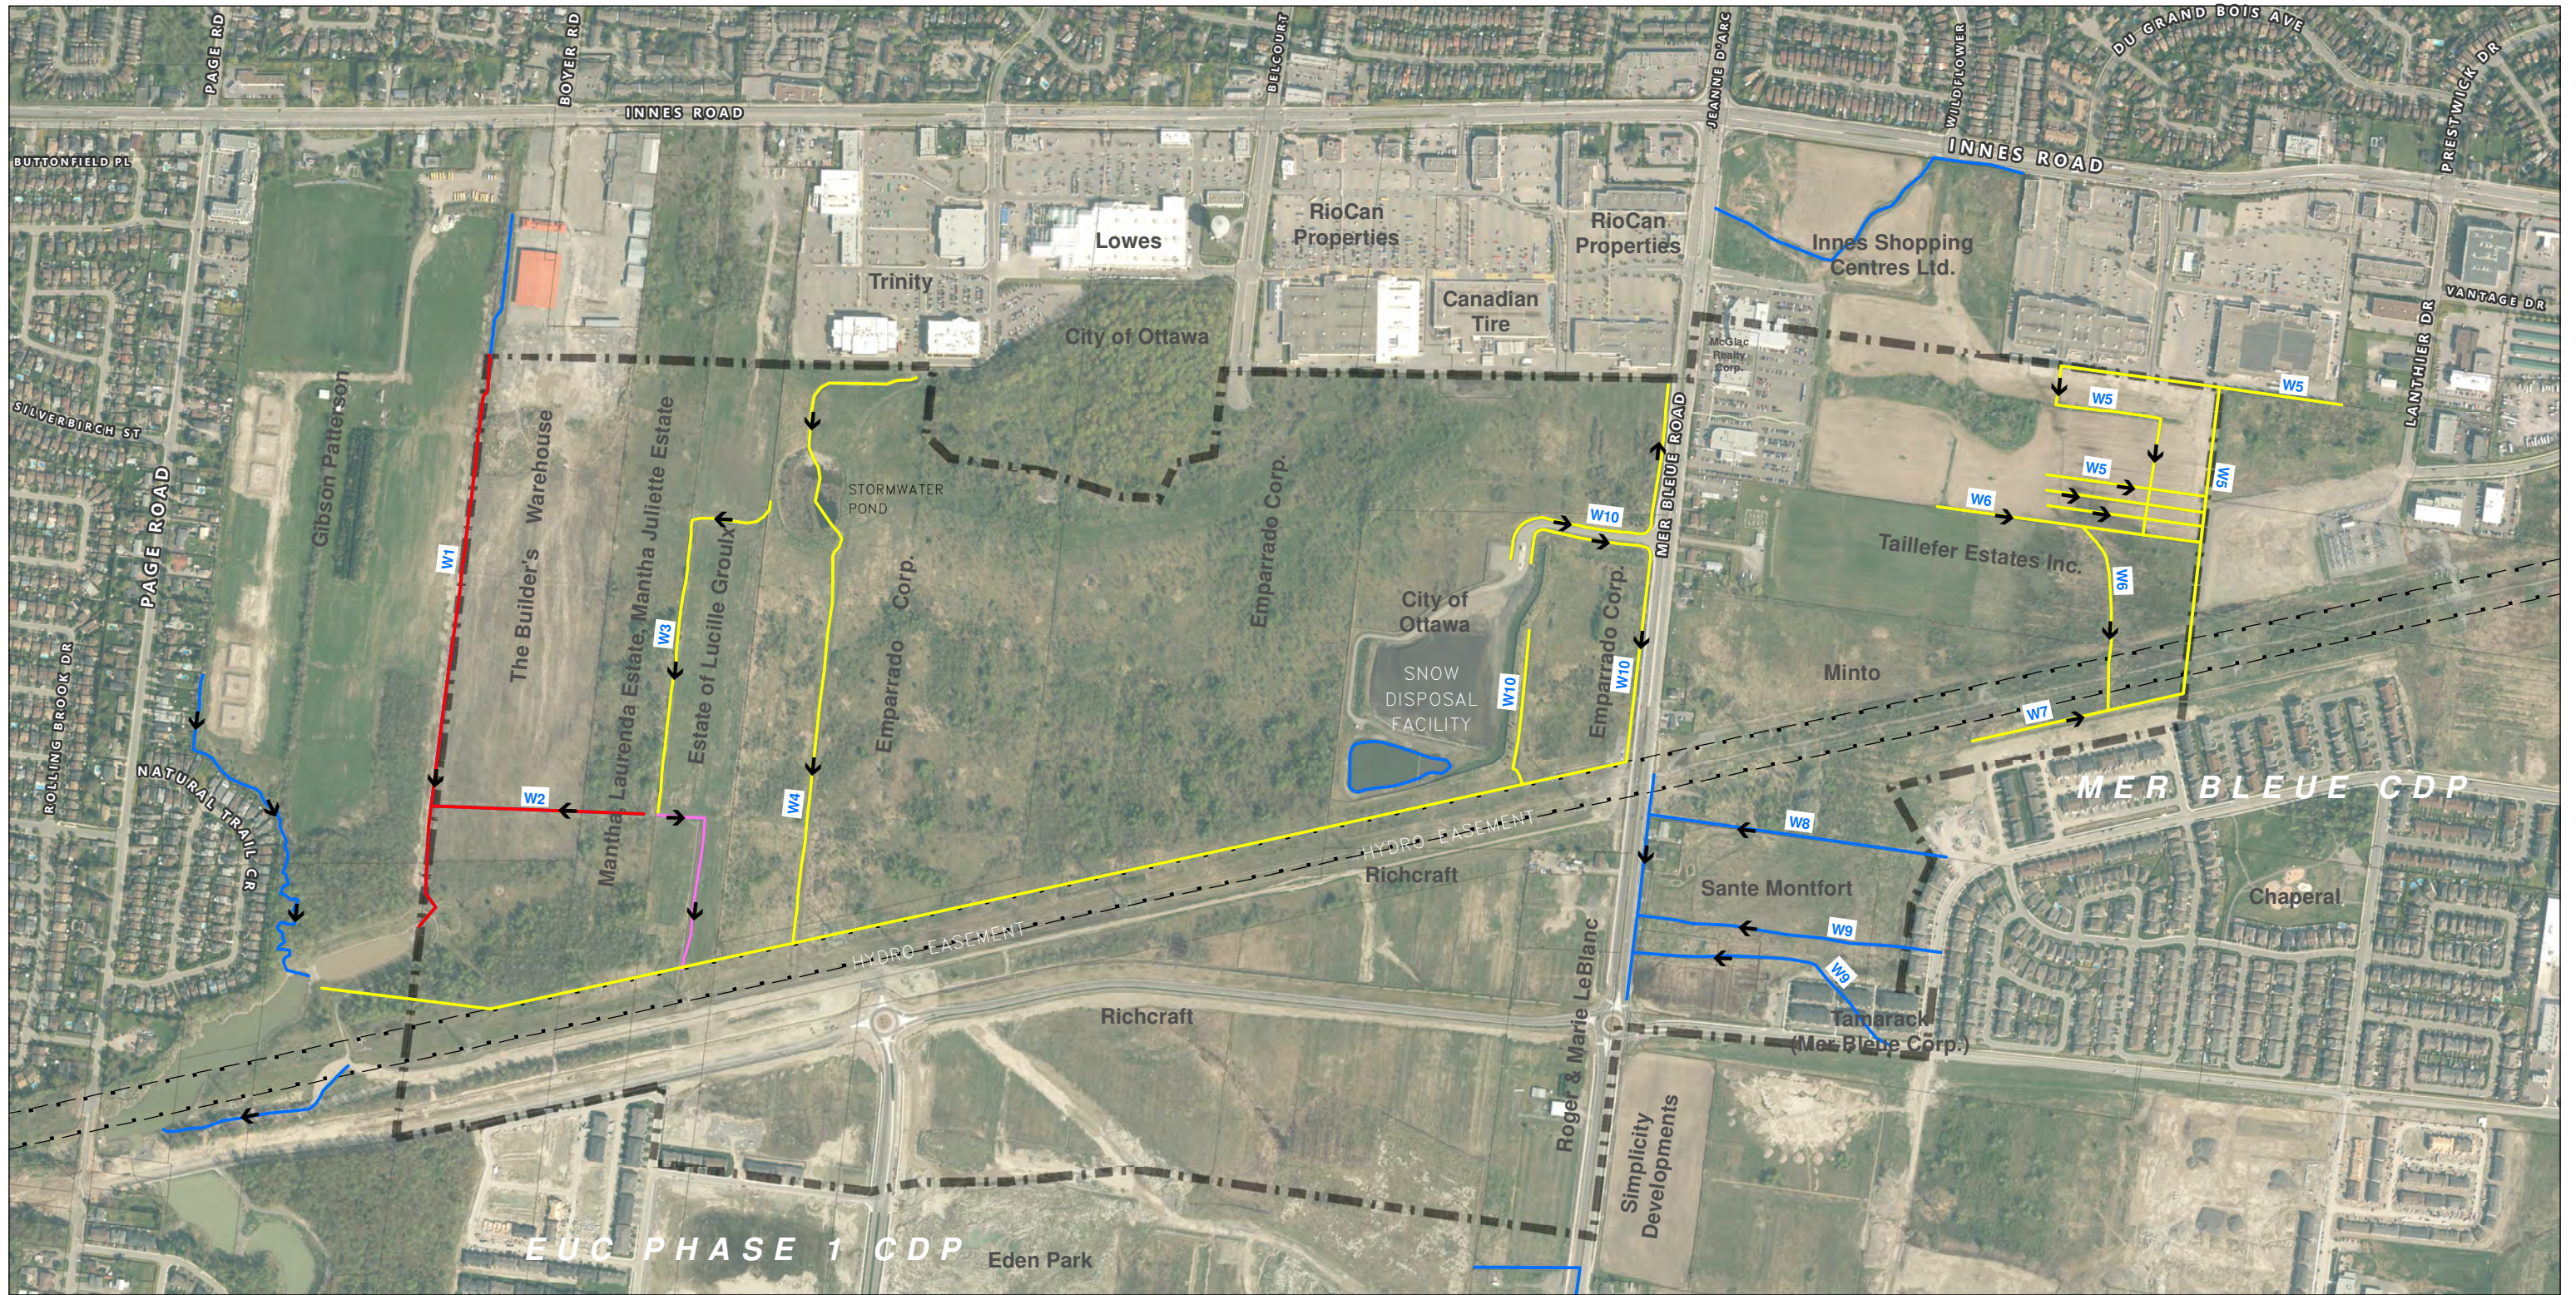
**Attachment 1:
Figure 1. Headwater Drainage Feature Management
Recommendations for the CDP Lands (NEA, 2018).**

**FIGURE 1: HEADWATER DRAINAGE FEATURE
 MANAGEMENT RECOMMENDATIONS FOR CDP LANDS**

The watercourse location and numbering used in this letter were maintained from the Draft Existing Conditions Report (NEA, 2015). Headwater drainage management recommendations for all of the CDP watercourses have been discussed below and illustrated in Attachment 1 of this letter.

- The feature was an agricultural ditch created to divert surface water flow and was disconnected from surrounding headwater features. Therefore, the feature was classified as No Management Required and verified during the RVCA March 14th, 2018 (Table 1 and Attachment 1). No additional surveys are recommended.
The downstream portion of the watercourse (south of the hydro easement) was included in Trails Edge Development DFO Authorization (10-HCAA-CA4-00350),

- The management recommendations were No Management Required (Table 1 and Attachment 1). Therefore, no additional surveys are recommended.
- The downstream portion of the watercourse (south of the hydro easement) was included in Trails Edge Development DFO Authorization (10-HCAA-CA4-00350), dated March 26th, 2013. The permitted works were completed and the feature has been infilled. This portion of the feature was labelled as Reach 4 in Trails Edge Development Plan (NEA, 2013)(Attachment 5). The upstream stormwater flows have been redirected into a drainage feature that runs east-west along the hydro easement and outlets into the stormwater pond.

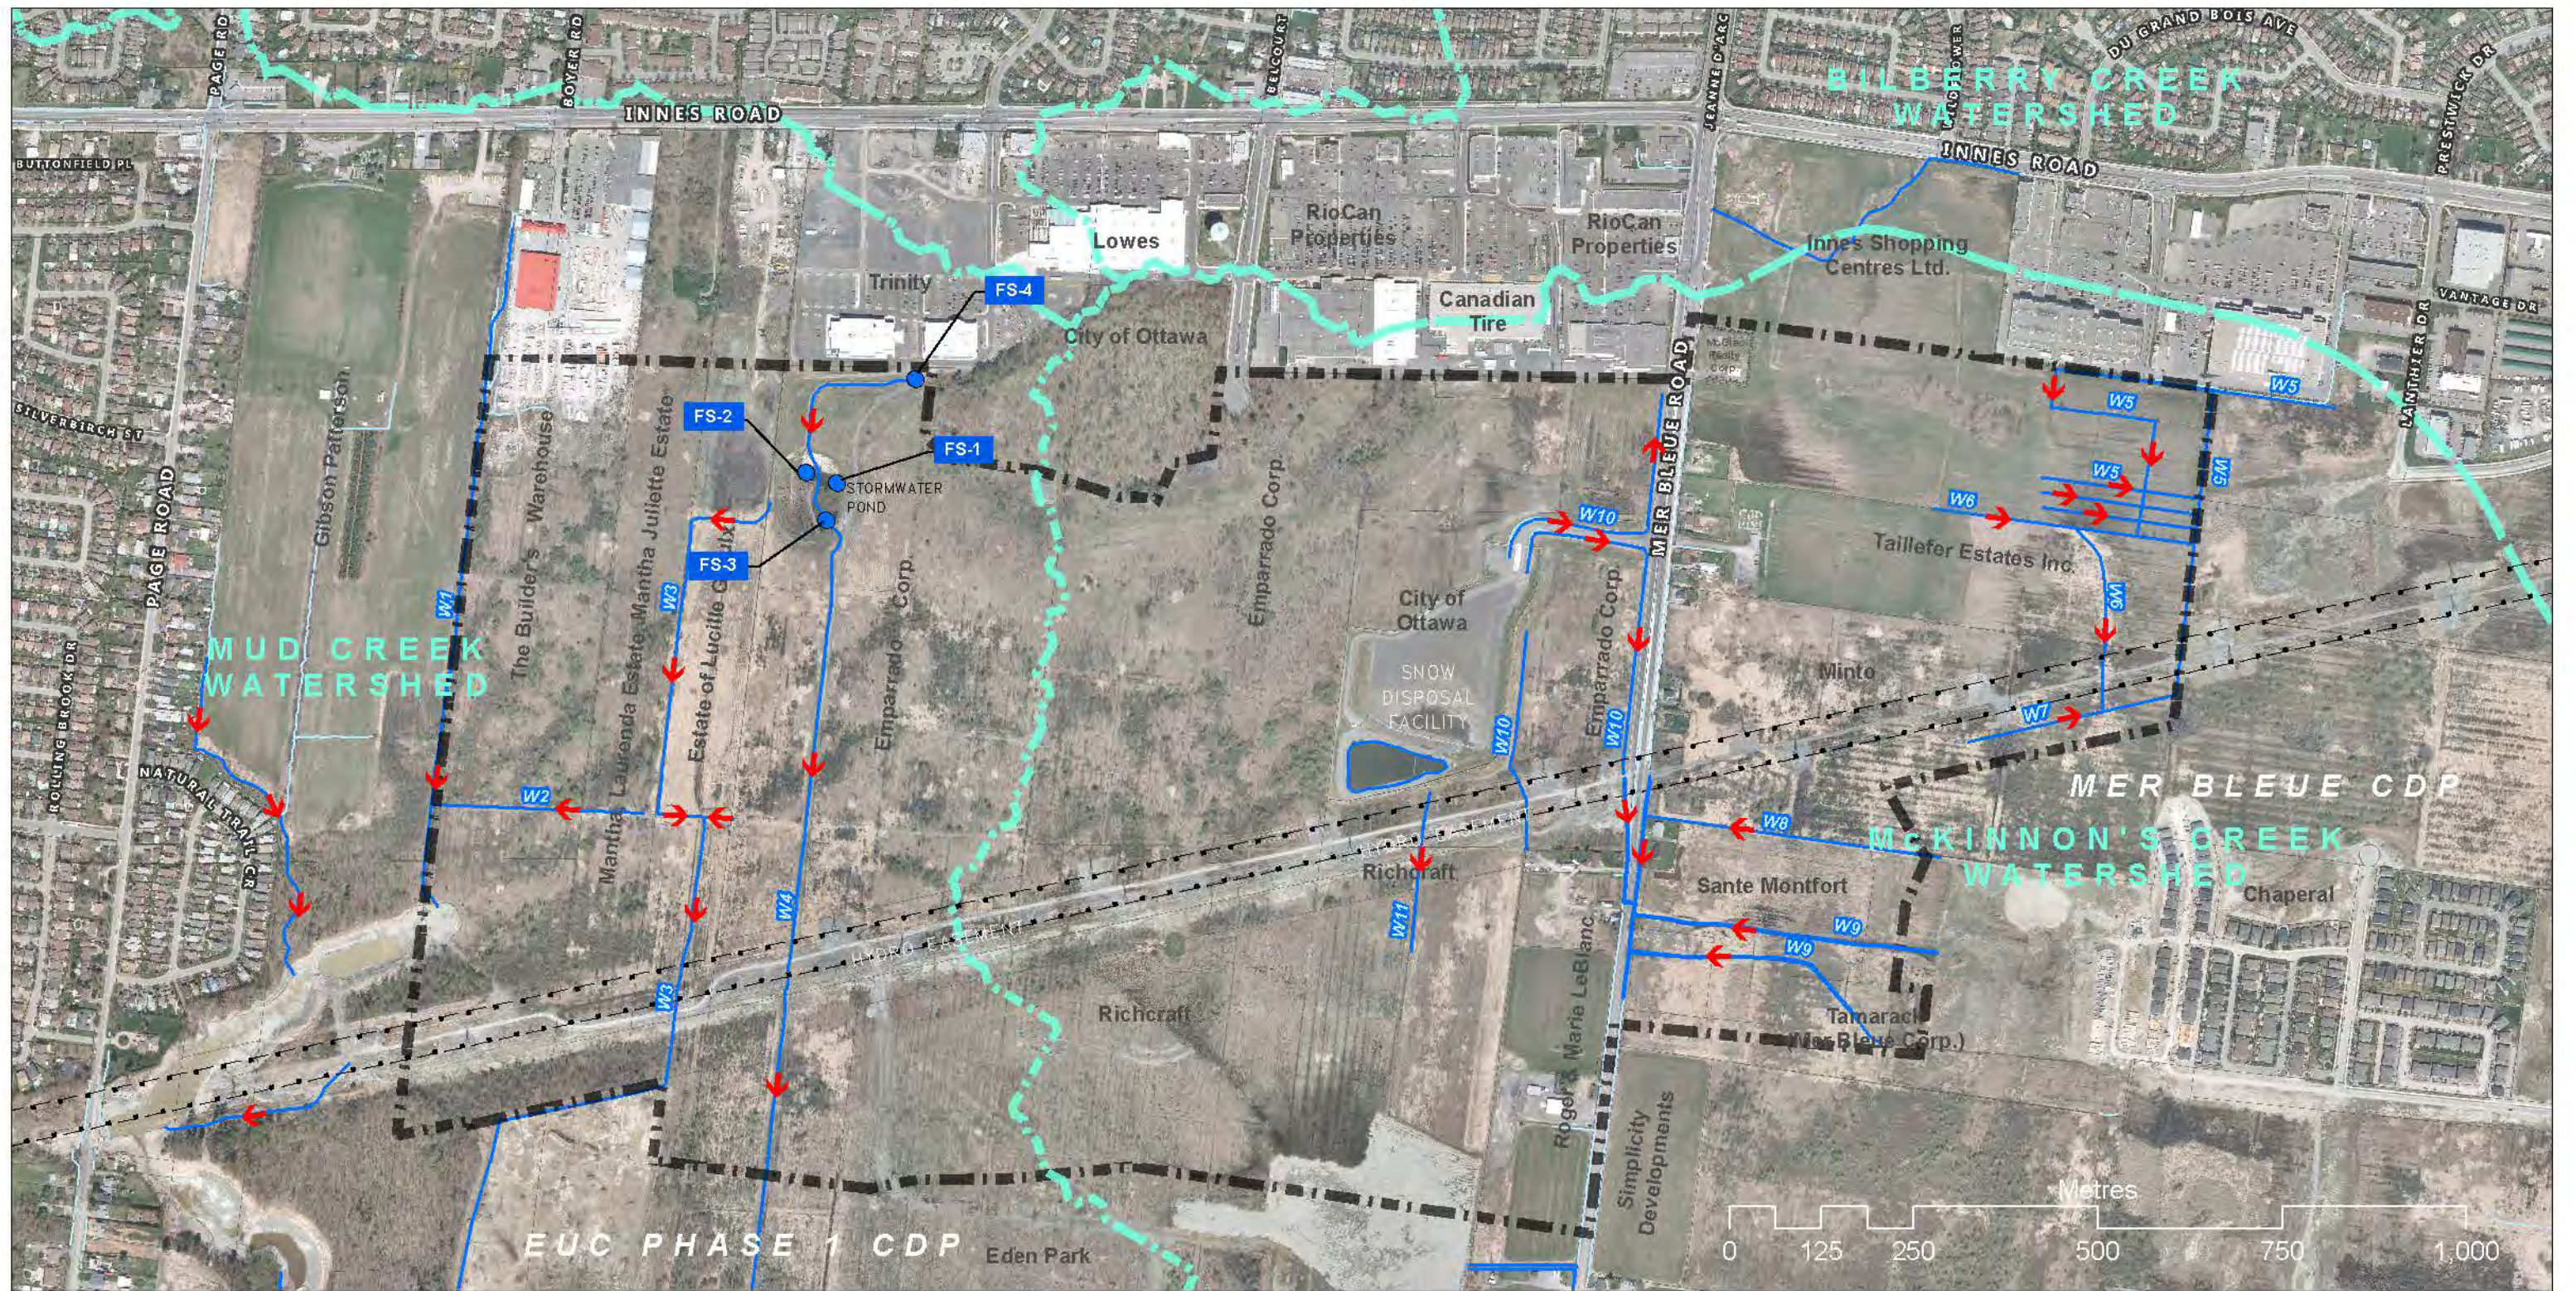
**Attachment 2:
Figure 2. Watercourse, Aquatic Stations and Flow Direction (NEA,
2015).**

**FIGURE 2: WATERCOURSES,
AQUATIC STATIONS & FLOW DIRECTION**

NEA conducted a rapid HDF assessment of the CDP watercourses in 2014 and provided the results in the Draft Existing Conditions Report (NEA, 2015). In 2014, 10 potential headwater features were identified within the CDP area (Attachment 2). Since then, several assessments have been conducted on CDP properties that contained watercourses.

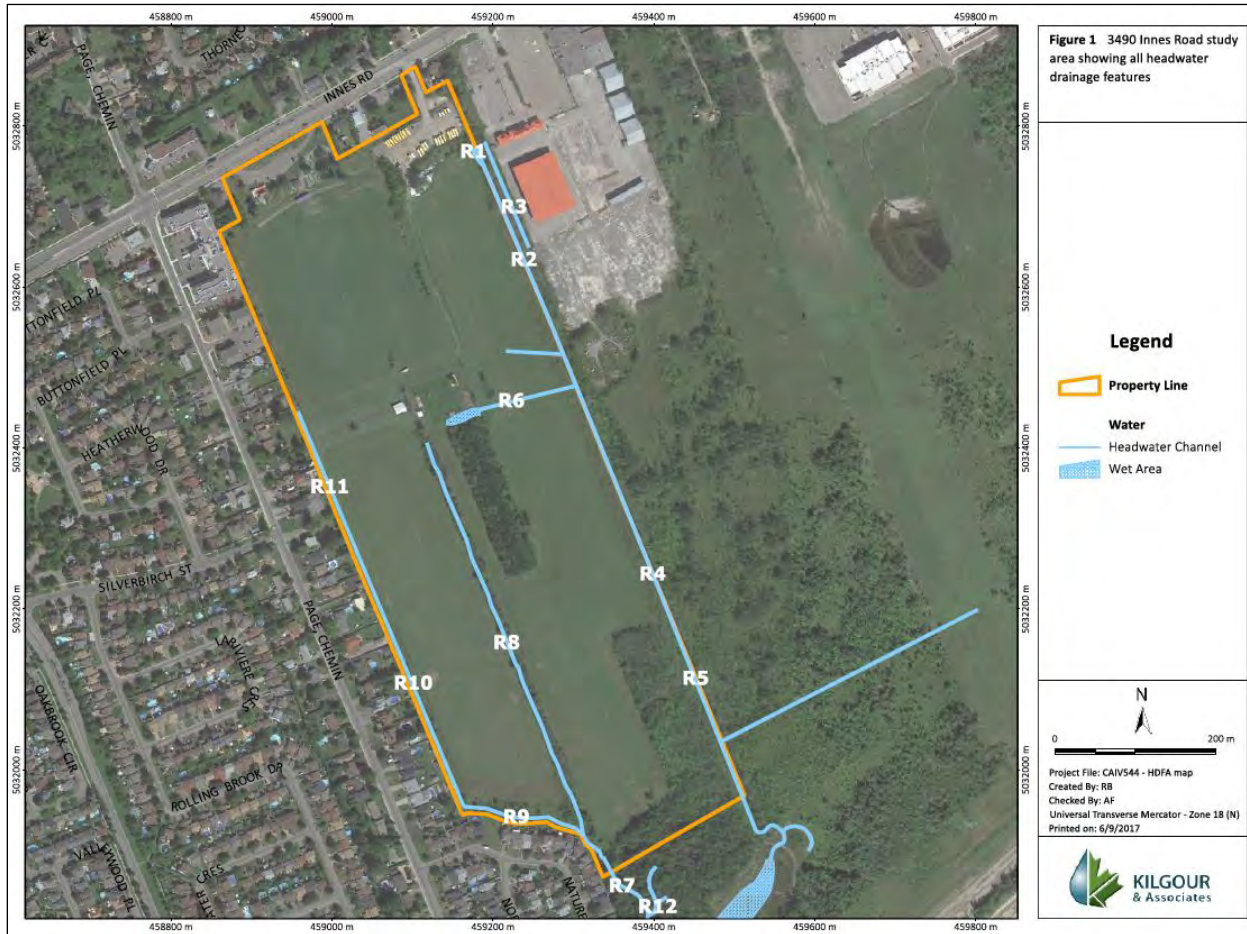
**Attachment 3:
Figure 1. HDF Reaches (Kilgour & Associates, 2017).**

Figure 1. HDF reaches

- The 2017 HDF assessments by Kilgour & Associates provide adequate surveys and management recommendations based on the HDF methods (Table 1). Therefore, no additional surveys are recommended.
- Kilgour & Associates conducted a standard HDF assessment on this watercourse in 2016 and classified the management recommendation as Mitigation. Details can be found in *Headwater Drainage Feature Assessment 3490 Innes Road Development* (Kilgour & Associates, 2017). The watercourse was divided into four reaches (Attachment 3).
- W1 is within Rideau Valley Conservation Authority jurisdiction.

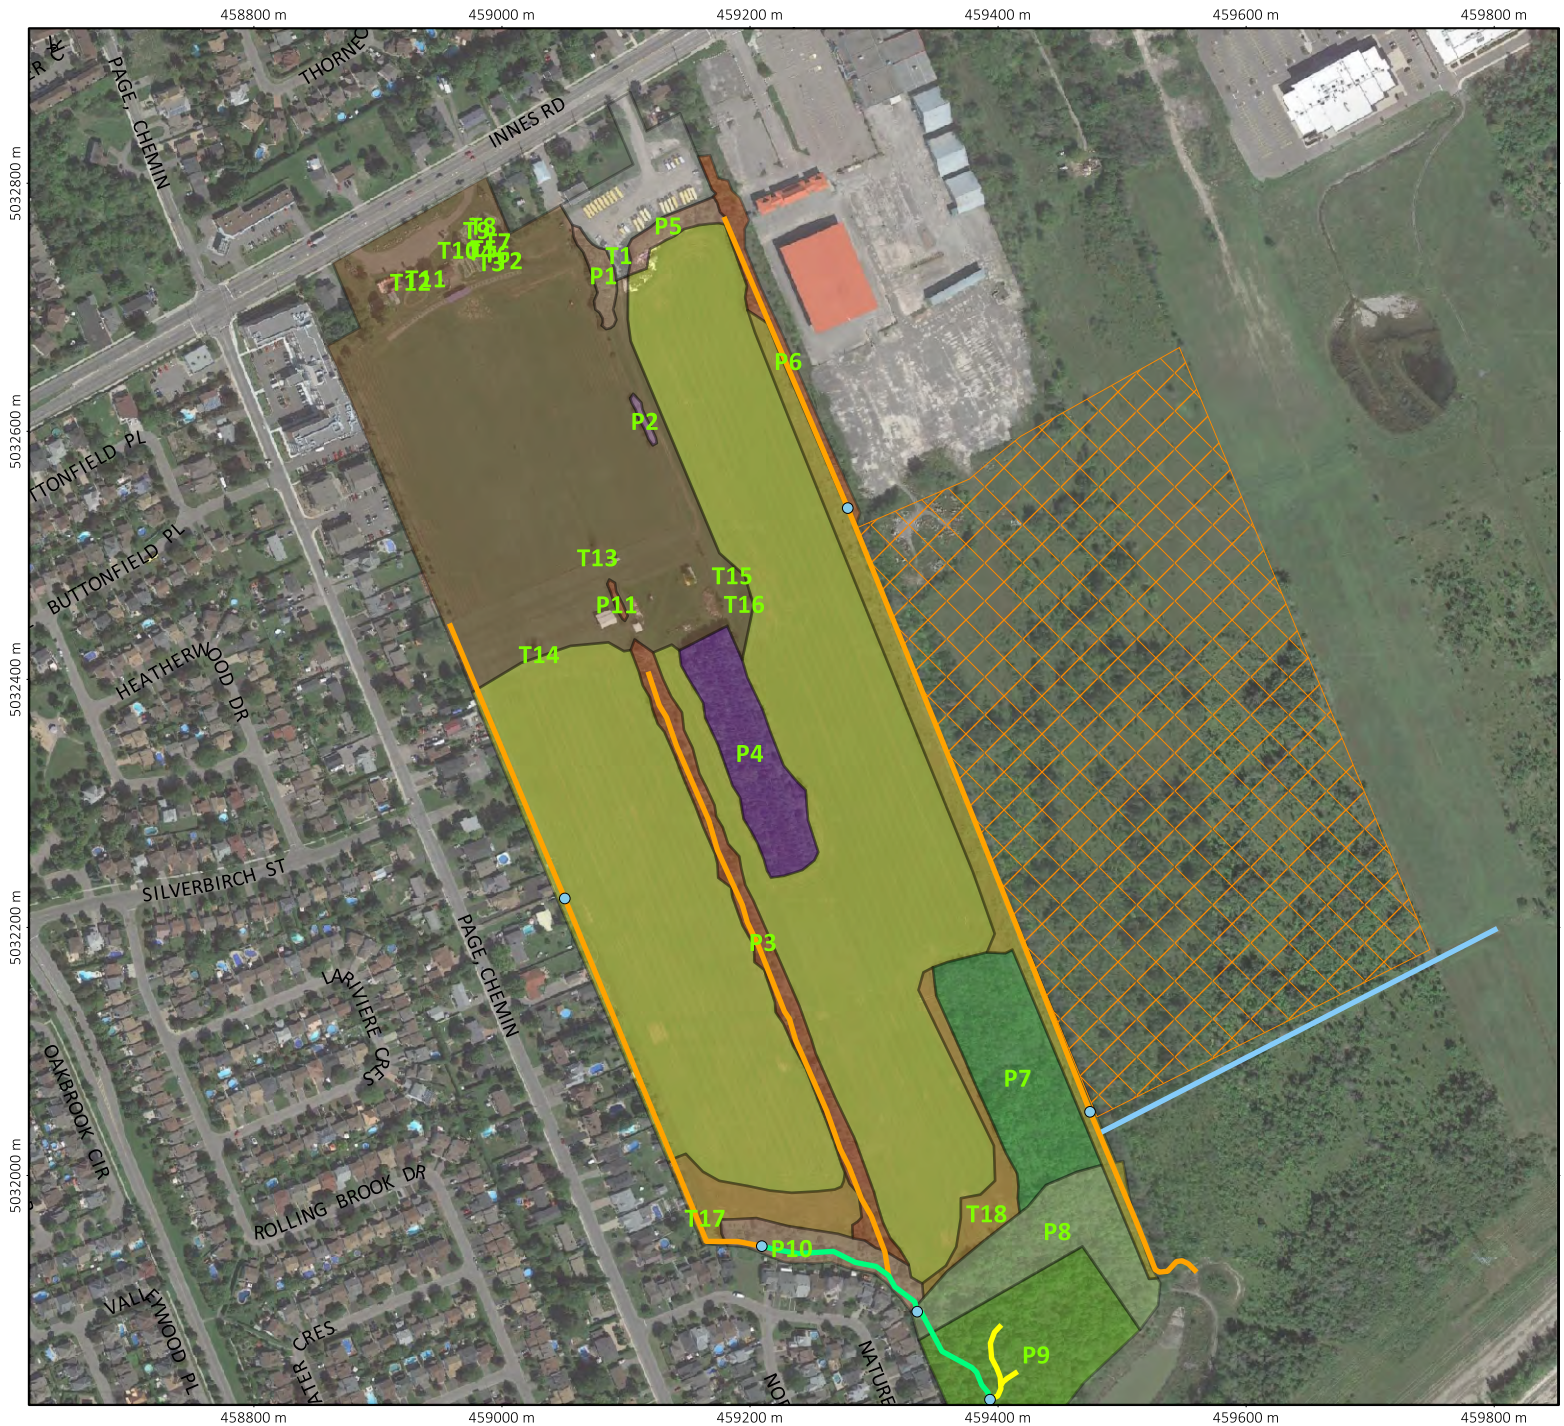
**Attachment 4:
Figure 2 Current Site Conditions (Kilgour & Associates, 2017).**

Figure 2 Current site conditions

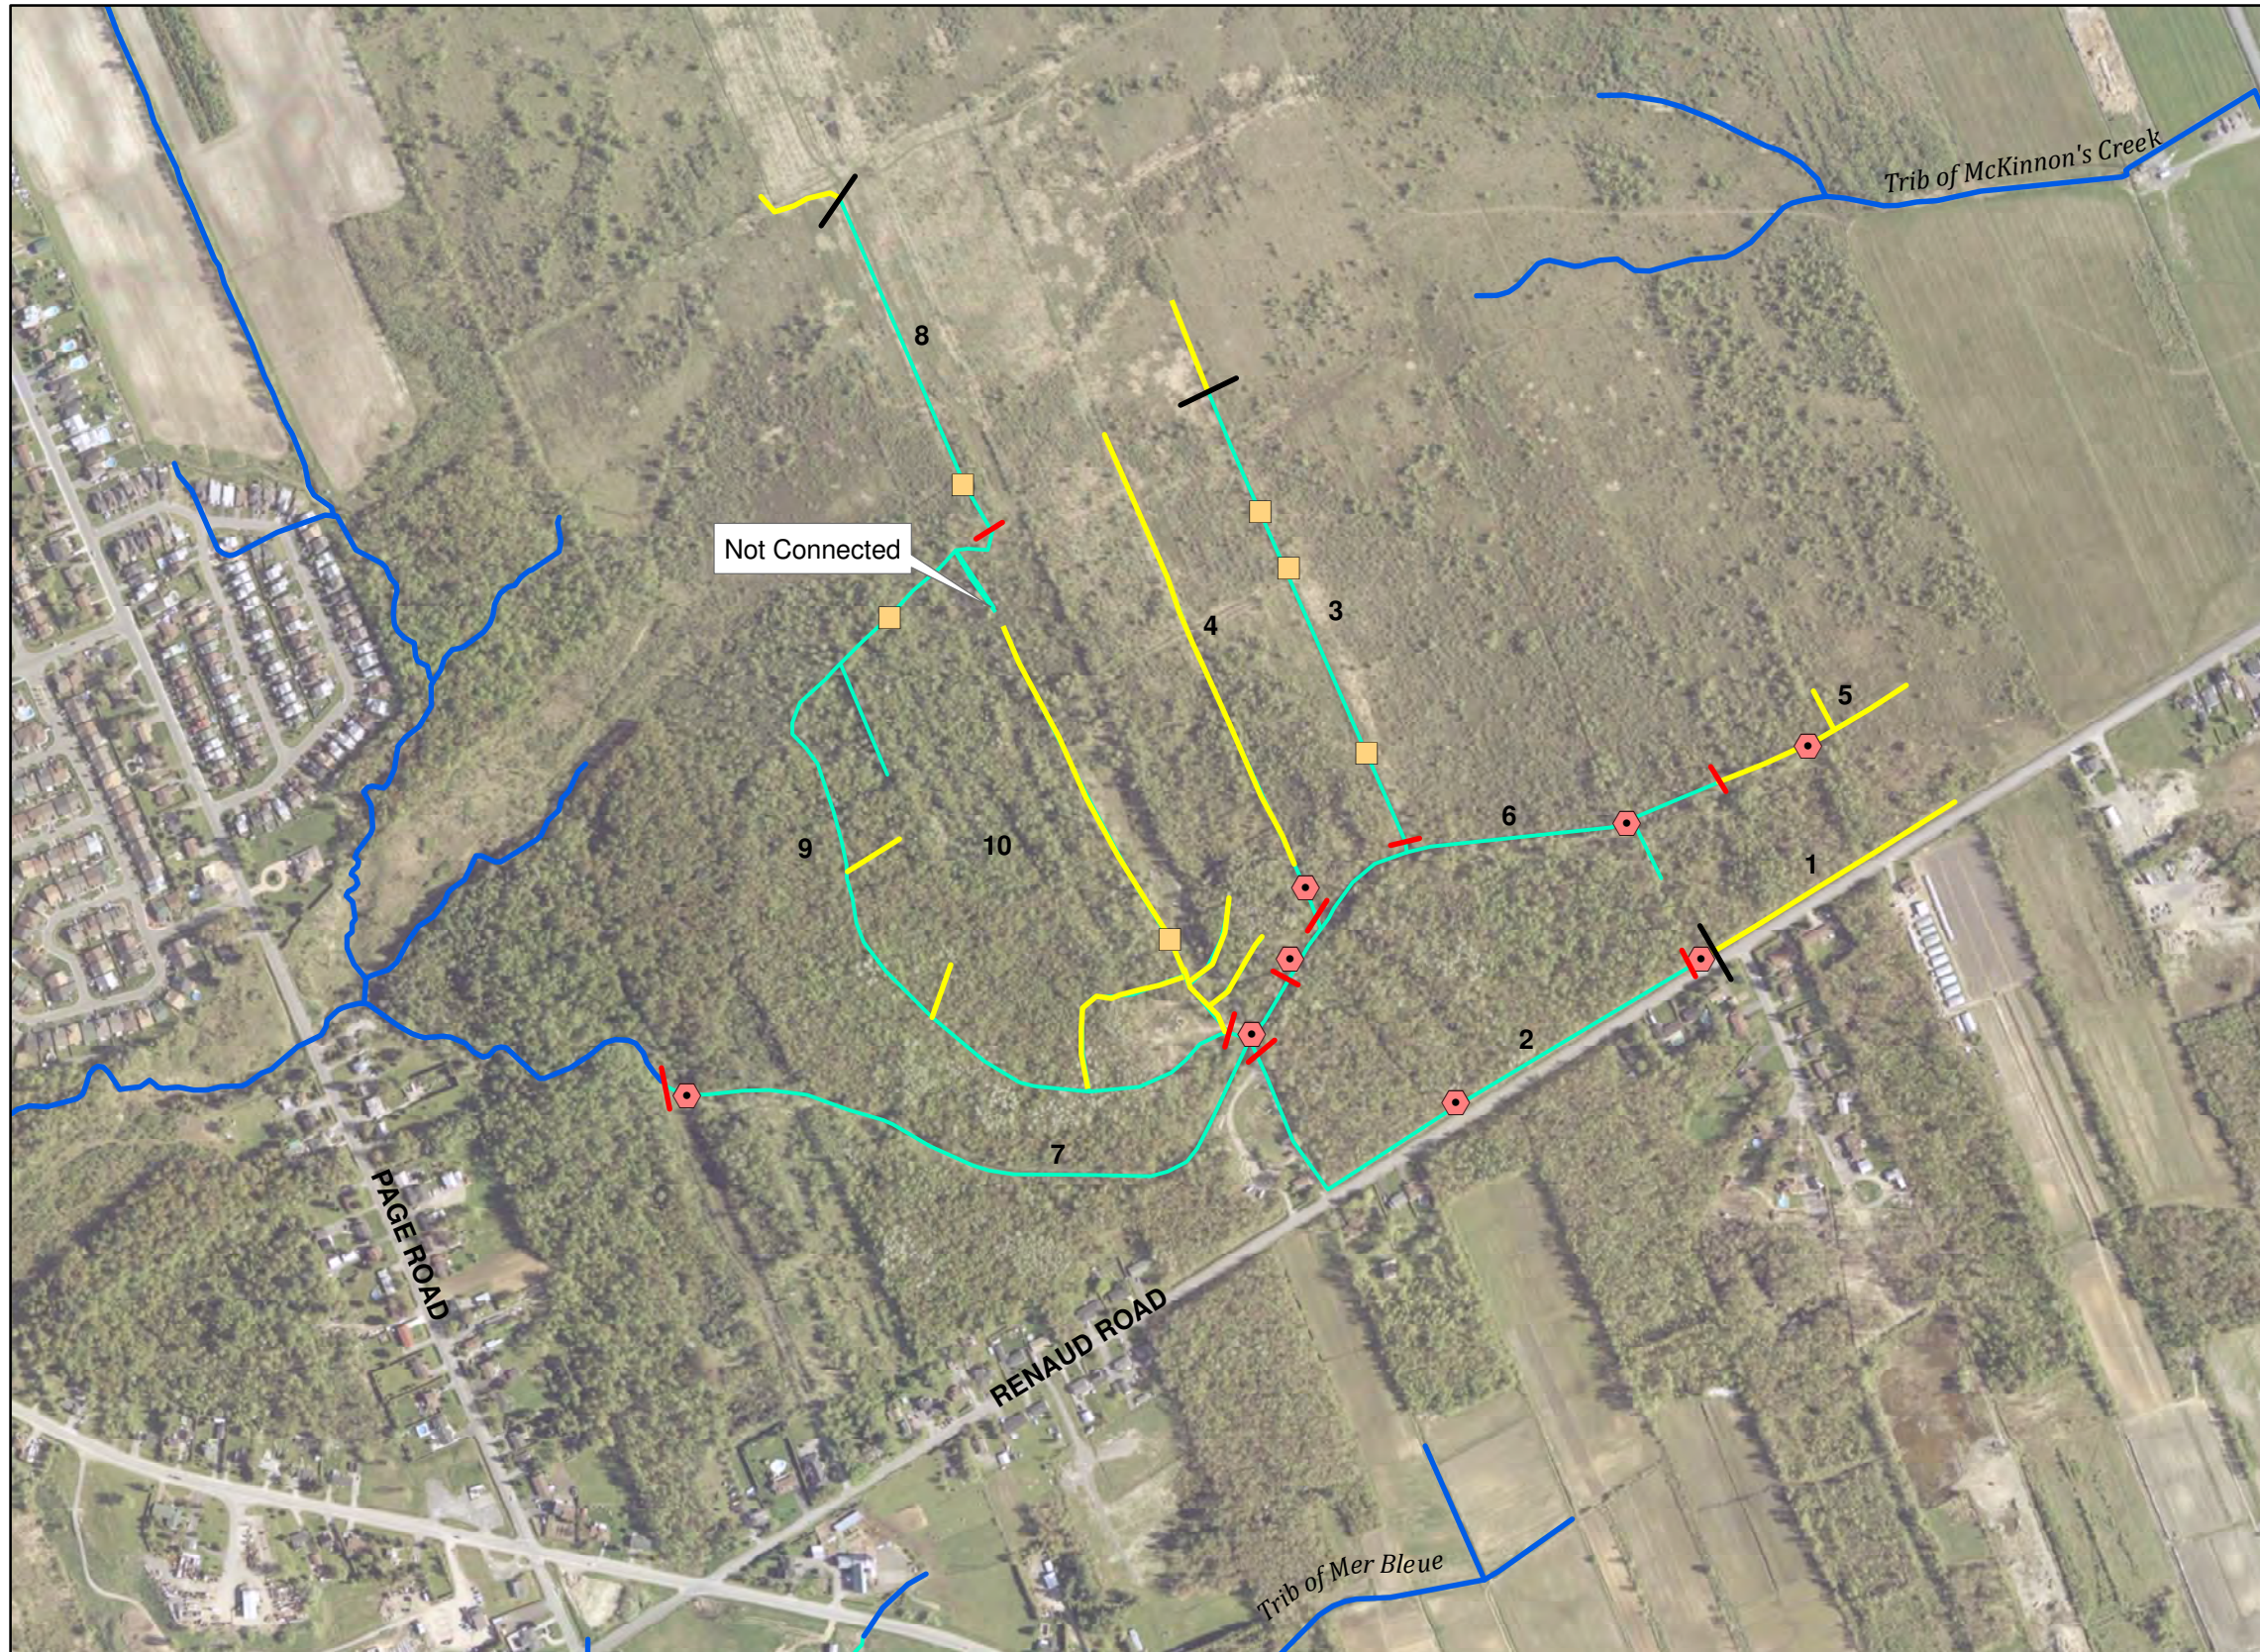
**Attachment 5:
Figure 1. Supplemental Fish and Fish Habitat Survey (NEA, 2013).**

FIGURE 1: SUPPLEMENTAL FISH & FISH HABITAT SURVEY

dated March 26th, 2013. The permitted works were completed and the feature has been infilled. This portion of the feature was labelled as Reach 8 in Trails Edge Development Plan (NEA, 2013), refer to Attachment 5. The upstream flows were redirected into a drainage feature that runs east-west along the hydro easement and outlets into the stormwater pond.

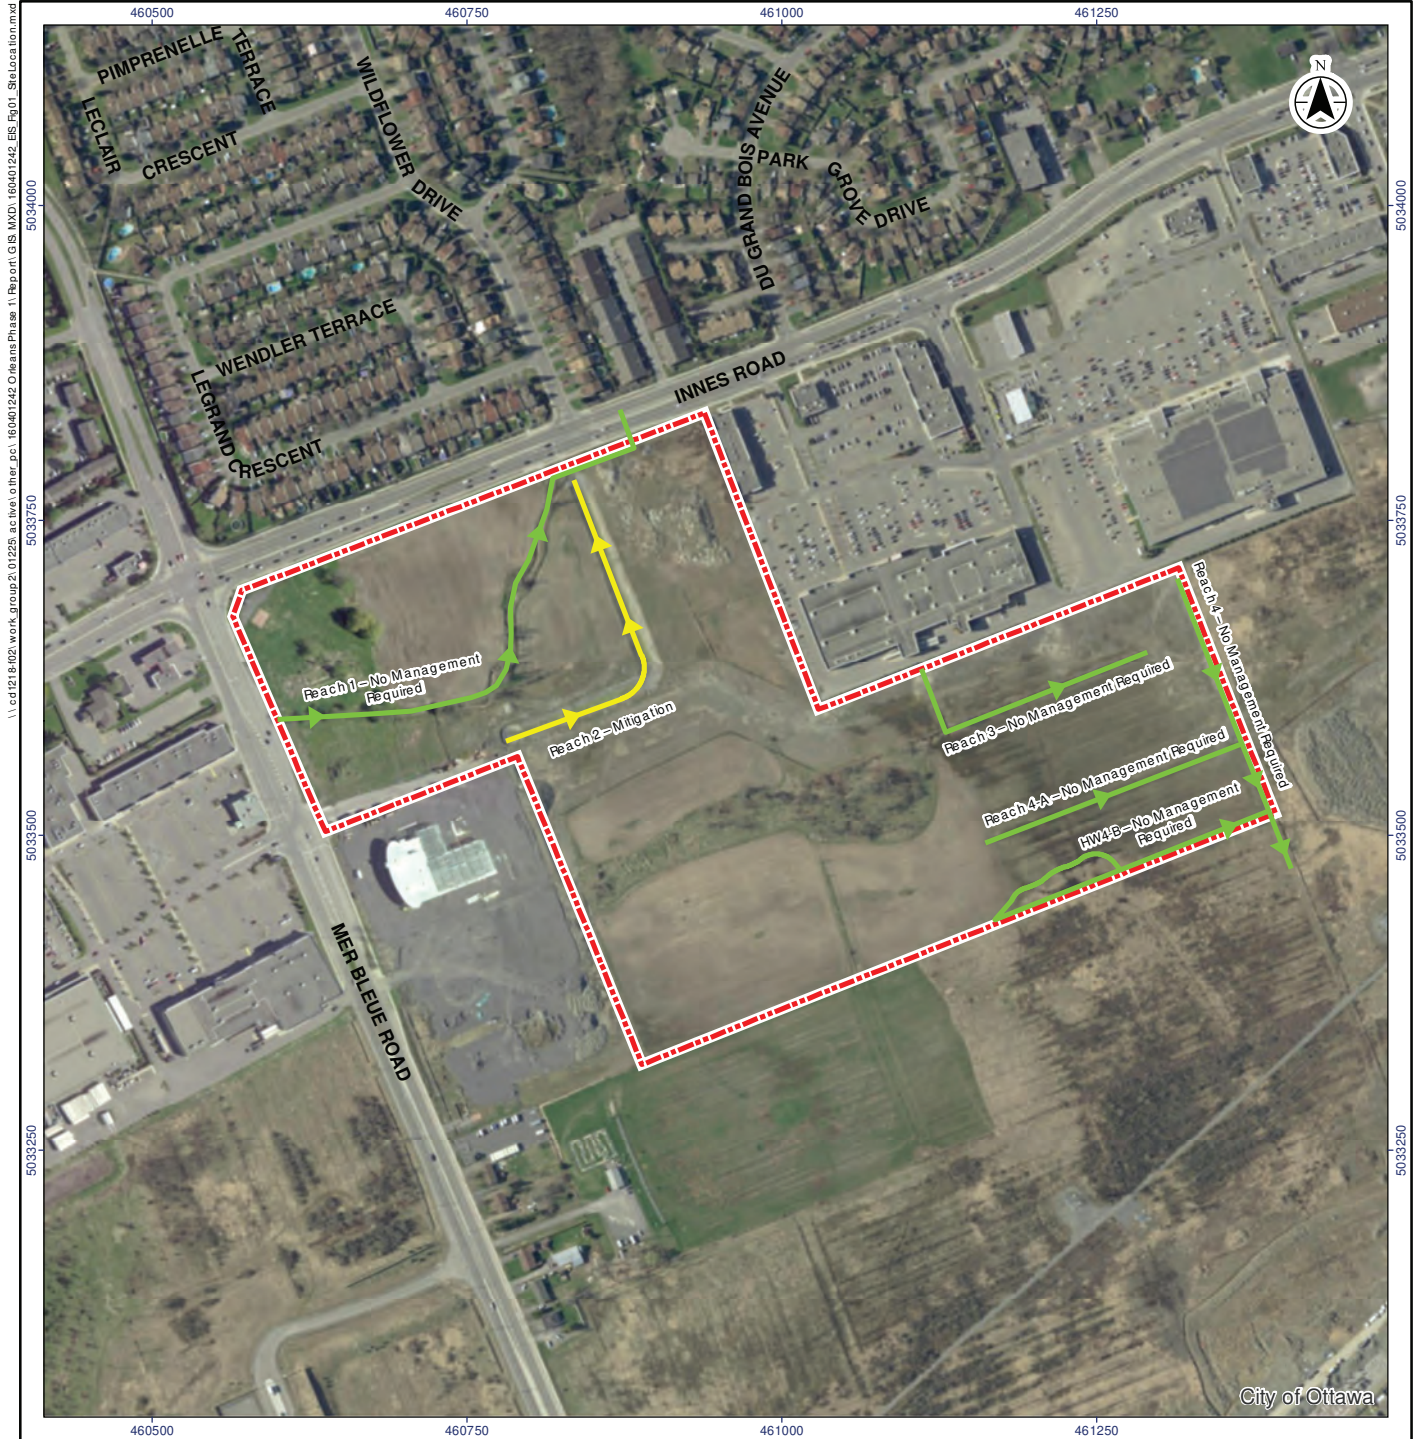
**Attachment 6:
Figure 3. Headwater Drainage Feature Management
Recommendations (Stantec, 2016).**

Headwater Drainage Feature Management Recommendations

- Stantec conducted a standard HDF assessment on the watercourse in 2016. Details can be found in the *Environmental Impact Statement with Headwaters Assessment for 4100 Innes Road/2025 Mer Bleue Road* (Stantec, 2016).
 - The watercourse was divided into two reaches, HDF 3 and HF4. Refer to Attachment 6.
 - The Management Recommendations were identified as follows:
 - HDF 3-No Management Required
 - HDF 4 (Reach 4-A)-No Management Required
- The 2016 HDF assessments by Stantec provides adequate management recommendation based on HDF methods (Table 1). Therefore, no additional surveys are recommended.
- W5 is within Rideau Valley and South Nation Conservation Authority jurisdiction.

- Stantec conducted a standard HDF assessment on the northern reach of this watercourse in 2016 (Attachment 6). Details can be found in the *Environmental Impact Statement with Headwaters Assessment for 4100 Innes Road/2025 Mer Bleue Road* (Stantec, 2016).

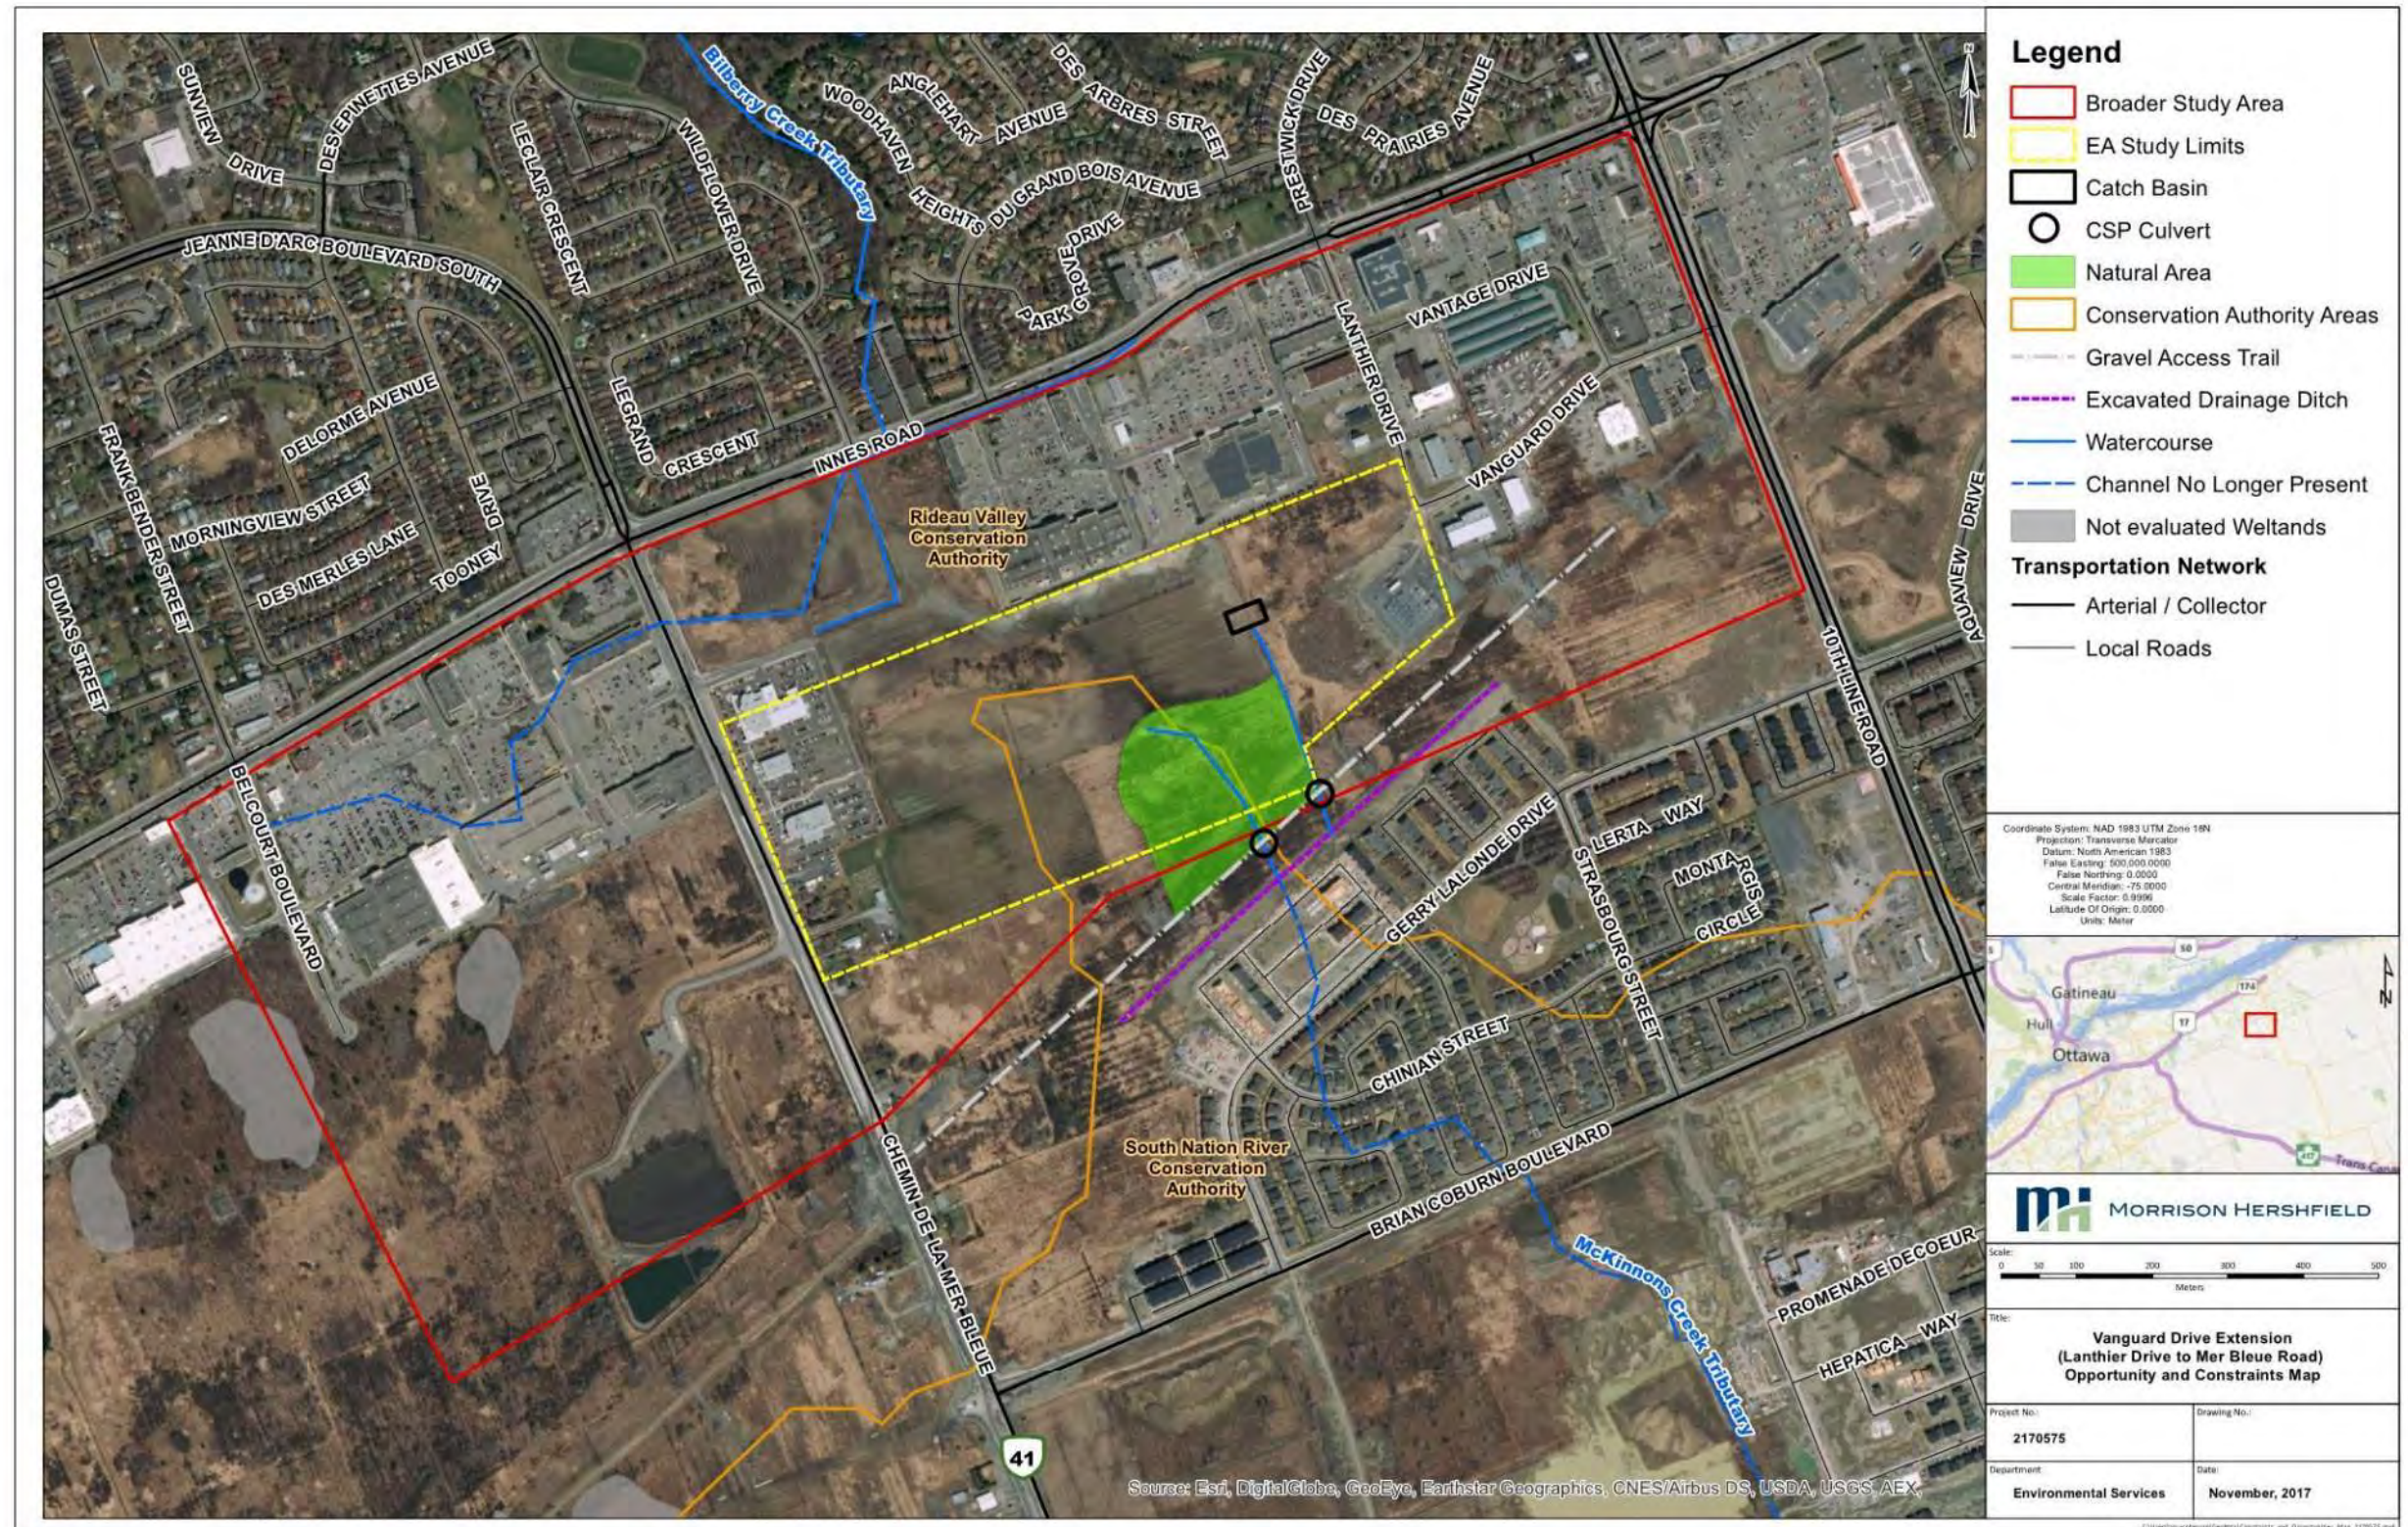
**Attachment 7:
Figure 1. Fisheries and Aquatic Environment memorandum,
dated December 12th, 2017 (Morrison Hershfield, 2017).**

Figure 1: Overview Map of Vanguard Drive Study Areas and Aquatic Habitat Values

- The management recommendations were identified as follows; HDF 4 (Reach 4-B) - No management required.
- Morrison Hershfield confirmed a reach of the southern portion of W6 was no longer present in 2017 (Attachment 7). Details can be found in the *Vanguard Drive EA-Fisheries Existing Conditions Memo* (Morrison Hershfield, 2017).
