Muncaster
Environmental
Planning Inc.

RE: 3200 Reids Lane, Osgoode
Tree Conservation Report and Environmental Impact Statement - Updated

3200 REIDS LANE, OSGOODE
TREE CONSERVATION REPORT and ENVIRONMENTAL IMPACT STATEMENT - UPDATED

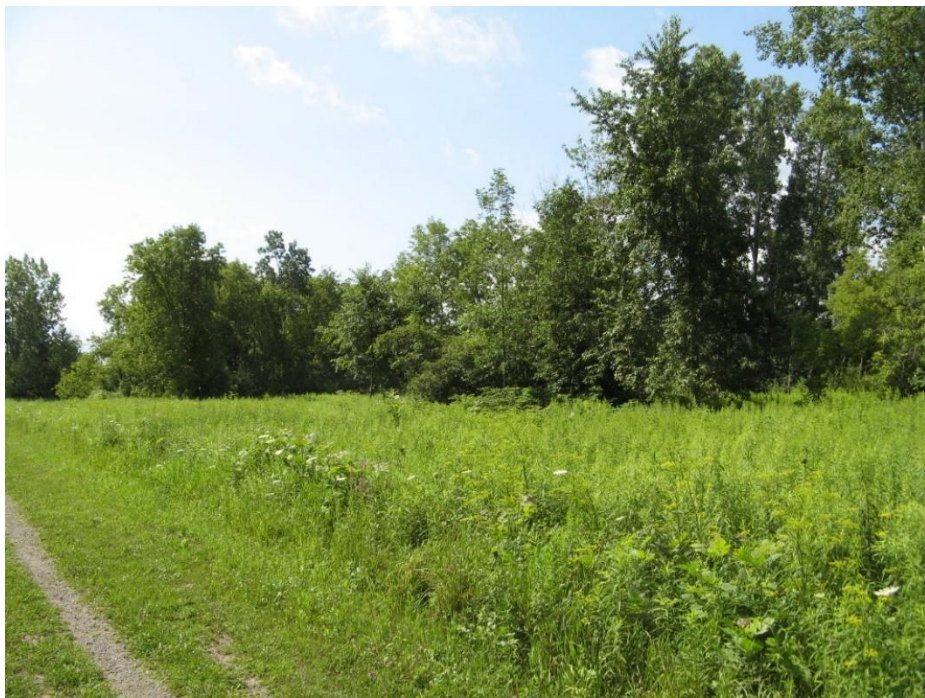
*Photo 1 – Cultural meadow and cultural woodland in the northeast portion of the site.
View looking south (July 15th, 2024)*

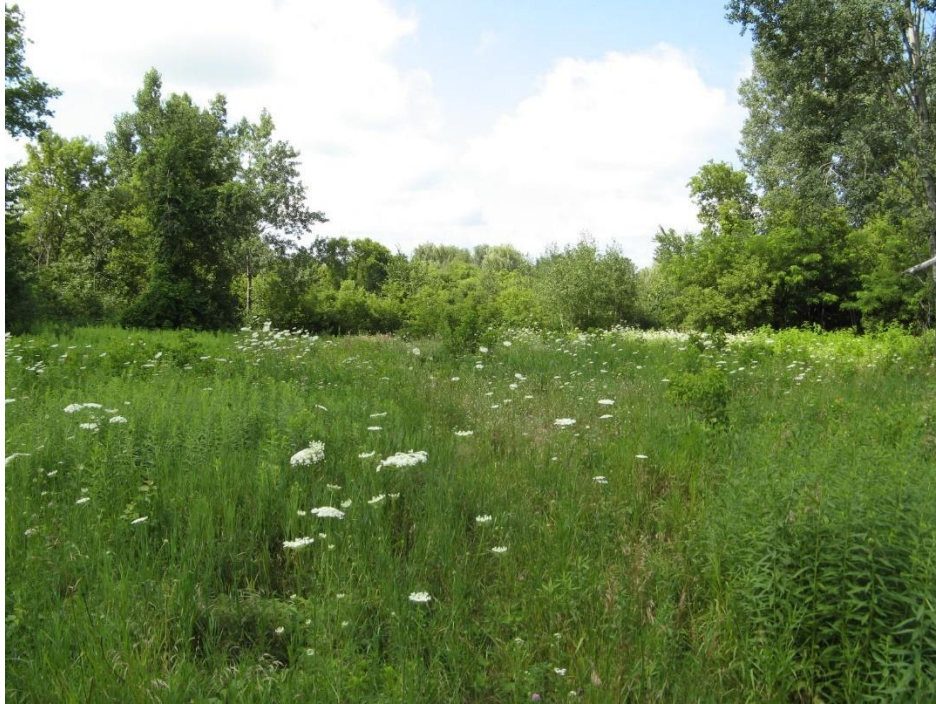
*Photo 2 – Cultural meadow in the central portion of the site.
View looking west (July 15th, 2024)*

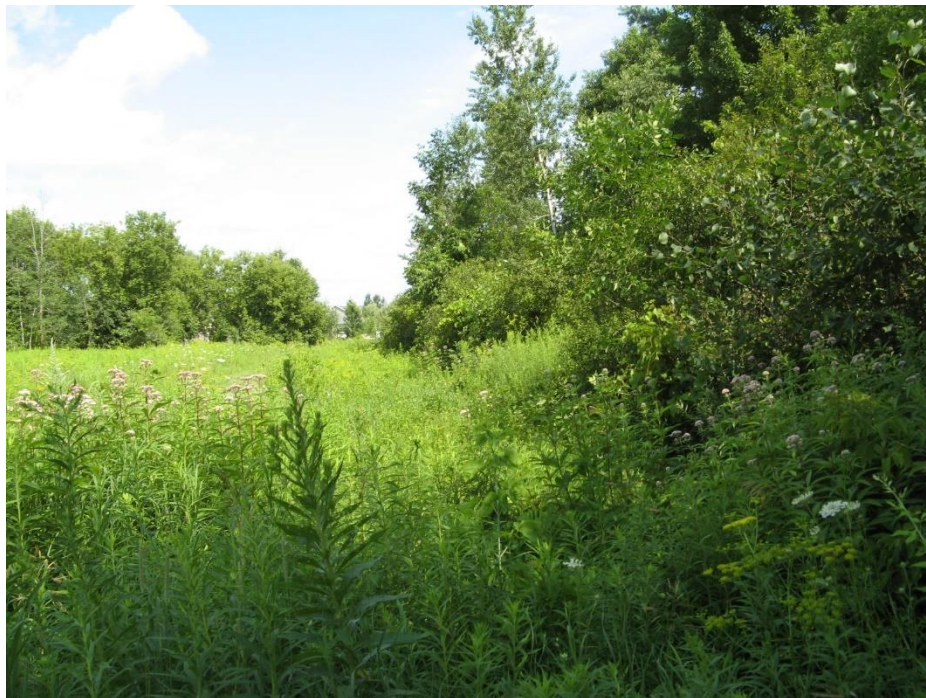
*Photo 3 – View along east property line. This example is
looking north from the midway point of the site (July 15th, 2024)*

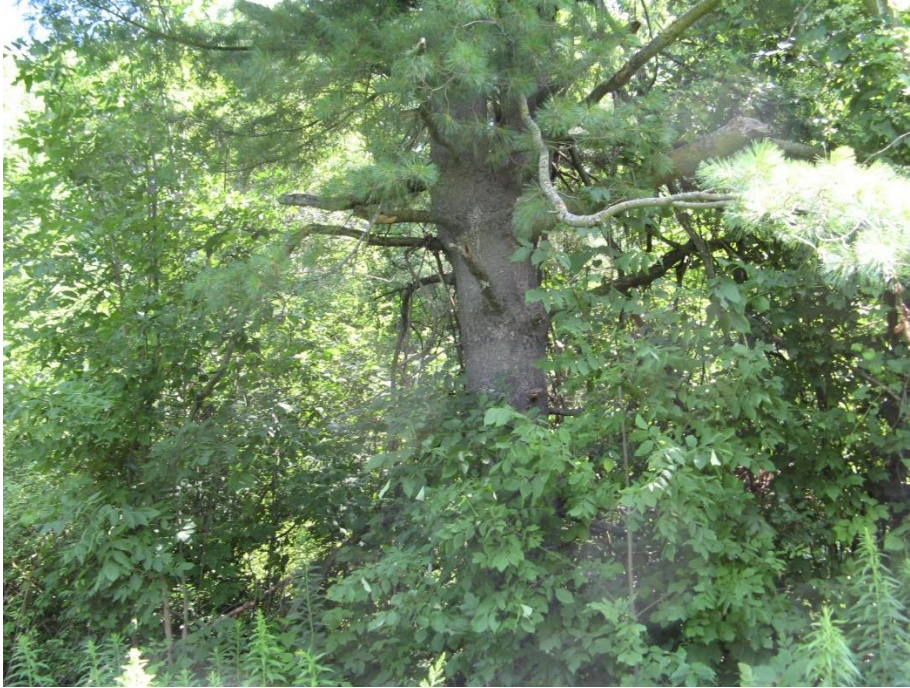
Photo 4 – This mature white pine appears to be the only tree immediately east to the site with a critical root zone extending onto the site. View looking east (July 15th, 2024)

There are no trees along the east property line due to a gravel pathway and associated open area between the pathway and the east property line. The meadow habitat extends slightly onto the City lands to the east, with glossy buckthorn shrubs and regenerating stems less than 10cm dbh dominating the lands to the east of the meadow (Photo 3). A 70cm dbh white pine appears to be the only tree with a critical root zone extending onto the site from the east (Photo 4). The trunk of this tree is approximately five metre to the east of the site on the City-owned property so the critical root zone would extend about two metres onto the site. No site alterations are planned in this area which could potentially impact the critical root zone. The critical root zone of this tree should be added to future servicing and grading plans.

3. Trees to be retained are to be protected with sturdy temporary fencing at least 1.2 metres in height installed from the tree trunk a distance of ten times the retained tree's diameter where possible. This protective fencing is also to be placed around the critical root zone of the adjacent mature white pine. Signs, notices, or posters are not to be attached to any tree. No grading, heavy machinery traffic, stockpiling of material, machinery maintenance and refueling, or other activities that may cause soil compaction are to occur within the critical root zones of the trees to be retained and protected. The root system,

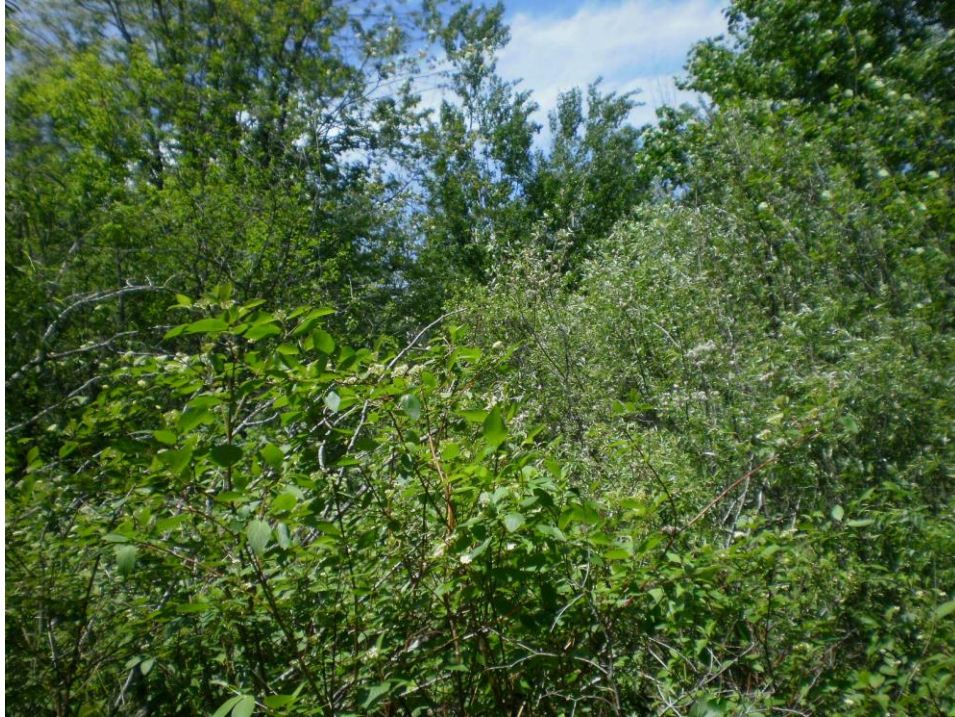
A cultural thicket is in the northwest portion of the site (Photo 6). Red raspberry, red-osier dogwood, black currant, slender willow, Bebb's willow, narrow-leaved meadowsweet, nannyberry and tartarian honeysuckle were representative of the shrub species, with regenerating trembling aspen, red maple, and green ash up to 8cm dbh also present. Ground flora species included wild carrot, meadow horsetail, blue grass, orchard grass, reed canary grass, common strawberry, tall buttercup, joe-pye-weed, Canada goldenrod, wild grape, common ragweed, and sensitive fern.

*Photo 6 – Cultural thicket in the northwest portion of the site.
View looking north (June 12th, 2019)*

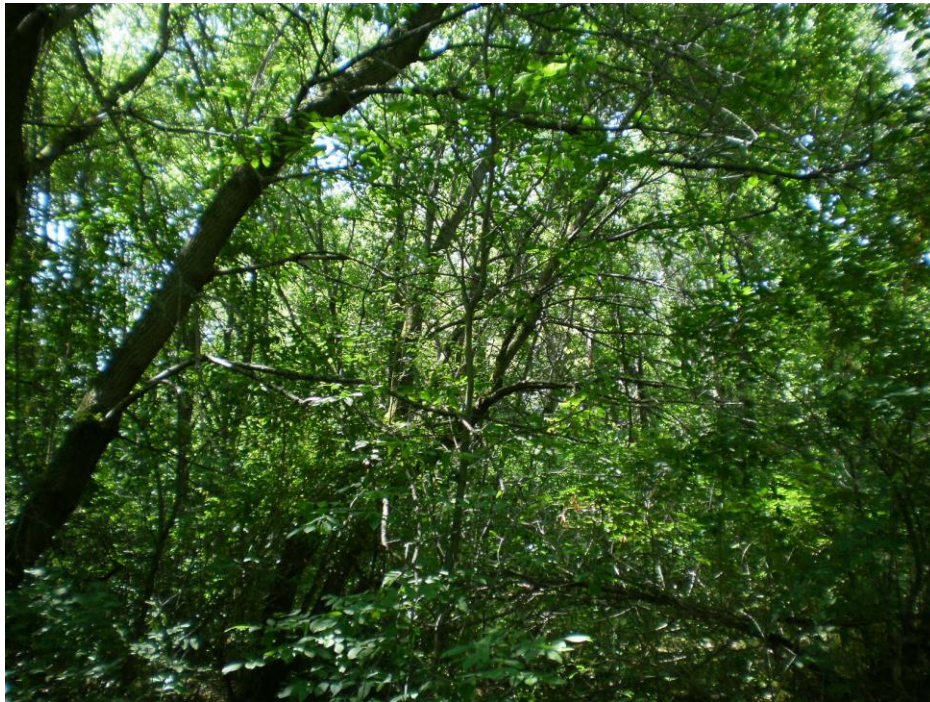
An upland deciduous forest dominates the centre and north portions of the site (Photo 8). This forest is generally young as the site was dominated by agricultural fields in 1976 aerial photography and generally clear of trees until the 1990s. Manitoba maple and trembling aspen were dominant, with sugar maple, red maple, white ash, green ash, white cedar, pin cherry, and white elm also present. The largest trees were poplars up to 35cm dbh. Most of the trees appeared to be in good condition, with the white ash either dead or with reduced leaf-out from emerald ash borer impacts. Grape vine coverage was extensive on many of the lower tree branches. Common buckthorn was dominant in portions of the understory of the upland deciduous forest, with glossy buckthorn, prickly gooseberry, grey dogwood, red raspberry, tartarian honeysuckle, red-osier dogwood, staghorn sumac, Japanese knotweed, and other shrub species observed. Regenerating balsam fir, ash, white elm, black walnut, and sugar maple stems were also present. The ground flora in the upland deciduous forest was generally reflective of disturbed conditions including common dandelion, garlic mustard, common ragweed, ground ivy, Canada goldenrod, wild grape, thicket creeper, blue violet, common strawberry, wild parsnip, common plantain, yellow avens, wild cucumber, field horsetail, common burdock, yellow wood sorrel, meadow horsetail, and enchanter's nightshade, with false nettle and sensitive fern also present.

*Photo 8 – Upland deciduous forest in the central-east portion of the site.
View looking west (August 8th, 2019)*

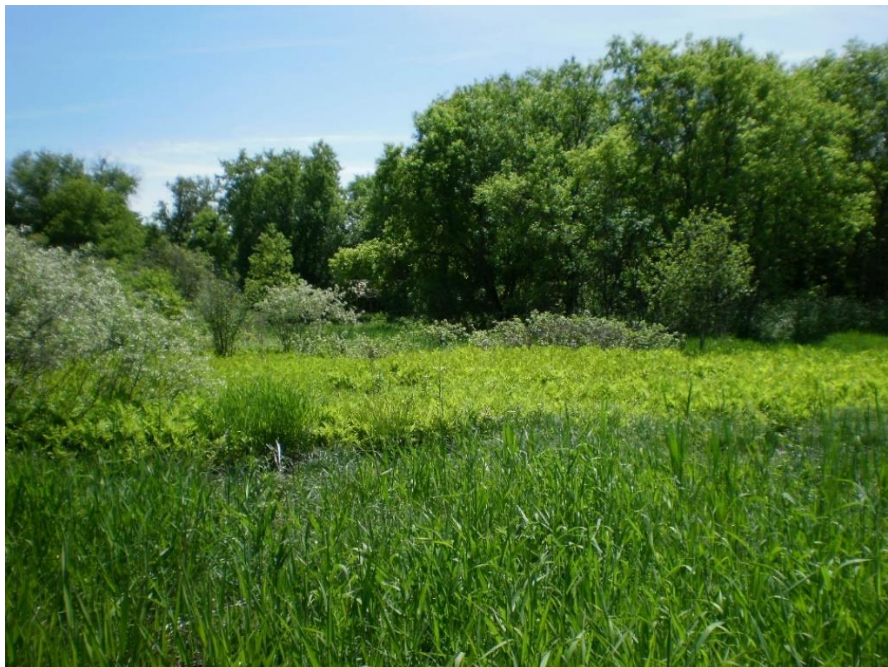
The cultural meadow and upland deciduous forest described above are present in the area of unevaluated RVCA wetland mapping in the north-central portion of the site. No wetland habitat was observed in the mapped location of the RVCA wetland. An area of meadow marsh is adjacent to the west-central site edge (Photos 9 and 10). This habitat has developed on former agricultural land against the recreational pathway. There appears to be no functional drainage under the recreational pathway in this area. The ground vegetation has become very thick and reed canary grass is dominant, with purple loosestrife well established in many areas and joe-pye-weed also common. Sensitive fern, broad-leaved cattail, marsh fern, water parsnip, cow vetch, lady's thumb, water horehound, common burdock, boneset, skunk cabbage, Canada goldenrod, wild carrot, blue vervain, nodding beggar's tick, soft-stem bulrush, fowl manna grass, and spotted jewelweed were also present, along with slender willow, red-osier dogwood, tartarian honeysuckle, and narrow-leaved meadowsweet shrubs. There are no features and functions associated with this small area (approximately 0.1 hectares) of meadow marsh for which the wetland would be considered provincially significant due to the small size, lack of

Photo 9 – Reed canary grass meadow marsh, with purple loosestrife common, along the central-west edge of the site. View looking southeast from recreational pathway (June 12th, 2019)

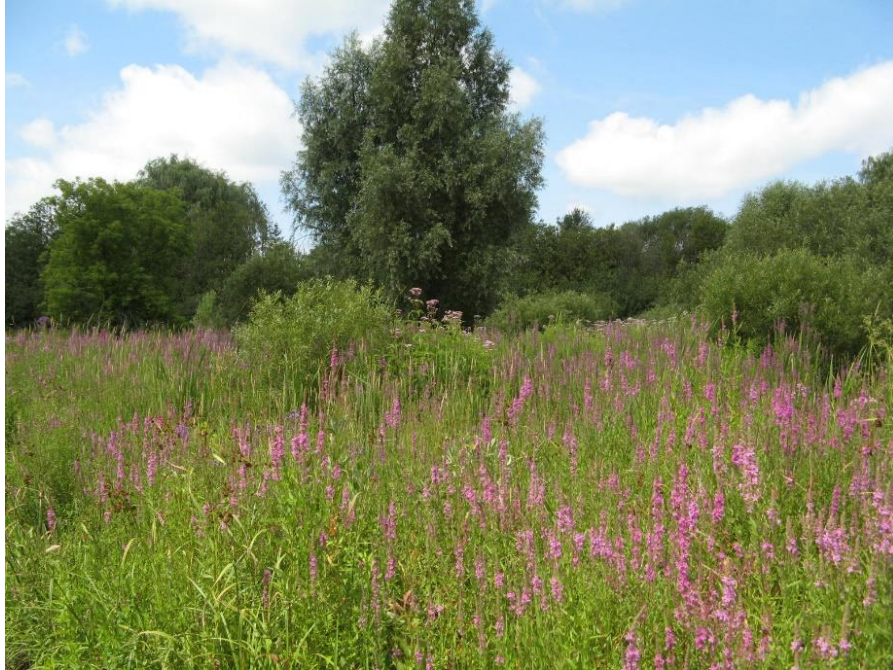
*Photo 10 – Another view of the meadow marsh with purple loosestrife flowering.
View looking northwest (July 15th, 2024)*

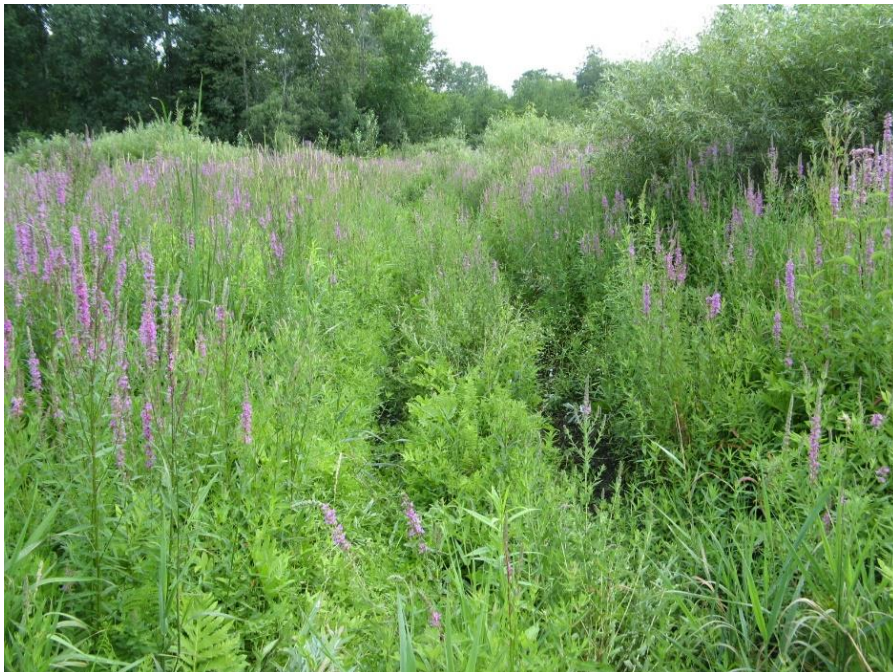
*Photo 11 – ATV ruts in the meadow marsh habitat along the alignment of the ditch mapped on
geoOttawa. View looking east from just east of the Osgoode Link Pathway (July 15th, 2024)*

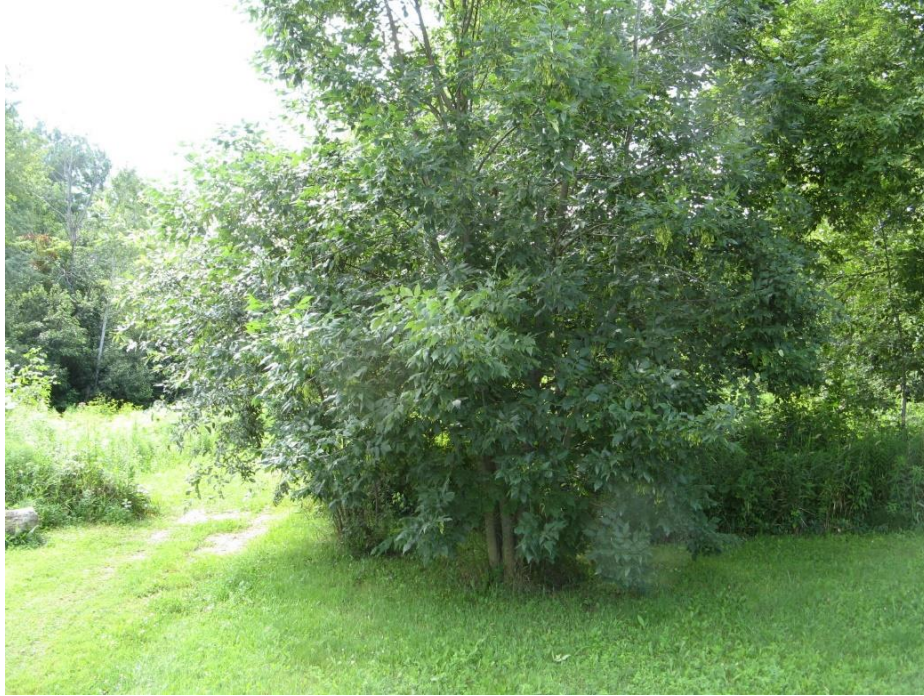
Photo 12 – Small coppice green ash on City-owned land immediately south of the existing cul-de-sac at the current end of Lombardy Drive. View looking south (July 15th, 2024)

South of the existing cul-de-sac off Lombardy Drive within the road allowance a small coppice green ash (Photo 12) and a 11cm dbh trembling aspen will be removed. The five stems of the green ash are 8cm, 9cm, 10cm, 10cm, and 12cm dbh. Leaf-out on the ash was good. There was extensive trunk damage on the aspen, though leaf-out was good. In addition, willow and poplar stems less than 10cm dbh will be removed.
