Kollaard Associates
Engineers

**PHASE II
ENVIRONMENTAL SITE ASSESSMENT
3200 REIDS LANE
CITY OF OTTAWA, ONTARIO**

REVISION 1: June 21, 2024
DATE: January 24, 2023

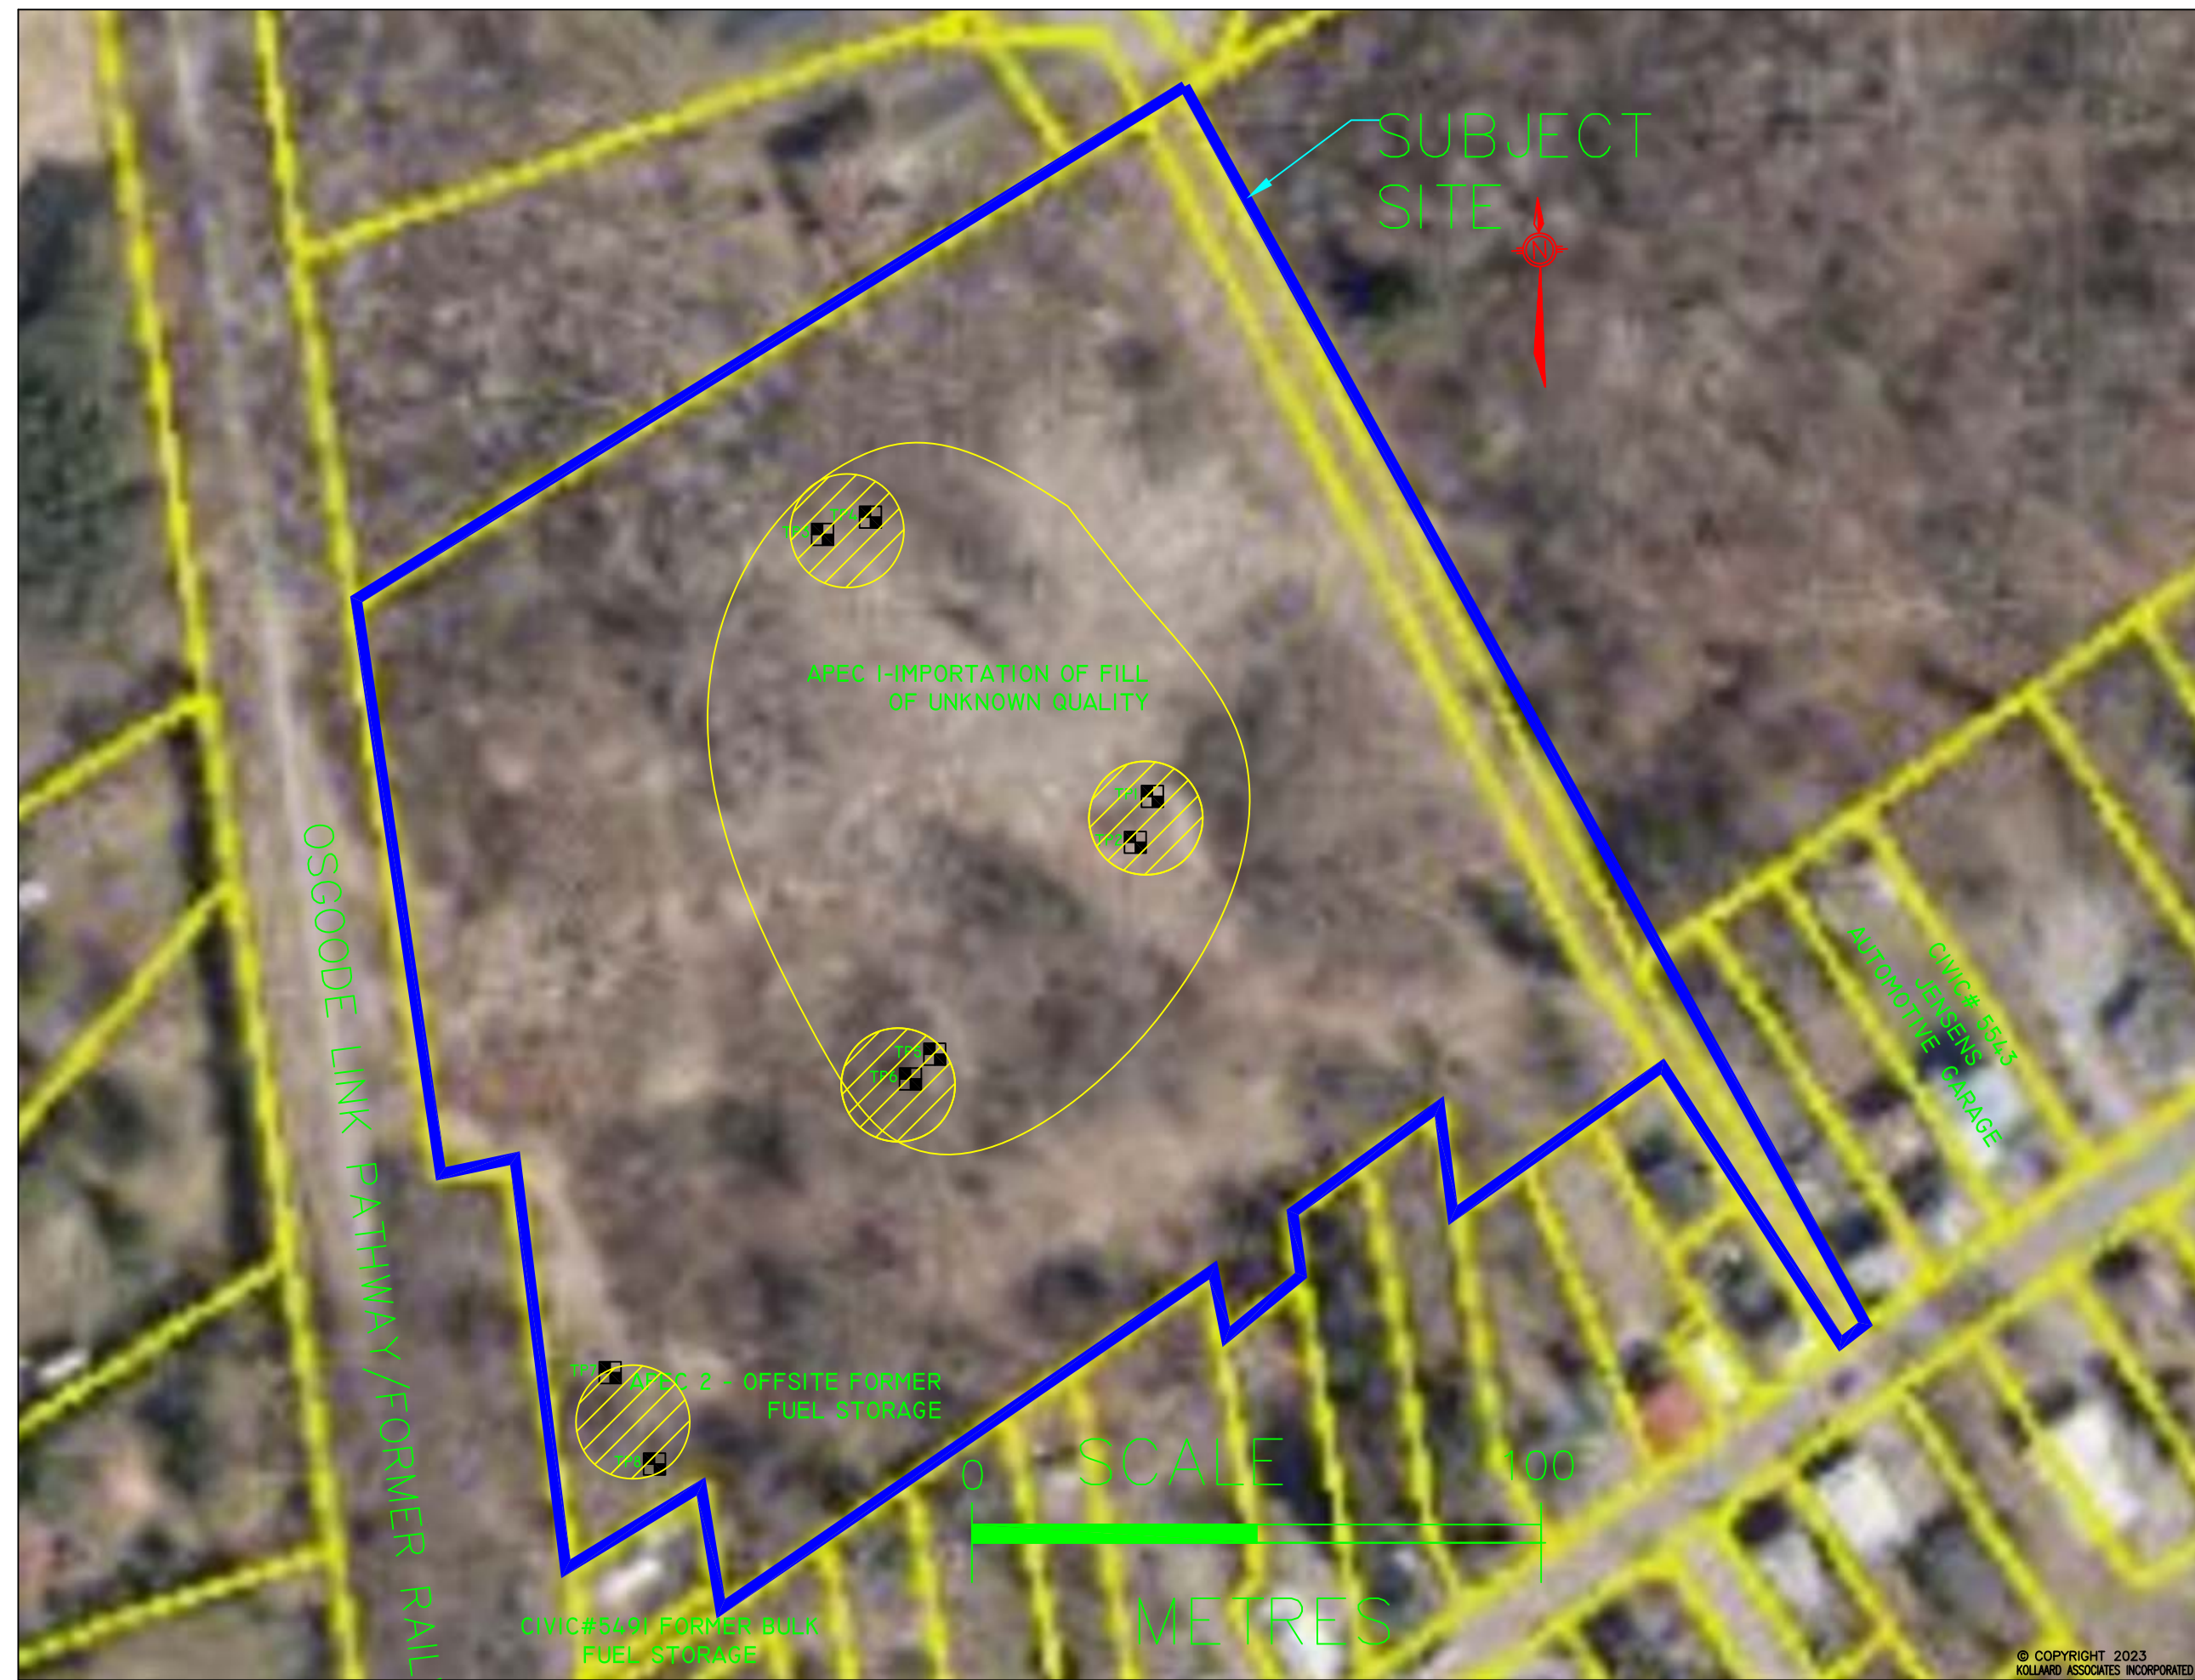
Figure 2 – Conceptual Site Model with APECs and Sample Locations

The locations of the samples are provided on the attached Figure 2. The cross sections (Figures 3 and 4) show the fill areas and underlying native soil and bedrock conditions at the site.

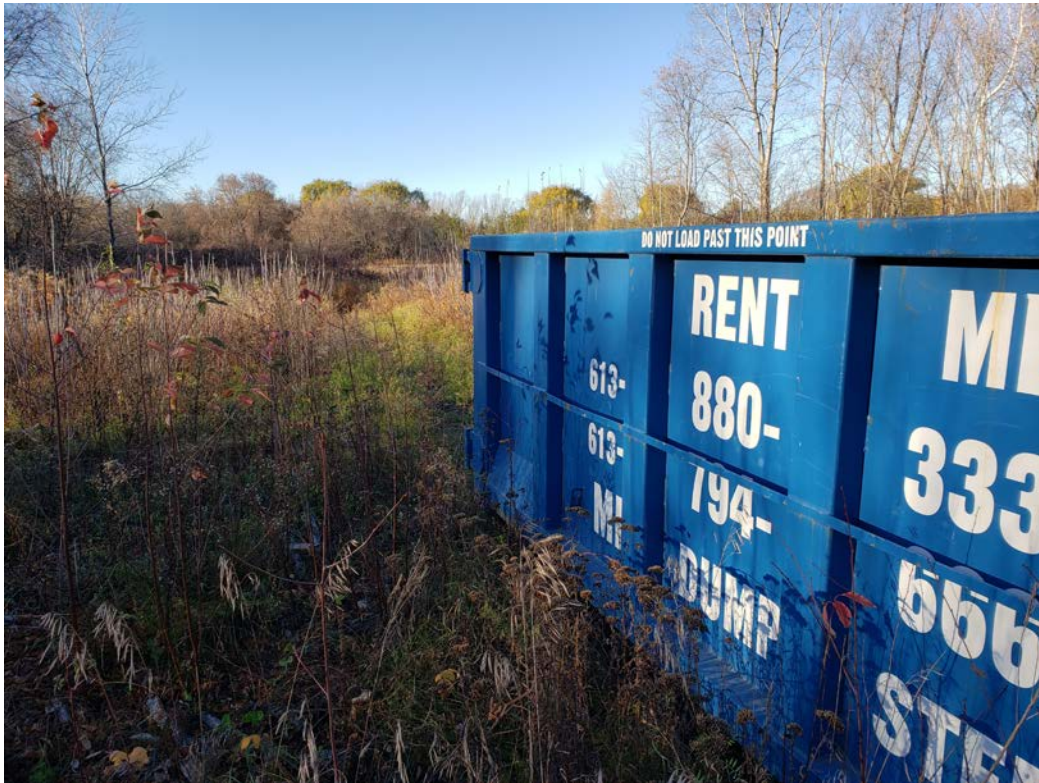
Photograph of dumpster Nov. 7, 2022

All materials that were excavated from Test pits 3 and 4 were placed in a dumpster that was observed by Kollaard Associates Inc. onsite on November 7 and 8, 2022. A subsequent site visit was carried out to determine whether the soil impacts were present in the native soils underlying the fill area at TP3. The underlying soil sample was obtained from the same test pit location from a depth of about 1.60 metres. That sample had non-detectible levels of all PAHs. The asphalt materials were removed from the site from the area of test pits 3 and 4 and no further soil assessment is necessary, based on the results of the additional testing on December 1, 2022.

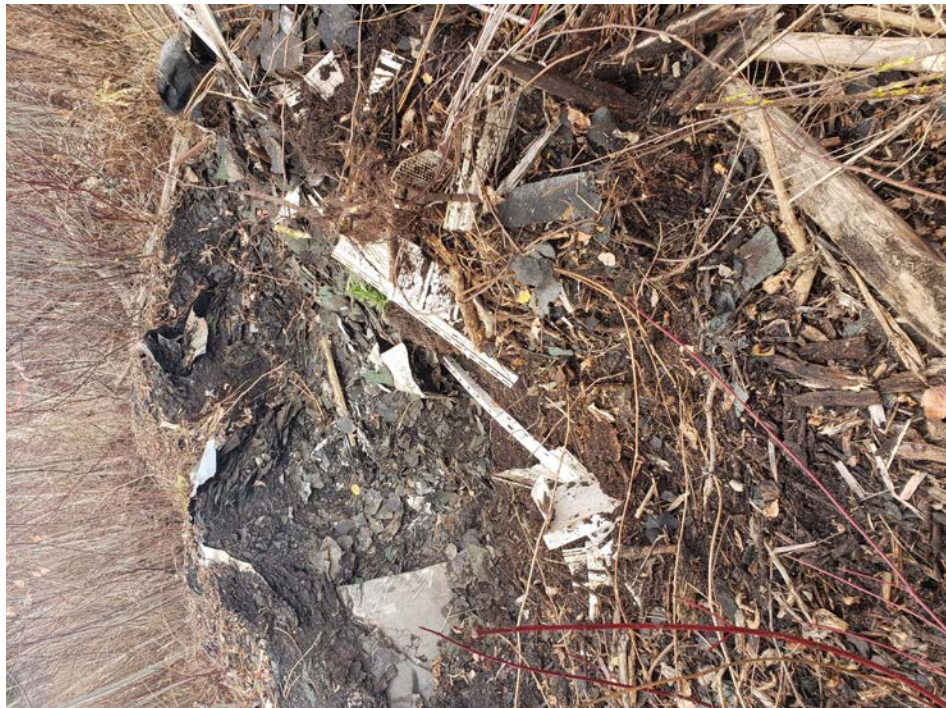
Surface debris removed Nov. 7, 2022

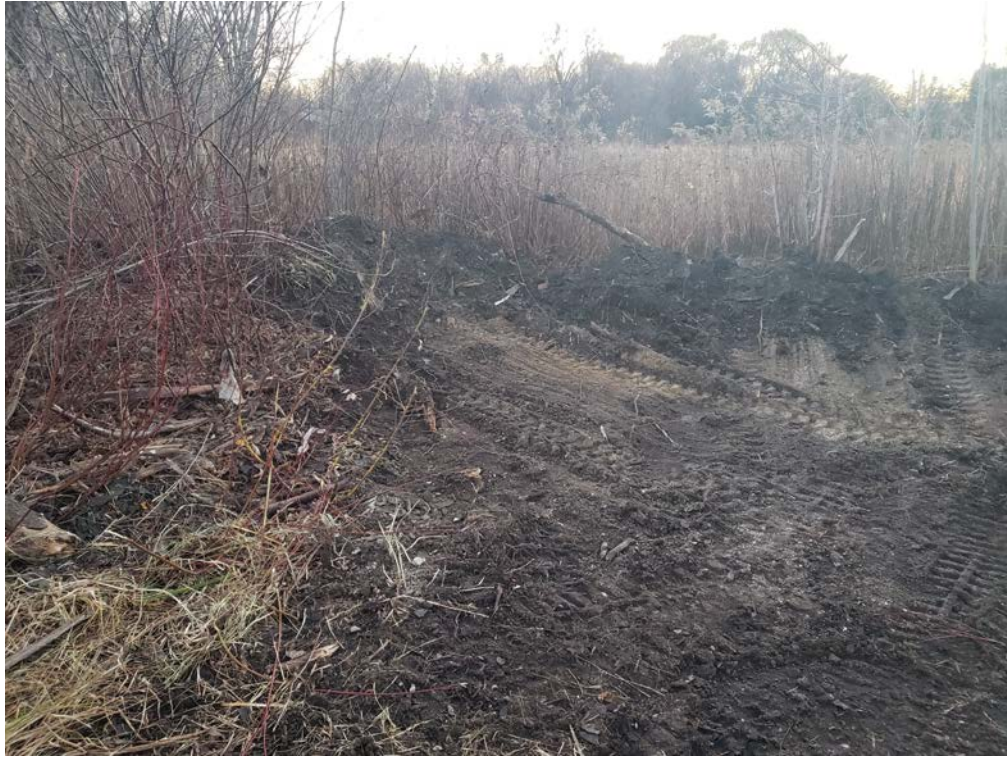
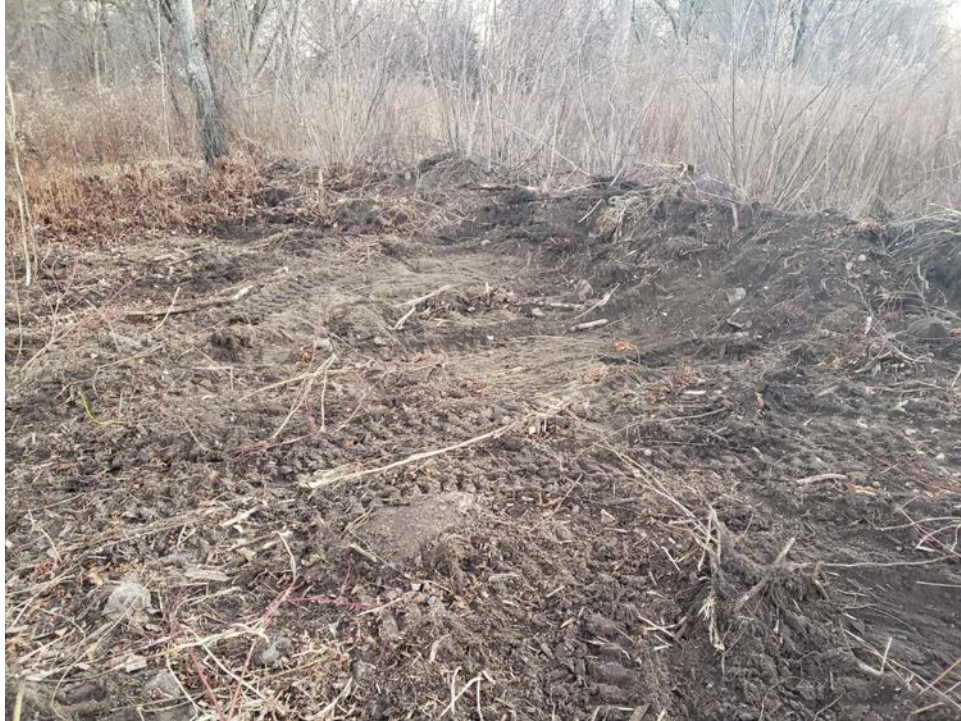
Photographs of surface of test pits 3 and 4, Nov. 8, 2022 after asphalt debris removed from test pits

Based on the information from all the samples obtained, it is considered that the soil at the site does not impacted by PAHs. However, the presence of asphalt (especially at TP3) within the fill materials did cause one soil sample to exceed allowable limits for PAHs, due to the presence of asphalt within the soil matrix. That sample was noted to have contained asphalt pieces. During sample preparation, pieces of asphalt were crushed and formed part of the soil sample tested. It is considered that the asphalt within the soil sample caused the exceedance in this sample. There was non-detectible presence of PAHs in the underlying soil. There were no PAHs detected in any other soil sample. As such, it is considered that the source of the exceedance is from the buried asphalt pieces rather than the soil itself. The soil at TP3 was similar in colour and appearance to the soil in other test pits. The main difference was the presence and amount of asphalt that was observed within that location, compared to other test pits. Trace asphalt was observed at TP1 and TP4. Of the four soil samples obtained from those test pits, there were non-detectible levels of PAHs.
