**PHASE II  
ENVIRONMENTAL SITE ASSESSMENT  
3200 REIDS LANE  
CITY OF OTTAWA, ONTARIO**

Crestview Innovations Inc.  
12 Escade Drive  
Nepean, ON  
K2G 6R9

DATE: January 24, 2023

210064

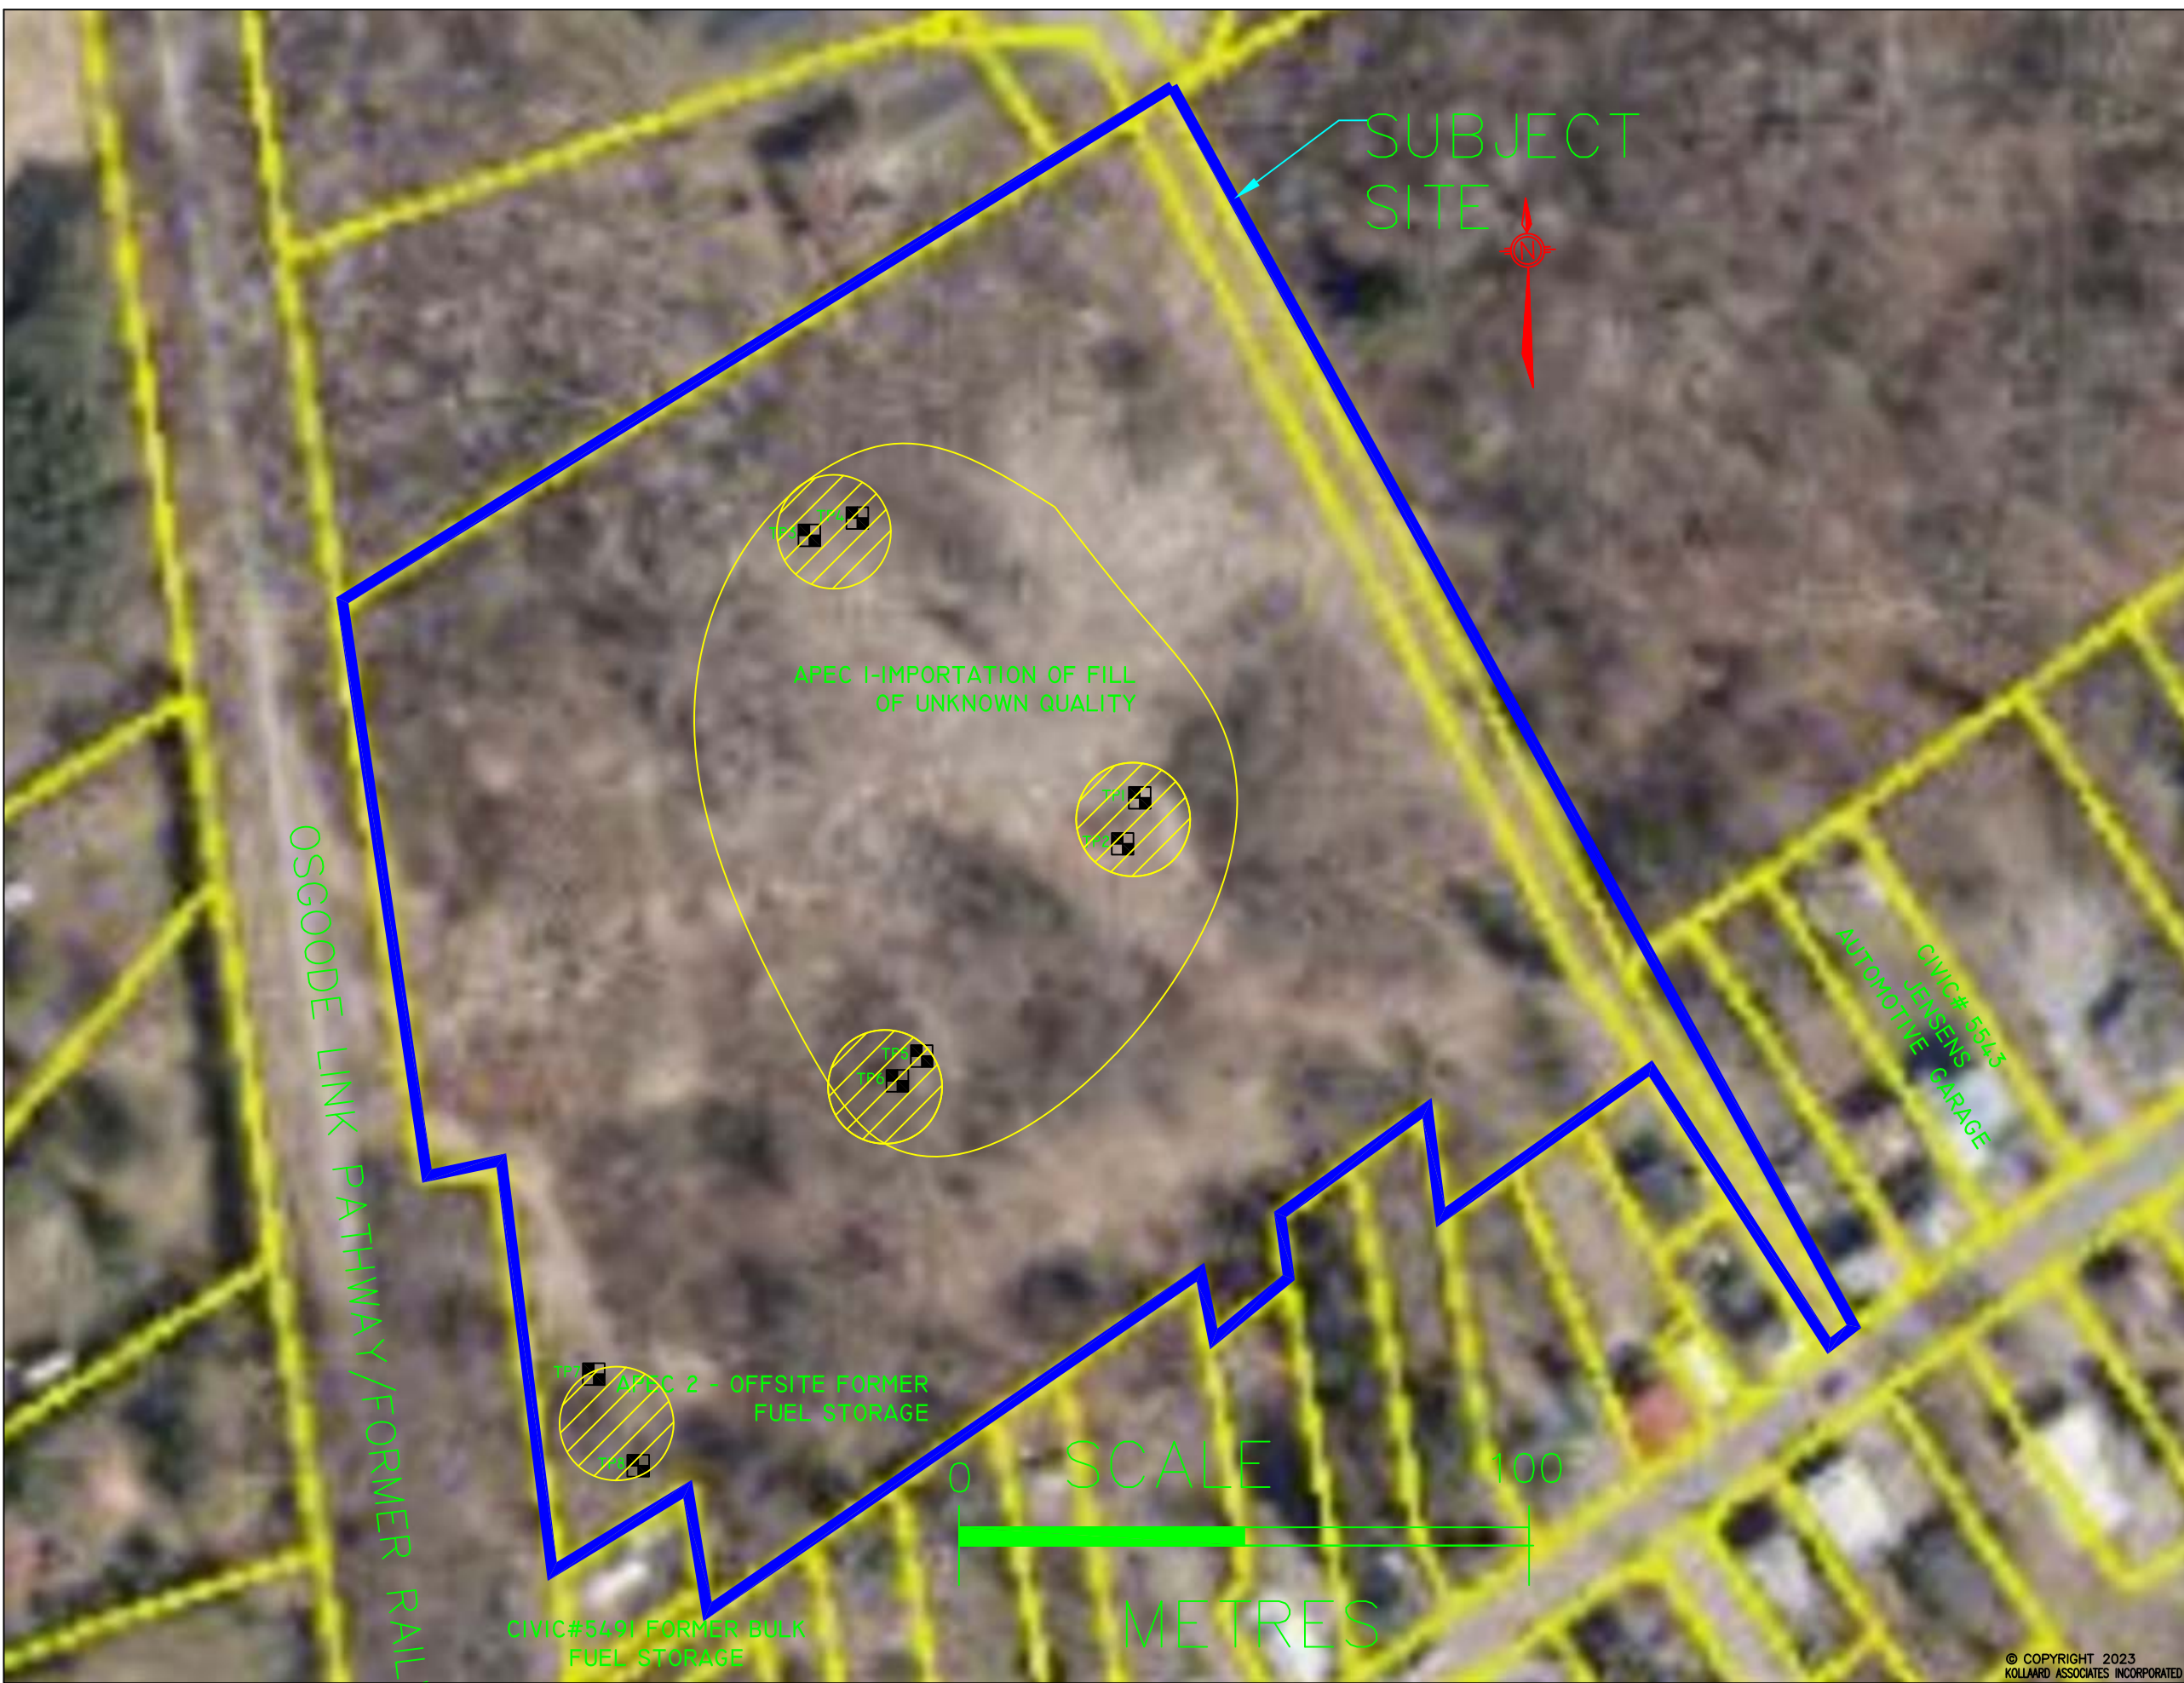
The locations of the samples are provided on the attached Figure 2. The cross sections (Figures 4 and 5) show the fill areas and underlying native soil and bedrock conditions at the site.
