**HYDROGEOLOGICAL INVESTIGATION
AND TERRAIN EVALUATION
PROPOSED RESIDENTIAL SUBDIVISION
3200 REIDS LANE
OSGOODE WARD, CITY OF OTTAWA
ONTARIO**

FILE # 210064

Crestview Innovations Inc.
12 Escade Drive
Nepean, ON
K2G 6R9

REVISION 1 May 10, 2023

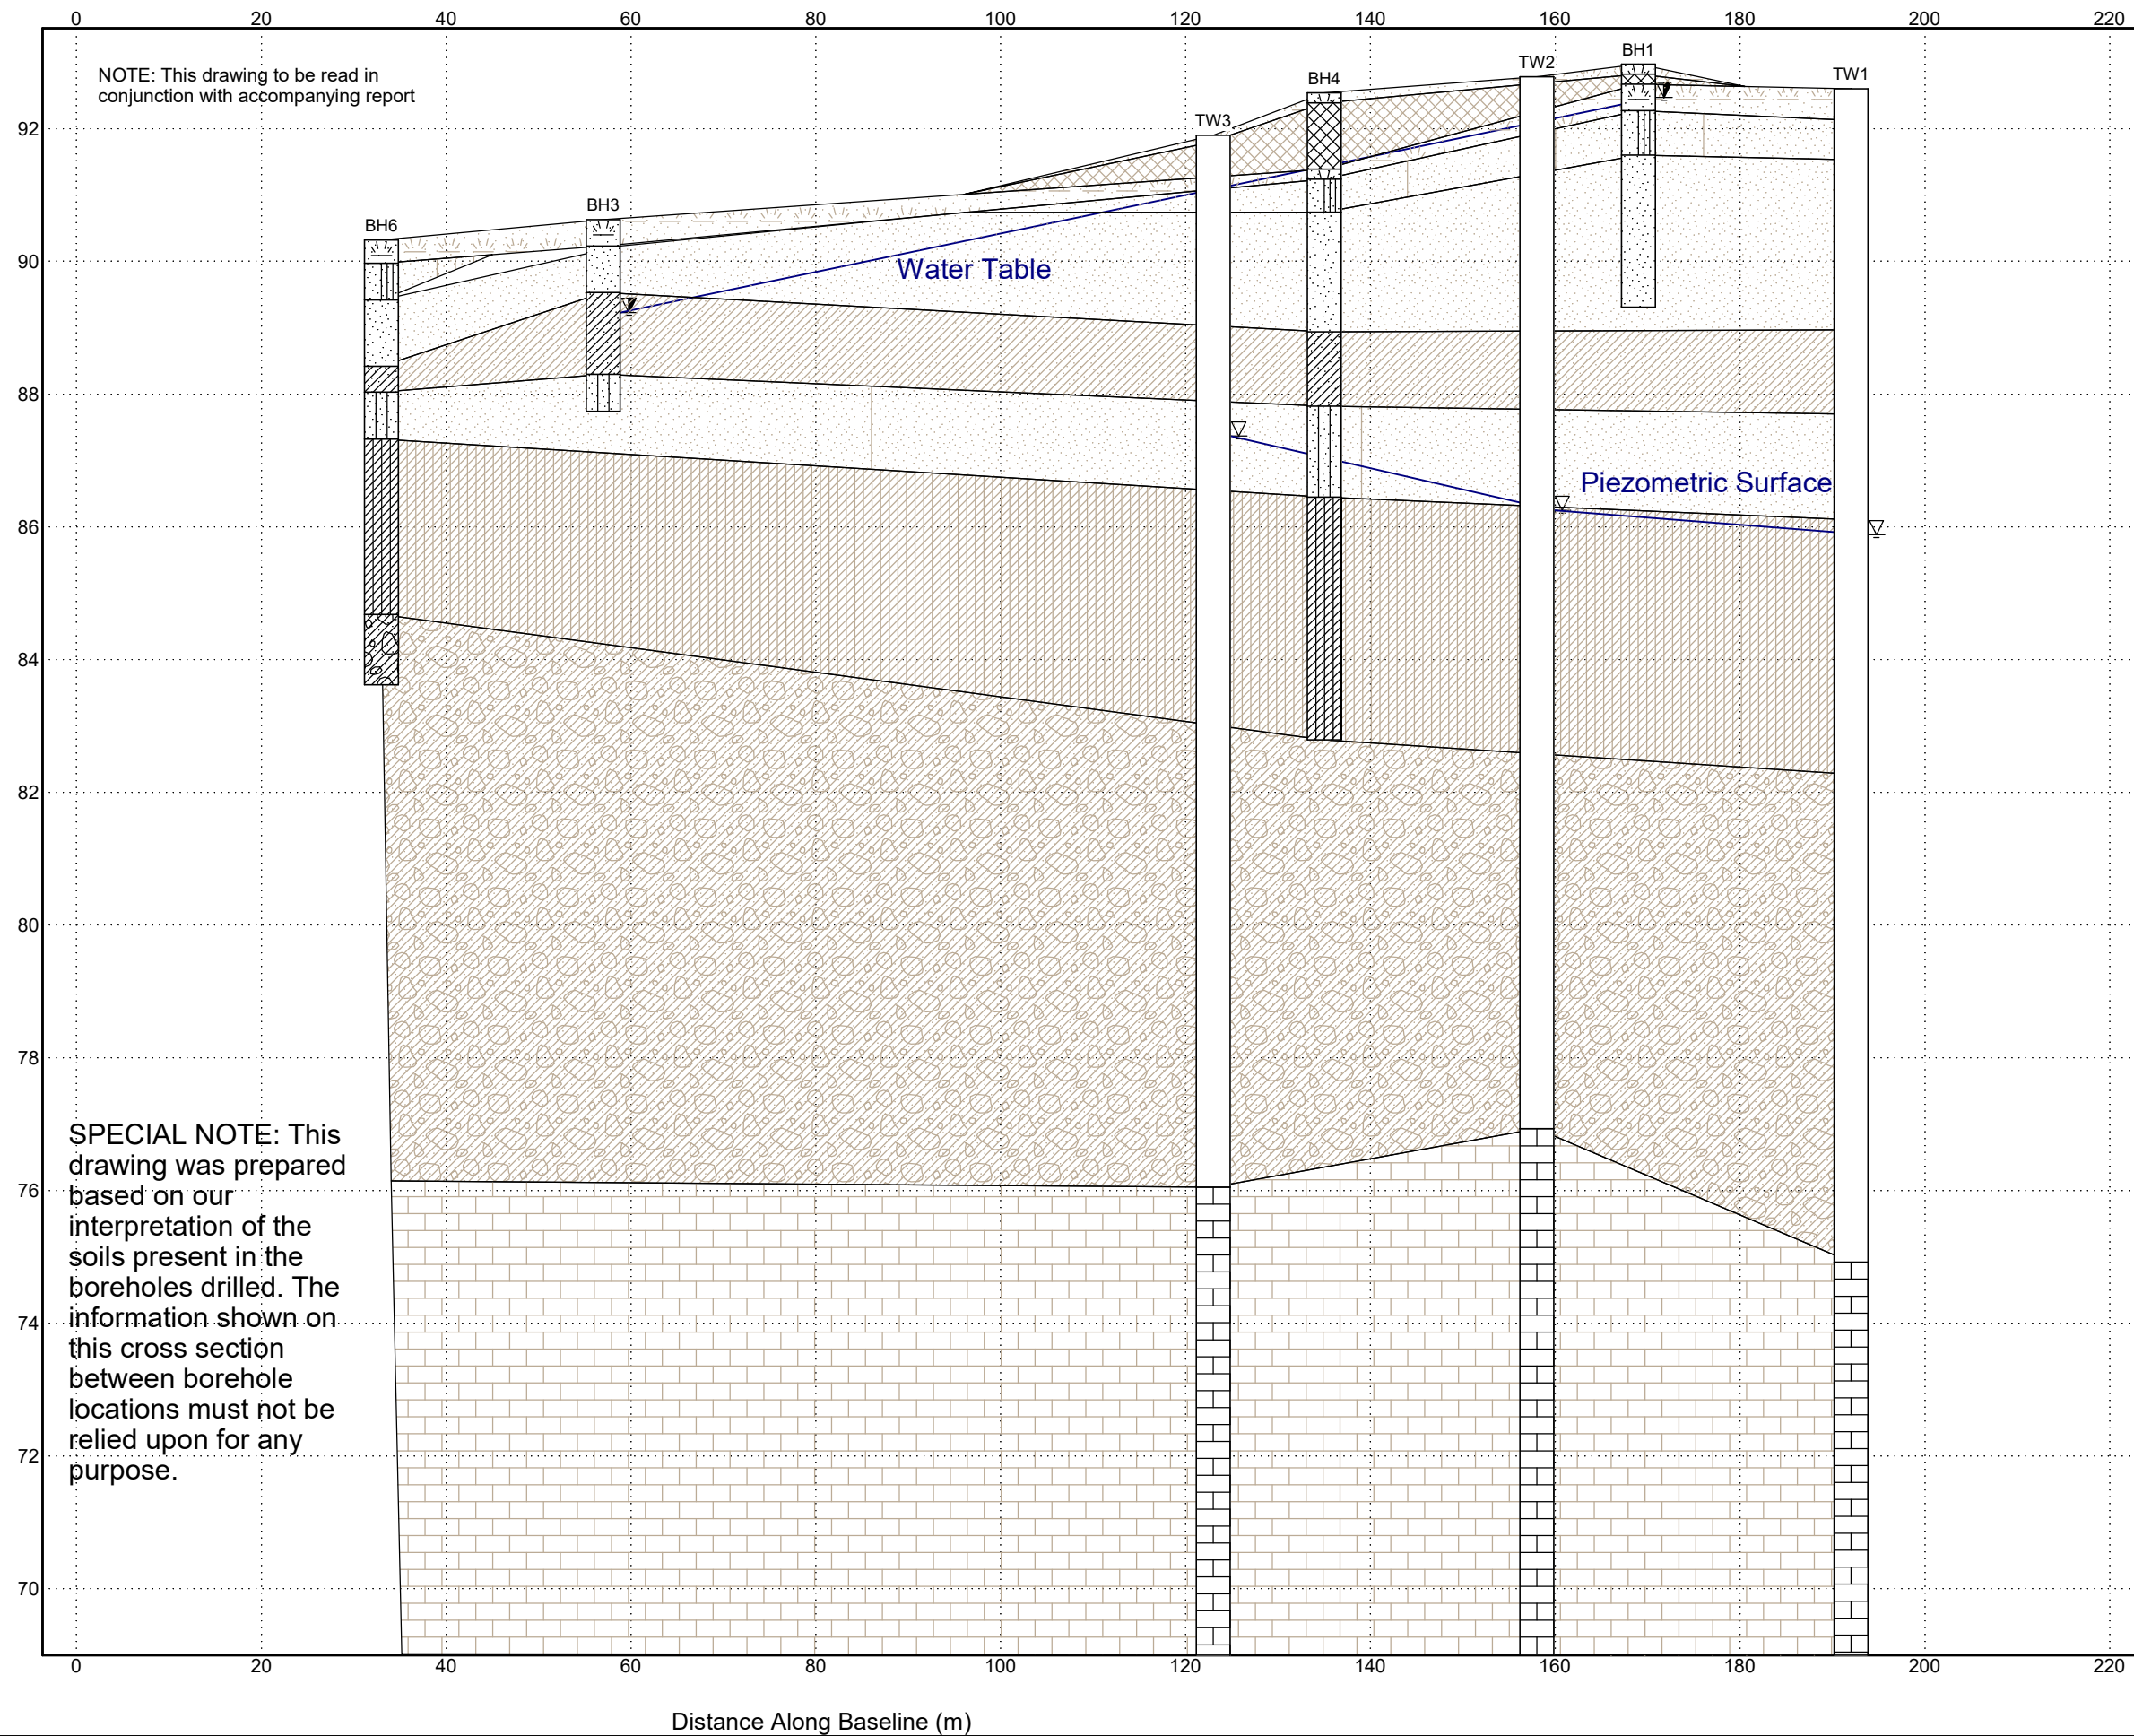
SPECIAL NOTE: This drawing was prepared based on our interpretation of the soils present in the boreholes drilled. The information shown on this cross section between borehole locations must not be relied upon for any purpose.

- The piezometric surfaces in the three water supply wells (see cross sections, Figures 4 and 5) are above the top of the aquifer (bedrock elevation); and
- the shape of the drawdown response curve observed in the pumping tests closely resembles the ideal response of a confined aquifer; and
- the storativity coefficient calculated using the drawdown response in adjacent wells is $\sim 2.0 \times 10^{-4}$, whereas specific yield in an unconfined aquifer is typically orders of magnitude higher; and
- Based on the depth and type of soils onsite, there is a confining unit consisting of silty clay and/or glacial till which are some 9 metres to 15 metres in thickness.

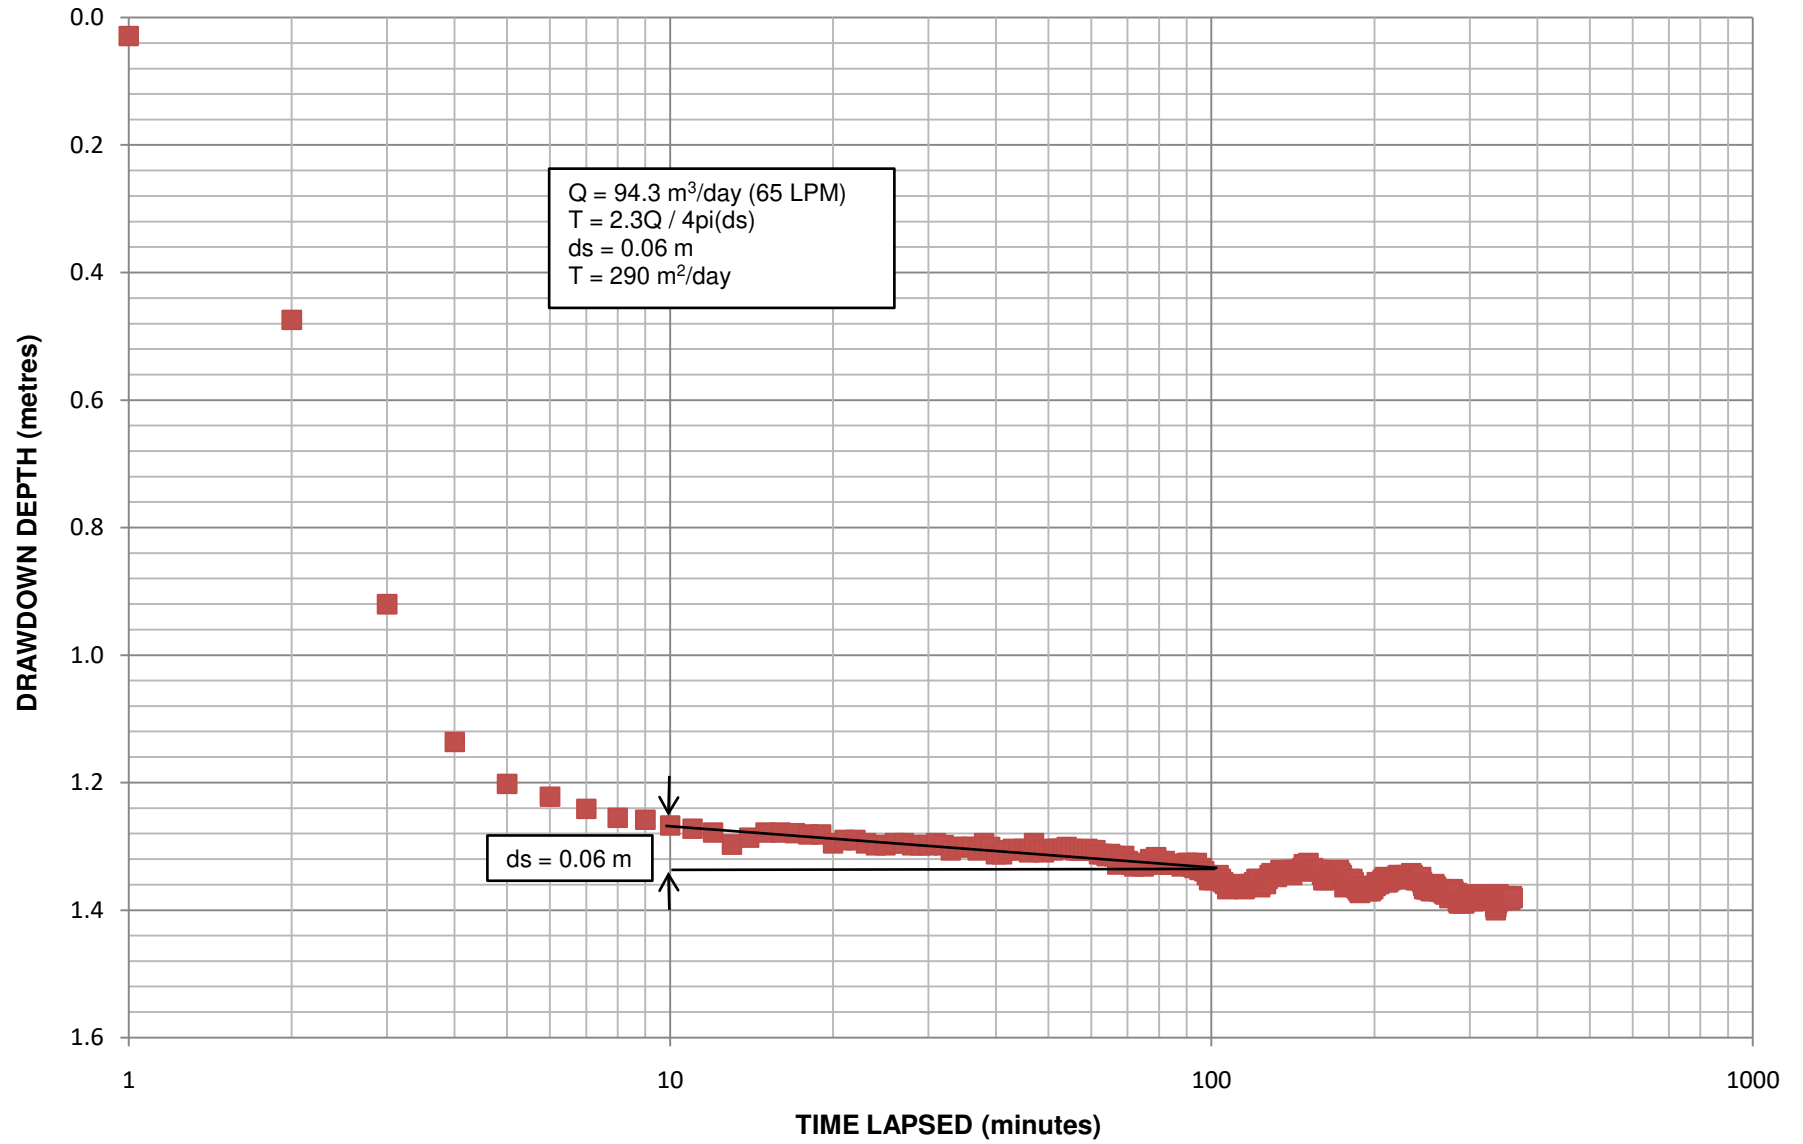
TW1-WELL DRAWDOWN VS. TIME-KOLLAARD FILE 210064

Time Lapsed (minutes)	Abs Pres (kPa)	Temp (°C)	Water Level (m)	Drawdown (m)
0	388.094	8.382	-6.86	0.00
1	387.814	8.282	-6.889	0.03
2	383.442	8.282	-7.334	0.47
3	379.072	8.282	-7.78	0.92
4	376.956	8.282	-7.996	1.14
5	376.305	8.282	-8.062	1.20
6	376.115	8.282	-8.082	1.22
7	375.925	8.282	-8.101	1.24
8	375.789	8.282	-8.115	1.26
9	375.754	8.182	-8.118	1.26
10	375.672	8.182	-8.127	1.27
11	375.618	8.182	-8.132	1.27
12	375.564	8.182	-8.138	1.28
13	375.374	8.182	-8.157	1.30
14	375.483	8.182	-8.146	1.29
15	375.564	8.182	-8.138	1.28
16	375.564	8.182	-8.138	1.28
17	375.555	8.082	-8.139	1.28
18	375.528	8.082	-8.141	1.28
19	375.528	8.082	-8.141	1.28
20	375.393	8.082	-8.155	1.30
21	375.447	8.082	-8.15	1.29
22	375.447	8.082	-8.15	1.29
23	375.393	8.082	-8.155	1.30
24	375.366	8.082	-8.158	1.30
25	375.366	8.082	-8.158	1.30
26	375.393	8.082	-8.155	1.30
27	375.393	8.082	-8.155	1.30
28	375.366	8.082	-8.158	1.30
29	375.366	8.082	-8.158	1.30

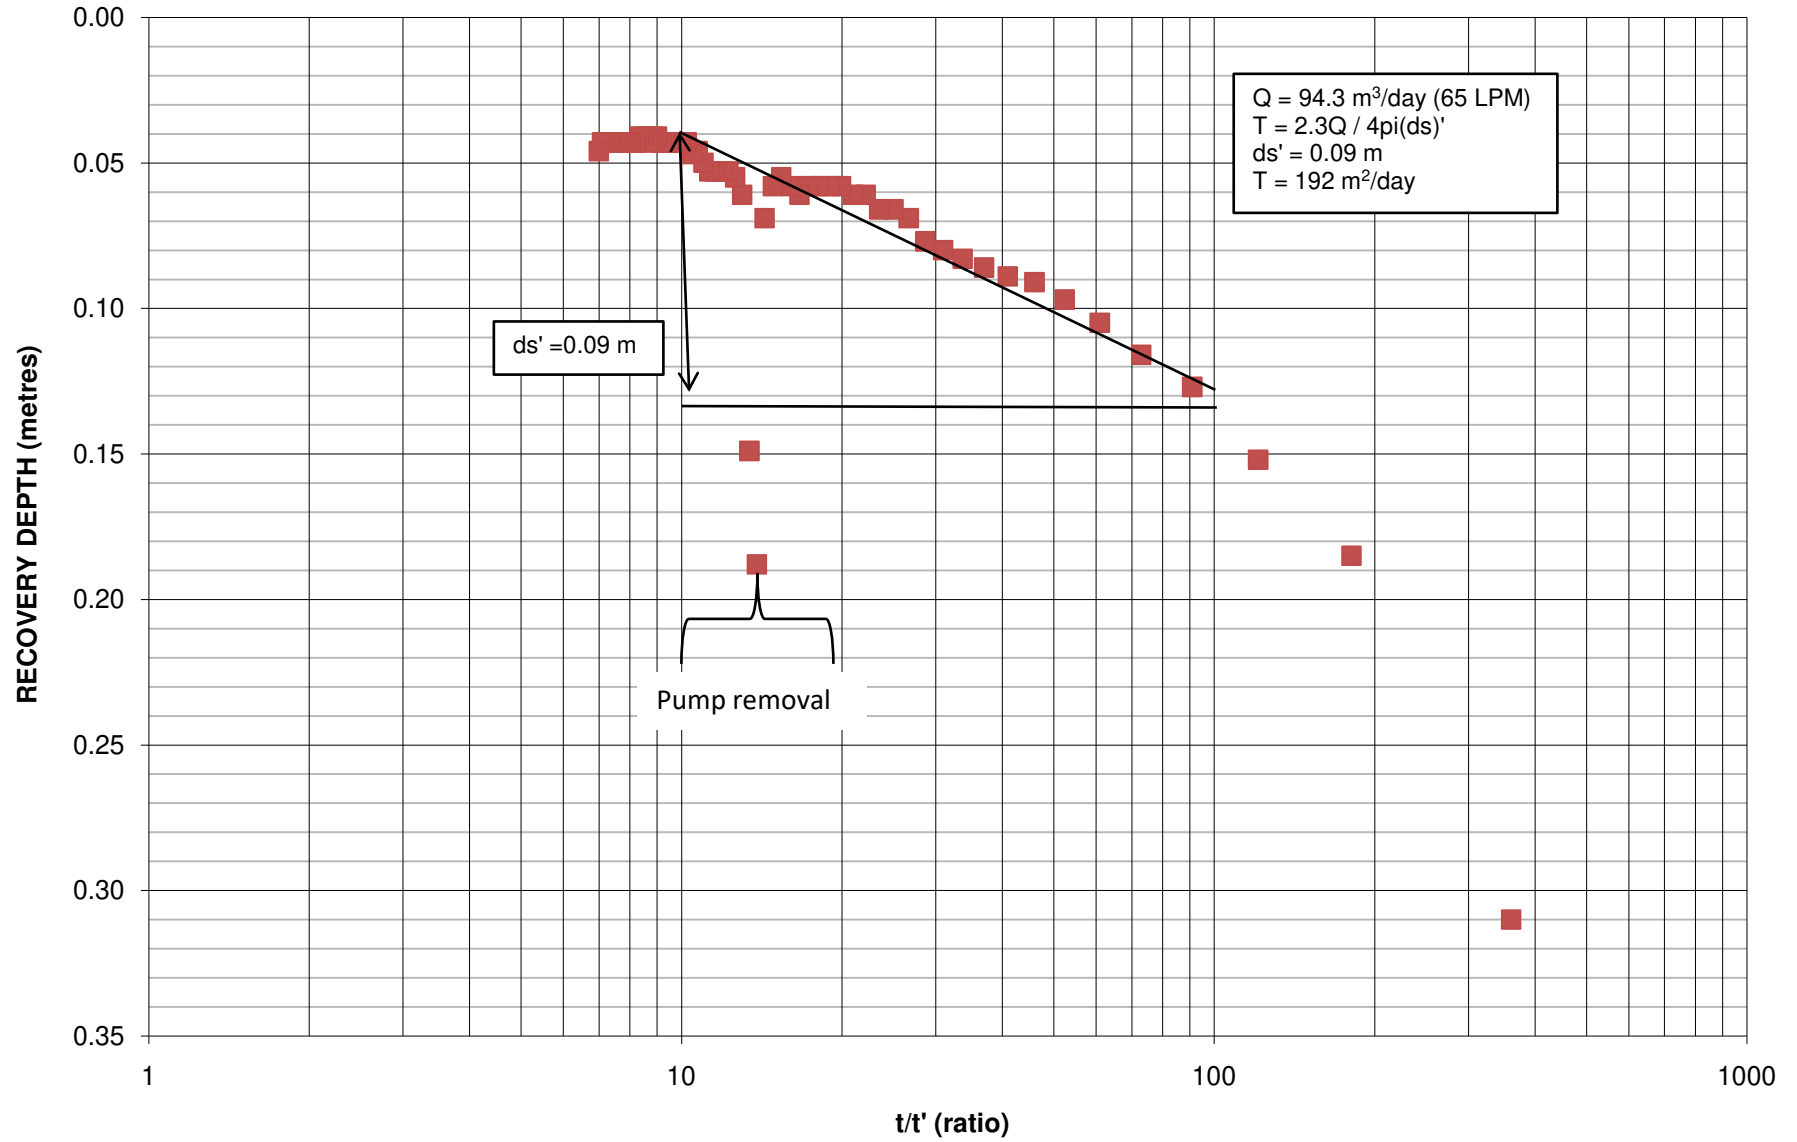
TW1- WELL RECOVERY VS. TIME - KOLLAARD FILE 210064

t'	t / t'	Abs Pres (kPa)	Temp (°C)	Water Level (m)	Drawdown (m)	Recovery (%)
1	361	385.053	8.082	-7.17	0.31	78%
2	181.0	386.275	8.082	-7.045	0.19	87%
3	121.0	386.601	8.082	-7.012	0.15	89%
4	91.0	386.846	8.082	-6.987	0.13	91%
5	73.0	386.954	8.082	-6.976	0.12	92%
6	61.0	387.063	8.082	-6.965	0.11	92%
7	52.4	387.144	8.082	-6.957	0.10	93%
8	46.0	387.199	8.082	-6.951	0.09	93%
9	41.0	387.226	8.082	-6.949	0.09	94%
10	37.0	387.253	8.082	-6.946	0.09	94%
11	33.7	387.28	8.082	-6.943	0.08	94%
12	31.0	387.307	8.082	-6.94	0.08	94%
13	28.7	387.335	8.082	-6.937	0.08	94%
14	26.7	387.416	8.082	-6.929	0.07	95%
15	25.0	387.443	8.082	-6.926	0.07	95%
16	23.5	387.443	8.082	-6.926	0.07	95%
17	22.2	387.498	8.082	-6.921	0.06	96%
18	21.0	387.498	8.082	-6.921	0.06	96%
19	19.9	387.525	8.082	-6.918	0.06	96%
20	19.0	387.525	8.082	-6.918	0.06	96%
21	18.1	387.525	8.082	-6.918	0.06	96%
22	17.4	387.525	8.082	-6.918	0.06	96%
23	16.7	387.498	8.082	-6.921	0.06	96%

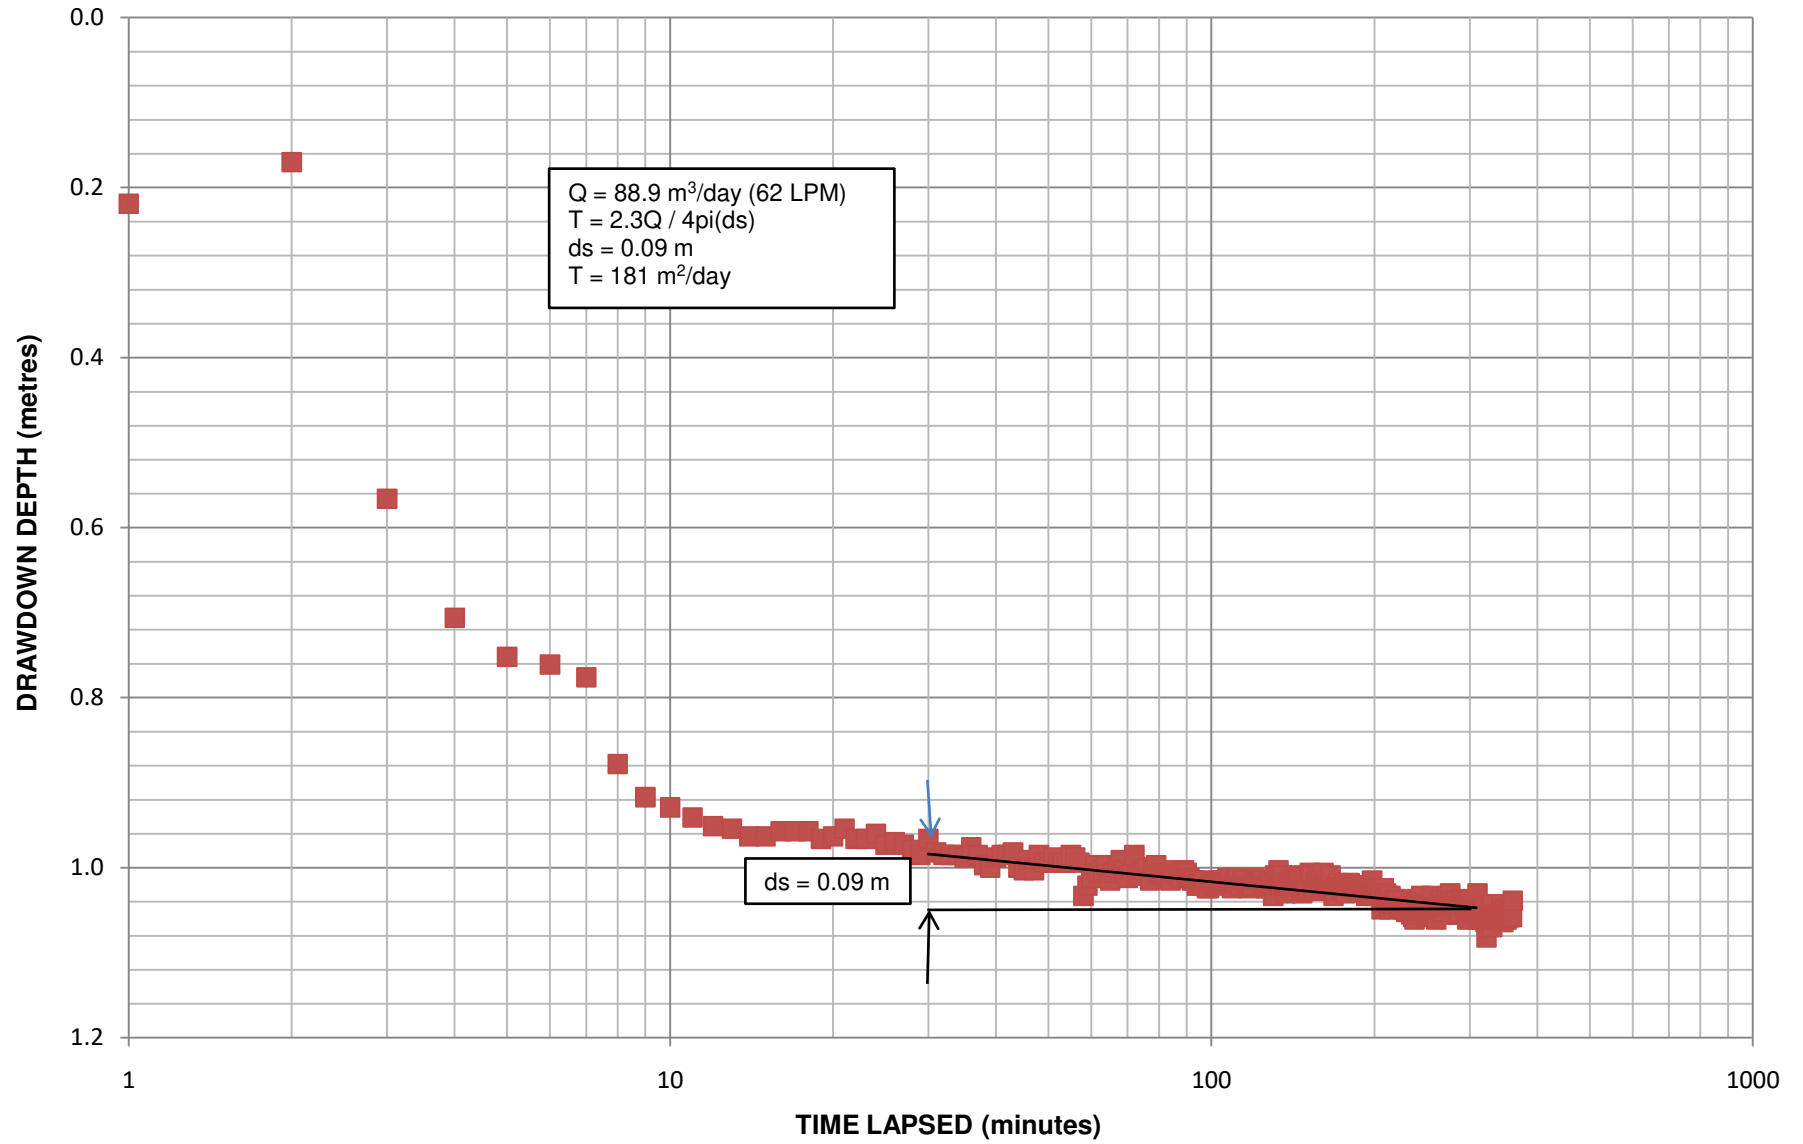
TW2-WELL DRAWDOWN VS. TIME-KOLLAARD FILE 210064

Time Lapsed (minutes)	Abs Pres (kPa)	Temp (°C)	Water Level (m)	Drawdown (m)
0	392.344	8.182	-6.68	0.00
1	390.194	8.182	-6.899	0.22
2	390.672	8.182	-6.85	0.17
3	386.79	8.182	-7.246	0.57
4	385.417	8.182	-7.386	0.71
5	384.969	8.182	-7.432	0.75
6	384.88	8.182	-7.441	0.76
7	384.73	8.182	-7.456	0.78
8	383.738	8.082	-7.558	0.88
9	383.35	8.082	-7.597	0.92
10	383.231	8.082	-7.609	0.93
11	383.112	8.082	-7.621	0.94
12	383.022	8.082	-7.631	0.95
13	382.992	8.082	-7.634	0.95
14	382.903	8.082	-7.643	0.96
15	382.903	8.082	-7.643	0.96
16	382.962	8.082	-7.637	0.96
17	382.955	7.983	-7.637	0.96
18	382.955	7.983	-7.637	0.96
19	382.866	7.983	-7.646	0.97
20	382.896	7.983	-7.643	0.96
21	382.985	7.983	-7.634	0.95
22	382.866	7.983	-7.646	0.97
23	382.866	7.983	-7.646	0.97
24	382.926	7.983	-7.64	0.96
25	382.806	7.983	-7.653	0.97
26	382.836	7.983	-7.65	0.97
27	382.806	7.983	-7.653	0.97
28	382.746	7.983	-7.659	0.98
29	382.687	7.983	-7.665	0.99
30	382.866	7.983	-7.646	0.97
