Phase One Environmental Site Assessment 37 Wildpine Court, Ottawa, Ontario

Wildpine Trails Inc.

Phase One Environmental Site Assessment

OTT-00259416-A0

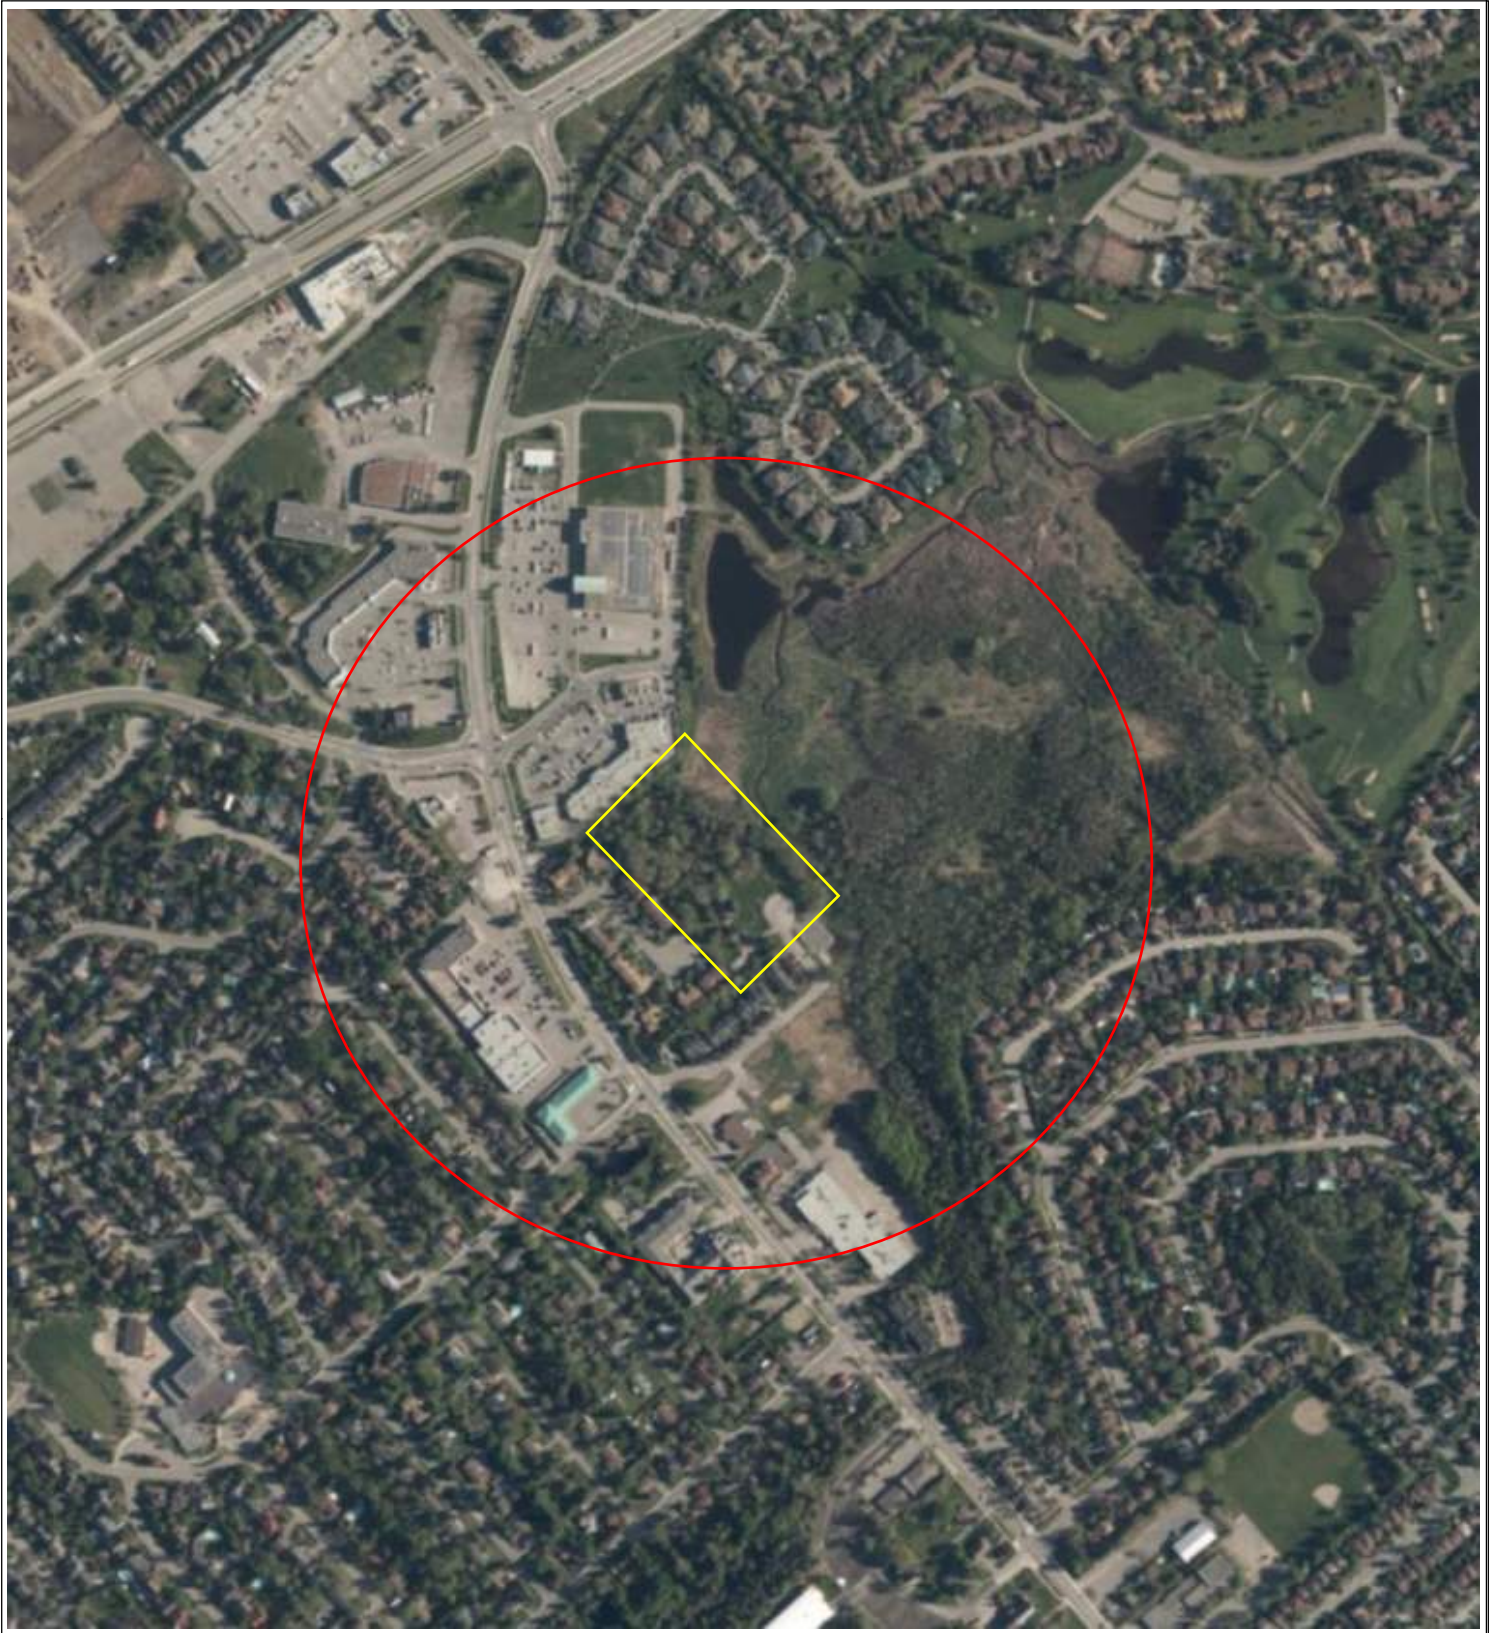
DATE: April 2020	PROJECT TITLE: PHASE ONE ENVIRONMENTAL SITE ASSESSMENT 37 Wildpine Court, Ottawa, Ontario	PROJECT No.: OTT-00259416-A0
DESIGN: LW	DRAWING TITLE: 1976 AERIAL PHOTOGRAPH	SCALE: AS SHOWN
DRAWN BY: LW		FIG E-1

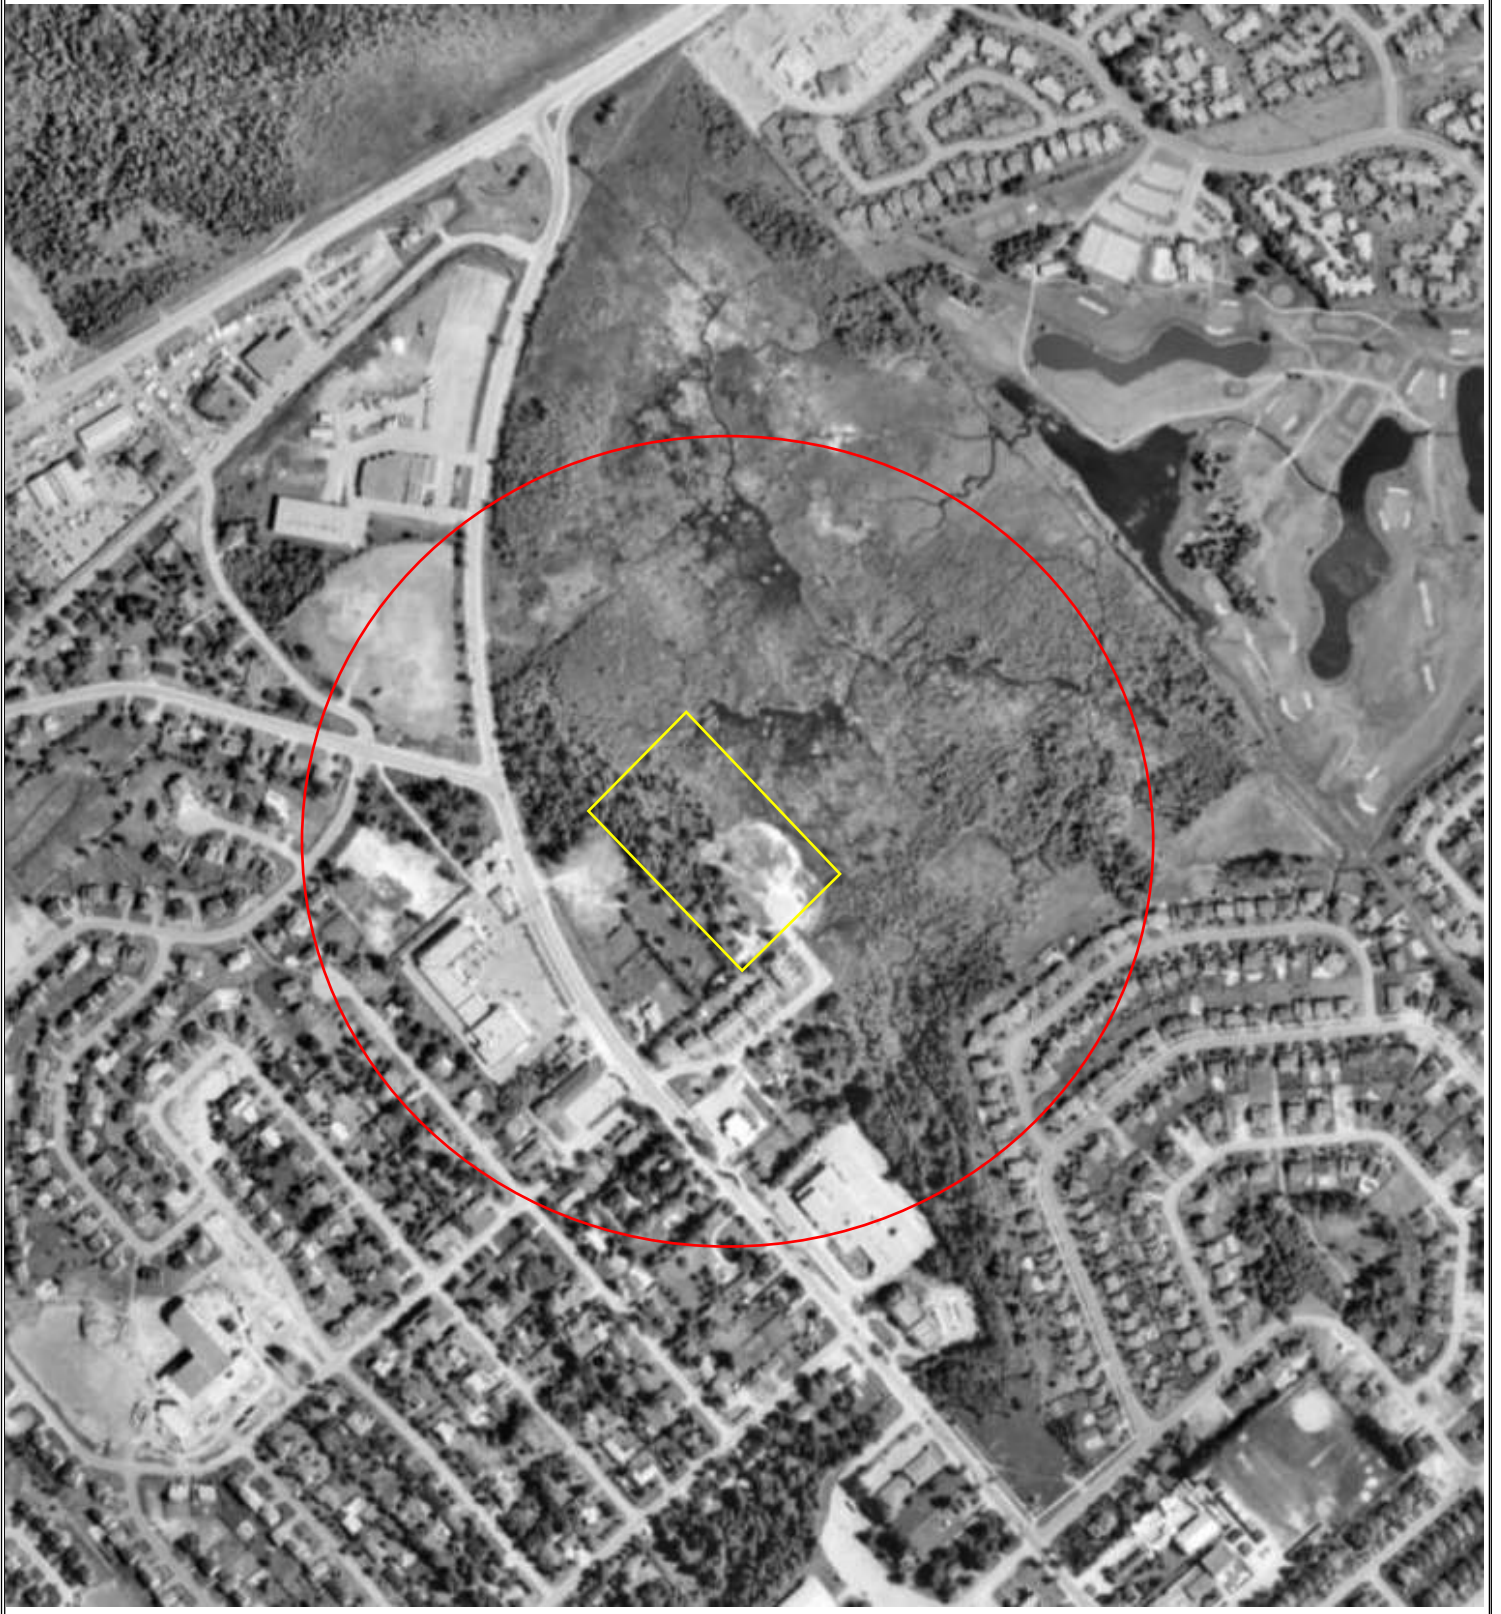
DATE: April 2020	PROJECT TITLE: PHASE ONE ENVIRONMENTAL SITE ASSESSMENT 37 Wildpine Court, Ottawa, Ontario	PROJECT No.: OTT-00259416-A0
DESIGN: LW	DRAWING TITLE: 1991 AERIAL PHOTOGRAPH	SCALE: AS SHOWN
DRAWN BY: LW		FIG E-2
		CHECKED: CK

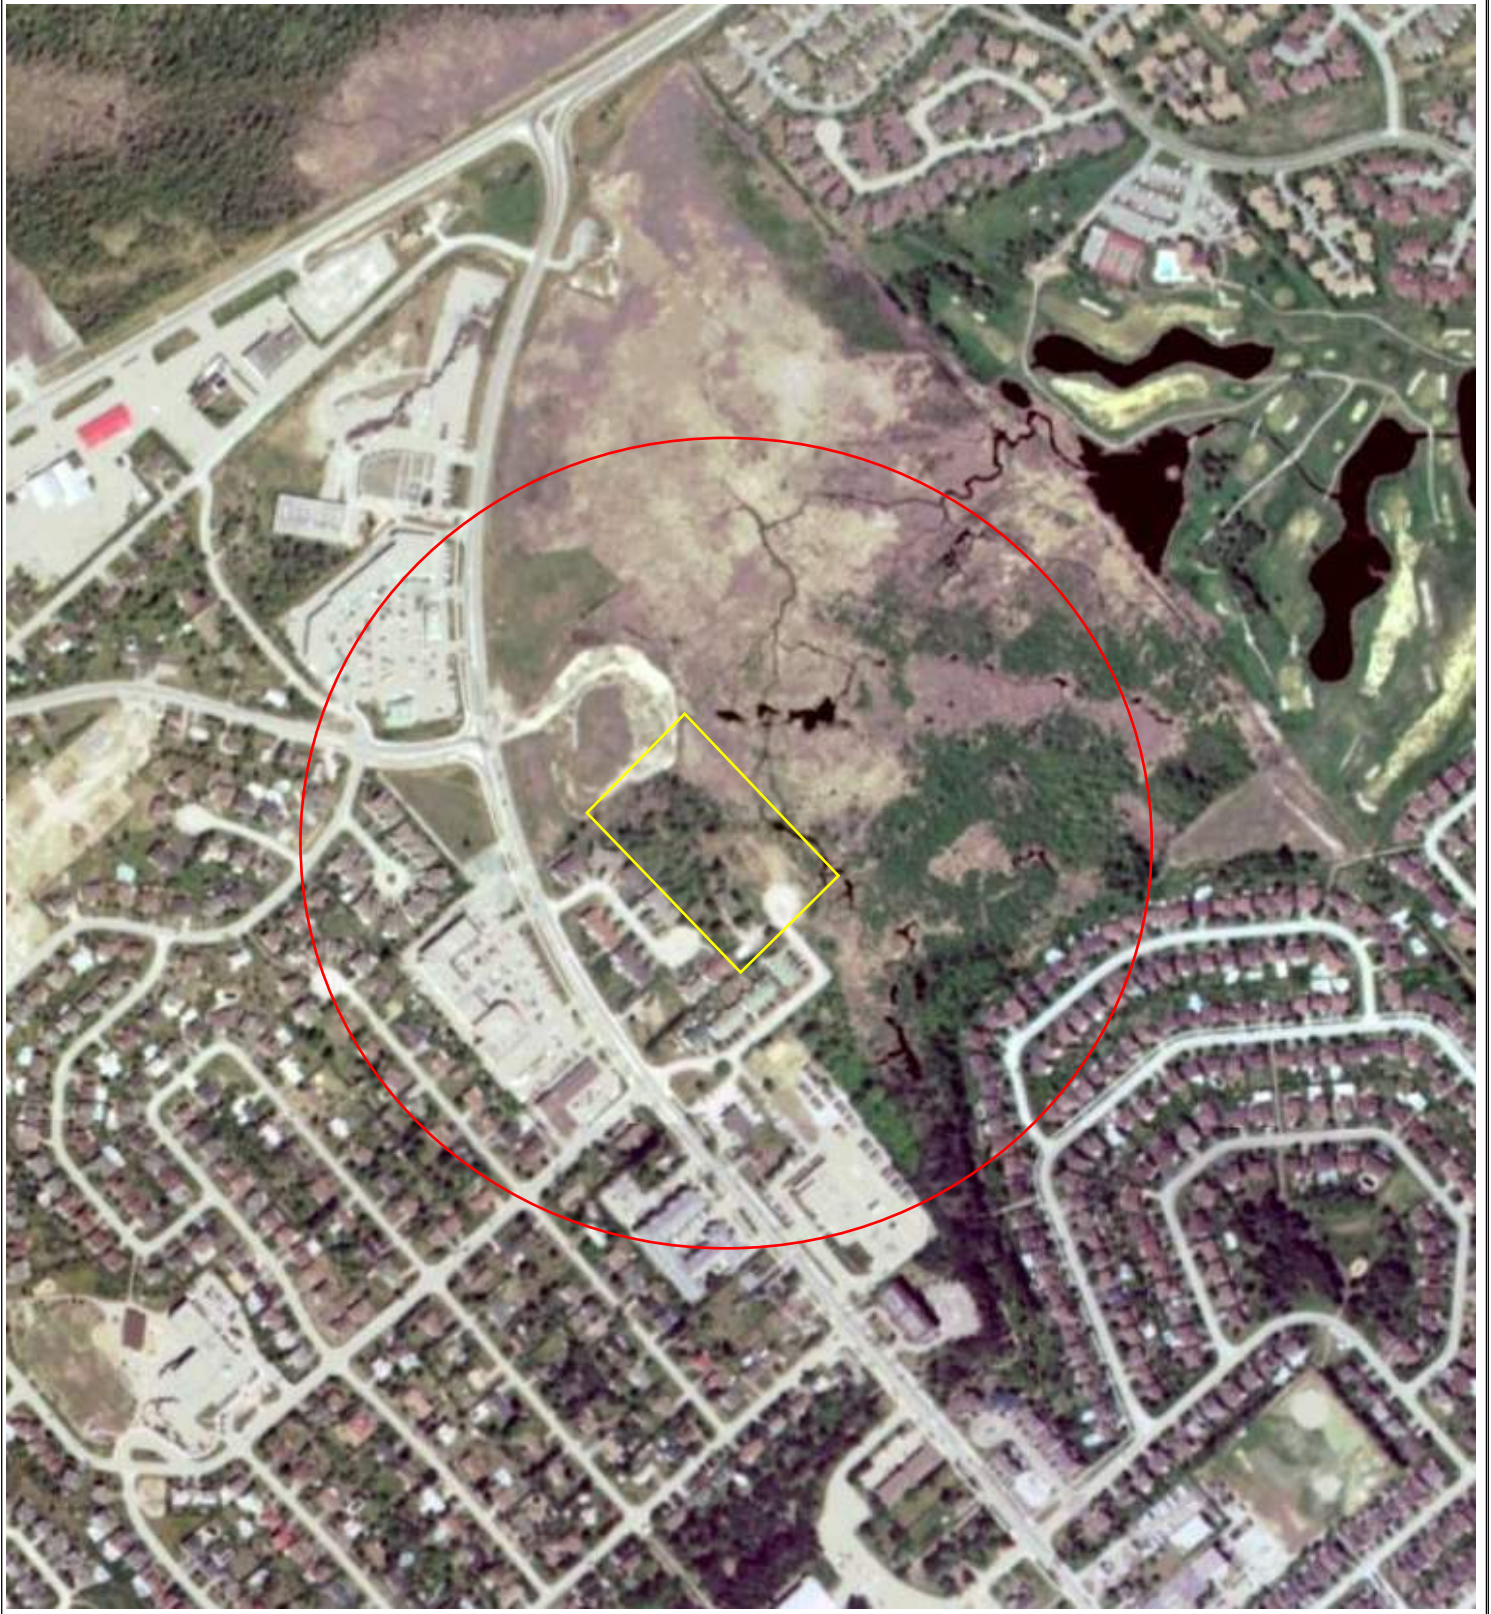
DATE: April 2020	PROJECT TITLE: PHASE ONE ENVIRONMENTAL SITE ASSESSMENT 37 Wildpine Court, Ottawa, Ontario	PROJECT No.: OTT-00259416-A0
DESIGN: LW	DRAWING TITLE: 1999 AERIAL PHOTOGRAPH	SCALE: AS SHOWN
DRAWN BY: LW		FIG E-3

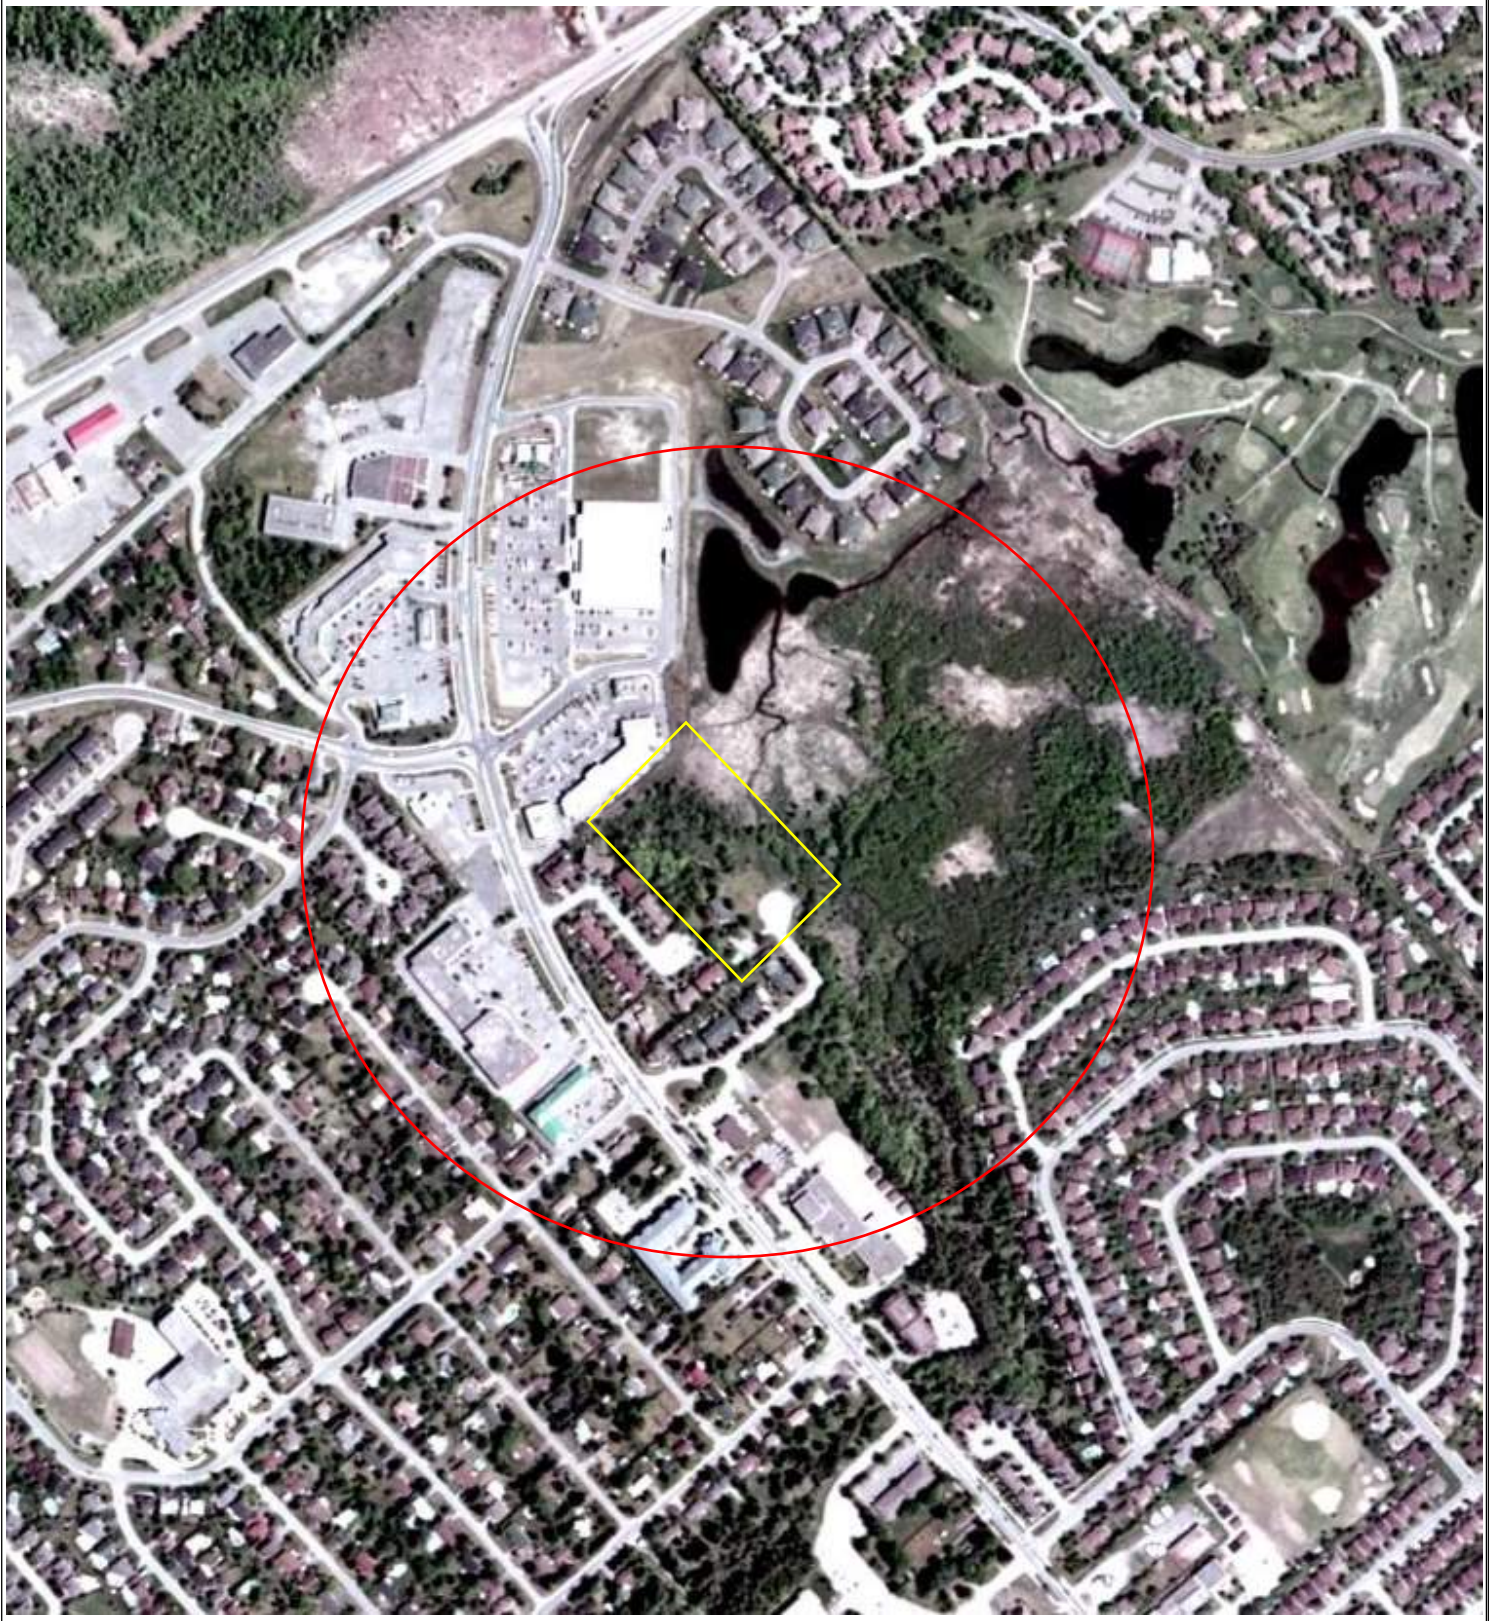
DATE:	April 2020	PROJECT TITLE:	PHASE ONE ENVIRONMENTAL SITE ASSESSMENT 37 Wildpine Court, Ottawa, Ontario	PROJECT No.:	OTT-00259416-A0
DESIGN:	LW	CHECKED:	CK	SCALE:	AS SHOWN
DRAWN BY:	LW	DRAWING TITLE:	2005 AERIAL PHOTOGRAPH		FIG E-4

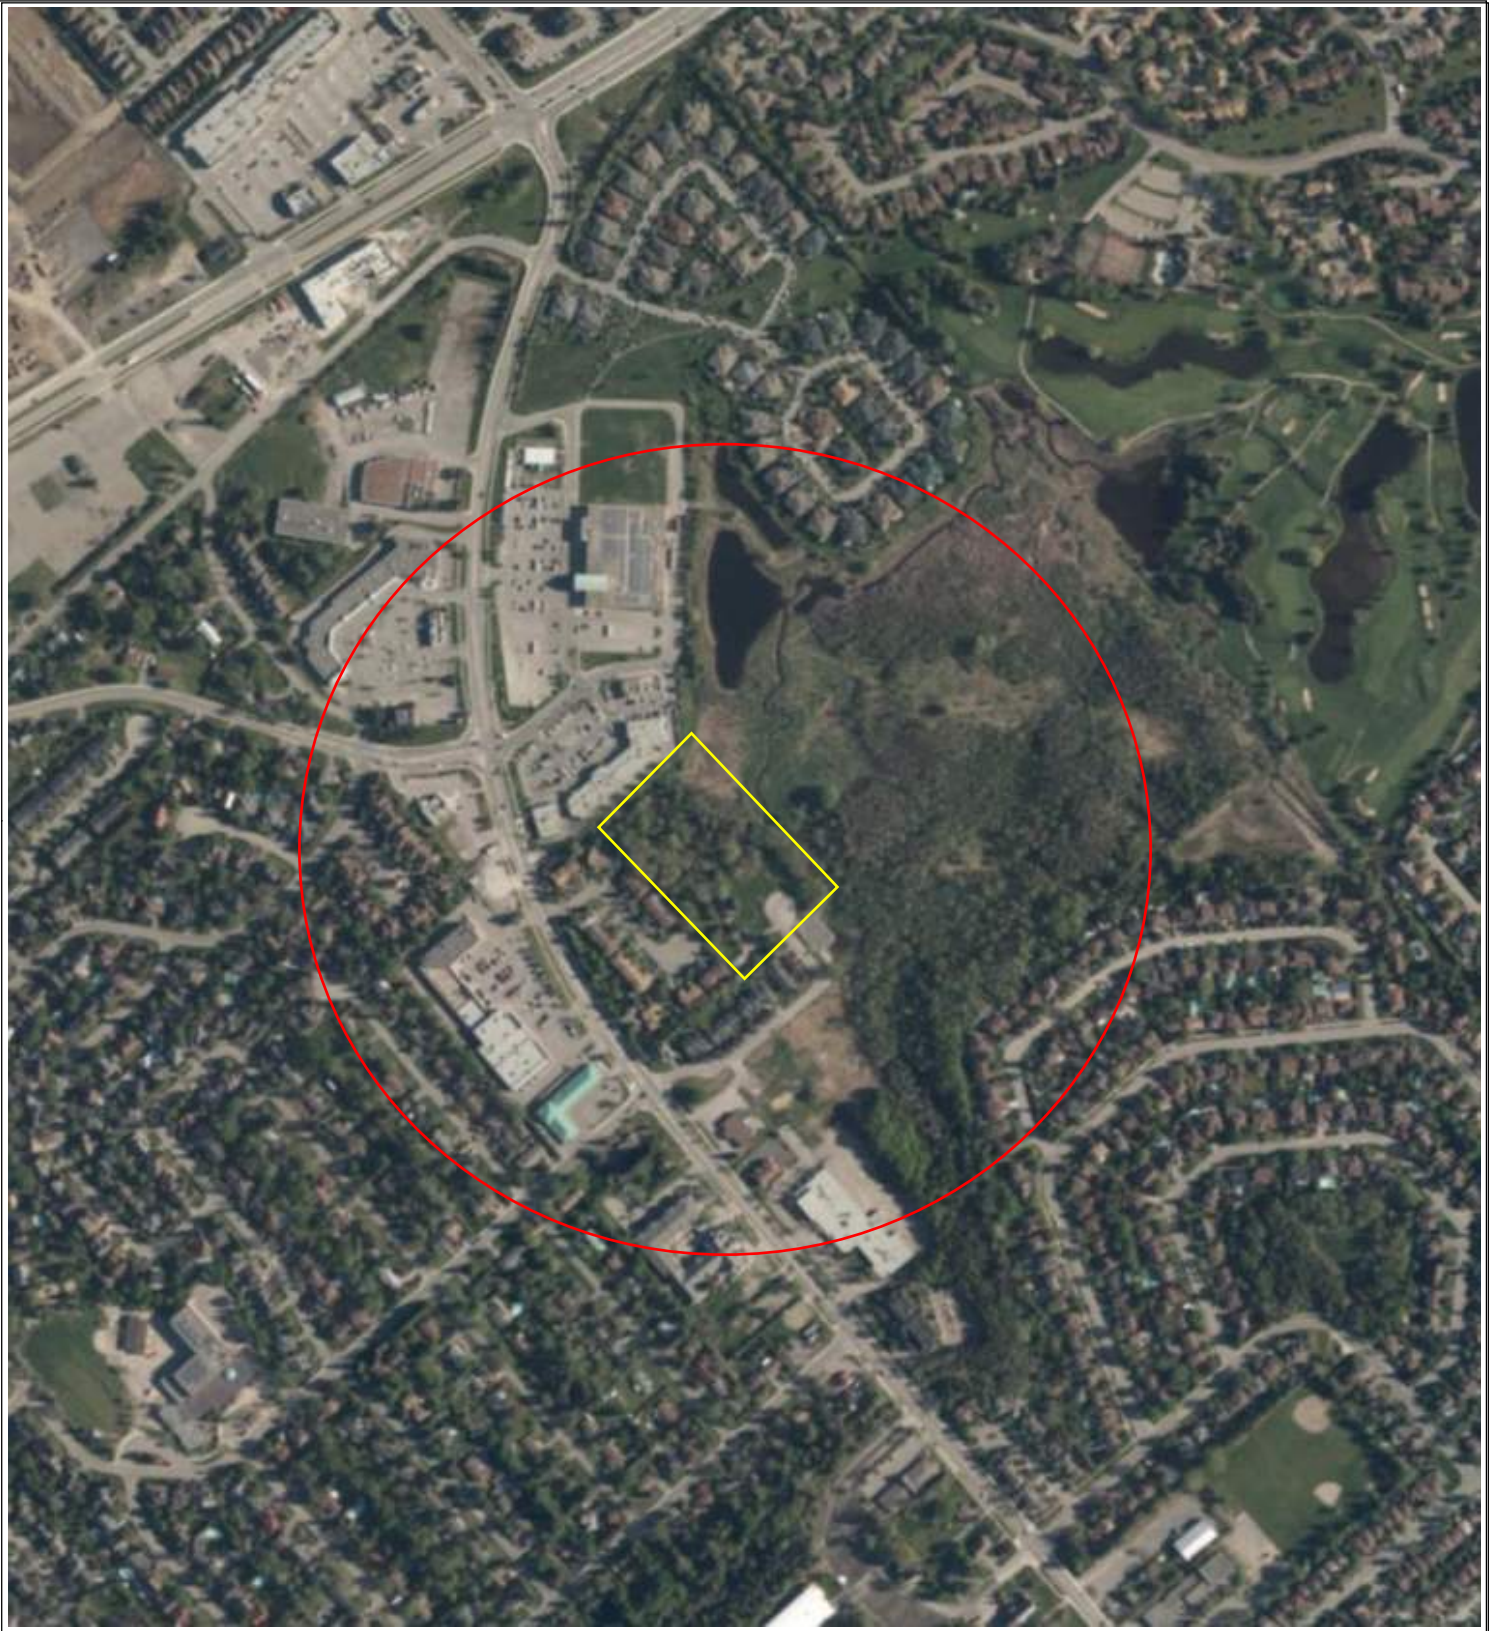
DATE: April 2020	PROJECT TITLE: PHASE ONE ENVIRONMENTAL SITE ASSESSMENT 37 Wildpine Court, Ottawa, Ontario	PROJECT No.: OTT-00259416-A0
DESIGN: LW	DRAWING TITLE: 2017 AERIAL PHOTOGRAPH	SCALE: AS SHOWN
DRAWN BY: LW		FIG E-5

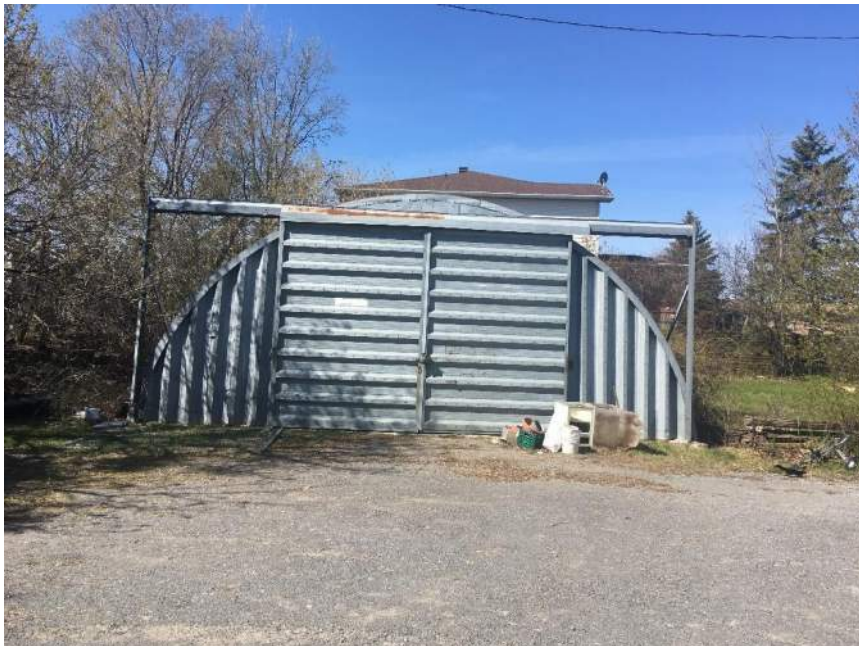
Photograph No. 2

View of Quonset hut in southwest corner of the property.

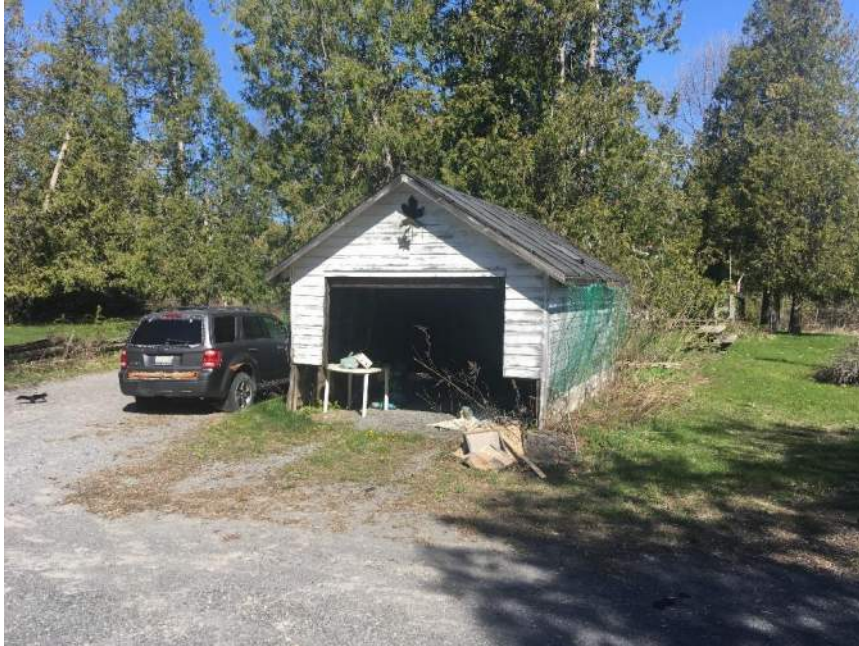
Photograph No. 3

Based on the age of the building at the Phase One property LBPs may be present. The painted surfaces observed in the residence during EXP's site visit were observed to be in fair to good condition. The painted surfaces on the shed are flaking and in poor condition

View of storage shed located south of residence.

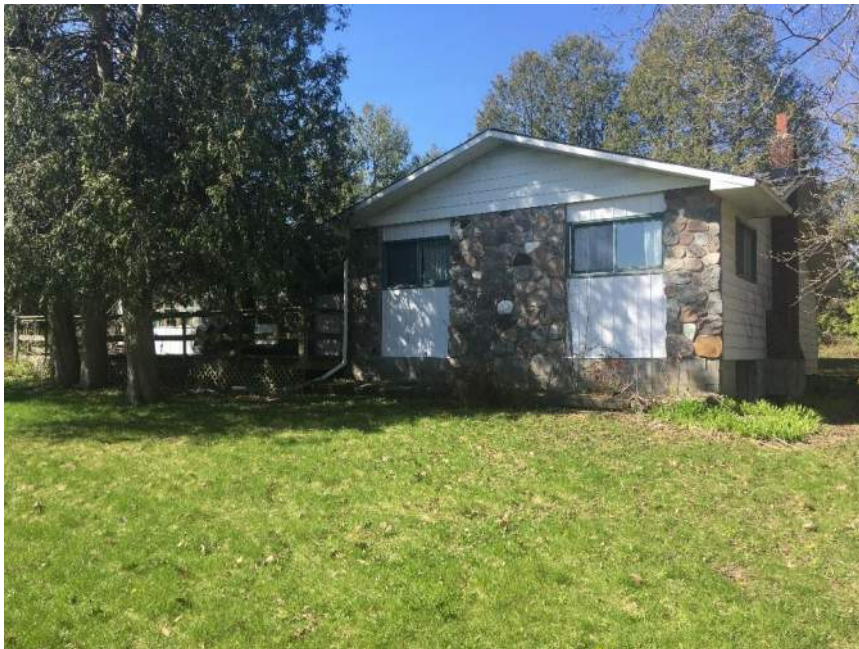
Photograph No. 4

View of the front of the residence looking west

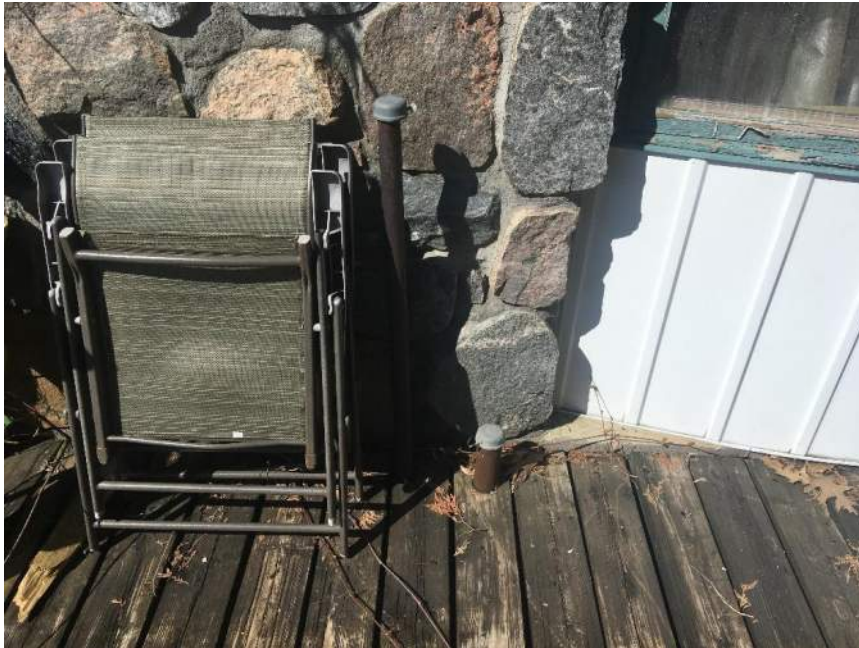
Photograph No. 5

EXP observed an above ground storage tank (AST) in the basement of the residence during the site reconnaissance. The residence has been heated using oil since it was built in 1971. The current oil AST was replaced 12 years ago. Both the tank and the concrete floor around the tank appeared to be in good condition. The former property owner was not aware of any spills or leaks occurring on the property.

View of fill/vent pipes located on the east side of the residence.

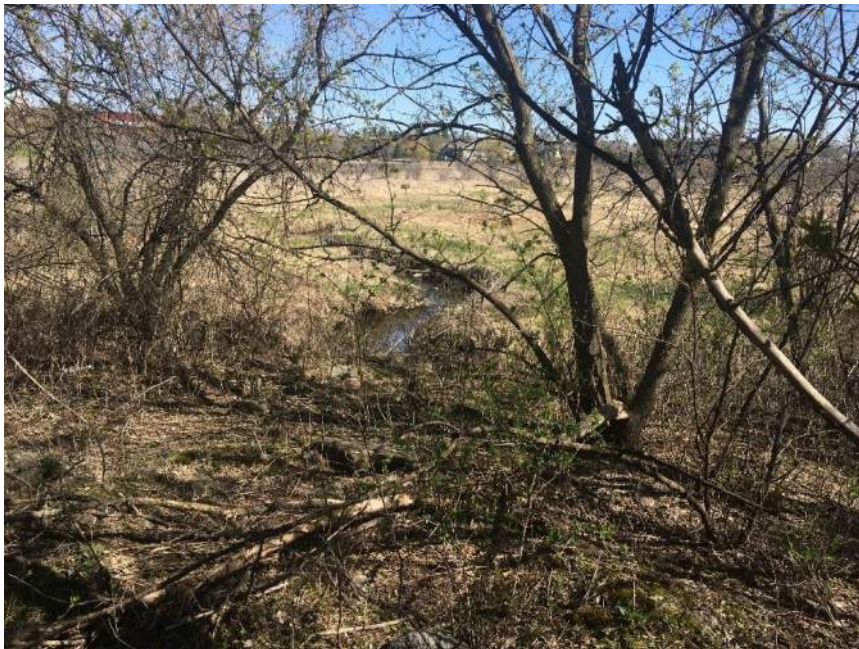
Photograph No. 6

View of Poole Creek and elevation change from the south and north parts of the property.
