Phase Two Environmental Site Assessment 37 Wildpine Court, Ottawa, Ontario

Wildpine Trails Inc.

Phase Two Environmental Site Assessment

OTT-00263154-A0

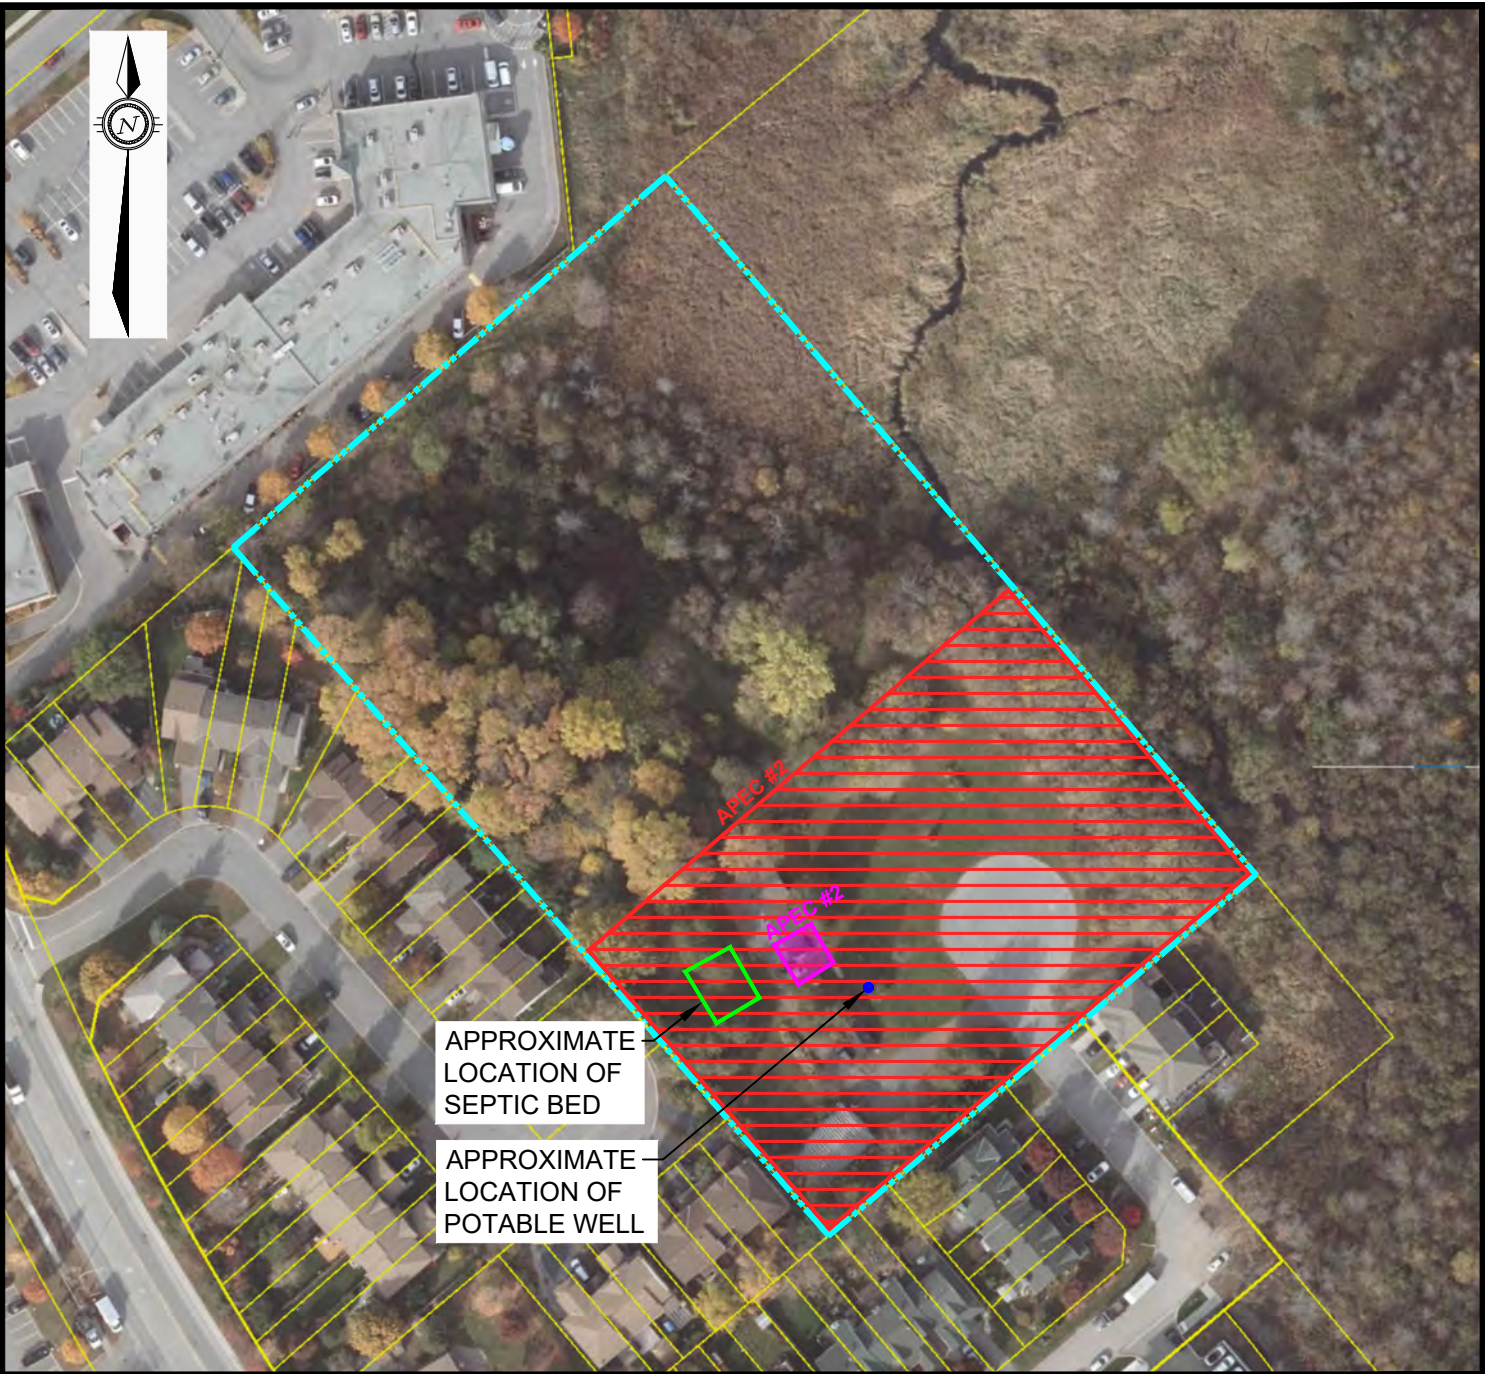
APPROXIMATE
LOCATION OF
SEPTIC BED

APPROXIMATE
LOCATION OF
POTABLE WELL

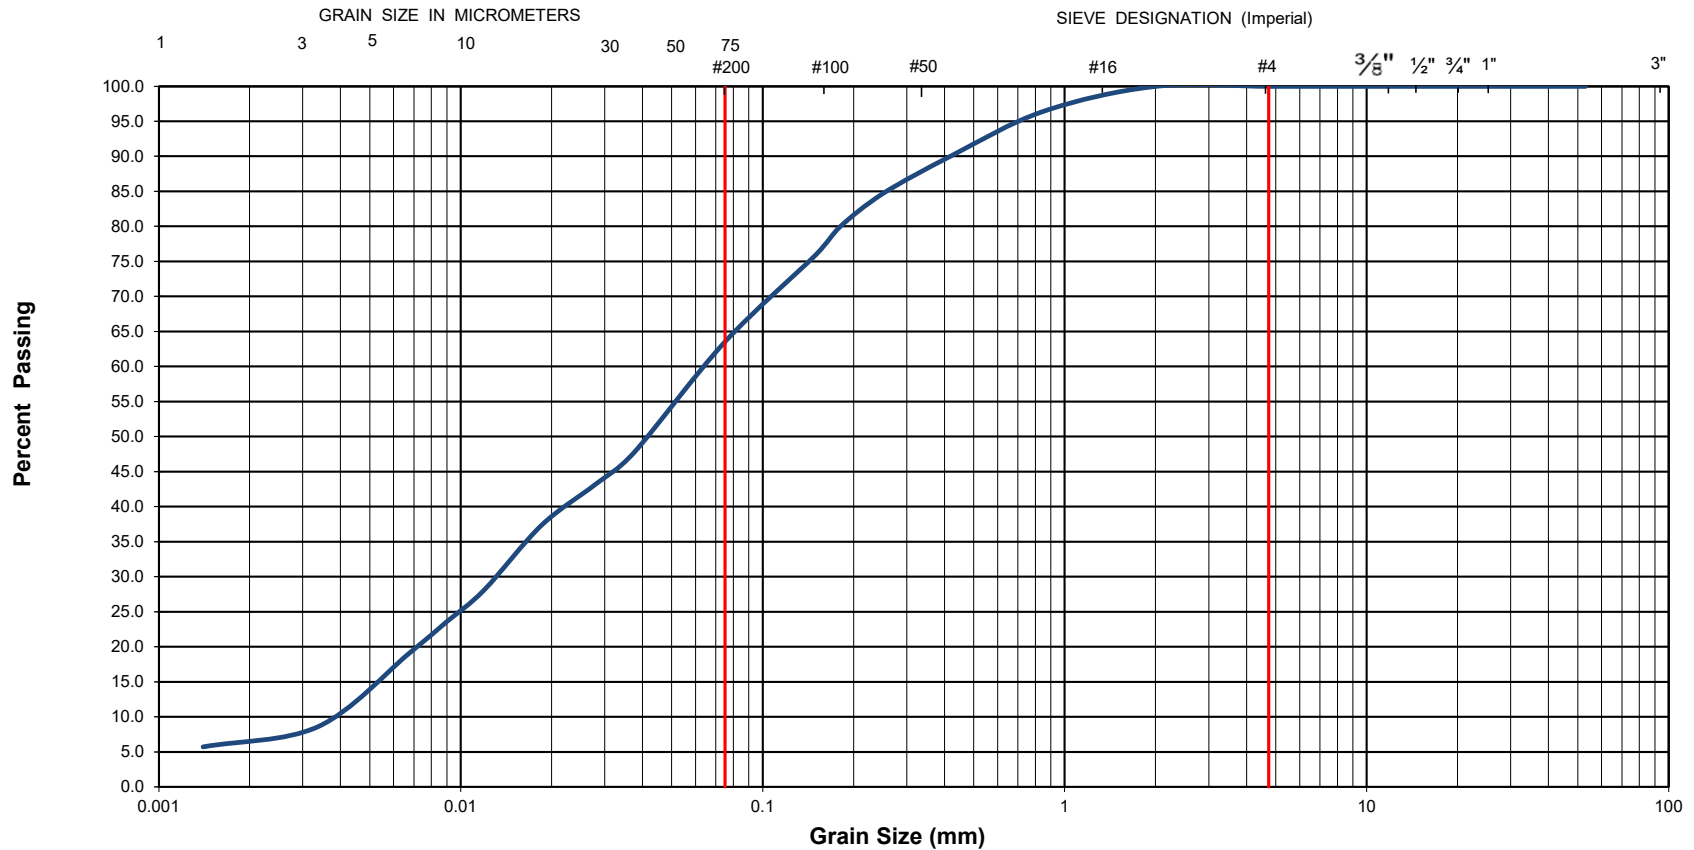
Unified Soil Classification System

EXP Project No.: OTT-00263154-A0	Project Name : Proposed Residential Development						
Client : Wildpine Trails Inc.	Project Location : 37 Wildpine Court, Ottawa, Ontario						
Date Sampled : December 11, 2020	Borehole No: BH-3	Sample No.: SS5	Depth (m) : 3.0-3.7				
Sample Description :	% Silt and Clay	64	% Sand	36	% Gravel	0	Figure :
Sample Description :	Organic Sandy SILT (ML)
