**Phase I Environmental Site Assessment**

3484, part of 3490 and 3592 Innes Road  
Ottawa, Ontario

Canadian Rental Development Services

Report: PE4288-1

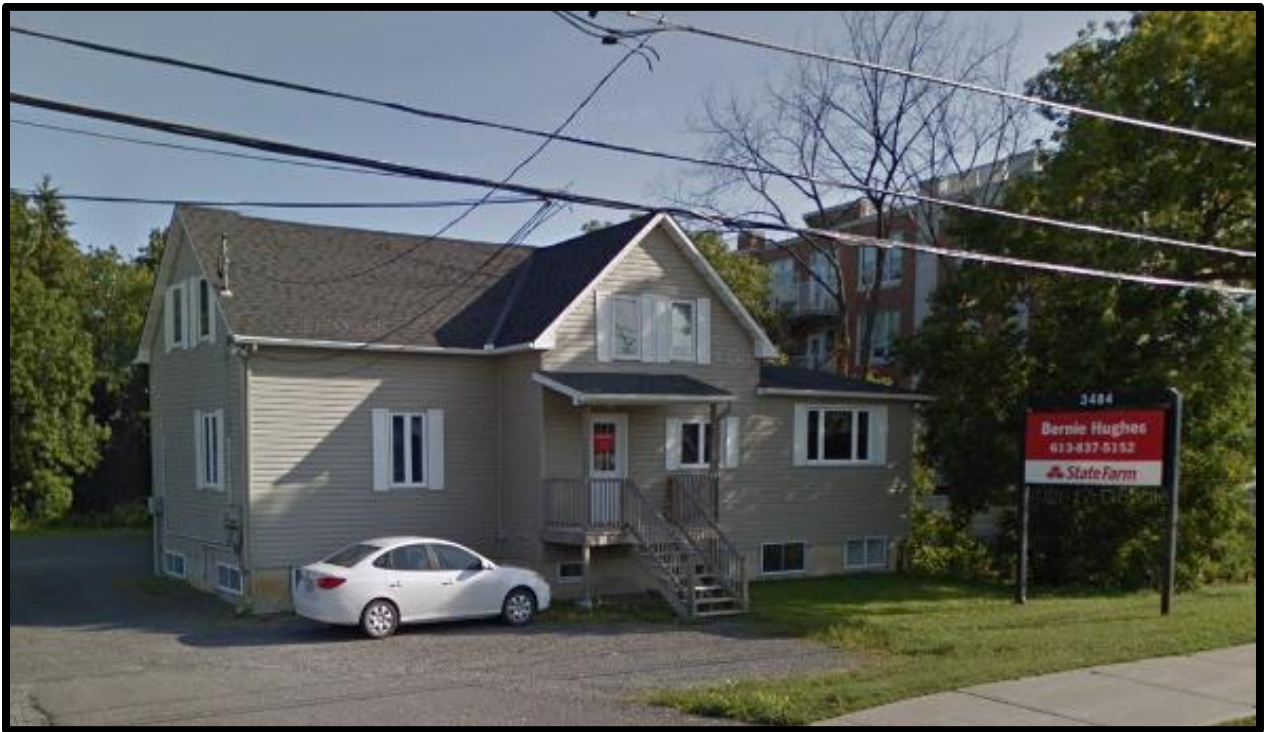
Photograph 6: View of the two-storey commercial/residential building on the northwestern portion of the site. Photograph taken facing southwest.

A drain was observed to be filled with clear and odourless water in the basement of the building addressed 3484 Innes Road. No pits or sumps were identified on the subject site. No environmental concerns were identified with regard to waste water discharge on the subject site.

Based on the age of the building located at 3484 Innes Road (late 1960s) and the residential dwelling addressed 3592 Innes Road (mid-1970s), potentially asbestos containing materials (ACMs) may be present. Potential ACMs include ceiling stipple, linoleum and dry-wall joint compound, which were observed to be in good condition at the time of the assessment. Additionally, lead-based paints may be present on original painted surfaces. Painted surfaces were observed to be in good condition at the time of the assessment. No immediate concerns with regards to hazardous building materials were identified on the subject property.
