232 Donald B. Munro Drive

Headwater Drainage Feature Assessment

Bowfin Environmental Consulting Inc.
168 Montreal Road
Cornwall, Ontario
K6H 1B3

October 2021

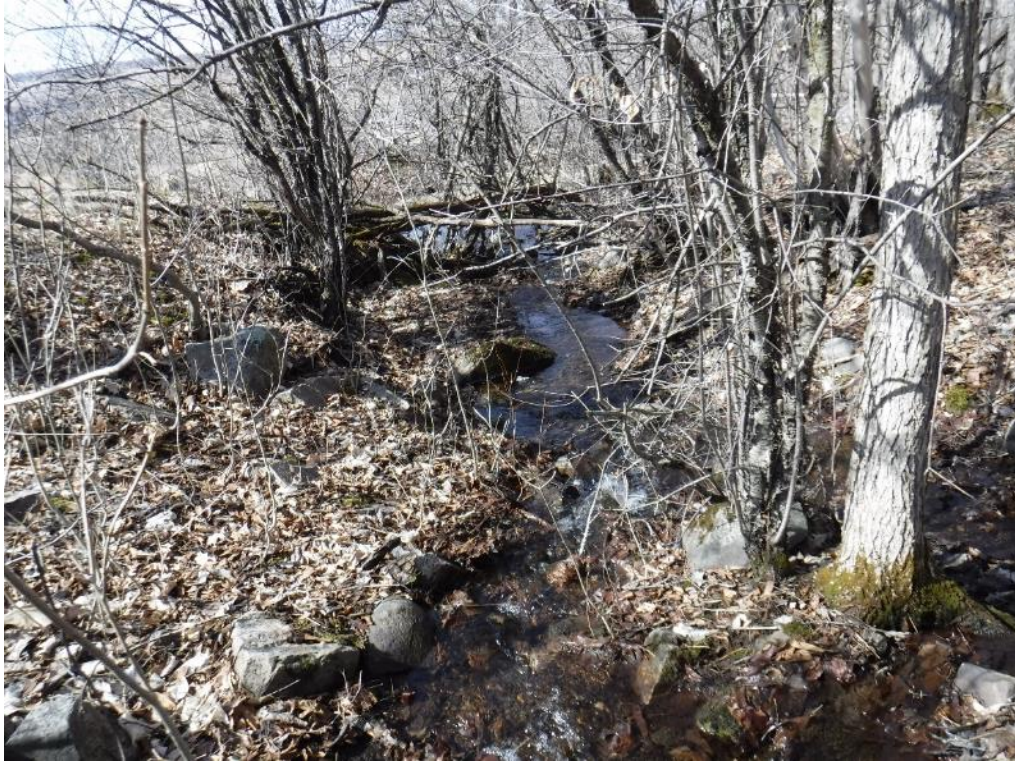
Photo 1: Feature 1, looking upstream at the northeast end of site (March 30, 2021)

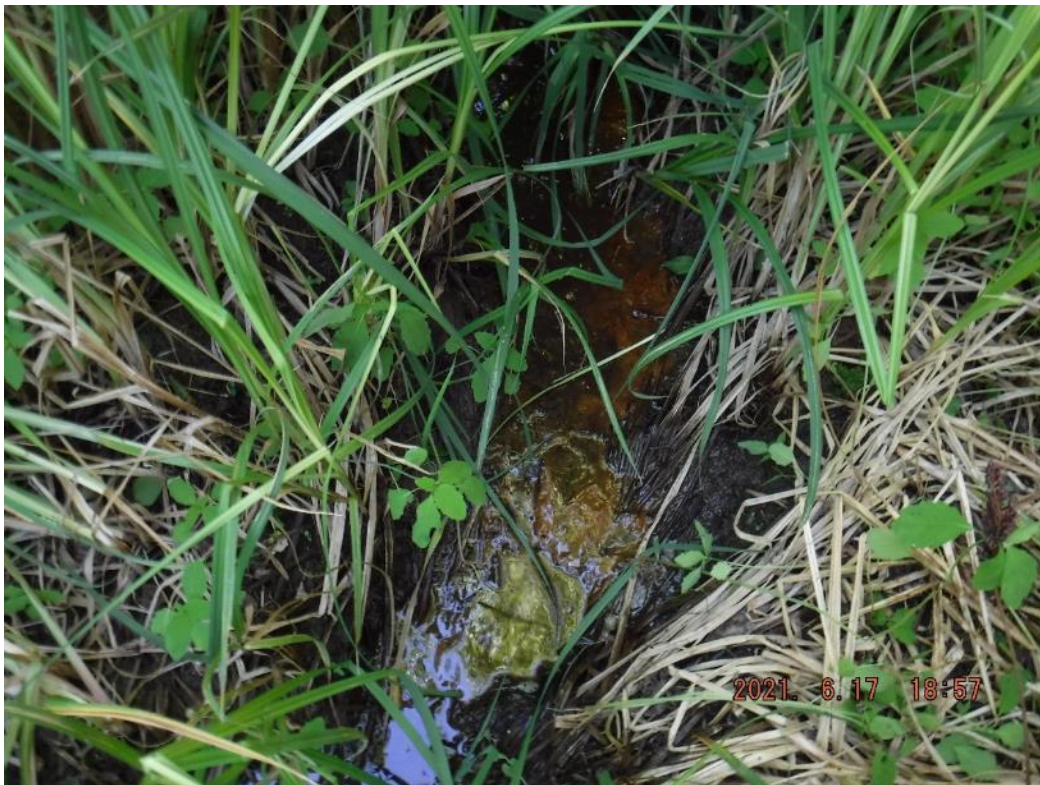
Photo 2: Feature 1, center of feature on site, during summer showing iron staining, evidence of groundwater upwelling (May 17, 2021)

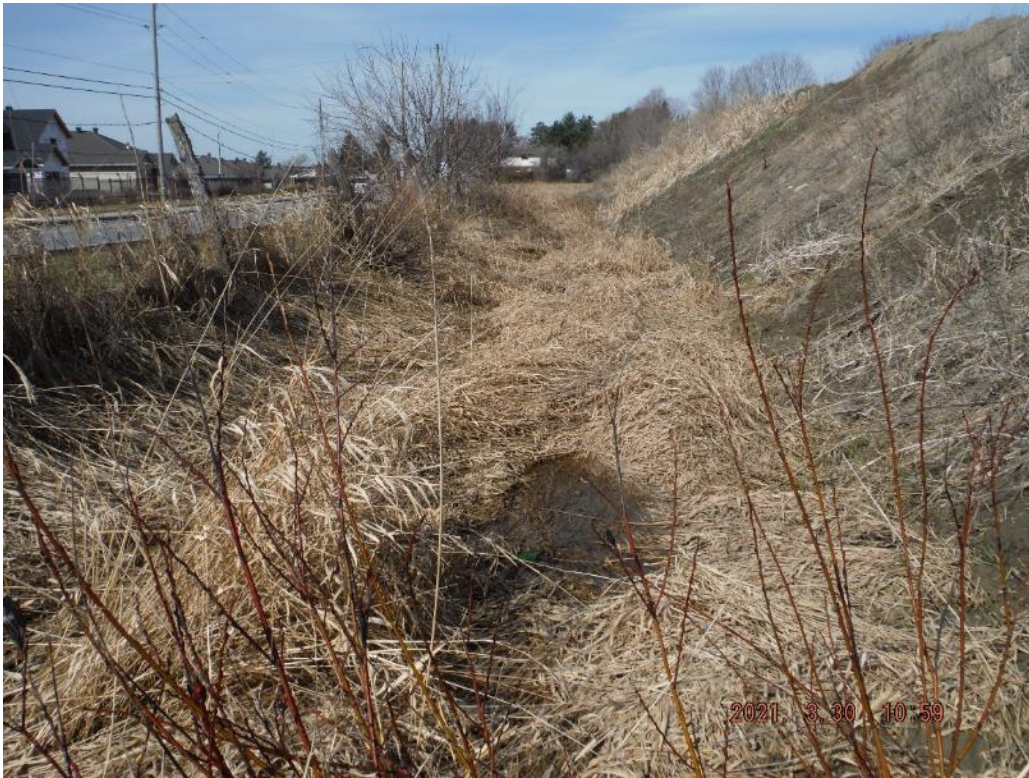
Photo 3: Feature 1, looking downstream next to Donald B. Munro Drive (March 30, 2021)

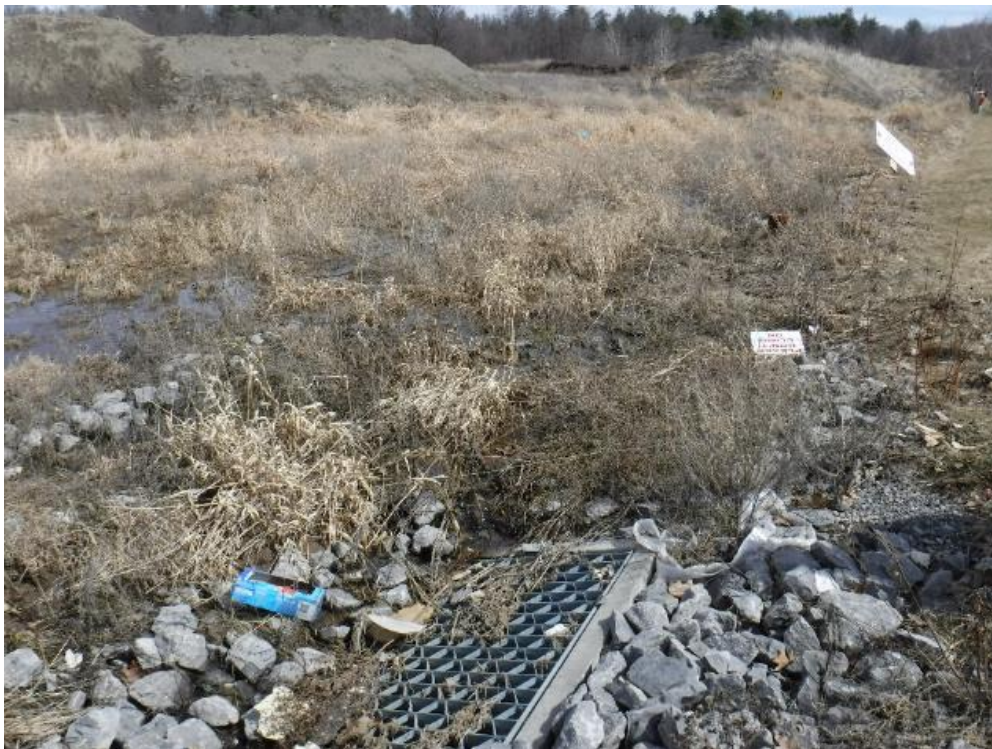
Photo 4: Looking upstream by inlet catch basin (March 30, 2021)

As mentioned above, this headwater feature is situated upstream of an inlet catch basin at Donald B. Munro Drive and its flow enters the storm water system. It is piped for about 300 m before being discharged from the southwest corner of Meadowridge Circle. A vegetated swale was noted at that location and a culvert under the railroad. GeoOttawa shows an open channel, that is about 200 m long, from this railroad to the Carp River (note that the geoOttawa stream layer is inaccurate at this location, likely predating the developments in the area). Whether this open channel provides direct fish habitat is unknown but likely poor (due to anticipated seasonal flows). The inlet catch basin is a permanent barrier, and this was confirmed through spring fish community sampling on site. No fish were observed or captured. See Appendix A for the complete Fish Habitat and Community Descriptions.

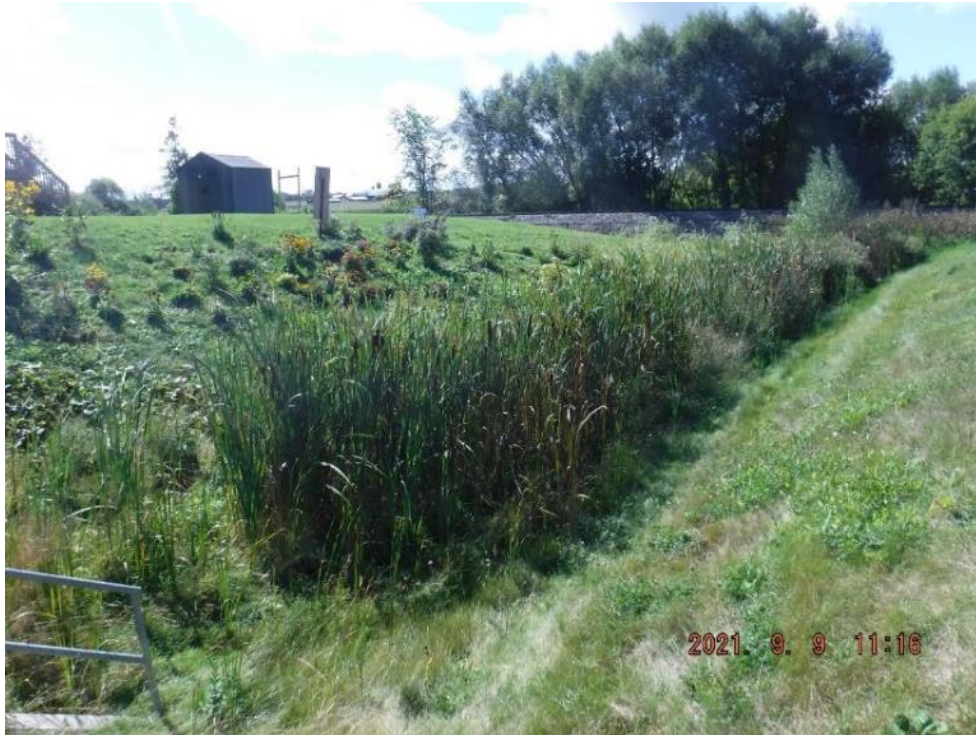
Photo 5: Feature 1, looking downstream from Meadowridge Circle (September 9, 2021)

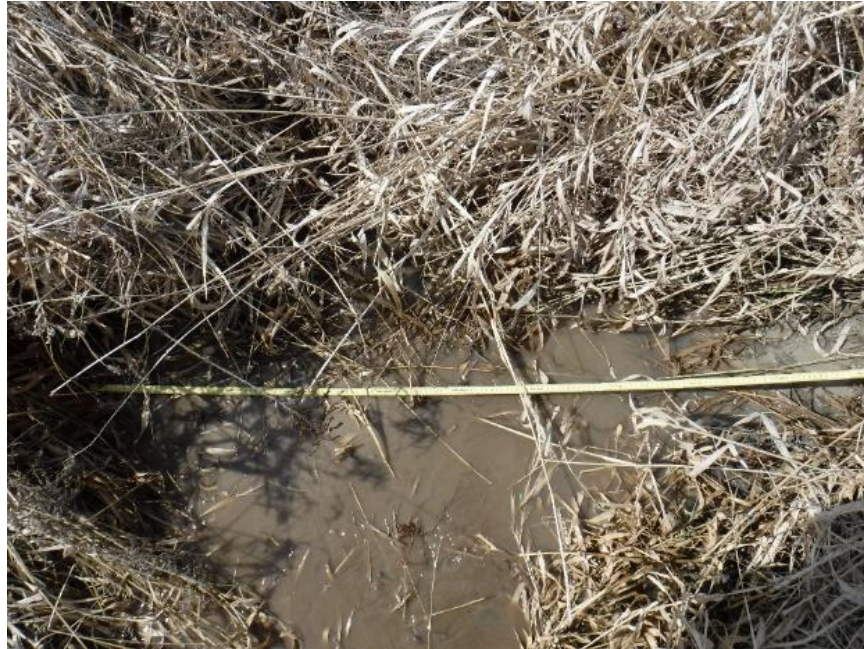
Photo A Downstream end of channel (vegetation was manually removed to allow for measurements) (March 30, 2021)

There are several barriers to fish, the first being the permanent, inlet catch basin at the downstream end which prevents Feature 1 from being fish habitat (confirmed with sampling April 2021). Just upstream of the drain the channel was heavily choked with reed canary grass without a distinct channel which would make movement difficult. Further upstream there are several smaller steps that could function as barriers to fish. The entire watercourse was dip netted downstream from station 1.

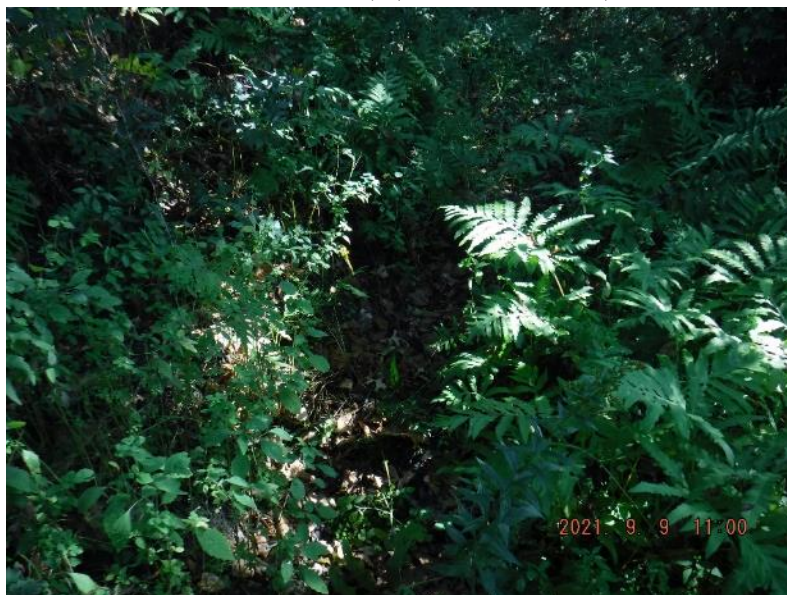
Photo B: Dry upstream end of channel (September 9, 2021)

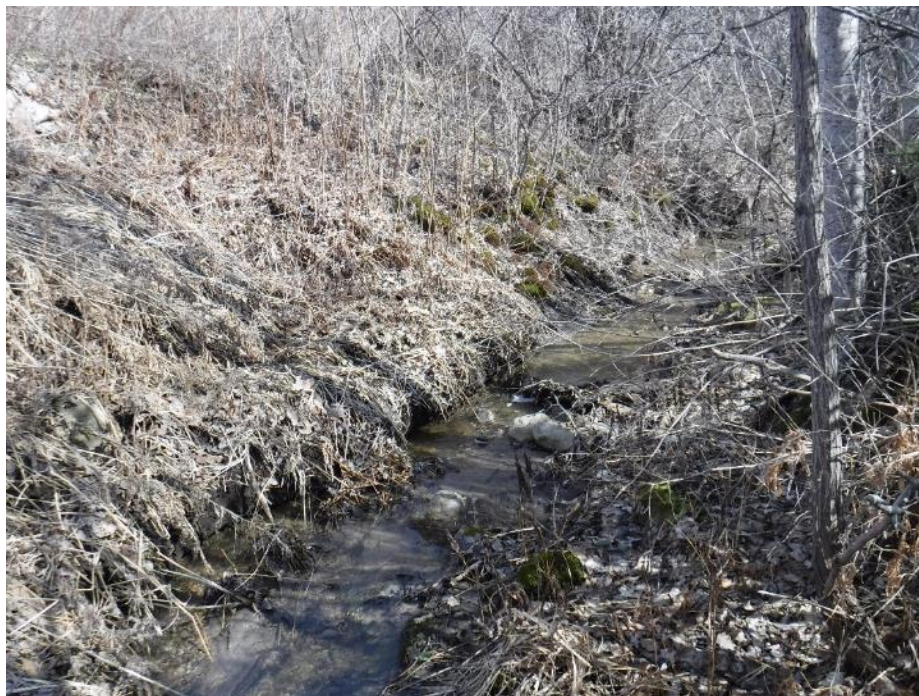
Photo C: Station 1 looking upstream (March 30, 2021)

This 60 m station was situated in the center of the feature. The average channel width was 1.8 m and the average bankfull height 13 cm. The average spring wetted width and depth were 0.9 m and 5 cm, respectively.

The substrate consisted primarily of fines with some gravel and the stream morphology was a glide. The in-water cover throughout the station was provided by overhanging vegetation. Both banks were steep in some areas and heavily vegetated throughout. Canopy cover was around 80%. Species observed were broad-leaved cattail, black walnut, basswood, American elm, trembling aspen, bur oak, shrub willow, speckled alder, Tartarian honeysuckle, sensitive fern, glossy buckthorn, reed canary grass, spotted jewelweed, sugar maple, red raspberry, and sedges.

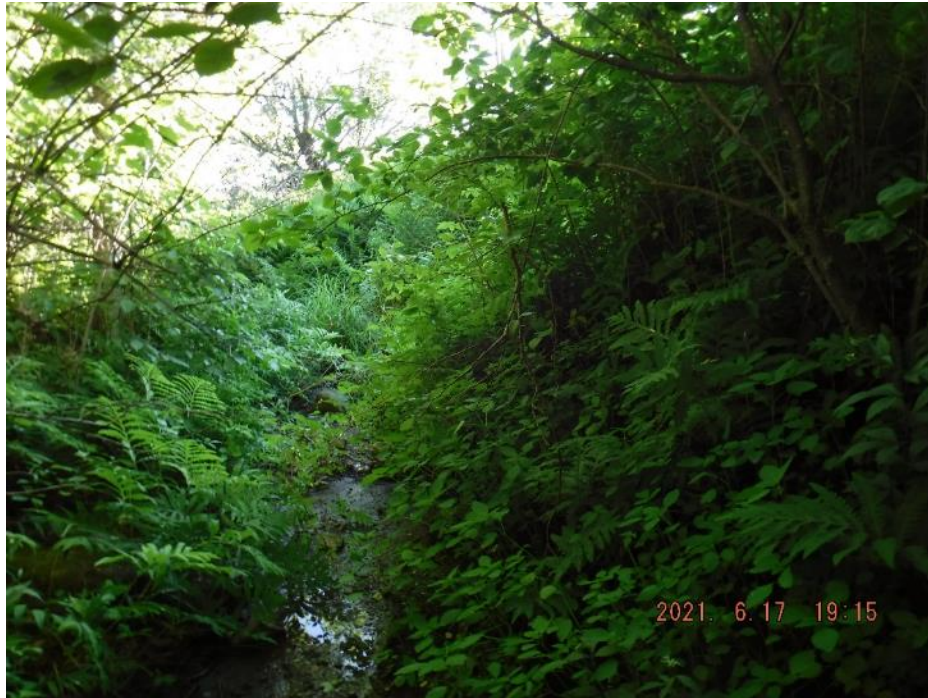
Photo D: Station 1 looking upstream (June 17, 2021)
