**TW21-1C Water Supply Assessment
Proposed Residential Development
Creekside 2 - Village of Richmond
2770 Eagleson Road
Ottawa, Ontario**

December 14, 2021
Project: 61899.03

**Re: TW21-1C Water Supply Assessment, Proposed Residential Development
Creekside 2 – Village of Richmond, 2770 Eagleson, Ottawa, Ontario**

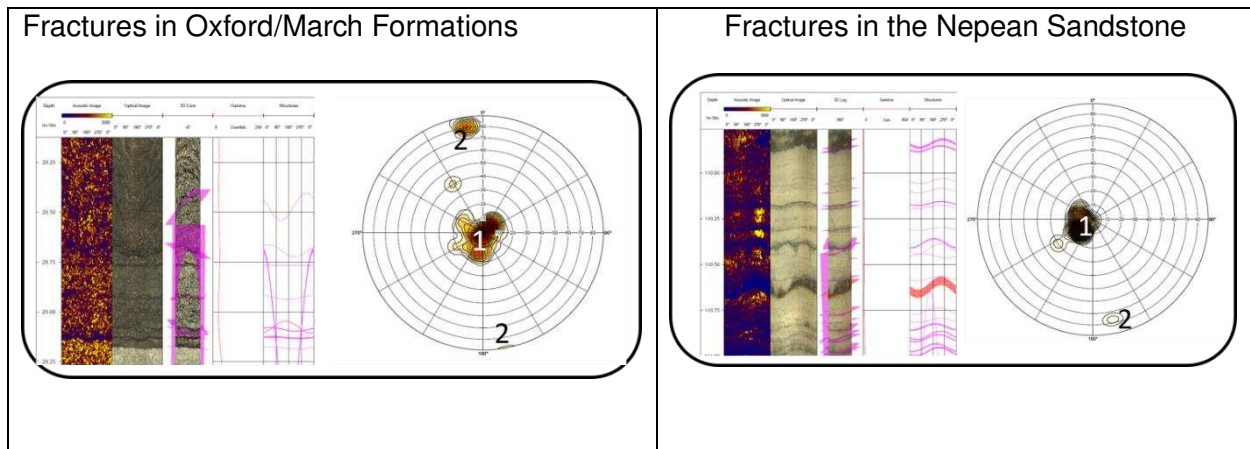
Figure D2 (Appendix D) - Illustration displaying primary fractures noted in Oxford/March and Nepean Formations.

Two primary fractures were noted in both the upper Oxford-March and lower Nepean formations and are shown in the summary images below.

Fracture set 1 represents bedding plane fractures. These fractures are relatively flat lying in both formations but the bedding in the Nepean Sandstone dips more uniformly at 5 to 10 degrees in an east – northeast direction. Fracture set 2 is sub-vertical and strikes at approximately 170 degrees but dips more prominently to the north in the deeper sandstone unit. The presence of a similarly orientated sub-vertical fracture set in both upper and lower bedrock formations may indicate a similar genesis. Fracture set 2 may transmit groundwater from the shallow limestone bedrock to the deeper sandstone unit.

Fracture apertures / fracture zones (low amplitude acoustic responses) in the Nepean Sandstone are typically wider than in the upper predominately limestone Formations which may explain why the sandstone has a much higher storage coefficient and transmissivity.

- It is likely that the sub-vertical fractures that cut across both the deep and shallow bedrock Formations can transmit groundwater to the deeper aquifer during pumping. The presence of a similarly orientated sub-vertical fracture set in both upper and lower bedrock formations may indicate a similar genesis.

- Fracture apertures / fracture zones in the Nepean Sandstone are typically wider than in the upper predominately limestone Formations which may explain why the sandstone has a much higher storage coefficient and transmissivity.
