Muncaster
Environmental
Planning Inc.

RE: Creekside Phase 2 Residential Development, Richmond
Environmental Impact Statement and Tree Conservation Report

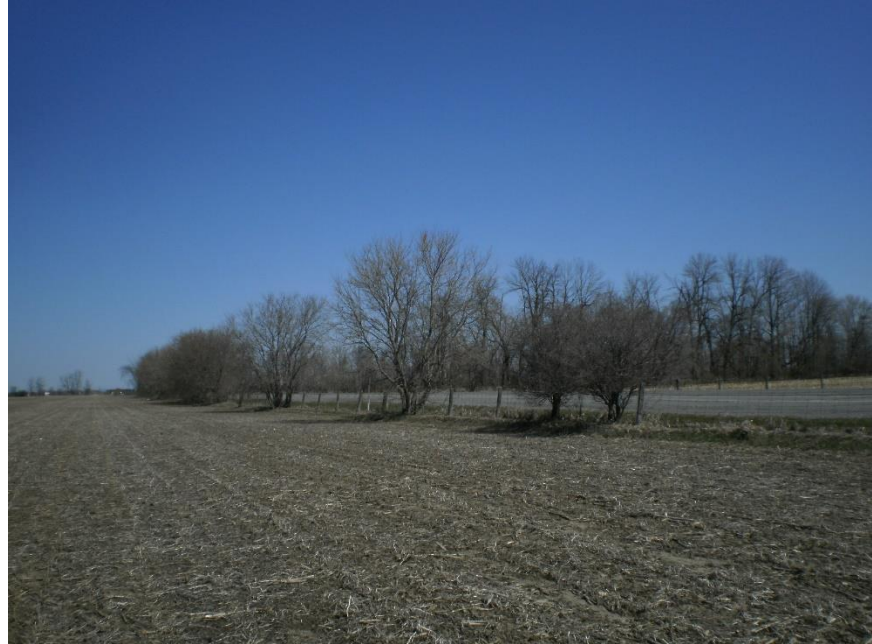
*Photo 3 – Scattered Manitoba maple along the east site edge, west of Eagleson Road.
View looking northeast*

Scattered deciduous trees are along the field edges. Coppice (multi-stem) Manitoba maples with individual stems up to 34cm diameter at breast height (dbh) dominate the deciduous trees along the central portion of the east site edge, on the west side of Eagleson Road (Photo 3). A few white elm are to the north of the Manitoba maples. Many of these elms appear dead, but a 38cm dbh white elm in the northwest corner of the site appeared to be in better condition (Photo 4). Hawthorn shrubs and regenerating Manitoba maple stems were among the deciduous trees.

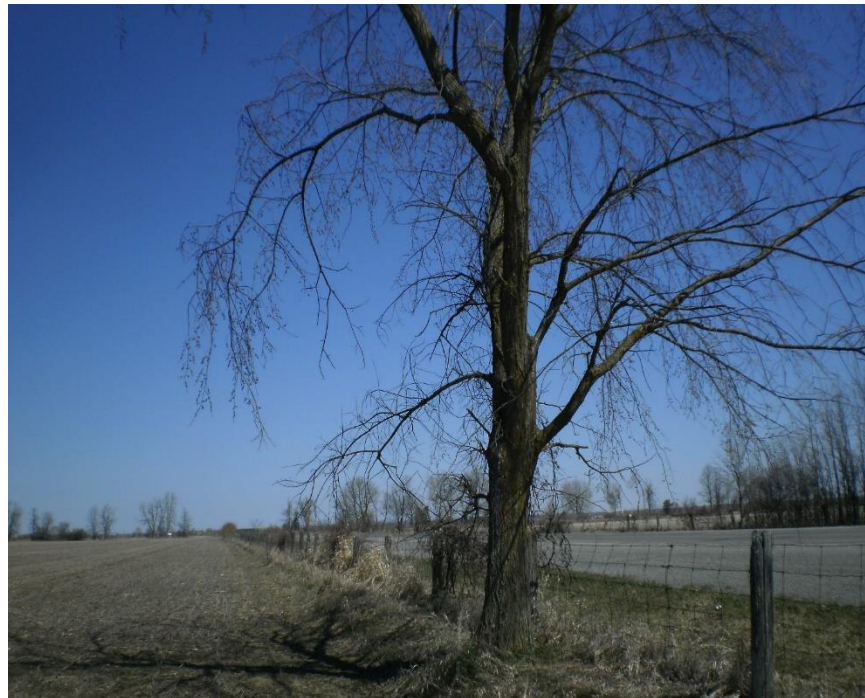
Photo 4 – White elm along the east site edge, west of Eagleson Road. View looking northeast

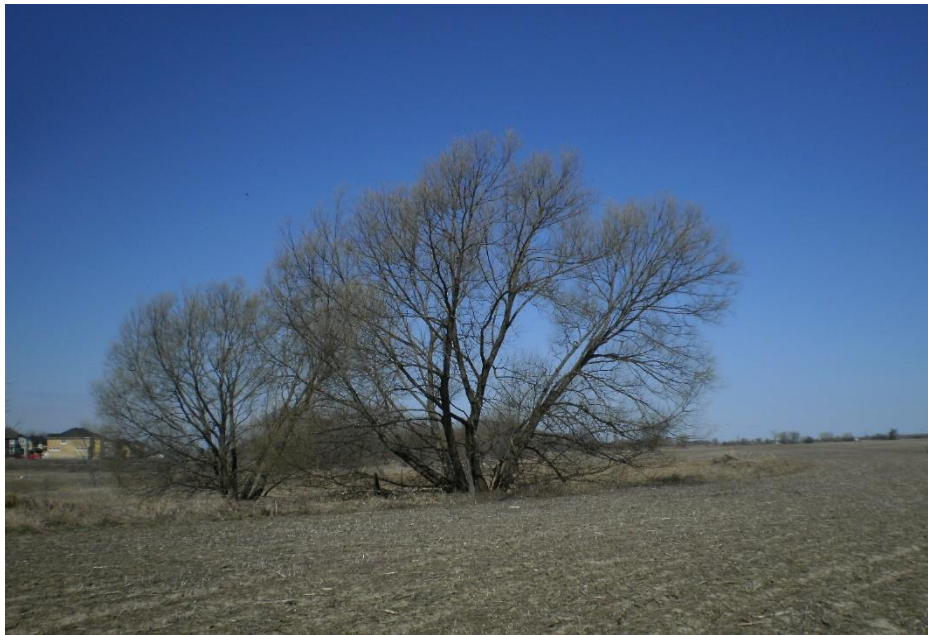
Manitoba maple and white elm up to 18cm and 25cm dbh are along the southeast edge of the site. Many of the Manitoba maple had damaged lower branches. A small area of cultural meadow in the southwest corner of the site included a couple of mature coppice crack willow with individual stems up to 55cm dbh (Photo 6). Manitoba maple and bur oak up to 25cm dbh and smaller white ash, green ash, and white elm are also in this area. There is a noticeable drop in the elevation west of the cultural meadow, and the site, towards the Flowing Creek Municipal Drain.

Photo 6 – Crack willow adjacent to the cultivated fields in the southwest corner of the site. View looking northwest

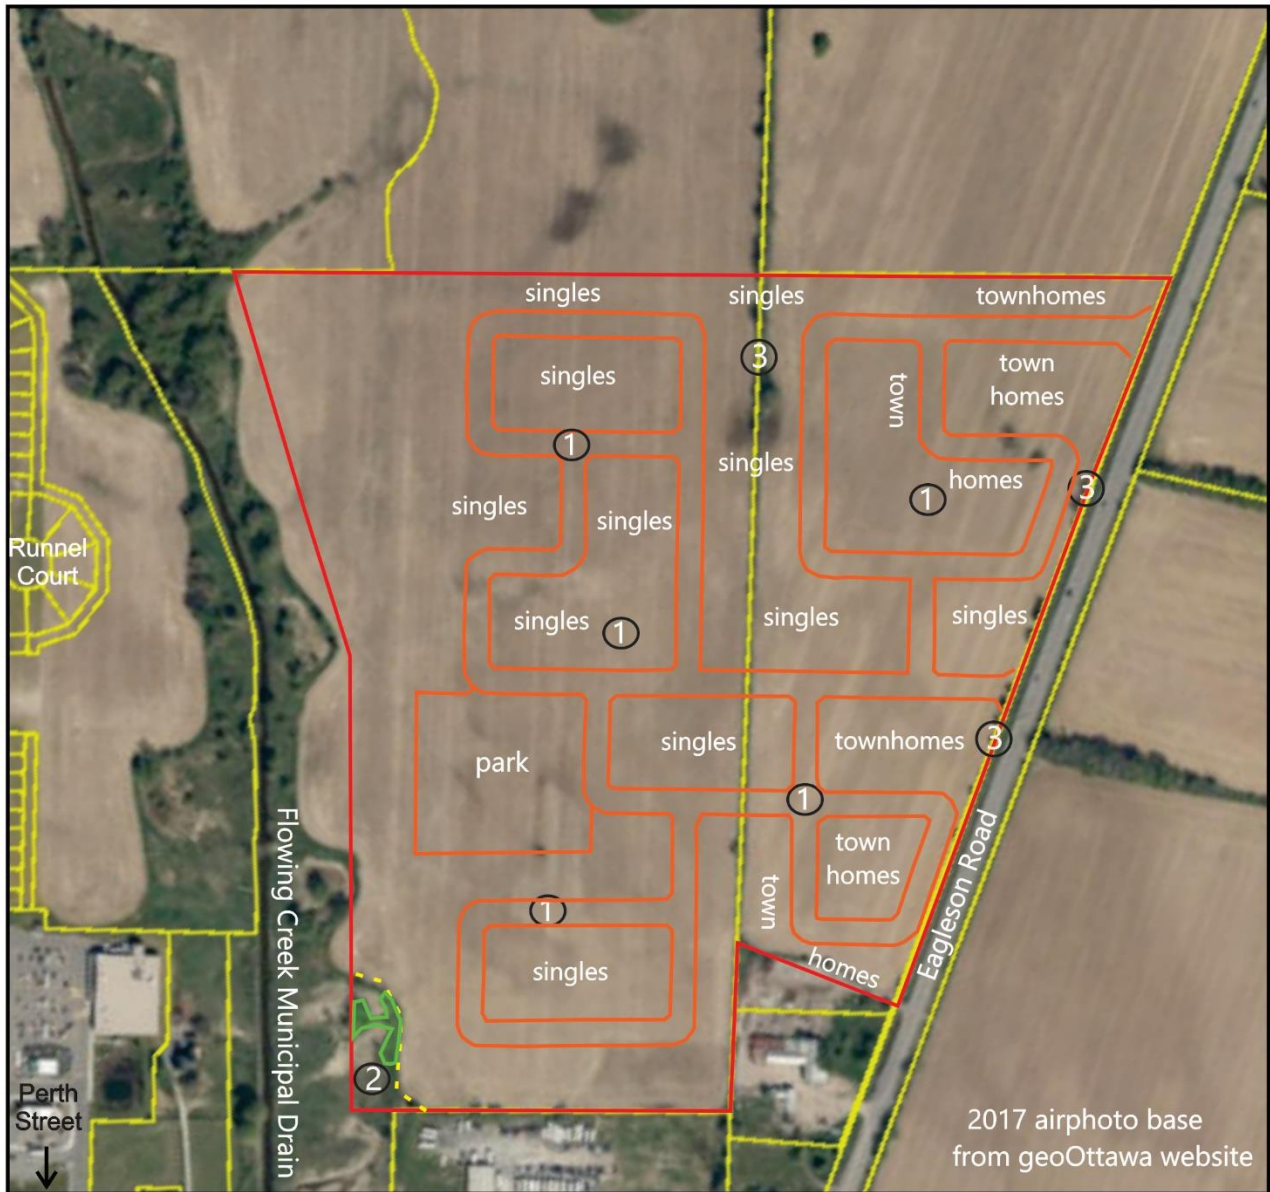
FILE: 20 - 01	Map 2	April 29, 2020
PROPOSED CONSERVED VEGETATION		
Creekside Phase 2 Richmond, City of Ottawa		
Prepared for:	Cardel Homes	
Prepared by:	 	Muncaster Environmental Planning Inc.

Due to the density of residential development and associated required urban servicing and grading, no tree retention is anticipated within the footprint of development. As shown on Map 2, some trees will be retained within a cultural meadow in the southwest corner of the site, west of the proposed residences.
