**CAIV 1341  
Tree Conservation Report  
Orleans Village Phase 4**

**March 28, 2022**

**KILGOUR & ASSOCIATES LTD.**  
[www.kilgourassociates.com](http://www.kilgourassociates.com)

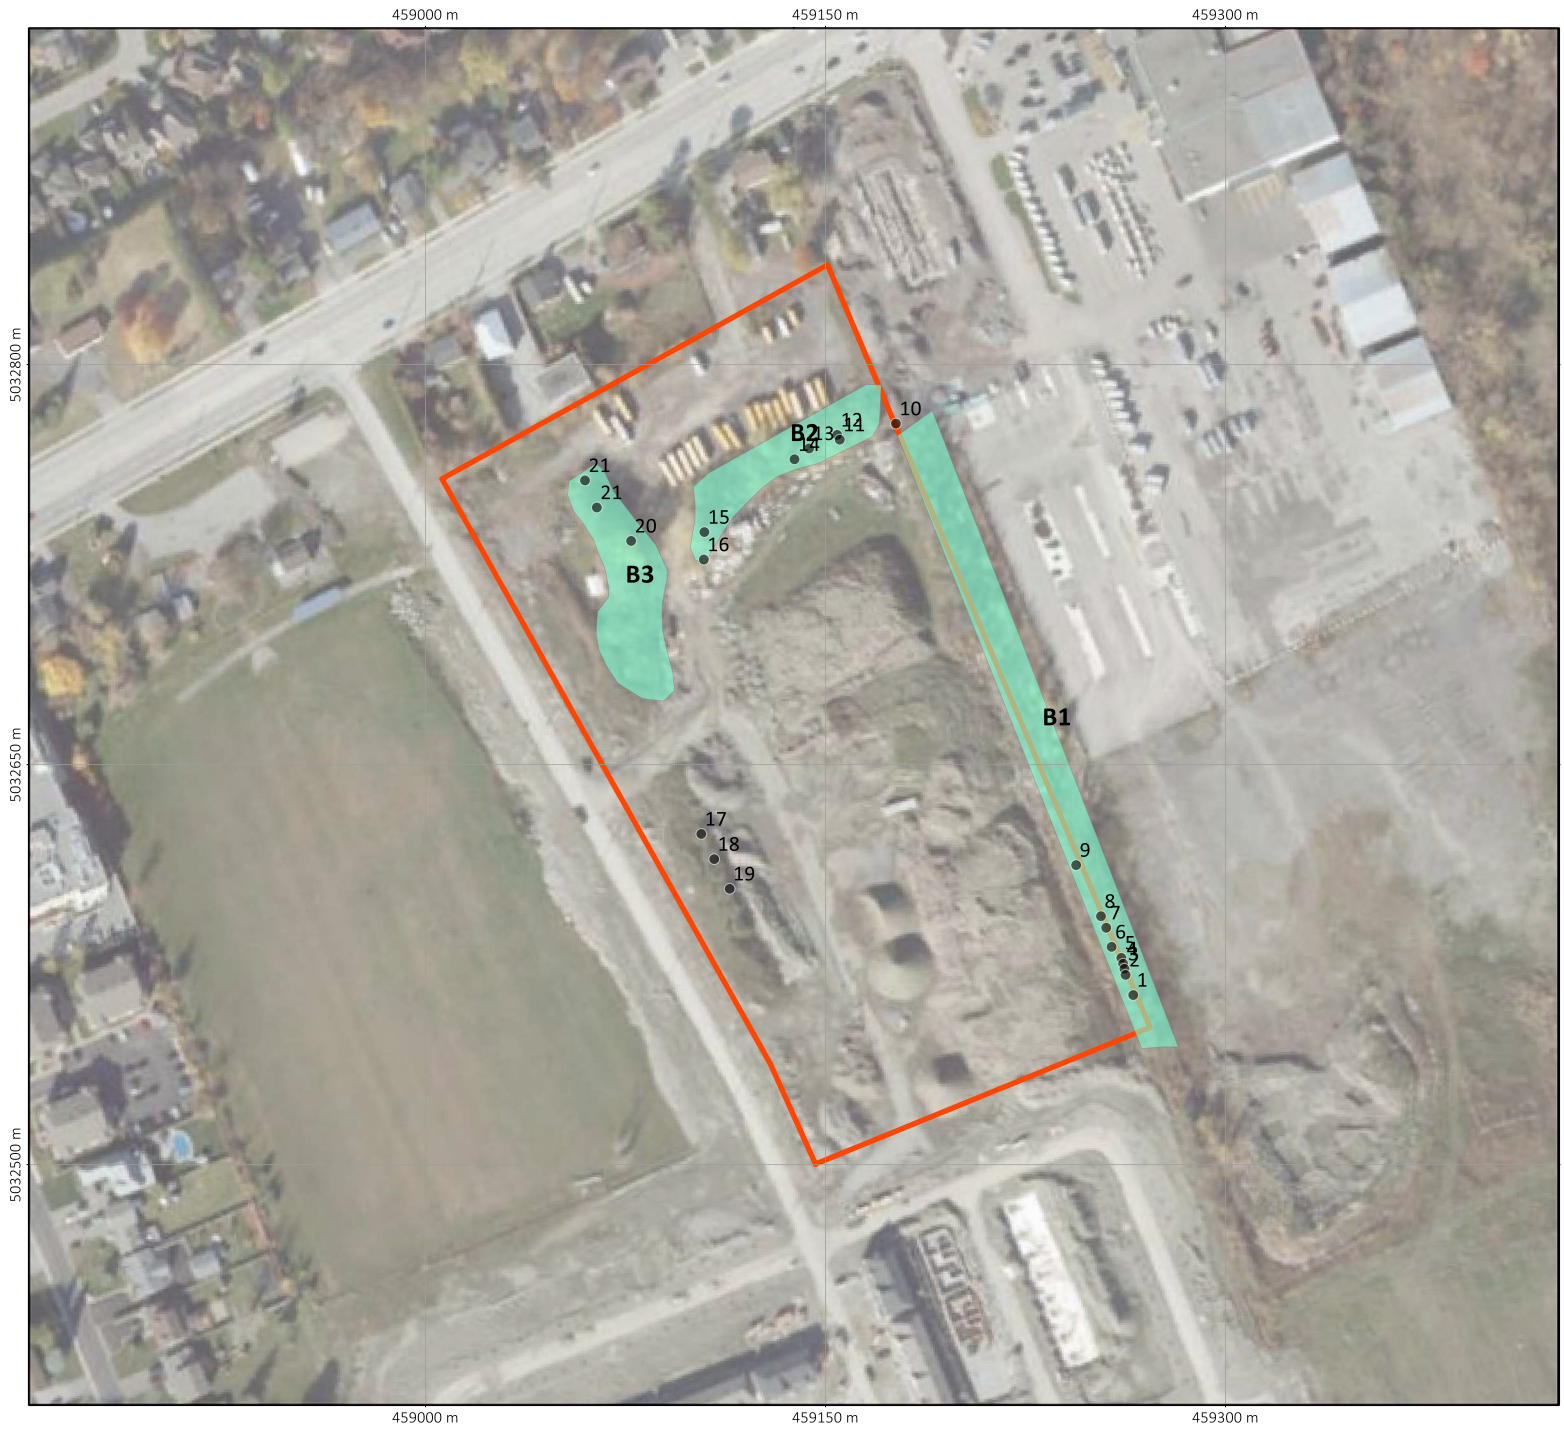
**Figure 1** Site context and tree locations

proposed development were identified, enumerated, mapped, their DBH measured, and their general health and condition documented (Appendix A, Figure 1).

In addition to the trees listed in Appendix A there were three “Blocks” of trees identified. Blocks were used to identify areas where canopy cover occurs on aerial imagery, but trees were either dead or smaller than 10cm DBH.

Block 1 (B1) Occurs along the eastern boundary of the Site and consists mainly of small Bur Oak, Balsam Poplar, and Manitoba Maple. The imagery available from geoOttawa shows many larger canopy trees occurring within this block, however, these large canopy trees (ash species) were dead at the time of the survey and are not included in the inventory.

Block 2 (B2) Occurs along the northern boundary of the Site between the existing school bus yard and the Site proper. This block has many small Manitoba Maples with multiple stems. Trees occurring within this block with a diameter greater than 10cm are captured within the inventory.

Block 3 (B3) Is situated along the western side of the side and occurs near the northern end of the site. Block three consists mainly of very small Manitoba Maples. Three large-diameter trees occur within this block and are captured within the individual tree inventory.

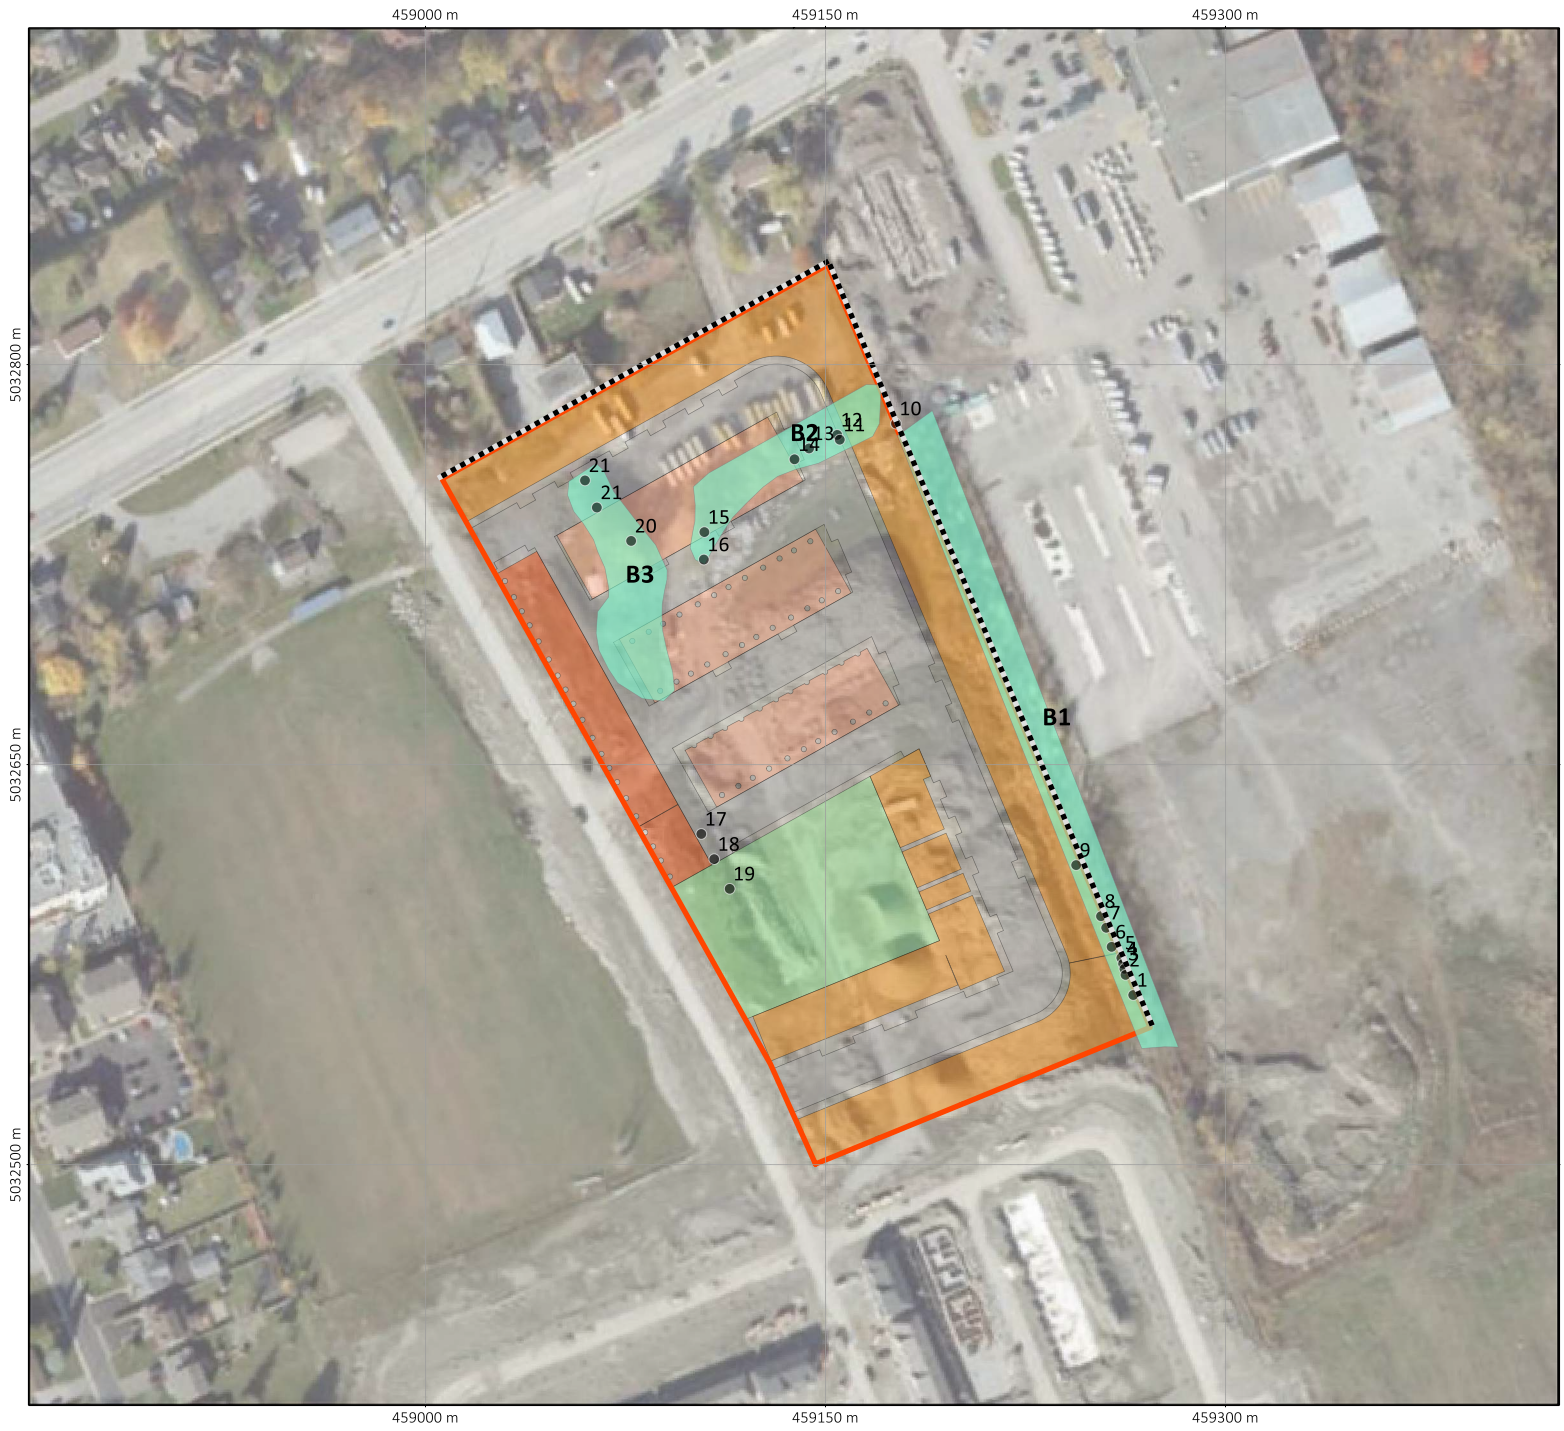
**Figure 2** Proposed development and tree locations

The proposed development will entail the regrading of the site and ultimately the construction of Phase 4 of Caivan Communities Orleans Village (Figure 2). The new community area will include 175 units in total with a 0.5 ha park. The grading and development of the will necessitate the removal of all site vegetation and site trees. This includes the removal of Tree Blocks B2 and B3, which are fully located on the site. Tree Block B1 straddles the eastern property line. However, the only stems within the block that are located on the adjacent property are dead ash trees. These will be removed for safety considerations along with the remainder of the block with permission from the adjacent landowner.

- Trees adjacent to the Site will not be removed or damaged.
- To minimize impacts to trees adjacent to the Site:
  - Erect a fence beyond the CRZ of the retained trees. The fence should be highly visible (orange construction fence) and paired with erosion and sediment control fencing.
