Geotechnical Investigation

Proposed Commercial Development Employment Lands – Riverside South

Ottawa, Ontario

Report PG4958-2 dated July 5, 2022

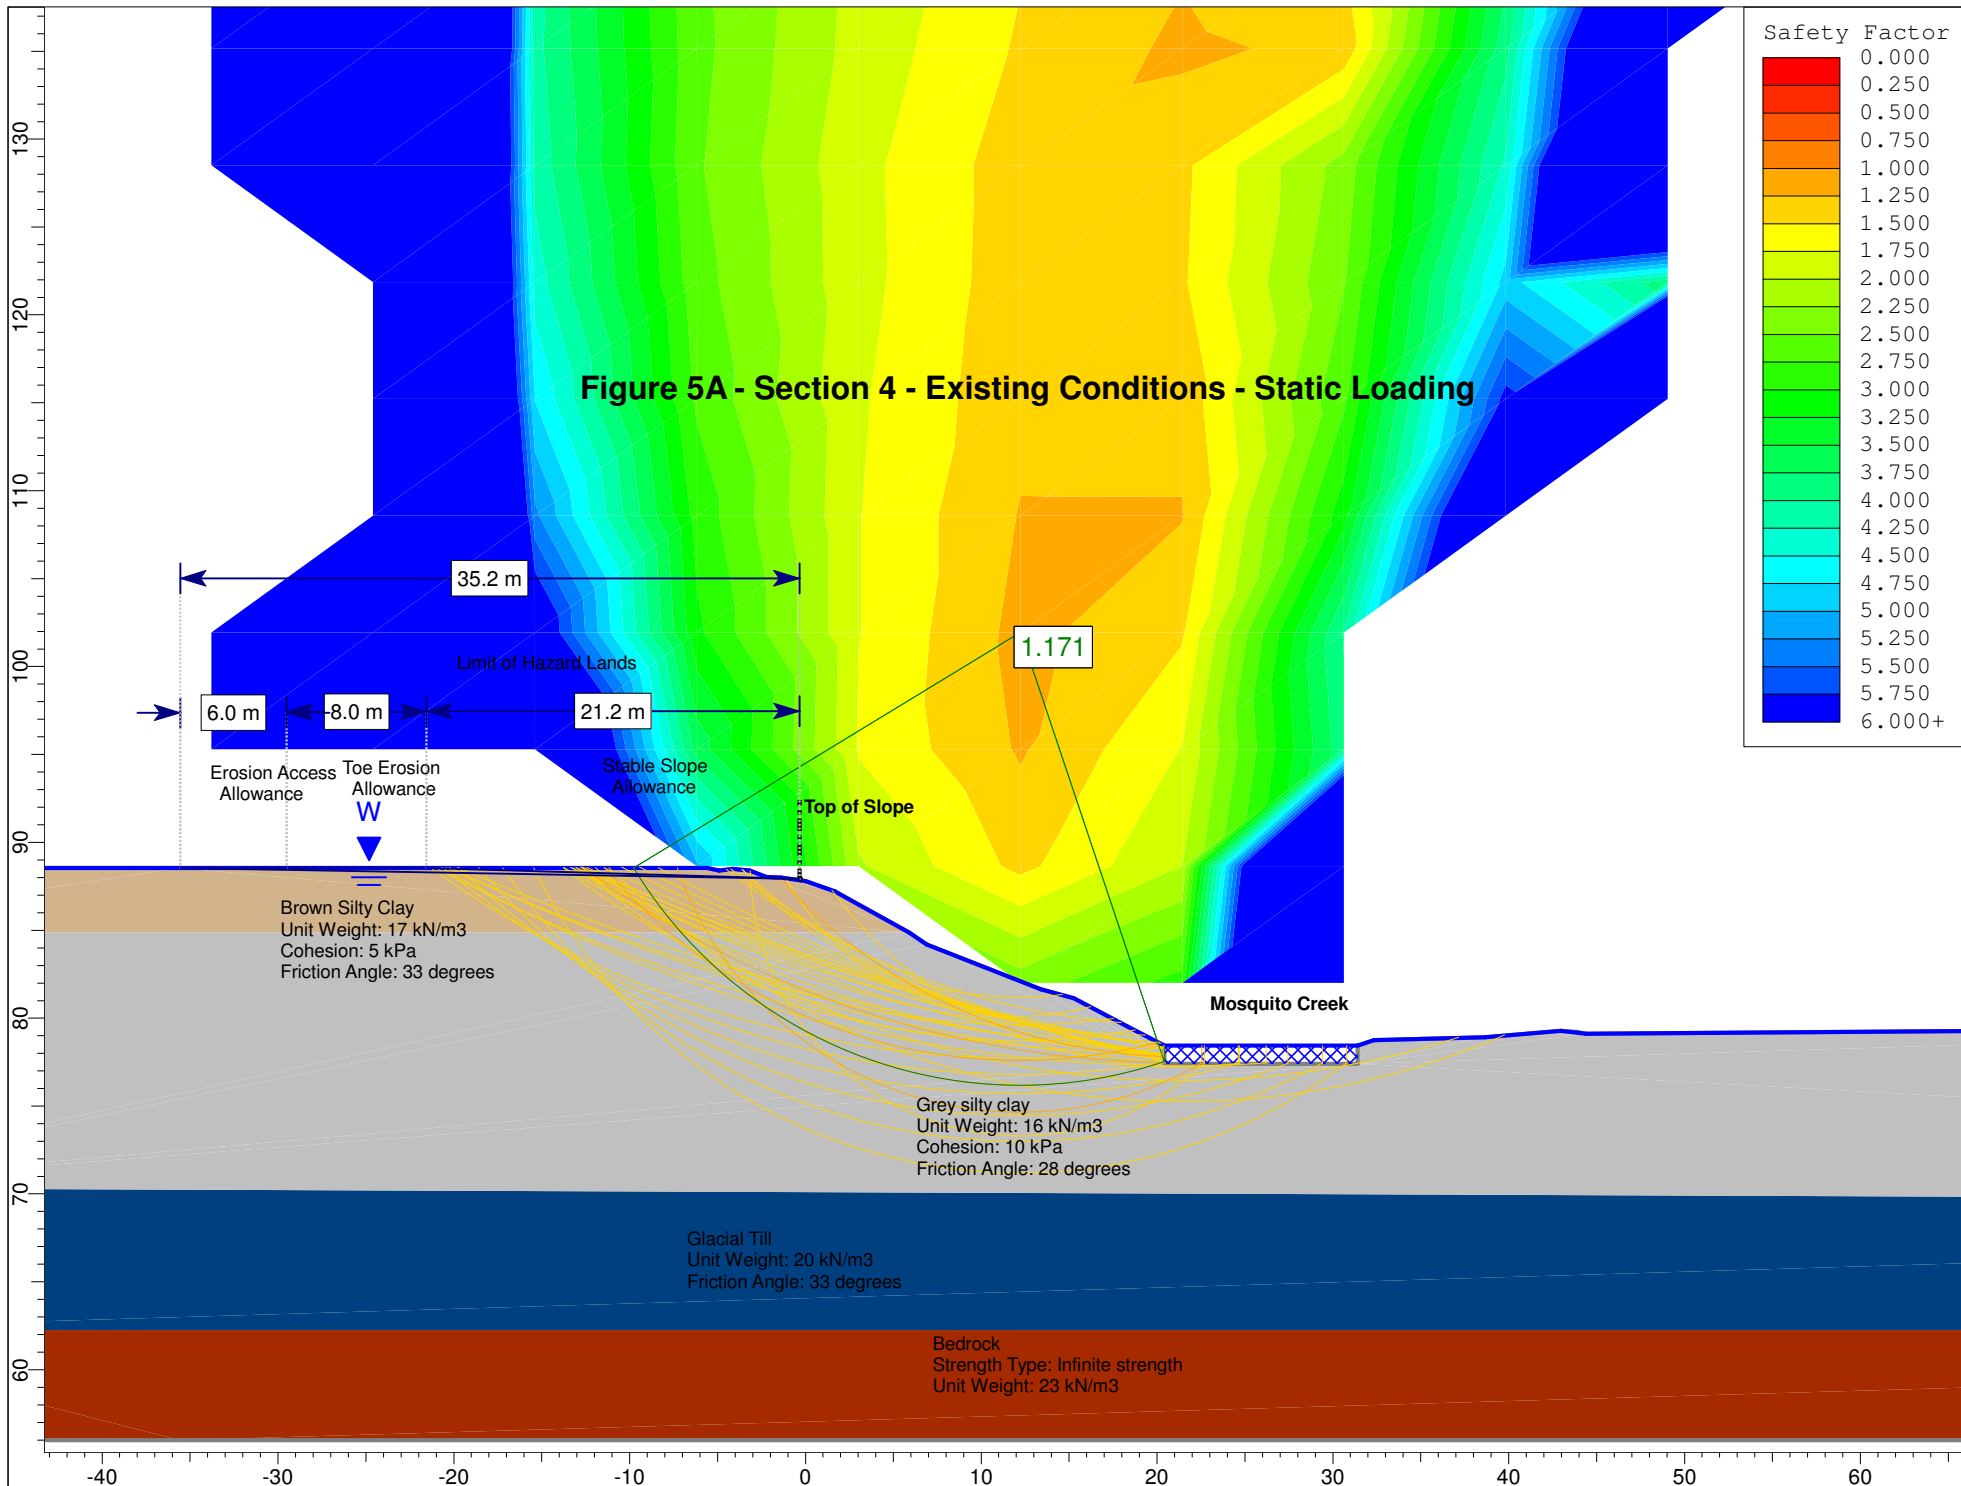
Figure 5A - Section 4 - Existing Conditions - Static Loading

The analysis of slope stability was carried out using SLIDE, a computer program that permits a two-dimensional slope stability analysis using several methods, including the Bishop's method, which is a widely used and accepted analysis method. The program calculates a factor of safety, which represents the ratio of the forces resisting failure to those favouring failure. Theoretically, a factor of safety of 1.0 represents a condition where the slope is stable. However, due to intrinsic limitations of the calculation methods and the variability of the subsoil and groundwater conditions, a factor of safety greater than one is usually required to ascertain that the risks of failure are acceptable. A minimum factor of safety of 1.5 is generally recommended for conditions where the failure of the slope would endanger permanent structures.

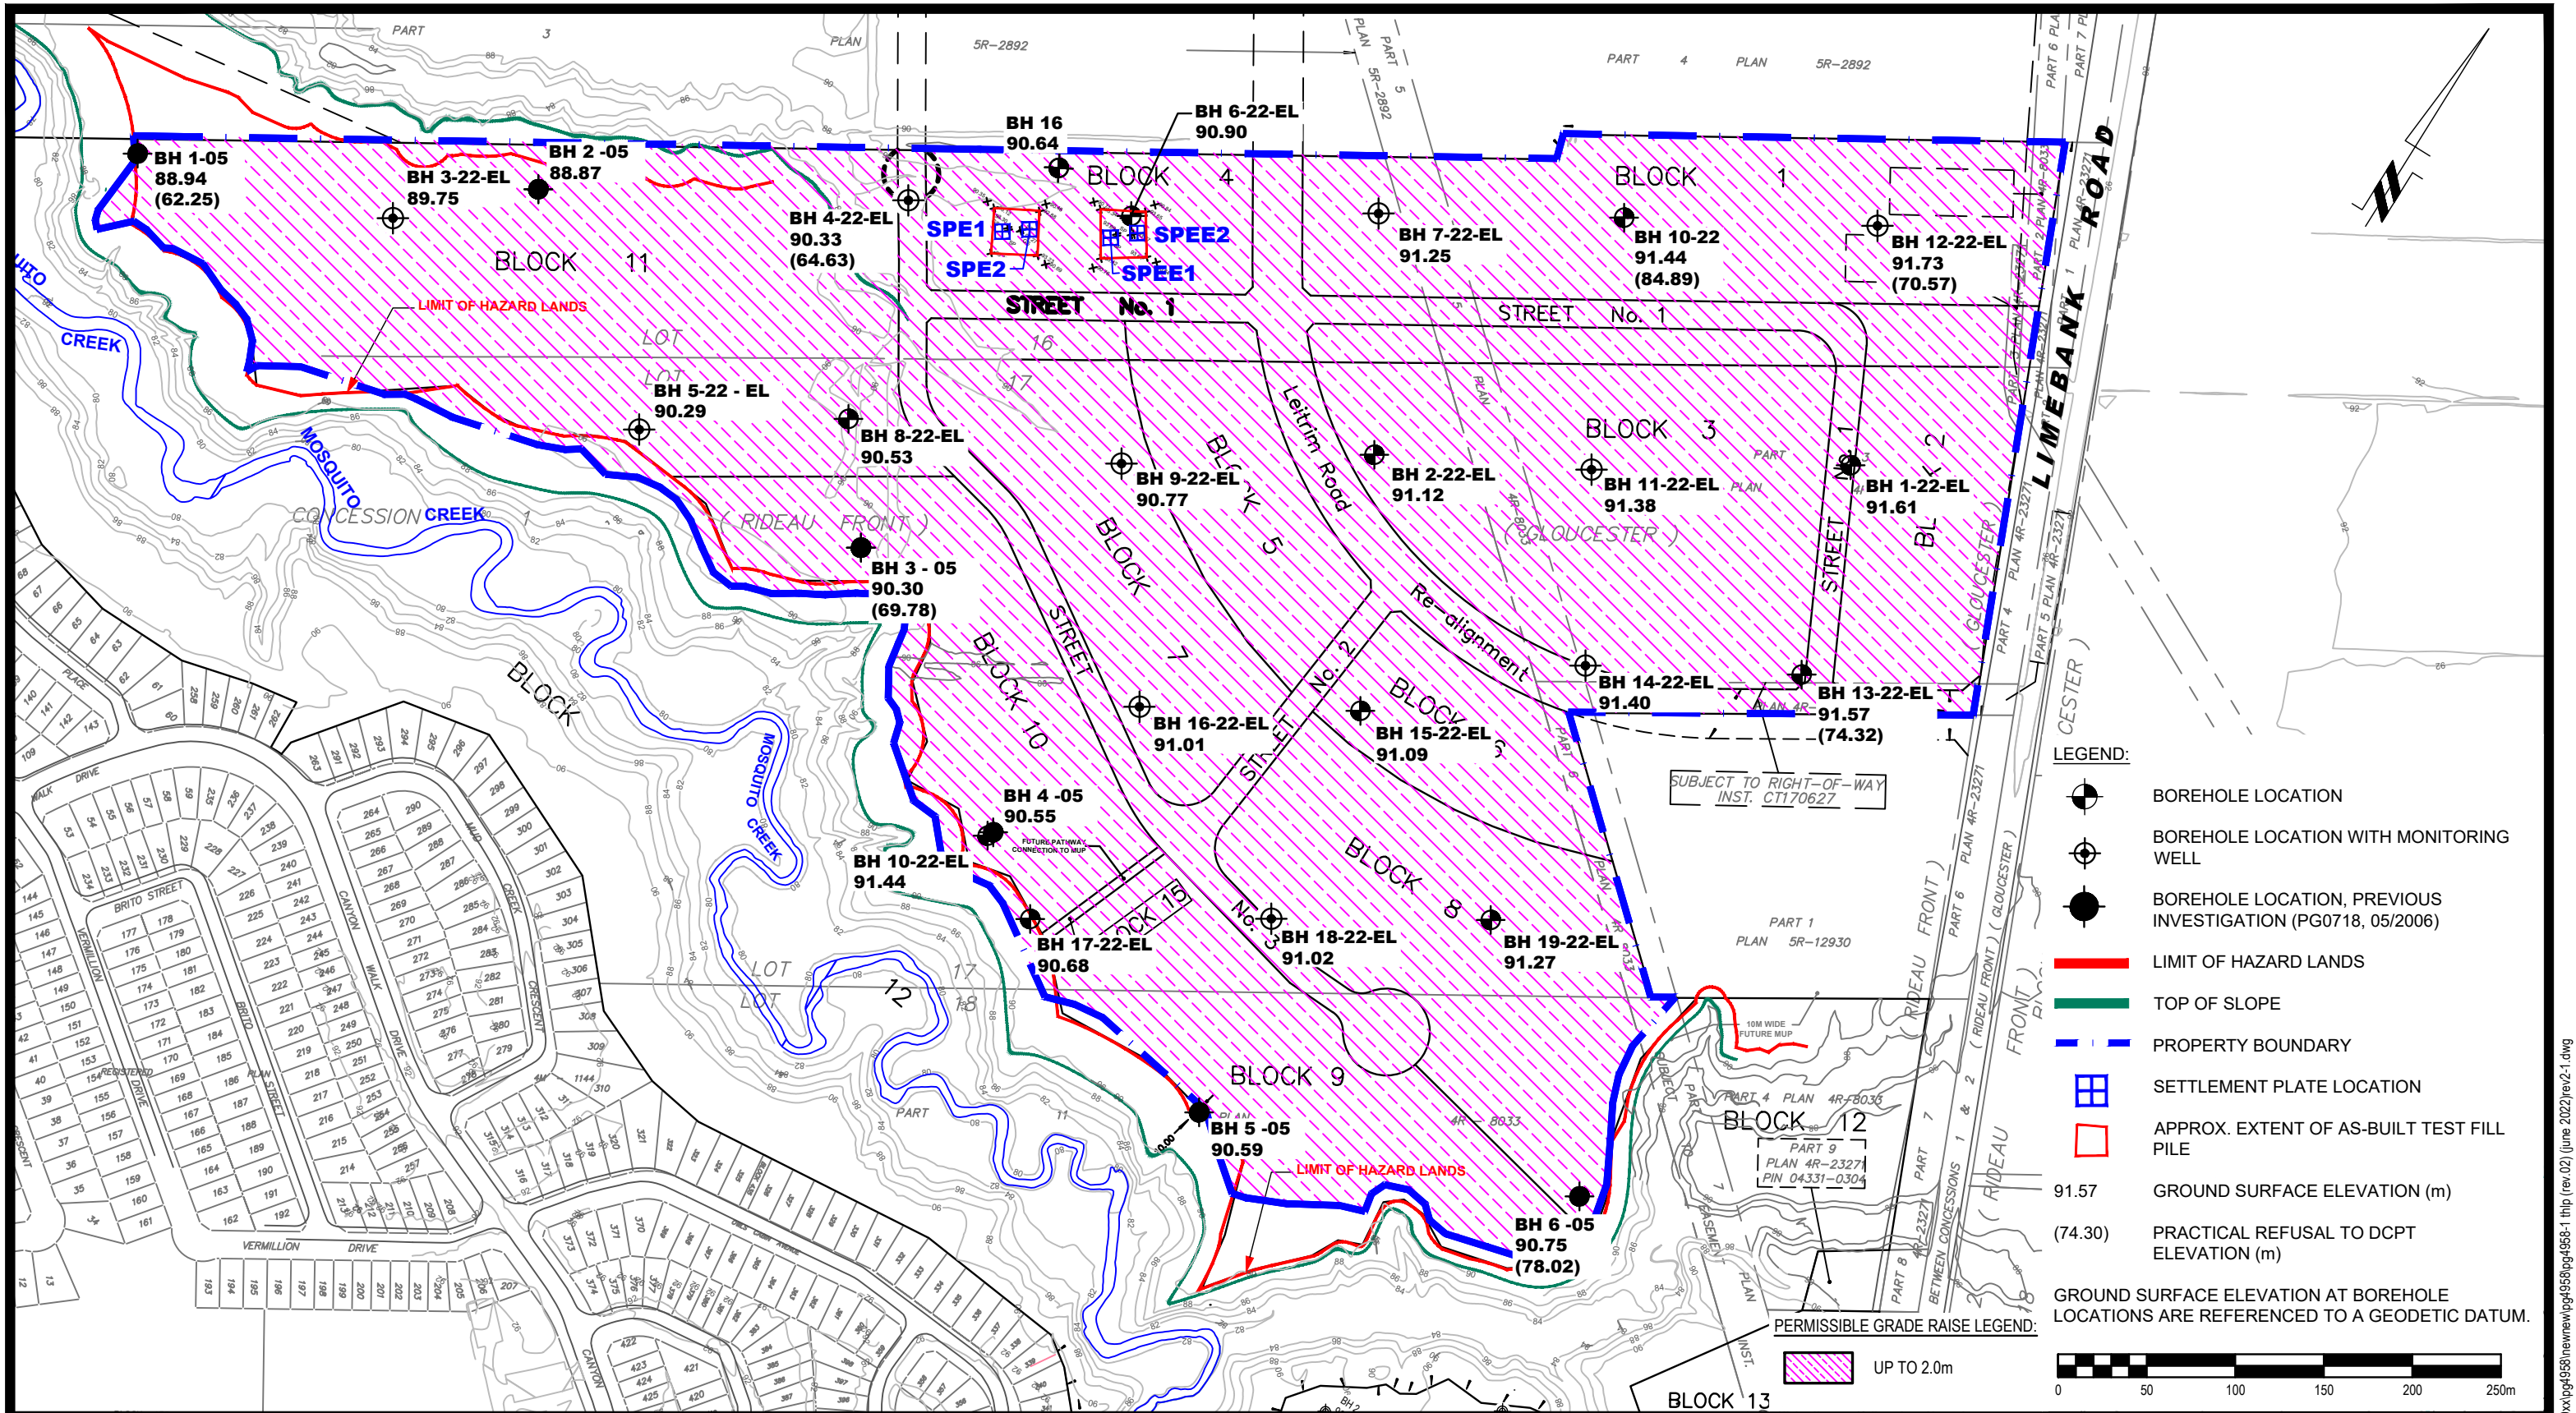
Scale:	1:4000	Date:	04/2022
Drawn by:	NFRV	Report No.:	PG4958-2
Checked by:	NP	Dwg. No.:	PG4958-9
Approved by:	DG	Revision No.:

Based on the undrained shear strength values of the silty clay deposit encountered throughout the subject site, the recommended permissible grade raise areas for buildings are defined in Drawing PG4958-9 - Permissible Grade Raise Plan in Appendix 2.

- LEGEND:**
- BOREHOLE LOCATION
 - BOREHOLE LOCATION WITH MONITORING WELL
 - BOREHOLE LOCATION, PREVIOUS INVESTIGATION (PG0718, 05/2006)
 - LIMIT OF HAZARDOUS LANDS
 - TOP OF SLOPE
 - PROPERTY BOUNDARY
 - SETTLEMENT PLATE LOCATION
 - APPROX. EXTENT OF AS-BUILT TEST FILL PILE
 - 91.57 GROUND SURFACE ELEVATION (m)
 - (74.30) PRACTICAL REFUSAL TO DCPT ELEVATION (m)
 - GROUND SURFACE ELEVATION AT BOREHOLE LOCATIONS ARE REFERENCED TO A GEODETIC DATUM.
- PERMISSIBLE GRADE RAISE LEGEND:**
- UP TO 2.0m

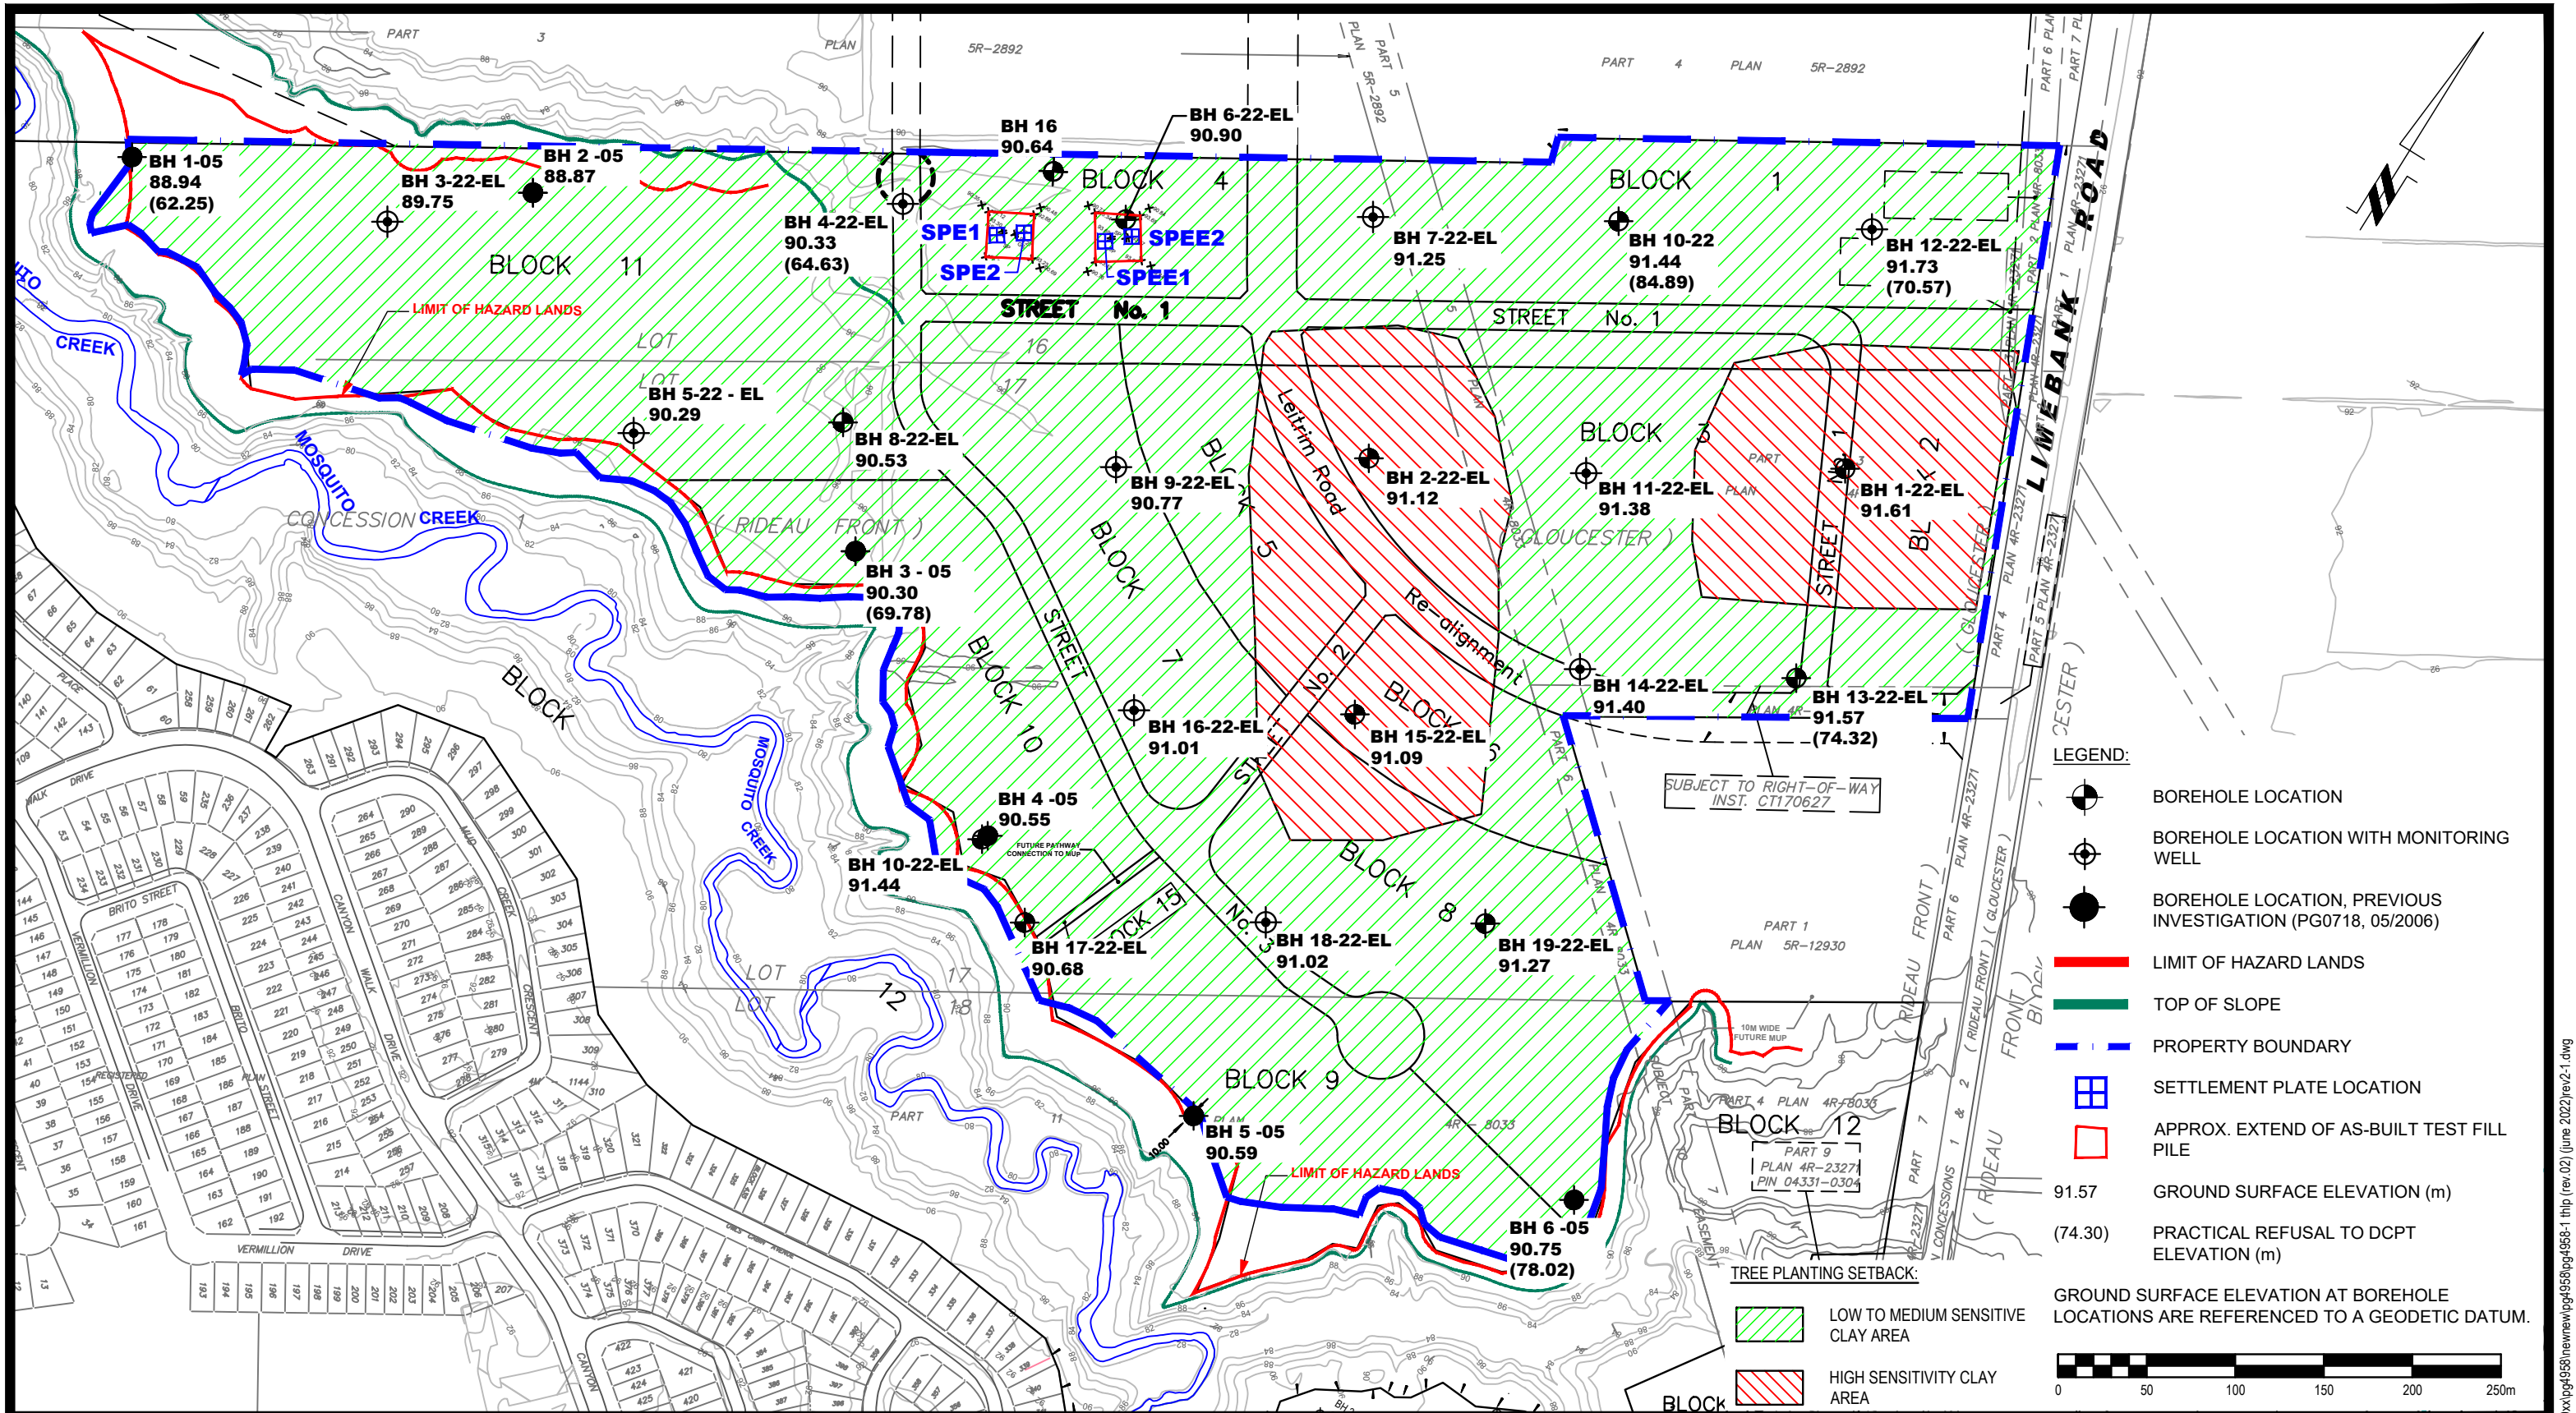
Based on the results of our review, two areas were defined within the subject site in which the tree planting restrictions are defined. The two areas are detailed below and are outlined in Drawing PG4958-10 - Tree Planting Setback Recommendations presented in Appendix 2.

A low to medium sensitivity clay soil was encountered between anticipated underside of footing elevations and 3.5 m below preliminary finished grade as per City Guidelines at the areas outlined in Drawing PG4958-10 - Tree Planting Setback Recommendations in Appendix 2. Based on our Atterberg Limits' test results, the modified plasticity limit does not exceed 40% in these areas. The following tree planting setbacks are recommended for the low to medium sensitivity area.
