Geotechnical Investigation

Proposed Commercial Development

3700 Twin Falls Place

Report PG4958-2 Revision 2 dated March 29, 2023

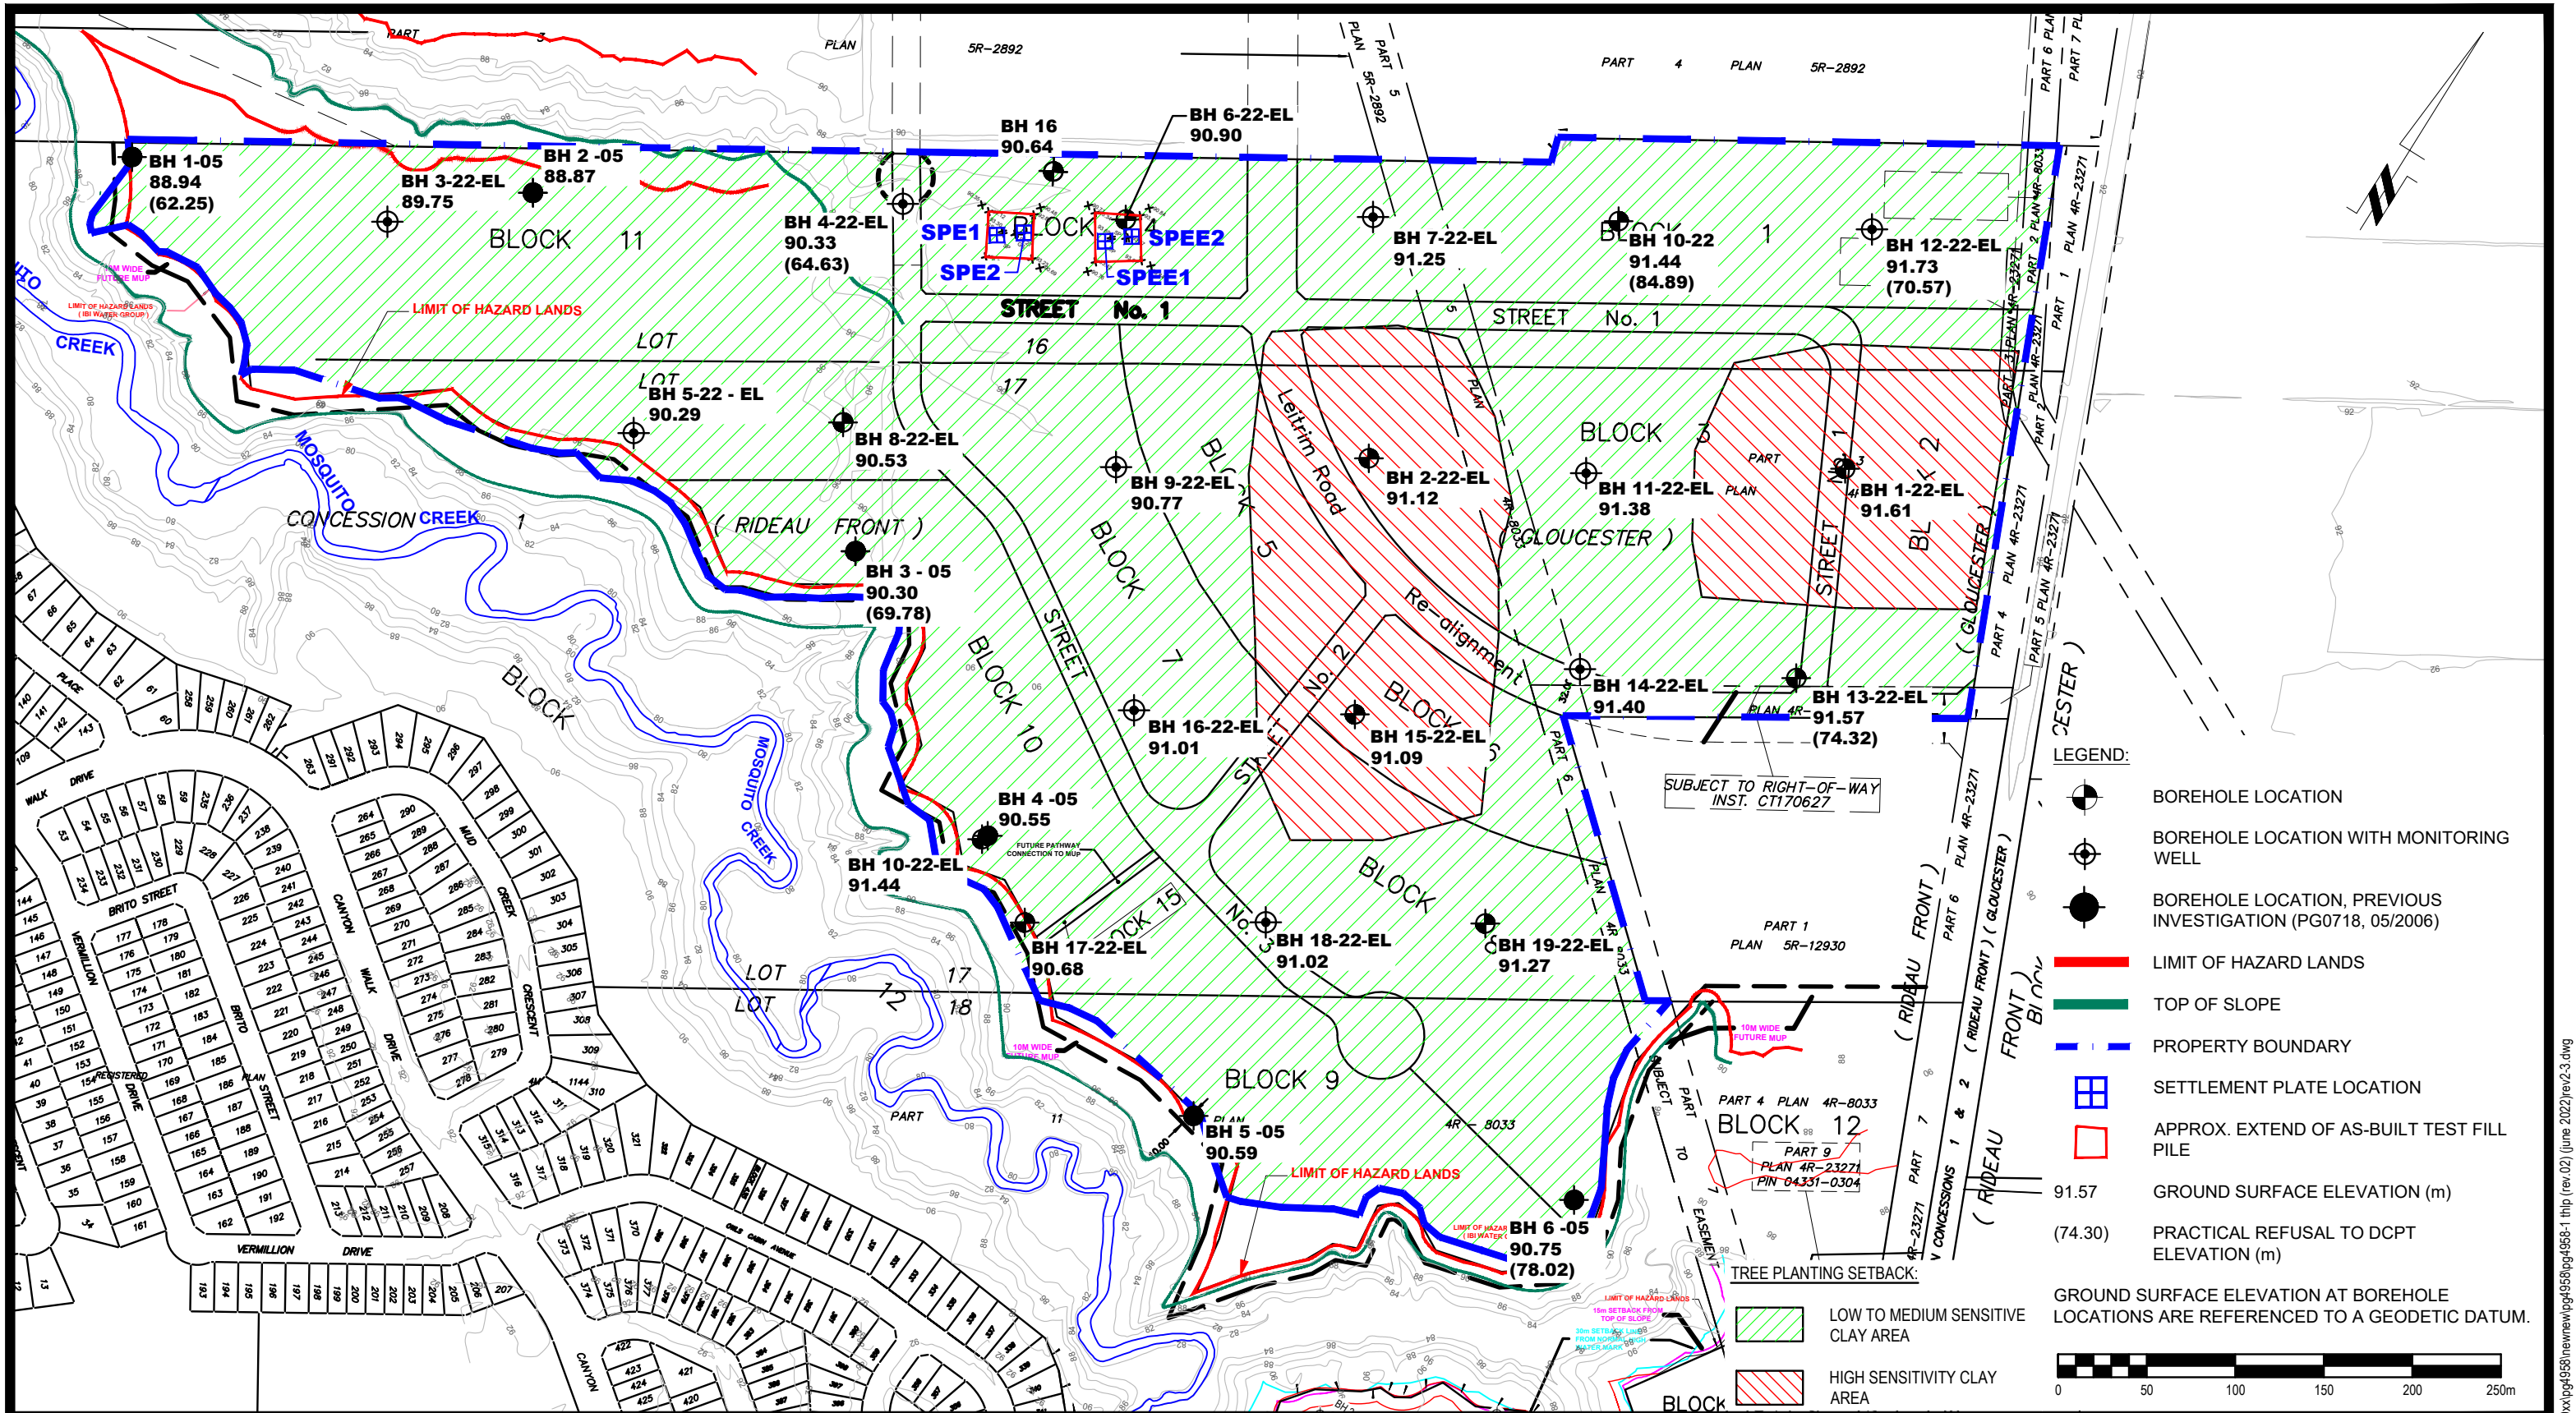
- LEGEND:**
- BOREHOLE LOCATION
 - BOREHOLE LOCATION WITH MONITORING WELL
 - BOREHOLE LOCATION, PREVIOUS INVESTIGATION (PG0718, 05/2006)
 - LIMIT OF HAZARD LANDS
 - TOP OF SLOPE
 - PROPERTY BOUNDARY
 - SETTLEMENT PLATE LOCATION
 - APPROX. EXTEND OF AS-BUILT TEST FILL PILE
 - 91.57 GROUND SURFACE ELEVATION (m)
 - (74.30) PRACTICAL REFUSAL TO DCPT ELEVATION (m)
 - GROUND SURFACE ELEVATION AT BOREHOLE LOCATIONS ARE REFERENCED TO A GEODETIC DATUM.
 - LOW TO MEDIUM SENSITIVE CLAY AREA
 - HIGH SENSITIVITY CLAY AREA

Based on the results of our review, two areas were defined within the subject site in which the tree planting restrictions are defined. The two areas are detailed below and are outlined in Drawing PG4958-10 - Tree Planting Setback Recommendations presented in Appendix 2.

A low to medium sensitivity clay soil was encountered between anticipated underside of footing elevations and 3.5 m below preliminary finished grade as per City Guidelines at the areas outlined in Drawing PG4958-10 - Tree Planting Setback Recommendations in Appendix 2. Based on our Atterberg Limits' test results, the modified plasticity limit does not exceed 40% in these areas. The following tree planting setbacks are recommended for the low to medium sensitivity area.
