Geotechnical Investigation

Proposed Residential Development
Cardinal Creek Village South
Old Montreal Road
Ottawa, Ontario

November 29, 2021

Report: PG5201-1
Revision 5

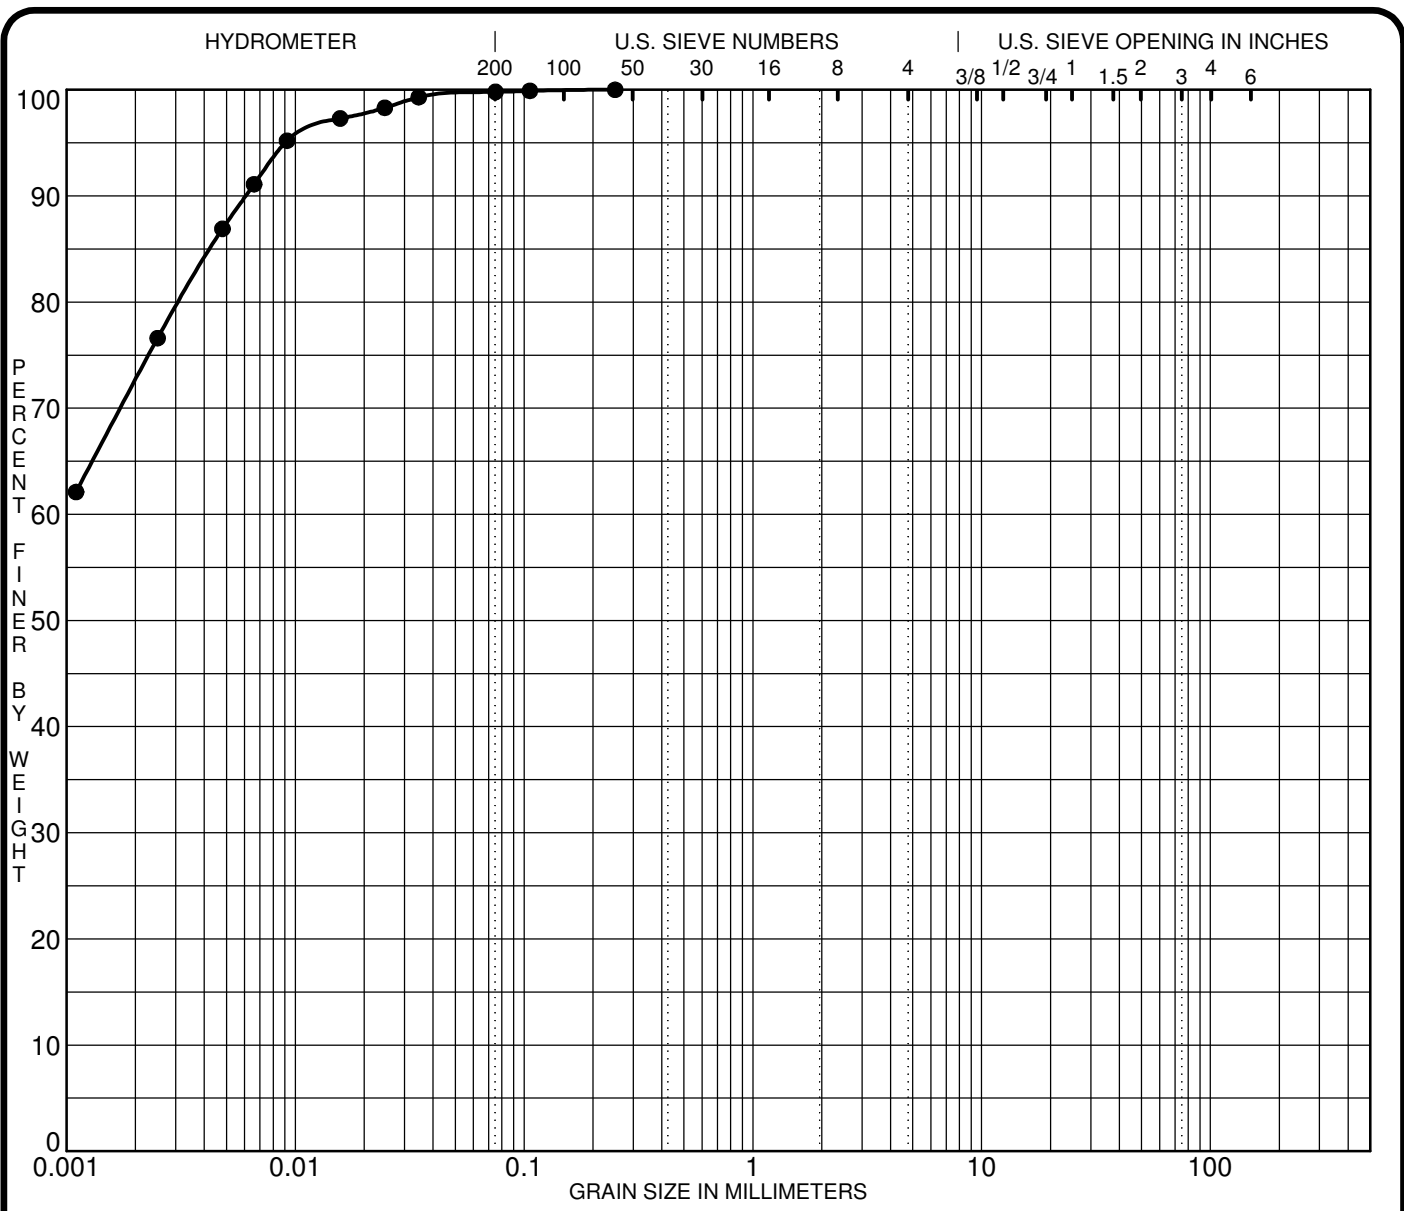
Specimen Identification	Classification	MC%	LL	PL	PI	Cc	Cu
● TP 2-21 G4	CH = Inorganic Clays of High Plasticity		71	29	42

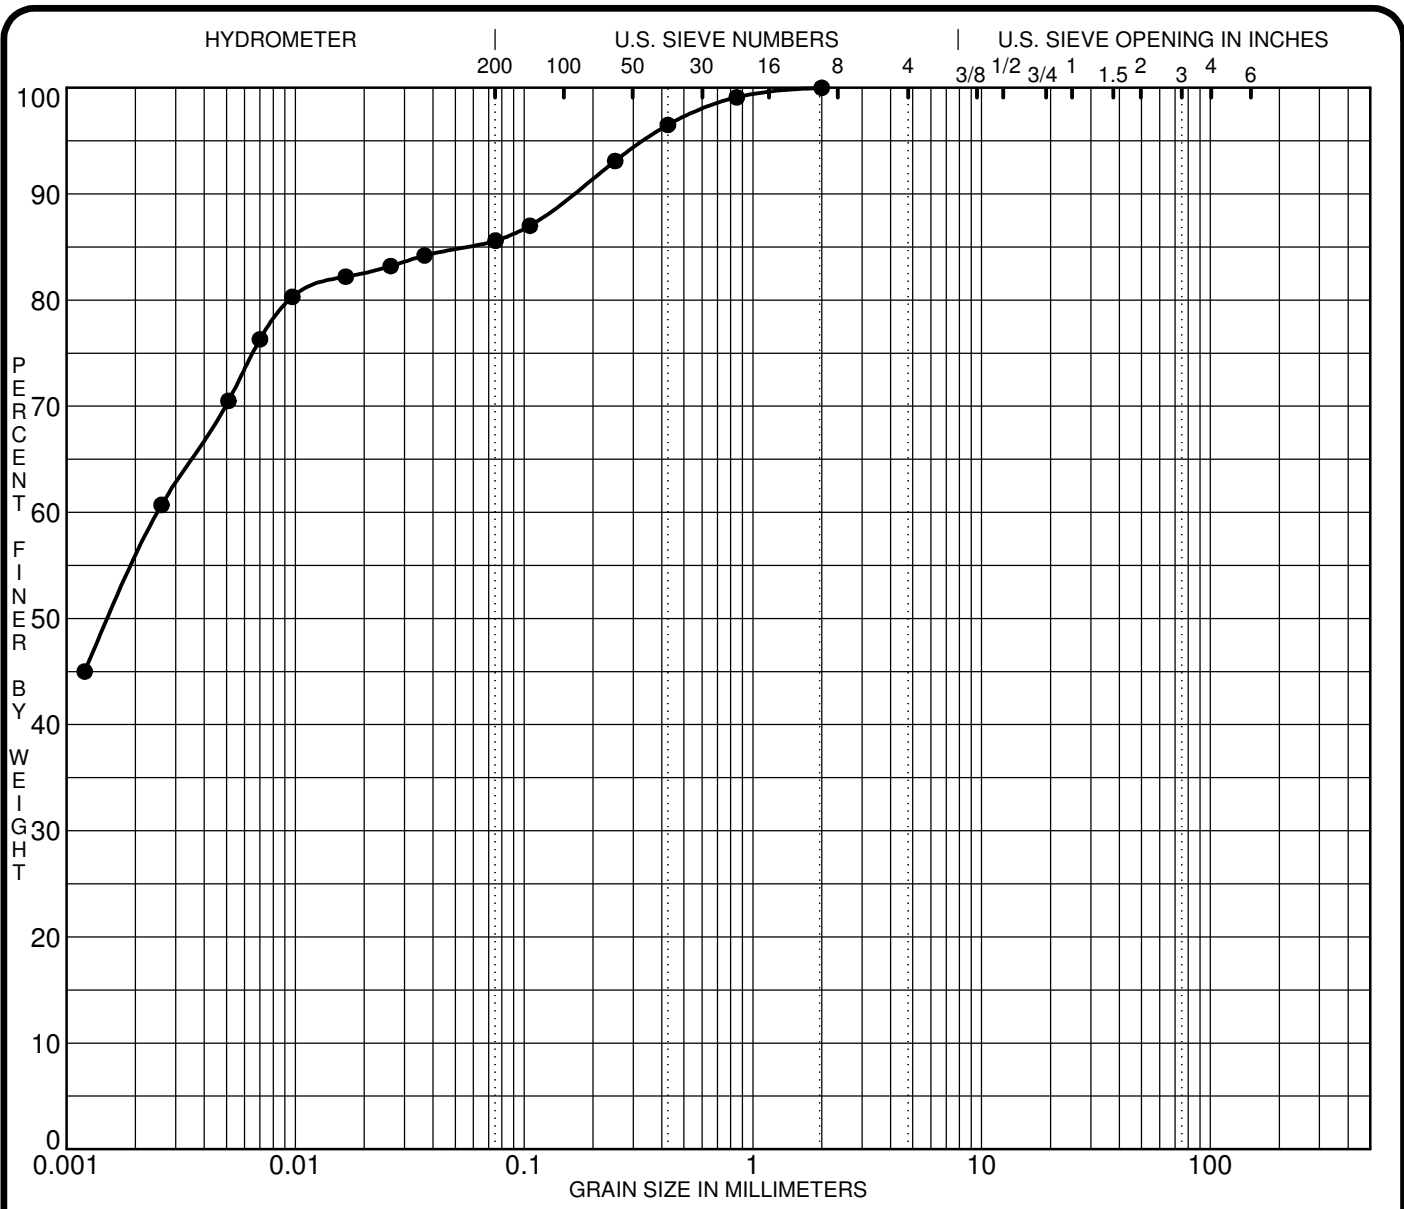
Specimen Identification	Classification	MC%	LL	PL	PI	Cc	Cu
● TP 7-21 G3	MH = Inorganic Silts of High Plasticity		59	32	27

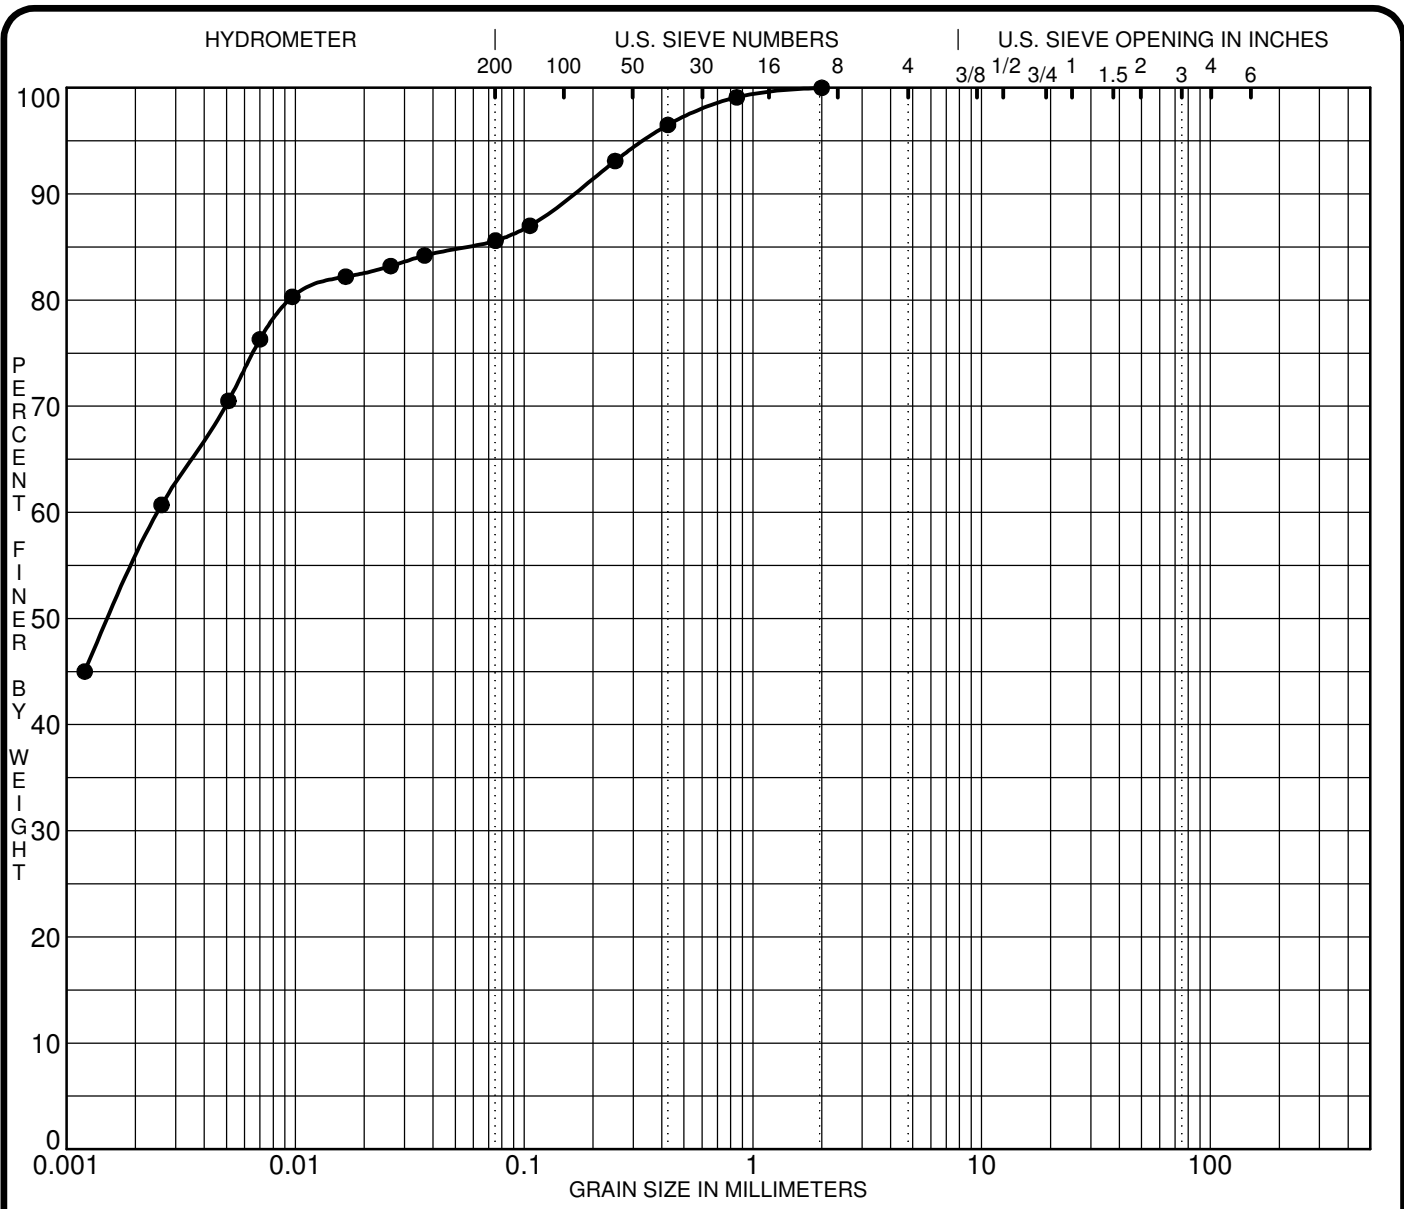
Specimen Identification	Classification	MC%	LL	PL	PI	Cc	Cu
● TP10-21 G4	MH = Inorganic Silts of High Plasticity		60	33	27

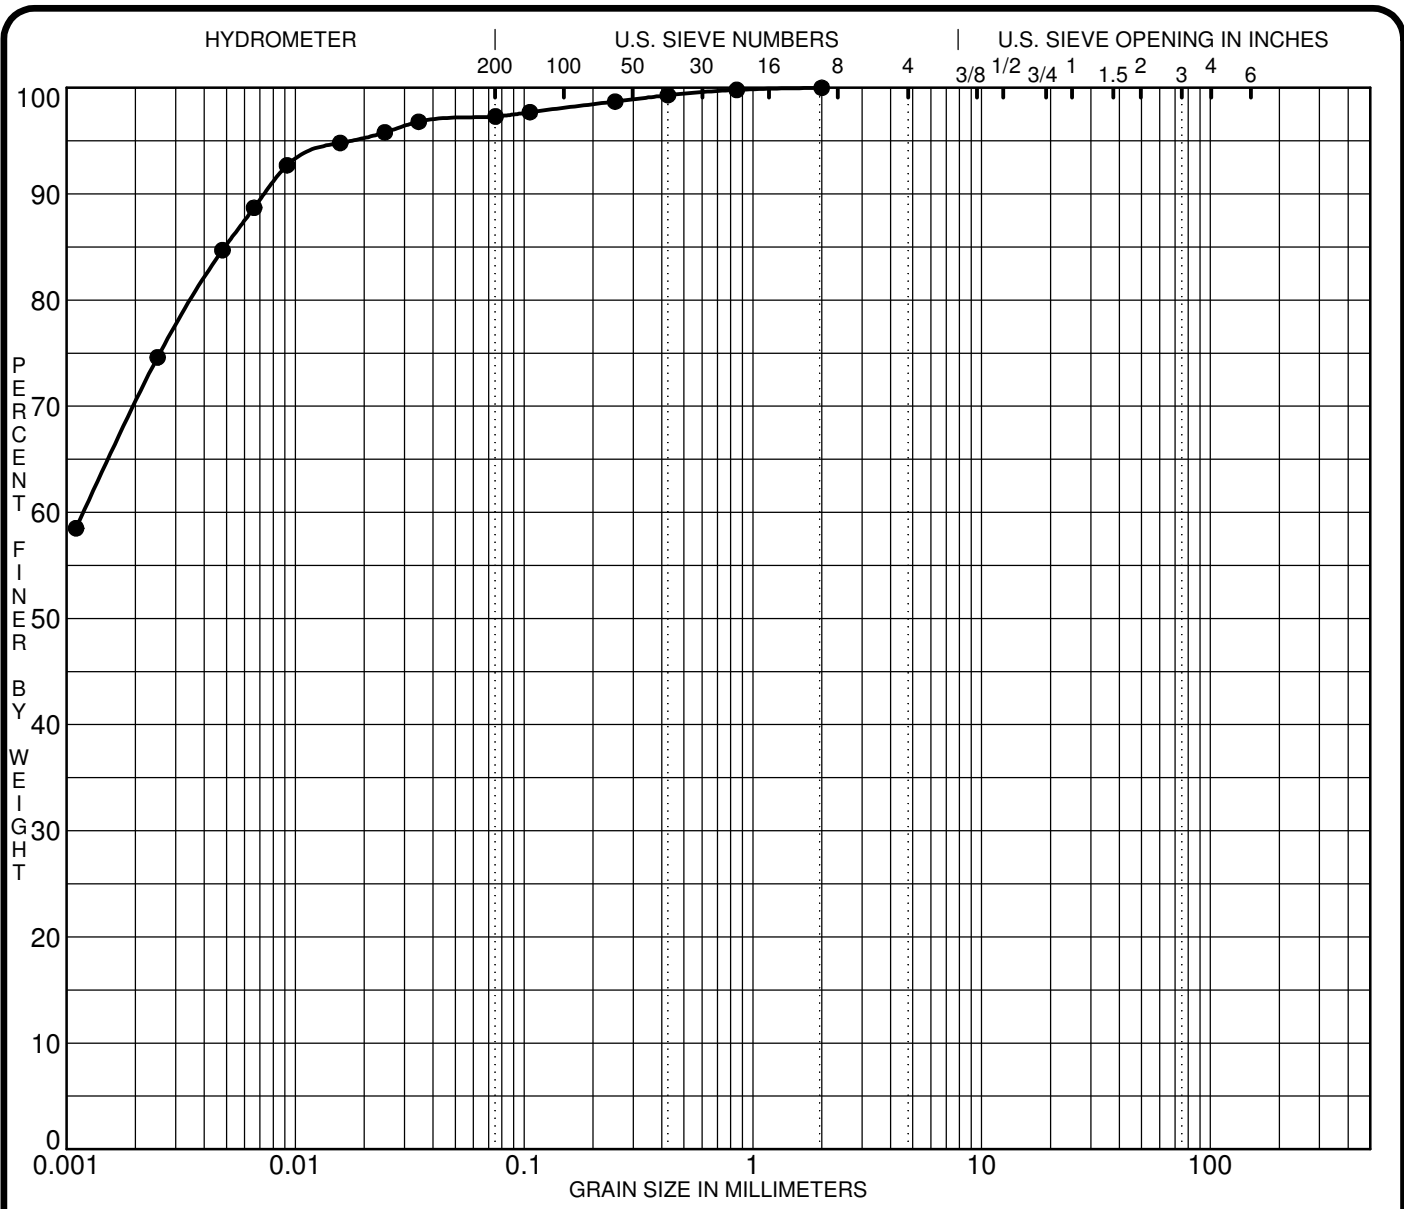
Specimen Identification	Classification	MC%	LL	PL	PI	Cc	Cu
● TP12-21 G2	MH = Inorganic Silts of High Plasticity		75	37	38

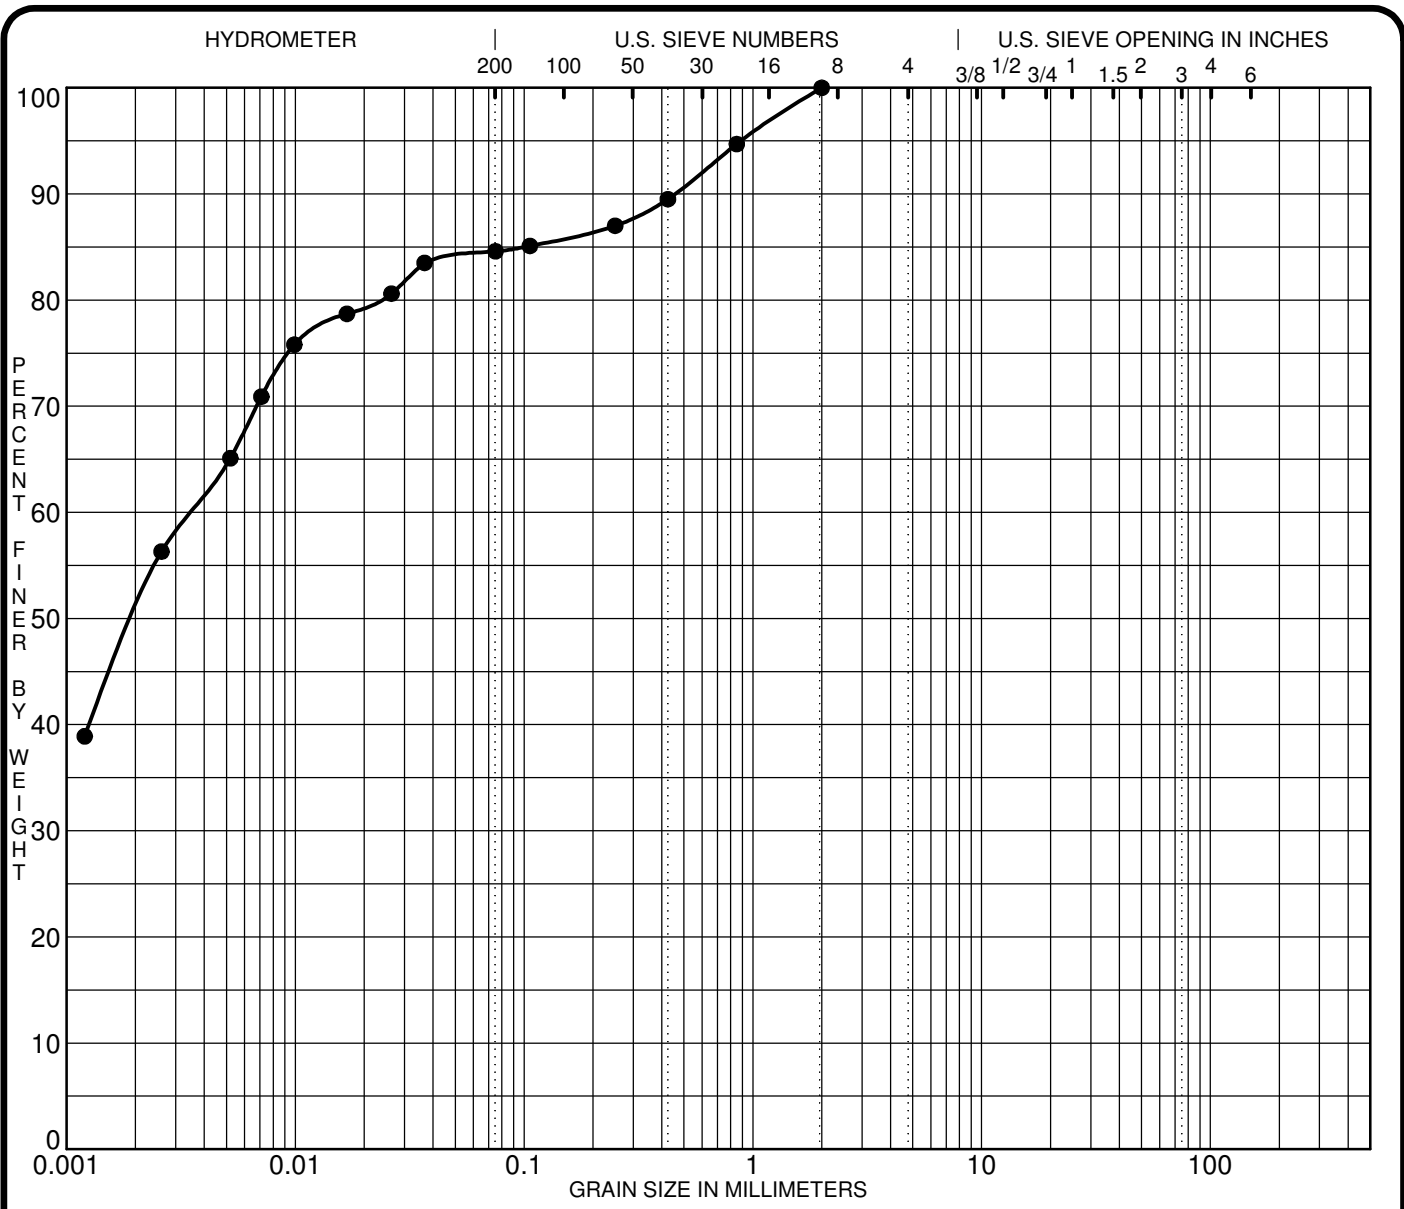
Specimen Identification	Classification	MC%	LL	PL	PI	Cc	Cu
● TP18-21 G1	MH = Inorganic Silts of High Plasticity		66	36	30

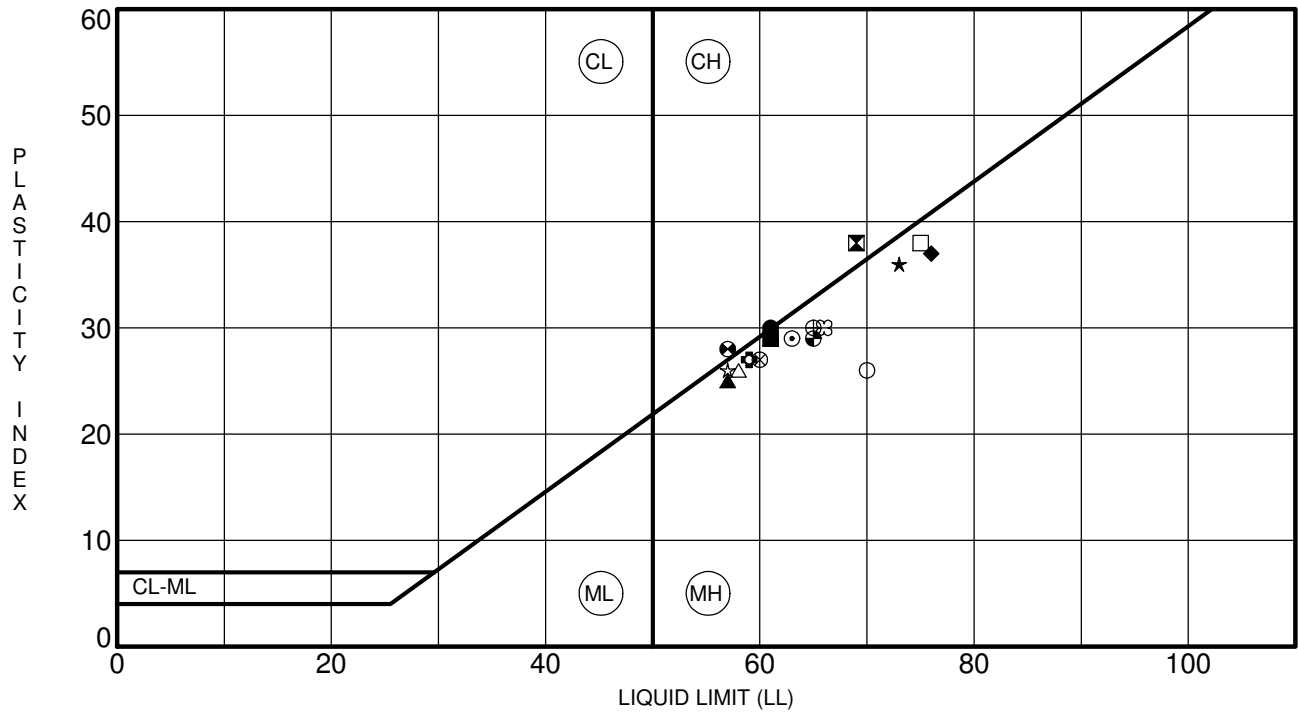
Specimen Identification	LL	PL	PI	Fines	Classification
● TP 1-21 G4	61	31	30		CH = Inorganic Clays of High Plasticity
⊠ TP 3-21 G3	69	31	38		CH = Inorganic Clays of High Plasticity
▲ TP 4-21 G3	57	32	25		MH = Inorganic Silts of High Plasticity
★ TP 5-21 G3	73	37	36		MH = Inorganic Silts of High Plasticity
⊙ TP 6-21 G2	63	34	29		MH = Inorganic Silts of High Plasticity
⊕ TP 7-21 G3	59	32	27	85.6	MH = Inorganic Silts of High Plasticity
○ TP 8-21 G3	70	44	26		MH = Inorganic Silts of High Plasticity
△ TP 9-21 G2	58	32	26		MH = Inorganic Silts of High Plasticity
⊗ TP 10-21 G4	60	33	27	85.6	MH = Inorganic Silts of High Plasticity
⊕ TP 11-21 G4	65	35	30		MH = Inorganic Silts of High Plasticity
□ TP 12-21 G2	75	37	38	97.3	MH = Inorganic Silts of High Plasticity
⊕ TP 16-21 G1	57	29	28		CH = Inorganic Clays of High Plasticity
⊕ TP 17-21 G1	65	36	29		MH = Inorganic Silts of High Plasticity
☆ TP 17-21 G2	57	31	26		MH = Inorganic Silts of High Plasticity

⊗ TP 18-21 G1	66	36	30	84.6	MH = Inorganic Silts of High Plasticity
■ TP 19-21 G2	61	32	29		MH = Inorganic Silts of High Plasticity
◆ TP 20-21 G1	76	39	37		MH = Inorganic Silts of High Plasticity

Atterberg limits testing, as well as associated moisture content testing, was completed on the recovered silty clay samples at selected locations throughout the subject site. The results of the Atterberg limits tests are presented in Table 1 and on the Atterberg Limits Results sheet in Appendix 1. The test samples classify as inorganic clays of high plasticity (CH) and inorganic silts of high plasticity (MH), in accordance with the Unified Soil Classification System (USCS).

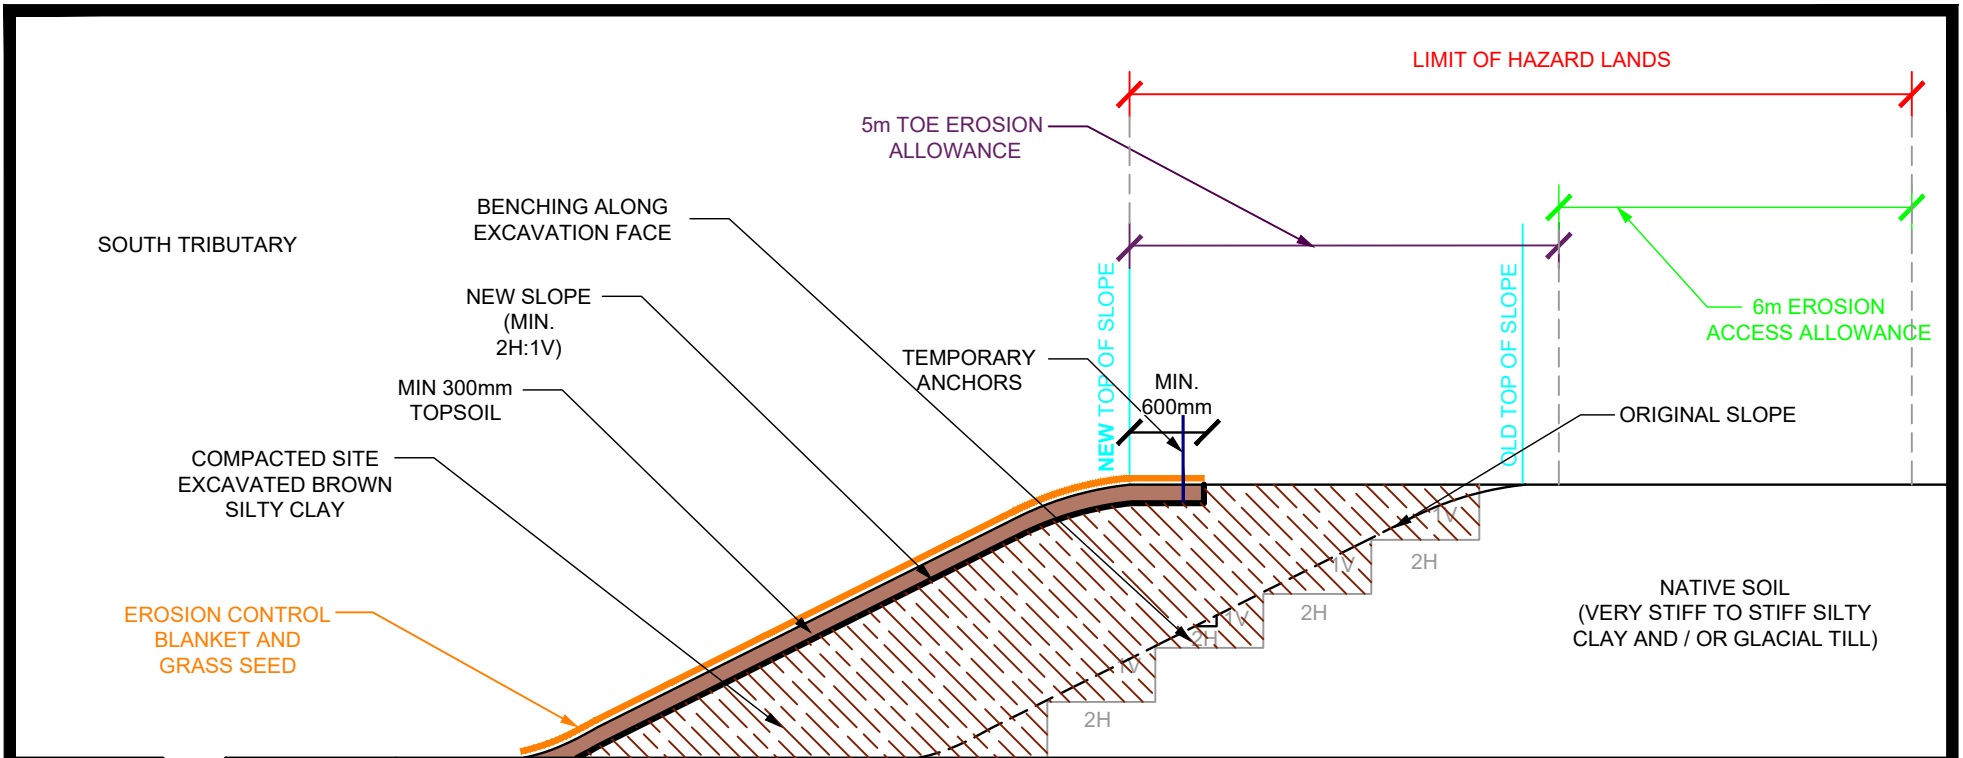
Drawing No.: **FIG. 42**

- SITE EXCAVATED MATERIAL SUCH AS WORKABLE, BROWN SILTY SAND OR ANY APPROVED SITE EXCAVATED MATERIAL, FREE OF DELETERIOUS FILL SUCH AS ORGANICS OR CONSTRUCTION DEBRIS, CAN BE USED AS BACKFILL MATERIAL TO IN-FILL CURRENT SLOPE AND EXTEND THE SLOPE FACE TO MATCH THE EXISTING ADJACENT SLOPES.
