FINAL REPORT

Phase One Environmental Assessment

Proposed Development at Riverside Drive and Hunt Club Road, Ottawa Ontario

Golder Associates Ltd.

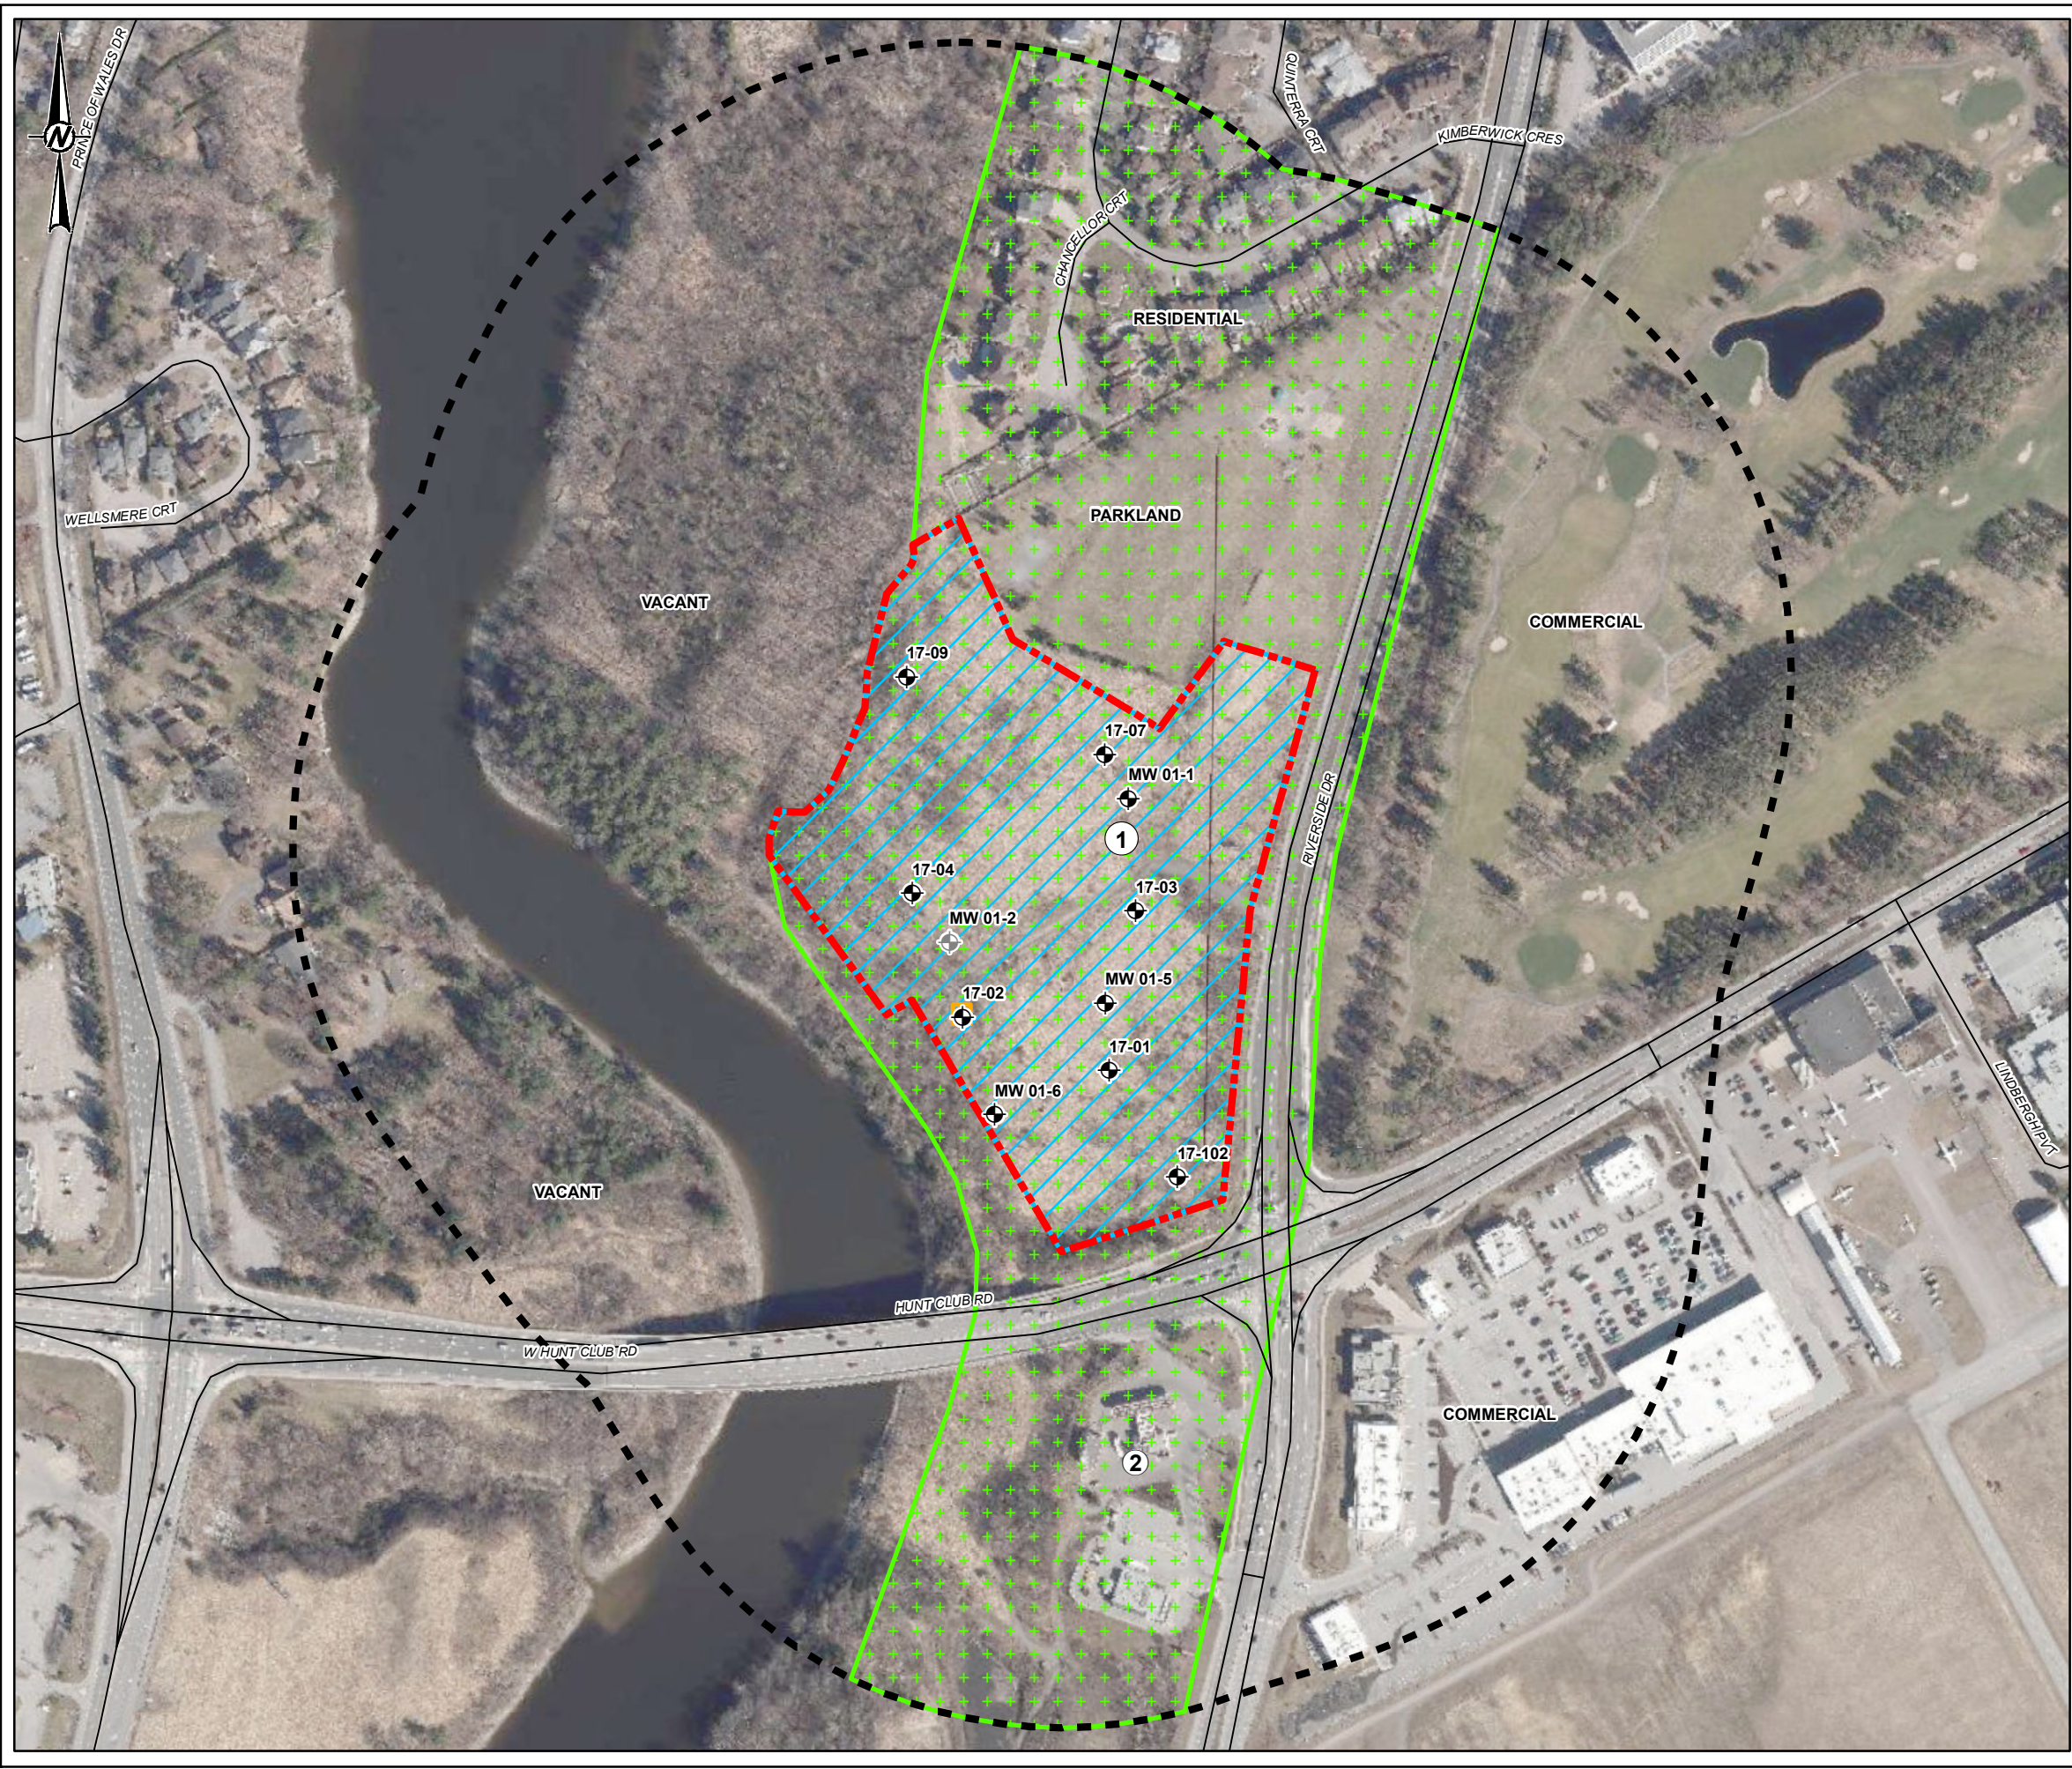
- EXISTING MONITORING WELL LOCATION OBSERVED DURING THE PHASE ONE ESA SITE VISIT
- EXISTING MONITORING WELL LOCATION NOT OBSERVED DURING THE PHASE ONE ESA SITE VISIT
- ROADWAY
- APPROXIMATE LIMIT OF FORMER REMEDIATION
- PHASE ONE SITE
- PHASE ONE STUDY AREA
- APEC 1 (SITE-WIDE)
- LOCATION OF PCA 1

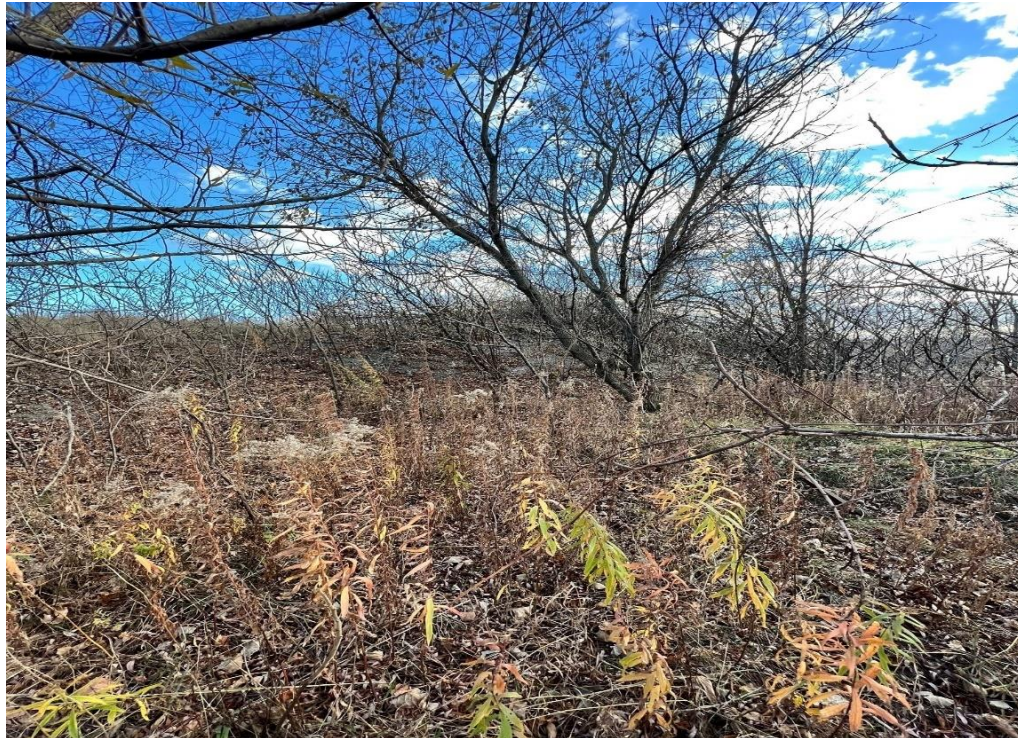
Photo 1: Looking west at the Site from the central portion of the eastern Site boundary. A higher elevation hill is present, with lifeless foliage.

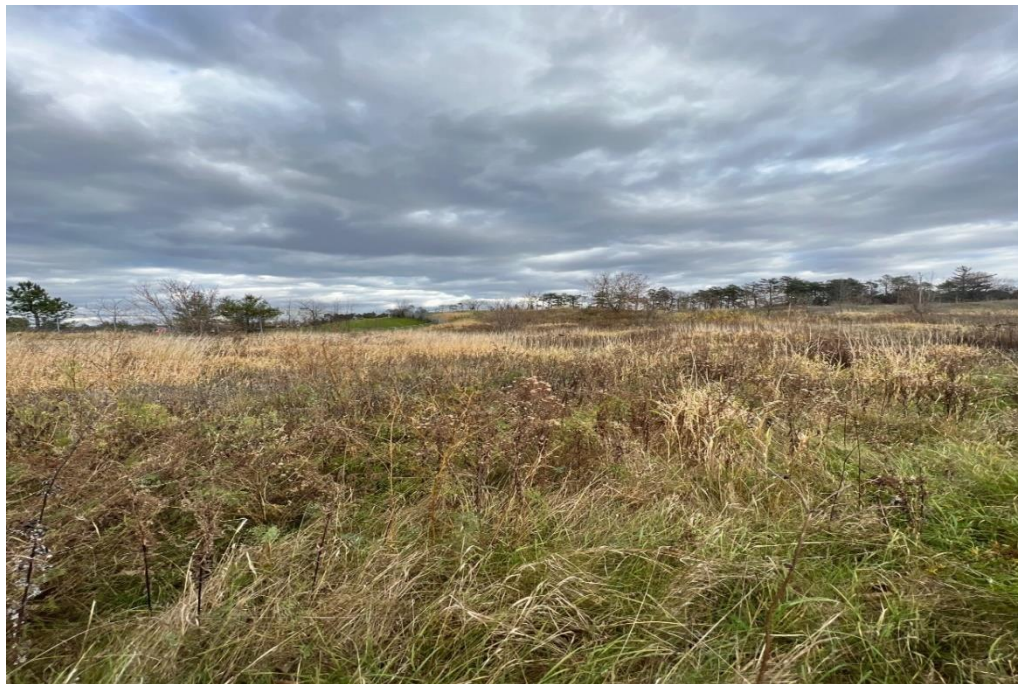
Photo 2: Looking north at the northern portion of the Site. The northeast corner of the Site with a high elevation is visible.

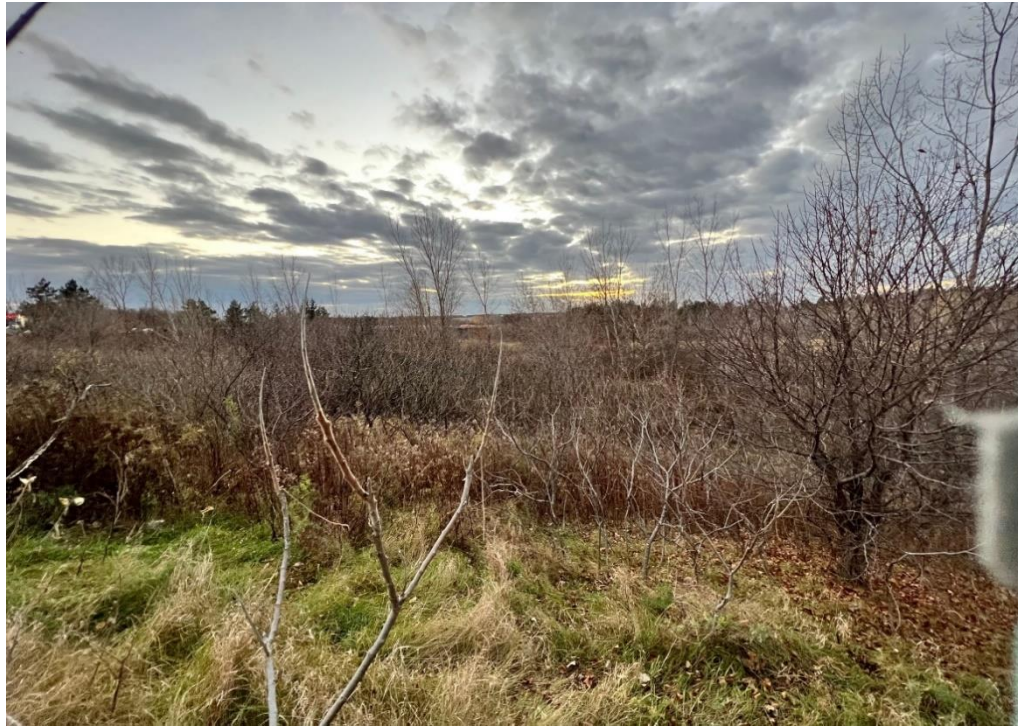
Photo 3: View of the eastern portion of the Site looking northwest.

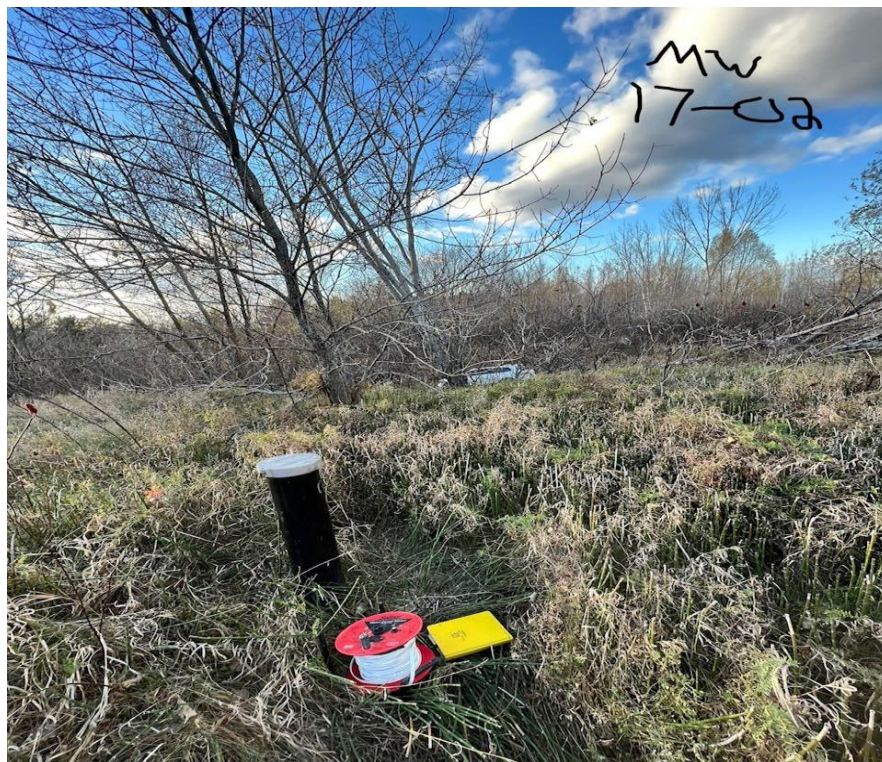
Photo 5: Monitoring well located on the southern portion of the Site near the western Site boundary.

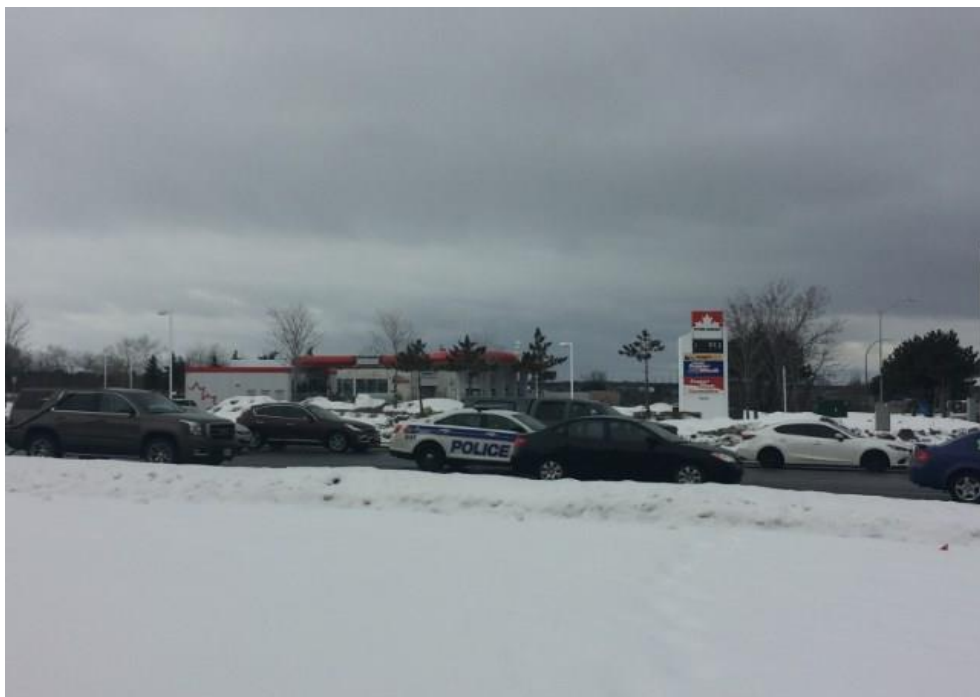
Photo 8: Looking west at the retail fuel outlet located on the surrounding lands south of the Site at the southeast corner of Hunt Club Road and Riverside Drive.
