**RE: 1086 Antochi Lane Residential Development
Environmental Impact Statement and Tree Conservation Report**

**1086 ANTOCHI LANE
ENVIRONMENTAL IMPACT STATEMENT and TREE CONSERVATION REPORT**

**1086 Antochi Lane
Manotick, City of Ottawa**

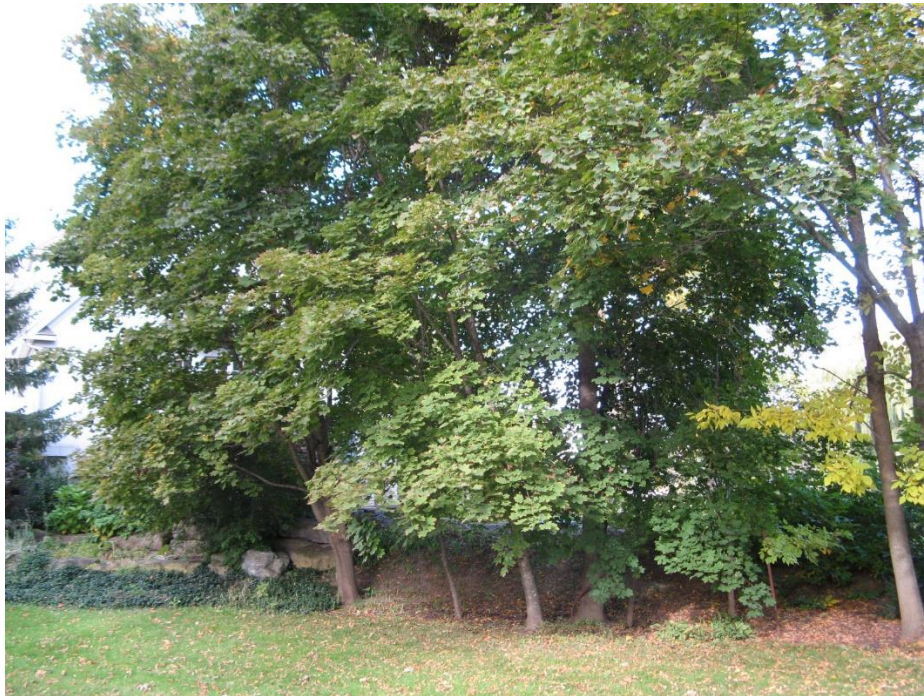
*Photo 2 – Norway maples along north property line in the northeast corner of the site
(Tree group # 2). View looking northwest*

The critical root zones of trees along the west portion of the north property line (Tree group # 2) will extend up to three metres onto the site. No impacts are anticipated on the critical root zone of these Norway maples and ash trees as the closest potential disturbance to their root systems will be greater than twenty metres from the tree trunks.

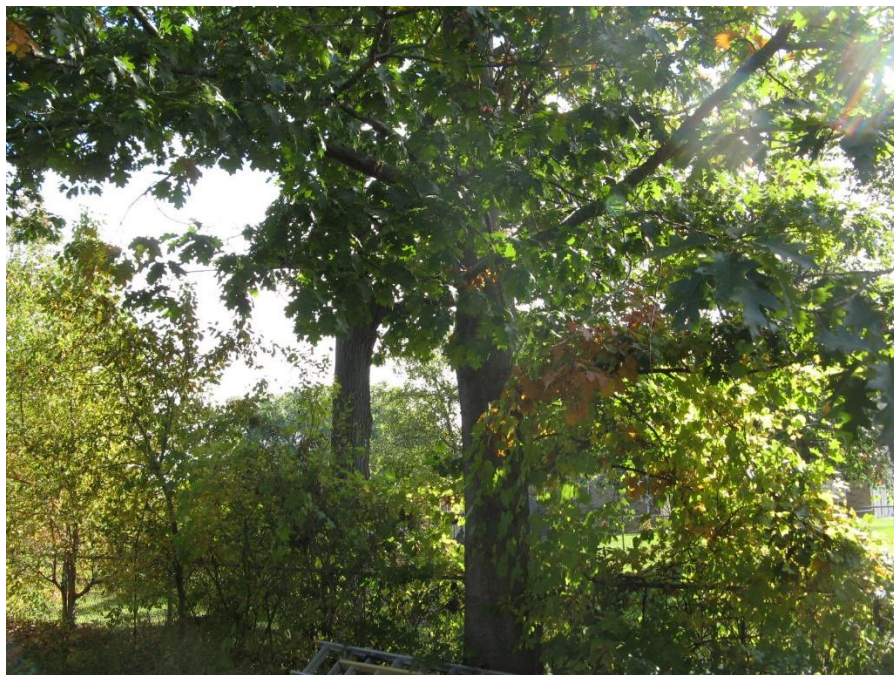
*Photo 6 – Red oak (Tree # 13) and adjacent red oak to the south the southeast corner of the site.
View looking southeast*

Along the east portion of the south site boundary no impacts are anticipated on the 60cm dbh red oak (adjacent to Tree group # 13) approximately two metres to the south of the site as this area is at the outer edge of the thirty metre river setback. Further west, the critical root zones of the white spruce and other trees (Tree group # 14) adjacent to the south property line will extend onto the site up to 1.5 metres and will likely be impacted by construction of the propose retaining wall. Discussions are required with the adjacent landowner at 1099 Orchard Hollow Drive regarding potential removal of the trees followed by plantings of native tree species in locations acceptable to the adjacent landowner.
