**Geotechnical Investigation
Proposed Residential Development
1086 Antochi Lane
Ottawa, Ontario**

February 7, 2023
Project: 100152.004

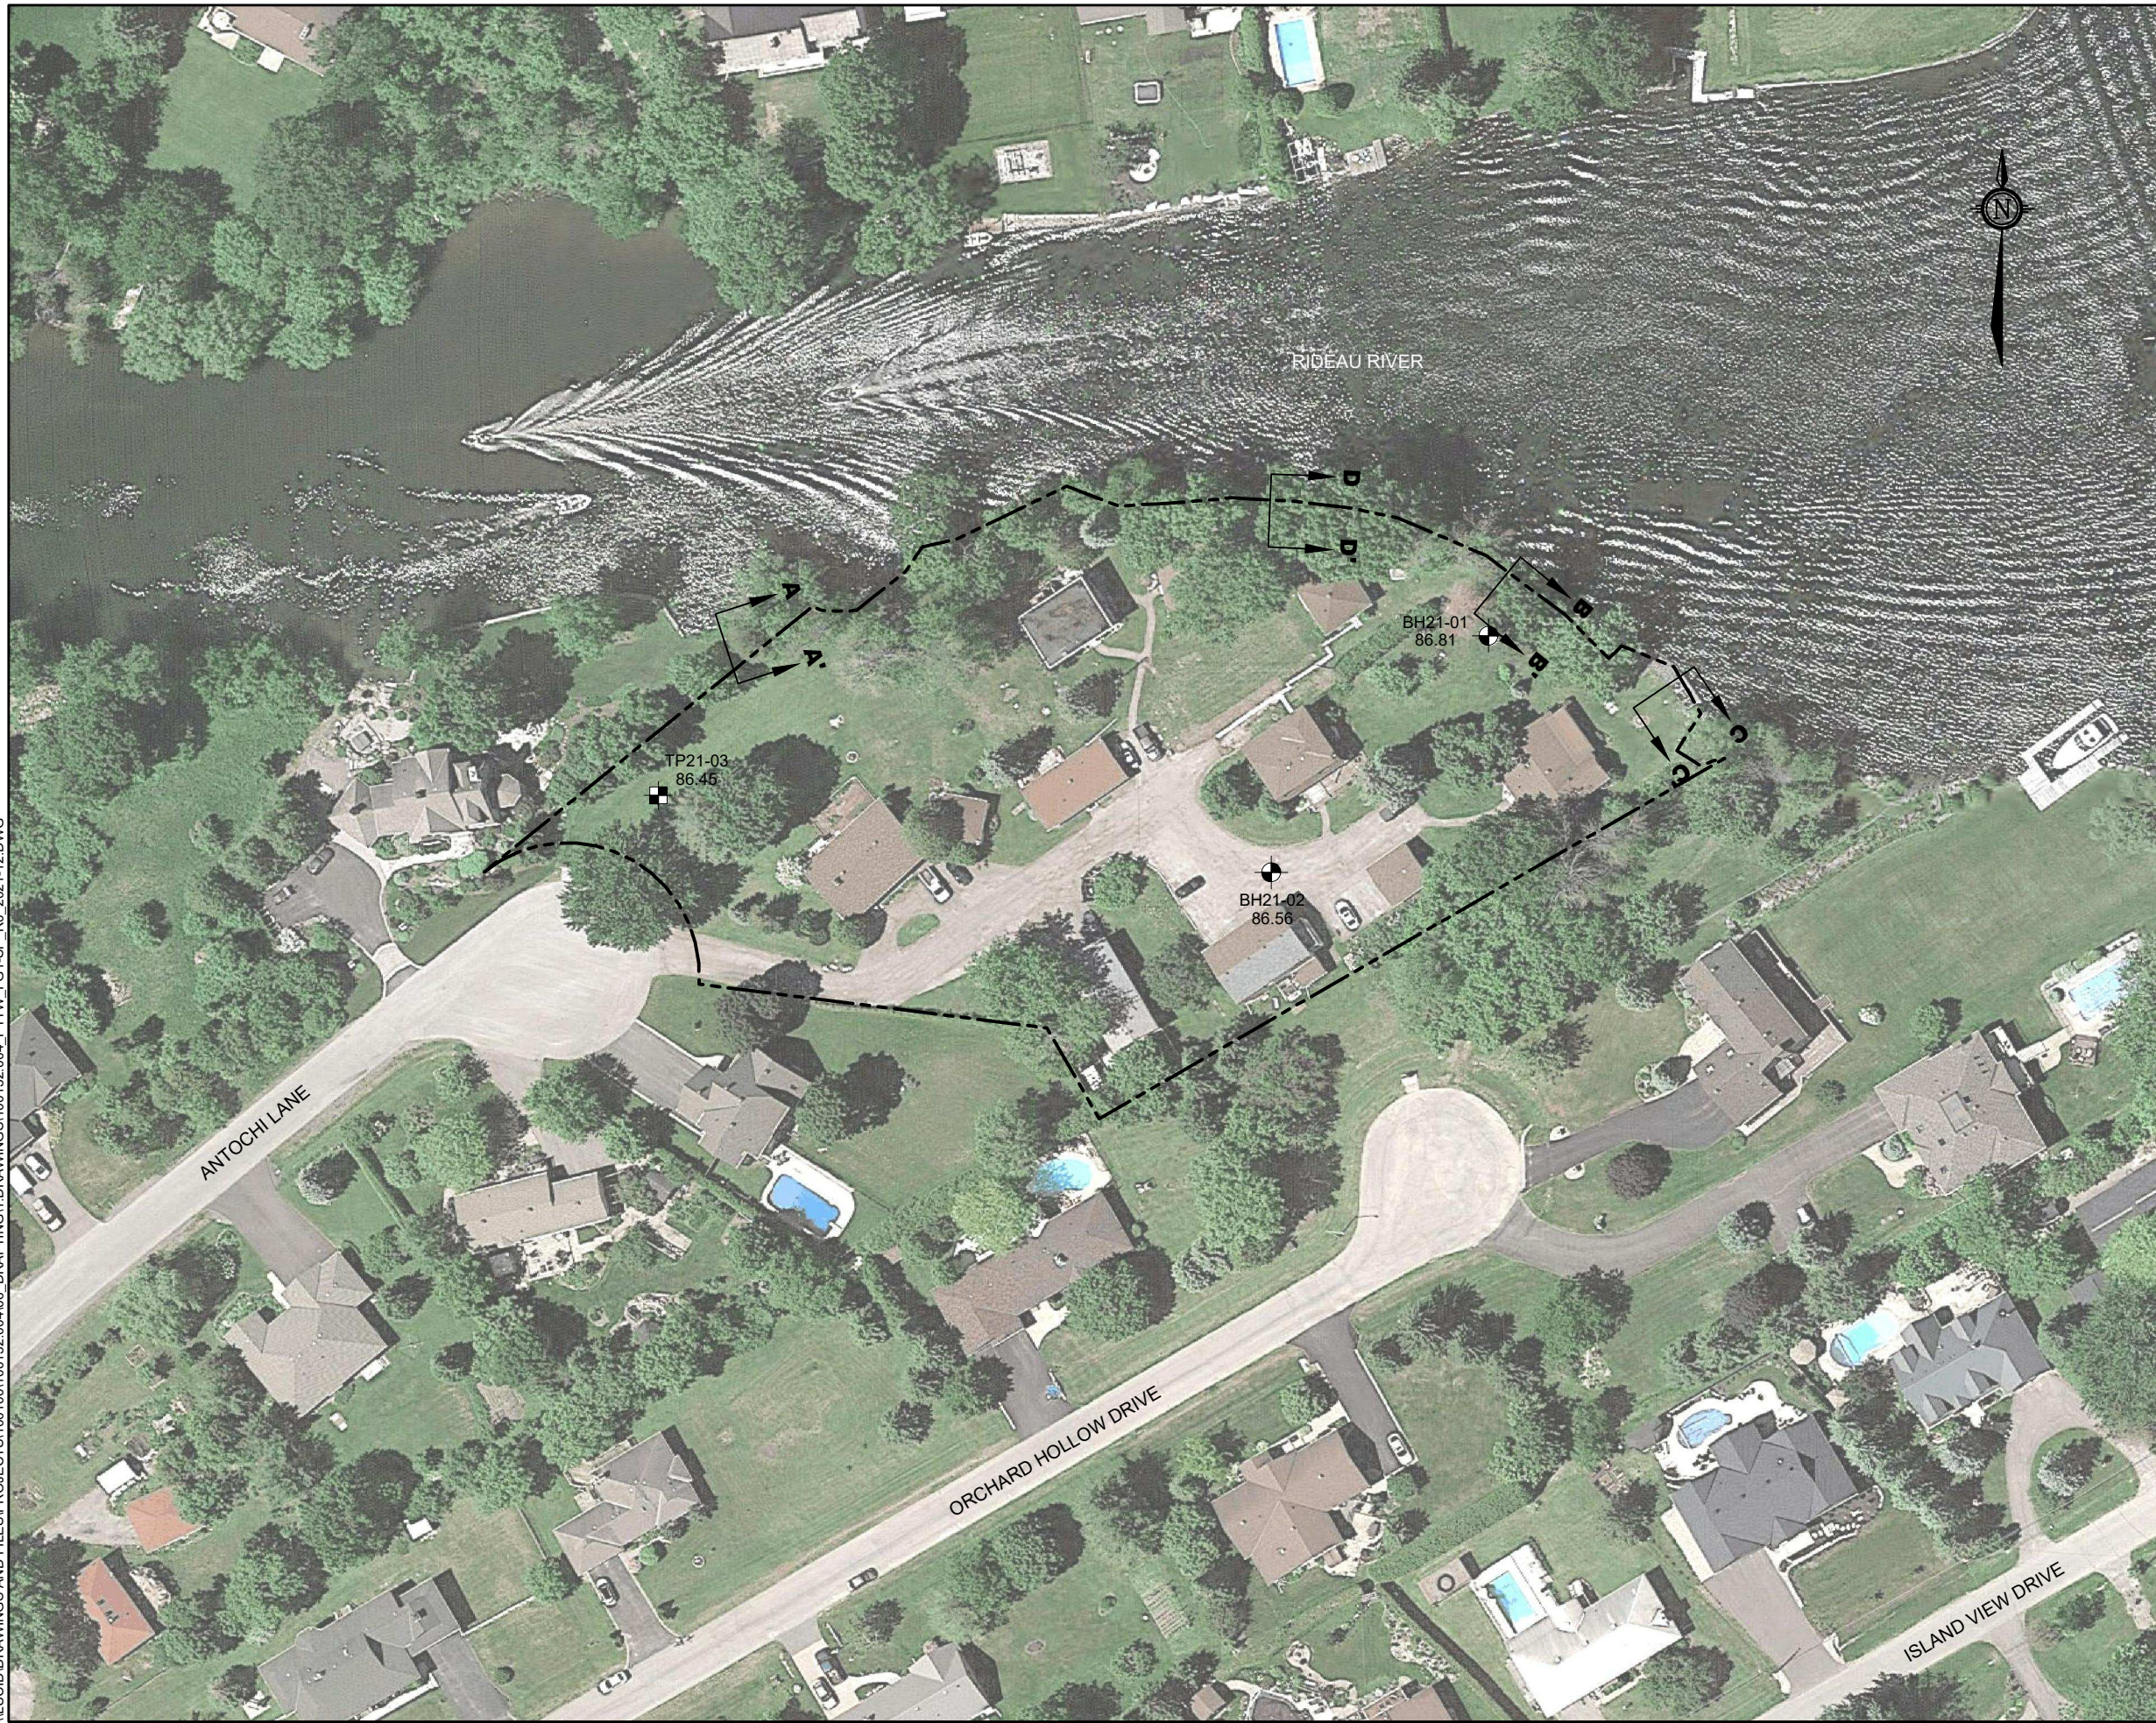
- BH/ TP # — BOREHOLE/ TEST PIT ID
- XX.XX — GROUND SURFACE ELEVATION, IN METRES
GEODETTIC DATUM
- BOREHOLE LOCATION
(current investigation by GEMTEC)
- TEST PIT LOCATION
(current investigation by GEMTEC)
- SLOPE CROSS SECTION LOCATION IN PLAN
(current investigation by GEMTEC)
- APPROXIMATE PROPERTY BOUNDARY

Descriptions of the subsurface conditions logged in the boreholes are provided on the Record of Test Hole Sheets in Appendix A. The results of the laboratory classification testing are provided on the Record of Borehole sheets and in Appendix B. The results of chemical testing completed on one soil sample are provided in Appendix C. The results of the slope stability analysis are provided in Appendix D. The approximate locations of the test holes are shown on the Site Plan, Figure 1.

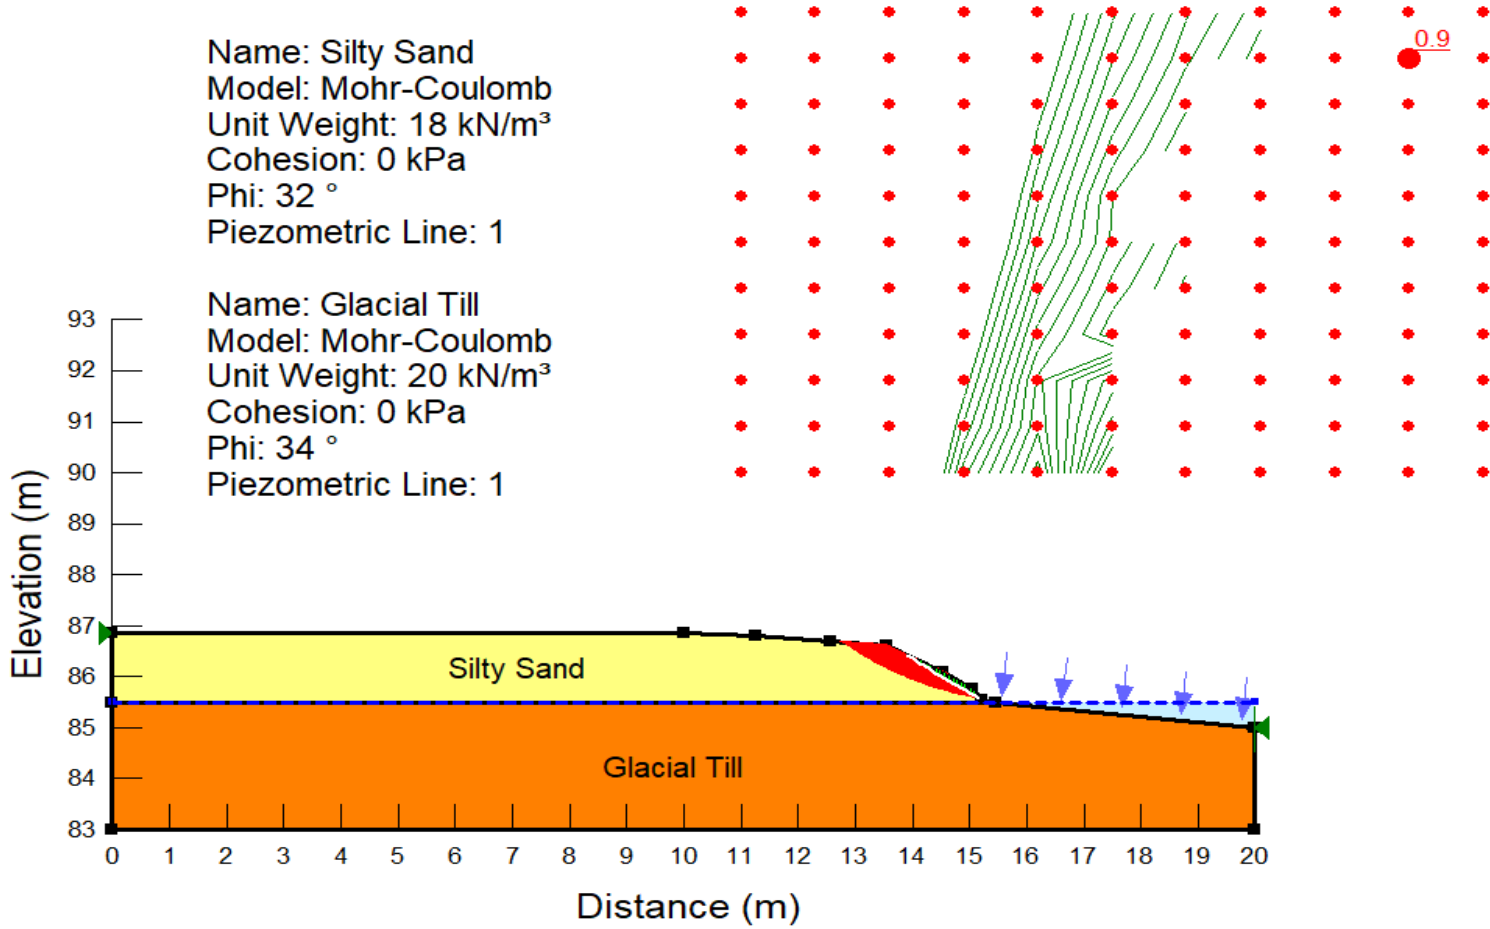
Slope Cross Section B-B
