Phase Two Environmental Site Assessment (ESA)

1495 Heron Road, Ottawa, ON

Canada Lands Company CLC Limited
Draft Report
601699-02

December 2022
02111459.000

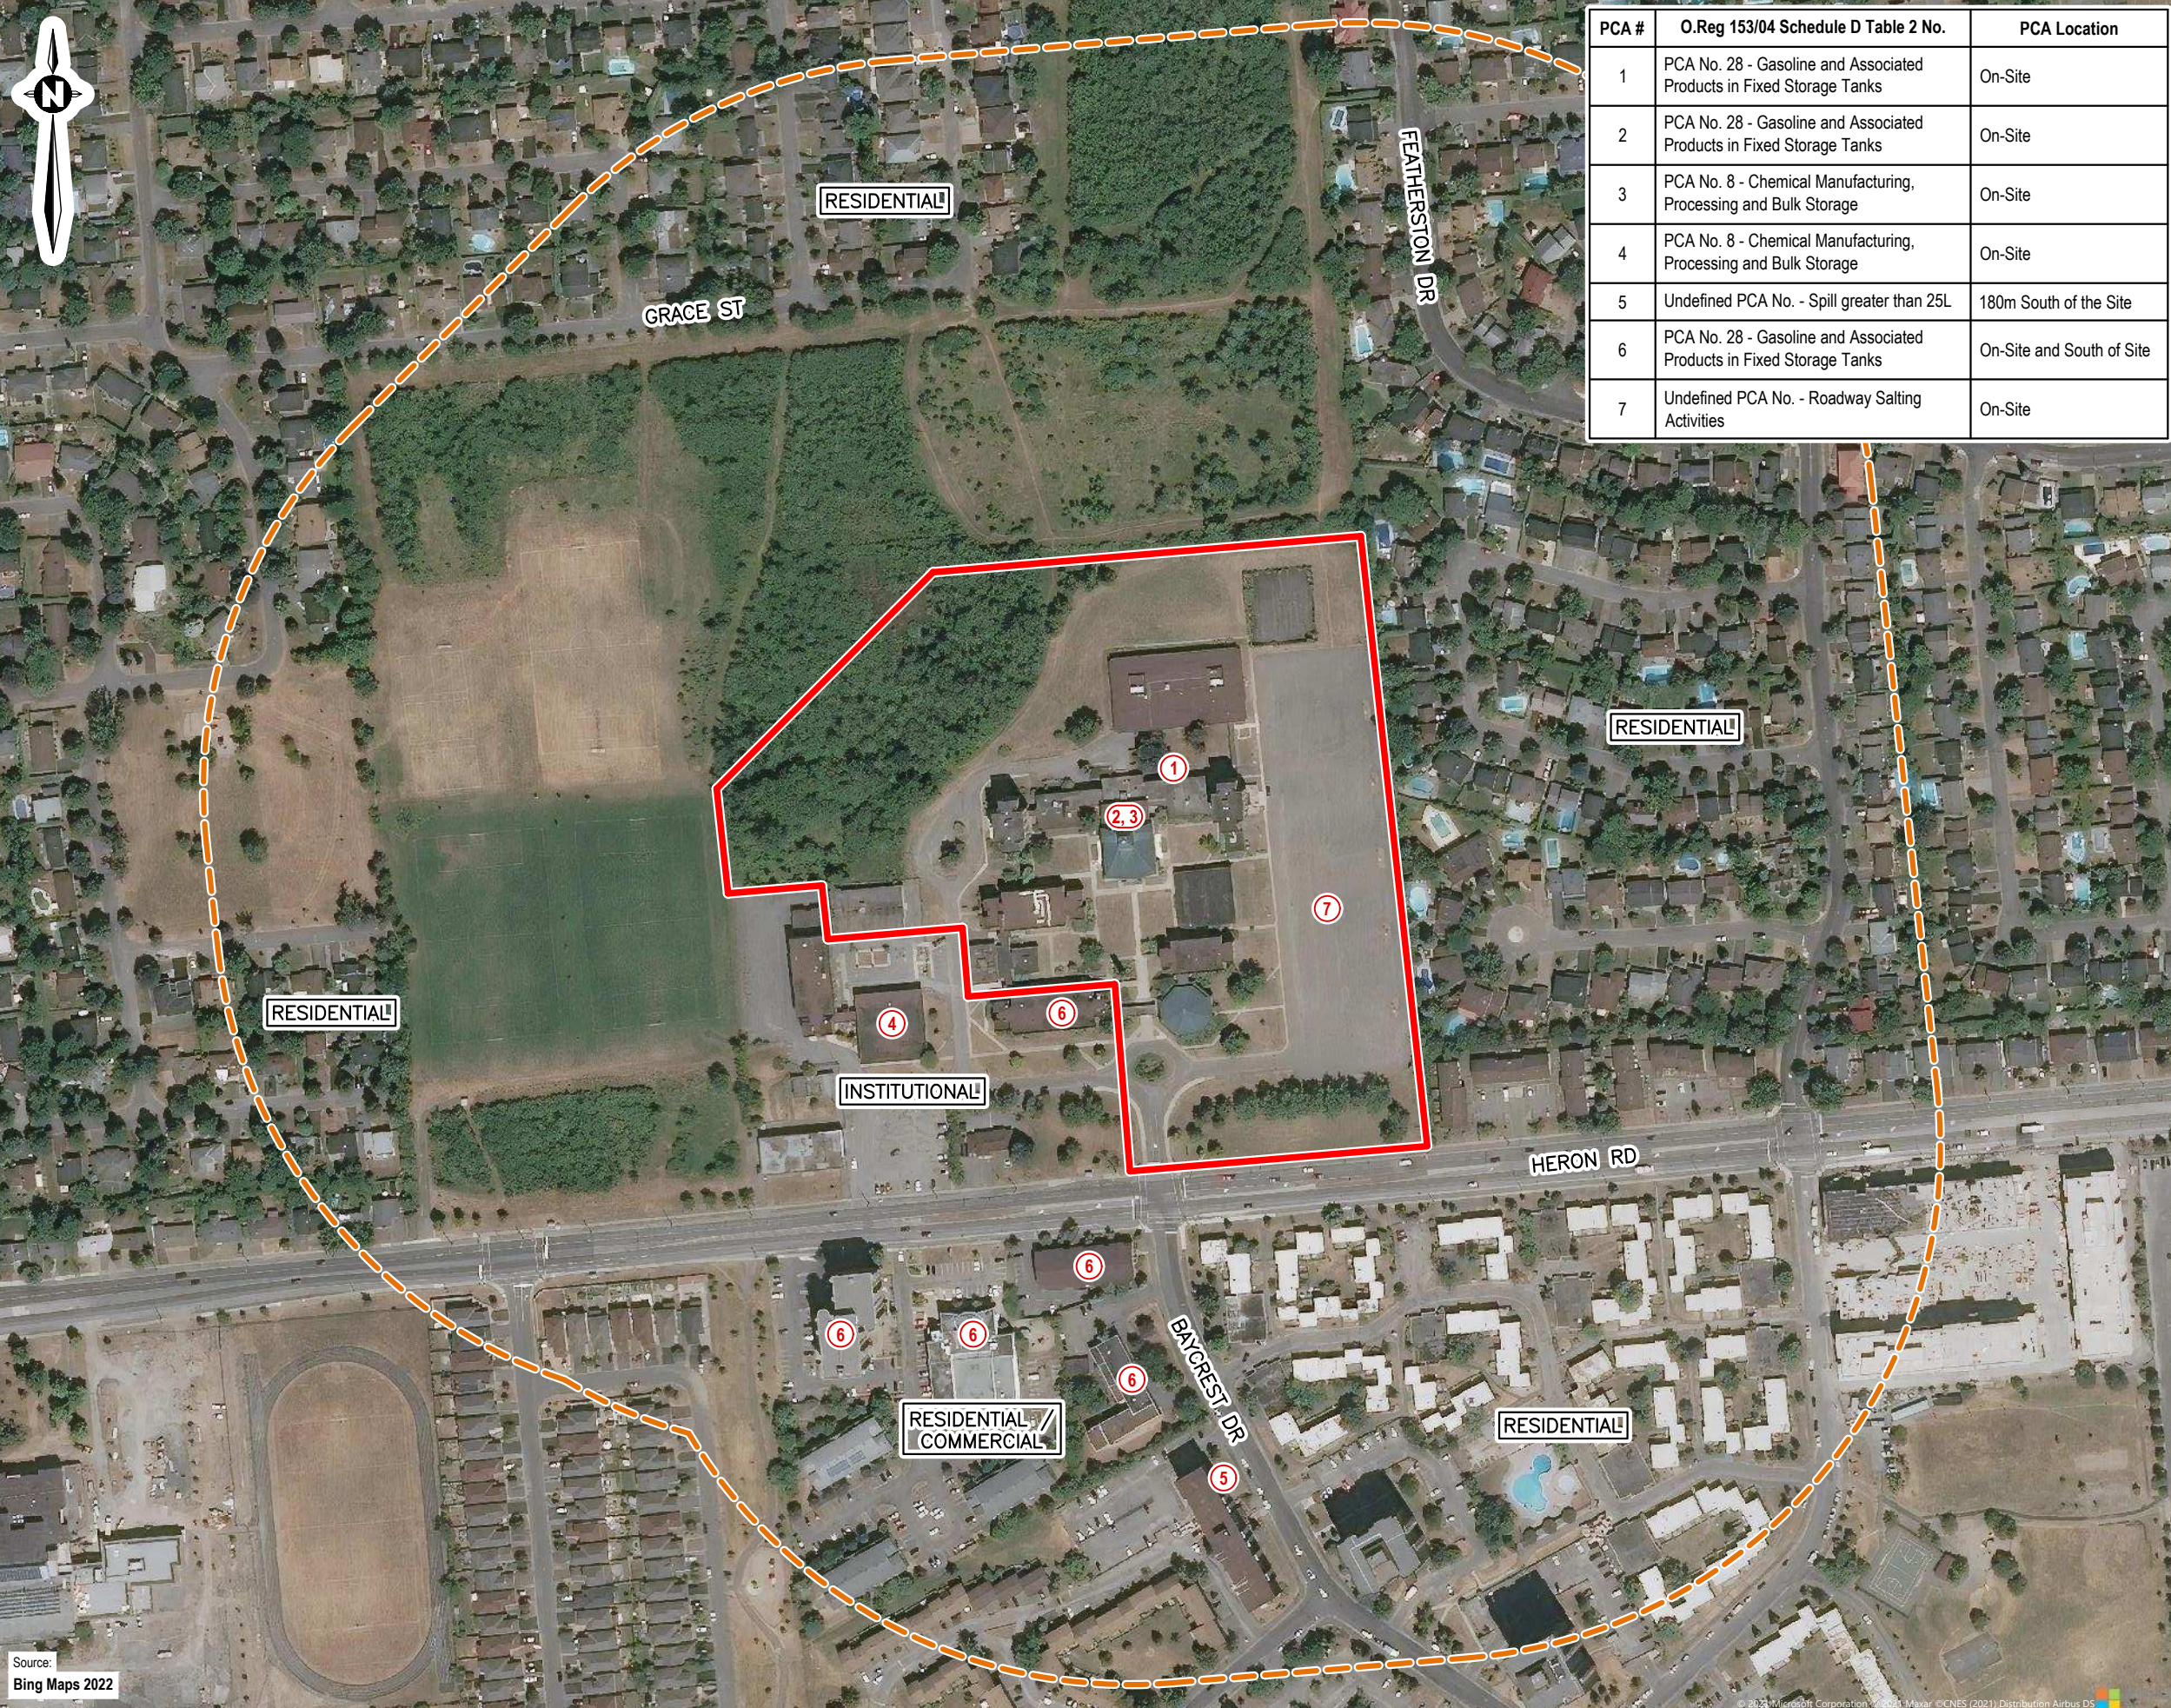
Drawing: 2 PCA.dwg Folder: L:\TSCAD\Projects\Vantage Point\02111459_Heron Rd\2021 Phase I\ESAD\DWGs Monday, November 28, 2022 @ 15:32 by Joven Mendoza

| PCA # | O.Reg 153/04 Schedule D Table 2 No. | PCA Location |
| 1 | PCA No. 28 - Gasoline and Associated Products in Fixed Storage Tanks | On-Site |
