# Phase One Environmental Site Assessment

1495 Heron Road, Ottawa, ON

Canada Lands Company CLC Limited Final Report Reference no. 02111459.000

November 2022

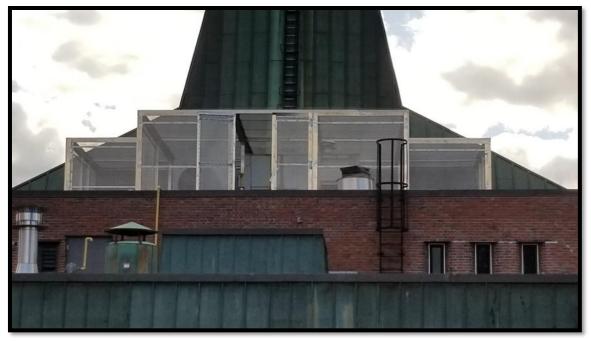
Photograph 4: View of the rear of Building A of the Site, facing south. Rooftop mechanical equipment is present on top of the building.

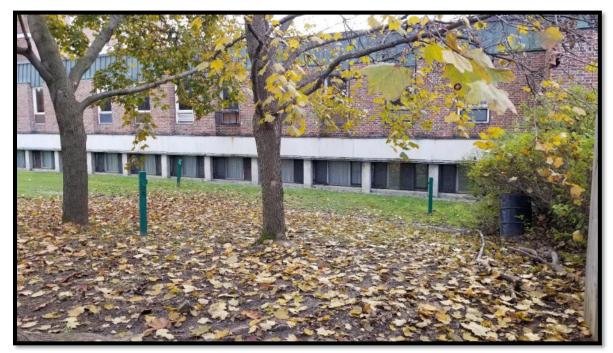
There were three (3) monitoring wells observed on the Site exterior and one (1) monitoring well observed within Building A during the Site reconnaissance. These monitoring wells were installed during the DST Phase Two ESA in 2015 (see Section 3.1.5).

Photograph 5: View of a northern side of Building B. Three (3) monitoring wells, installed by DST in 2015, can be seen (facing south).

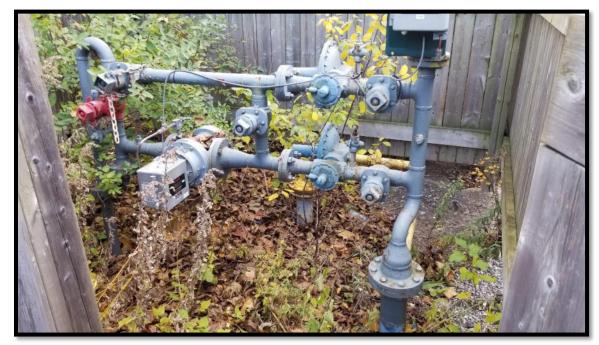
Photograph 7: Natural gas enclosure, observed between Buildings B and M. Site utilities are present underground, throughout the complex.

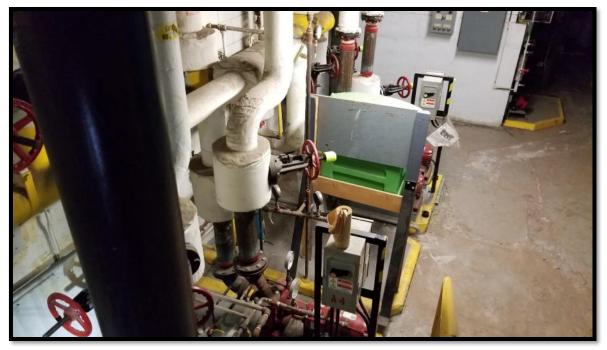
The Site buildings at 1495 Heron Road are heated by boilers and cooled by heating, ventilation and air conditioning (HVAC) units, as well as portable window air conditioners in select locations. Rooftop and ground-level HVAC units were observed.

Photograph 8: View of the mechanical room within Building A.

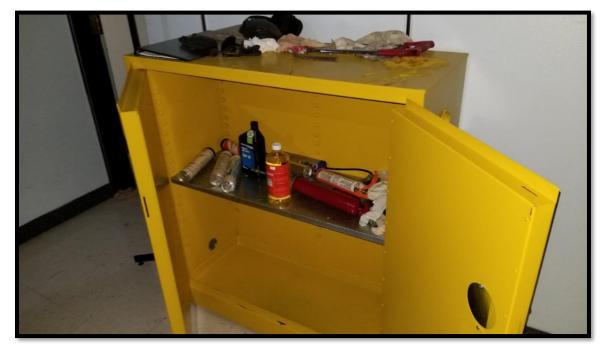
Minor quantities of chemicals were observed on Site during the Site reconnaissance, including commercial cleaning and maintenance chemicals. No evidence of spills or stains were observed in the vicinity of any chemical storage areas.

Photograph 9: View of miscellaneous stored chemicals, observed within the basement of Building A.

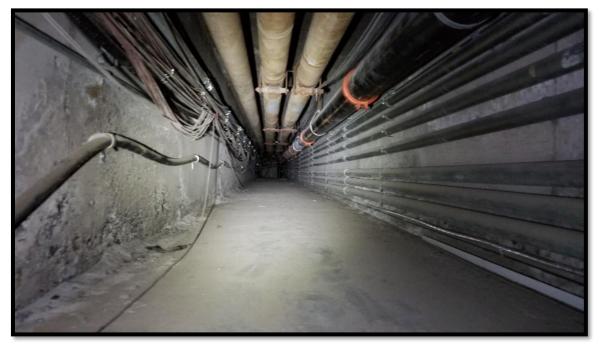
All site buildings except Building M are developed with basements. Below-ground utility tunnels were observed connecting several buildings on Site. Further, a below-ground tunnel connects Buildings A, E, and J for underground travel and utility servicing.

Photograph 10: View of a utility tunnel between two buildings within the complex (July 2019).
