**RE: Karson Holdings Inc.
3711, 3715, 3719 and 3725 Carp Road
Updated Environmental Impact Statement**

I have completed an update to our 2010 Environmental Impact Statement (EIS) for a proposed mixed-use development at 3711, 3715, 3719 and 3725 Carp Road in the southwest portion of the Village of Carp. This EIS is prepared in support of an application for Draft Plan of Subdivision approval for the redevelopment of the site and has been updated to address the August 28th, 2024 City comments.

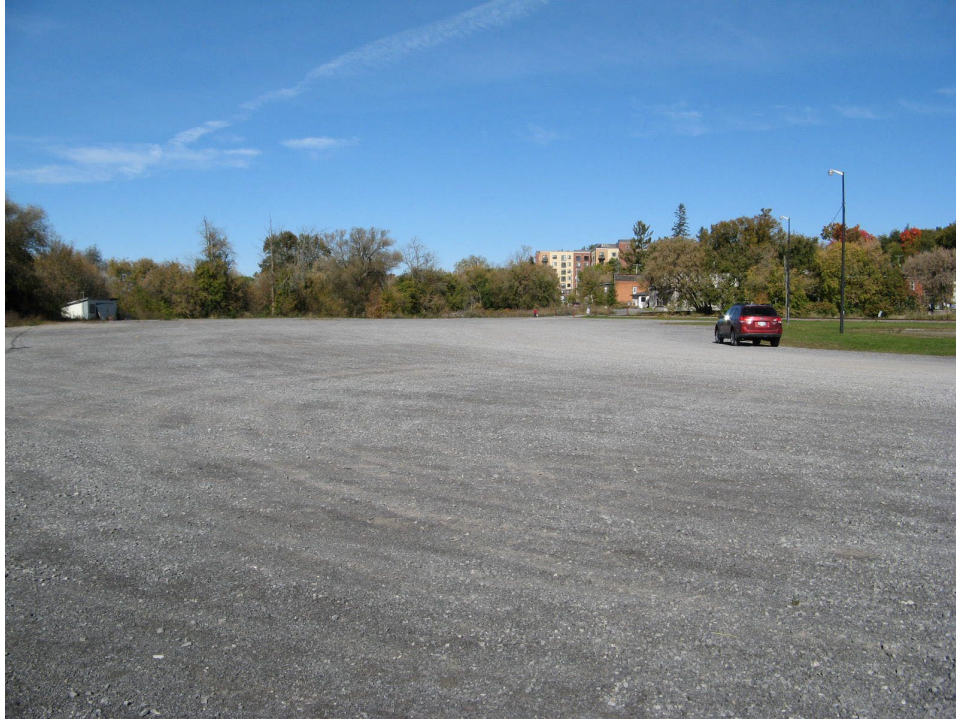
The balance of the site outside of the riparian corridor is highly disturbed with a single layer of pea gravel over a compressed base (Photos 1 and 2). The residences along the west side of Carp Road, other structures save for one shed at edge of riparian corridor, and trees among the former residences have been removed. Some areas have been seeded with grass (Photo 2), with no vegetation on the majority. The only woody vegetation remaining in the central and west portions of the site is a small regenerating coppice green ash, with individual stems less than 5 cm dbh.

Photo 1 – Core of the site looking north from south-central portion

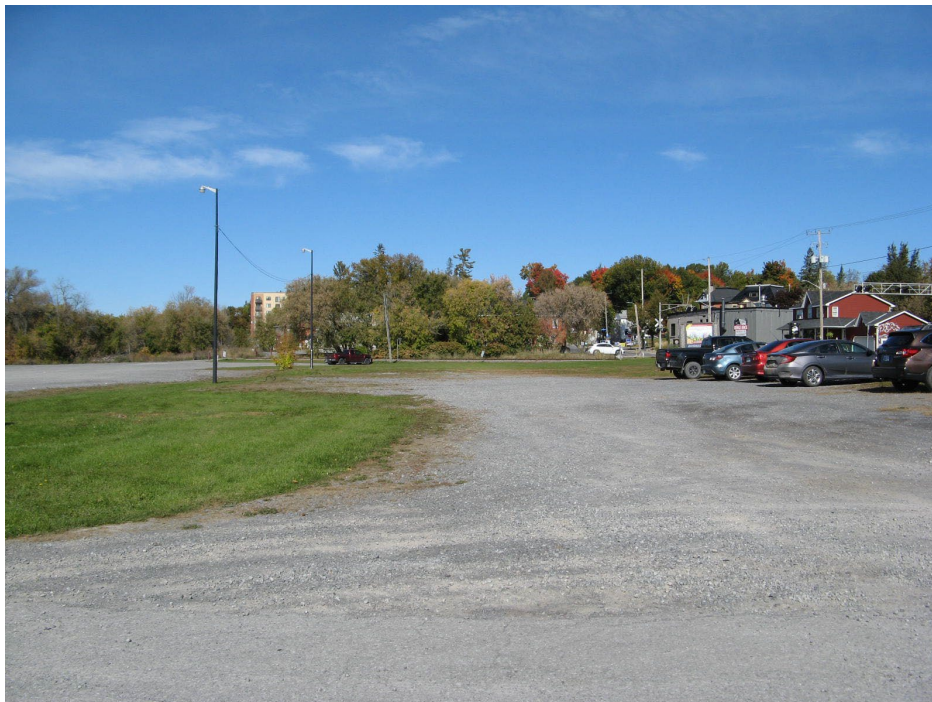
Photo 2 – East portion of the site, adjacent to Carp Road. Some areas have been seeded with others used for parking. View looking north

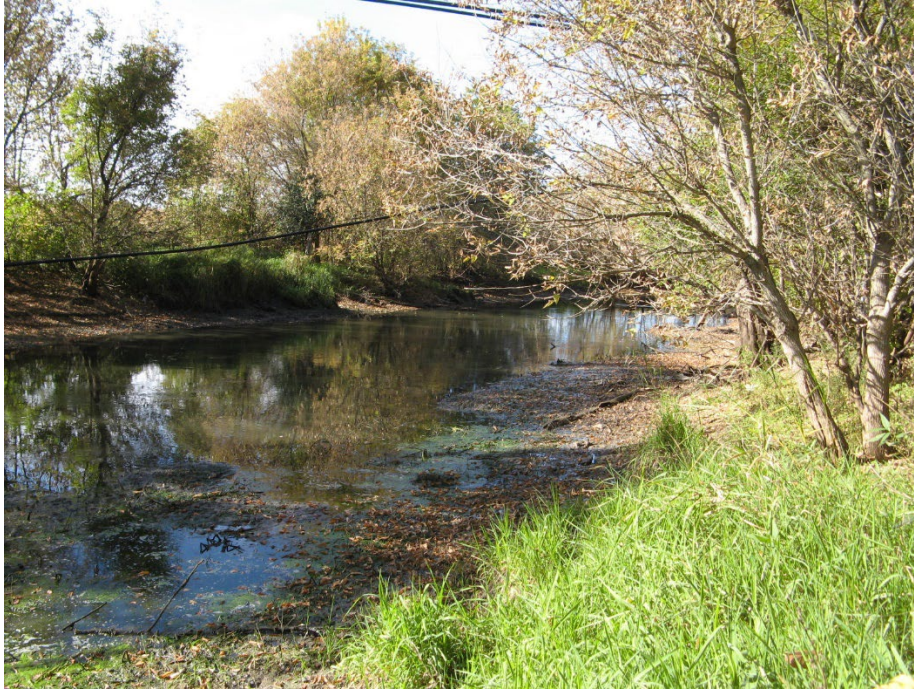
Photo 3 –Carp River adjacent to the southeast portion of the site. View looking northwest

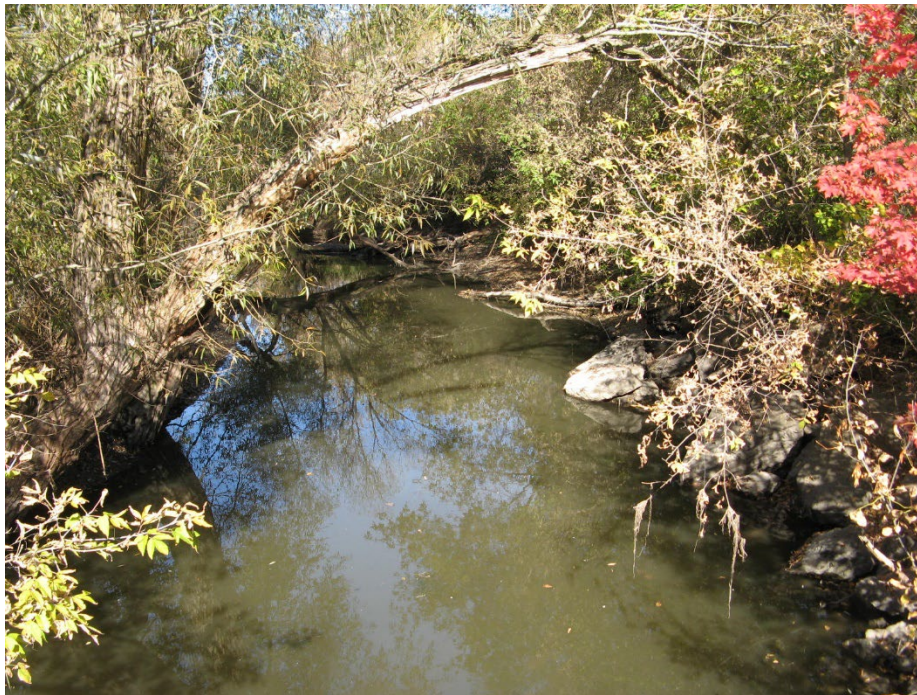
The riparian corridor of the Carp River in the vicinity of the site is generally described by Robinson (2004) as non-vegetated, though as described here there is good canopy cover at the site. The extent of woody vegetation in the portions of the corridor closest to the shoreline, along the north and east sides of the river, has increased since 2010 and the entire corridor where vegetation is present is now referred to as a cultural woodland on Figure 1. To the west of the Carp River, the land use is dominated by agricultural activity, including cultivated fields and hayfields. An access lane/footbridge crosses the Carp River adjacent to the north portion of the site.

Photo 4 – Good cover provided by riparian vegetation on both sides of the Carp River adjacent to the north portion of the site. Note rock protection along east shoreline. View looking north

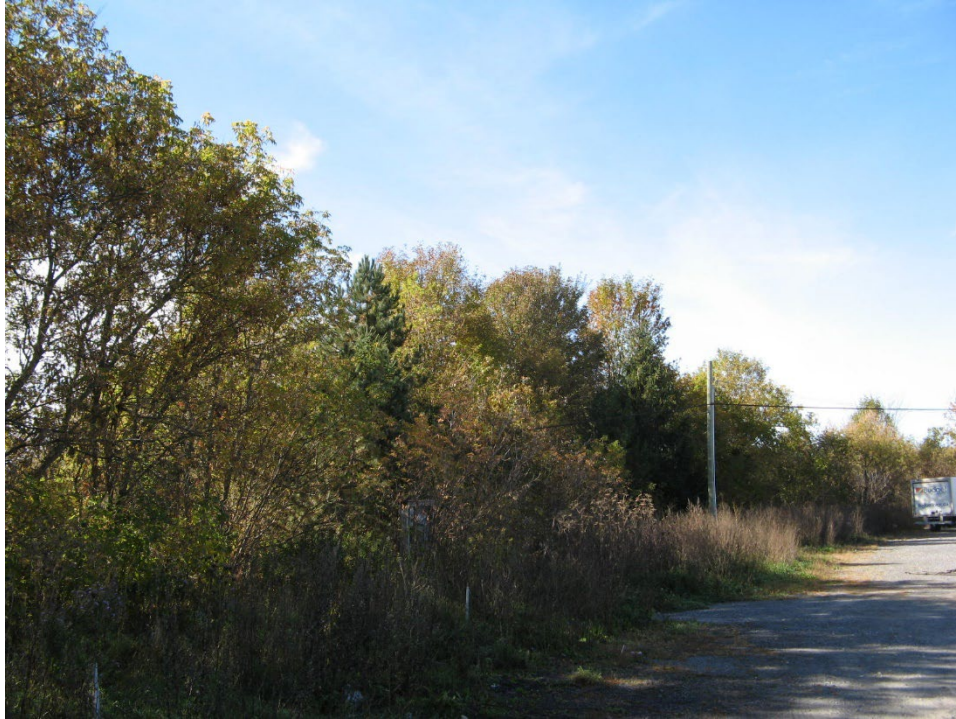
Woody vegetation within the riparian corridor along the periphery of the site includes mature crack willows and a dominance of younger Manitoba maple. The crack willows are coppice (multi-stem), with the larger individuals stems up to 70cm diameter at breast height (dbh) (Photo 6). The Manitoba maples are also generally coppice examples in the range of in the range of 30 - 35cm dbh (Photo 5). Many of the crack willow and Manitoba maple have major broken or dead limbs. Although Manitoba maple is generally not a desired tree species due to its poor form, susceptibility to damage and short life span, the trees along the Carp River shoreline provide important functions in the riparian corridor associated with aquatic and terrestrial cover, bank stability and a food source. White ash, up to 45cm dbh, are along the east side of the Carp River in the north portion of the site, along with Manitoba maple, white elm, red maple, and crack willow. Since 2010 the ash appear impacted by the emerald ash borer and the trees are now dead or have greatly reduced leaf-out (Photo 7). Green ash and white elm up to 30cm dbh are scattered through the vegetated portion of the riparian corridor. Most of these trees are dead or have reduced leaf-out. Conifer representation in the riparian corridor includes a few white spruce and red pine in the south portion of the site, with stems up to 28 and 20cm dbh respectively.

Photo 5 – Manitoba maples along the riparian corridor in the west portion of the site and east of the Carp River. View looking north

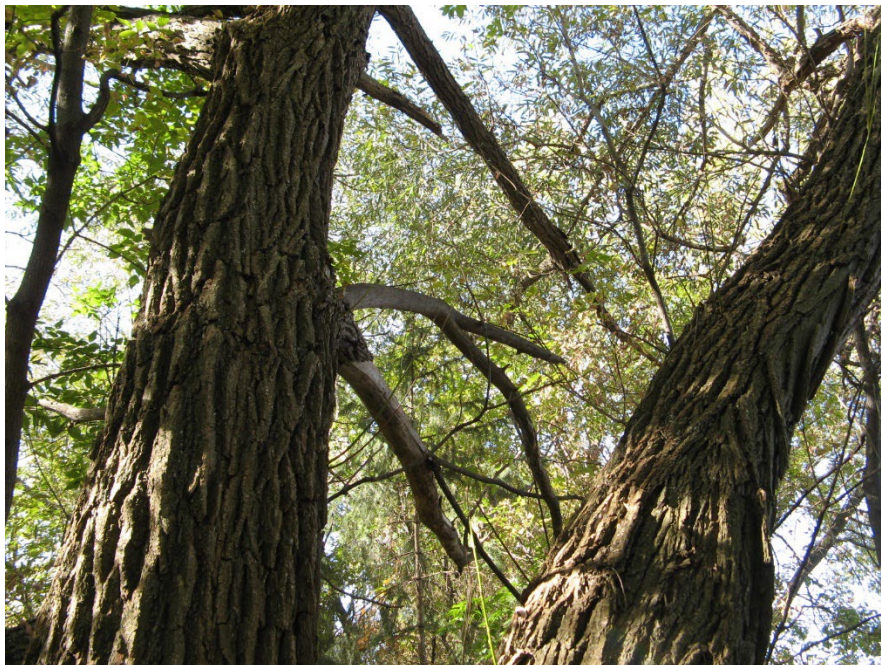
Photo 6 – Mature crack willow in the southeast portion of the site, north of the Carp River and west side Carp Road. View looking southwest

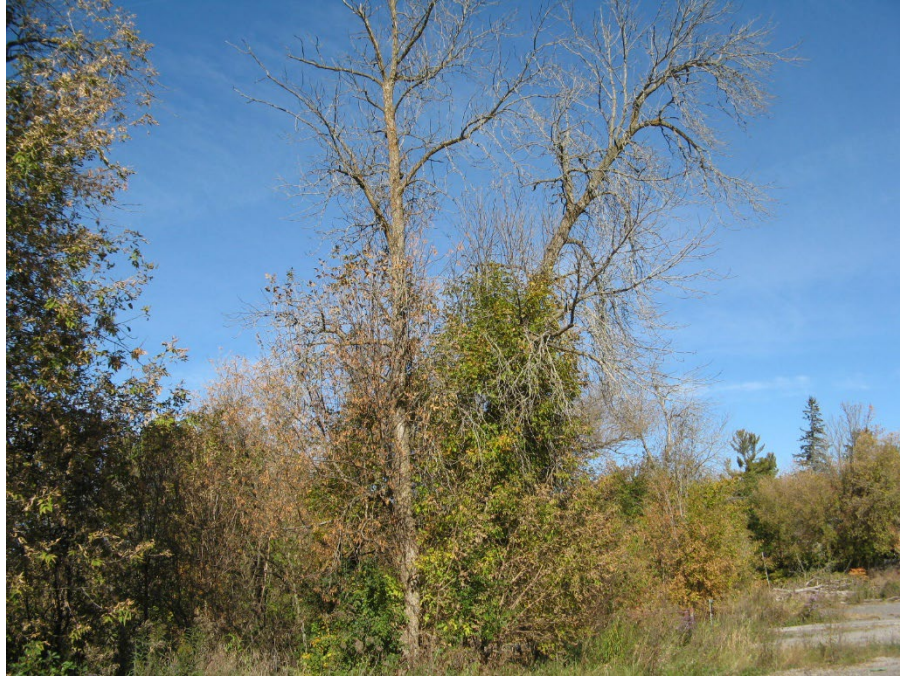
Photo 7 – White ash in very poor condition in the northwest corner of the site, to the east of the Carp River. View looking north.

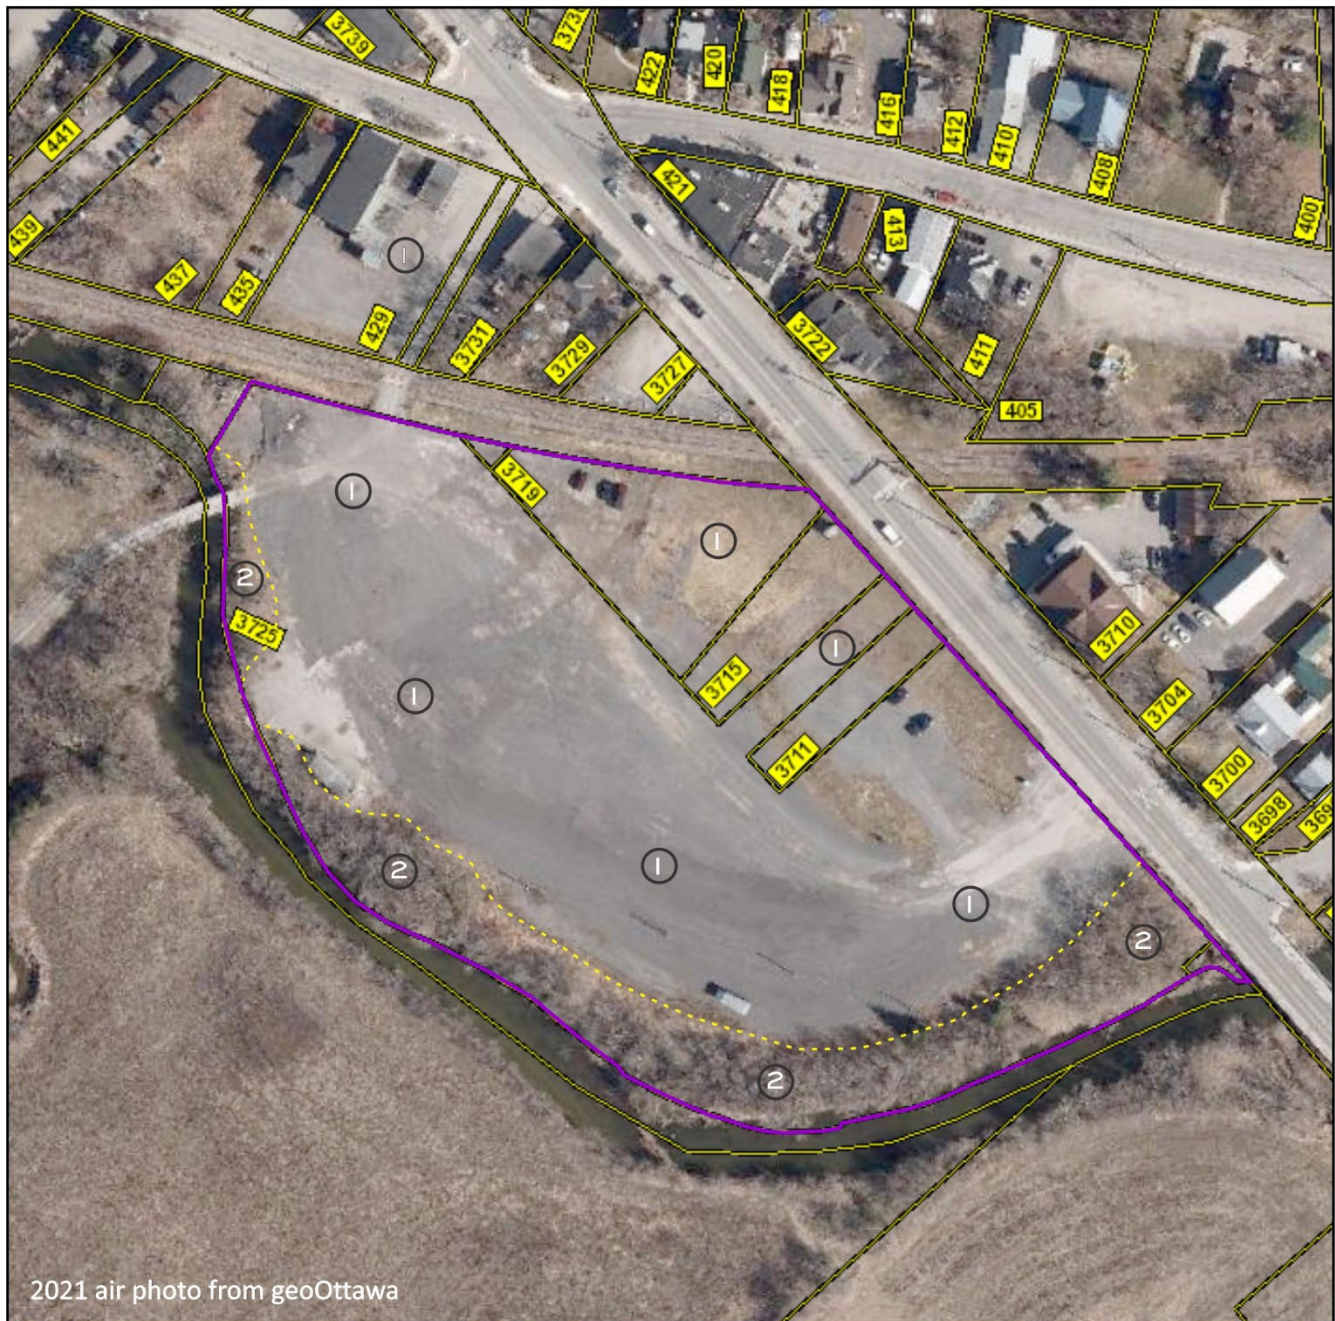
Figure 1

- 1 Cultural meadow/disturbed
- 2 Cultural woodland

NATURAL ENVIRONMENT FEATURES

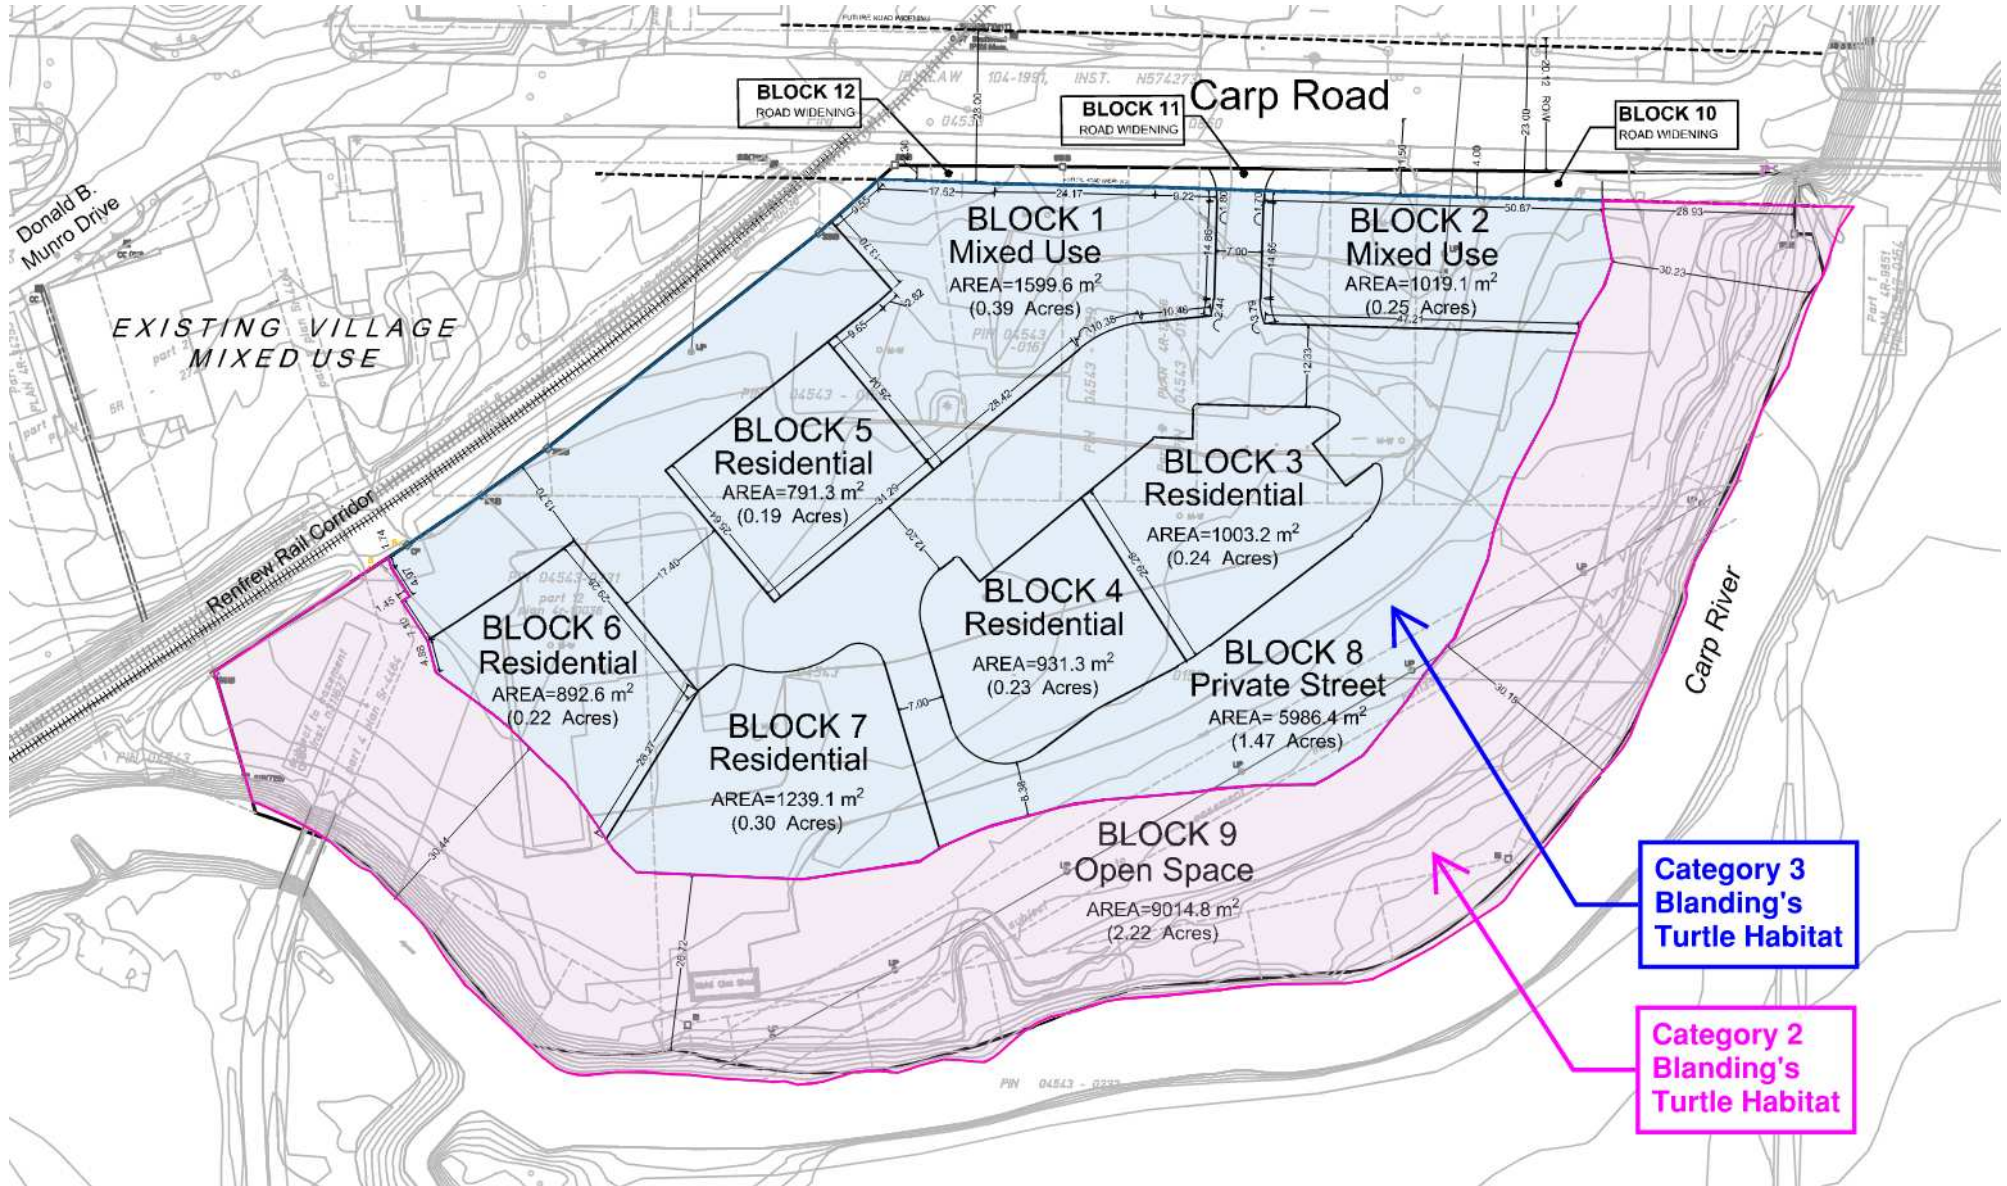
FIGURE 2 – BLANDING’S TURTLE HABITAT

The Category 2 and 3 Blanding's turtle habitat has been mapped for the site on Figure 2. All of the Category 2 habitat (red shading on Figure 2) within and adjacent to the ravine corridor will be retained with pathways of impermeable material within the outer portion of the 30 metre setback. These minor site alterations in the outer portion of the Category 2 habitat will be more than offset by enhancements of currently highly disturbed areas as shown on the Landscape Concept. Portions of the Category 2 habitat that extend beyond the floodplain will be permeable landscape areas and provide better environmental conditions than the current single layer of pea

gravel over a compressed base. The compressed base is very solid and does not represent potential nesting habitat for turtles. Mitigation measures are presented below to protect any turtle utilization of the site, including installation of permanent turtle exclusion fencing. Although the development portion of the site represents Category 3 Blanding's turtle habitat (grey shading on Figure 2) per the General Habitat Description, no suitable wetland habitat for turtles was observed on the site and no adjacent wetland habitat is present to which Blanding's may utilize the site to reach suitable habitat. No suitable turtle nesting habitat was observed on the site. A loss of approximately 1.34 hectares of Category 3 habitat is projected, though the migrating function of Category 3 habitat is not anticipated for the site. Given the retention of Category 2 habitat with some permeable pathways and the improvement over larger areas of Category 2 habitat, the lack of functional Category 3 habitat, and the permanent exclusion fencing and other recommended mitigation measures, this assessment concludes that an Overall Benefit Authorization under the Endangered Species Act would not be required for Blanding's turtle.

8. Permanent turtle exclusion fencing is to be installed along river setback limit, as shown on the Landscape Concept. Where a proposed pathway will be within the 30 metre setback, the fencing will be adjacent to and on the river side of the pathway. The permanent fencing is to be installed after the installation of the temporary silt fencing but before other site alterations occur;

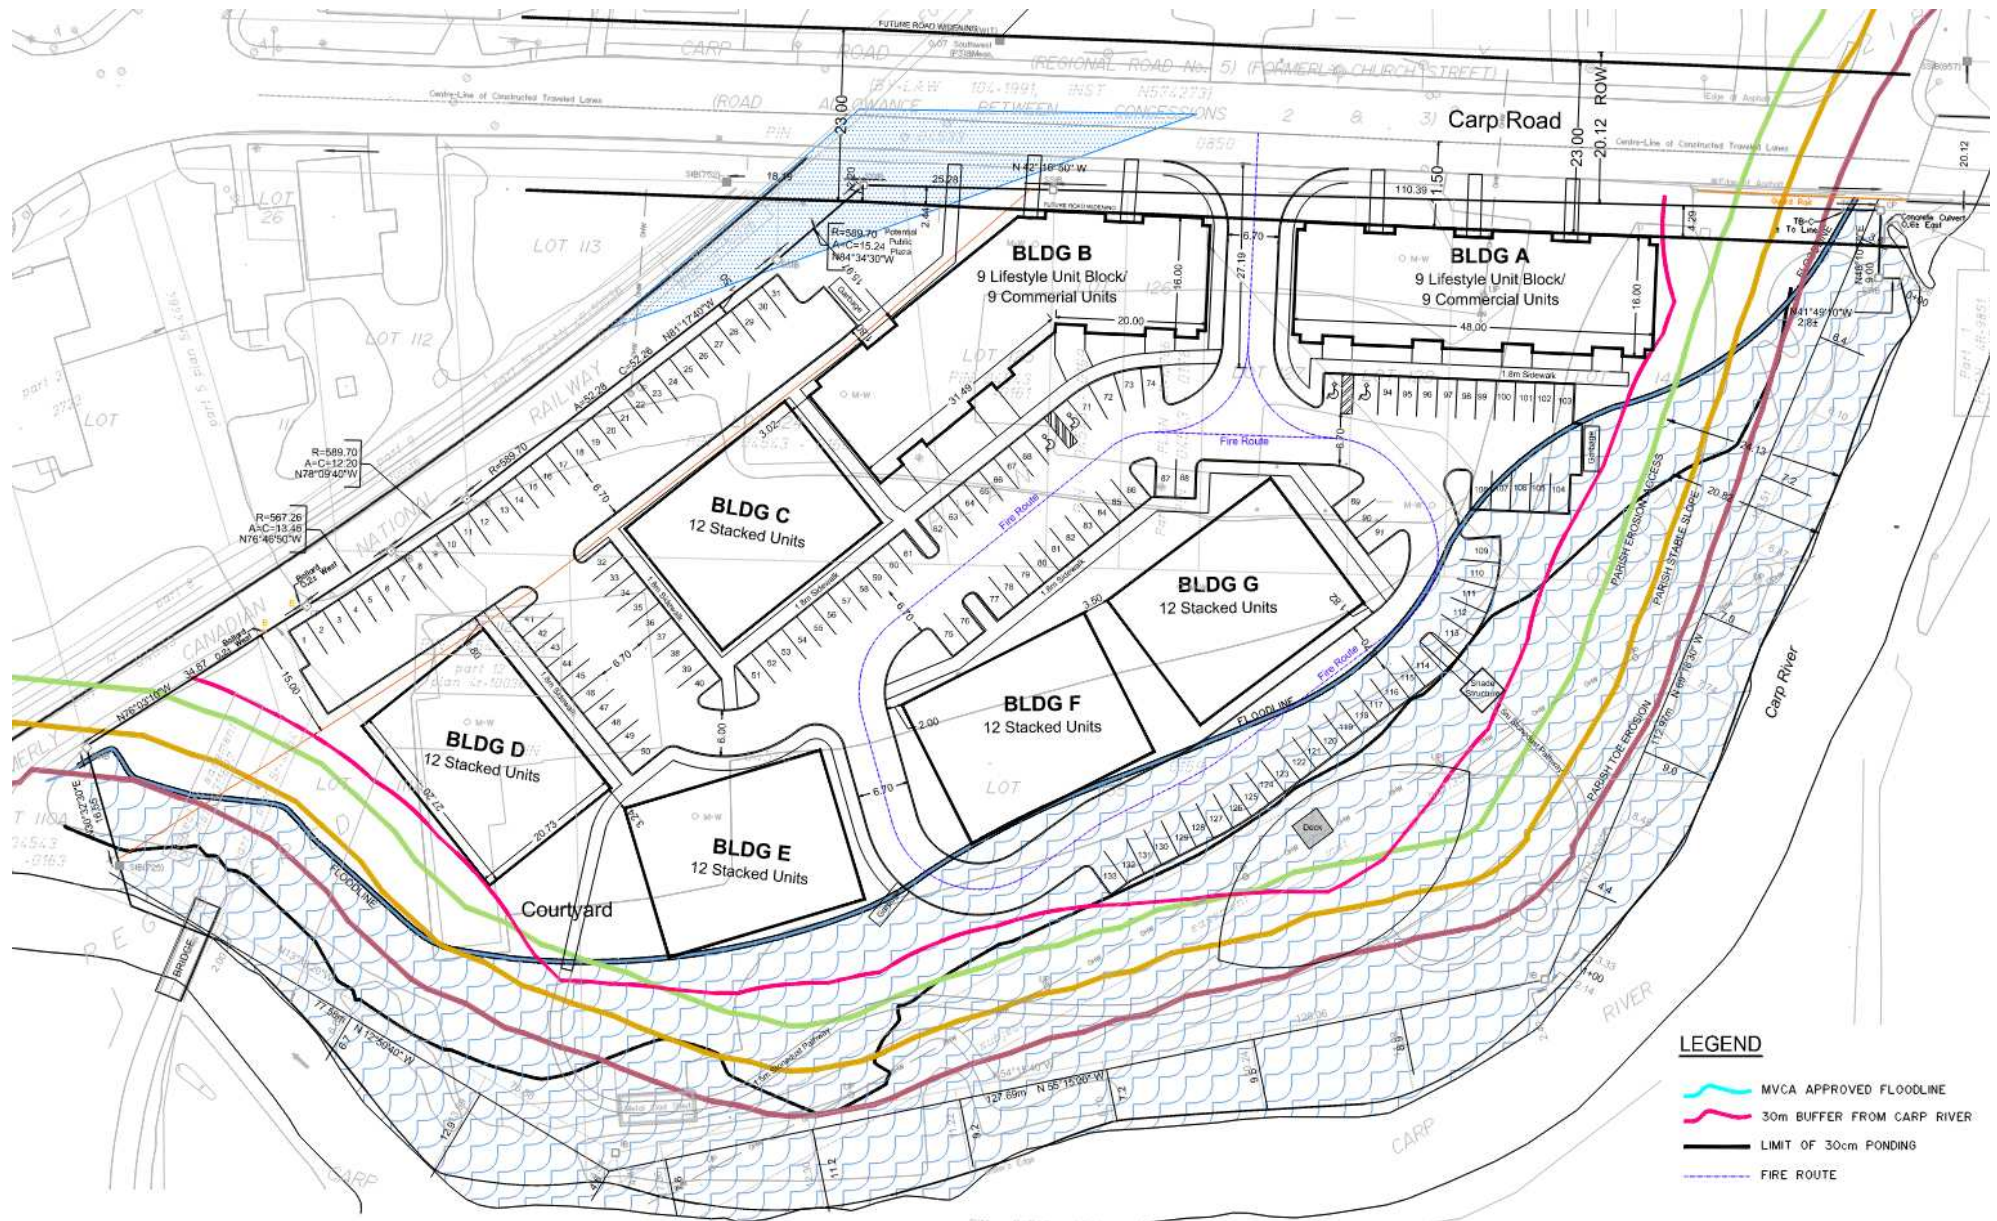
FIGURE 3 – CONCEPT PLAN with CONSTRAINTS (from NOVATECH)

A total of 96 units are proposed for the site, represented by 78 residential units and 18 commercial units (Figure 3). The units will be in seven buildings, with a combination of residential and commercial units in the buildings fronting onto Carp Road. In keeping with the Village of Carp Community Design Plan, the buildings will be built adjacent to and closer to Carp Road and the required parking lot will be constructed between the rear of the buildings and the Carp River. The 146 parking surface parking spaces will be setback from the Carp River as a result the Carp River's meander belt width, erosion hazard limit and the depth of the flood plain. The erosion hazard limit was delineated by PARISH Geomorphic (2009). The toe erosion allowance was calculated as 13.5 metres, measured perpendicular from the bankfull edge of channel. The stable slope allowance and the erosion access allowance are each 6 metres (PARISH Geomorphic, 2009), with the potential to utilize the proposed parking lot for the

The proposed redevelopment shown on Figure 3 is setback from the Carp River through a combination of the Carp River's meander belt width, erosion hazard limit and the depth of the floodplain. The greater of these limits is more than 15 metres from the top of slope and 30 metres from the normal high water mark.
