Date: October 5, 2009

Project: 03-09-02

Subject: Erosion Hazard Limit for Karson Kartage Konstruction Head Office in Carp, ON

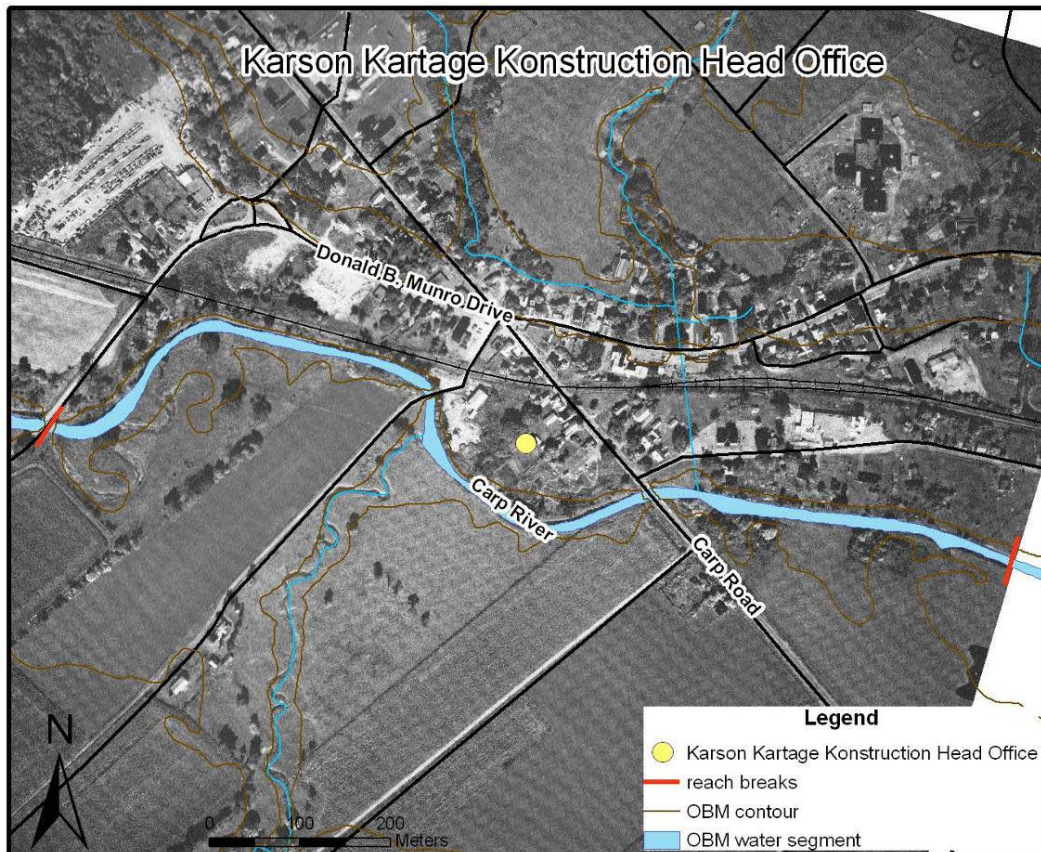
Figure 1: The Carp River and the Town of Carp showing the location of the proposed development and stream reach used for analysis.

Novatech Engineering Consultants Ltd. is preparing a development plan for the existing Karson Kartage Konstruction Head Office site in the Town of Carp (**Figure 1**). A conservative belt width of 20 times the bankfull stream width had previously been delineated and is now limiting the capacity for development on these lands. PARISH Geomorphic Ltd. has been retained to complete an Erosion Hazard Limit study to refine the hazard allowance as defined in *Understanding Natural Hazards* (Ontario Ministry of Natural Resources, 2001) and the *Technical Guide – River & Stream Systems: Erosion Hazard Limit* (Ontario Ministry of Natural Resources, 2002).

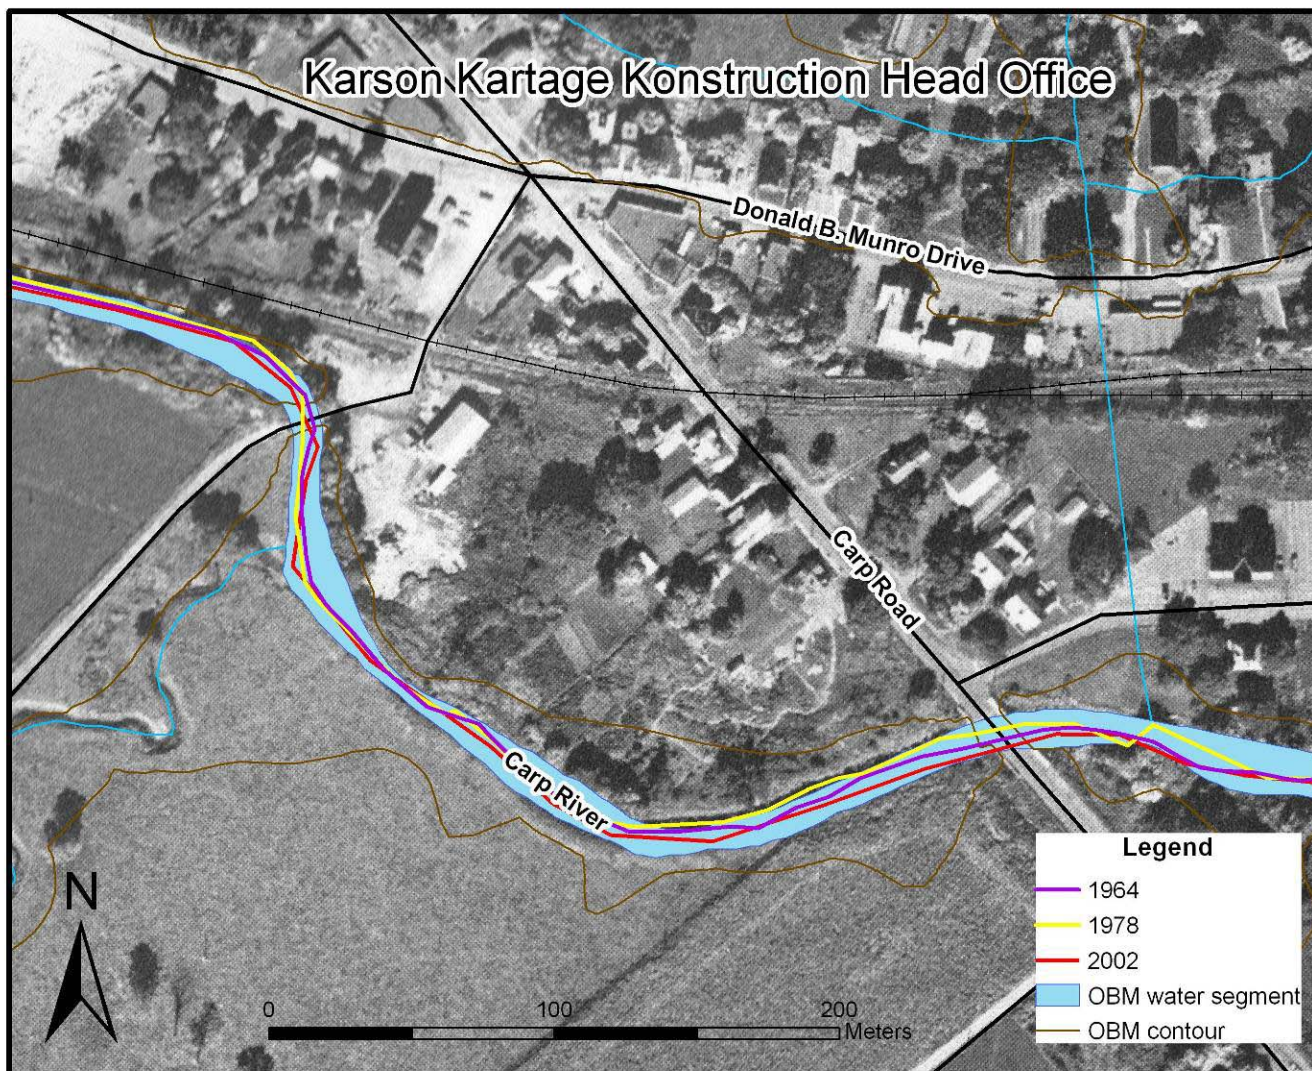
Figure 2: Overview of the Karson Kartage Konstruktion site with the location of the historical channel centrelines, and Ontario Basic Mapping water segments as marked.

To determine the average annual channel migration rate, aerial photographs from 1964, 1978, and 2002 were georectified using GIS software and Ontario Basic Mapping (OBM) control points (building corners, road intersections, etc.). The location of the stream centerlines were traced from the images (see **Figure 2**). The distances between historical channel locations were measured at 18 locations, every 70m along the channel. Yearly channel migration rates were calculated by dividing the average change in channel position by the time period (m/yr). The 100-year migration rate was obtained by multiplying the yearly migration rate by 100 years. The results of these calculations are summarized in **Table 1**.

1964 to 1978	1978 to 2002	1964 to 2002
Average channel migration (m)	2.1	3.2	3.0
Average migration/year (m)	0.15	0.14	0.08
100-year migration (m)	14.7	13.5	8.0

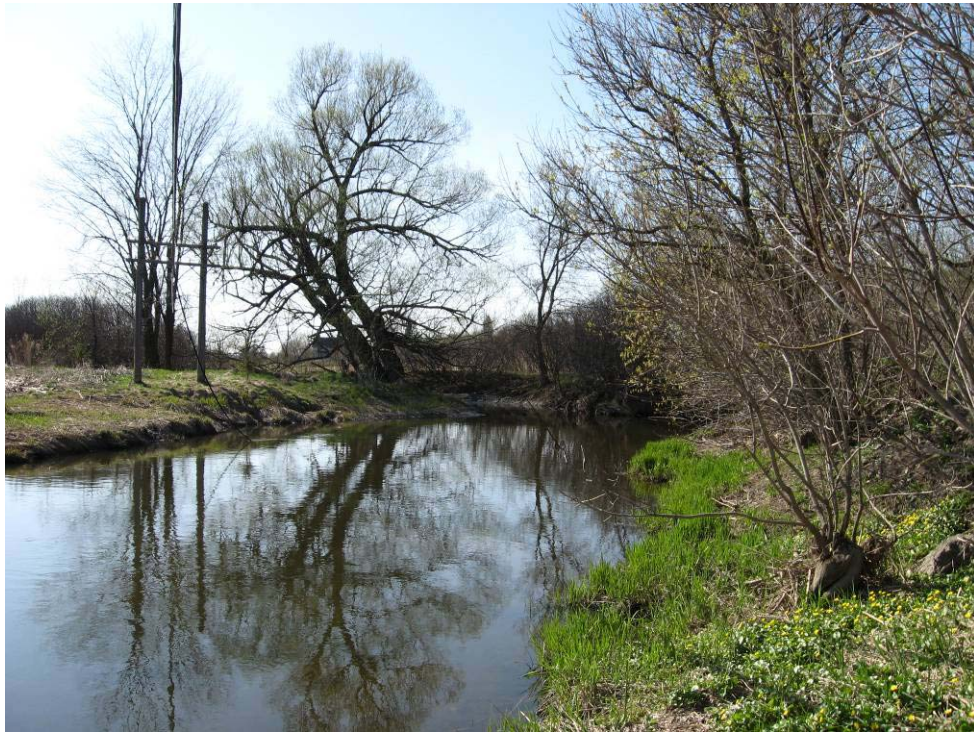
Figure 3: Looking downstream, partially confined conditions on right bank

The Carp River is partially confined by an approximately 2m-high valley wall along the Karson property and is unconfined to the south. As such, the erosion hazard limit for confined systems is applied to the Karson property.

Field reconnaissance was completed by Parish Geomorphic on April 29, 2009 to assess site conditions. The Carp River was walked the length of the Karson Kartage Konstruction property. The water level at the time of the visit was 0.75 to 1.25m below the bankfull level. Photographs of the site are shown in **Figures 3 and 4**.

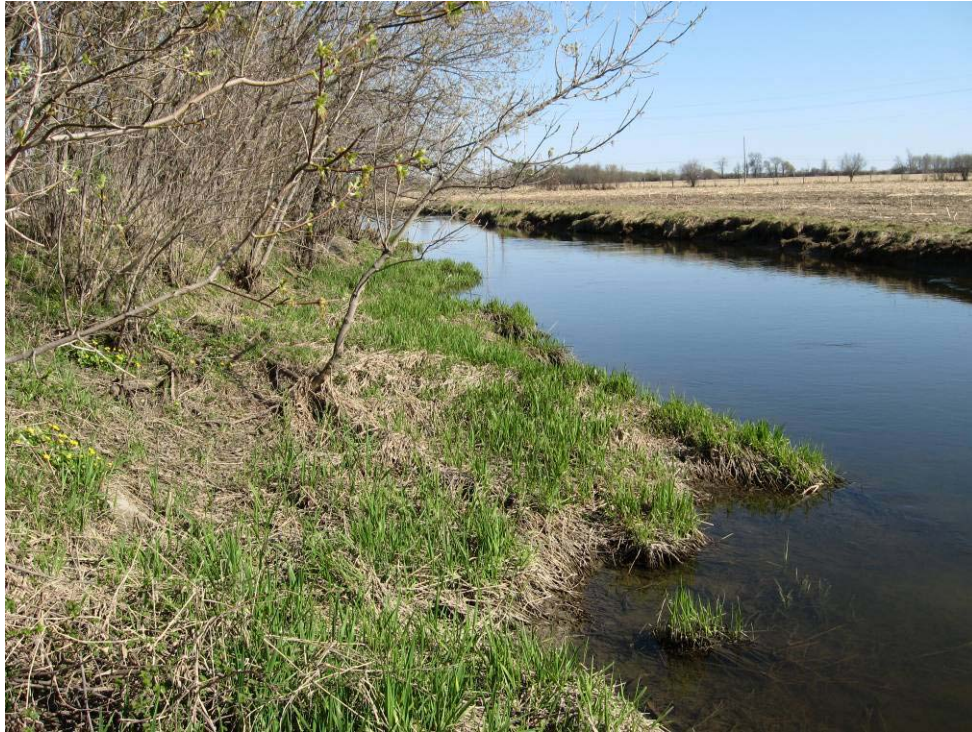
Figure 4: Looking upstream, unconfined floodplain on left bank

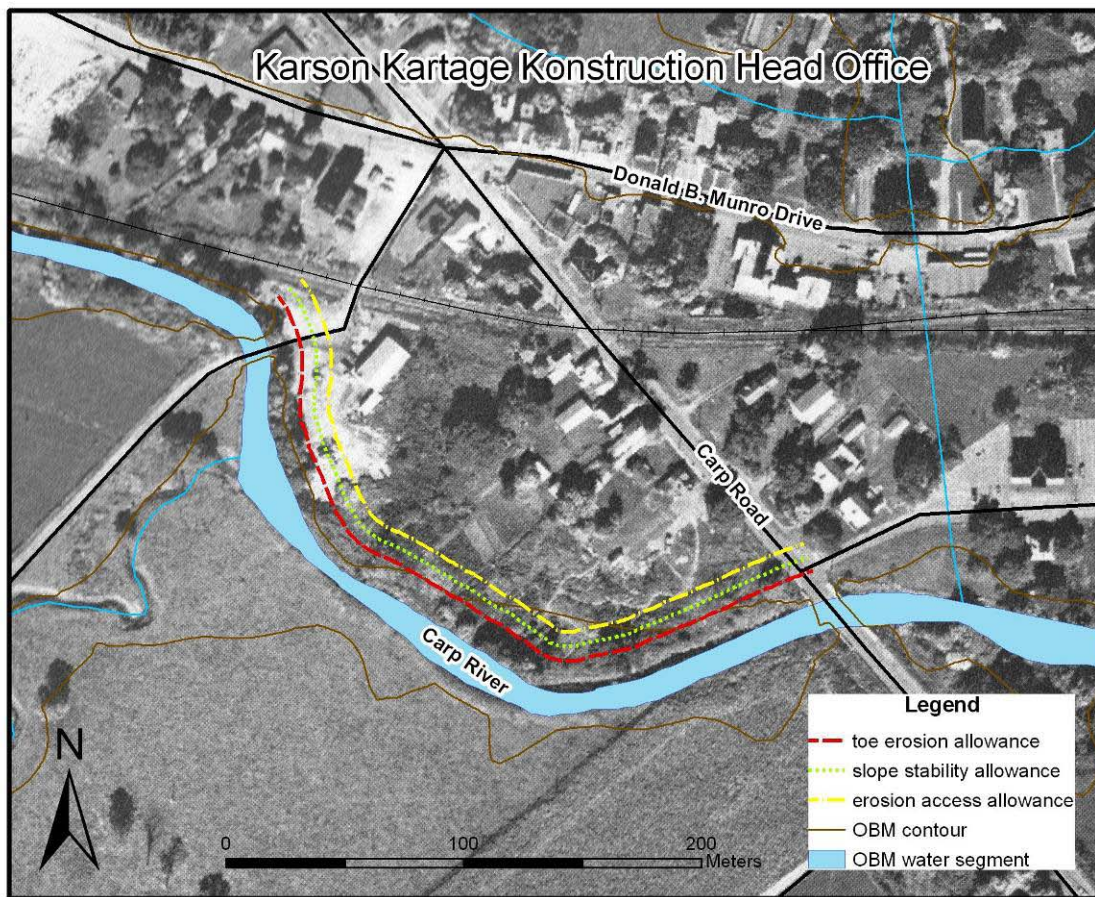
Figure 5: Karson property with the erosion hazard limit as marked (toe erosion allowance + slope stability allowance + erosion access allowance).

It is recommended that the erosion hazard limit for a confined system be applied to the Karson Kartage Konstruction property as per the analysis in this memorandum. This replaces the 20-times-bankfull-width meander belt allowance that was previously defined. All structures should be located above the 100-year flood line. All other services should be located the toe erosion allowance (13.5m) plus the stable slope allowance (suggested 3:1 slope) from the bankfull water edge. Consultation with the MVCA may allow for the erosion access allowance to be included within the parking lot area. The toe erosion allowance (13.5m), stable slope allowance (6m), and erosion access allowance (6m) are delineated in **Figure 5**. In this figure, the three lines are offset from the Ontario Basic Mapping (2007) stream layer for the Carp River. It should be noted that the OBM stream layer overlaps with the property line in some locations, and that this line could be refined from a more accurate bankfull edge of water field survey.
