Geotechnical Investigation

Proposed Mixed Use Development

3725 Carp Road - Ottawa, Ontario

Report PG2103-1 dated April 11, 2023

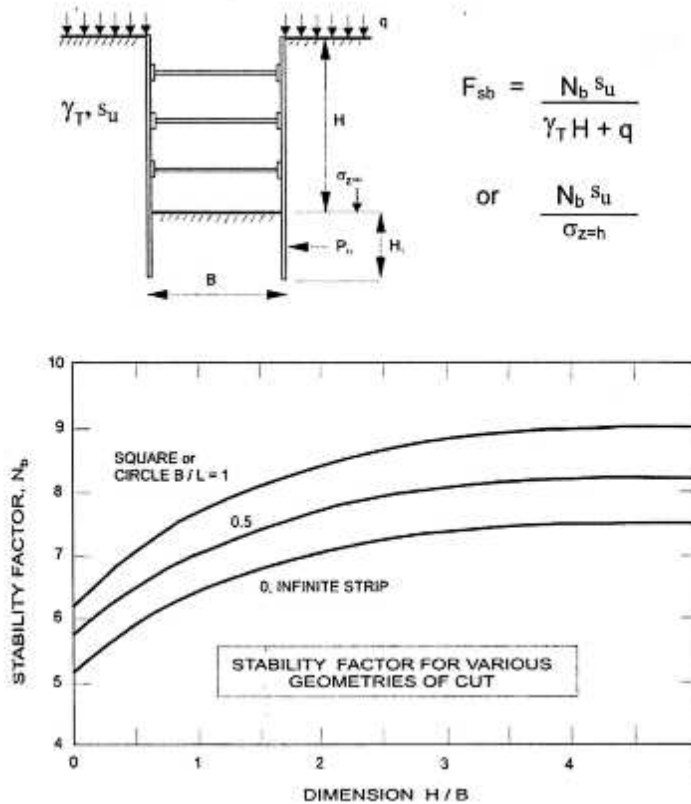
Figure 1 - Stability Factor for Various Geometries of Cut

s_u - undrained shear strength of the soil below the base level

σ_z - total overburden and surcharge pressures at the bottom of the excavation

In the case of soft to firm clays, a factor of safety of 2 is recommended for base stability.

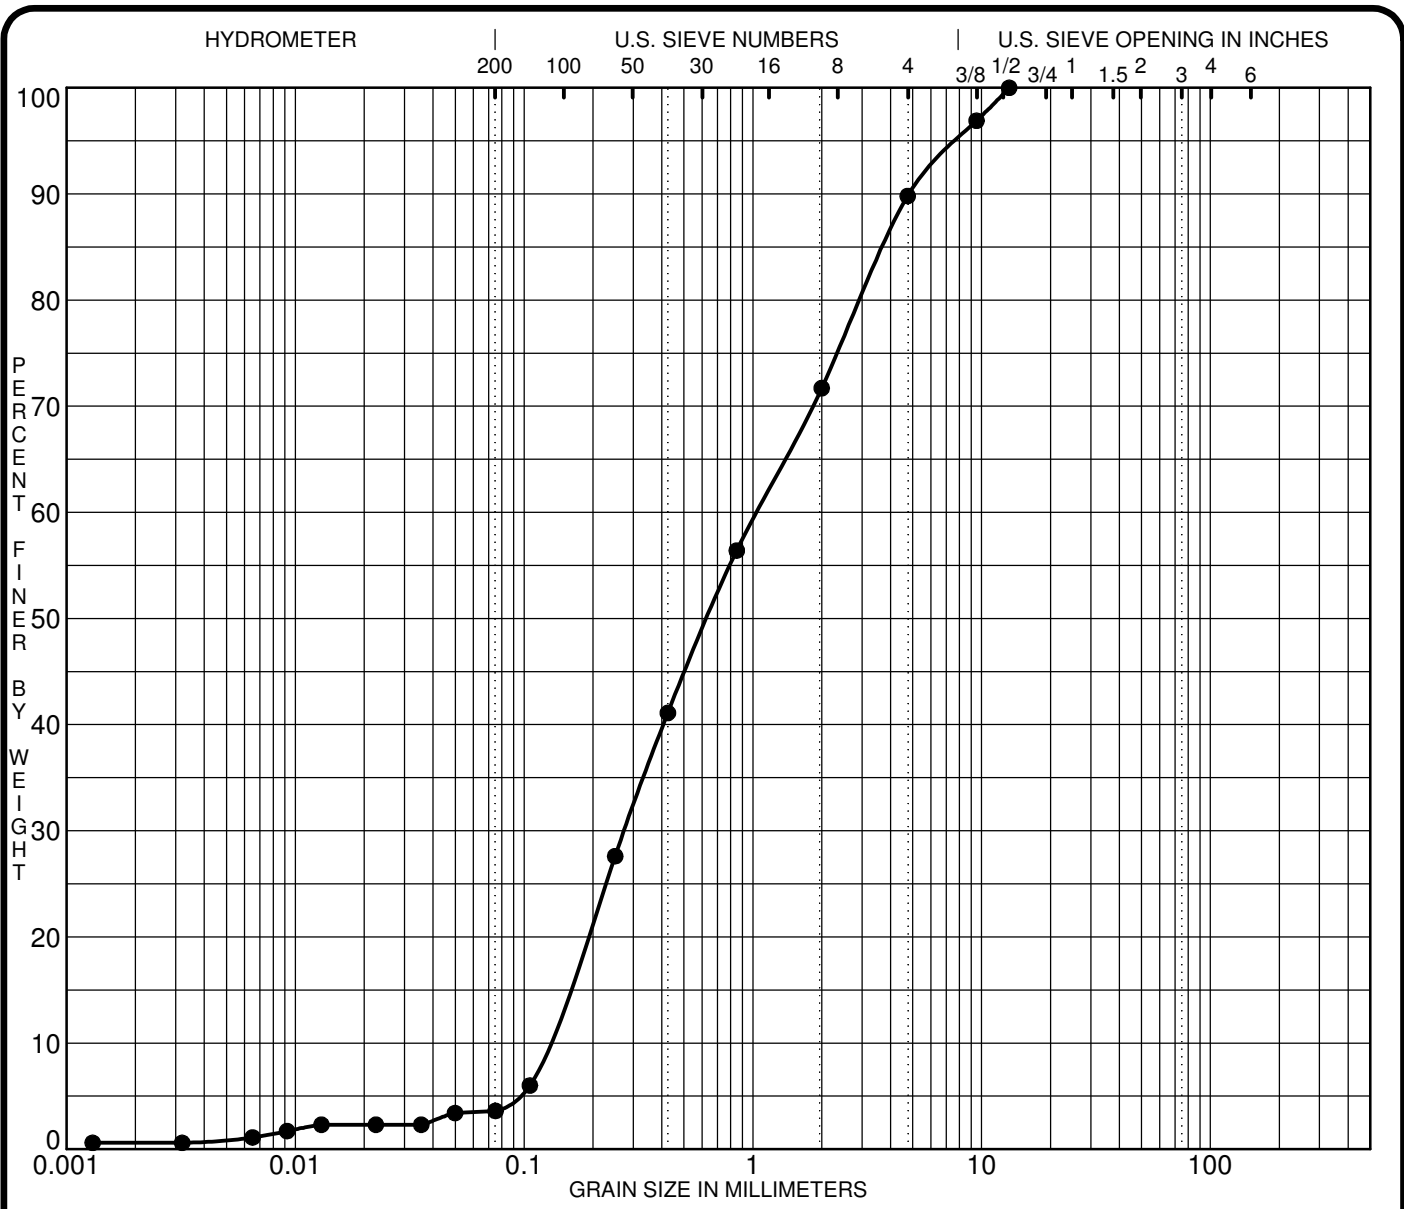
GRAIN SIZE DISTRIBUTION

Specimen Identification	Classification				MC%	LL	PL	PI	Cc	Cu
● BH 3-23 SS7									0.58	8.4
☒										
▲										
★

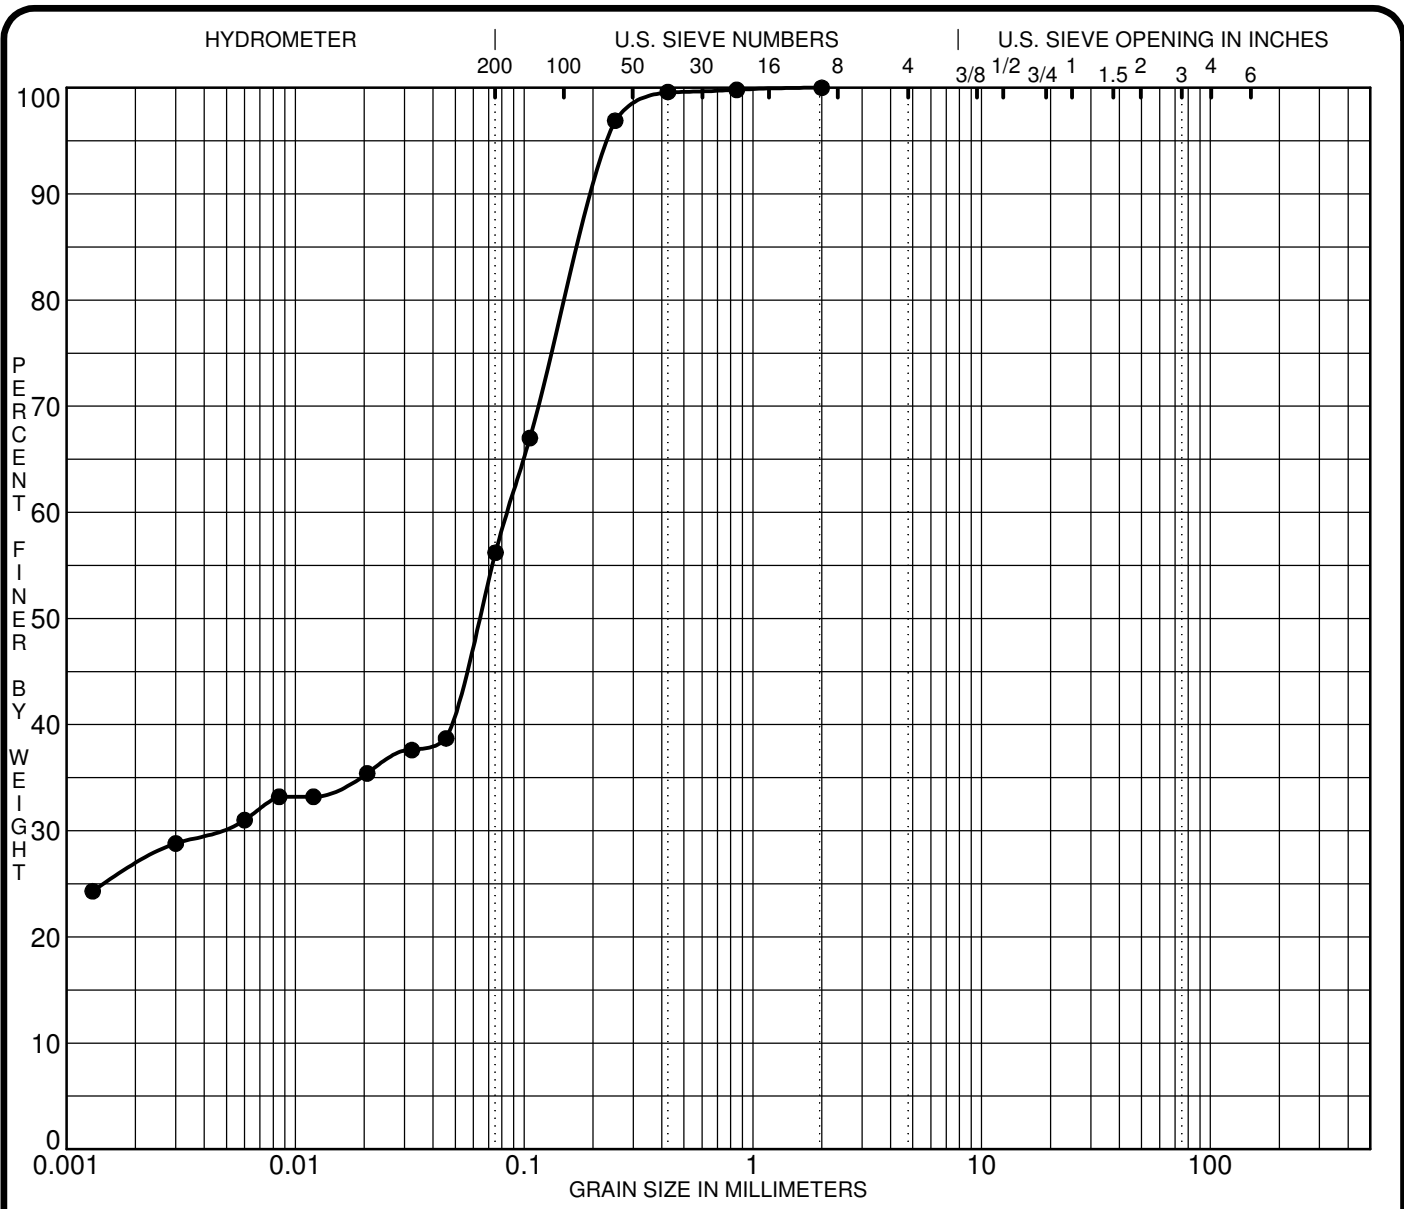
GRAIN SIZE DISTRIBUTION

Specimen Identification	Classification				MC%	LL	PL	PI	Cc	Cu
● BH 9-23 SS8										
☒										
▲										
★

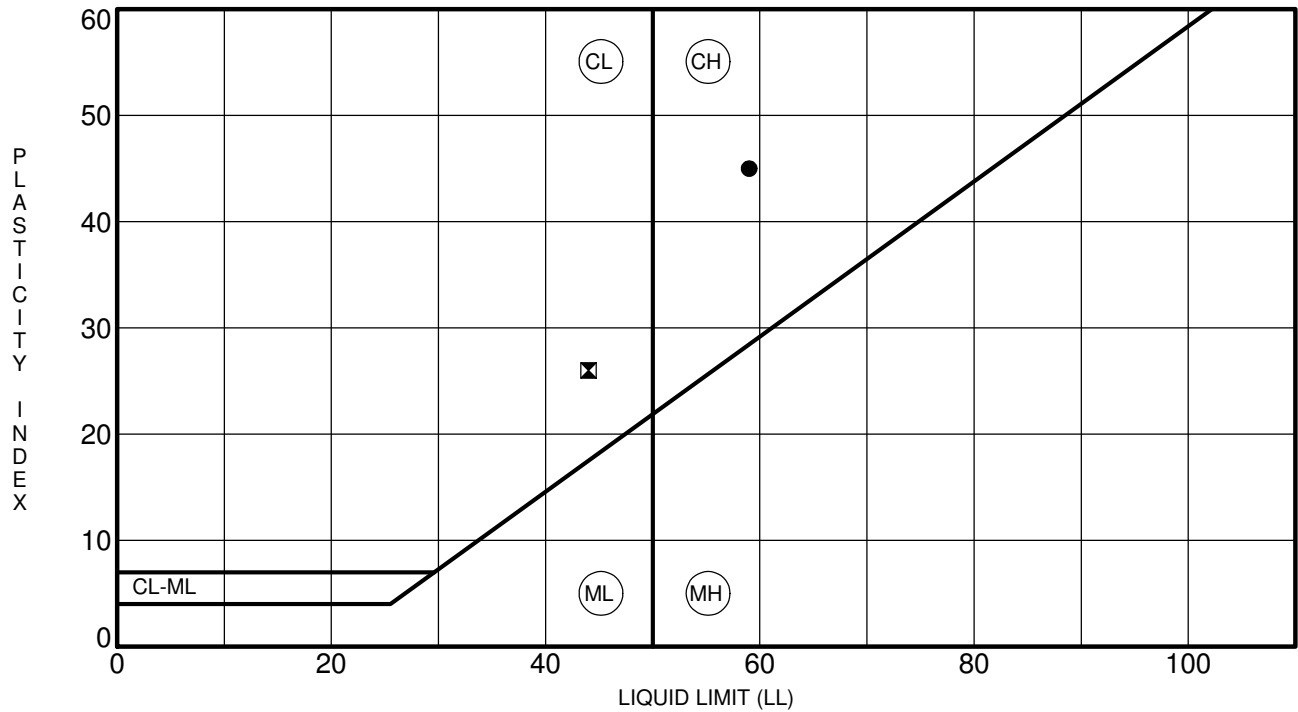
Specimen Identification	LL	PL	PI	Fines	Classification
● BH 4-23 SS6	59	14	45		CH - Inorganic clay of high plasticity
▣ BH 5-23 SS5	44	18	26		CL - Inorganic clay of low plasticity

Atterberg limits testing, as well as associated moisture content testing, was completed on the recovered silty clay samples at selected locations throughout the subject site. The results of the Atterberg limits are presented in Table 1 and on the Atterberg Limits Results sheet in Appendix 1.

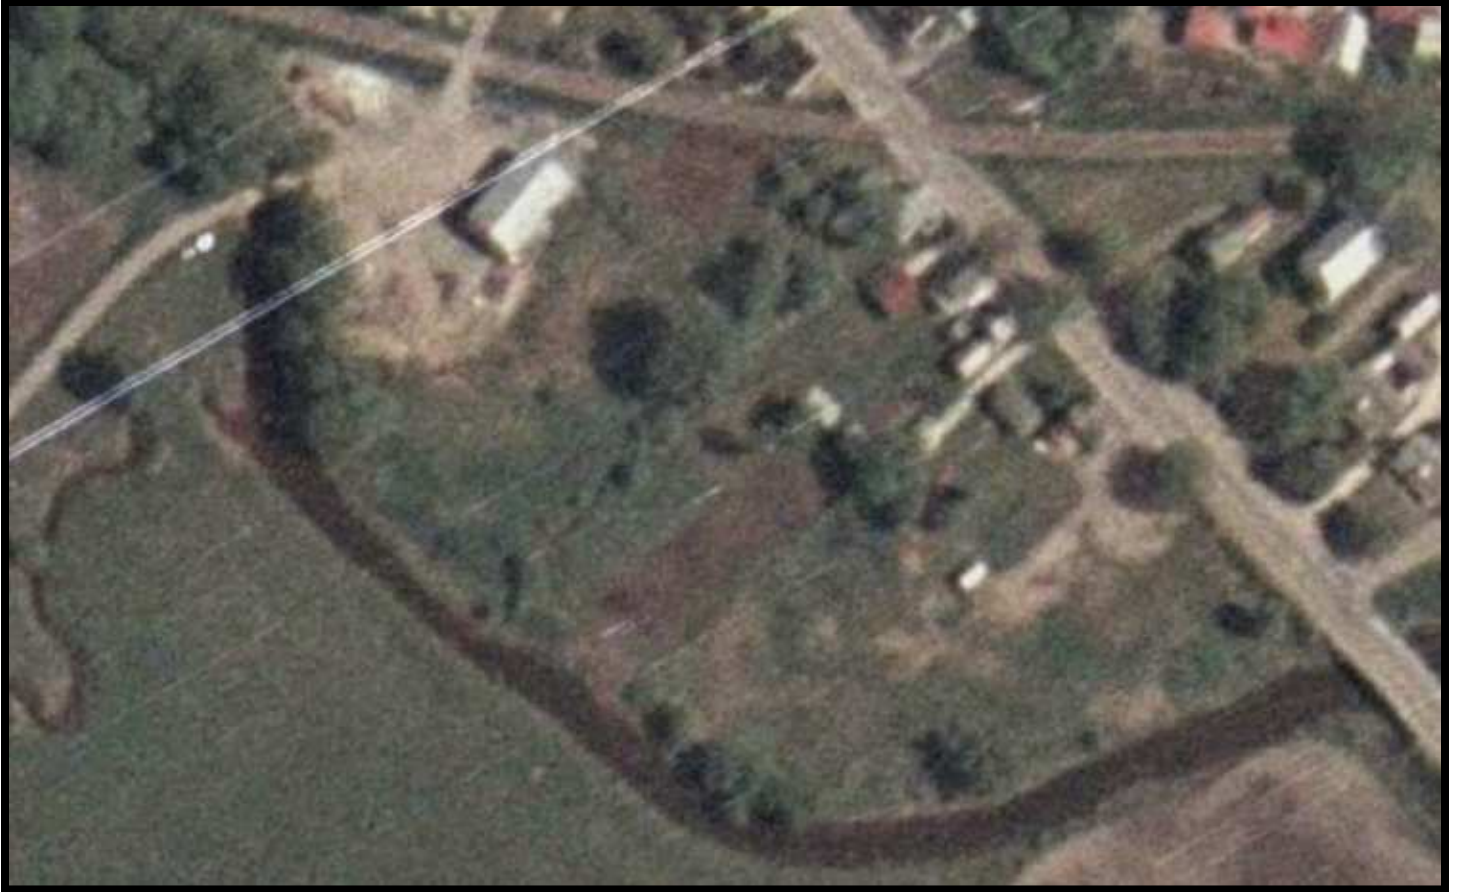
FIGURE 2

Aerial Photograph – 1976

The subject site is generally vacant with the exception of a shed located towards the west boundary of the subject site. It should be noted that historical aerial photographs of the site indicate a series of buildings were previously located throughout the area and subject site. Figure 2 to Figure 7, included in Appendix 2 of this report, depict the historical photographs of the subject site.

Based on the historical photos and field observations, a drainage ditch was present between the 50s to the 70s within the central portion of the site. The ditch was then replaced by a concrete storm pipe and backfilled to accommodate new developments. The abandoned, existing storm pipe was noted along the central portion of the slope face and expected to have been discharging its contents into the Carp River. The pipe is currently abandoned but is expected to be insufficiently decommissioned. It should further be noted that the slope was excavated to accommodate the placement of the storm pipe which created the existing bulge in the slope face.

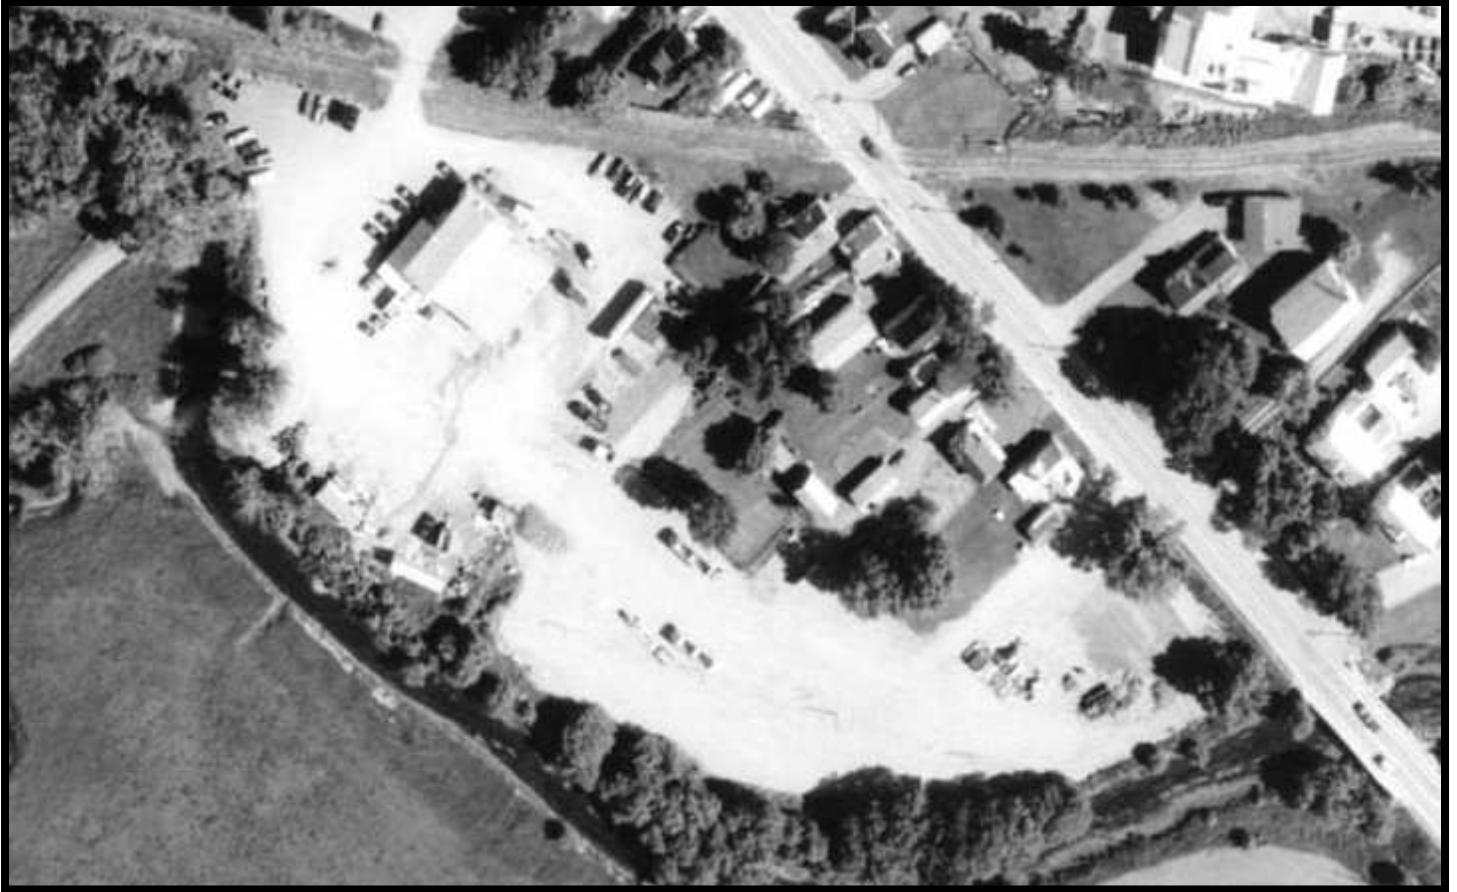
FIGURE 3

Aerial Photograph – 1991

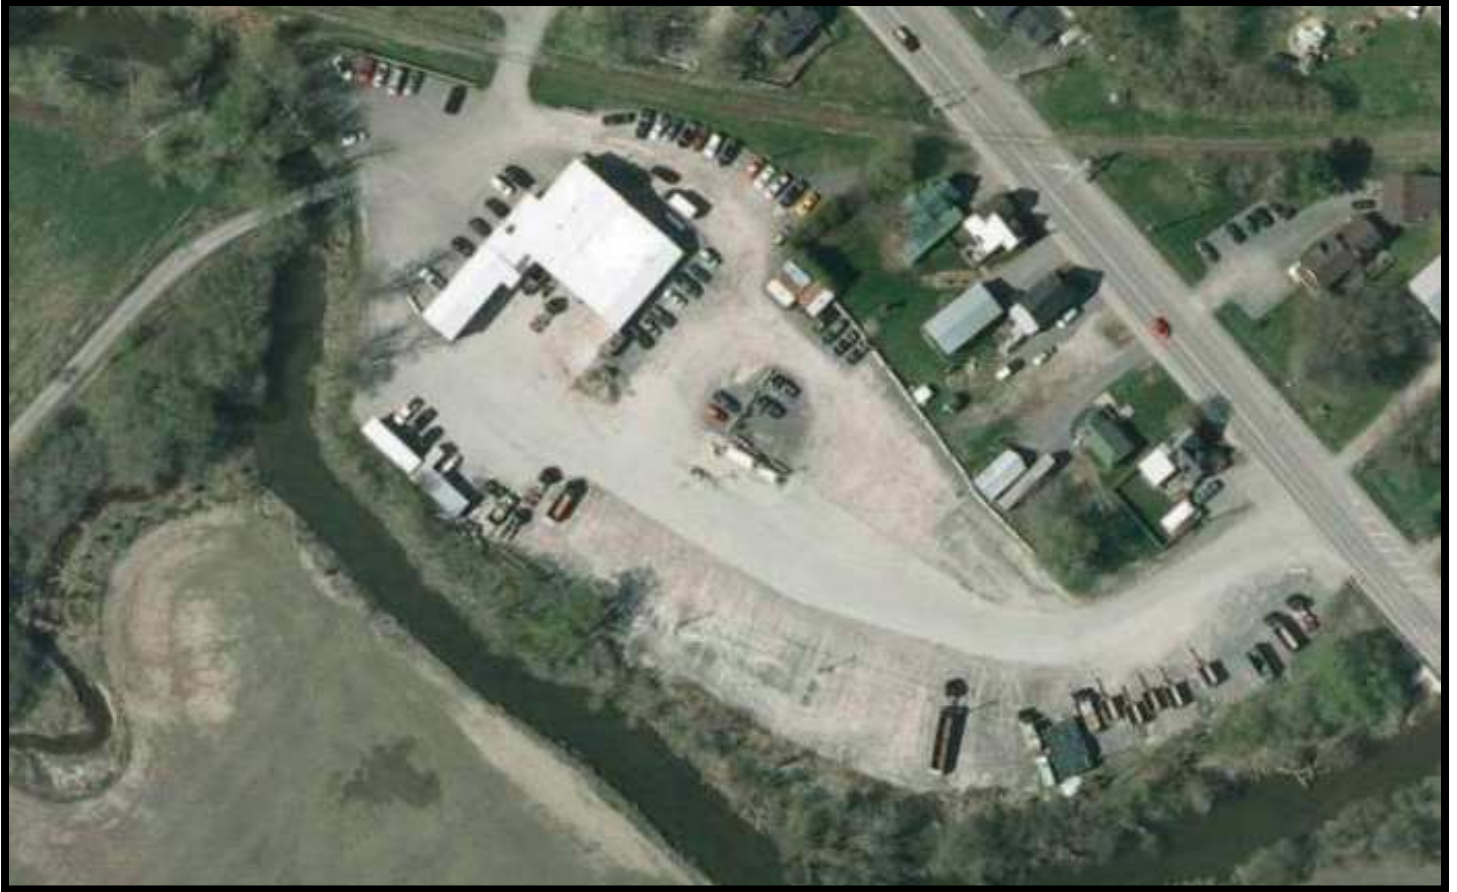
FIGURE 4

Aerial Photograph – 2011

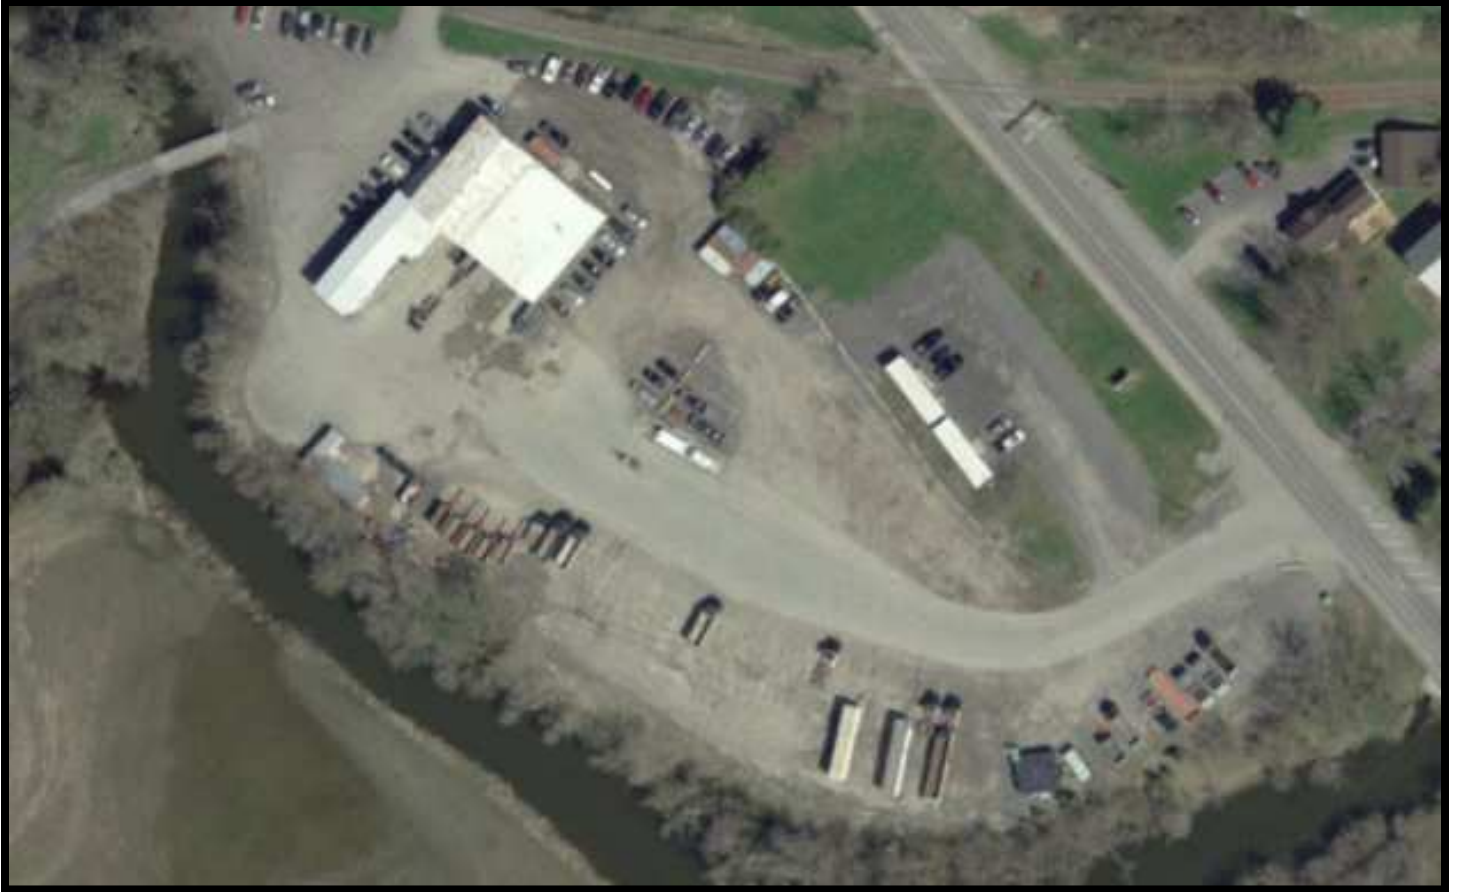
FIGURE 5

Aerial Photograph – 2014

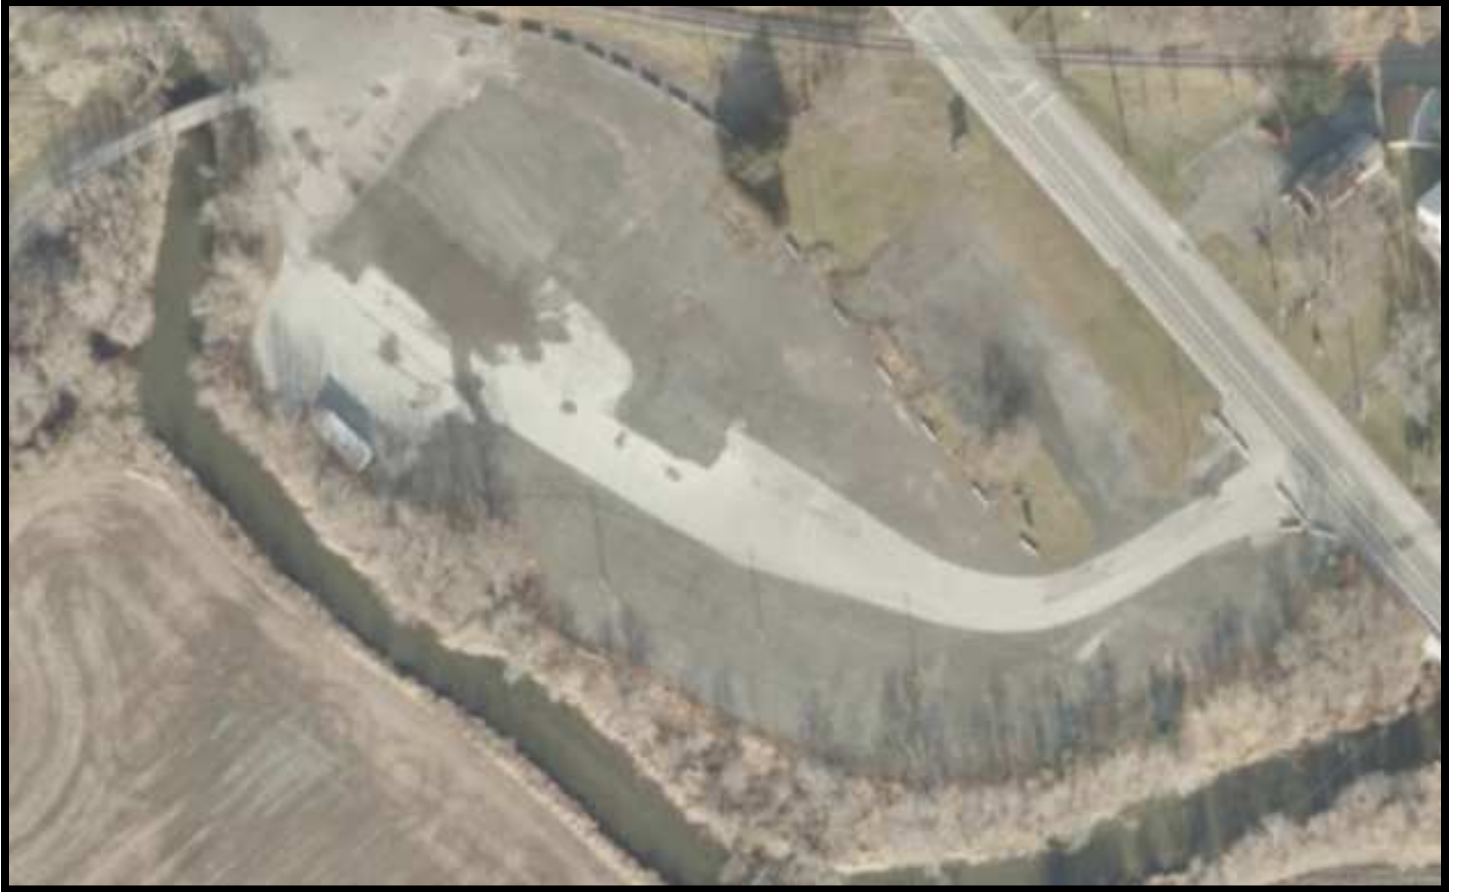
FIGURE 6

Aerial Photograph – 2015

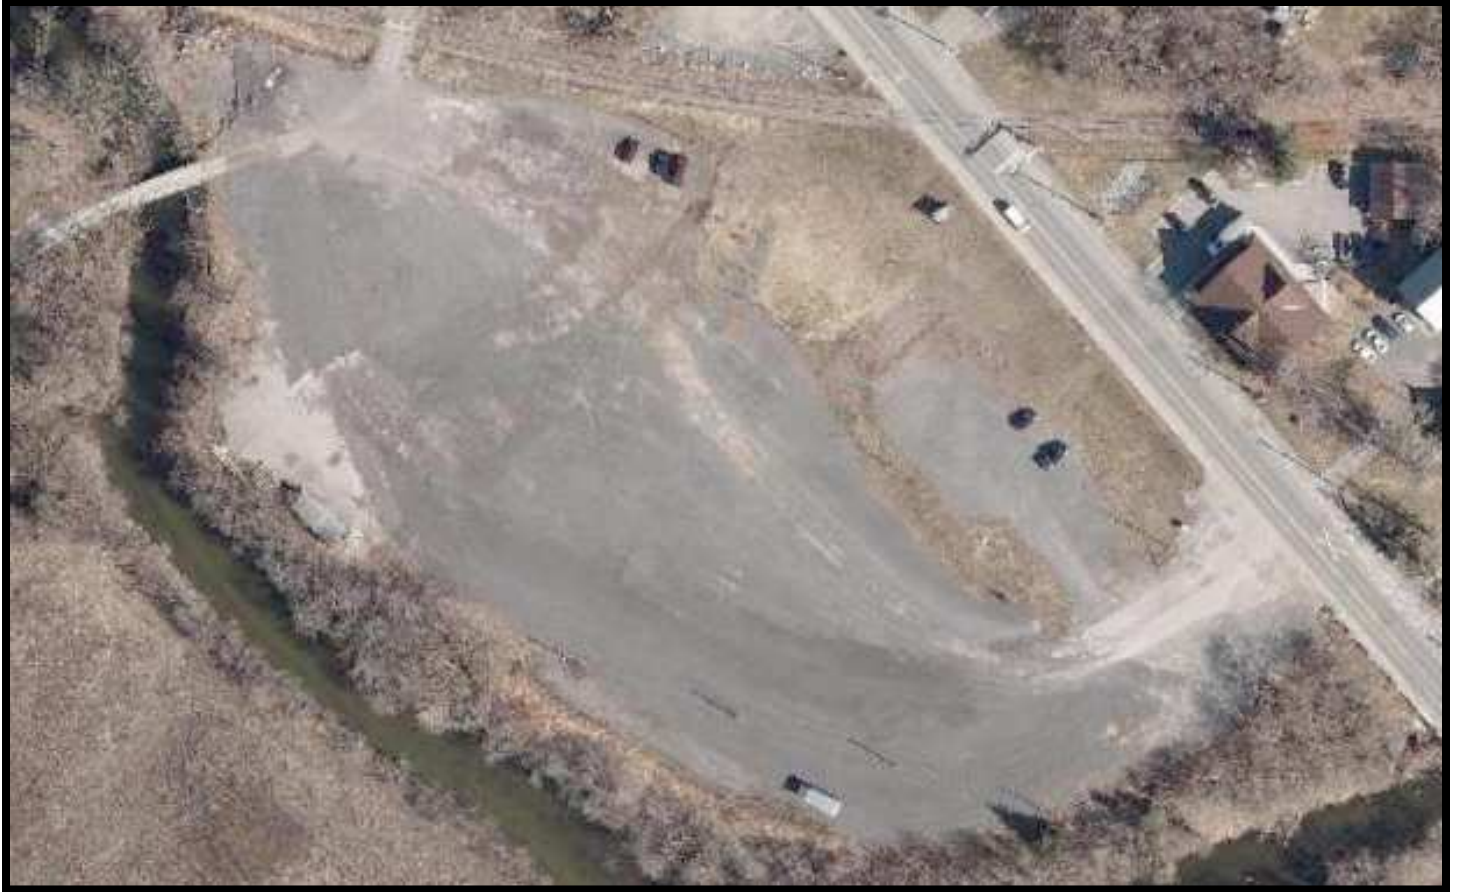
FIGURE 7

Aerial Photograph – 2021

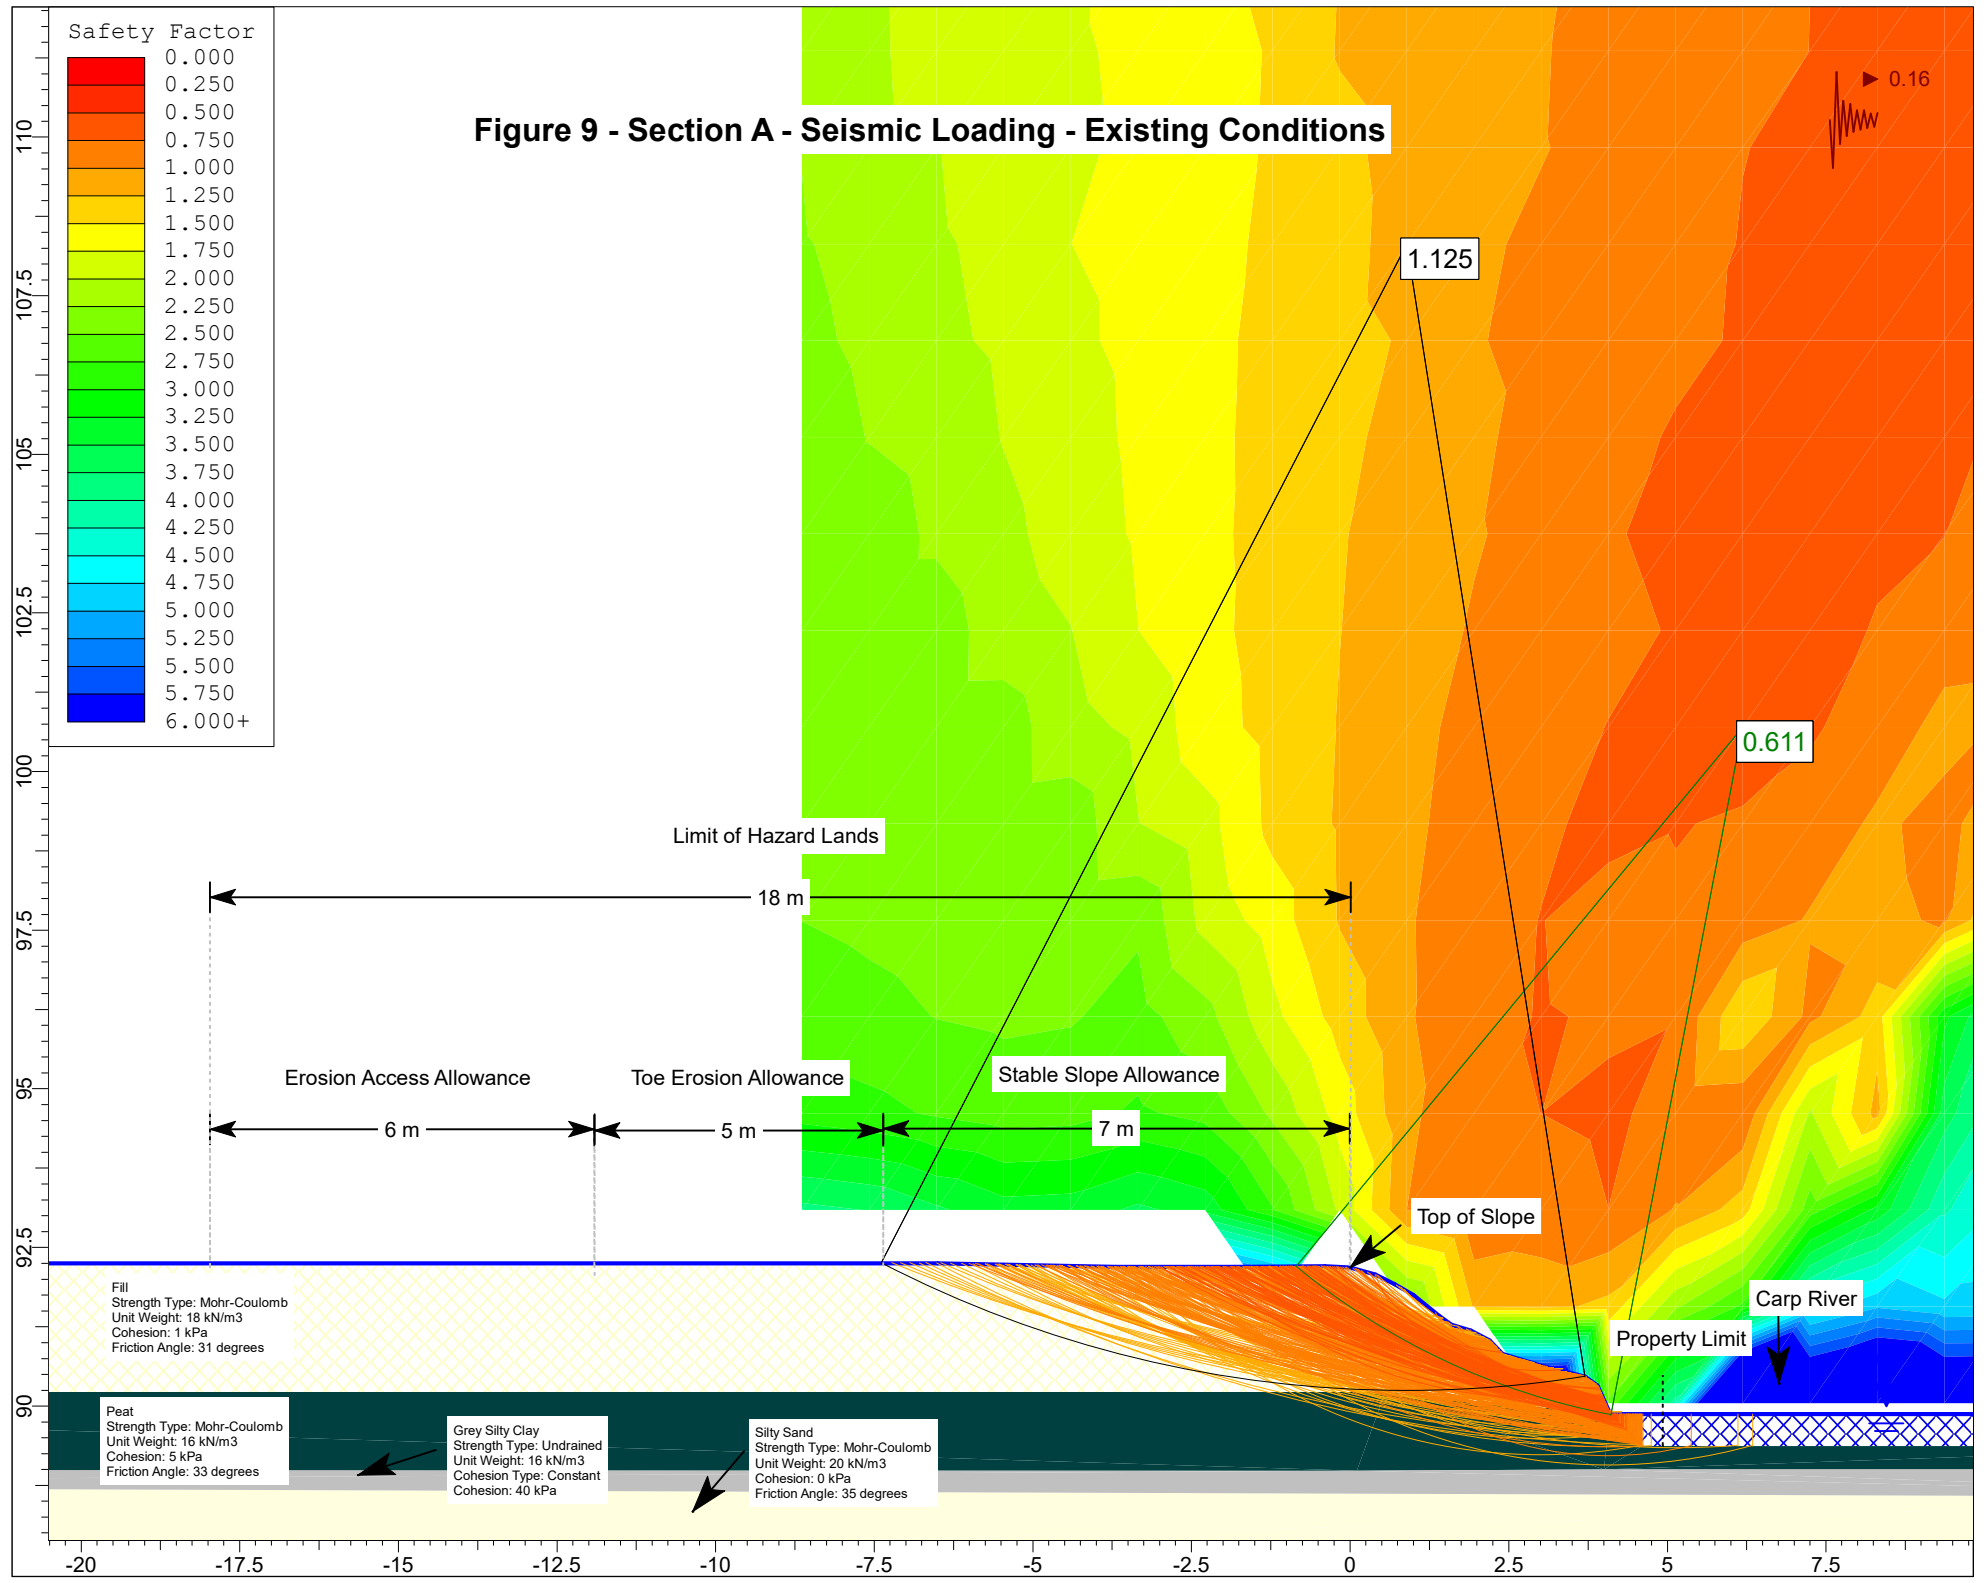
Figure 9 - Section A - Seismic Loading - Existing Conditions

Due to the presence of Carp River bordering the subject site, a slope stability assessment was carried out considering the slope conditions present in the subject site and along the sidewalls of the aforementioned watercourse. The results of the slope stability assessment are discussed further in Subsection 6.8 of this report.

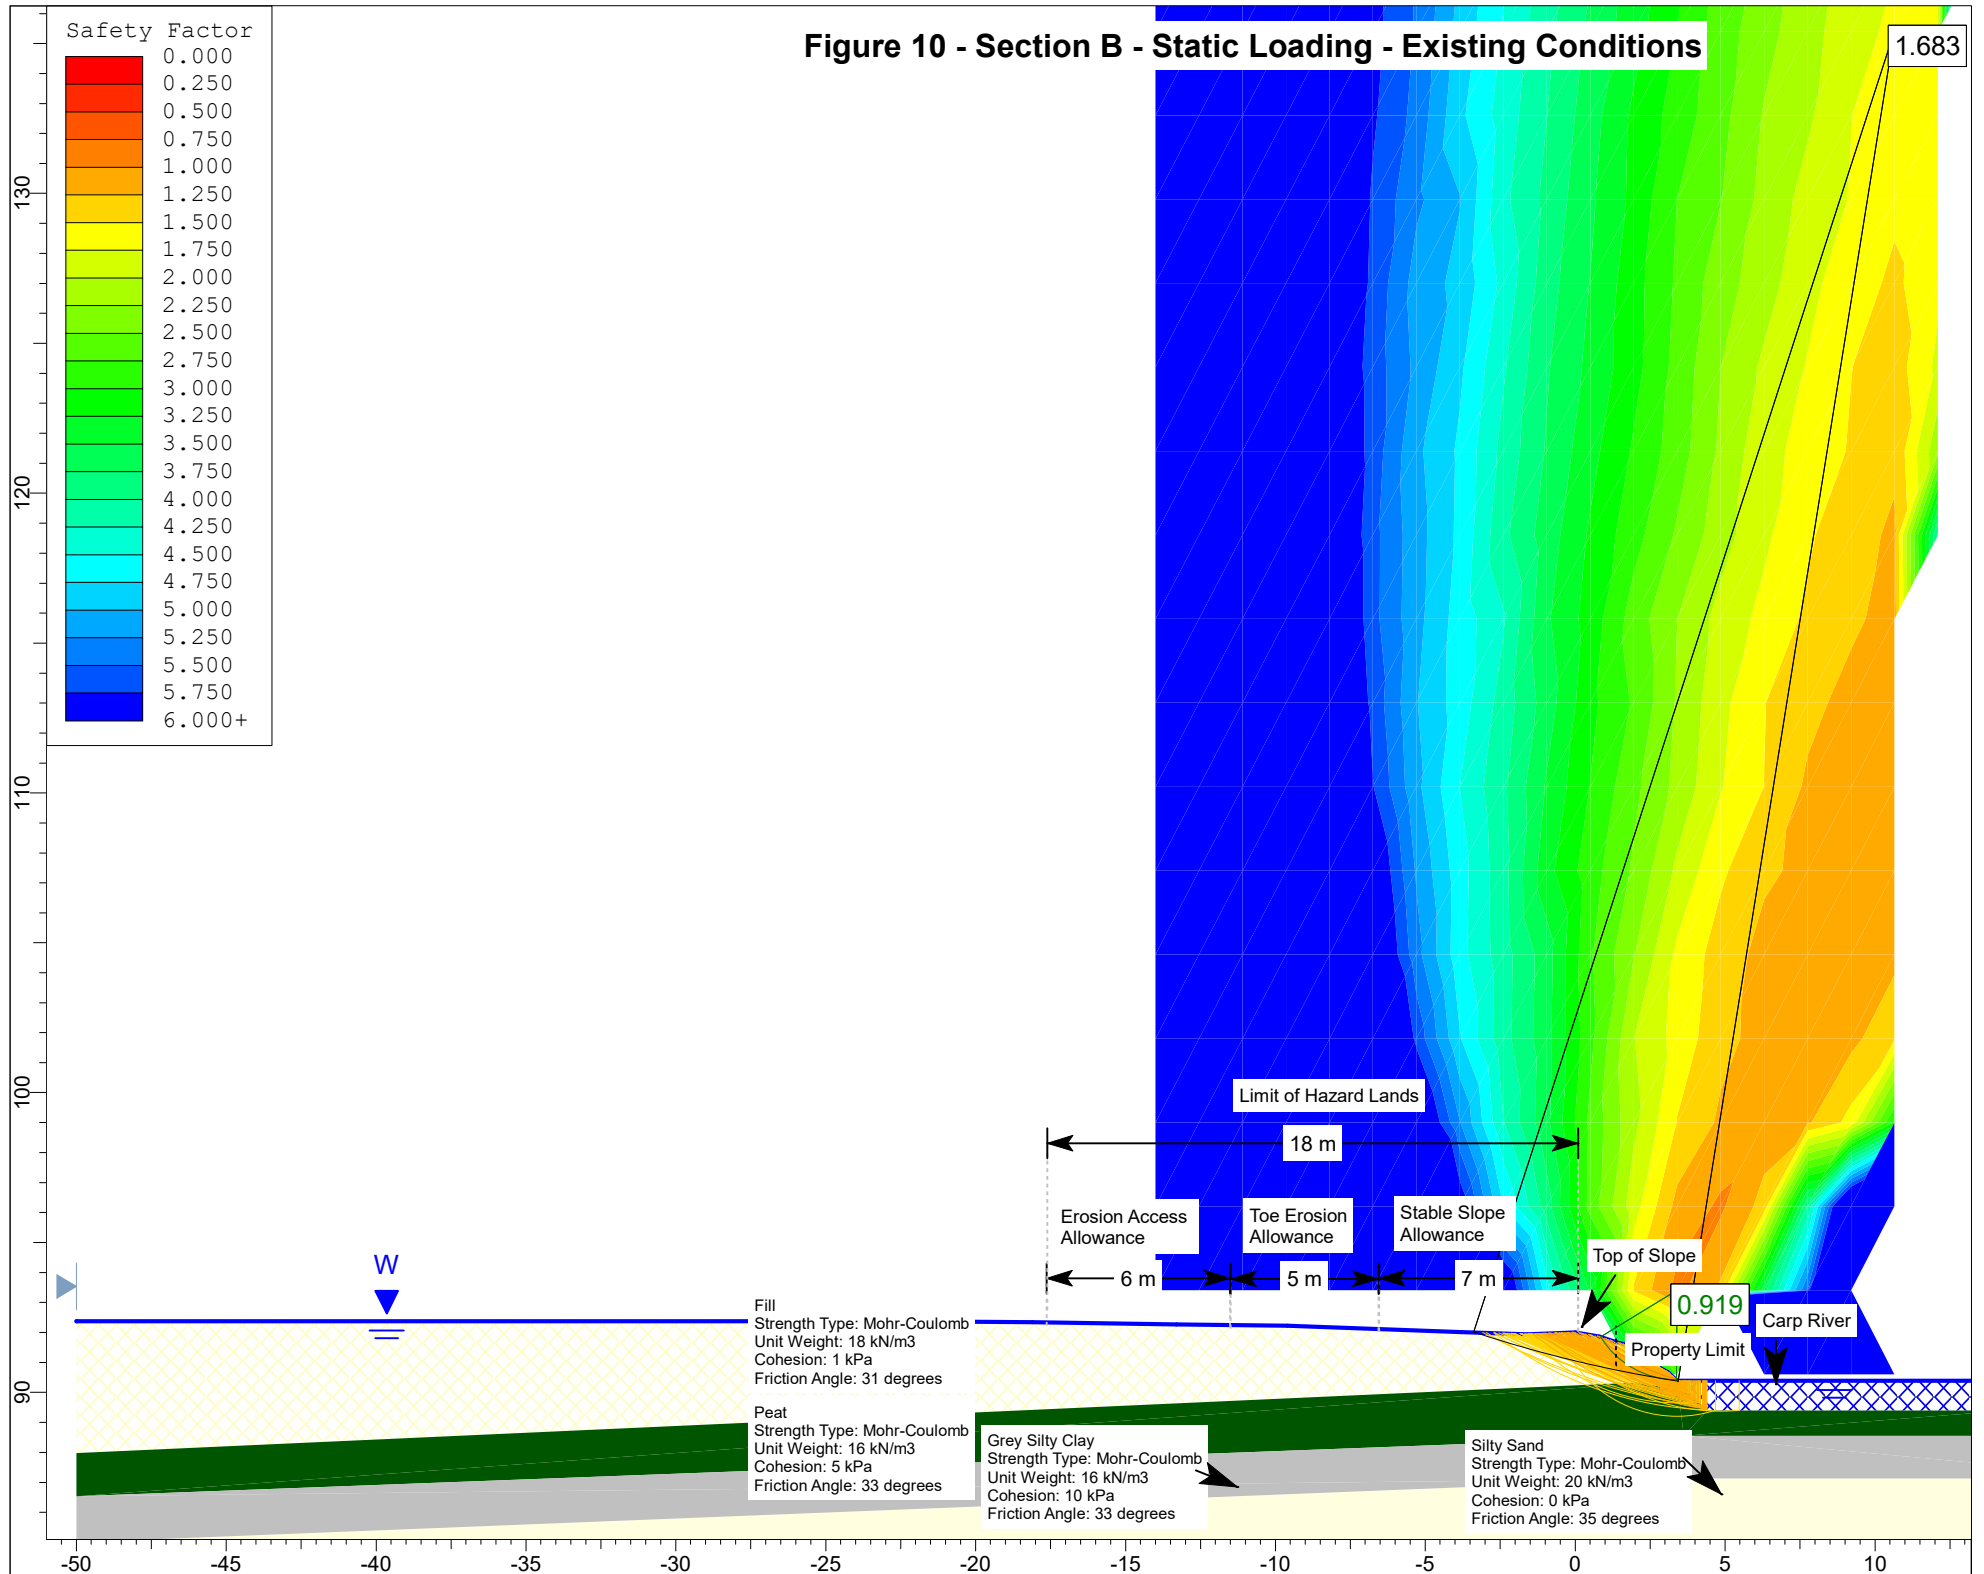
Figure 10 - Section B - Static Loading - Existing Conditions

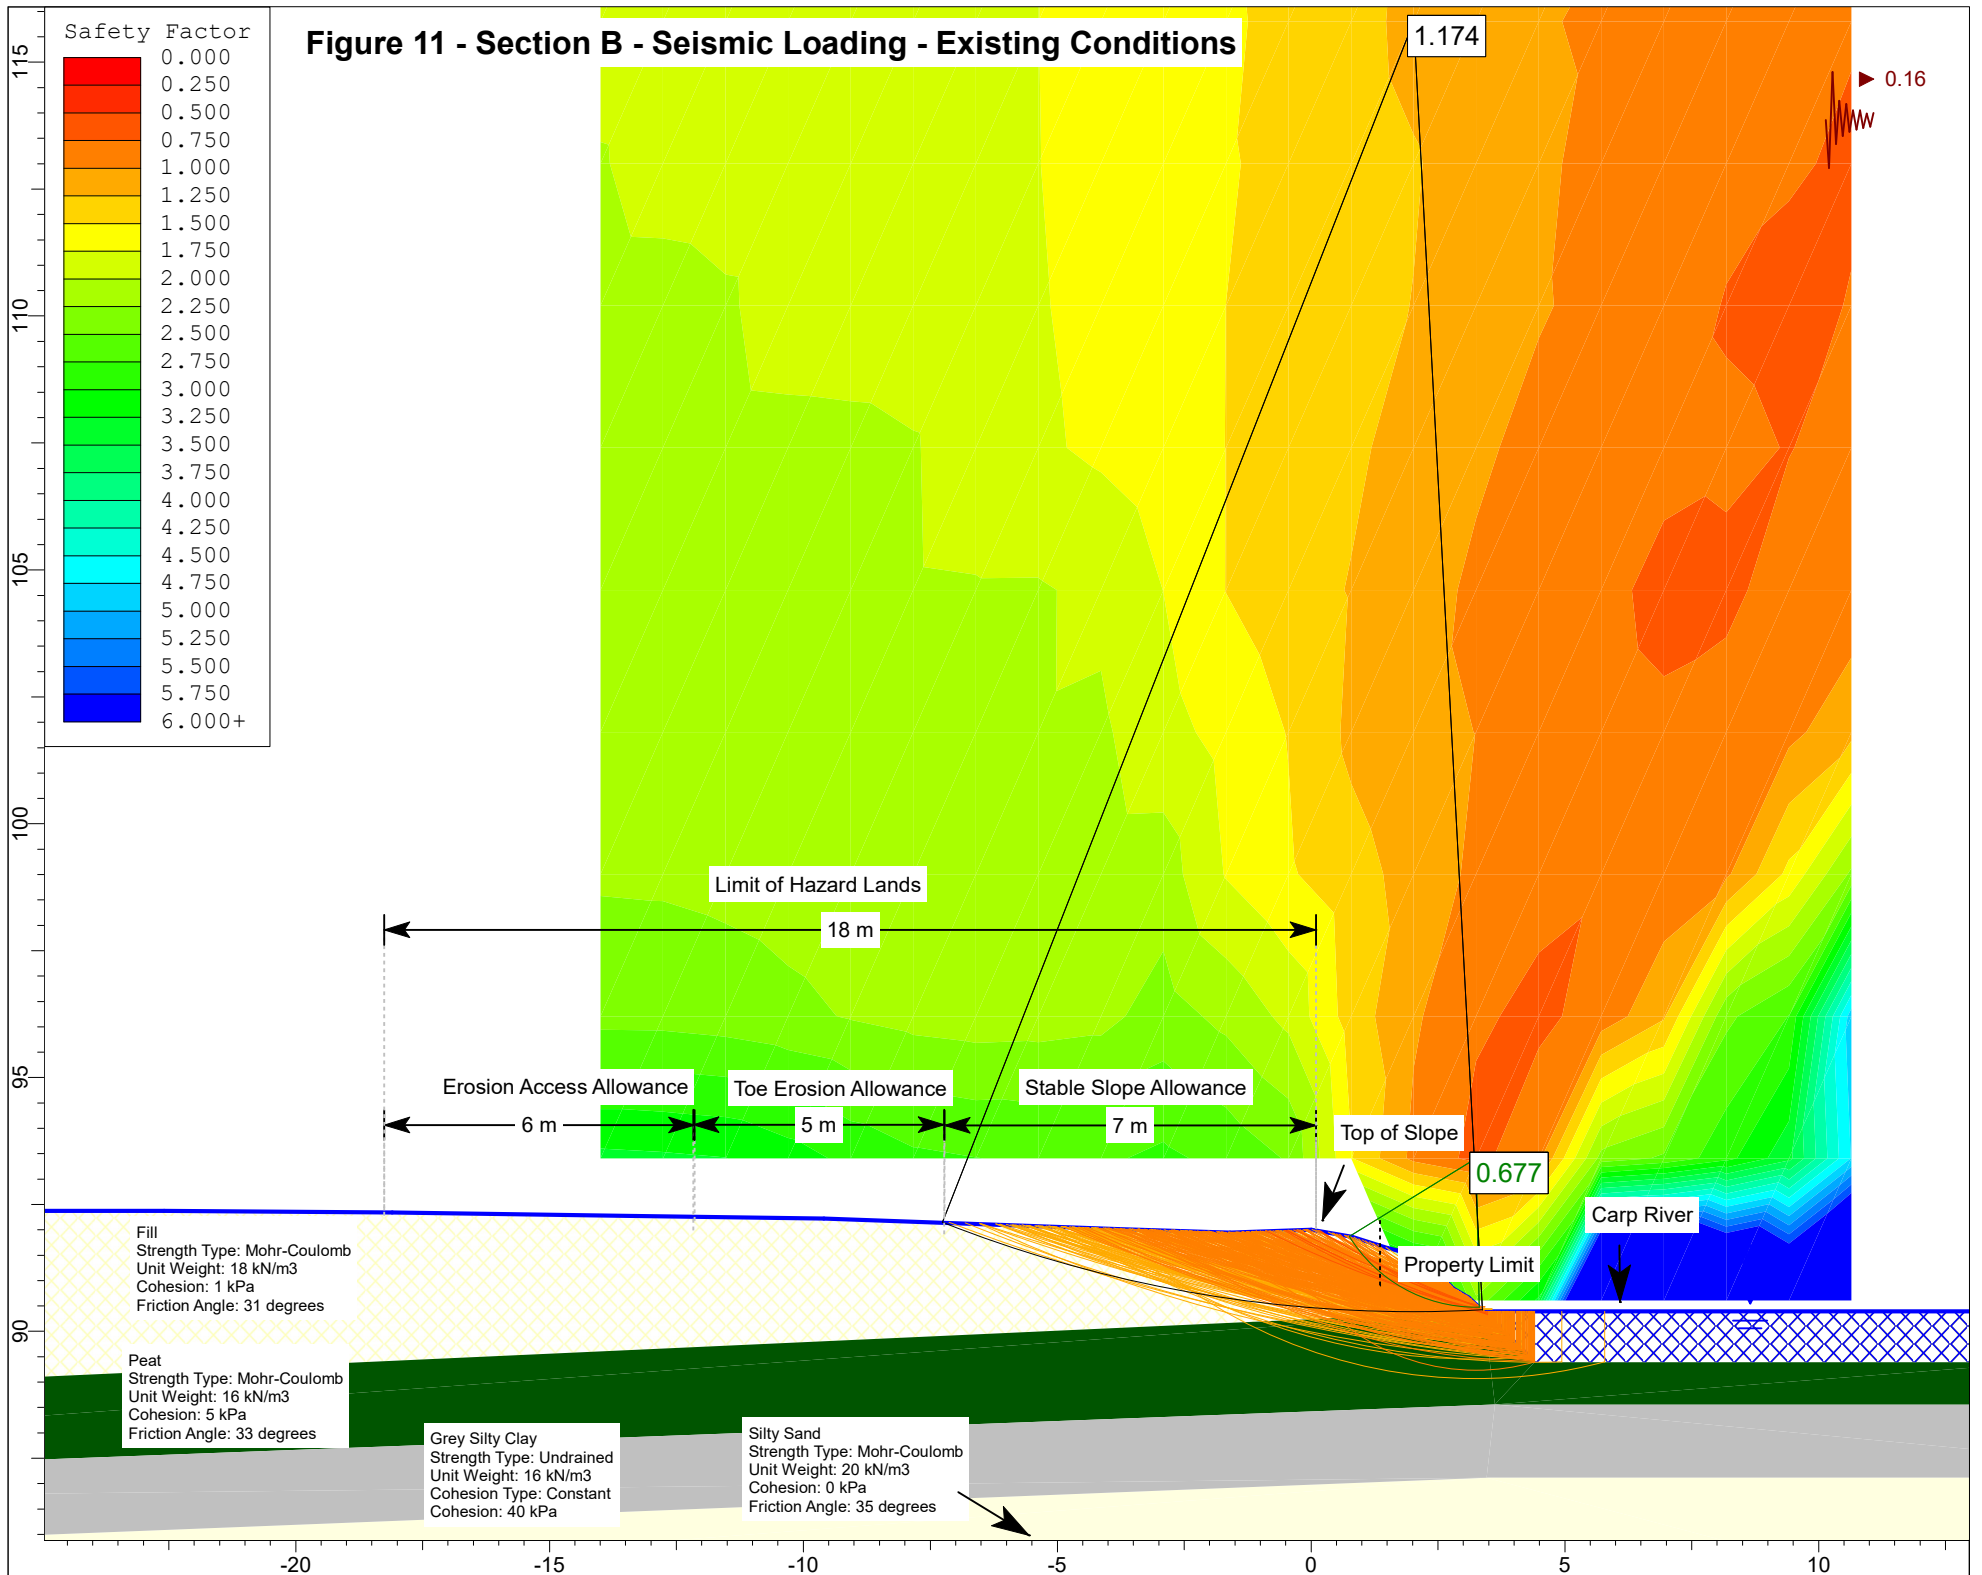
Figure 11 - Section B - Seismic Loading - Existing Conditions
