Geotechnical Investigation

Proposed Mixed Use Development

3725 Carp Road - Ottawa, Ontario

Report PG2103-1 dated April 11, 2023

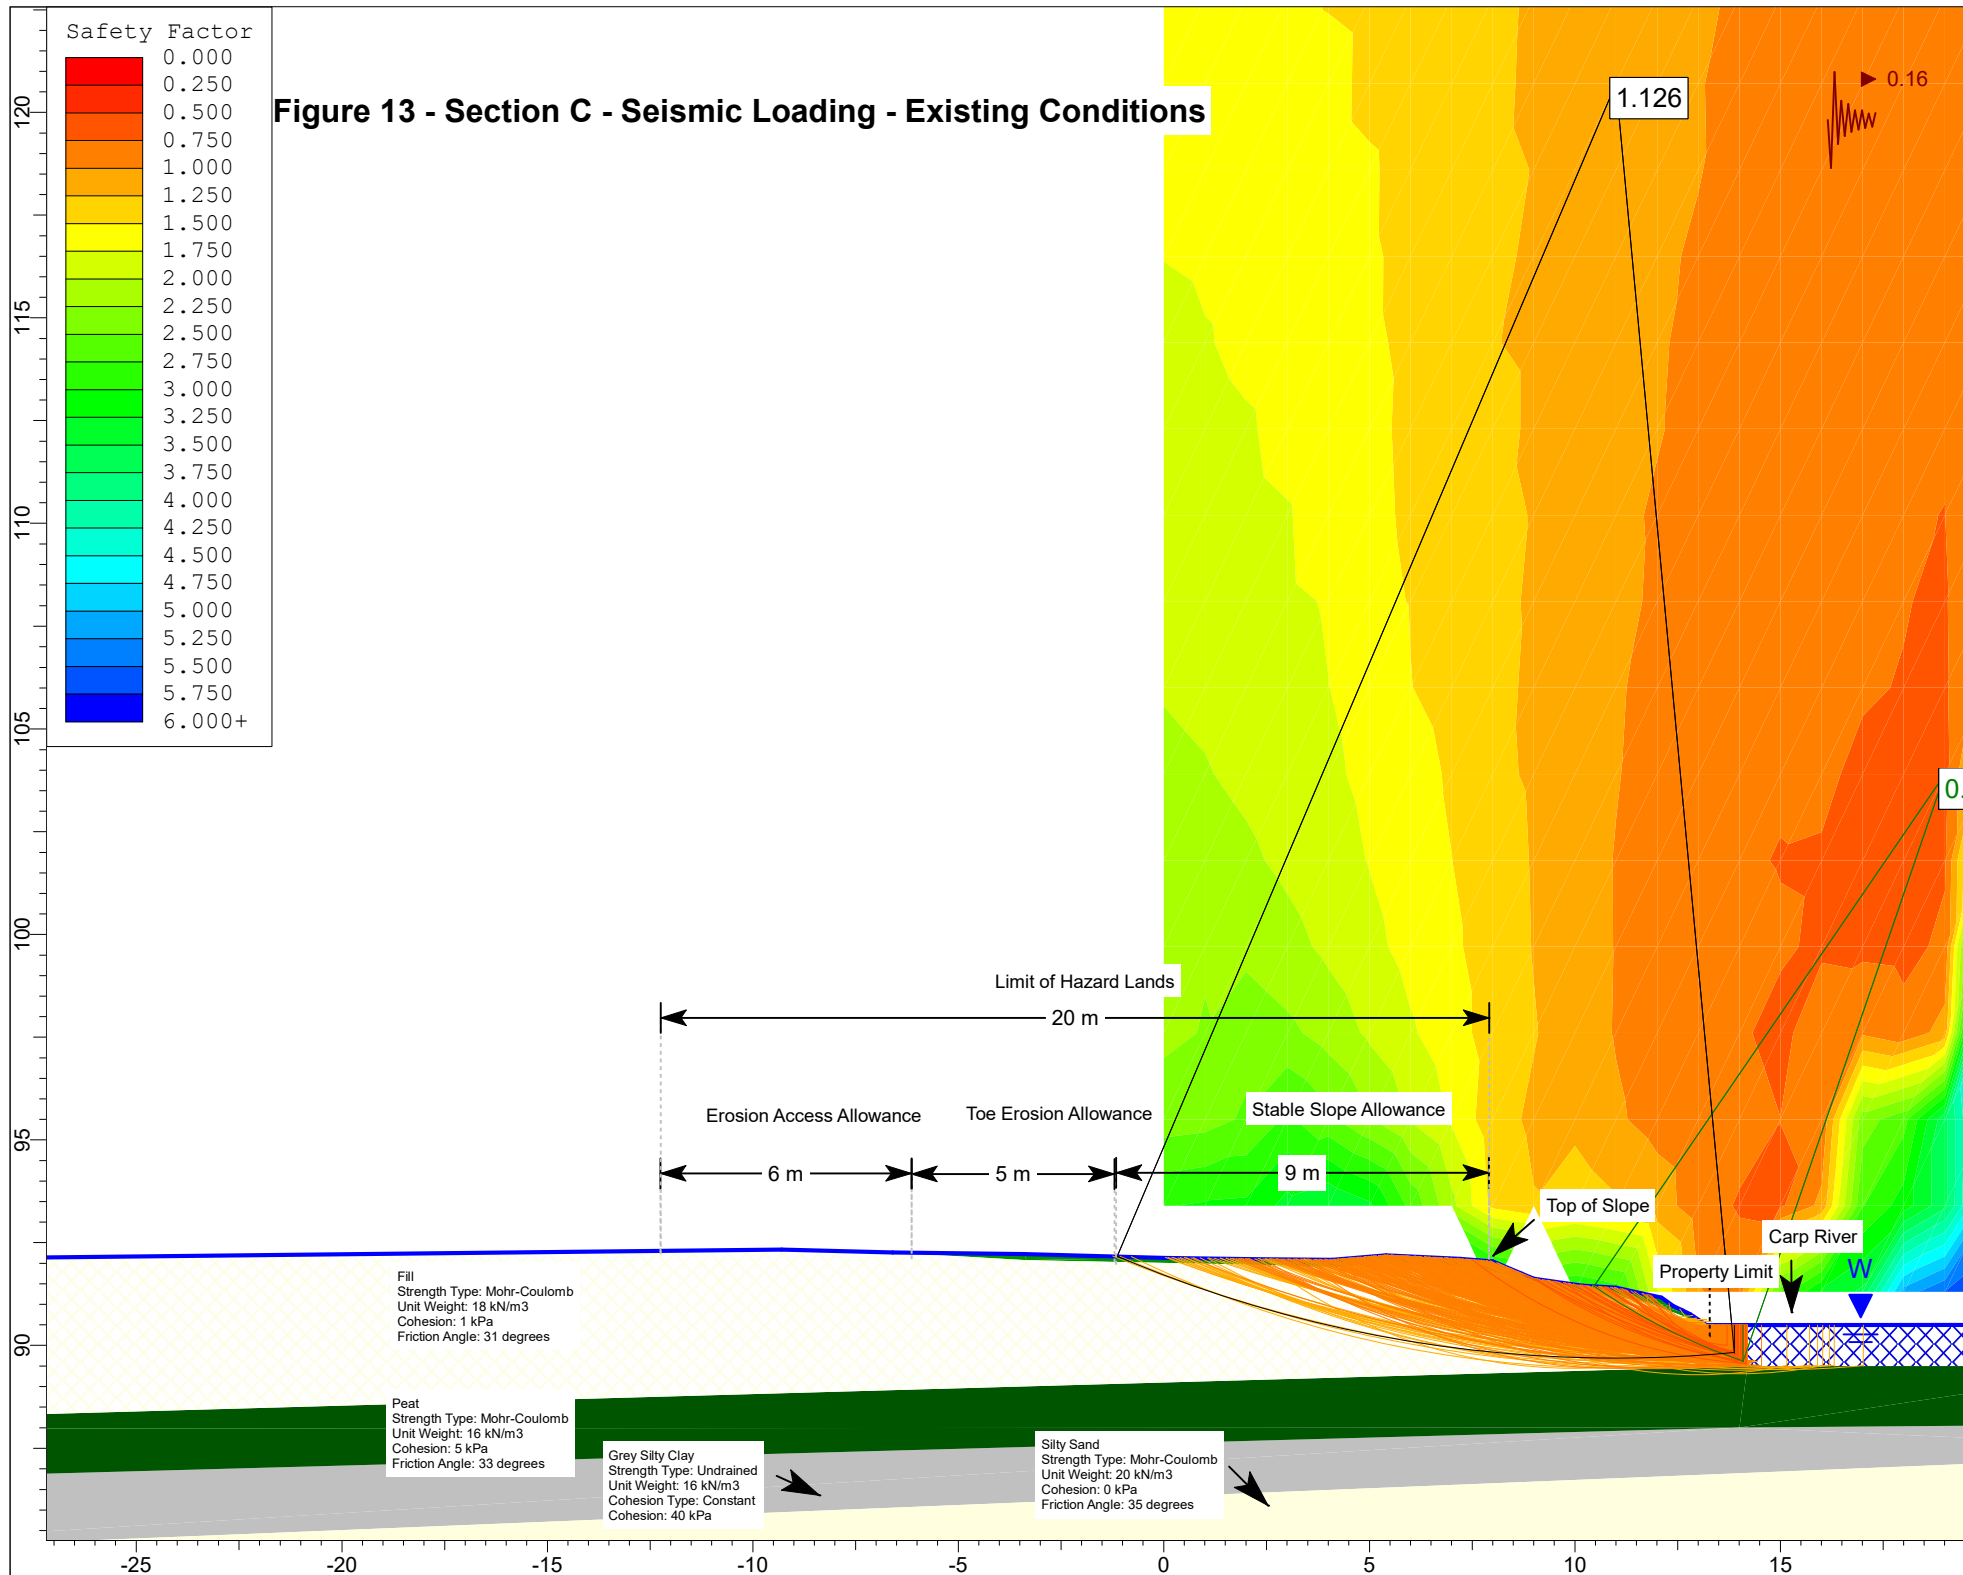
Figure 13 - Section C - Seismic Loading - Existing Conditions

Due to the presence of Carp River bordering the subject site, a slope stability assessment was carried out considering the slope conditions present in the subject site and along the sidewalls of the aforementioned watercourse. The results of the slope stability assessment are discussed further in Subsection 6.8 of this report.

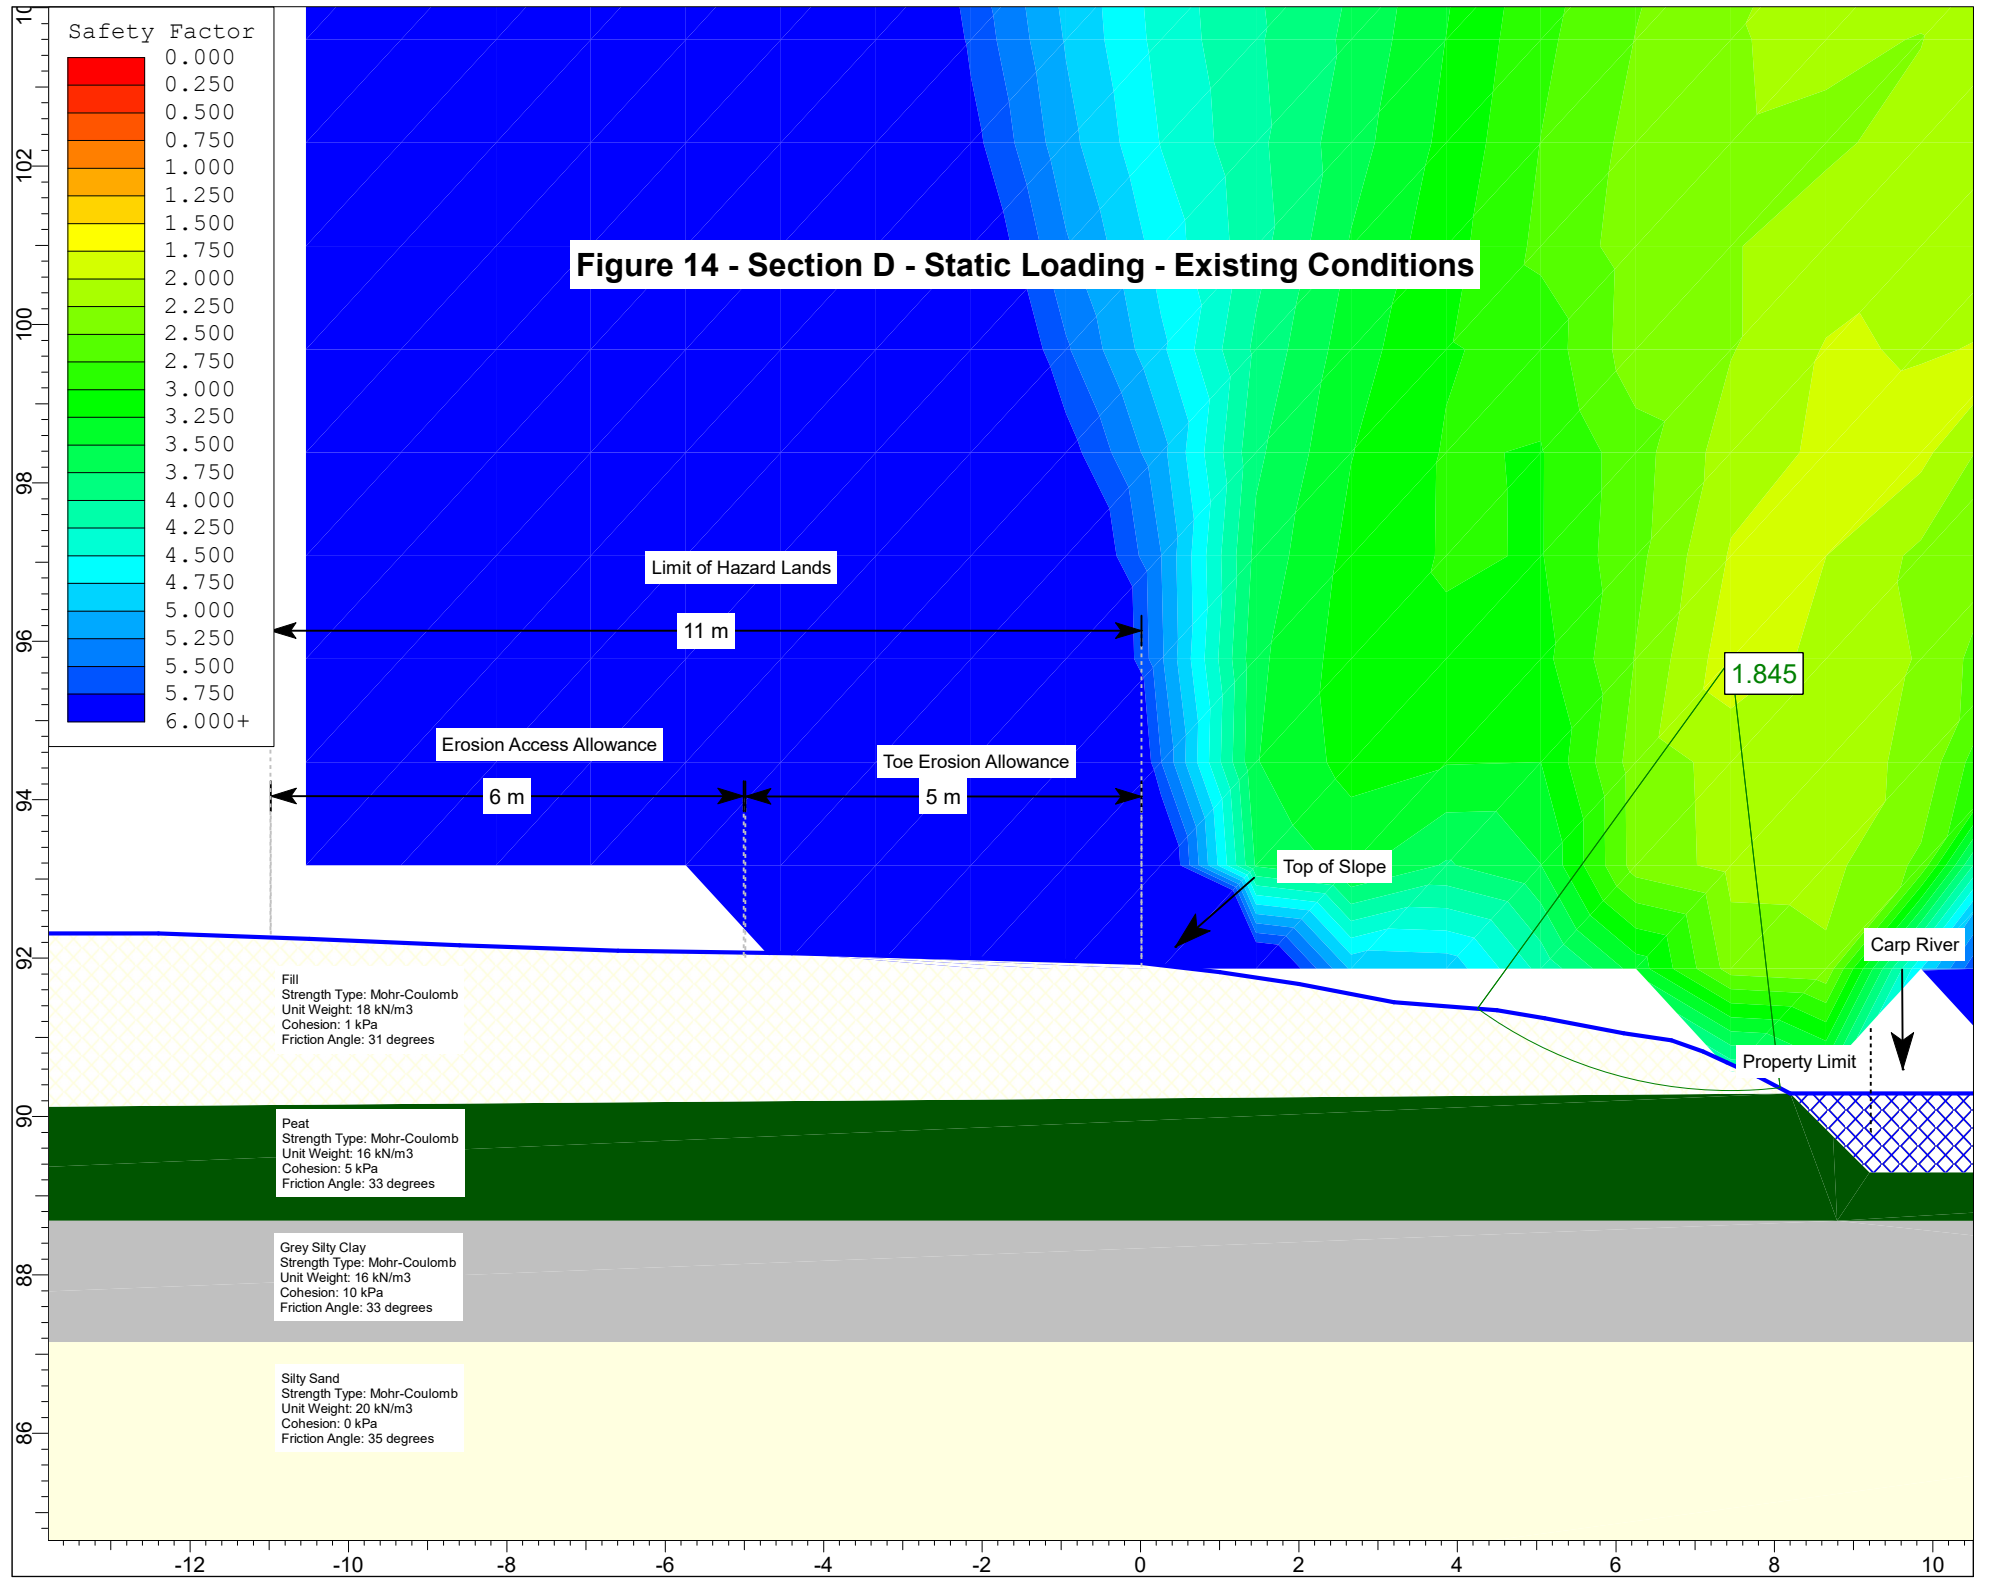
Figure 14 - Section D - Static Loading - Existing Conditions

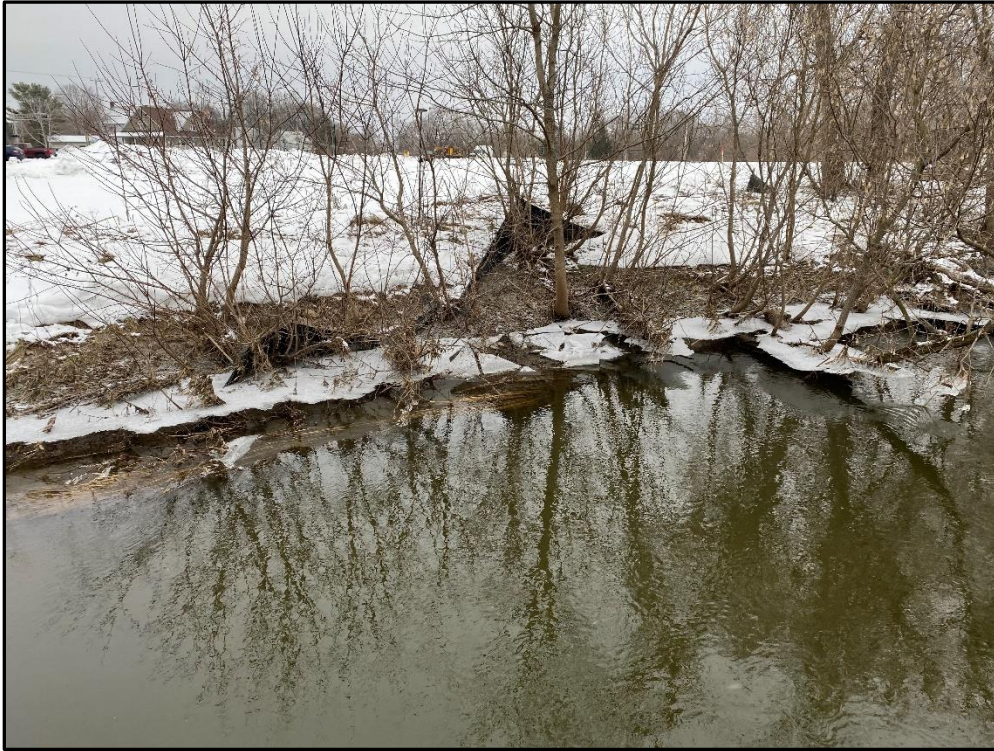
Photo 1: Area of Cross-Section A. Photograph taken at north portion of site, facing southeast.

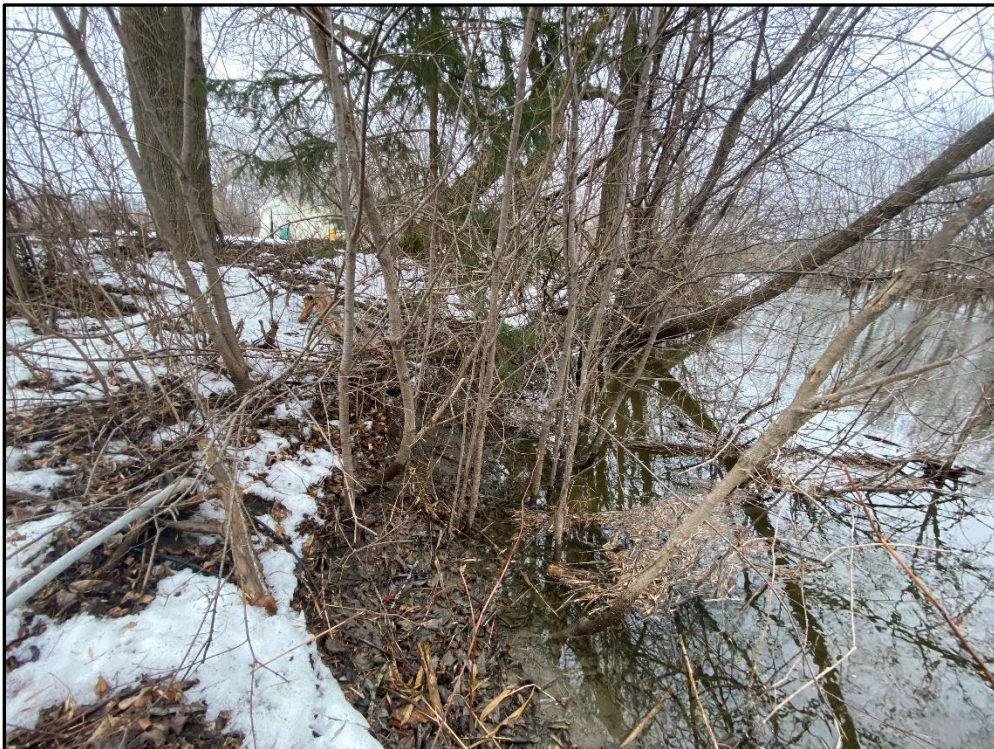
Photo 2: Area of Cross-Section A. Sidewall of watercourse and slope face observed to be covered with vegetation. Photograph taken facing southwest.

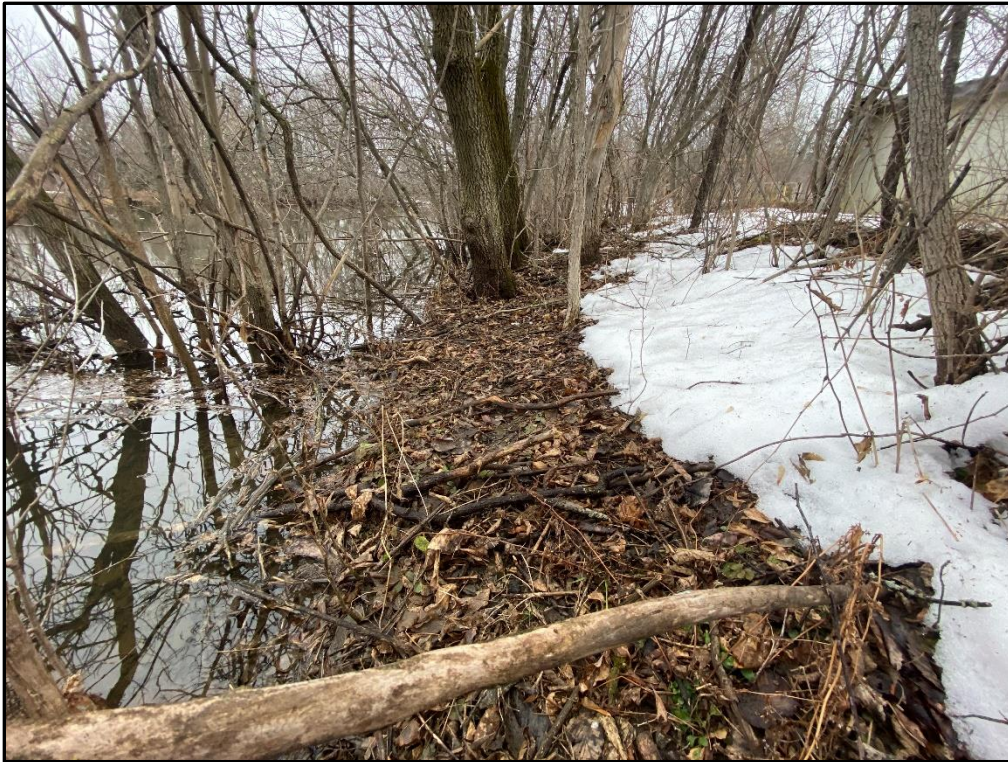
Photo 3: Area of Cross-Section B. The gentle slope face is observed to be covered with vegetation. Photograph taken facing northwest.

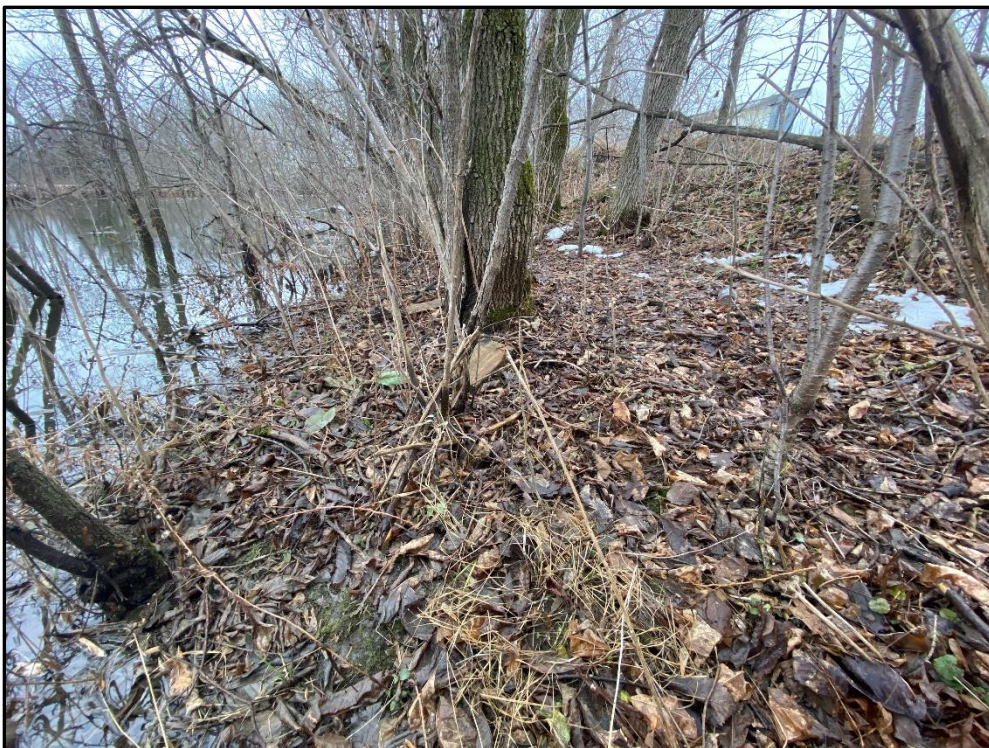
Photo 4: Watercourse observed to be overflowing the slope face. General area observed to be covered with vegetation. Photograph taken facing west.

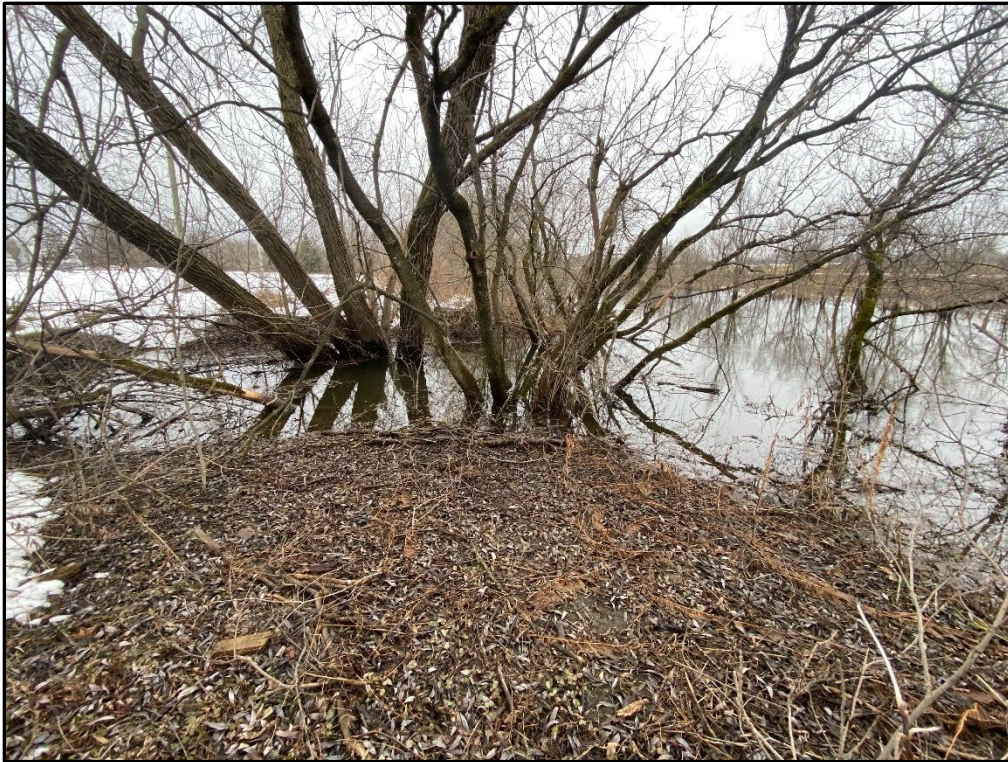
Photo 5: Photograph of area south of Cross-Section C. The slope face is observed to be smooth and covered with vegetation. Photograph taken facing southeast.

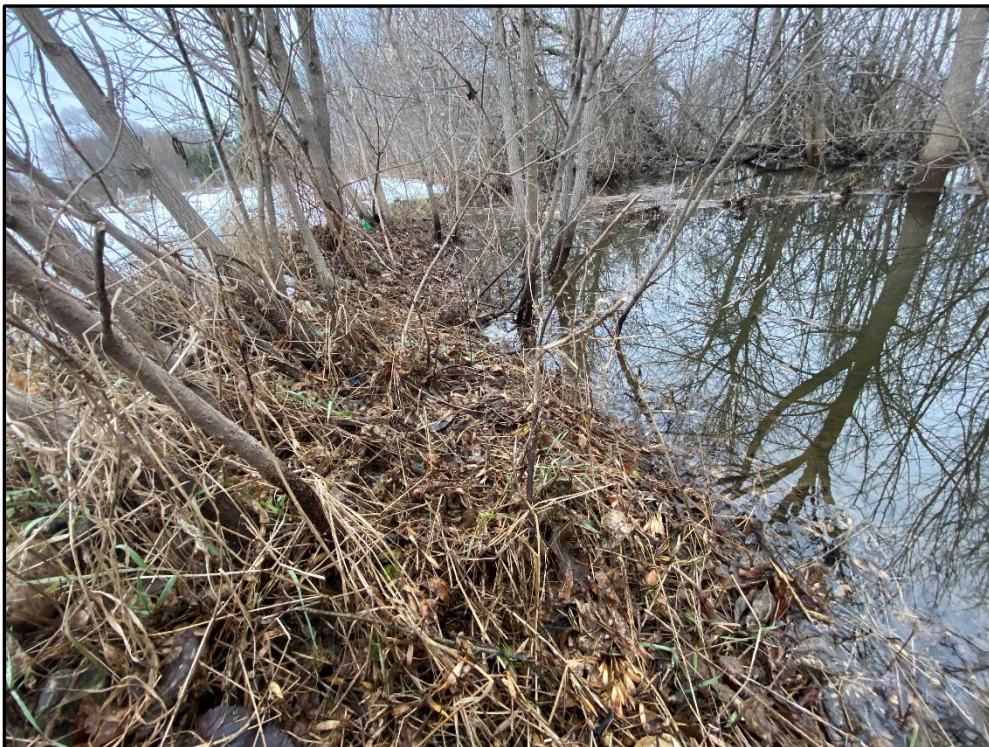
Photo 6: Area of watercourse covered with vegetation and did not appear to have been affected by erosion. Photograph taken facing southeast.

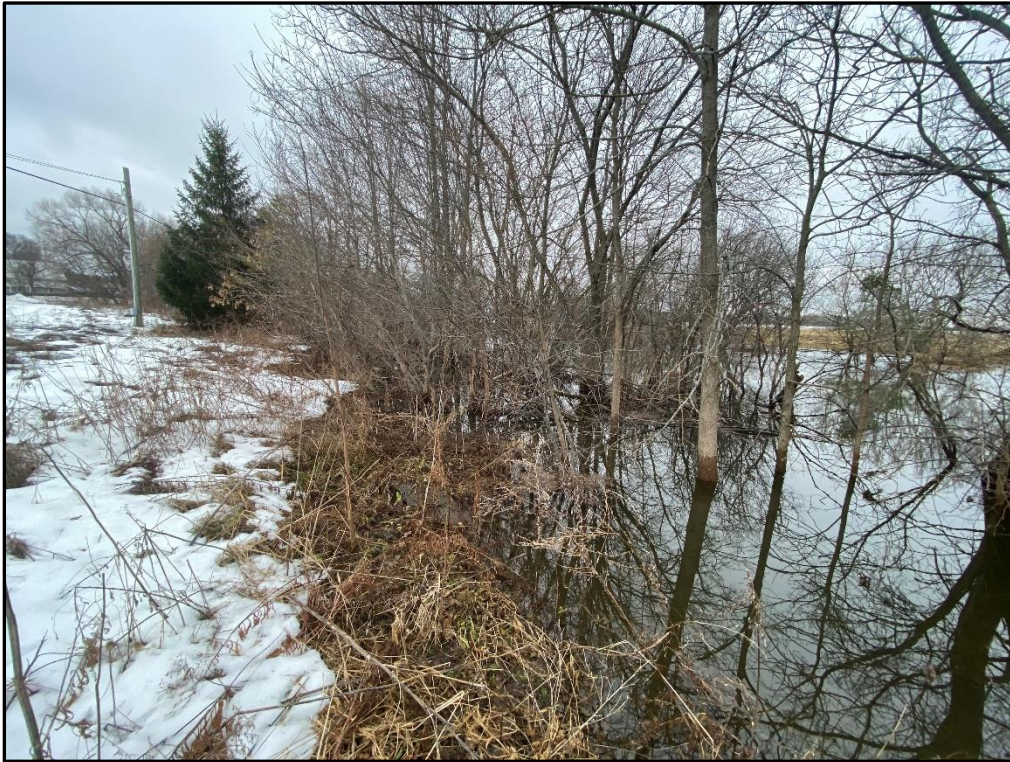
Photo 7: Watercourse sidewall is observed to be covered with vegetation. Photograph taken facing east.

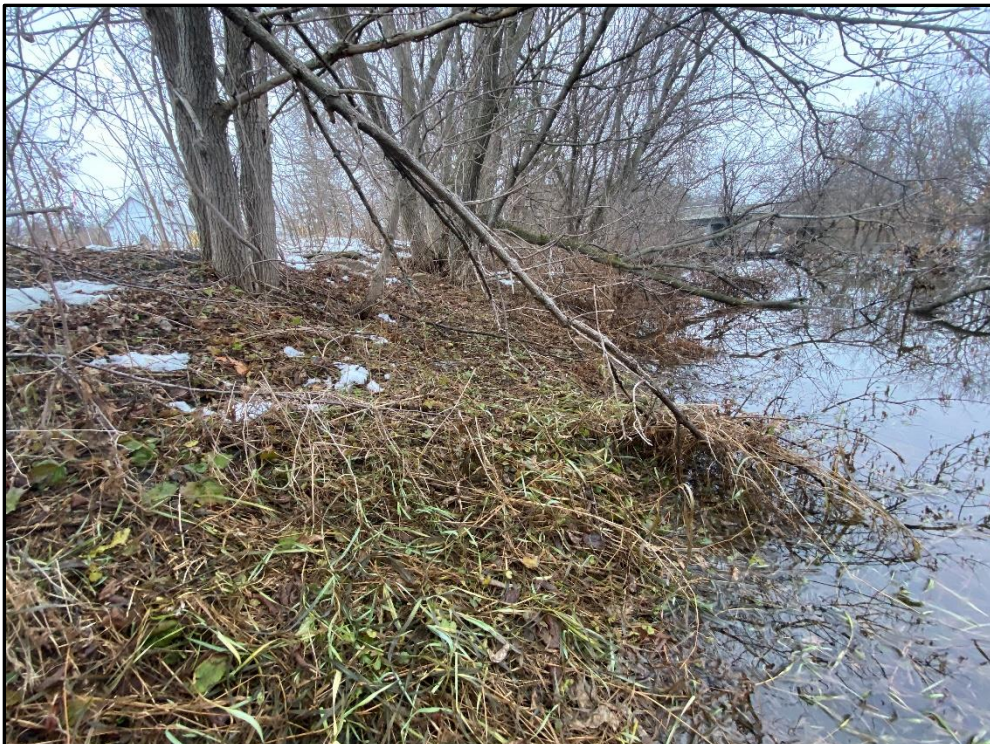
Photo 8: Slope face and watercourse sidewall observed to be covered with vegetation. Signs of erosion were not observed during the site visit. Photograph taken facing northeast.
