Phase I Environmental Site Assessment

2009 & 2013 Prince of Wales Drive
Nepean (Ottawa), Ontario

Jane Thompson Architect
404 MacKay Street
Ottawa, Ontario

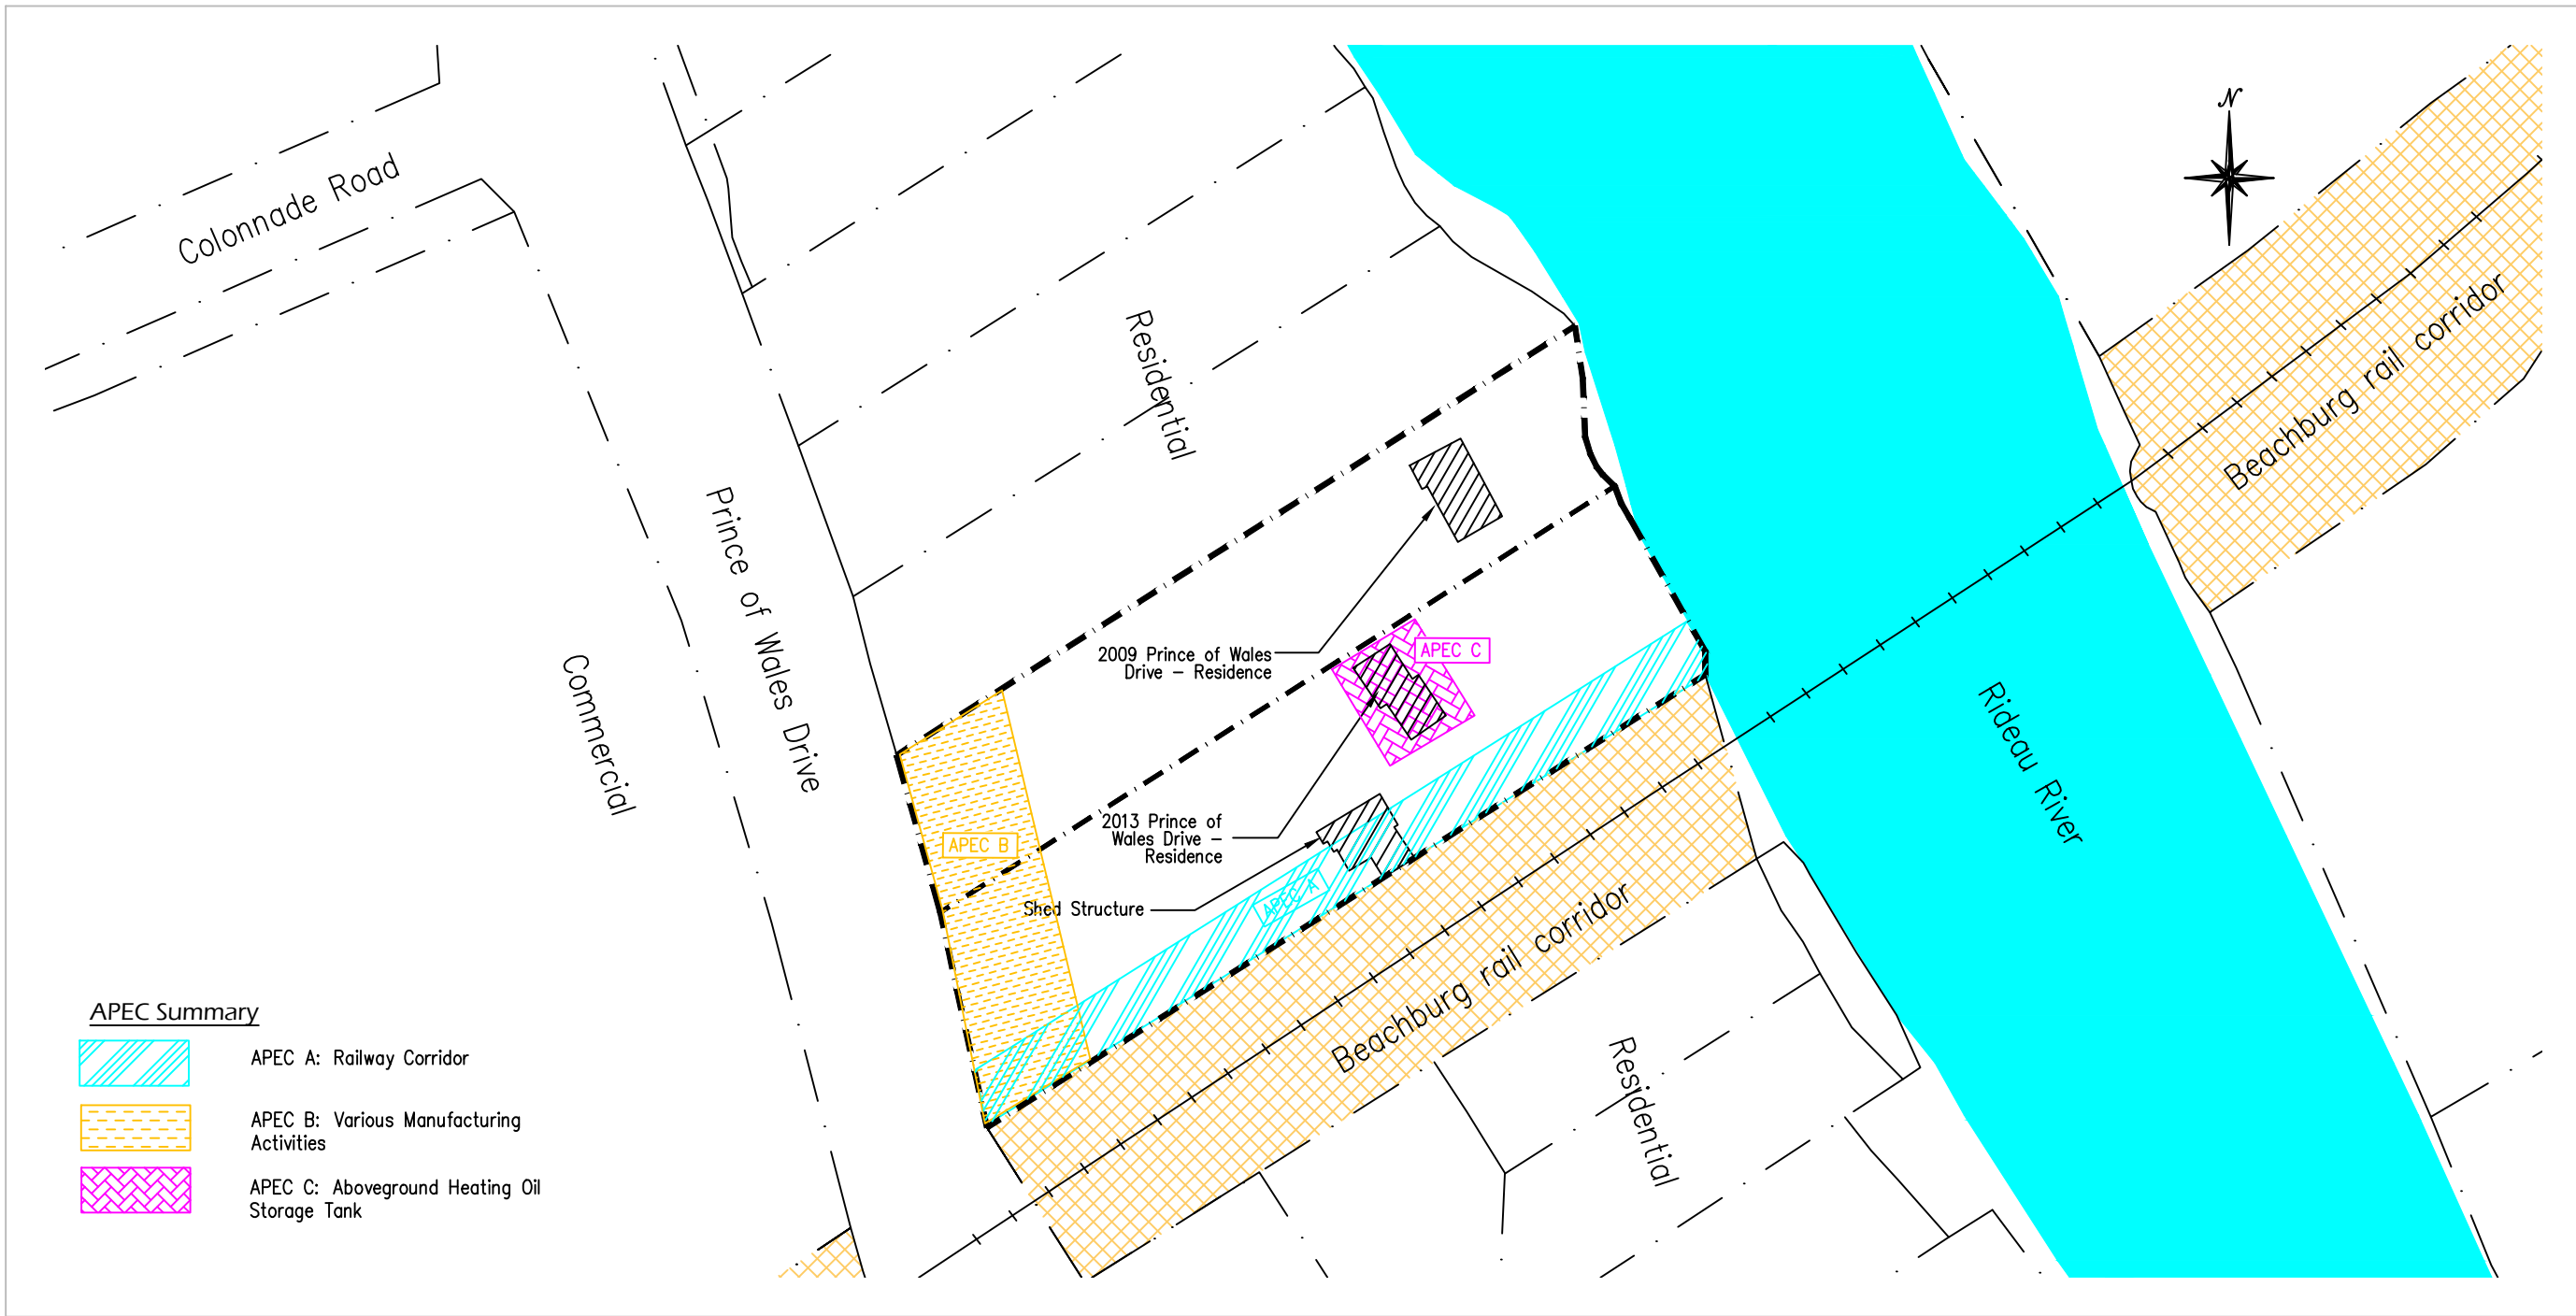
FIGURE 3

- APEC Summary**
-

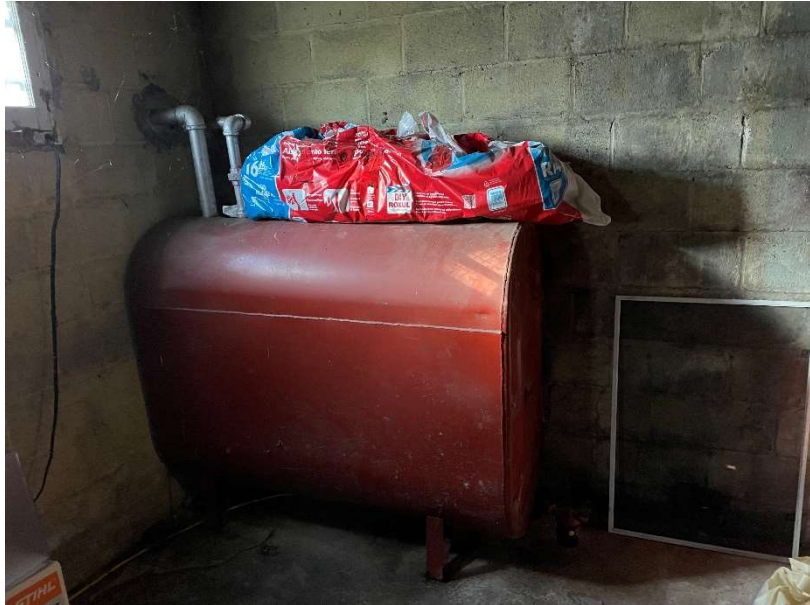
| Photograph No. 7 | |

| Description: 2013 Prince of Wales Drive: Aboveground heating oil storage tank located in the basement of residence. | |

| O. Reg 153/04 Schedule D PCA | Location of PCA | Description and Source Information | Contribution to an APEC |
|---|--|--|---|
| PCA 28: Gasoline and Associated Products Storage in Fixed Tanks. | On-Site, basement of 2013 Prince of Wales Drive. | An AST was observed during the Site visit. | The PCA is located on the Site and is therefore automatically considered to contribute to an on-site APEC. |

Based on the findings of the Phase One ESA, it is recommended that a Phase Two ESA be conducted on the Site to confirm the presence/absence of impacts in the areas of potential environmental concern identified.

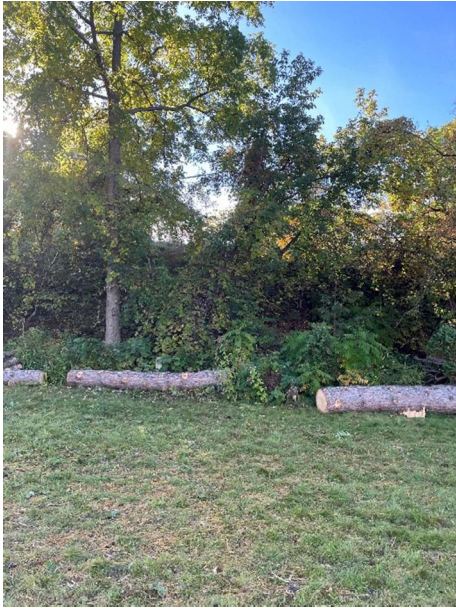
| Photograph No. 9 | |

| Description: Southern extent of the subject Site. Southern perimeter of 2009 Prince of Wales Drive adjacent to rail corridor. | |

| O. Reg 153/04 Schedule D PCA | Location of PCA | Description and Source Information | Contribution to an APEC |
|---|--|--|---|
| PCA 46: Rail Yards, Tracks and Spurs | The Beachburg Rail Corridor, along the southern perimeter of the Site. | Observed through aerial photography and Site Visit. | Due to the type of the activity and location being along the southern perimeter of the Site, this record is considered to represent an APEC to the southern portion of the Site. |

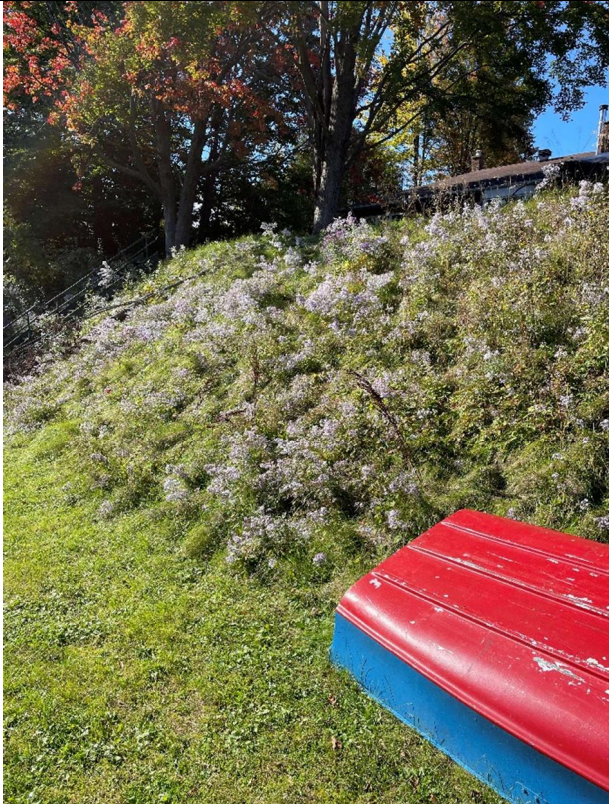
| Photograph No. 12 | |

| Description: Slope present along the eastern portion of the subject Site. | |
