Phase One Environmental Site Assessment

8599 & 8600
Jeanne D'Arc
Boulevard
Ottawa, Ontario

Prepared for:
3223701 Canada Inc.

LOP22-024A

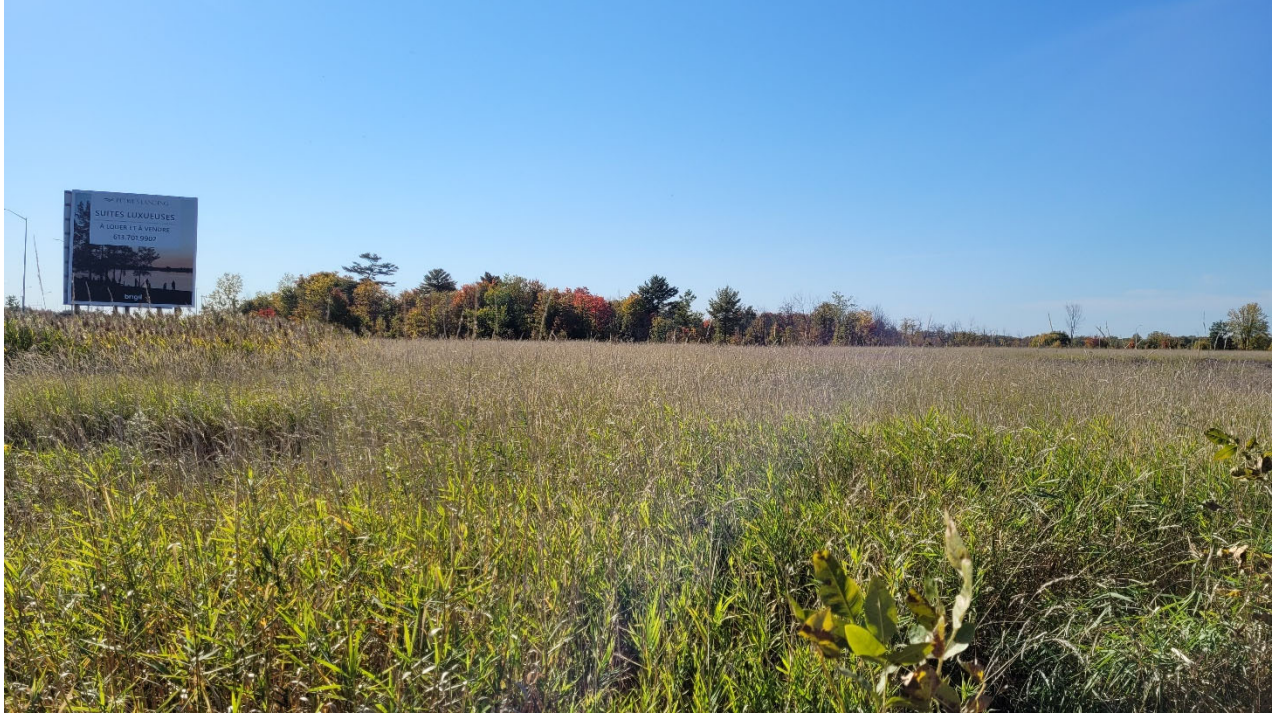
Photograph 1: View of the south portion of the Phase One Property looking west. View shows the Phase One Property to be overgrown with vegetation.

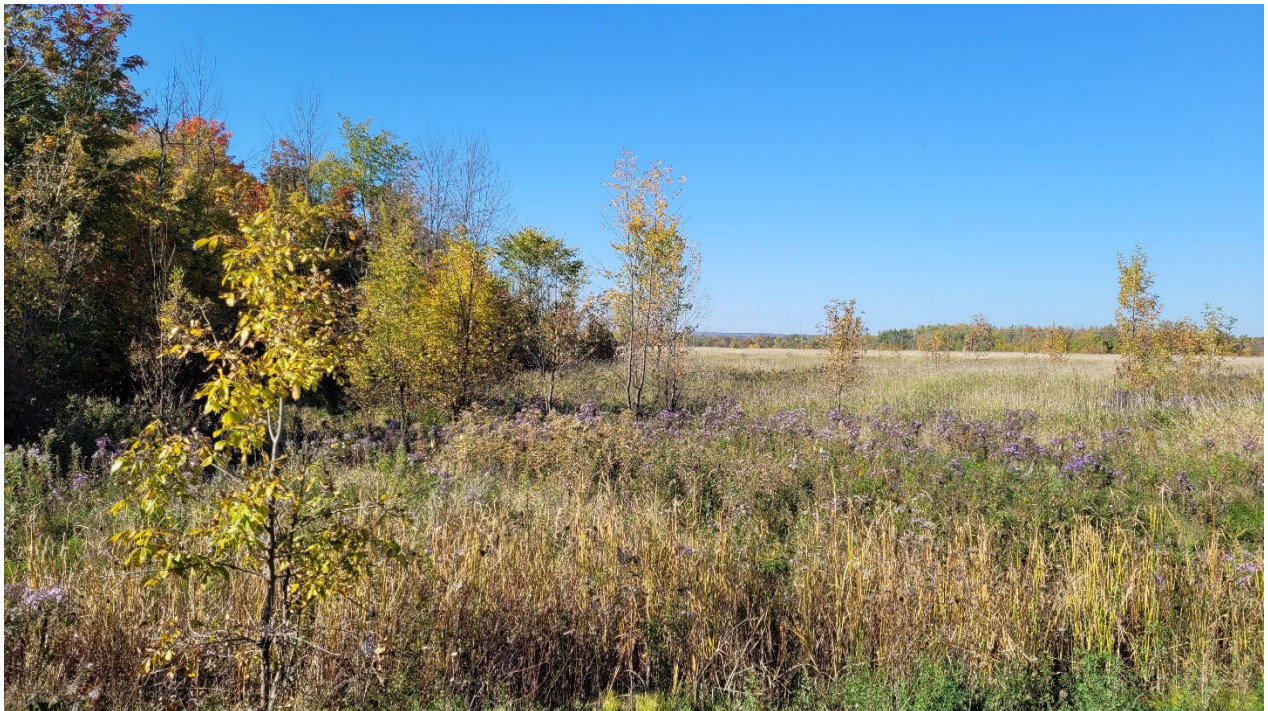
Photograph 2: View of the west side of the Phase One Property looking north. Mature trees can be observed on the left side of the photograph, which is the top of an embankment leading to Taylors Creek.

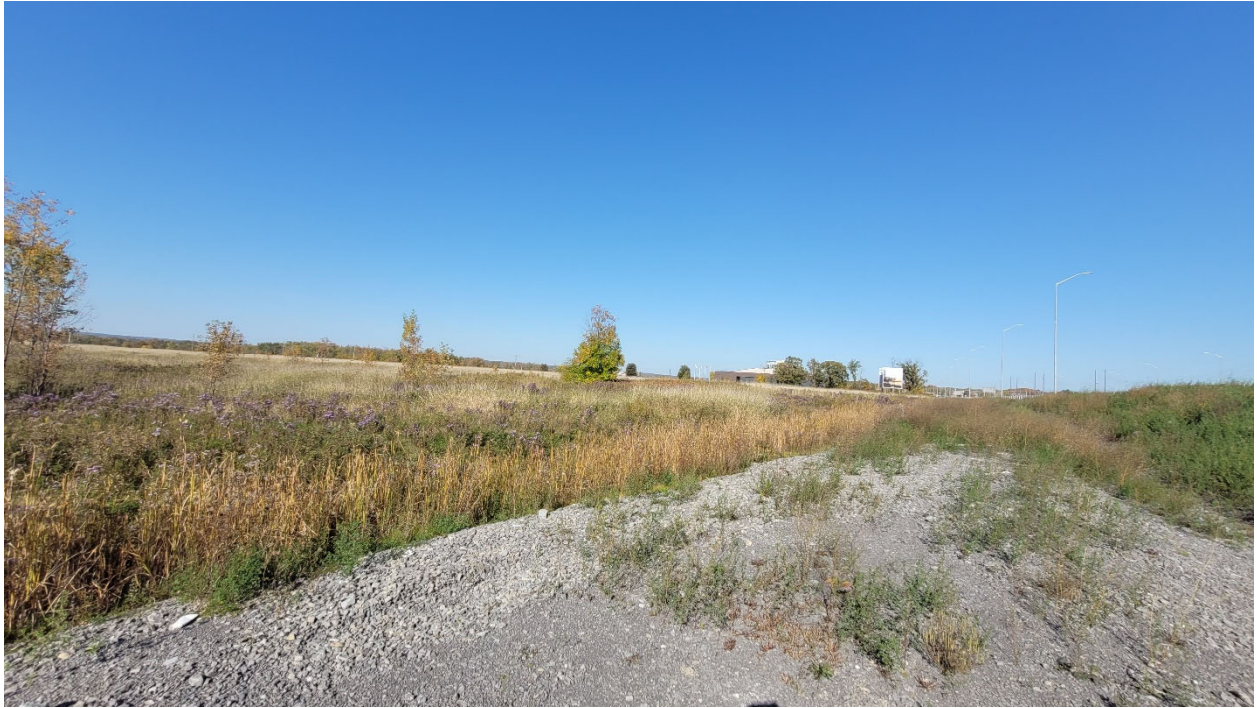
Photograph 3: View of the south side of the Phase One Property, looking east. La Cite Collegial can be seen in the distance; La Cite borders the east Property limits.

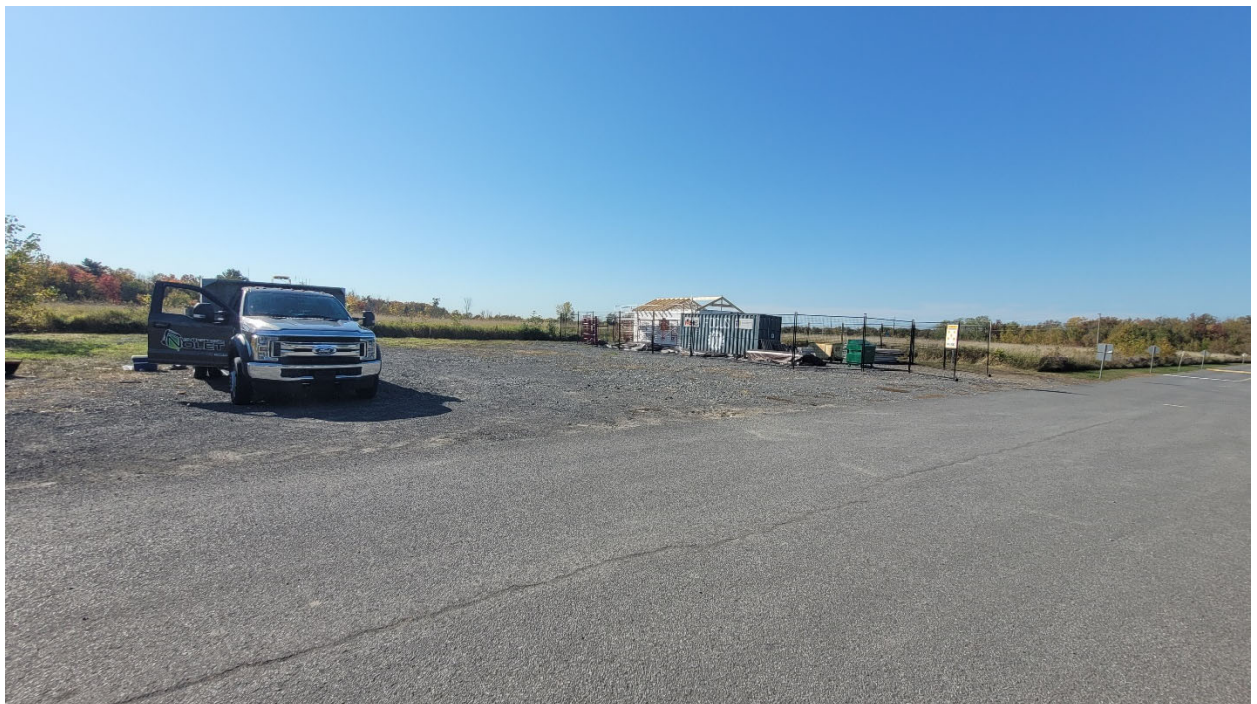
Photograph 4: View of a gravel pad and carpentry training area for La Cite Collegial on the east portion of the Phase One Property.

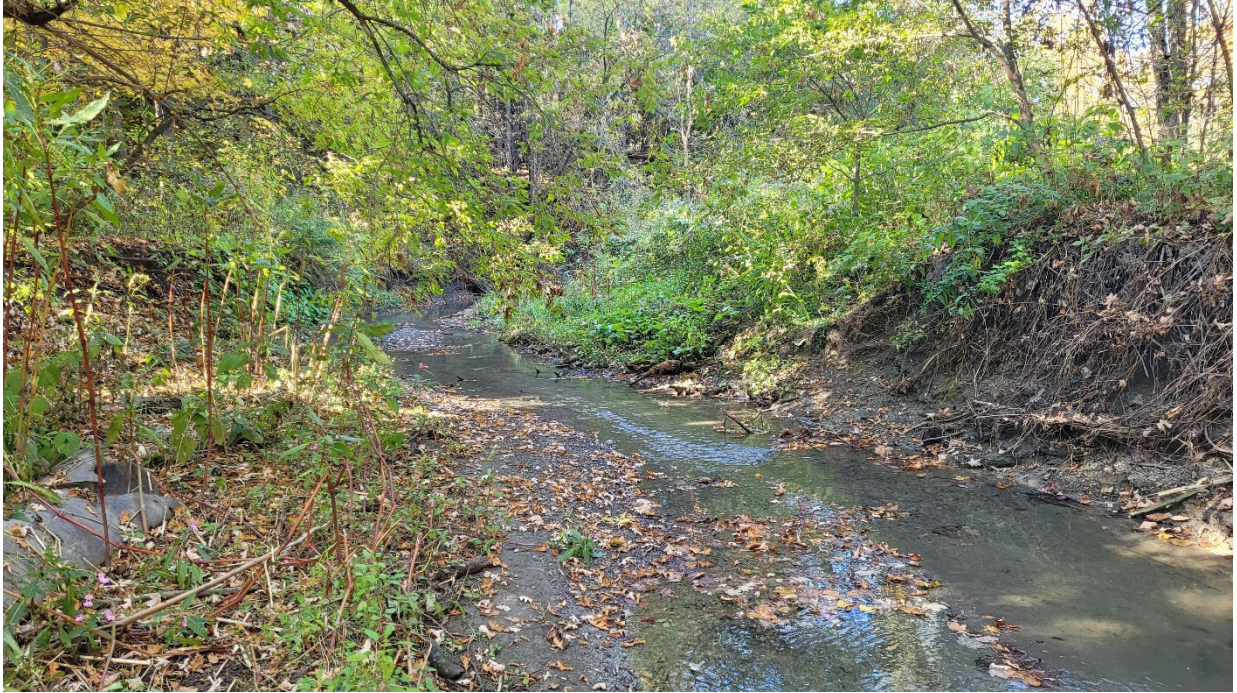
Photograph 5: View of Taylors Creek on the west portion of 8600 Jeanne D'Arc Boulevard; view is looking north.

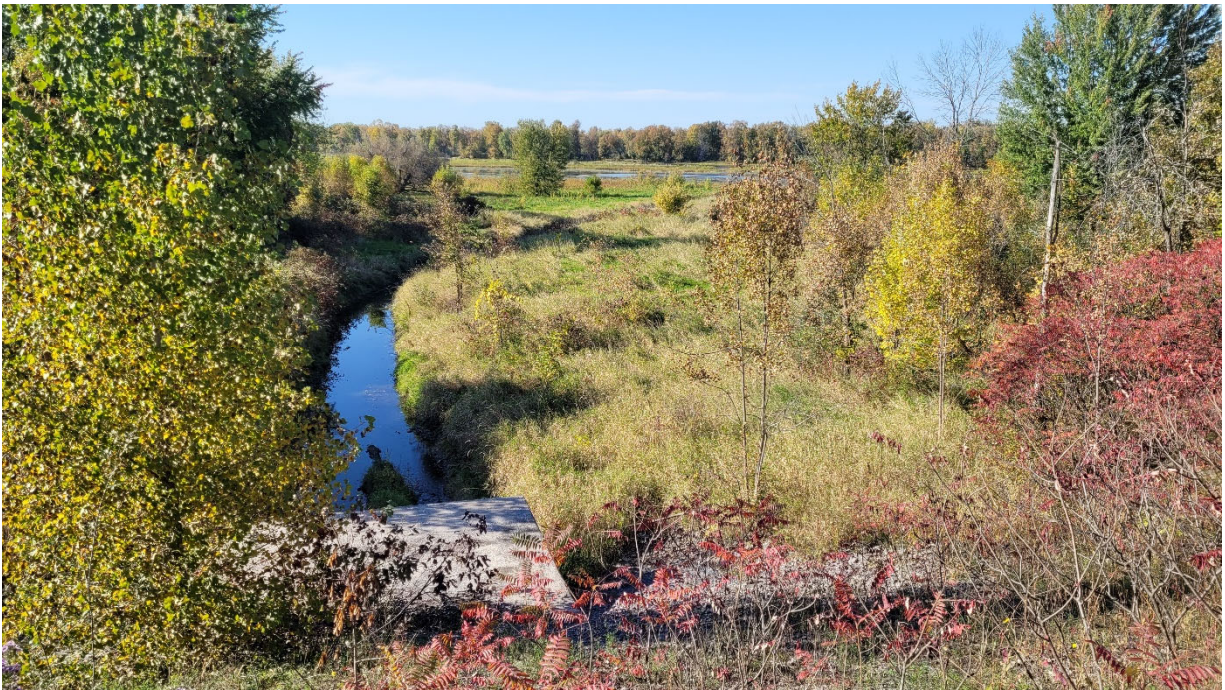
Photograph 6: View of Taylors Creek on the west portion of 8599 Jeanne D'Arc Boulevard; view is looking north towards the Ottawa River.

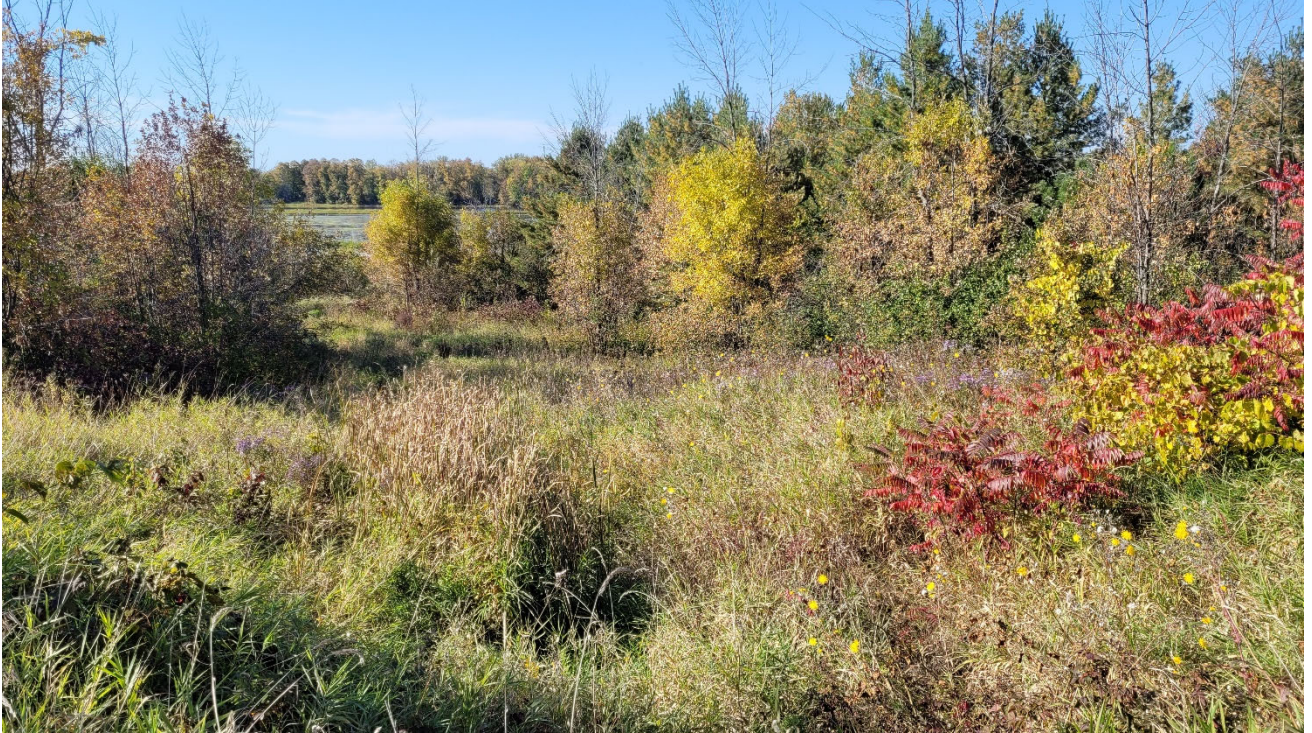
Photograph 7: View of the north portion of the Phase One Property (8599 Jeanne D'Arc), looking north. The Ottawa River can be seen further north of the Property.

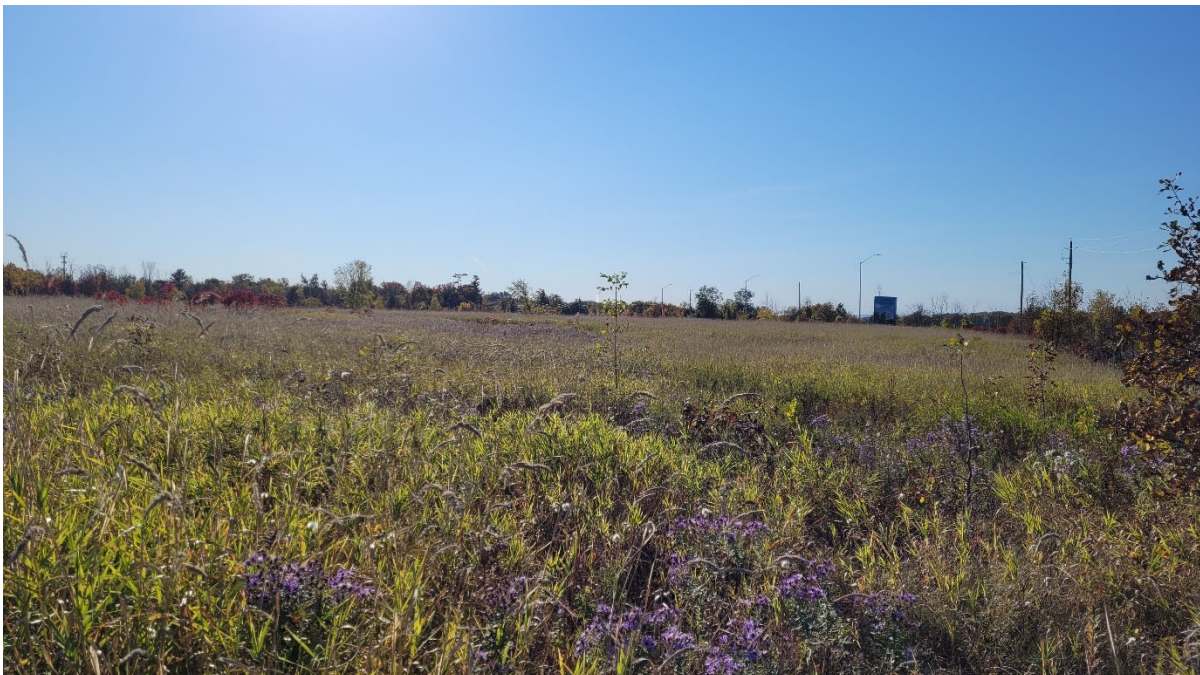
Photograph 8: View of the north portion of 8600 Jeanne D'Arc looking west. Jeanne D'Arc Boulevard is present on the left side of the photograph.
