**Hydrogeological Investigation & Terrain
Analysis
Proposed Residential Subdivision
Cedar Lakes Subdivision, Phase 3 and 4
Greely, Ontario**

ARK Engineering and Development
2691 Old Highway 17
Rockland, Ontario
K4K 1W3

December 27, 2023

Project: 100554.003 – Rev 1

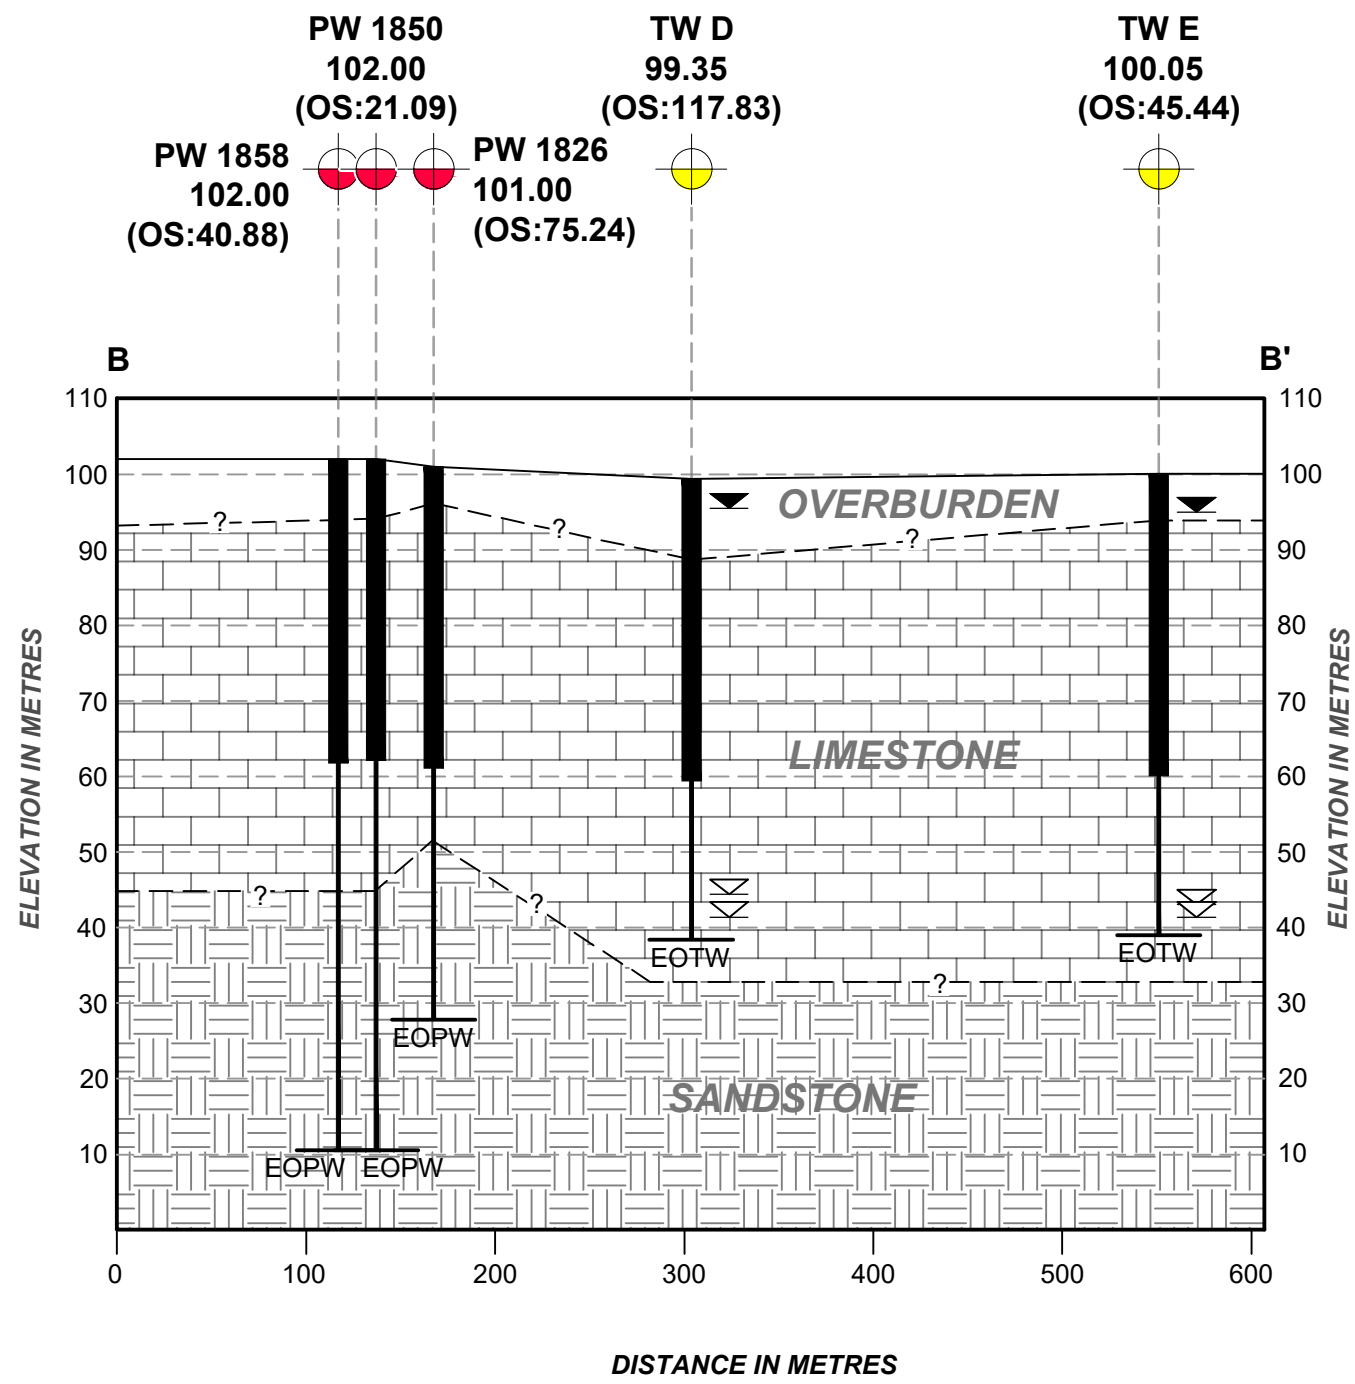
CROSS SECTION B - B'

HORIZONTAL 1:1000
VERTICAL 1:4000

An east-west hydrogeological cross-section (Figure 1A) across the site was prepared based information from onsite test wells, while a north-south cross section (Figure 1B) was prepared from private wells within approximately 100m (Figure 1). The boundaries between zones indicated on the cross-section have been interpreted based on available information as have conditions between the investigation points and are illustrative only. The actual conditions may differ somewhat from that indicated. The elevations are referenced to geodetic datum.

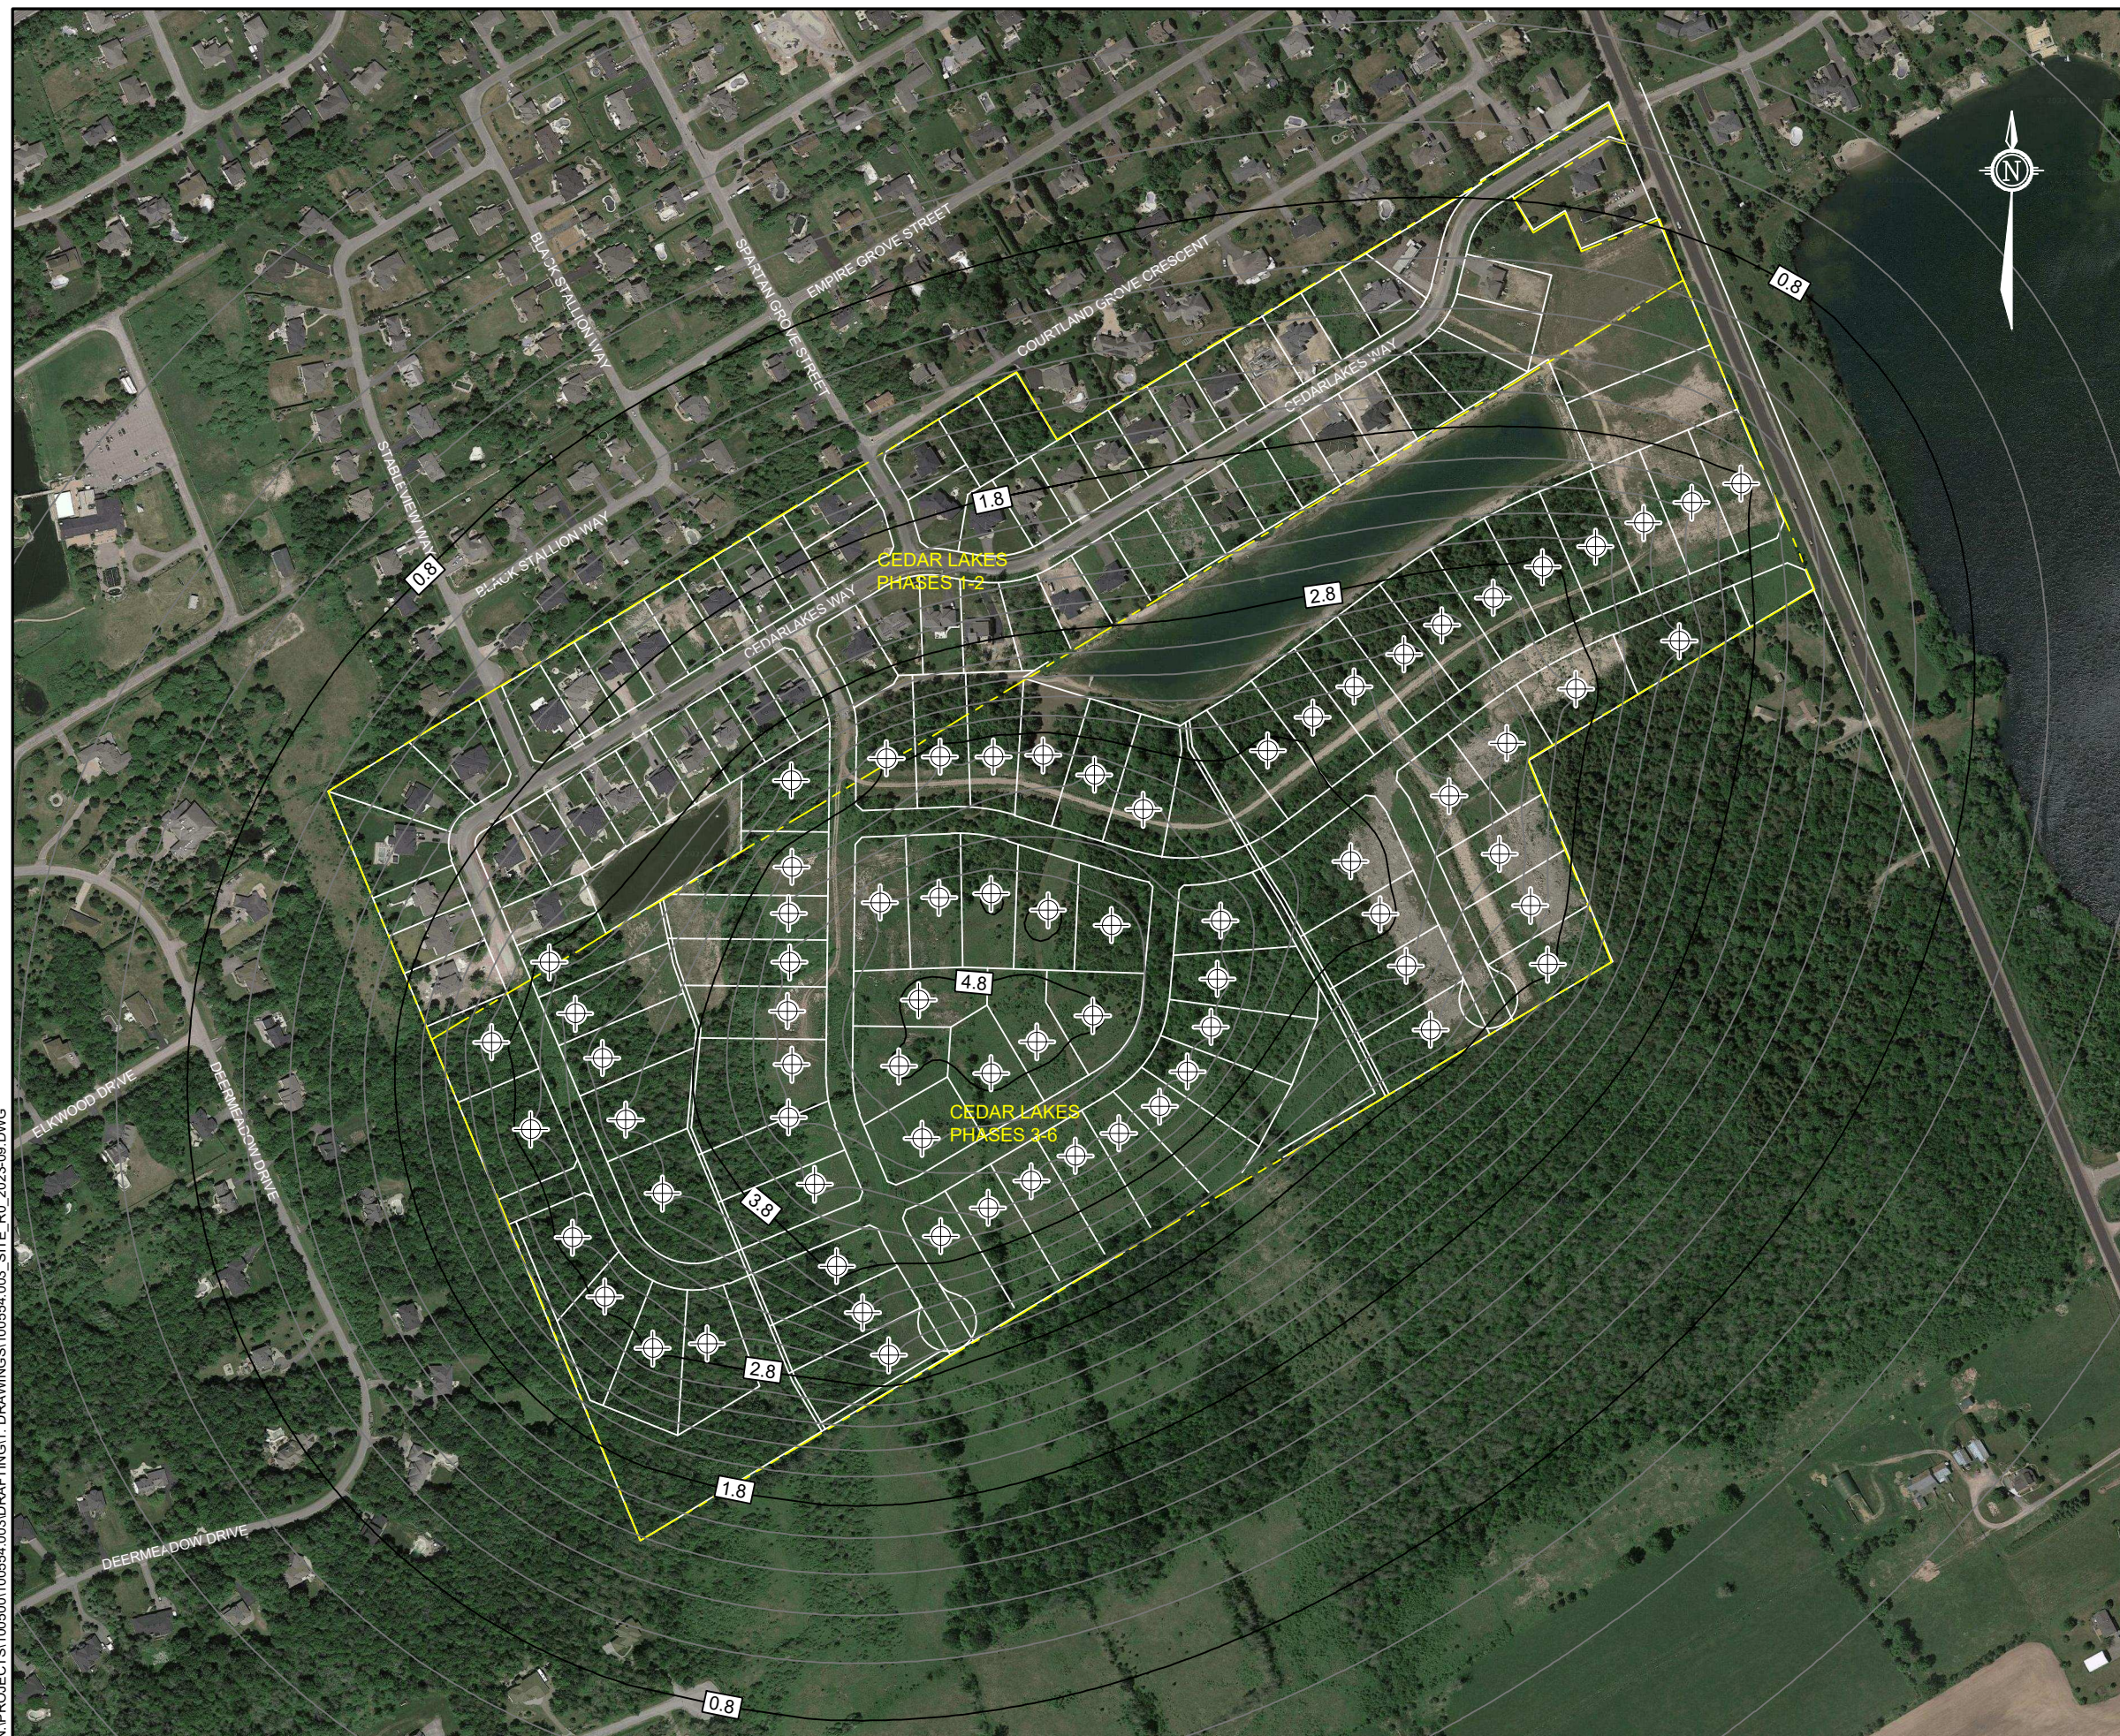
- PROPERTY BOUNDARY
- MINOR WATER TABLE DRAWDOWN CONTOUR, METRES
- MAJOR WATER TABLE DRAWDOWN CONTOUR, METRES
- 71 WELLS IN SIMULATION

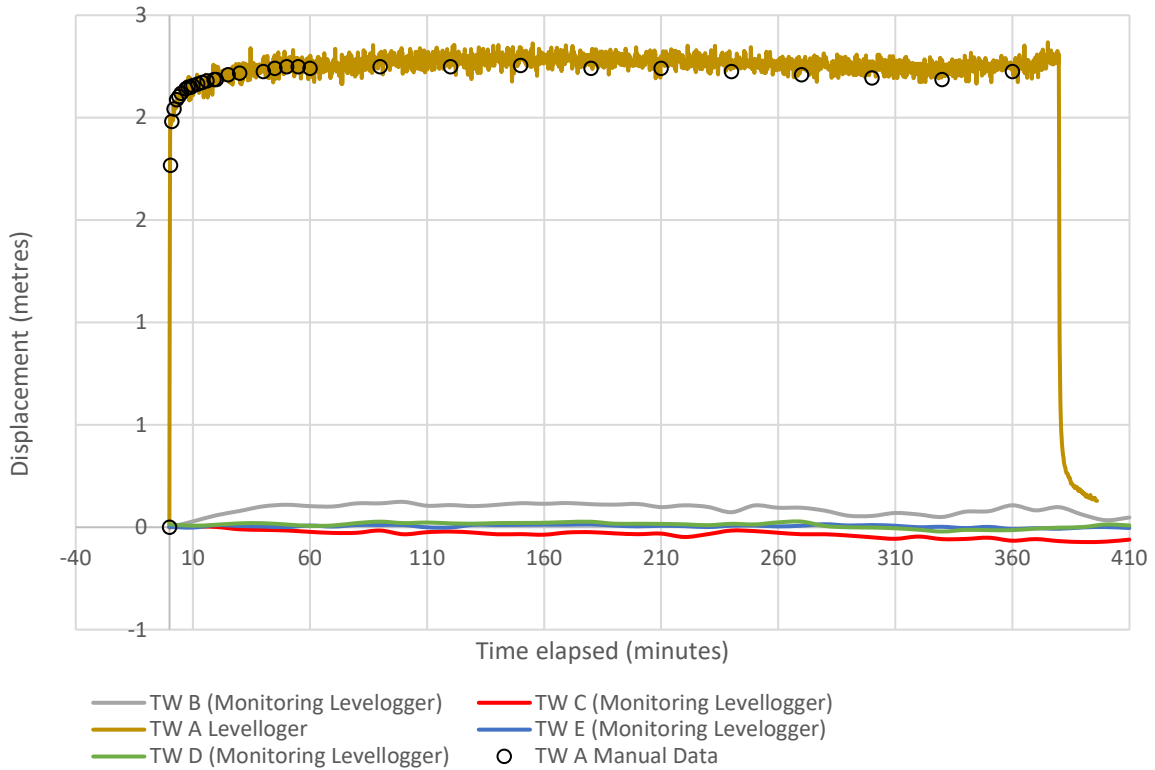
Pumping Test Data (TW A): Drawdown and Recovery

Water Levels TW A

Static : 5.43 m below top of casing
