# **Stittsville South W4 Future Neighborhood Area: Environmental Impact Study for the Draft Plan of Subdivision**

**2025-11-07**

## **Final Report**

Project Number: CAIV 1300.4

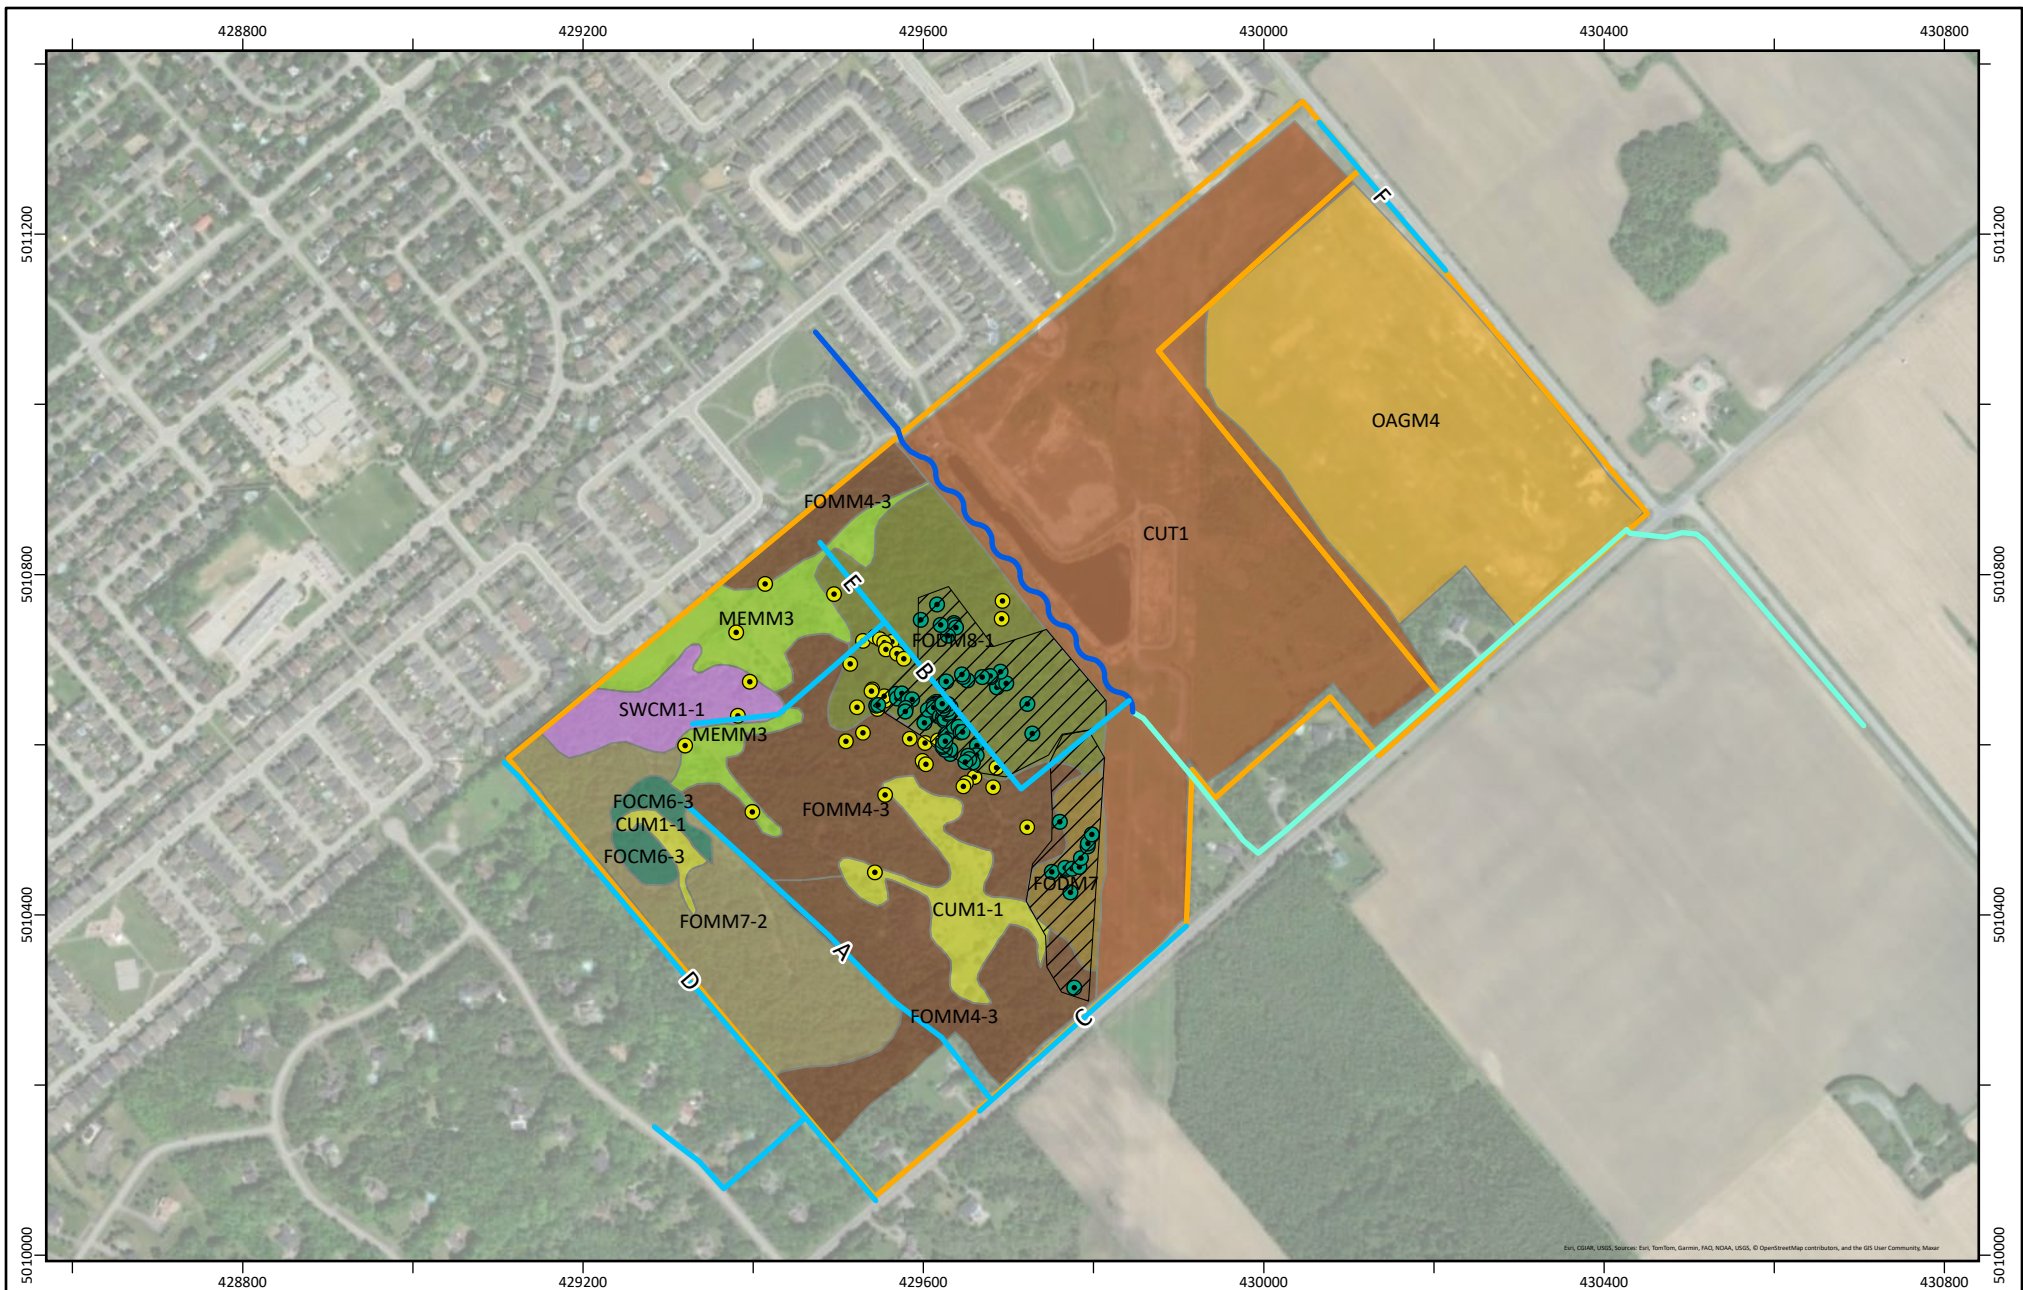
**Figure 3. Existing Conditions**

A total of ten distinct landcovers or ELC units were delineated on the Site (Figure 3). The majority of the western portion of the Site is a mixed Eastern White Cedar forest, a Poplar dominant deciduous forest, and meadow areas, with smaller areas of Scots Pine plantation and an Eastern White Cedar Swamp. The eastern portion of the Site is dominated by a thicket community and open agricultural lands. KAL Biologists were not permitted direct access to the small, residential parcels along Flewellyn Road as they are privately-owned. Road-side and aerial image reviews, however, indicate land cover on the small parcels (other than of the manicured spaces directly associated with houses and lawns) to correspond with the adjacent landcover of the Site. For each ELC unit identified, the dominant species observed, and any SAR plant species (highlighted in the descriptions below with an asterisk) are discussed in the following sections. An exhaustive list of all plant species observed in each ELC unit as well as tree sizes (DBH), where applicable is included in Appendix E.

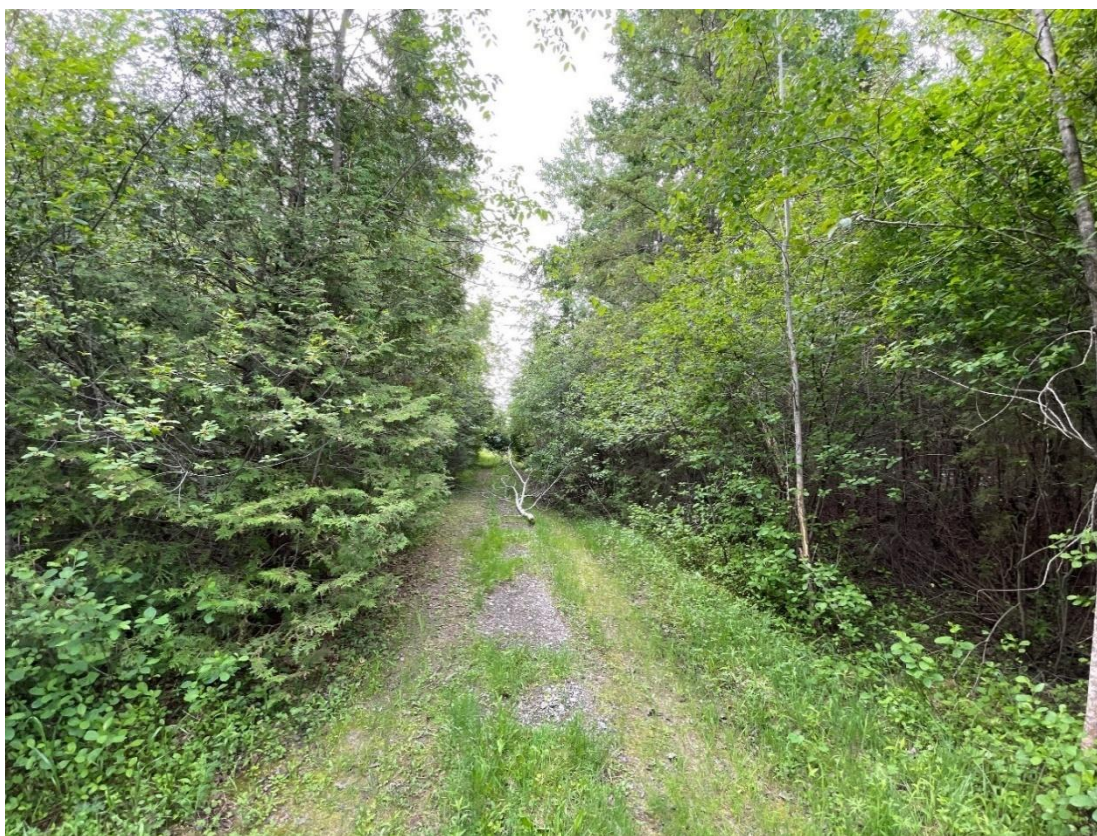
Figure 4. Dry - Fresh White Cedar – Hardwood Mixed Forest Type (FOMM4-3)

A broad swath of the western portion of the Site is characterized as a Dry - Fresh White Cedar – Hardwood Mixed Forest Type (FOMM4-3) community (Figure 4). It is dominated by Eastern White Cedar (*Thuja occidentalis*; 10-20 cm DBH), Trembling Aspen (*Populus tremuloides*; 10-20 cm DBH), Green Ash (*Fraxinus pennsylvanica*; 10-15 cm DBH), Large tooth Aspen (*Populus grandidentata*; ~15 cm DBH), White Spruce (*Picea glauca*; 30 cm DBH), White Pine (*Pinus strobus*; 25 cm DBH), Larch/Tamarack (*Larix laricina*; 15-20 cm DBH), American Beech (*Fagus grandifolia*; 10-15 cm DBH), and American Elm (*Ulmus americana*). Butternut\* (*Juglans cinerea*; 20-50 cm DBH) were observed scattered throughout this community.

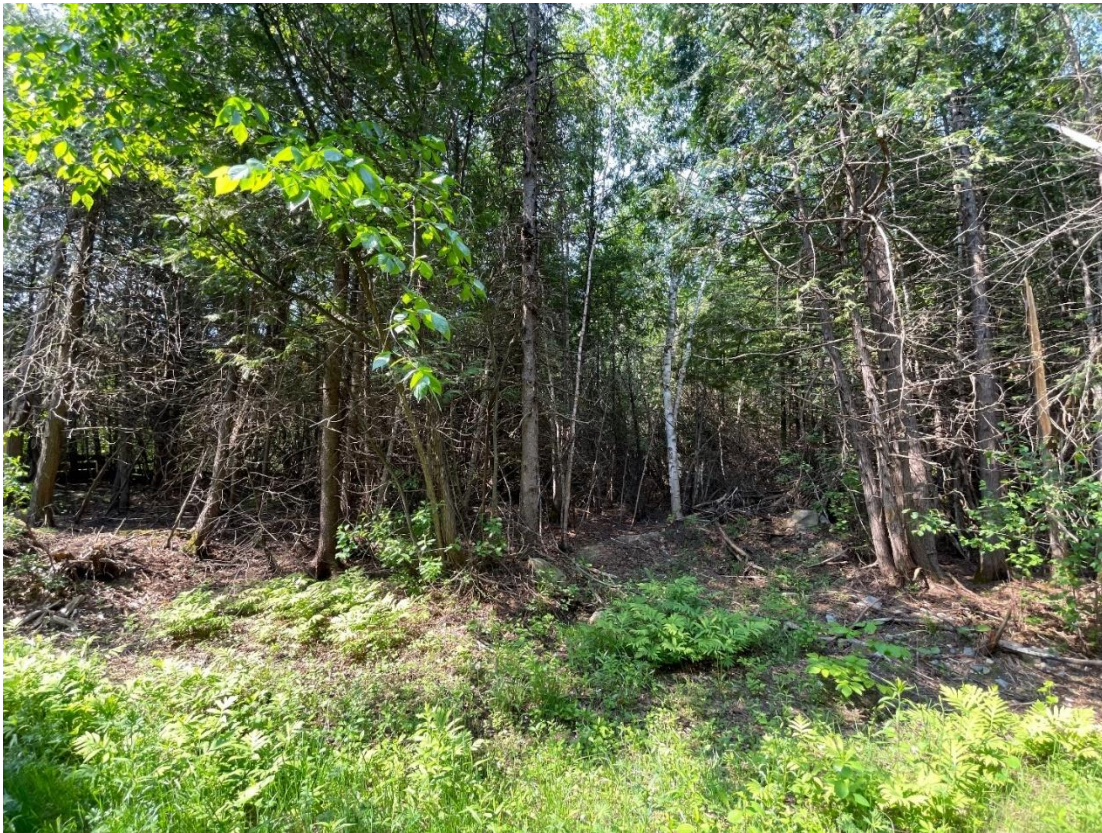
**Figure 5. Fresh - Moist White Cedar - Hardwood Mixed Forest Type (FOMM7-2)**

The western-most extent of the Site is characterized as a Fresh - Moist White Cedar - Hardwood Mixed Forest Type (FOMM7-2) community (Figure 5). It is dominated by Eastern White Cedar (*Thuja occidentalis*; 5-15 cm DBH), White Birch (*Betula papyrifera*; 10-20 cm DBH), Trembling Aspen (*Populus tremuloides*; 10-35 cm DBH), White Ash (*Fraxinus americana*; 5-8 cm DBH), White Spruce (*Picea glauca*; ~10 cm DBH), and Balsam Fir (*Abies Balsamea*) tree species.

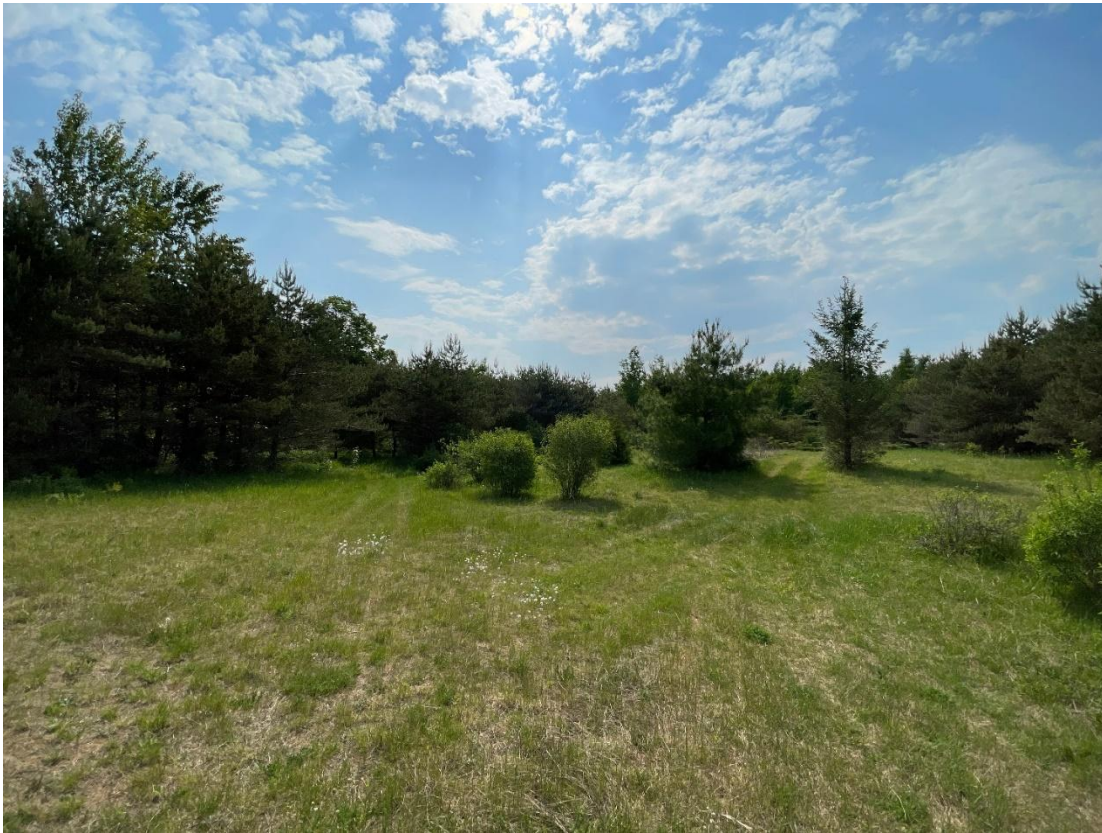
**Figure 6. Dry – Moist Old Field Meadow Type (CUM1-1)**

A Dry – Moist Old Field Meadow Type (CUM1-1; Figure 6) is located centrally on the Site. This area is characteristic of previous disturbance with scattered tree species including Large tooth Aspen (*Populus grandidentata*; ~5 cm DBH), Trembling Aspen (*Populus tremuloides*; 10-25 cm DBH), Eastern White Cedar (*Thuja occidentalis*; ~10 cm DBH), Scots Pine (*Pinus sylvestris*; 5-10 cm DBH), American Beech (*Fagus grandifolia*; ~10 cm DBH), Apple Spp. (*Malus*; 8-10 cm DBH), White Spruce (*Picea glauca*; 20-25 cm DBH), Larch/Tamarack (*Larix laricina*; ~5-10 cm DBH), Green Ash (*Fraxinus pennsylvanica*; <5 cm DBH). Dominant shrub and groundcover species included Common Juniper (*Juniperus communis*), Trembling Aspen (*Populus tremuloides*) saplings, Orchard Grass (*Dactylis glomerata*), Wild Strawberry (*Fragaria vesca*), Canada Goldenrod (*Solidago canadensis*), Poison Ivy (*Toxicodendron radicans*), Red Raspberry (*Rubus idaeus*), Alder Buckthorn (*Rhamnus frangula*), and Common Blackberry (*Rubus allegheniensis*).

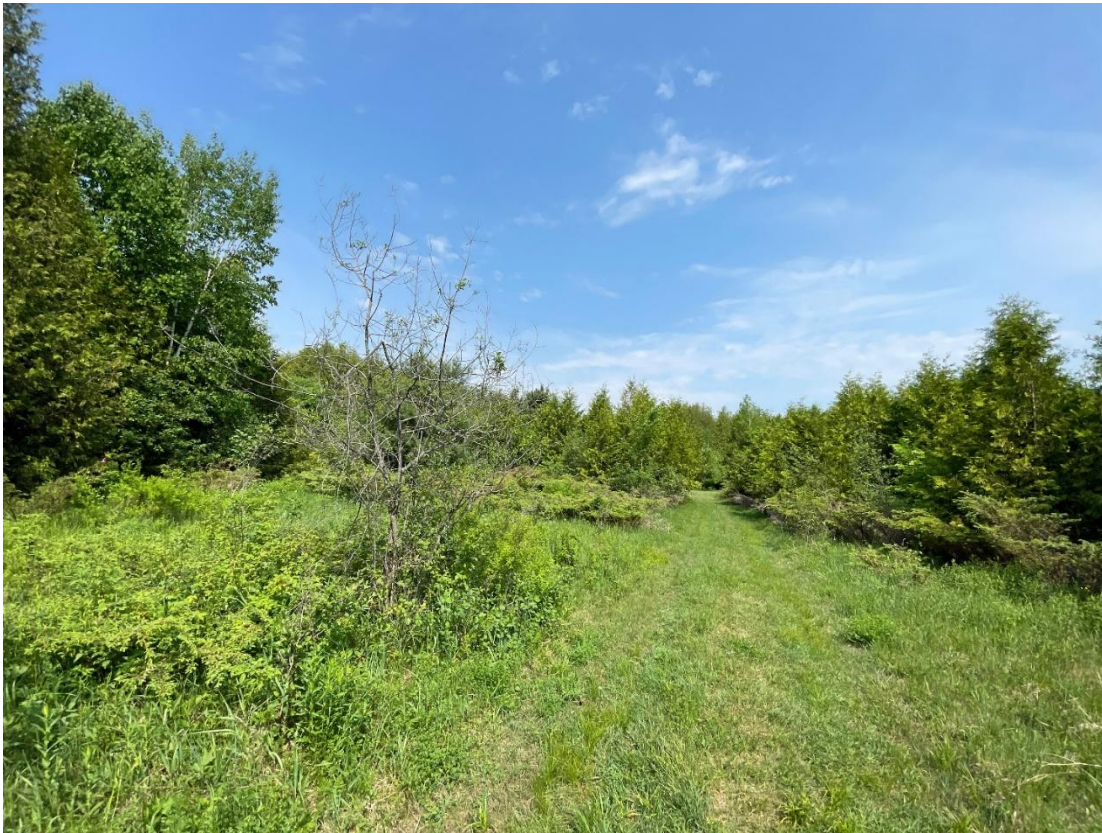
**Figure 7. Dry – Fresh Mixed Meadow Ecosite (MEMM3)**

A Dry – Fresh Mixed Meadow Ecosite (MEMM3) is located in the northwest corner of the Site (Figure 7). This area is mainly characterized by Eastern White Cedar (*Thuja occidentalis*), Scots Pine (*Pinus sylvestris*; ~10-20 DBH), Larch/Tamarack (*Larix laricina*; ~10 DBH), and scattered Butternut\* (*Juglans cinerea*; ~10-20 DBH) trees. Dominant shrub and groundcover species included Common Juniper (*Juniperus communis*), Orchard grass (*Dactylis glomerata*), Wild strawberry (*Fragaria vesca*), Canada Goldenrod (*Solidago canadensis*), Alder Buckthorn (*Rhamnus frangula*), and Common Blackberry (*Rubus allegheniensis*).

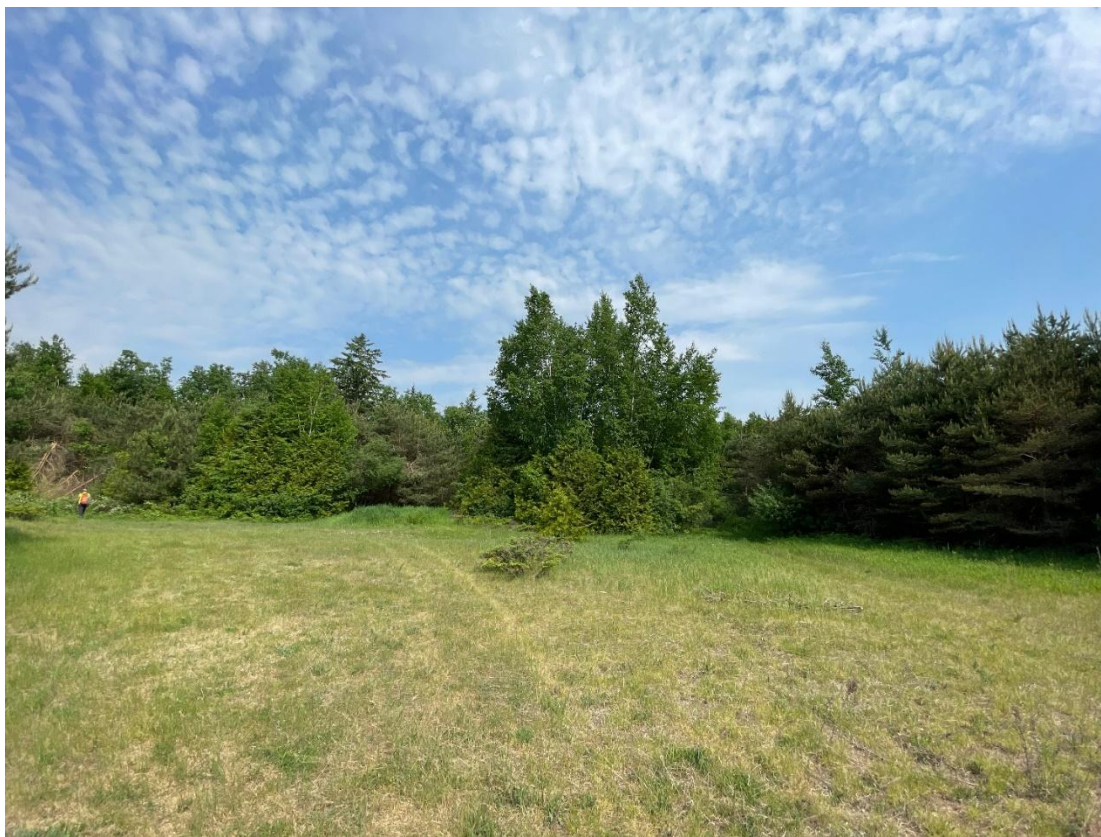
**Figure 8. Dry – Fresh Scots Pine Naturalized Coniferous Plantation Type (FOCM6-3)**

A Fresh Scots Pine Naturalized Coniferous Plantation Type (FOCM6-3) is located in the northwest corner of the Site (Figure 8). It is mainly dominated by Scots Pine (*Pinus sylvestris*; ~10-20 cm DBH), Jack Pine (*Pinus banksiana*; ~15 cm DBH), Eastern White Cedar (*Thuja occidentalis*), White Pine (*Pinus strobus*; ~20 cm DBH), White Birch (*Betula papyrifera*; 10-20 cm DBH), Butternut\* (*Juglans cinerea*), American Beech (*Fagus grandifolia*), and Green Ash (*Fraxinus pennsylvanica*; 10-15 cm DBH).

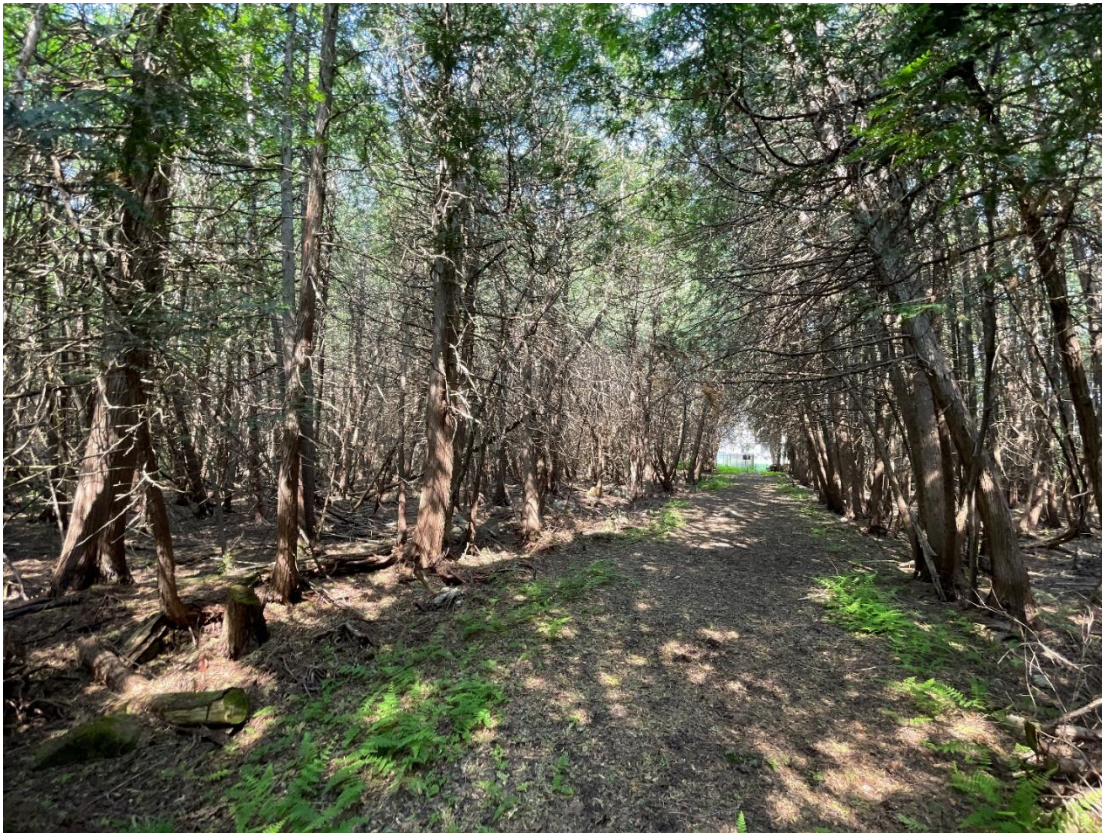
**Figure 9. White Cedar Mineral Coniferous Swamp (SWCM1-1)**

A White Cedar Mineral Coniferous Swamp (SWCM1-1) is located on Site (Figure 9). It is dominated by Eastern White Cedar (*Thuja occidentalis*) and has ground cover consisting of Bulblet Bladder Fern (*Cystopteris bulbifera*), Alder Buckthorn (*Rhamnus frangula*), Interrupted Fern (*Osmunda claytoniana*), Sensitive Fern (*Onoclea sensibilis*), and Poison Ivy (*Toxicodendron radicans*).

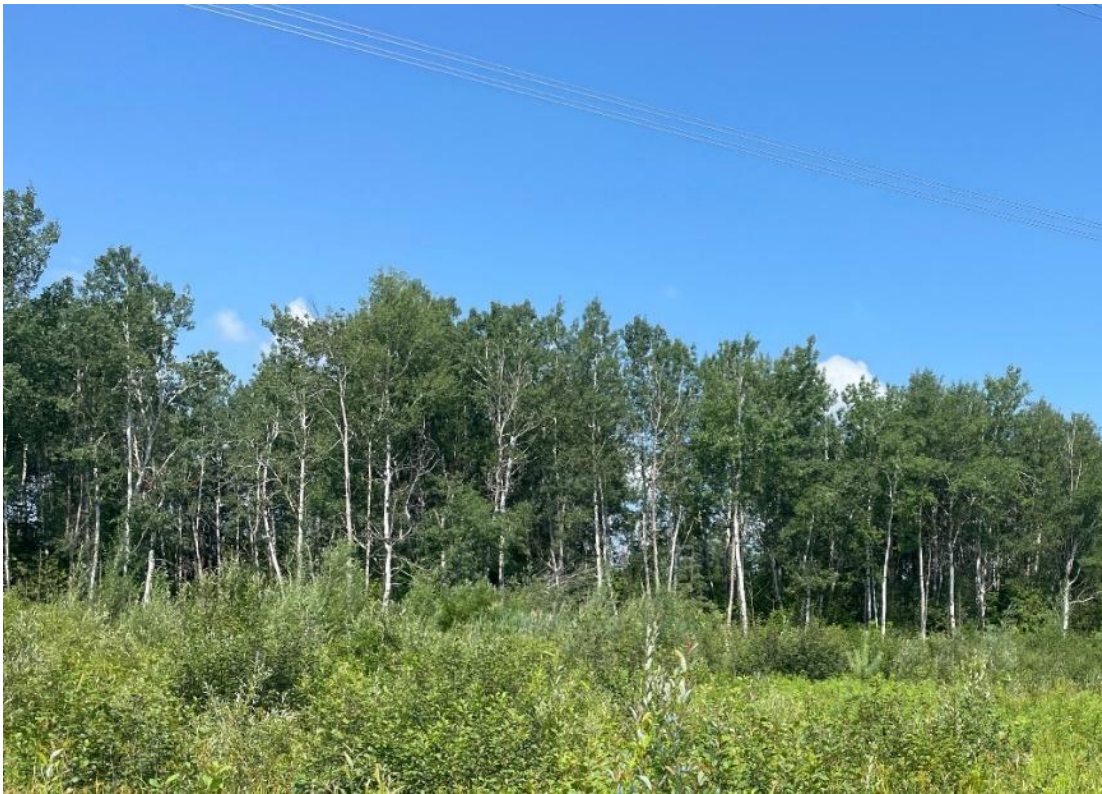
**Figure 10. Fresh – Moist Lowland Deciduous Forest Ecosite (FODM7)**

A Fresh-Moist Lowland Deciduous Forest Ecosite (FODM7) is located in the center of the Site (Figure 10). It is dominated by Trembling Aspen (*Populus tremuloides*) Eastern White Cedar (*Thuja occidentalis*), Butternut\* (*Juglans cinerea*), Black Ash\* (*Fraxinus nigra*), and Balsam Poplar (*Populus balsamifera*). Its ground cover consists of Common Buckthorn (*Rhamnus cathartica*), Poison Ivy (*Toxicodendron radicans*), White Panicle Aster (*Symphotrichum lanceolatum*), Riverbank Grape (*Vitis riparia*), Common Ragweed (*Ambrosia artemisiifolia*), and Yellow Sweet Clover (*Melilotus officinalis*).

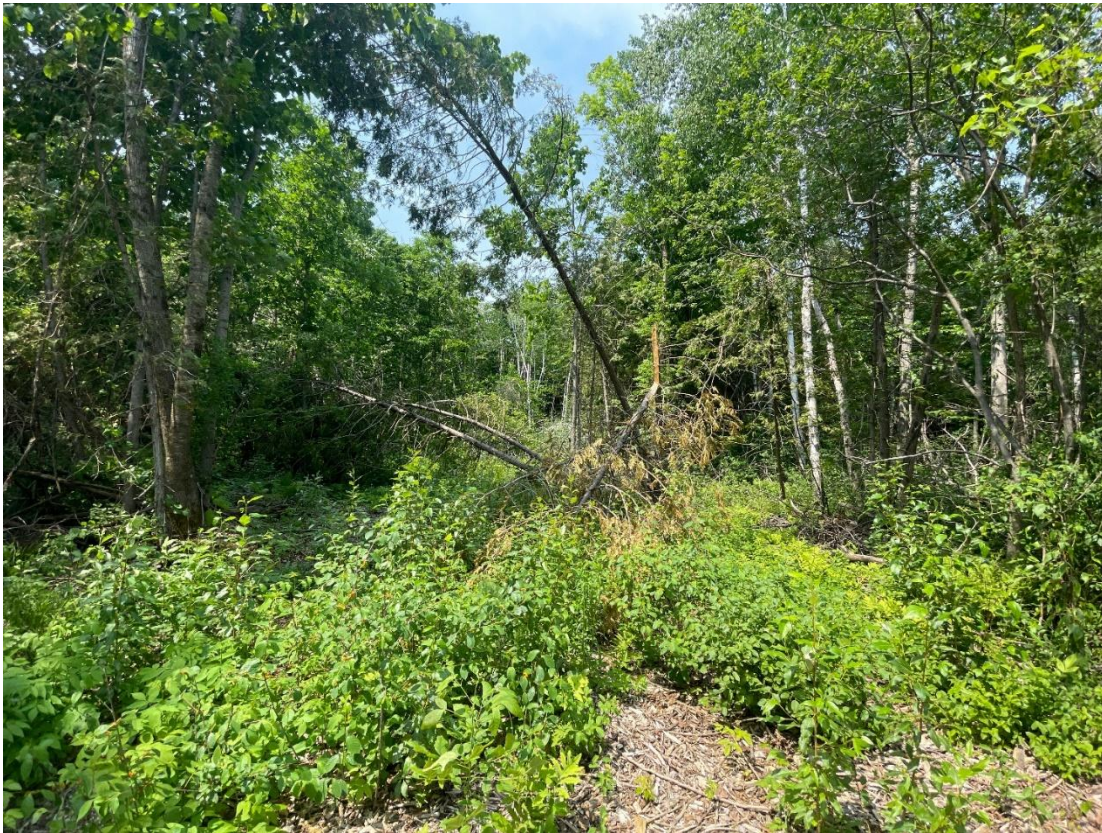
**Figure 11. Fresh – Moist Poplar Deciduous Forest Type (FODM8-1)**

A Fresh – Moist Poplar Deciduous Forest Type (FODM8-1; Figure 11) is located on Site and is dominated by Trembling Aspen (*Populus tremuloides*; 10-20 cm DBH), White Birch (*Betula papyrifera*; 10-20 cm DBH), Balsam Poplar (*Populus balsamifera*; 10-25 cm DBH), Butternut\* (*Juglans cinerea*; 10-20 cm DBH), Eastern White Cedar (*Thuja occidentalis*; 10-20 cm DBH), Basswood (*Tilia americana*; ~30 cm DBH), Red Maple (*Acer rubrum*; ~27 cm DBH), American Elm (*Ulmus americana*; 10-20 cm DBH), and Black Ash\* (*Fraxinus nigra*). Its dominant ground cover consists of Common Juniper (*Juniperus communis*), Trembling Aspen saplings (*Populus tremuloides*), Sensitive Fern (*Onoclea sensibilis*), Ostrich Fern (*Matteuccia struthiopteris*), Interrupted Fern (*Osmunda claytoniana*), Canada Goldenrod (*Solidago canadensis*), Poison Ivy (*Toxicodendron radicans*), Alder Buckthorn (*Rhamnus frangula*), Bloodroot (*Sanguinaria*), and Meadow Horsetail (*Equisetum pratense*).

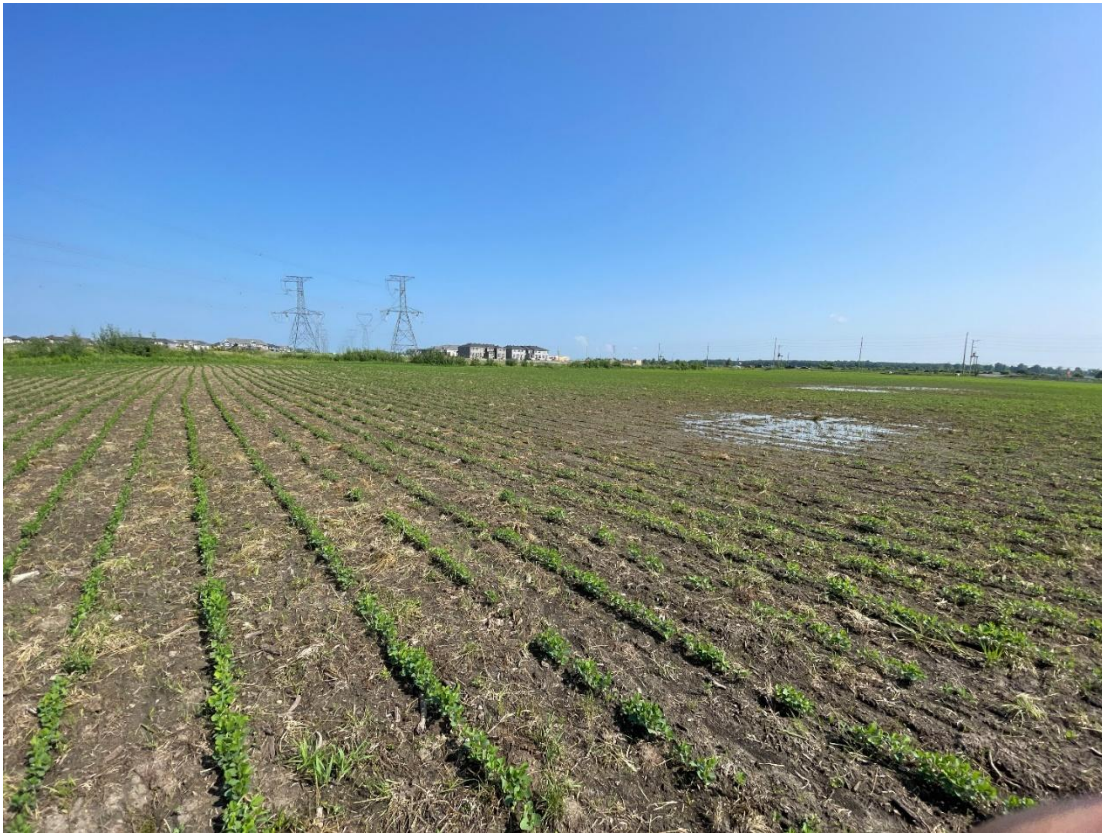
**Figure 12. Medium Mineral Open Pasture Type (OAGM4)**

A Medium Mineral Open Pasture Type (OAGM4) on Site (Figure 12) is dominated by planted crop cultivar and scattered shrub community species such as Canada Goldenrod (*Solidago canadensis*), Meadow Horsetail (*Equisetum pratense*), Purple Aster (*Symphyotrichum patens*), Common Mullein (*Verbascum thapsus*), Meadow Buttercup (*Ranunculus acris*), Wild Strawberry (*Fragaria vesca*), and Common Dandelion (*Taraxacum officinale*).

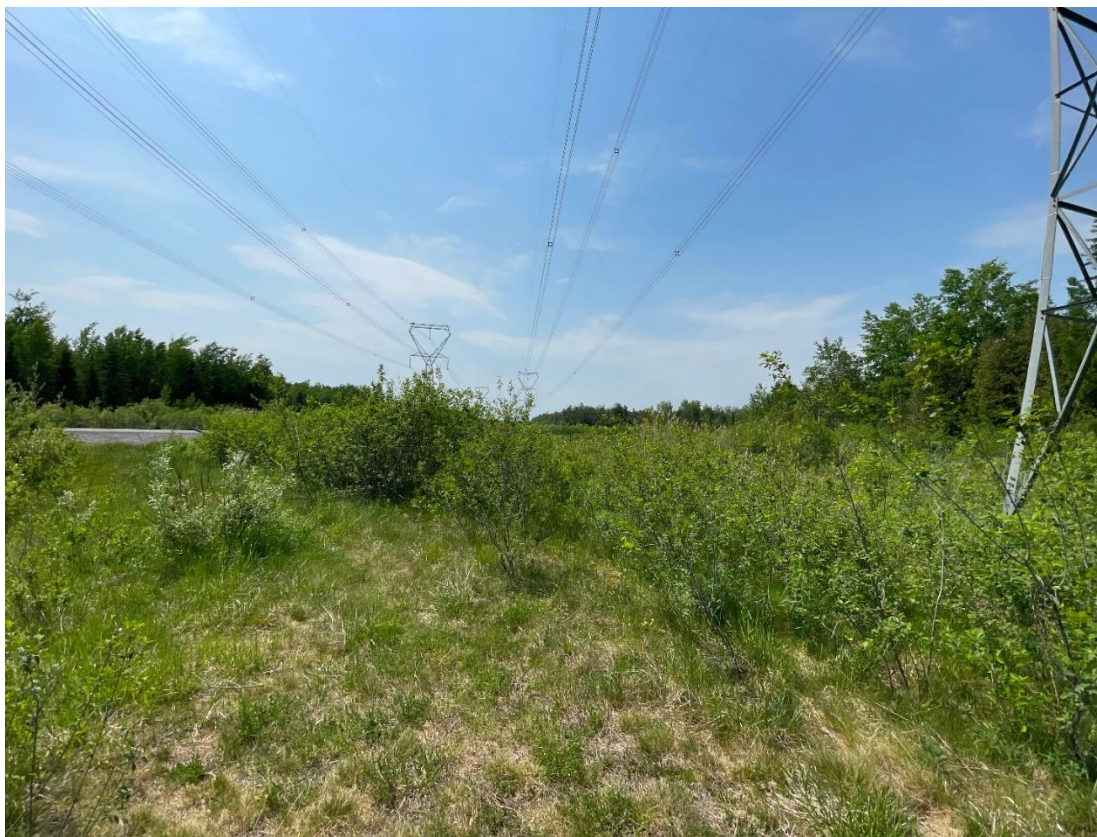
**Figure 13. Cultural Thicket Ecosite (CUT1)**

A Cultural Thicket Ecosite (CUT1; Figure 13) on Site is dominated by Bebb's Willow (*Salix bebbiana*), Alder Buckthorn (*Rhamnus frangula*), Trembling Aspen Saplings (*Populus tremuloides*), White Willow (*Salix alba*), White Meadowsweet (*Spiraea alba*), and Common Milkweed (*Asclepias syriaca*).

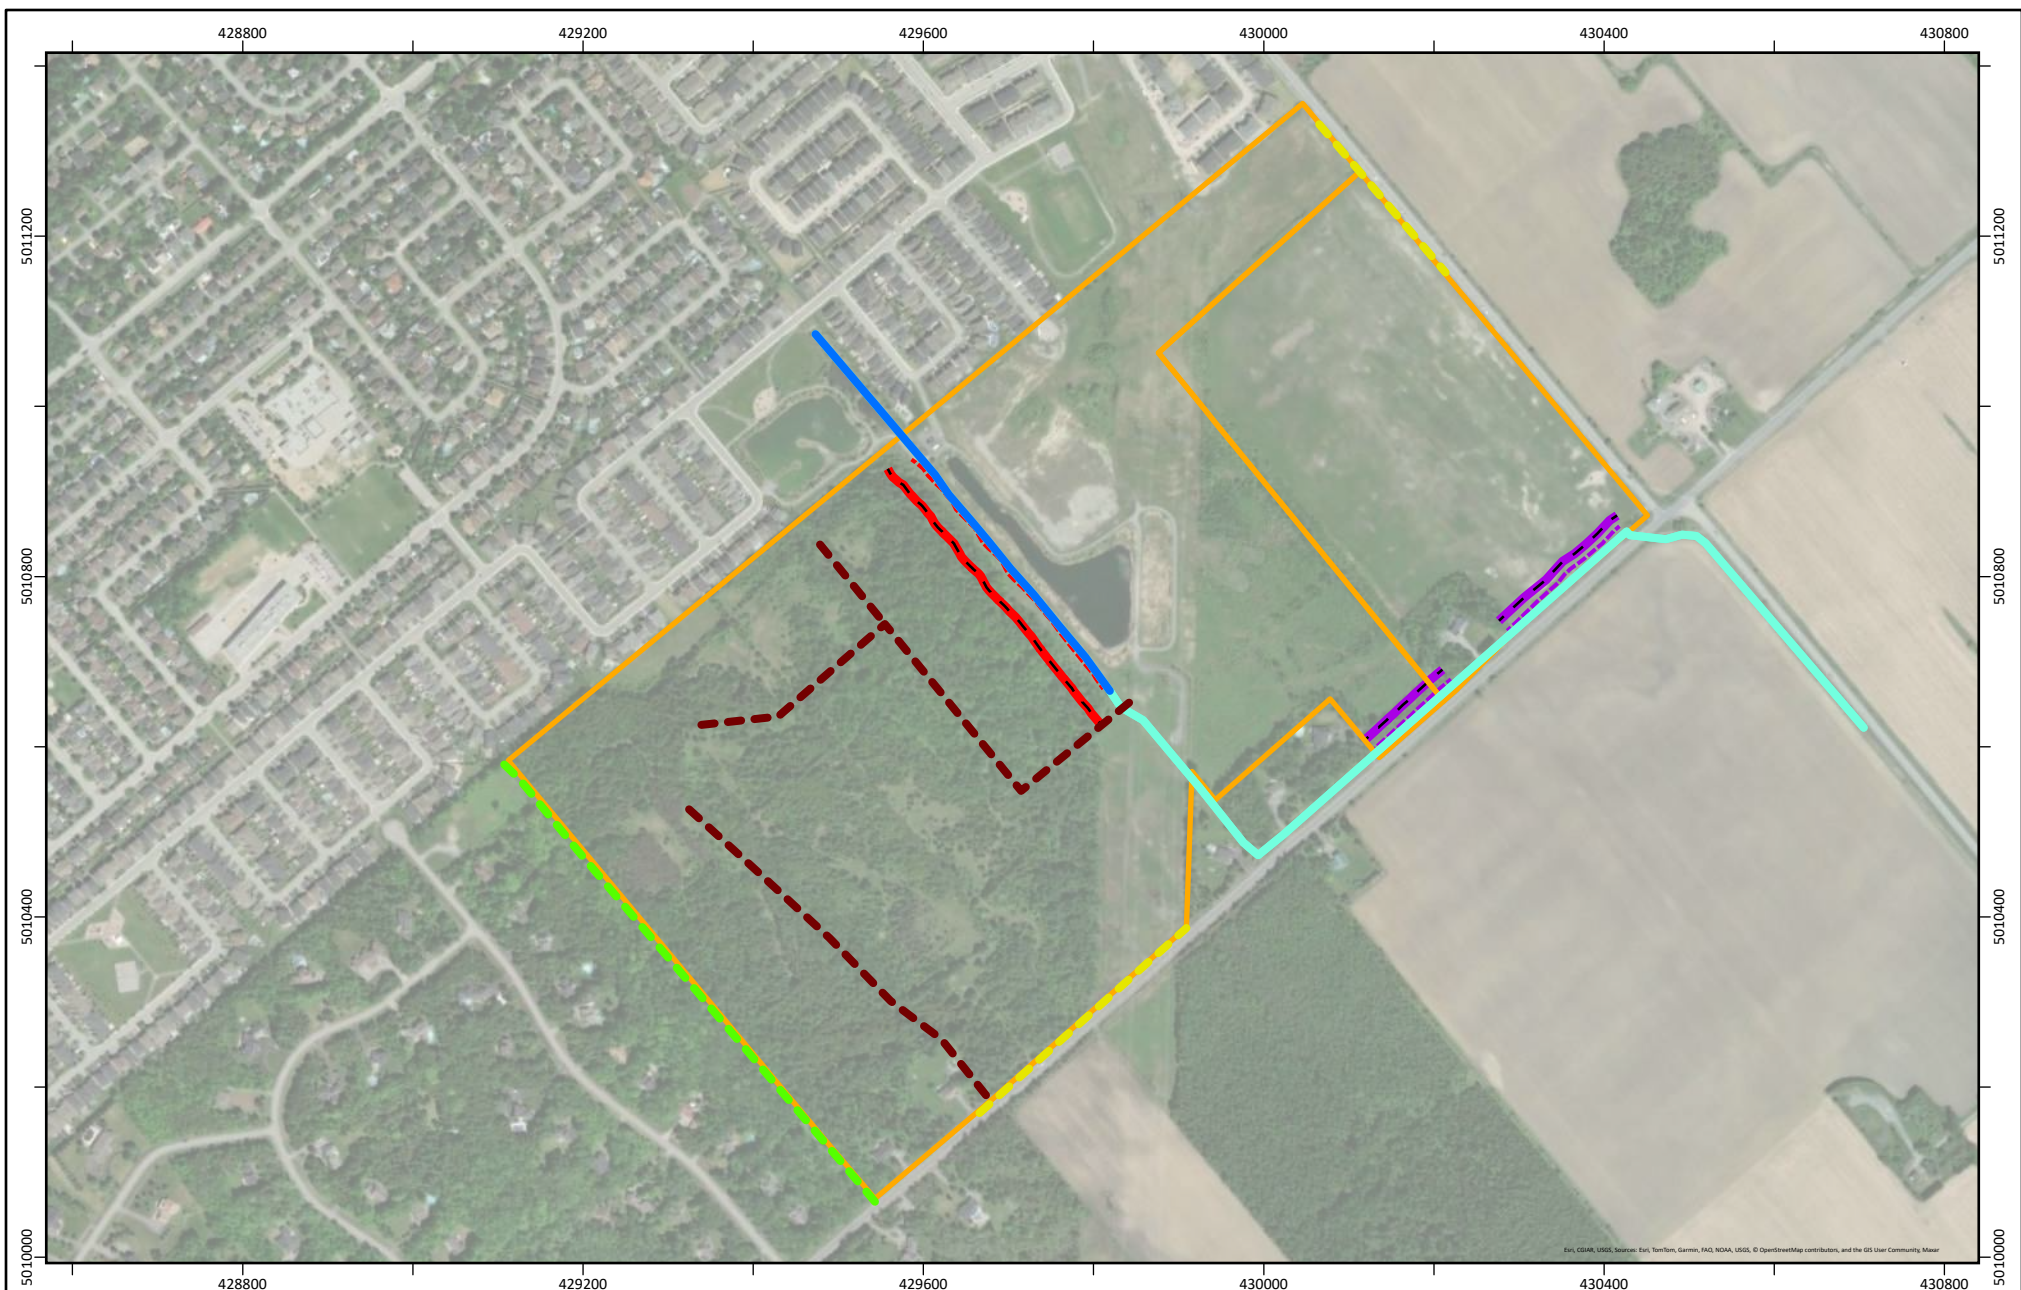
**Figure 14. Watercourse Setbacks**

- 15 m from TOS
- 30 m from TOB
- - - Top of Bank
- - - Top of Slope
- Development Site

Tributary B originates within the SWCM1-1 community and flows southeast, eventually joining with Tributary E. It has a man-made standing water pool present with interstitial flow towards the Faulkner Drain. While areas of standing water can potentially function as amphibian breeding habitat, no amphibians were observed within this reach. The chain of classification descriptors leads to a management directive of Protection for this reach.

Tributary C is a roadside ditch feature that originates at the southwestern corner of the Site, at the terminus of Tributary D. It flows eastward, joining the Faulkner Drain. Tributary C is a permanent feature that has water present year-round. This feature was confirmed to function as amphibian breeding habitat and fish habitat. The chain of classification descriptors leads to a management directive of Protection for this reach. It is recommended that this feature be retained to maintain overland flow conditions on the Site and along Flewellyn Road.

Tributary E is a constructed, linear channel feature that originates within the FOMM4-3 and MEMM3 vegetation communities and flows south eventually turning eastward joining the Faulkner Drain. It has intermittent standing water pools present with intermittent flow towards Faulkner Drain. Standing water contributes to groundwater recharge and can function as amphibian breeding habitat. Breeding amphibians were observed within this reach. The chain of classification descriptors leads to a management directive of Protection for this reach.

Tributary F is a roadside ditch feature located along Shea Road at the eastern Site boundary. It is located adjacent to an idle agricultural field and connects downstream to the Faulkner Drain at the intersection with Flewellyn Road. It primarily functions as a drainage feature supporting spring run-off and after heavy rainfall. Breeding amphibians were not observed within this reach. Significant groundworks have and continue to occur in the southern portion of this tributary, and a large portion of this tributary has been altered and/or removed. This chain of classification descriptors leads to a management directive of Protection for this reach.
