# **Phase II – Environmental Site Assessment**

Tunney's Pasture (Block 8)  
Ottawa, Ontario

Prepared for Arcadis IBI Group

**Report: PE6038-2**

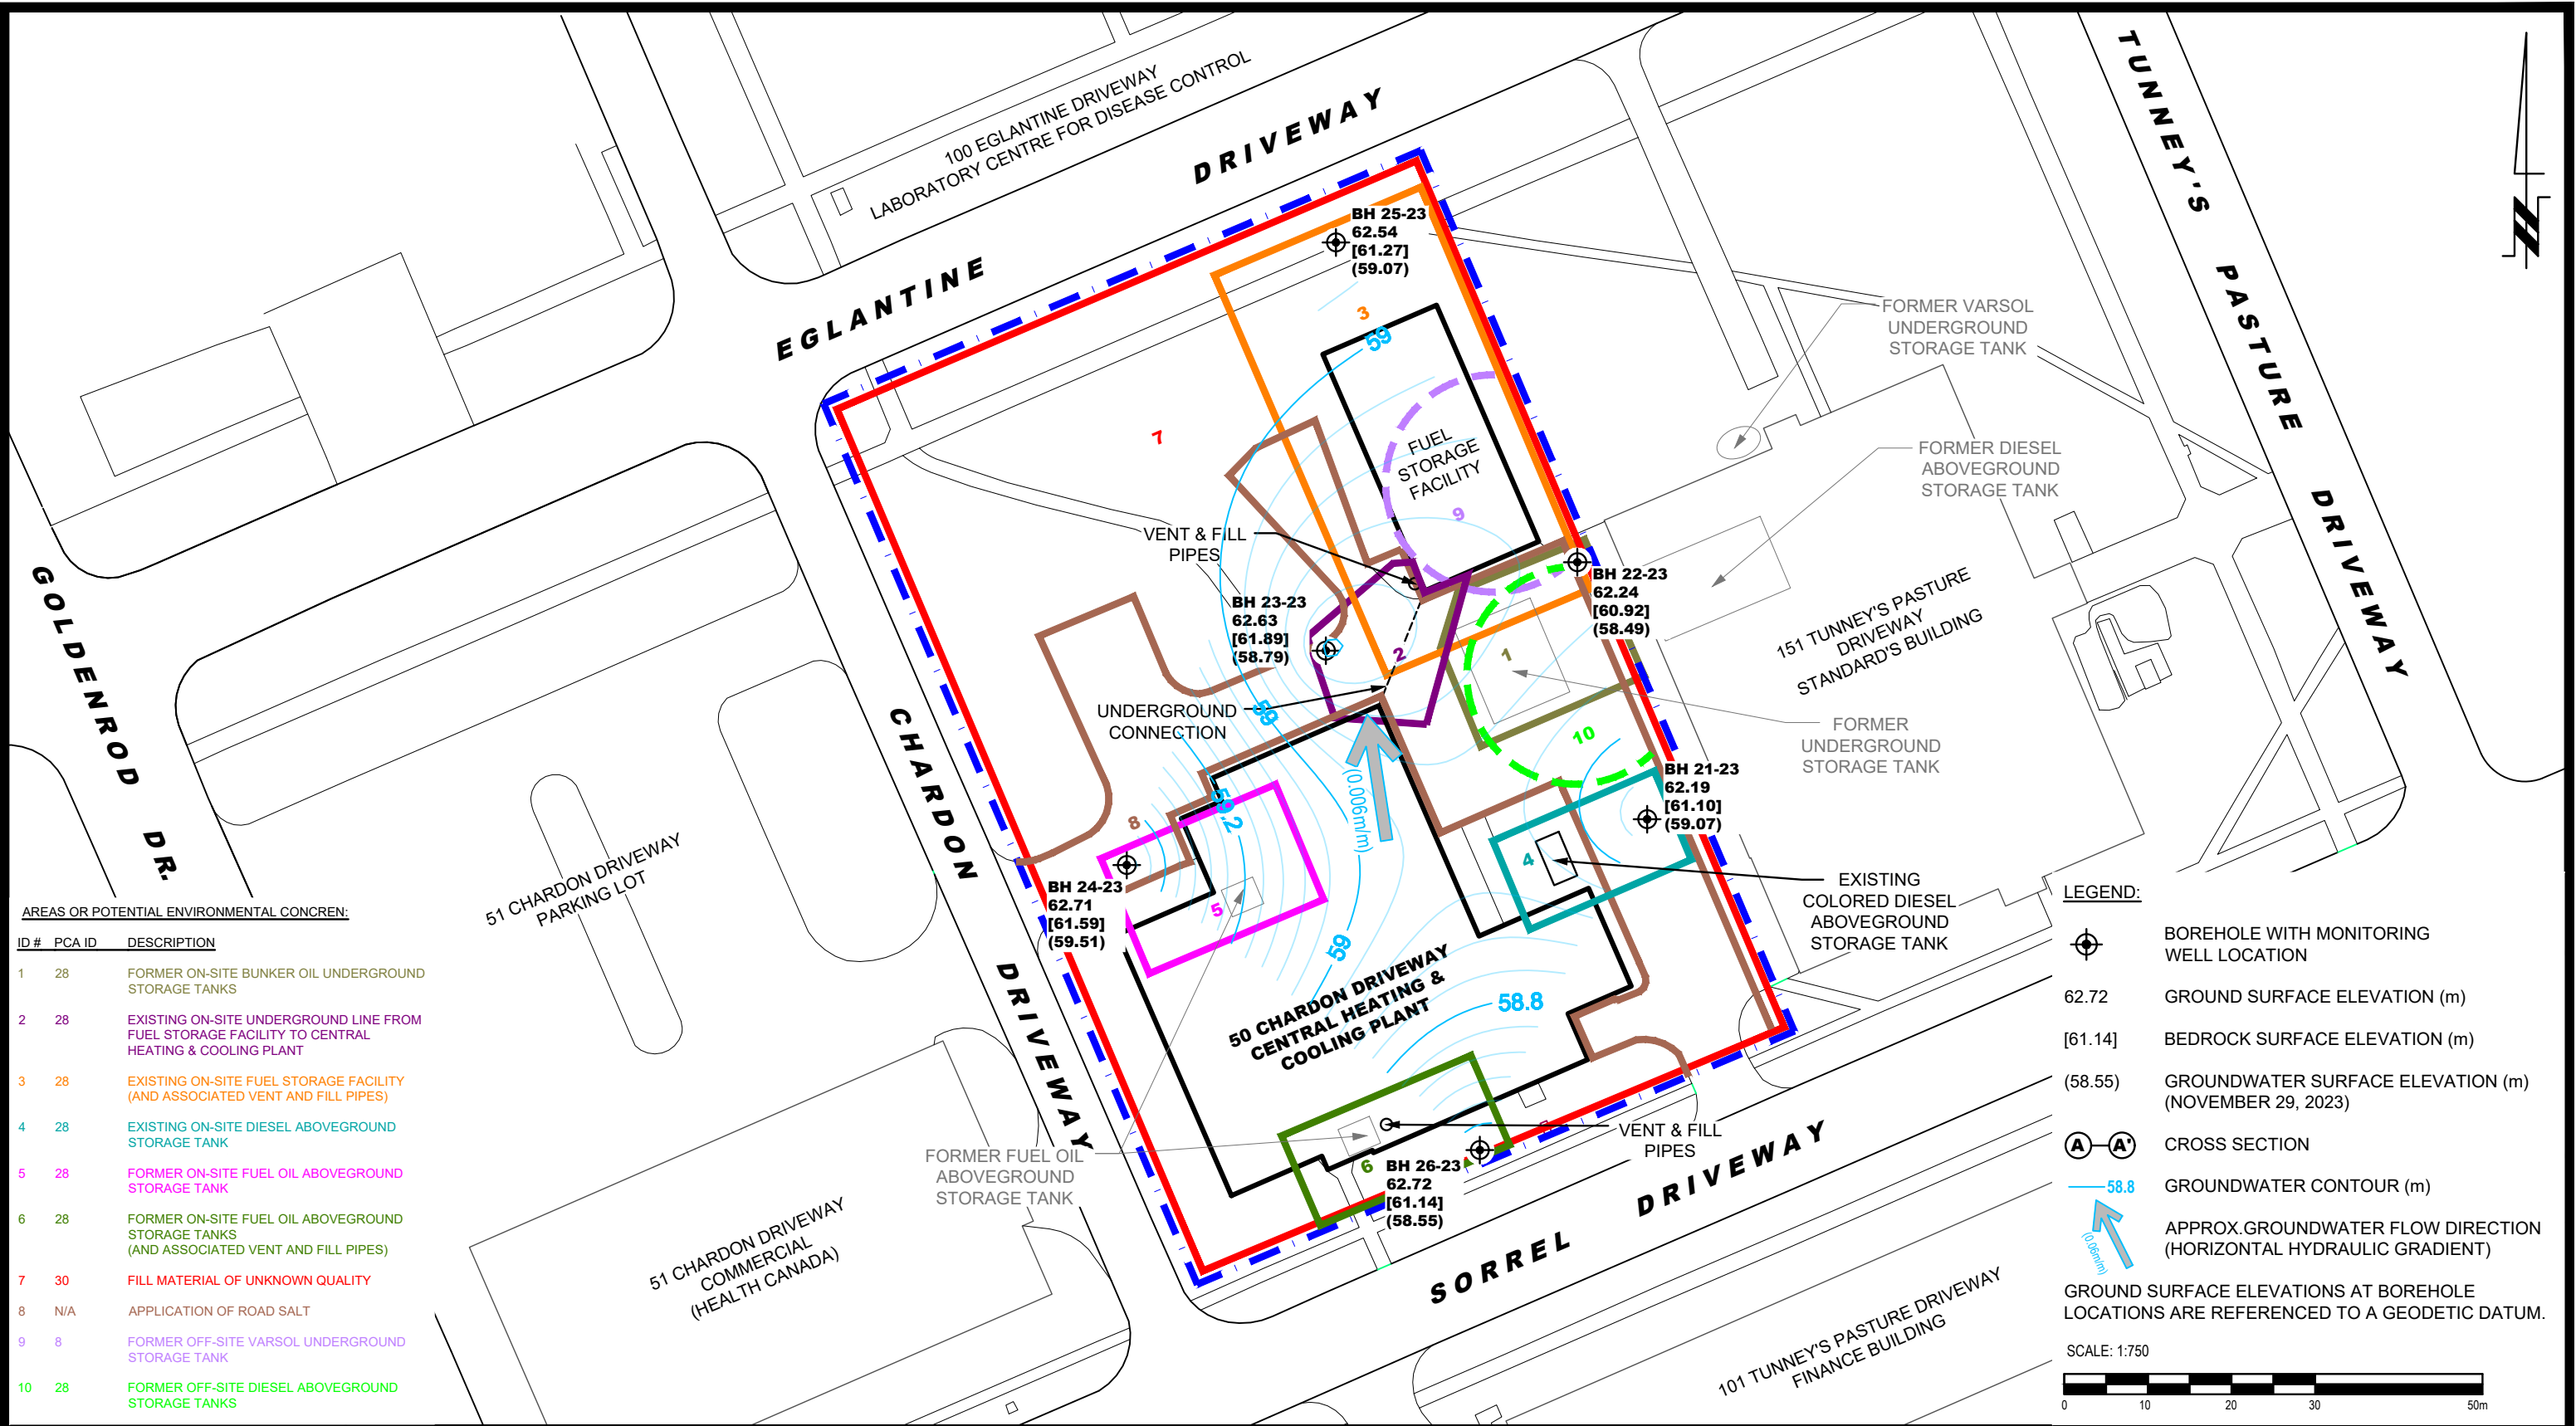
Using the groundwater elevations recorded during the November 28, 2023 sampling event, groundwater contour mapping was completed as part of this assessment. According to the mapped contour data, illustrated on Drawing PE6038-3 – Test Hole Location Plan in the appendix, the groundwater flow on the Phase II Property was calculated to be in a northerly direction. A horizontal hydraulic gradient of approximately 0.006 m/m was also calculated as part of this assessment. It should be noted that groundwater levels are expected to fluctuate throughout the year with seasonal variations.

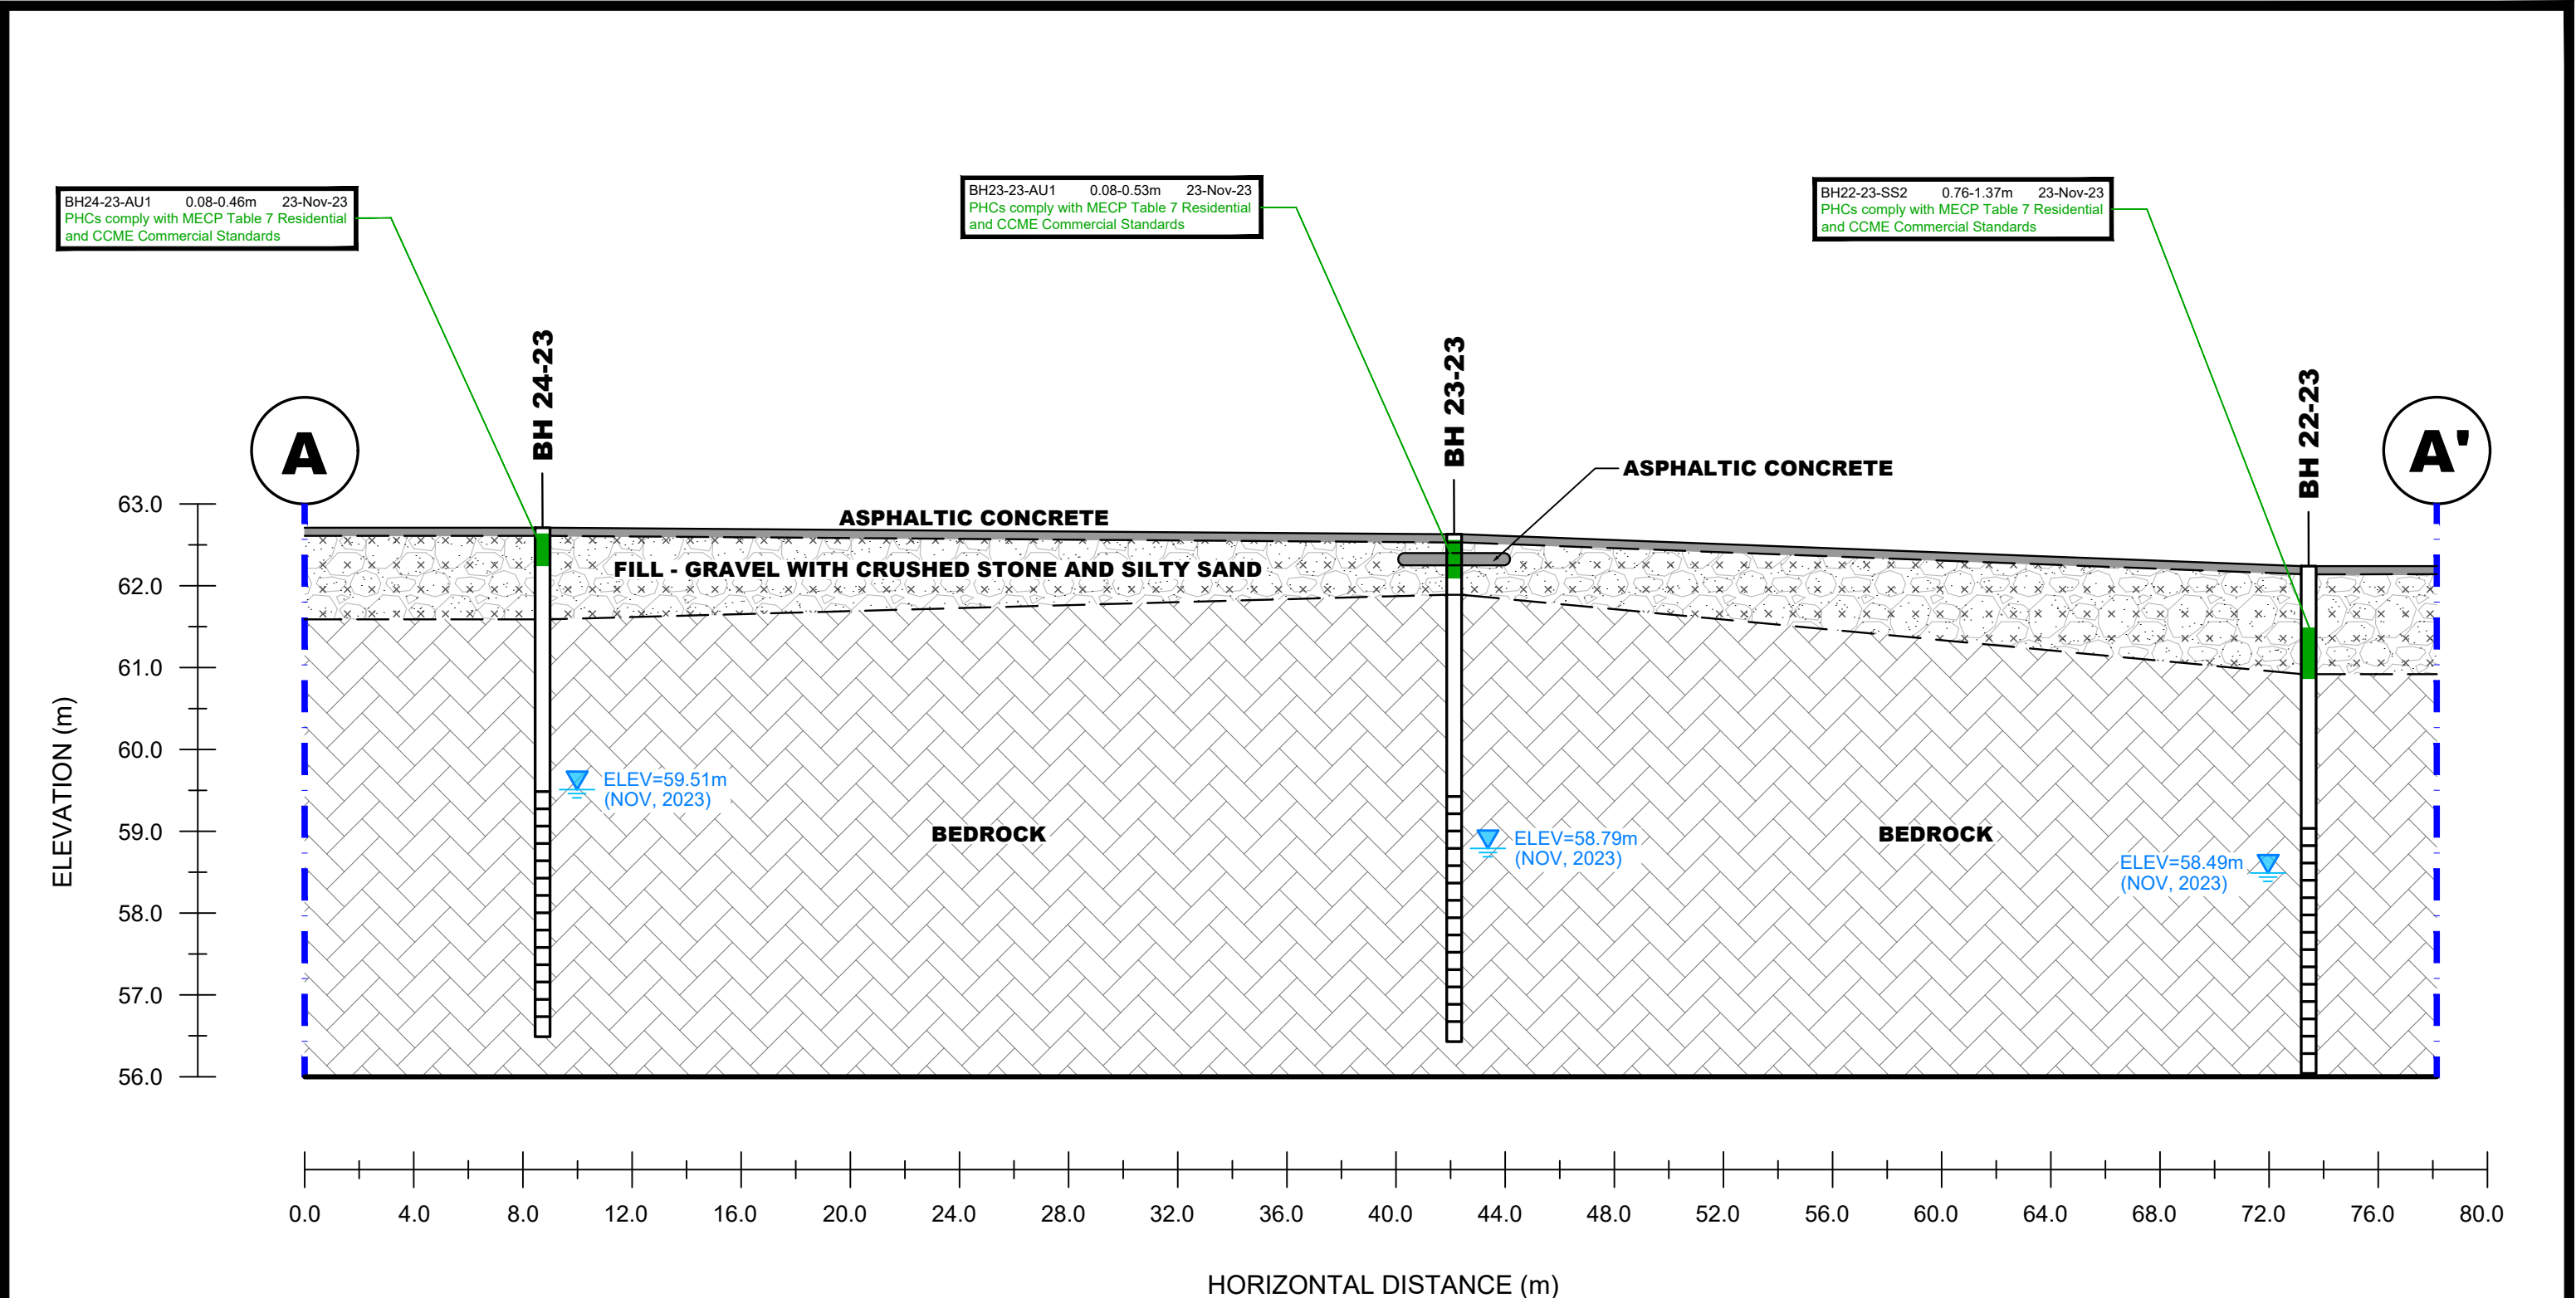
The fill material present beneath the surficial asphalt at BH21-23 is impacted above provincial MECP standards with heavier fractions of petroleum hydrocarbons (PHC F<sub>3</sub> and PHC F<sub>4</sub> gravimetric) and polycyclic aromatic hydrocarbons. Given the shallow soil conditions, this sample may have been influenced by the presence of asphalt inclusions in the sample.

SOIL RESULT COMPLIES WITH THE MECP TABLE 7  
RESIDENTIAL AND/OR CCME COMMERCIAL STANDARDS

SOIL RESULT EXCEEDS THE MECP TABLE 7 RESIDENTIAL  
& CCME COMMERCIAL STANDARDS

| | | | | Title: CROSS SECTION A-A' - SOIL (PHCs) | | | | | | |

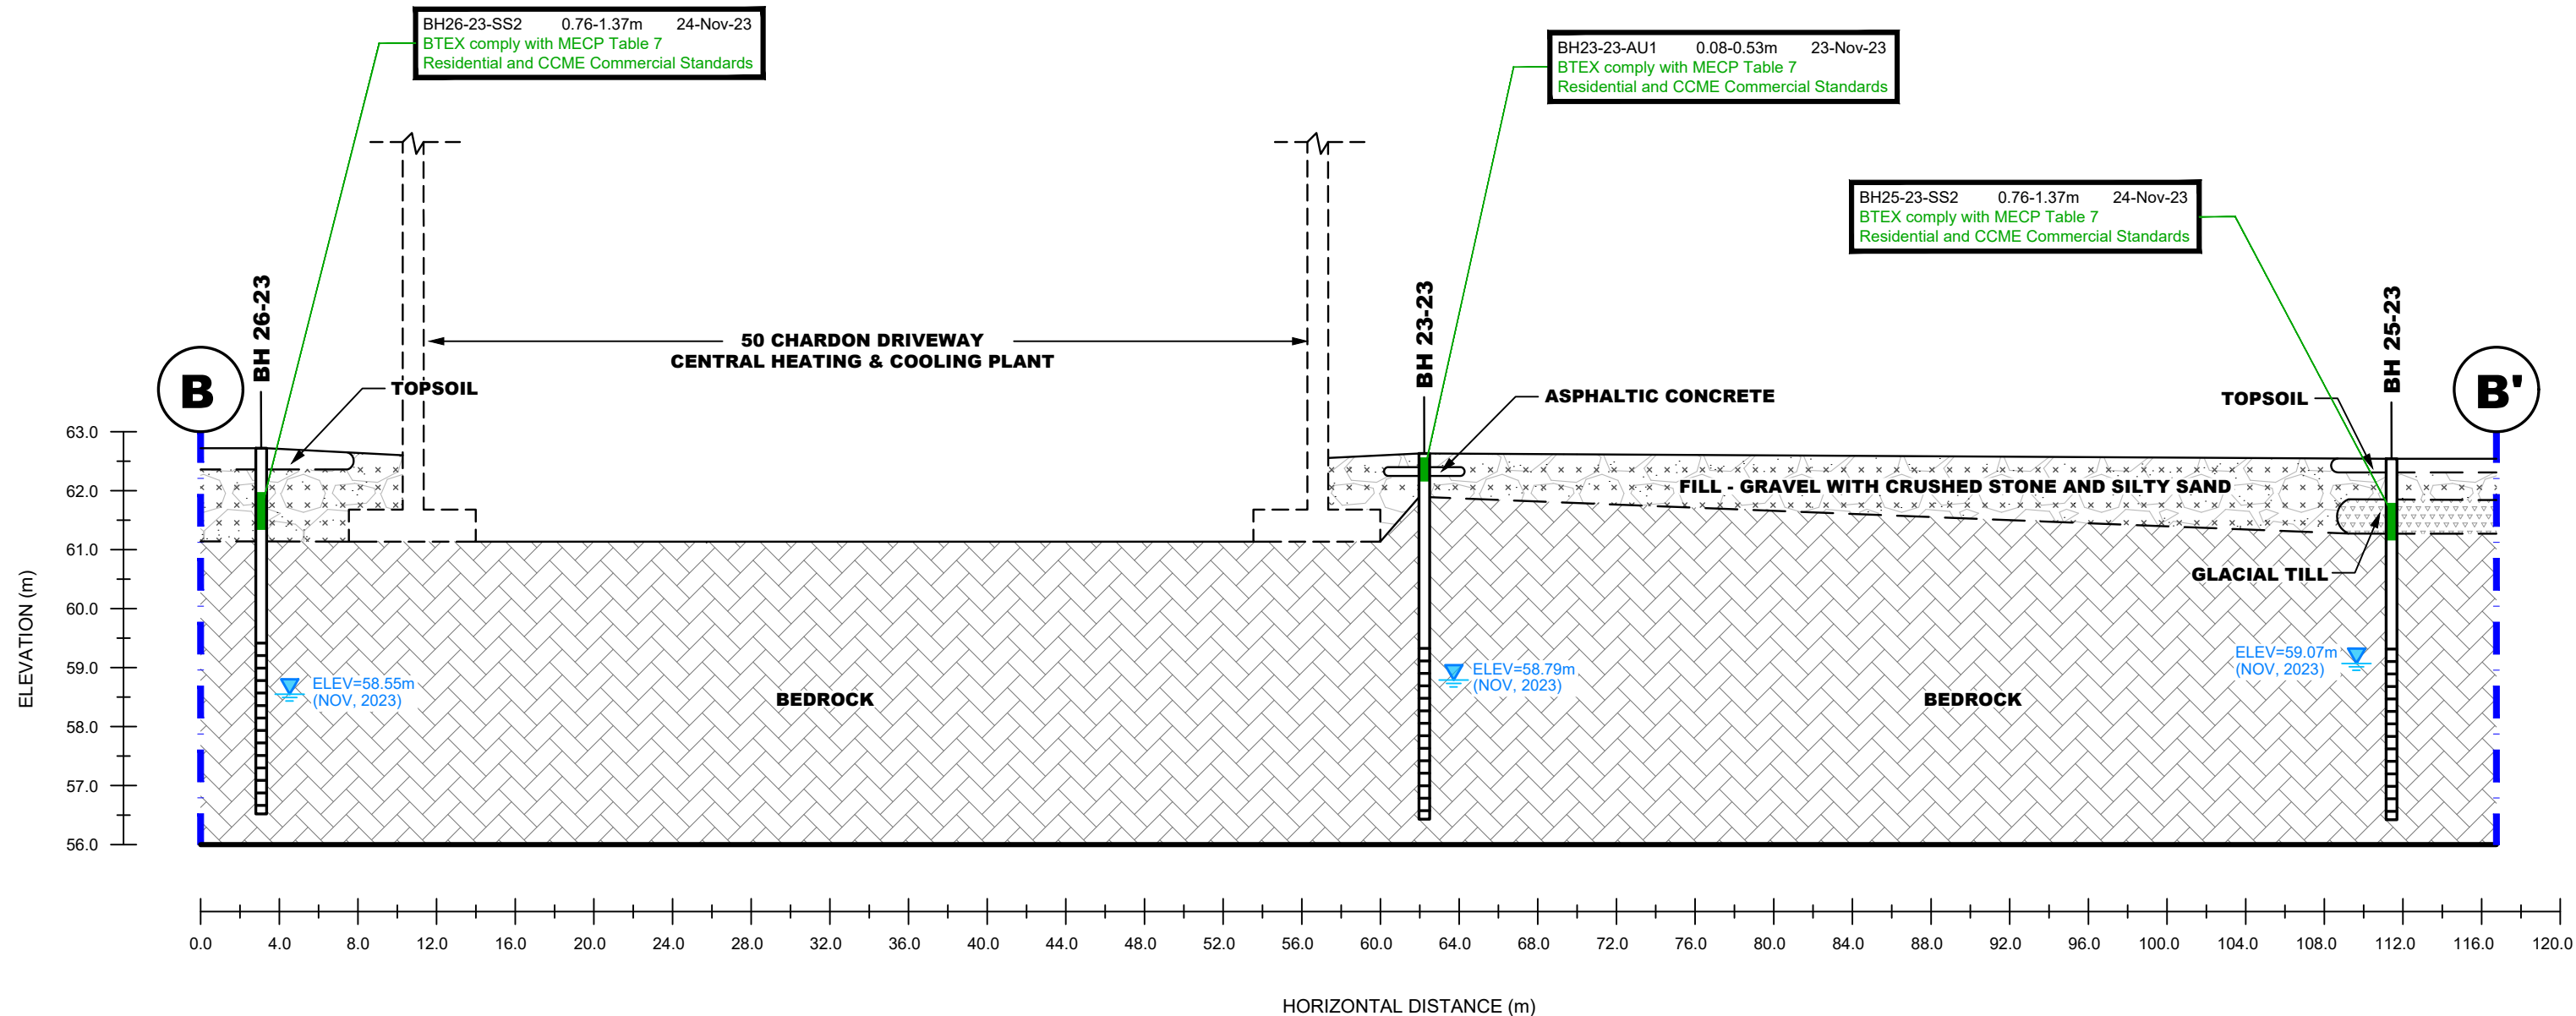
| | | | | CROSS SECTION B-B' - SOIL (BTEX, VOCs) | | | | | | |

SOIL RESULT COMPLIES WITH THE MECP TABLE 7  
RESIDENTIAL AND/OR CCME COMMERCIAL STANDARDS

SOIL RESULT EXCEEDS THE MECP TABLE 7  
RESIDENTIAL AND/OR CCME COMMERCIAL STANDARDS
