# 2510 St. Laurent Blvd – Tree Conservation Report

Prepared for Claridge Homes  
by Arcadis | IBI Group  
January 30, 2024

| REPORT TITLE: | 2510 St Laurent Blvd - Tree Conservation Report |

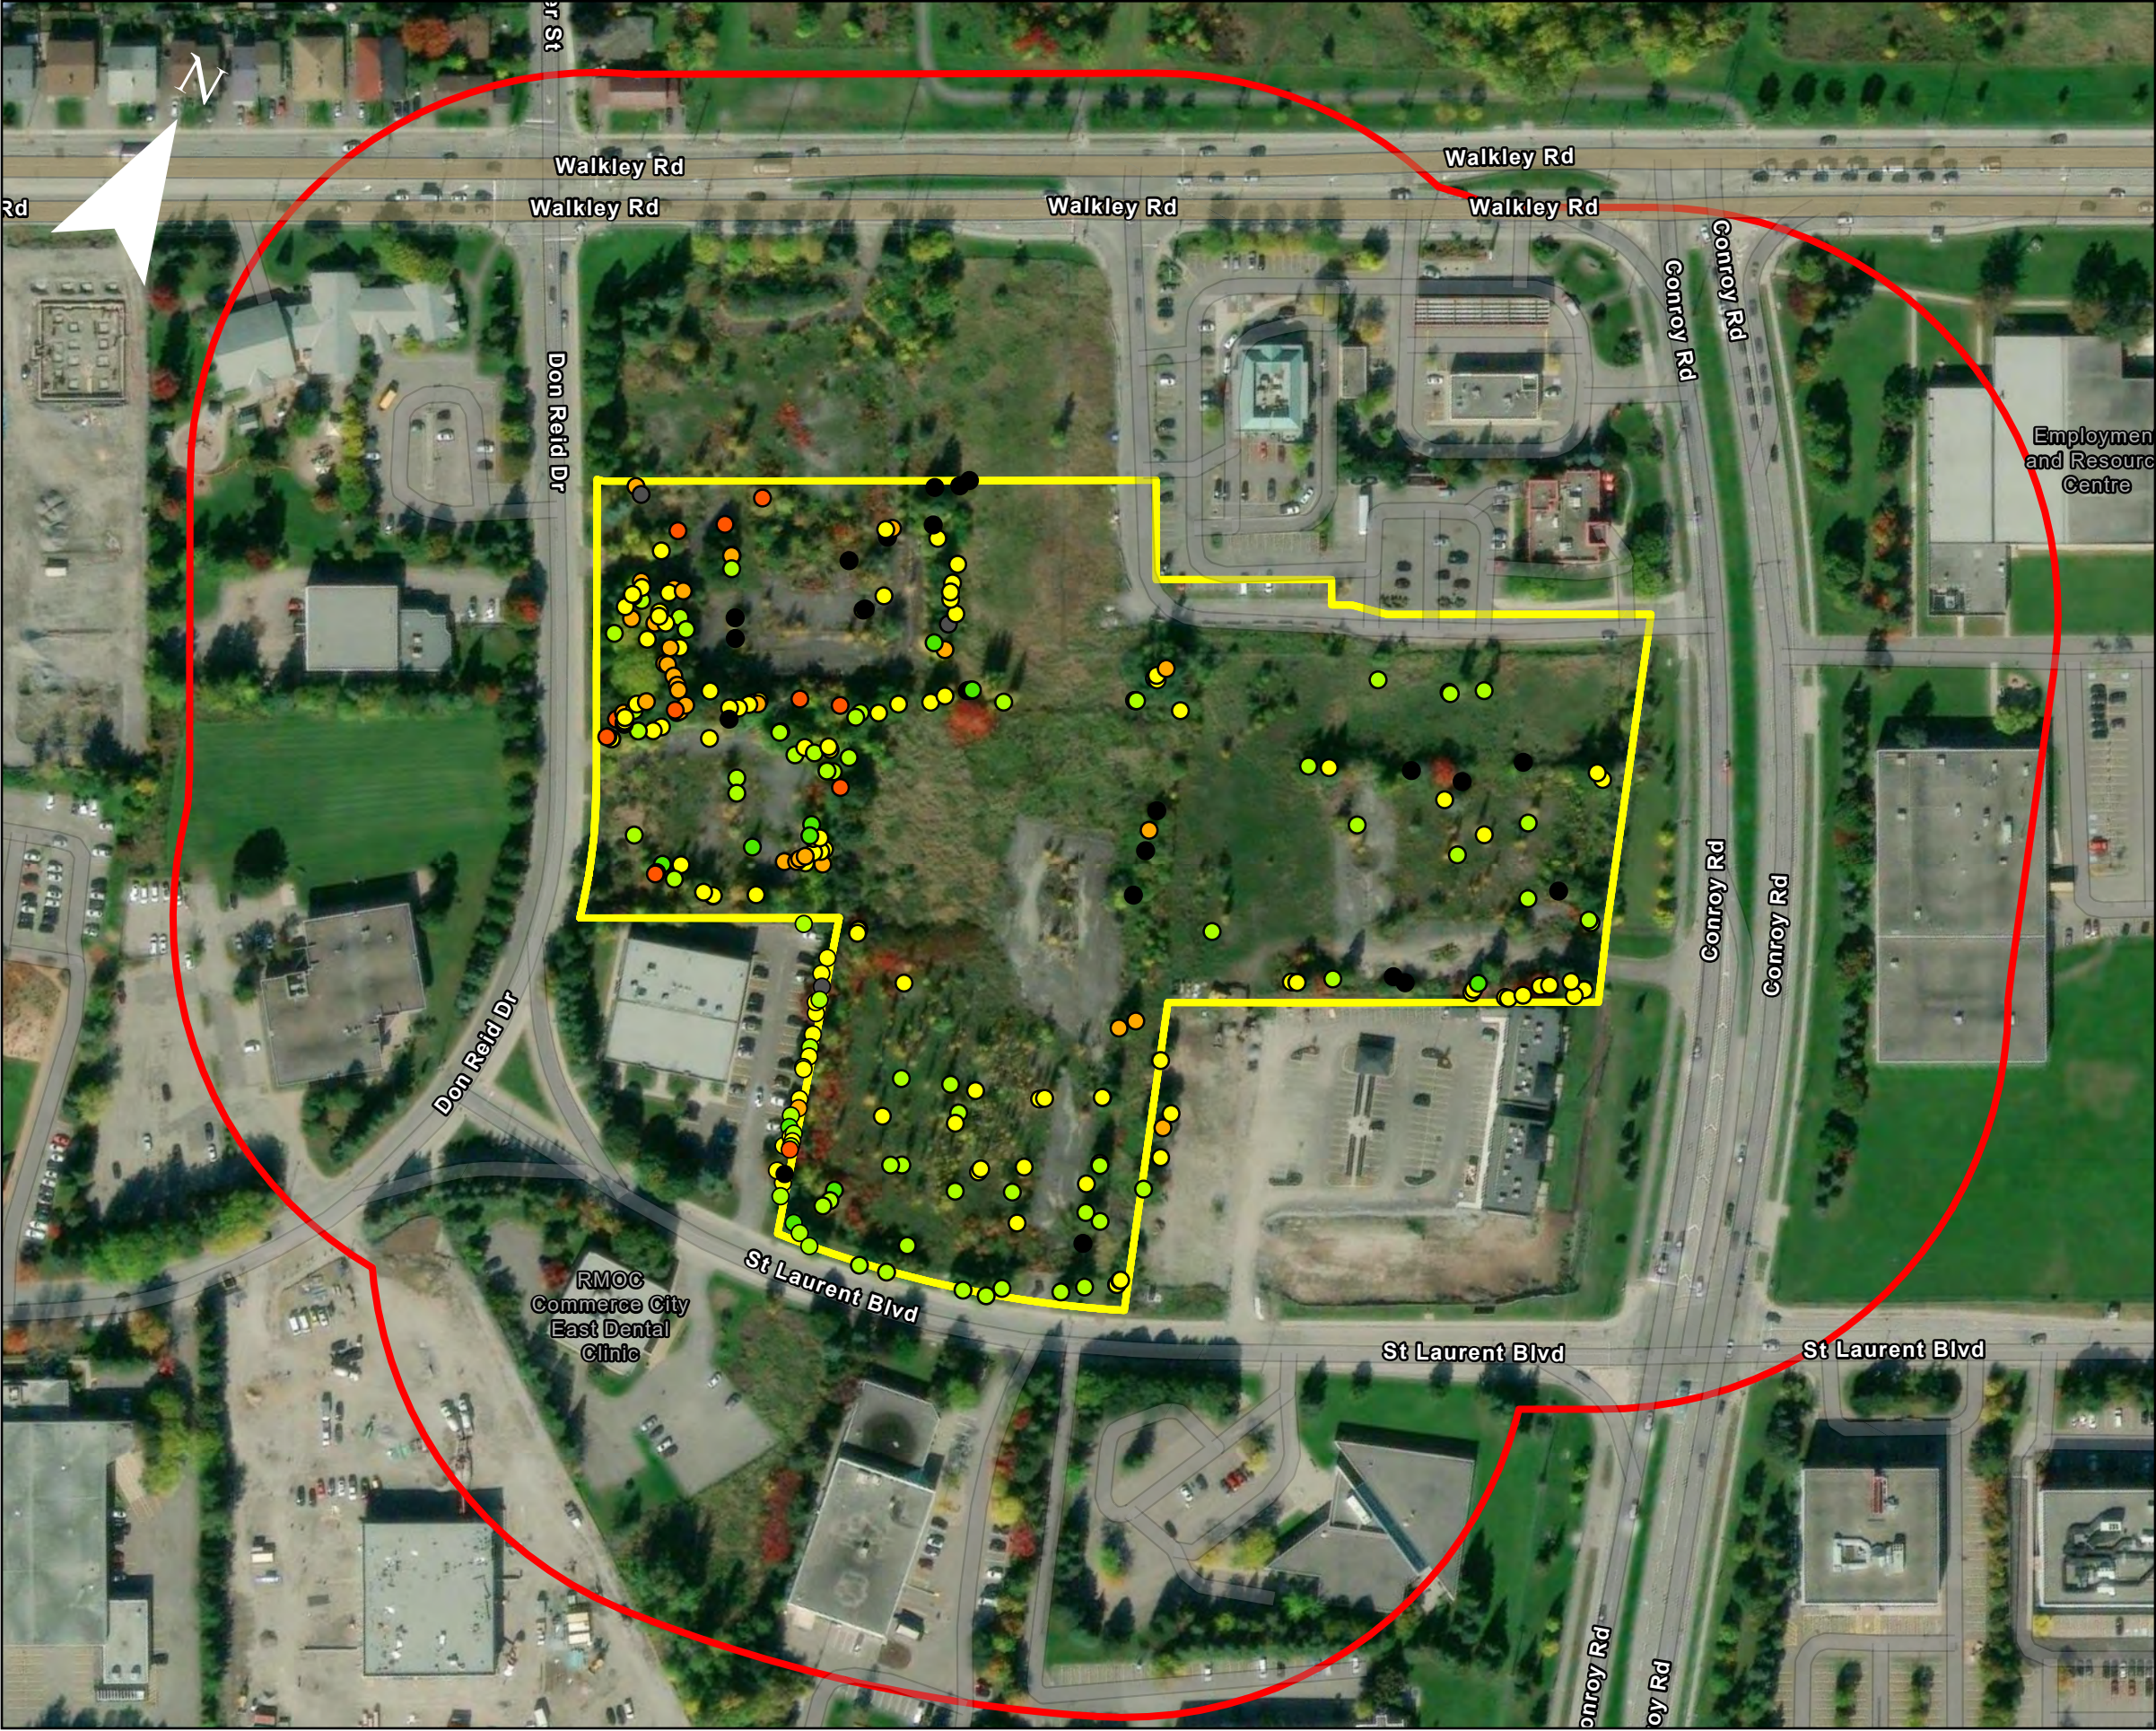
Figure: 1

The vegetation on this vacant commercial property (Figures 1-3.3) can be described as a disturbed urban tree stand composed of several non-native and invasive tree species of various sizes and stages of development. The trees within the tree stand may provide cover and nesting habitat services for birds and other wildlife. However, none of the inventoried trees possessed cavities that would be suitable for any significant wildlife habitat.

2510 St. Laurent Blvd:  
Study Area

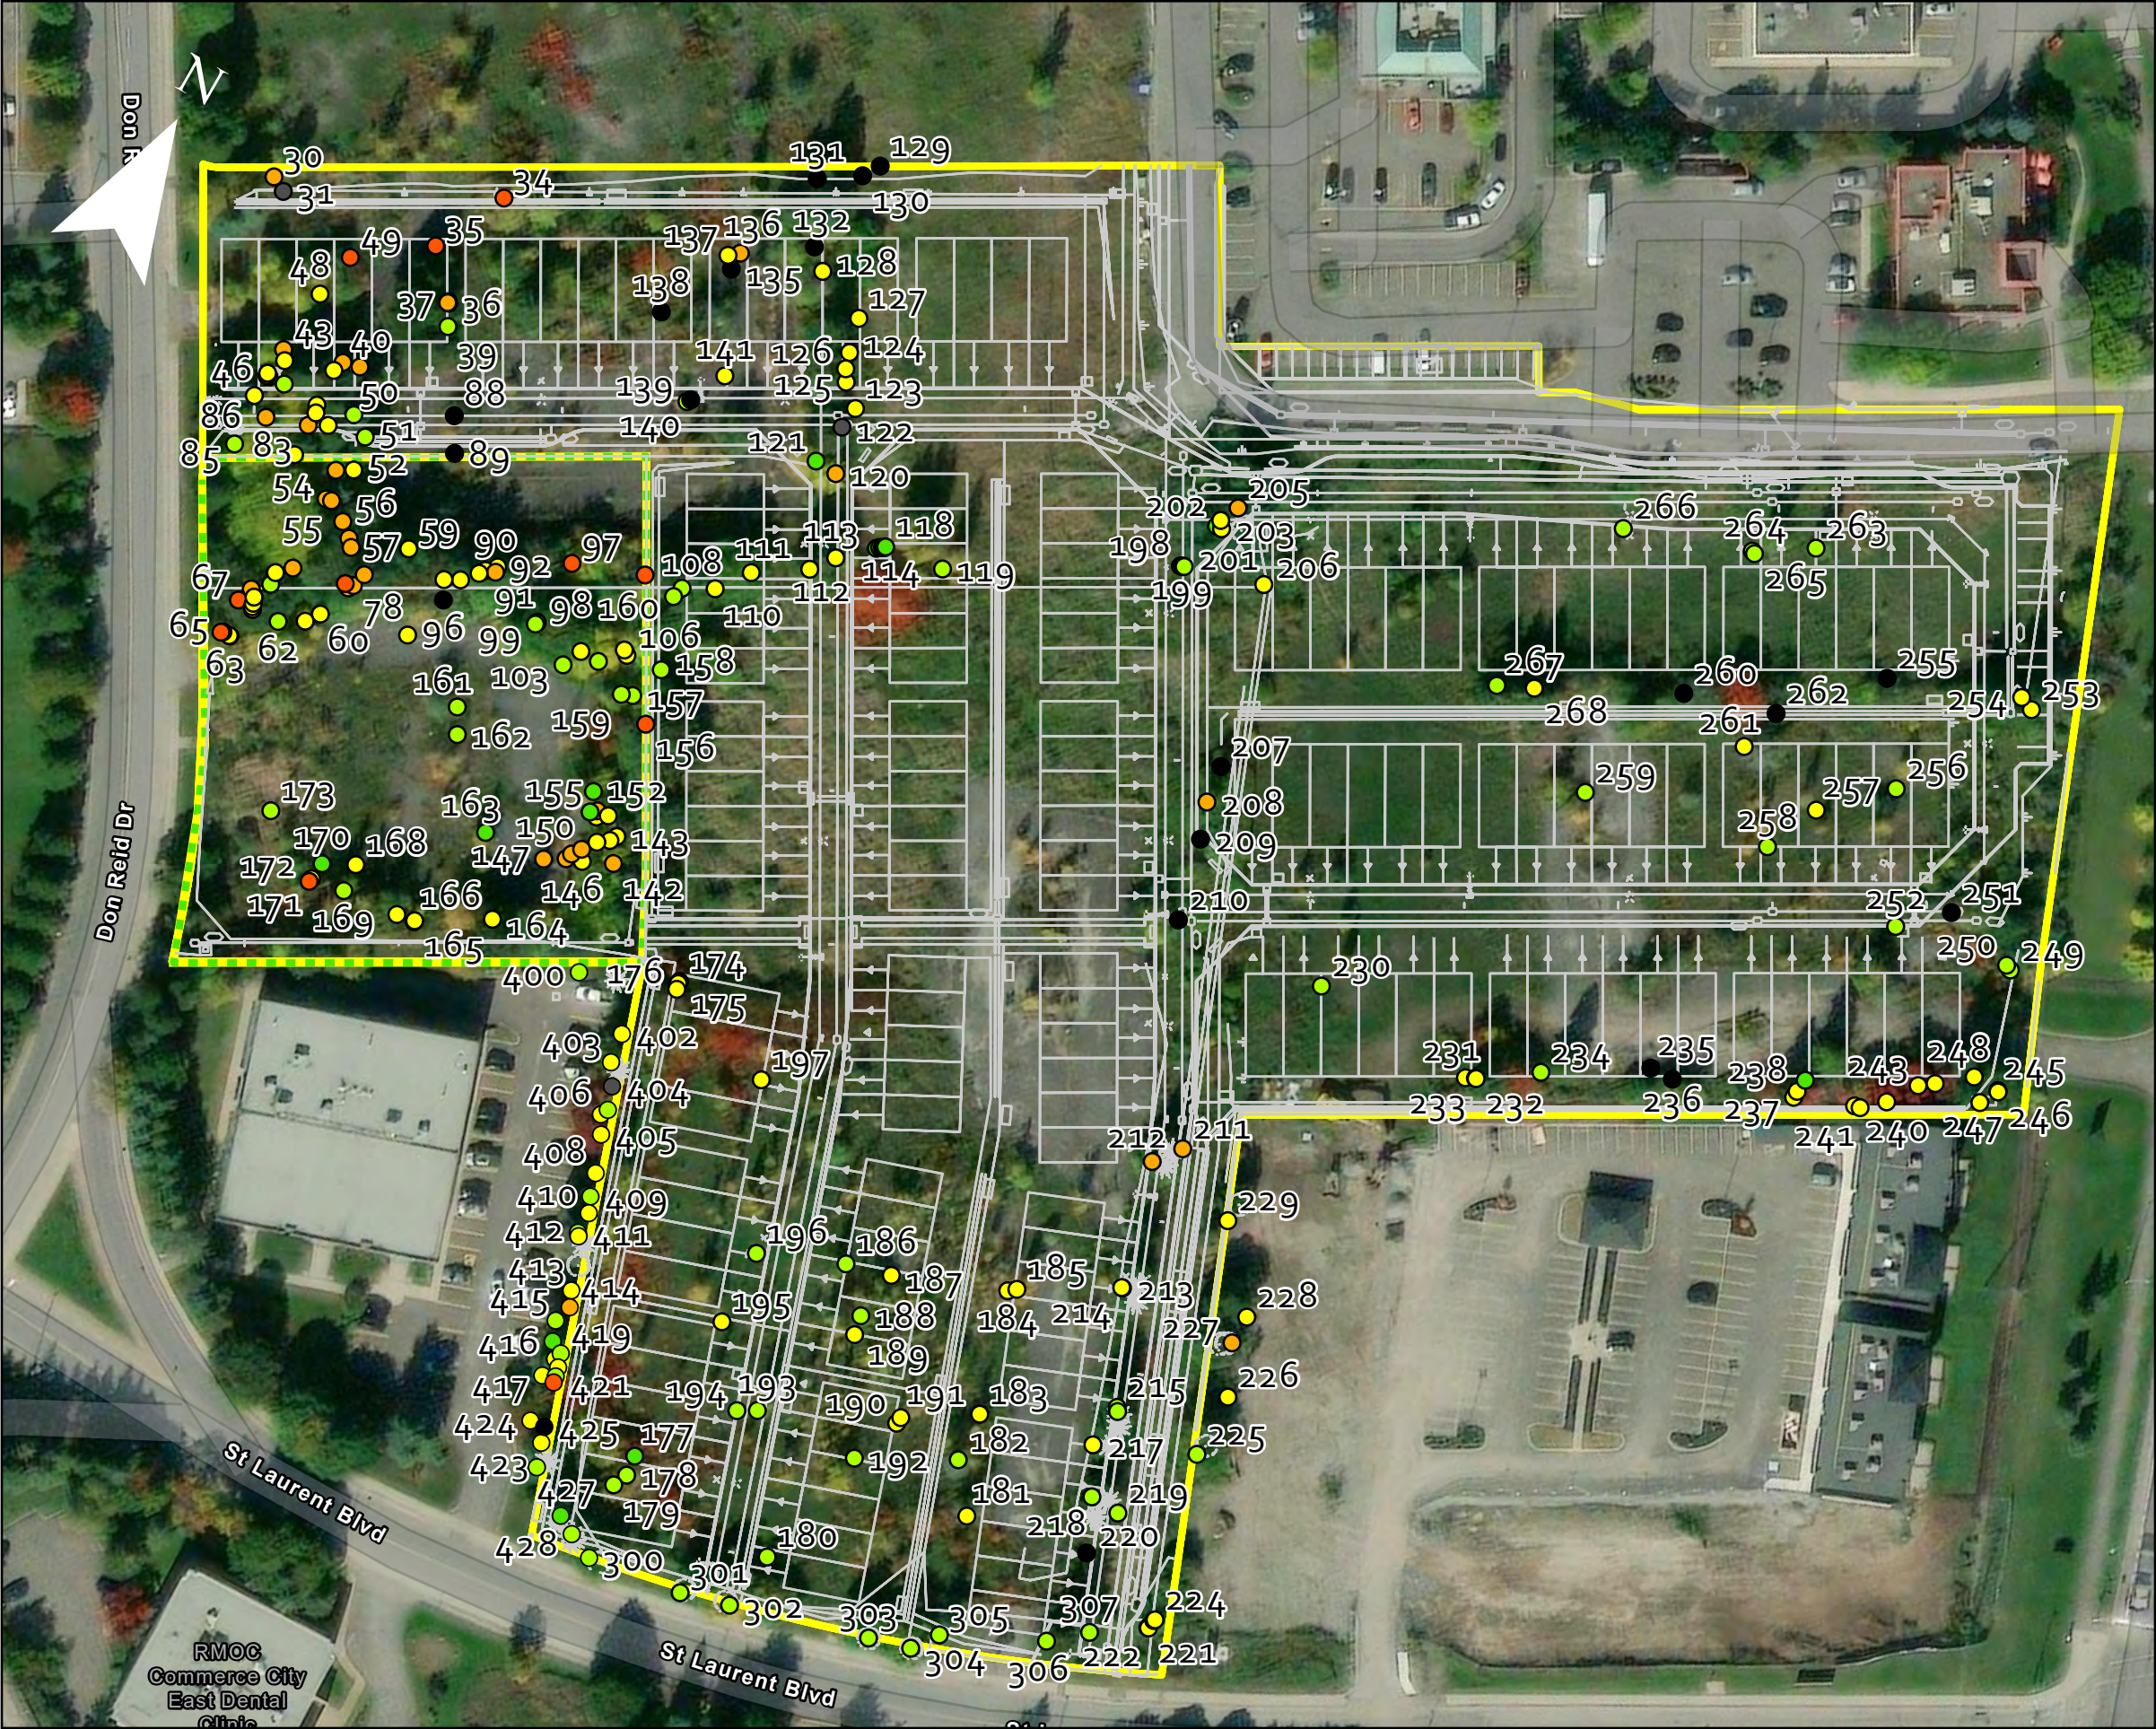
Figure: 2

**The Critical Root Zone (CRZ) of 159 trees located within the Subject Property are in direct conflict with the proposed site plan (Figure 2) and will require removal.** Physical impacts on the CRZ by construction activities rapidly deteriorates the overall health, quality, and ecological service of the tree.

2510 St. Laurent Blvd:  
Site Plan

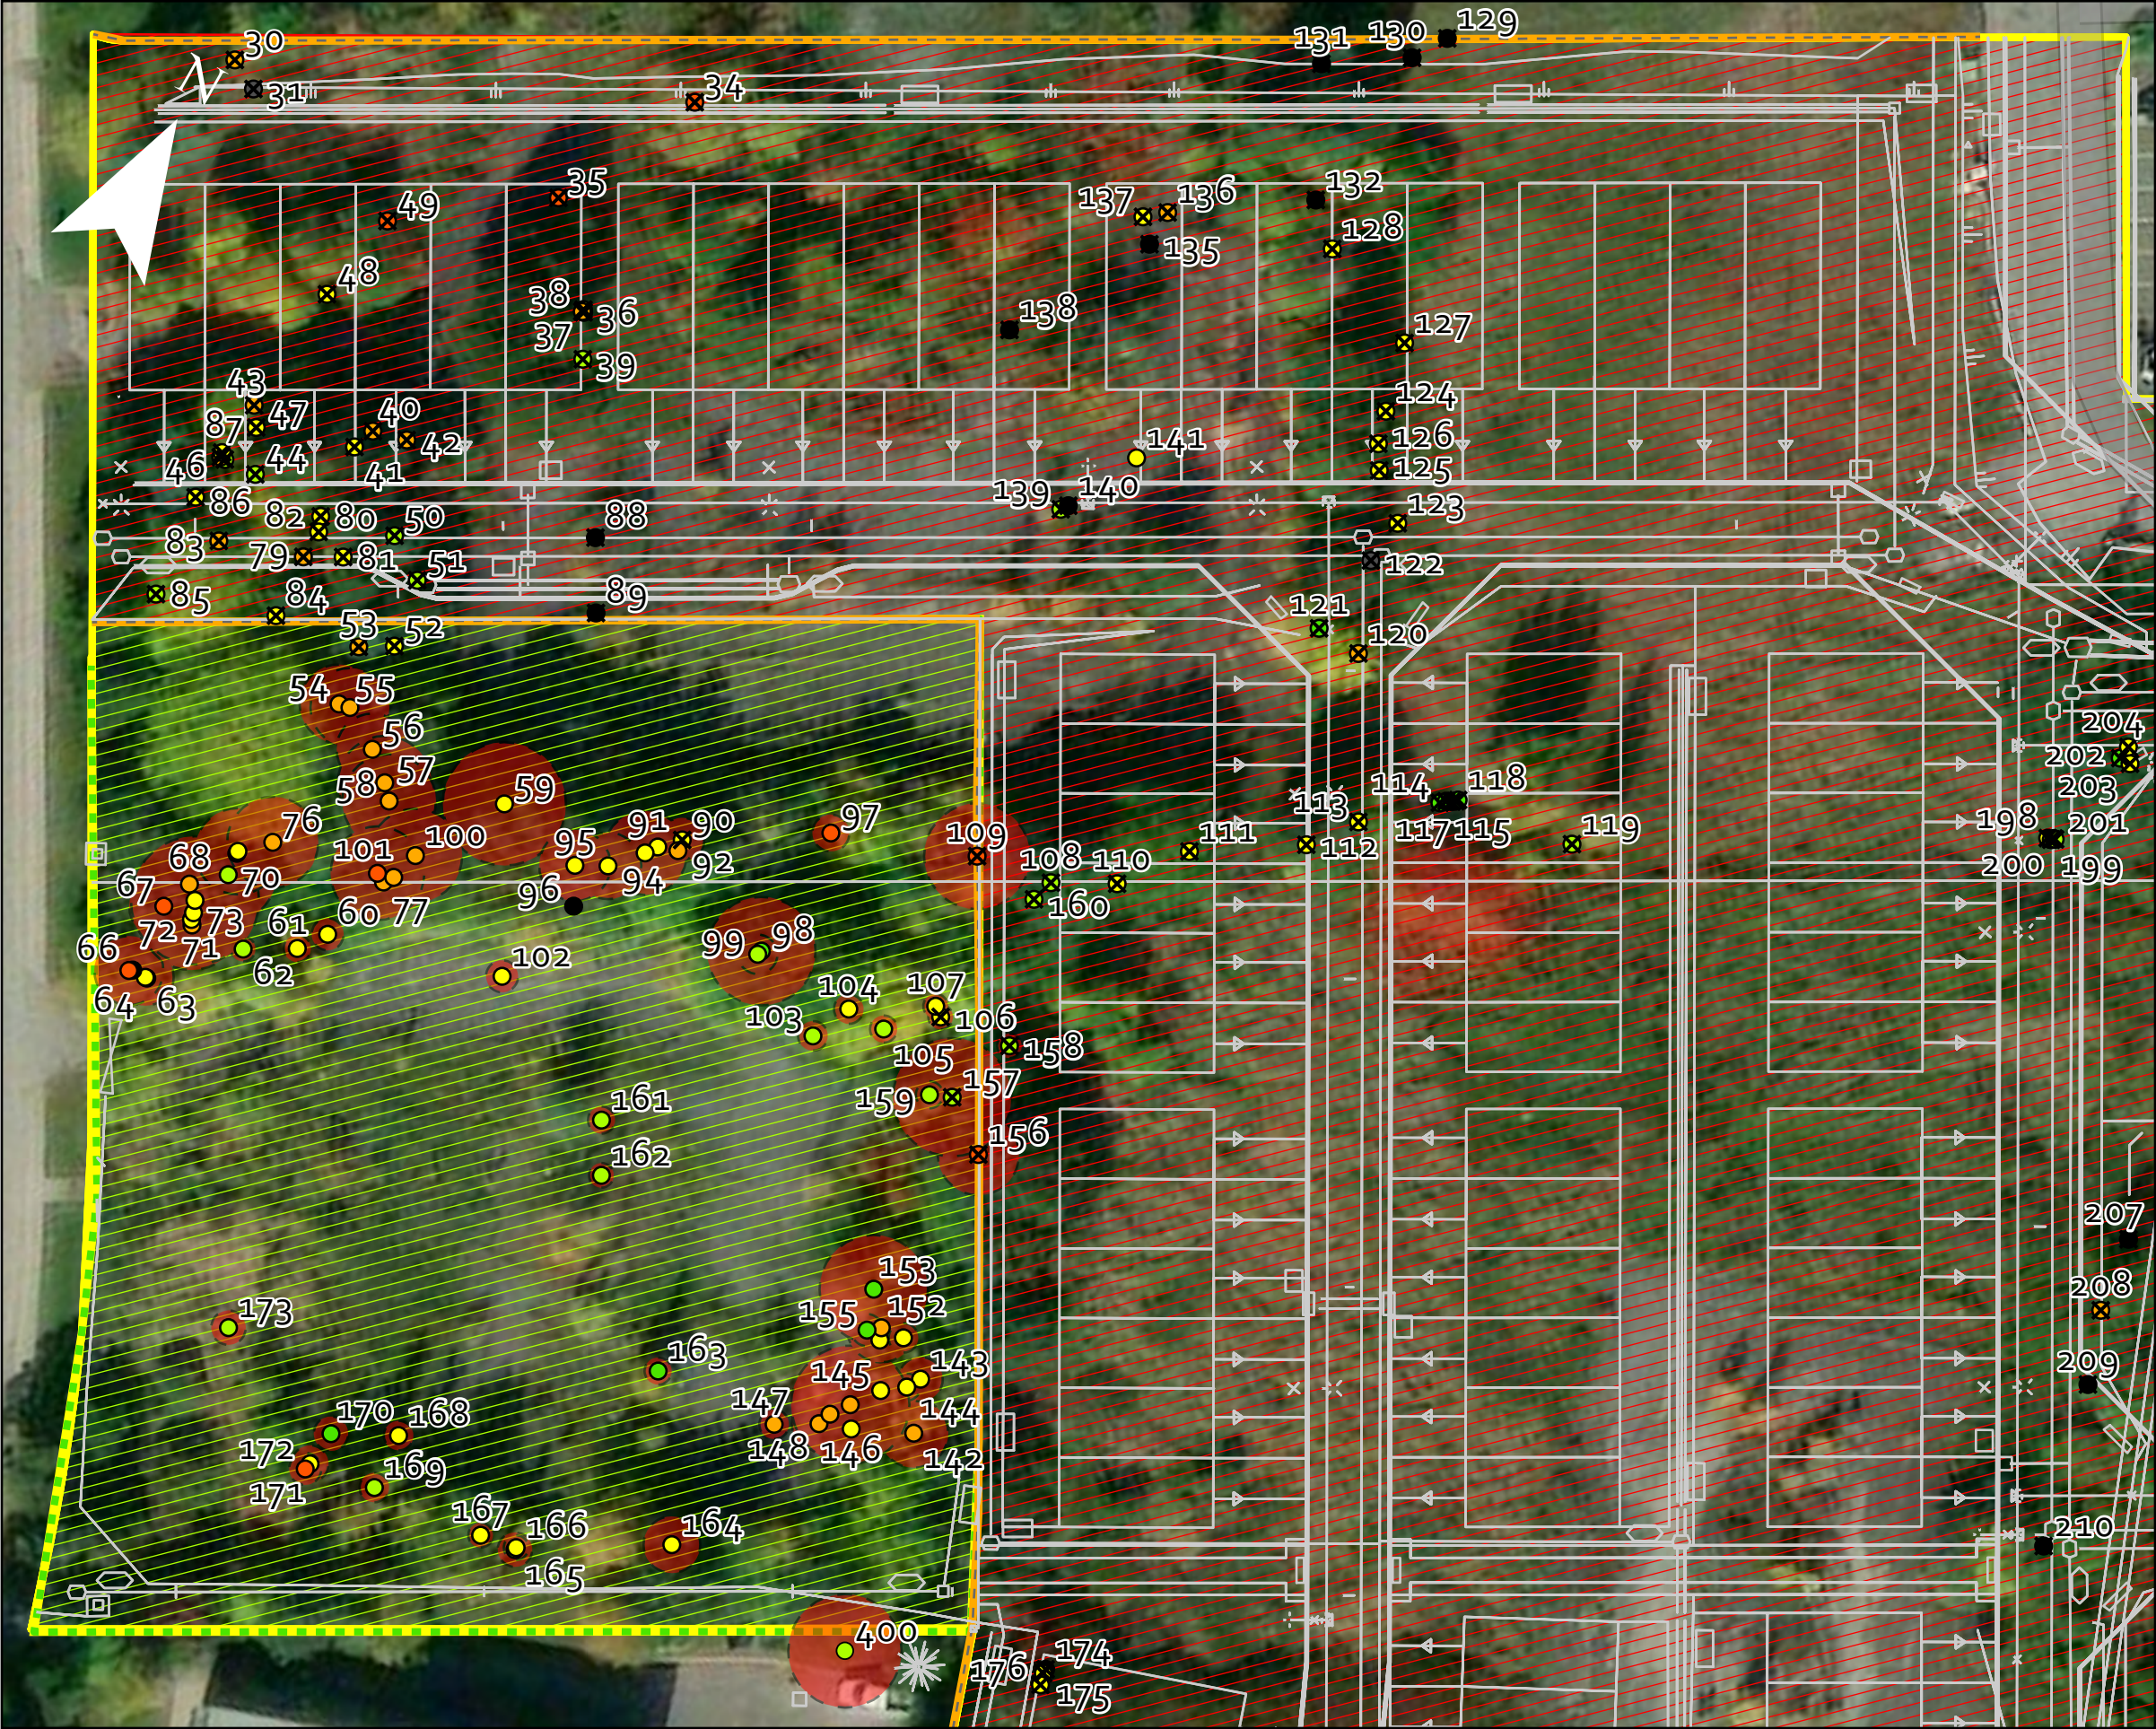
**Figure: 3.1**

To protect trees in properties adjacent to the Subject Property orange snow fence should be installed to serve as tree protection fencing along the perimeter of the construction footprint (**Figures 3.1-3.3**). Additionally, to ensure that no harm is caused to breeding birds, tree removal and vegetation clearing should be avoided during the migratory bird season (April 15 – August 15) as specified by The City of Ottawa's Environmental Impact Study Guidelines.

2510 St. Laurent Blvd:  
Tree Protection and Removals:  
Area-A

- Tree Protection Fencing shall be installed as per the mapping in **Figures 3.1-3.3** of the TCR to protect the CRZ of the trees to be retained.
  - Tree protection fencing must be at least 1.2m in height, and constructed of rigid or framed materials (e.g. moduloc - steel, plywood hoarding, or snow fence on a 2"x4" wood frame) with posts 2.4m apart, such that the fence location cannot be altered. All supports and bracing must be placed outside of the CRZ, and installation must minimise damage to existing roots, as per the City of Ottawa Tree Protection Specification (**Appendix C**).

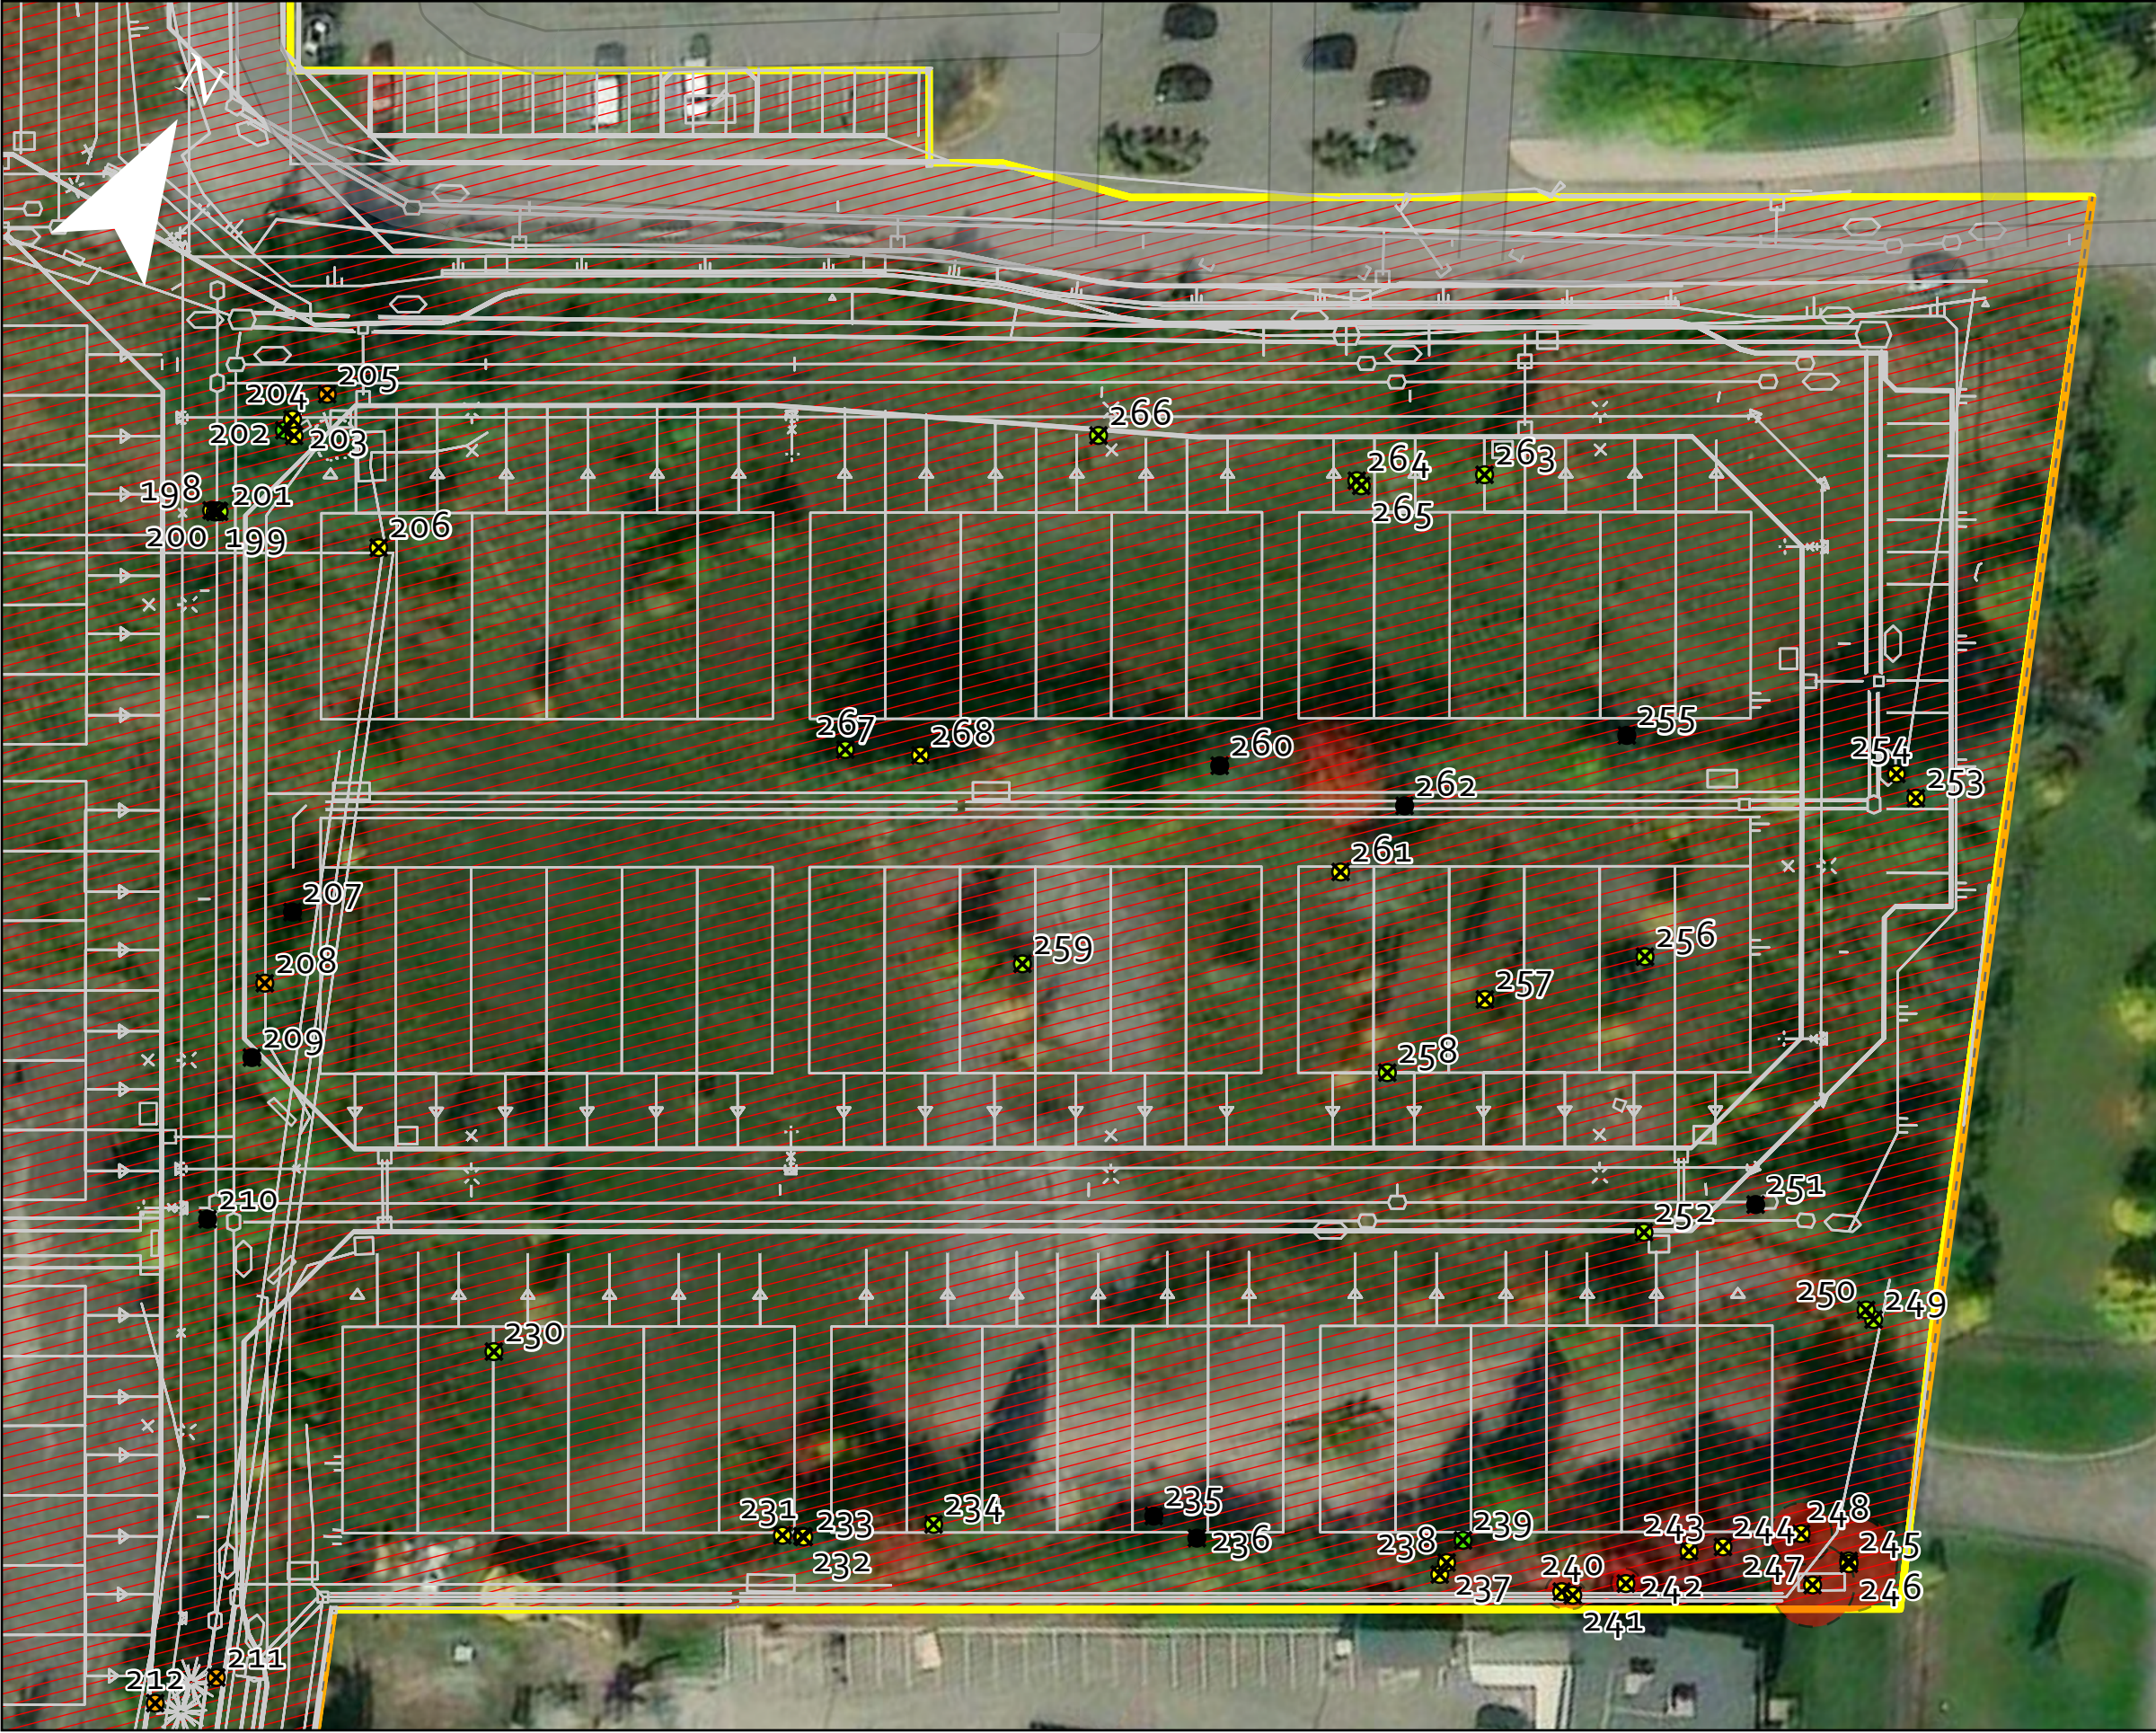
### Figure: 3.2

2510 St. Laurent Blvd:  
Tree Protection and Removals:  
Area-B

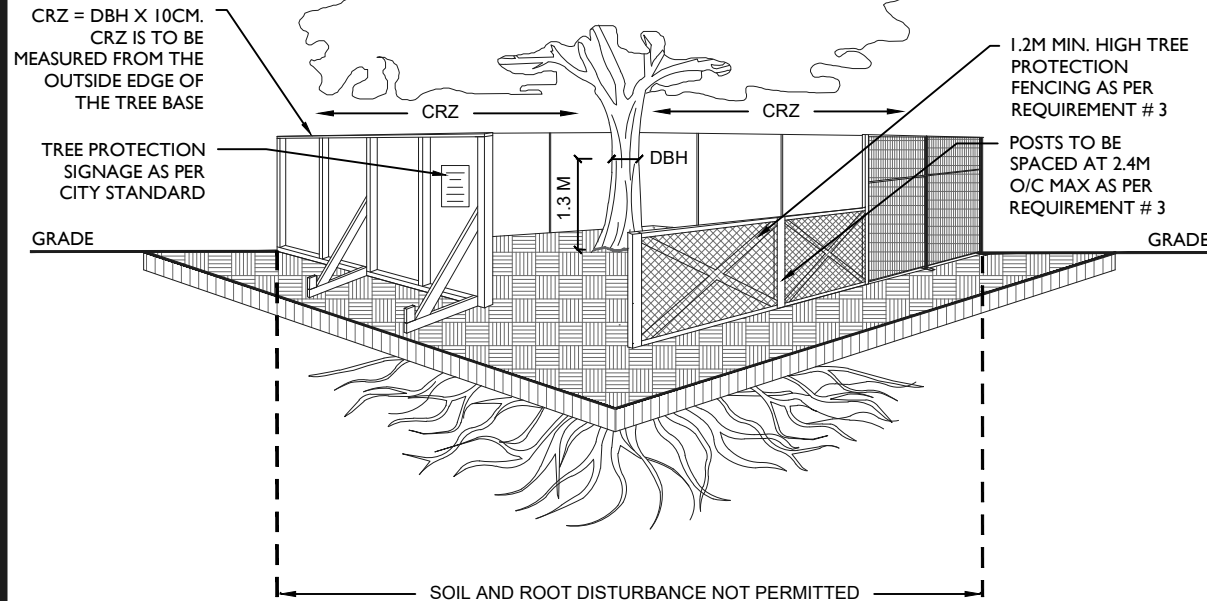
PLAN VIEW

- DO NOT EXTEND HARD SURFACE OR SIGNIFICANTLY CHANGE LANDSCAPING
3. TREE PROTECTION FENCING MUST BE AT LEAST 1.2M IN HEIGHT, AND CONSTRUCTED OF RIGID OR FRAMED MATERIALS (E.G. MODULOC - STEEL, PLYWOOD HOARDING, OR SNOW FENCE ON A 2"X4" WOOD FRAME) WITH POSTS 2.4M APART, SUCH THAT THE FENCE LOCATION CANNOT BE ALTERED. ALL SUPPORTS AND BRACING MUST BE PLACED OUTSIDE OF THE CRZ, AND INSTALLATION MUST MINIMISE DAMAGE TO EXISTING ROOTS. (SEE DETAIL)
