Geotechnical Investigation – Heron Gate Village Subdivision

June 2, 2025

Prepared for:
EFI Engineering

Cambium Reference: 22801-001

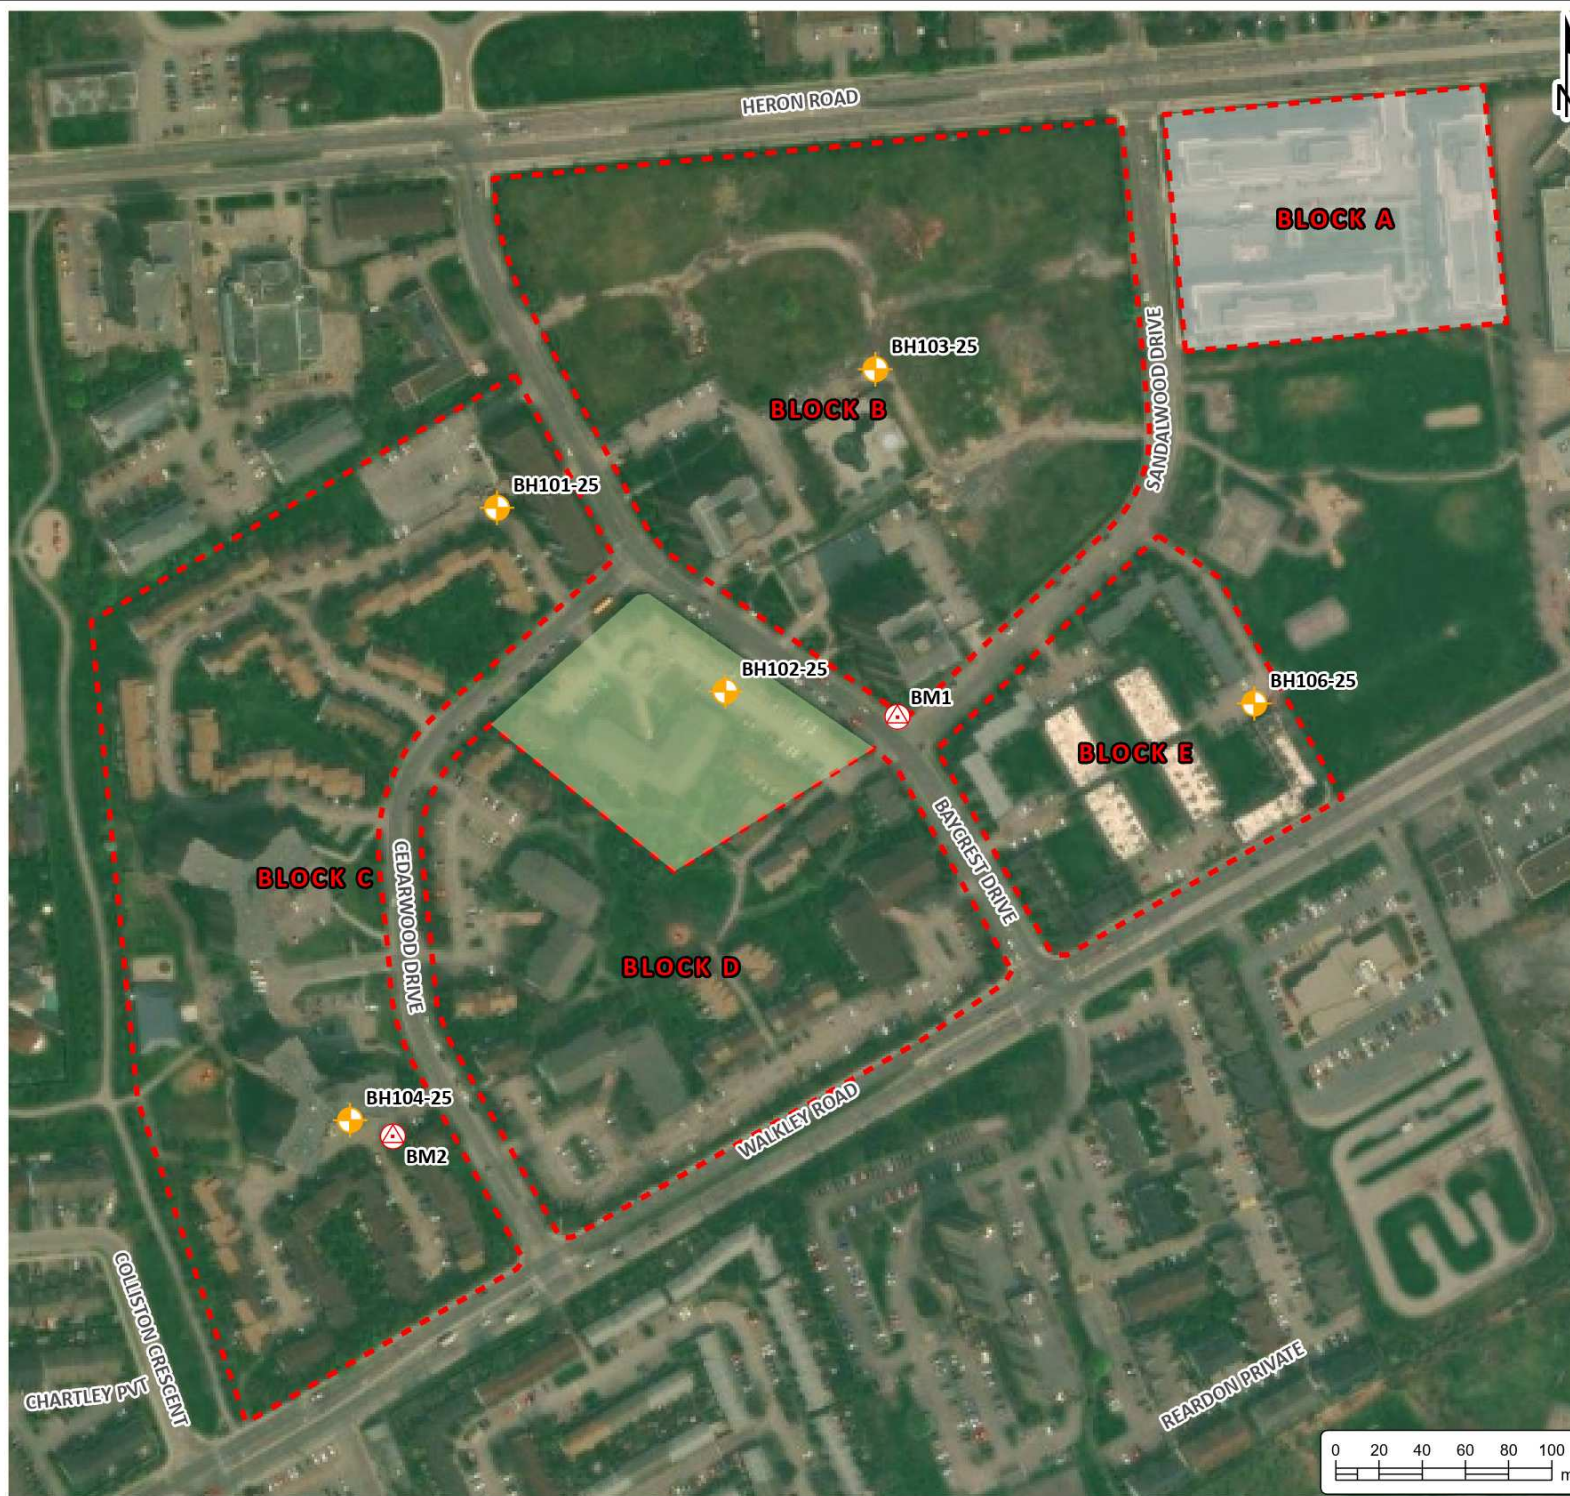
A borehole investigation was conducted at the site from March 25 to 28, 2025 to assess subsurface conditions. A total of 6 boreholes, designated BH101-25 through BH106-25, were advanced in the relative locations shown on the attached Figure 2, to a maximum depth of 9.8 m below ground surface (bgs).

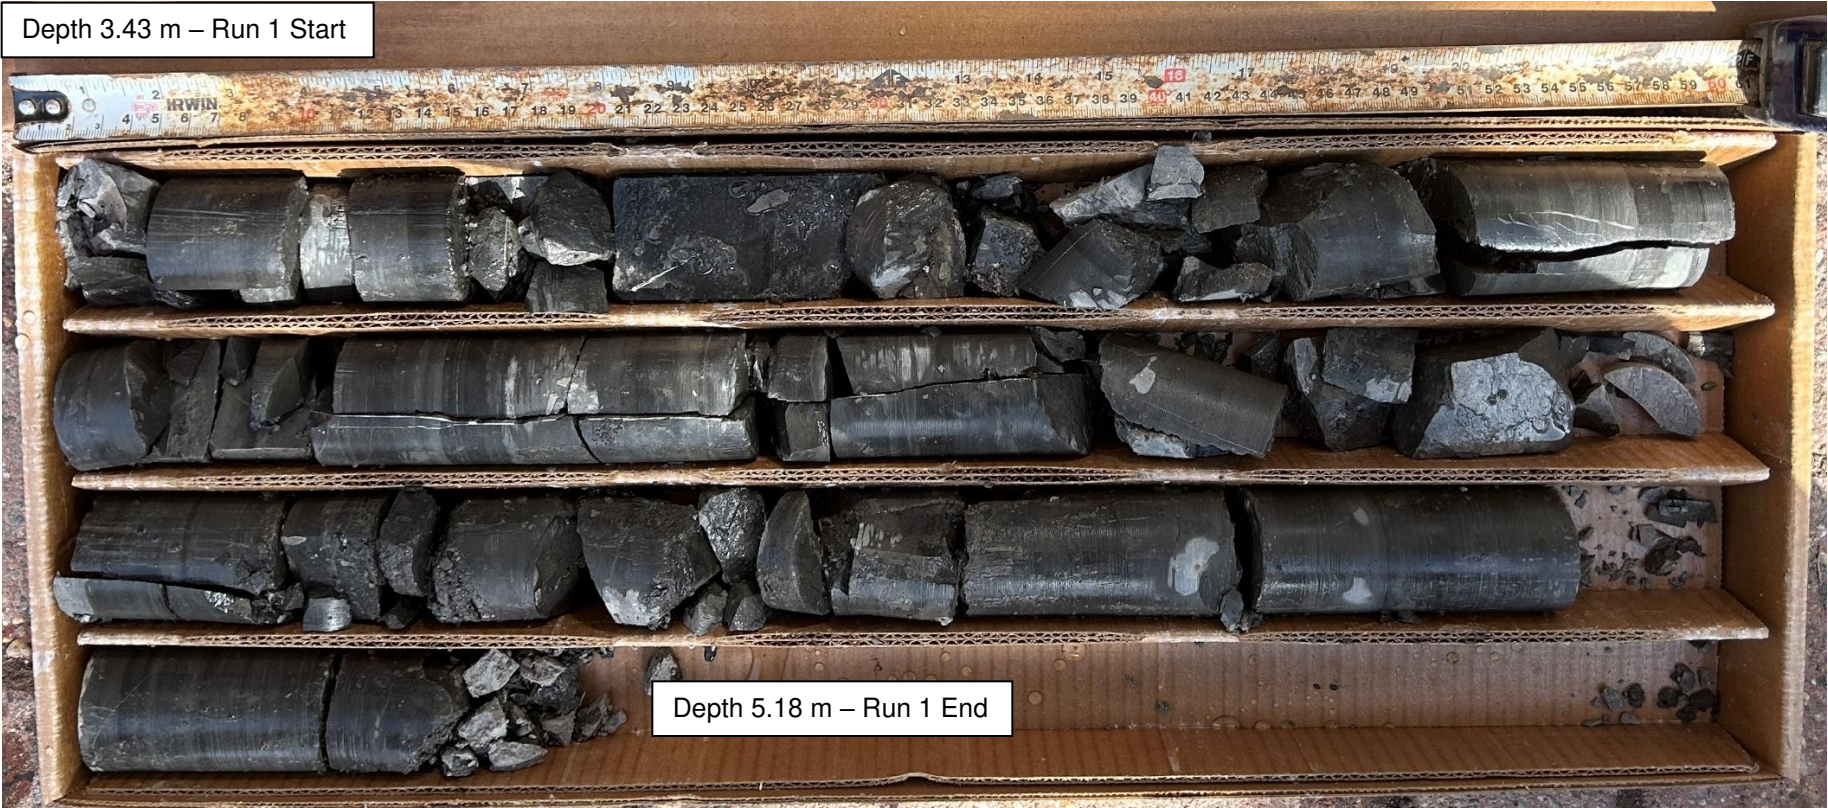
PROJECT No.	PHASE	Rev.	FIGURE
22801	001		B1-1

BH101-25
Cored length of 3.43 to 6.76 mbgs
Core Box 1 of 2

The borehole and rock core logs are provided in Appendix A. Site soil and groundwater conditions and our geotechnical recommendations are presented in the following sections of this report. Rock core samples were photographed prior to packaging and the photos are provided in Appendix B.

Based on available geological mapping, the local bedrock appears to consist of shale of the Billings Formation. This type of shale is known to degrade upon exposure to oxygen; the bedrock samples were therefore wrapped with plastic to maintain the in-situ moisture content and as-recovered condition as much as possible.

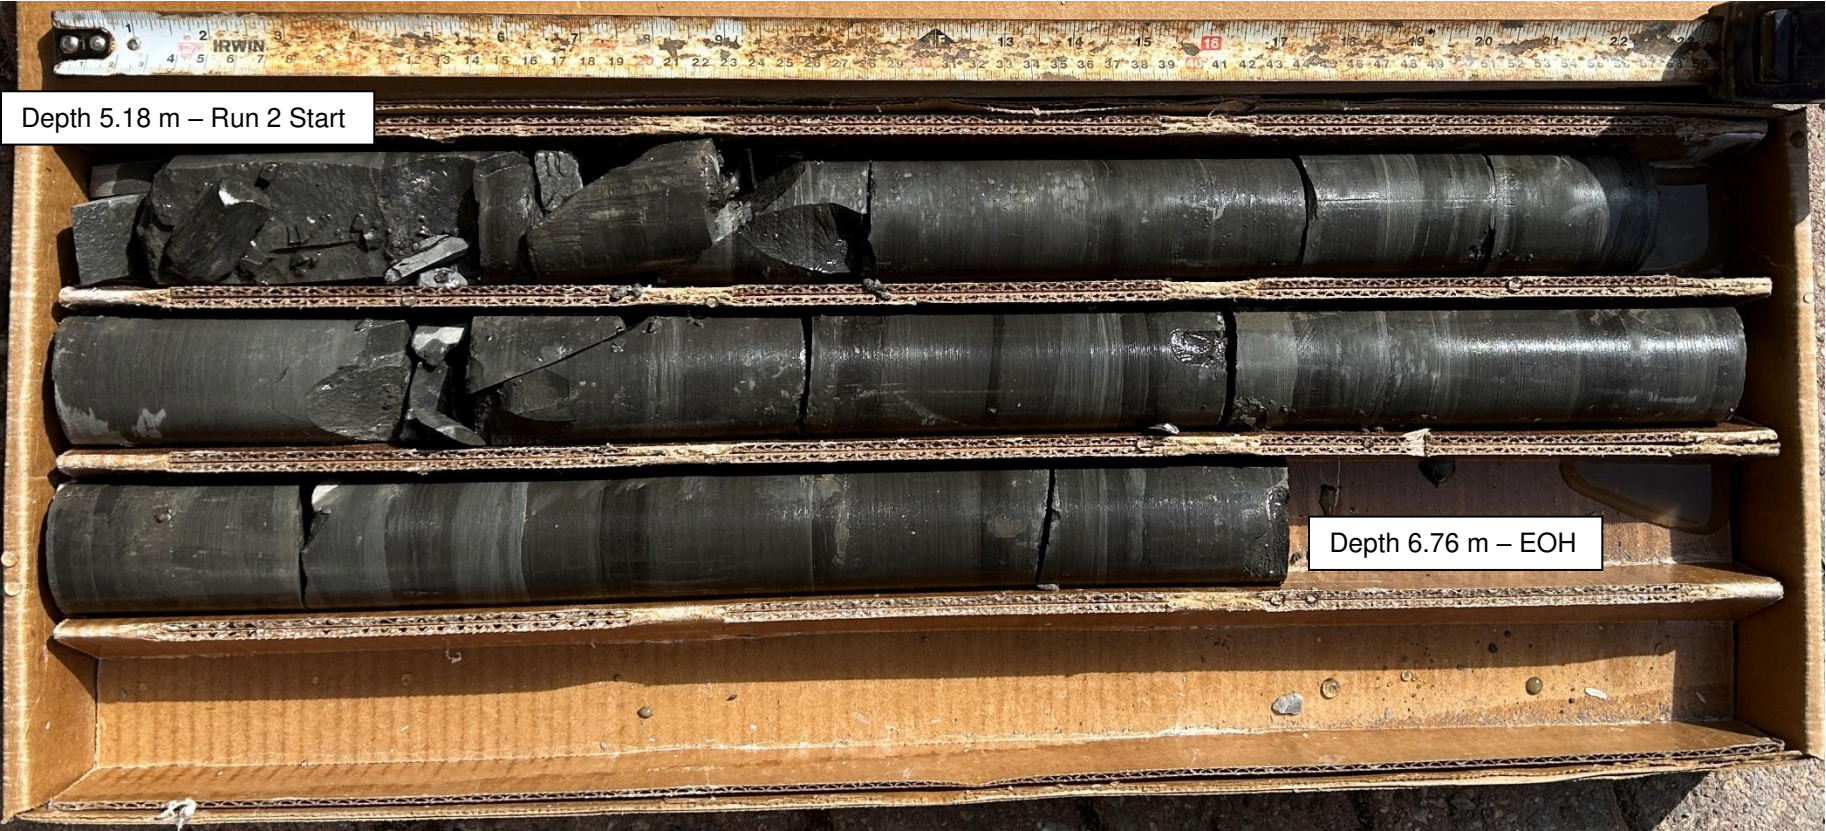
PROJECT No.	PHASE	Rev.	FIGURE
22801	001		B1-2

BH101-25
Cored length of 3.43 to 6.76 mbgs
Core Box 2 of 2

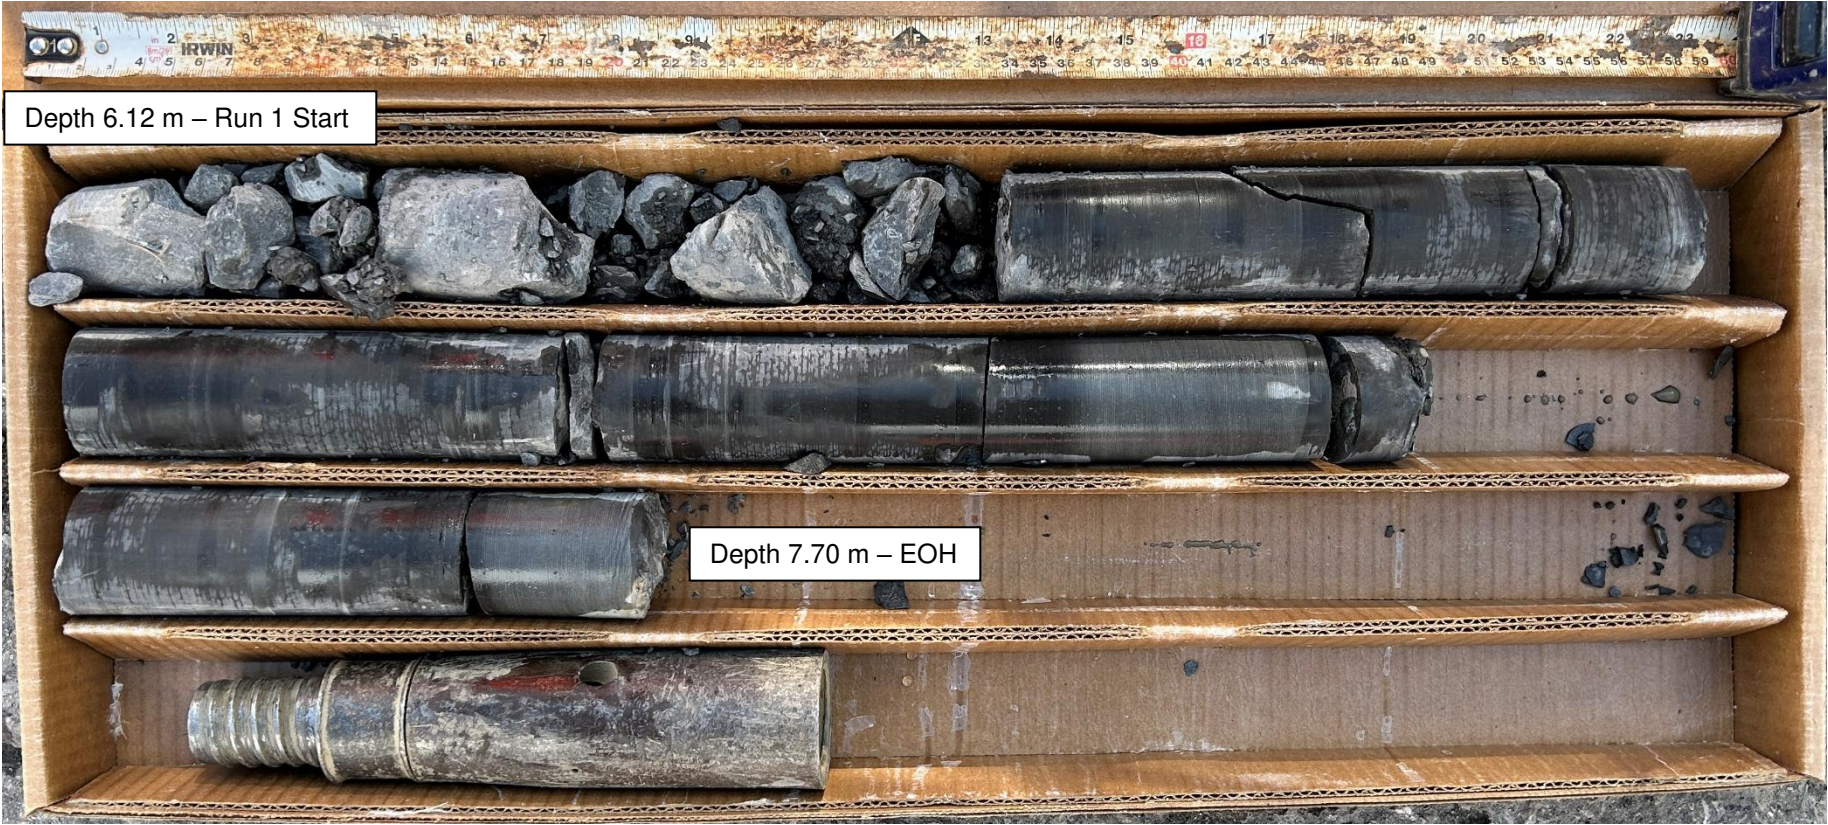
PROJECT No.	PHASE	Rev.	FIGURE
22801	001		B2

BH102-25
Cored length of 6.12 to 7.70 mbgs
Core Box 1 of 1

Depth 6.12 m – Run 1 Start

Depth 7.70 m – EOH

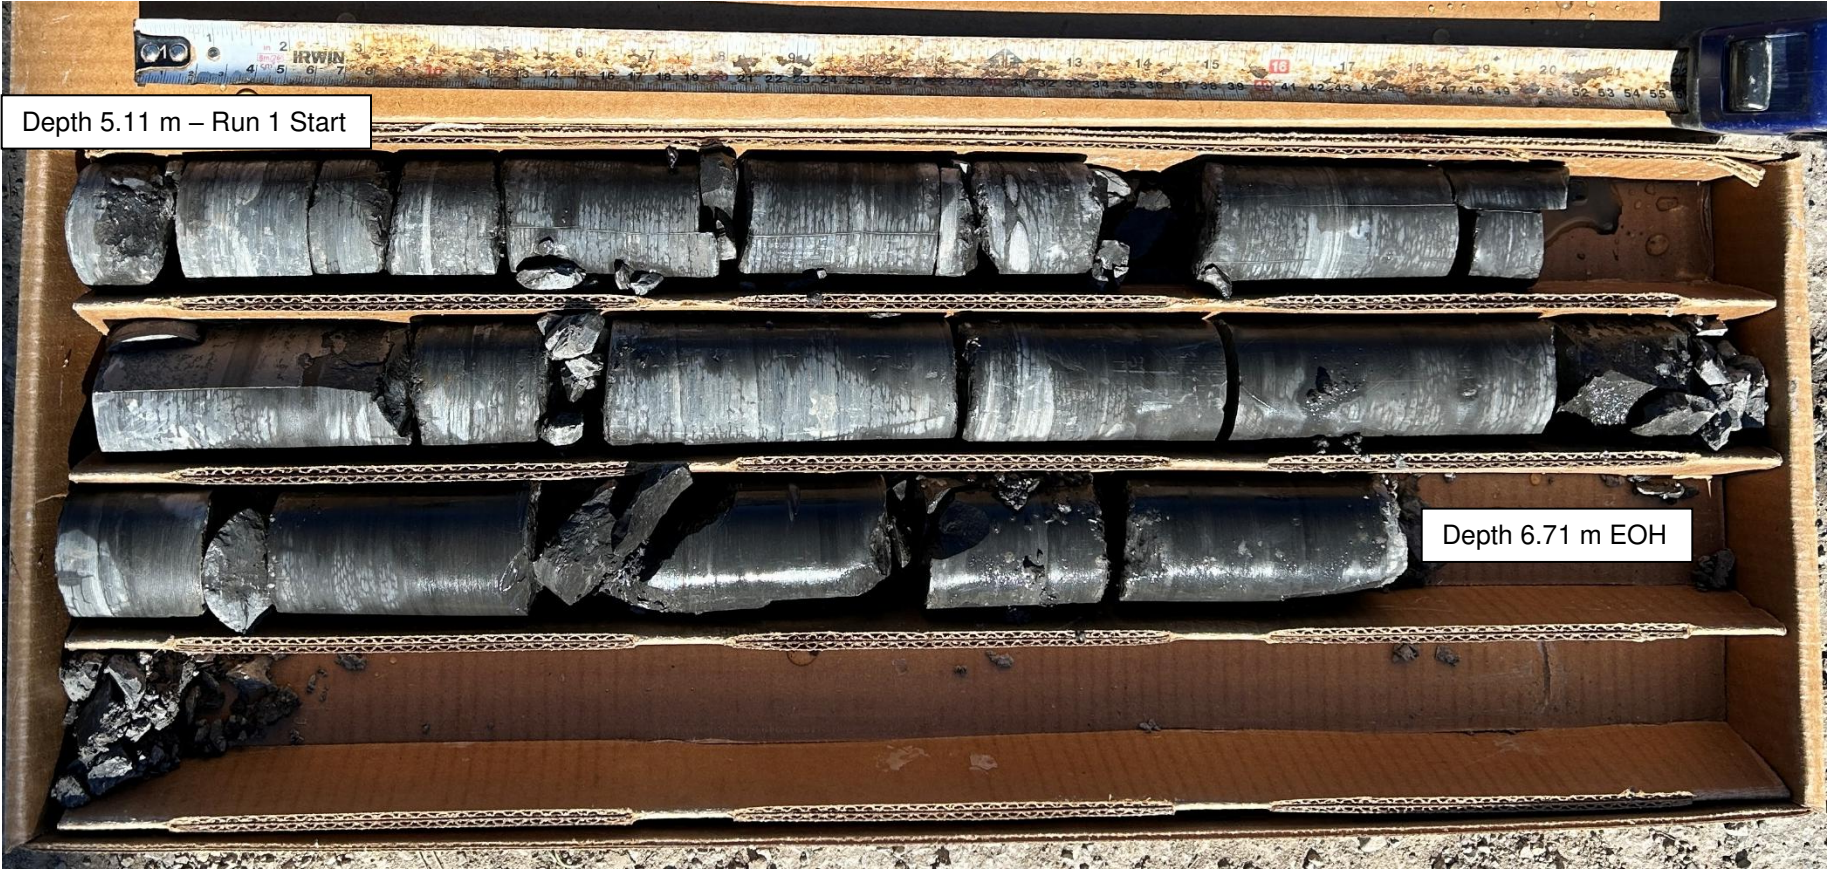
PROJECT No.	PHASE	Rev.	FIGURE
22801	001		B3

BH103-25
Cored length of 5.11 to 6.71 mbgs
Core Box 1 of 1

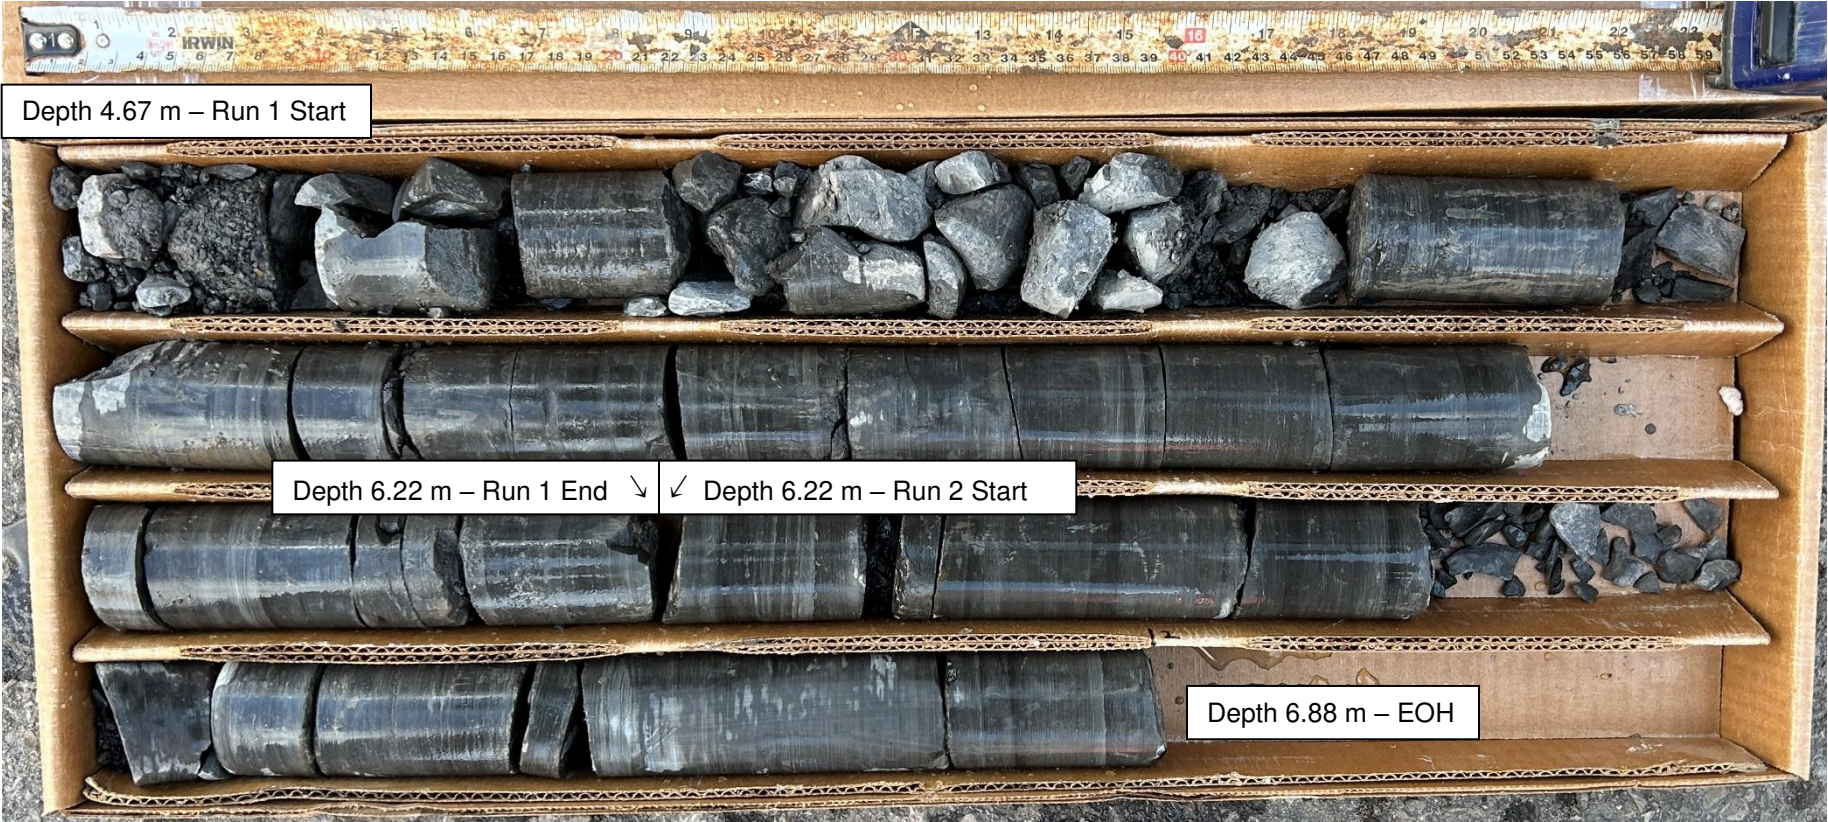
PROJECT No.	PHASE	Rev.	FIGURE
22801	001		B4

BH104-25
Cored length of 4.67 to 6.88 mbgs
Core Box 1 of 1

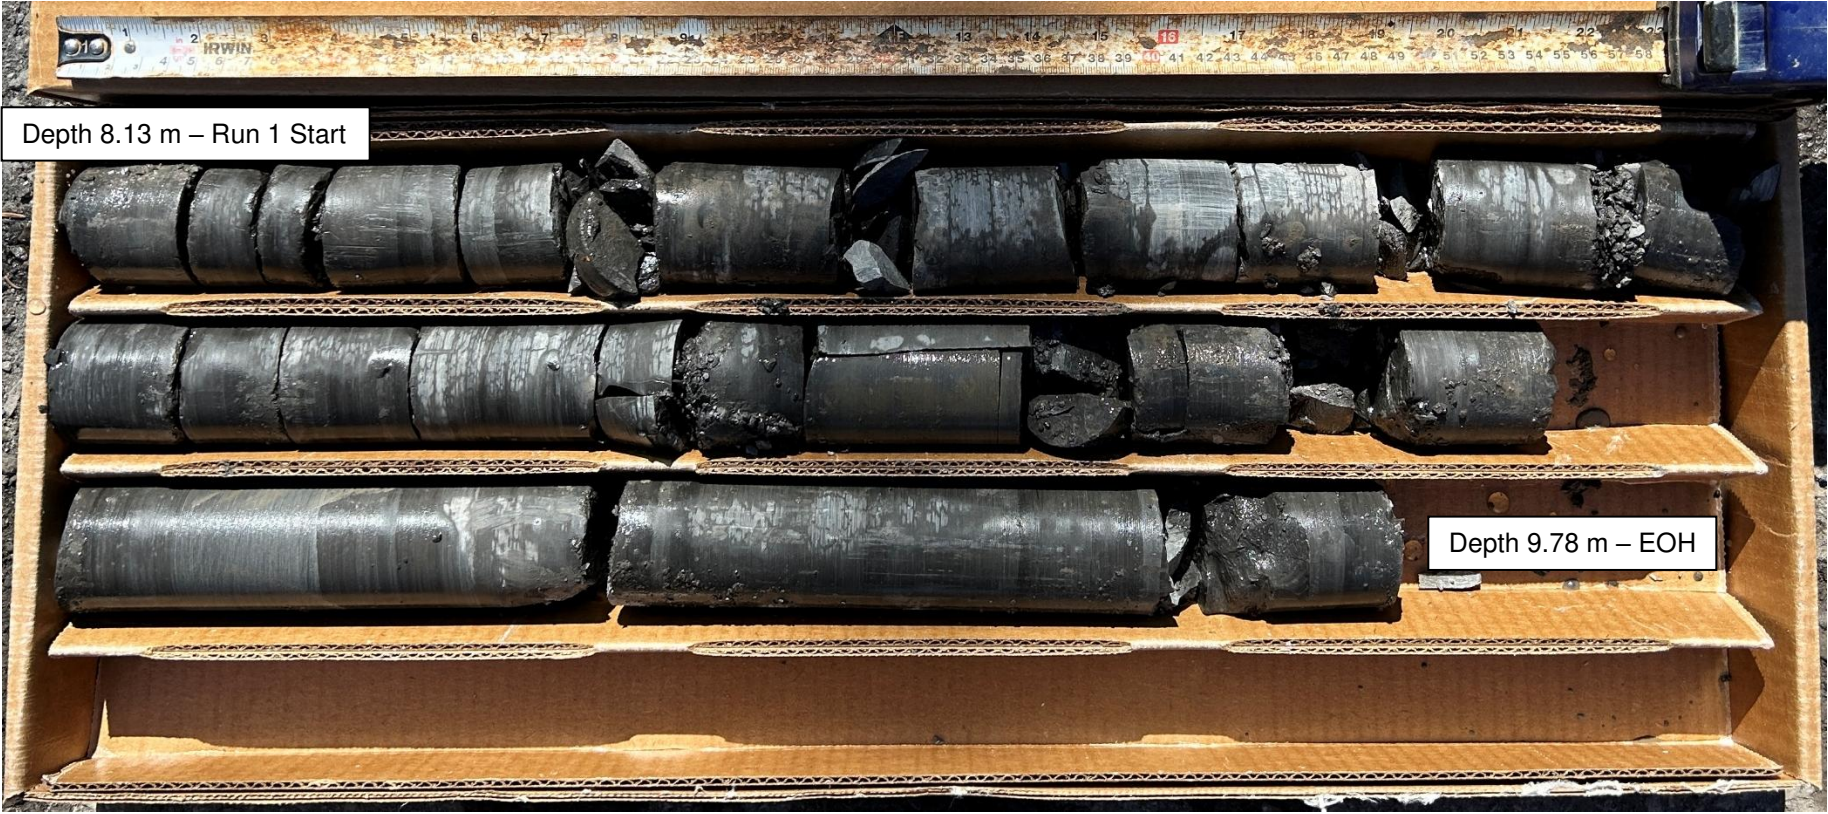
PROJECT No.	PHASE	Rev.	FIGURE
22801	001		B5

BH105-25
Cored length of 8.13 to 9.78 mbgs
Core Box 1 of 1

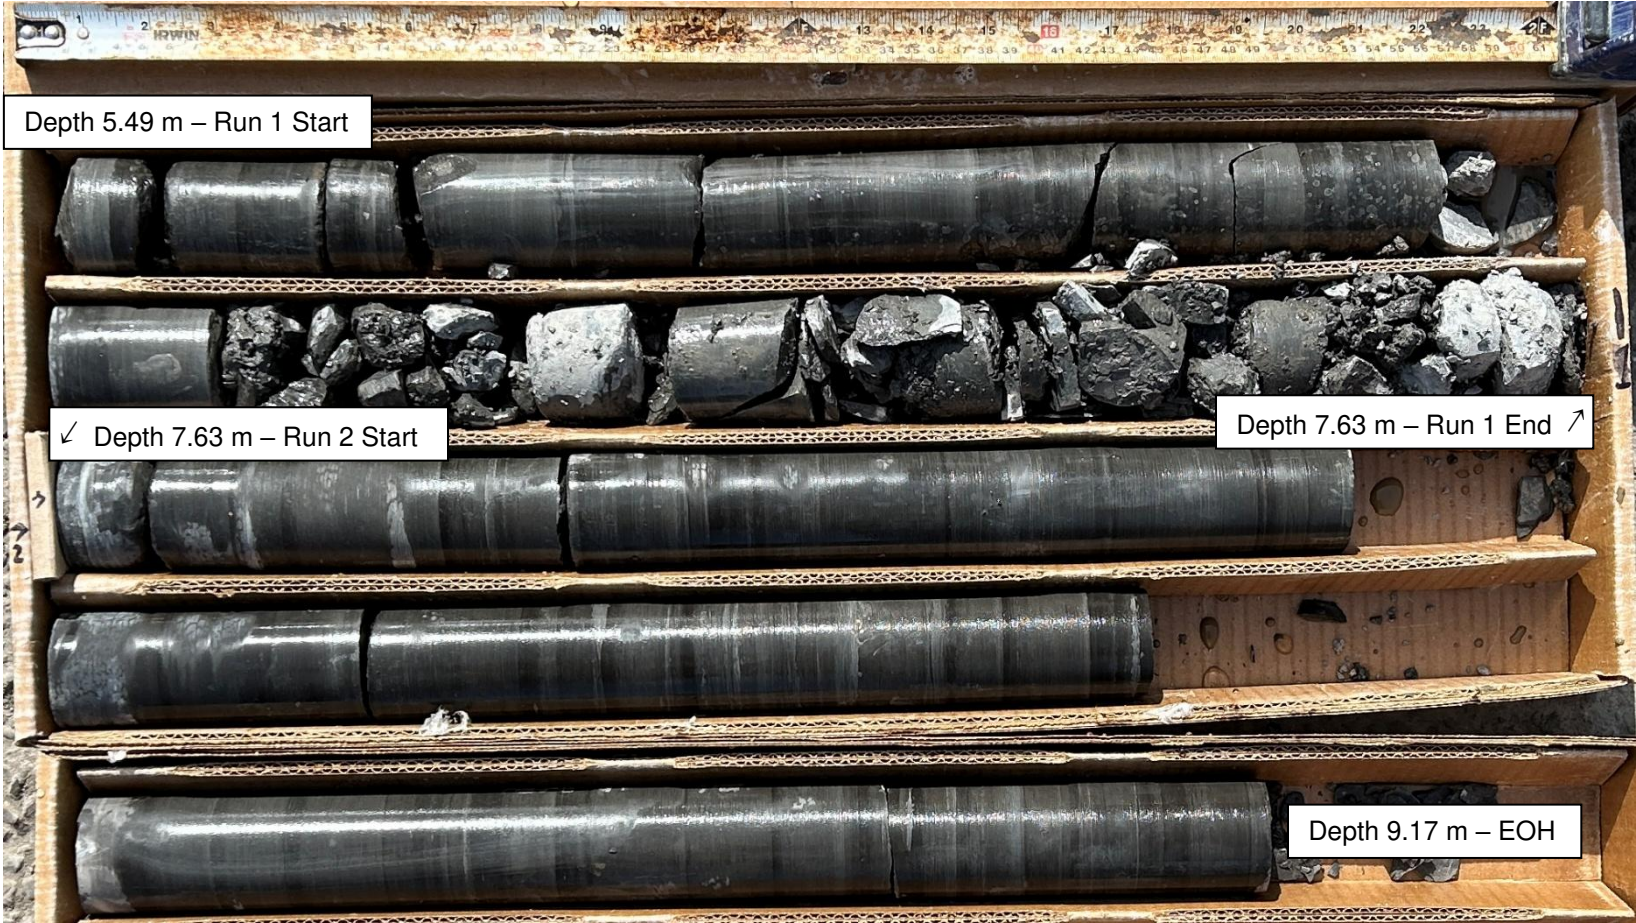
BH106-25
Cored length of 5.49 to 9.17 mbgs
Core Box 1 and 2 of 2

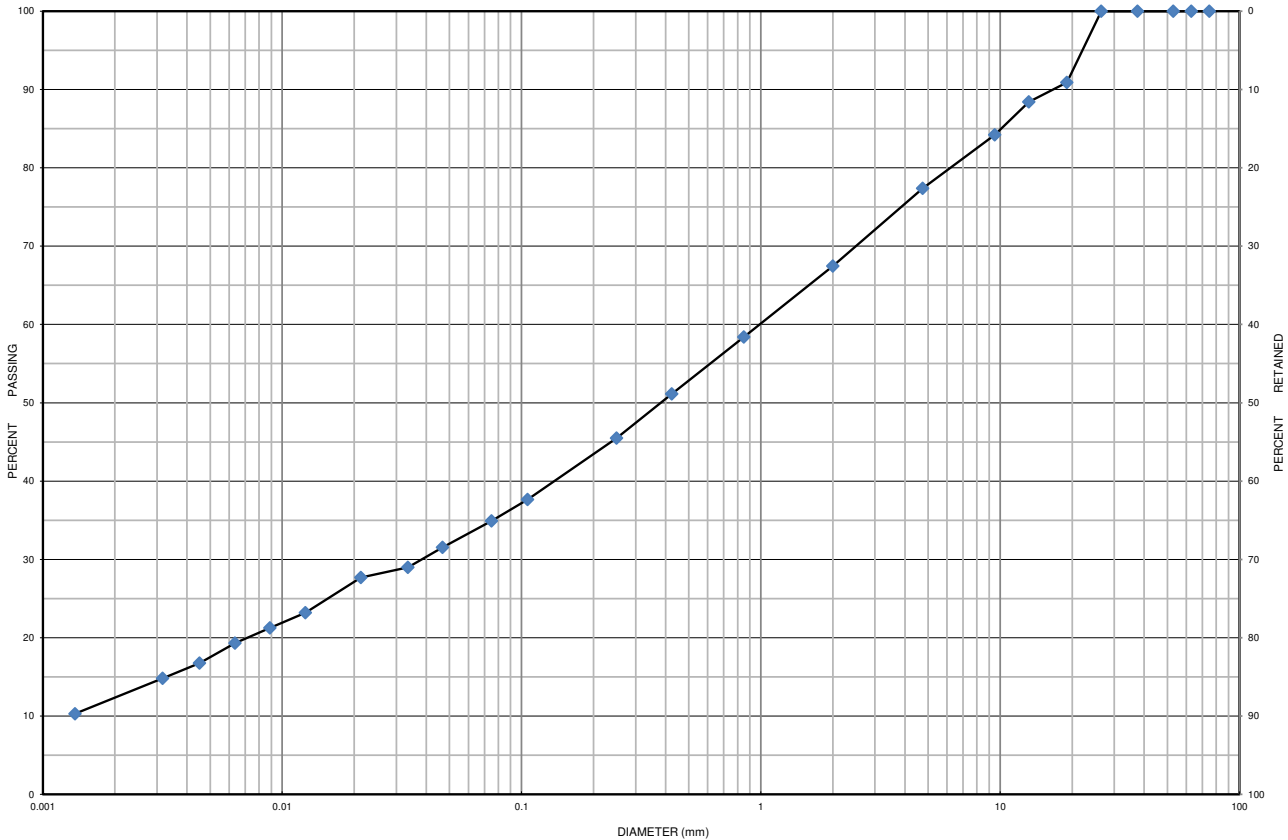
Lab Sample No: S-25-0554

Borehole No.	Sample No.	Depth	Gravel	Sand	Silt	Clay	Moisture
BH 101-25	SS 2	0.8 m to 1.4 m	23	42	23	12	11.6
Description		Classification	D ₆₀	D ₃₀	D ₁₀	C _u	C _c
Gravelly Silty Clayey Sand		SM	1.000	0.039	-	-	-

Sample Location	Depth (mbgs)	Soil	% Gravel	% Sand	% Silt	% Clay	% Moisture
BH101-25 SS2	0.8 - 1.4	Gravelly Silty Sand, some Clay	23	42	23	12	11.6
BH102-25 SS1B	0.8 to 1.4	Clayey Silt and Sand, trace Gravel	1	39	42	18	38.7
BH104-25 SS2	0.8 - 1.4	Gravelly Silty Sand, some Clay	13	49	24	14	10.1
BH105-25 SS3	1.5 – 2.1	Silty Sand, some Gravel, Some Clay	11	47	29	13	8.7
BH105-25 SS2	0.8 – 1.4	Silty Sand, some Gravel, Some Clay	10	48	27	15	11.0

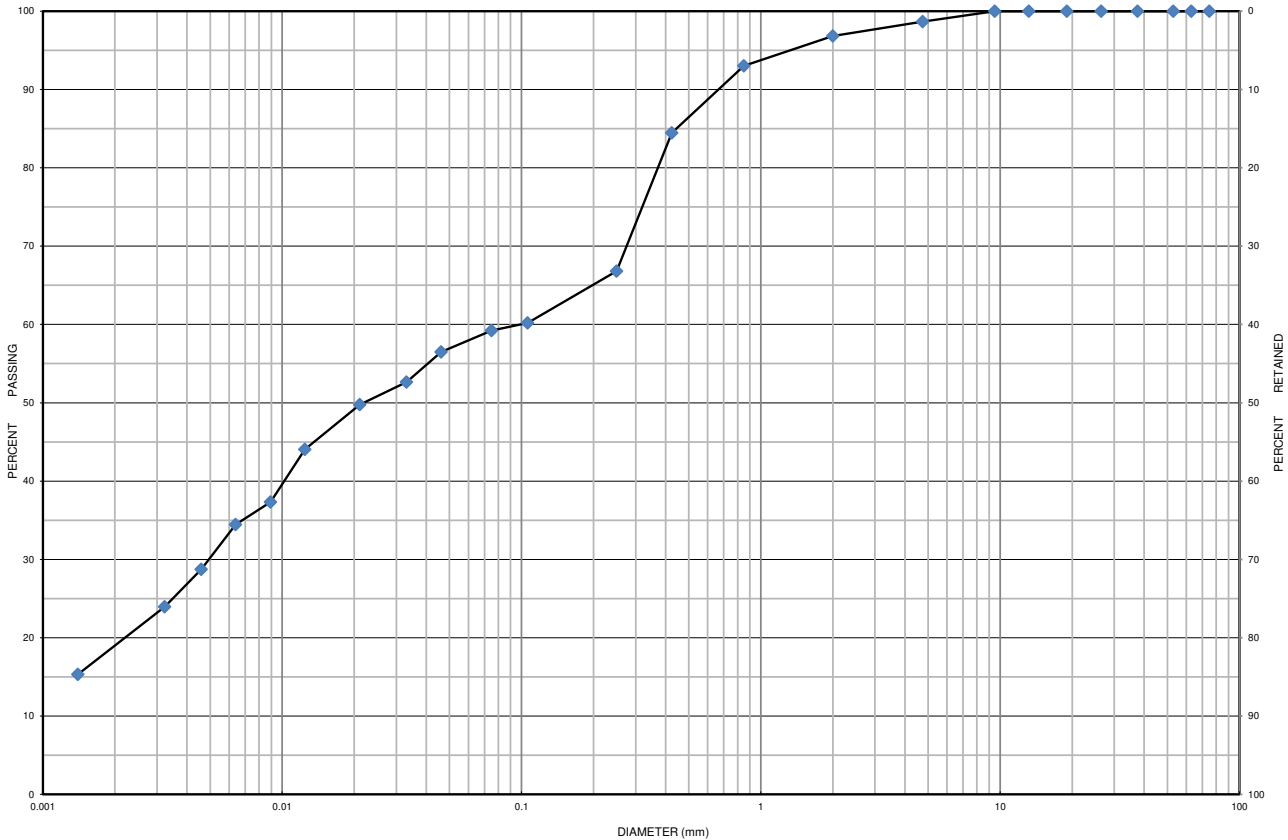
Lab Sample No: S-25-0556

Borehole No.	Sample No.	Depth	Gravel	Sand	Silt	Clay	Moisture
BH 102-25	SS 1B	0.4 m to 0.8 m	1	39	42	18	38.7
Description		Classification	D ₆₀	D ₃₀	D ₁₀	C _u	C _c
Clayey Silt and Sand trace Gravel		ML	0.100	0.005	-	-	-

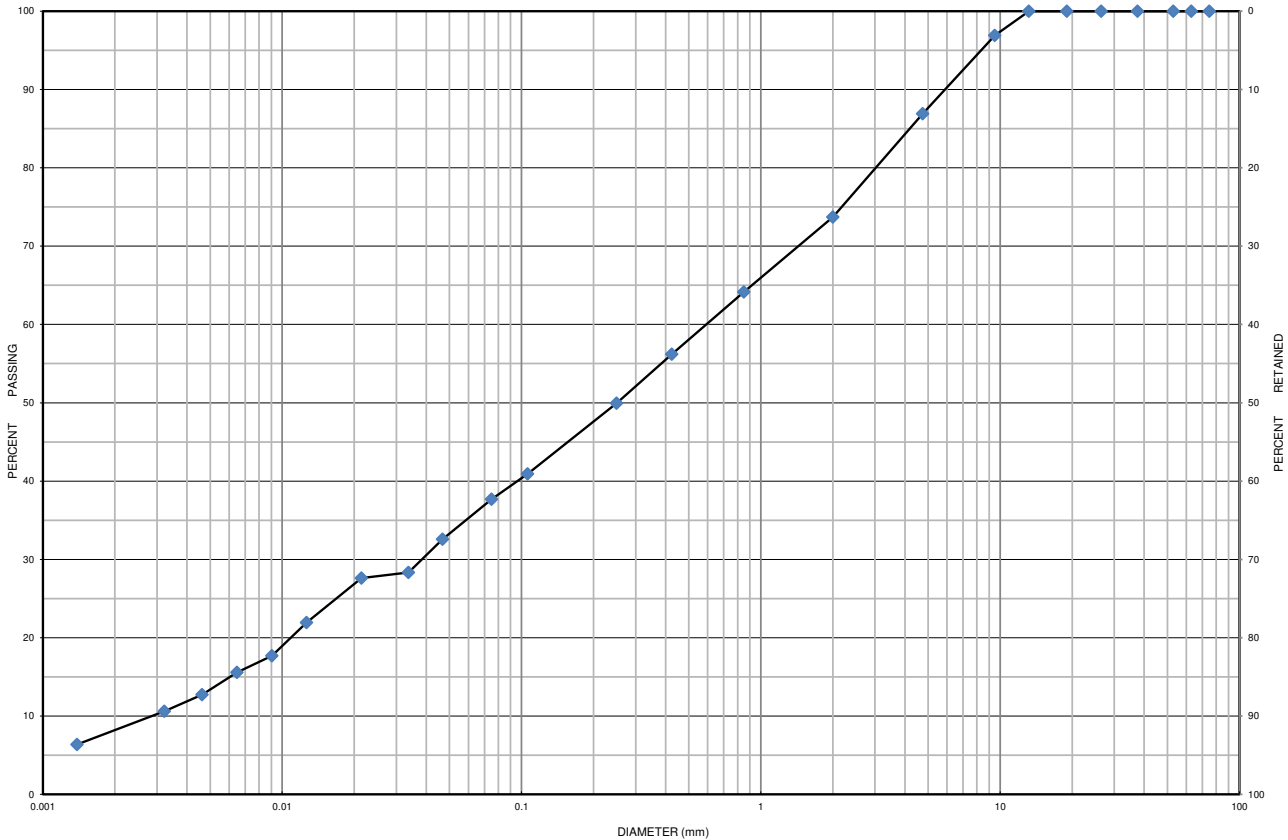
Lab Sample No: S-25-0558

Borehole No.	Sample No.	Depth	Gravel	Sand	Silt	Clay	Moisture
BH 103-25	SS 4	2.3 m to 2.9 m	13	49	30	8	6.9
Description		Classification	D ₆₀	D ₃₀	D ₁₀	C _u	C _c
Silty Gravelly Sand some Clay		SM	0.6000	0.0390	0.0028	214.29	0.91

Sample Location	Depth (mbgs)	Soil	% Gravel	% Sand	% Silt	% Clay	% Moisture
BH103-25 SS4	2.3 - 1.9	Gravelly Silty Sand, some Clay	13	49	30	8	6.9
BH106-25 SS4	2.3 – 2.9	Silty Sand, some Gravel, Some Clay	7	44	33	16	11.0

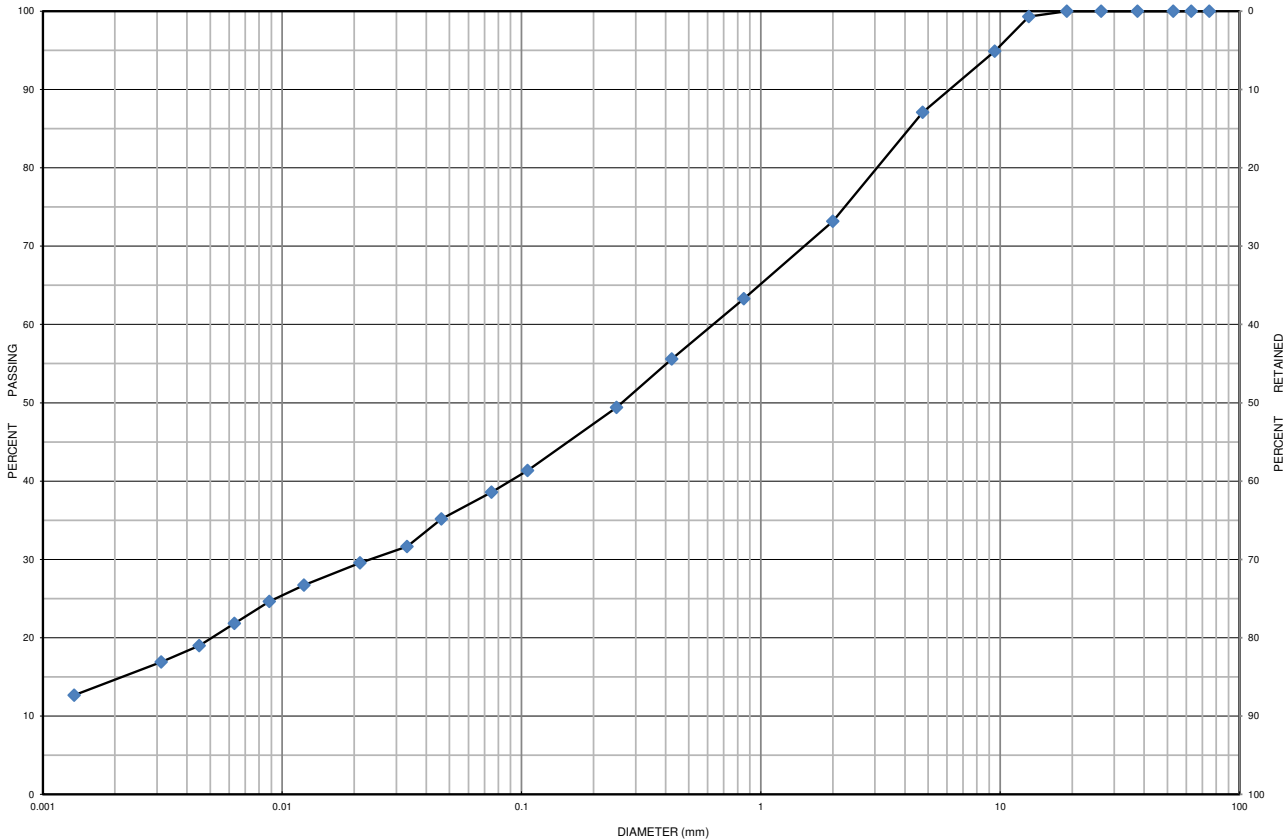
Location: BH 104-25 SS 2

Borehole No.	Sample No.	Depth	Gravel	Sand	Silt	Clay	Moisture
BH 104-25	SS 2	0.8 m to 1.4 m	13	49	24	14	10.1
Description		Classification	D ₆₀	D ₃₀	D ₁₀	C _u	C _c
Silty Clayey Gravelly Sand		SM	0.630	0.024	-	-	-

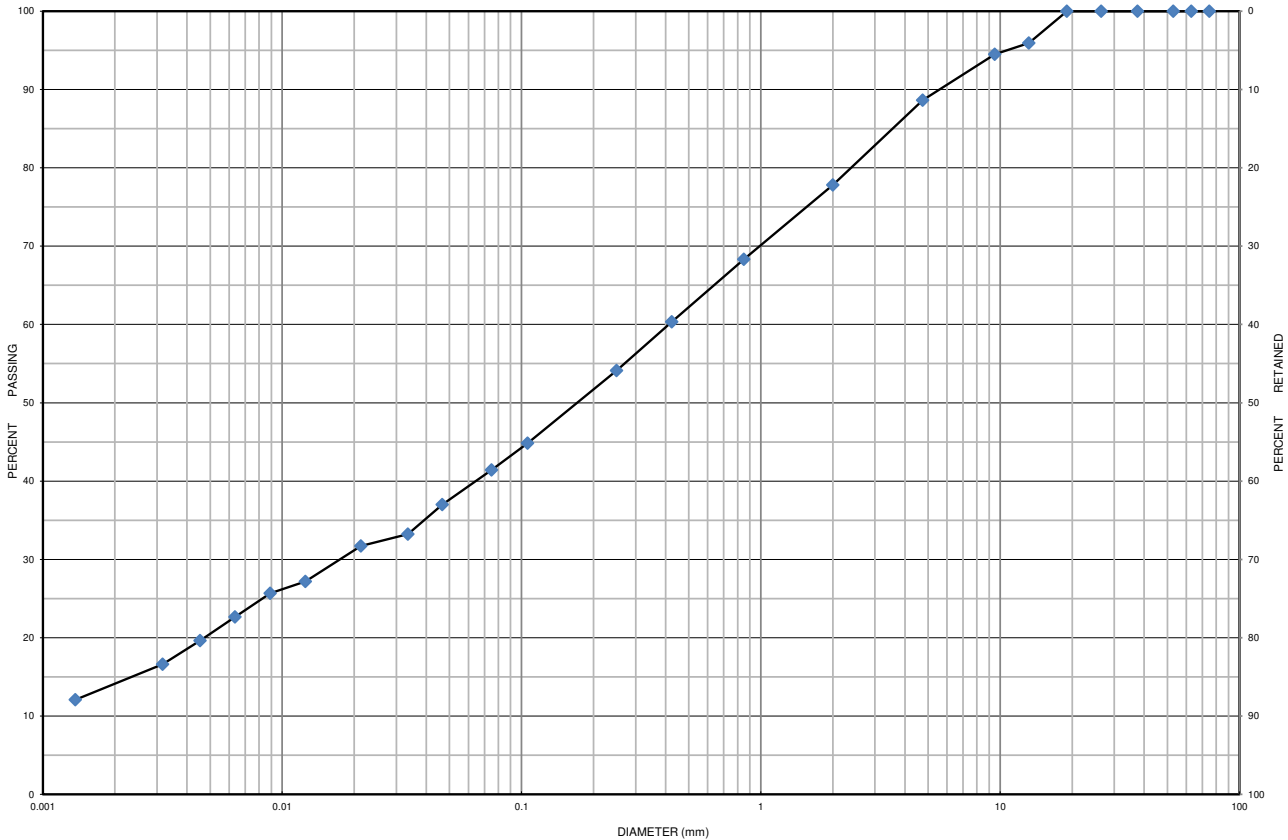
Lab Sample No: S-25-0562

Borehole No.	Sample No.	Depth	Gravel	Sand	Silt	Clay	Moisture
BH 105-25	SS 3	1.5 m to 2.1 m	11	47	29	13	8.7
Description		Classification	D ₆₀	D ₃₀	D ₁₀	C _u	C _c
Silty Clayey Sand some Gravel		SM	0.410	0.018	-	-	-

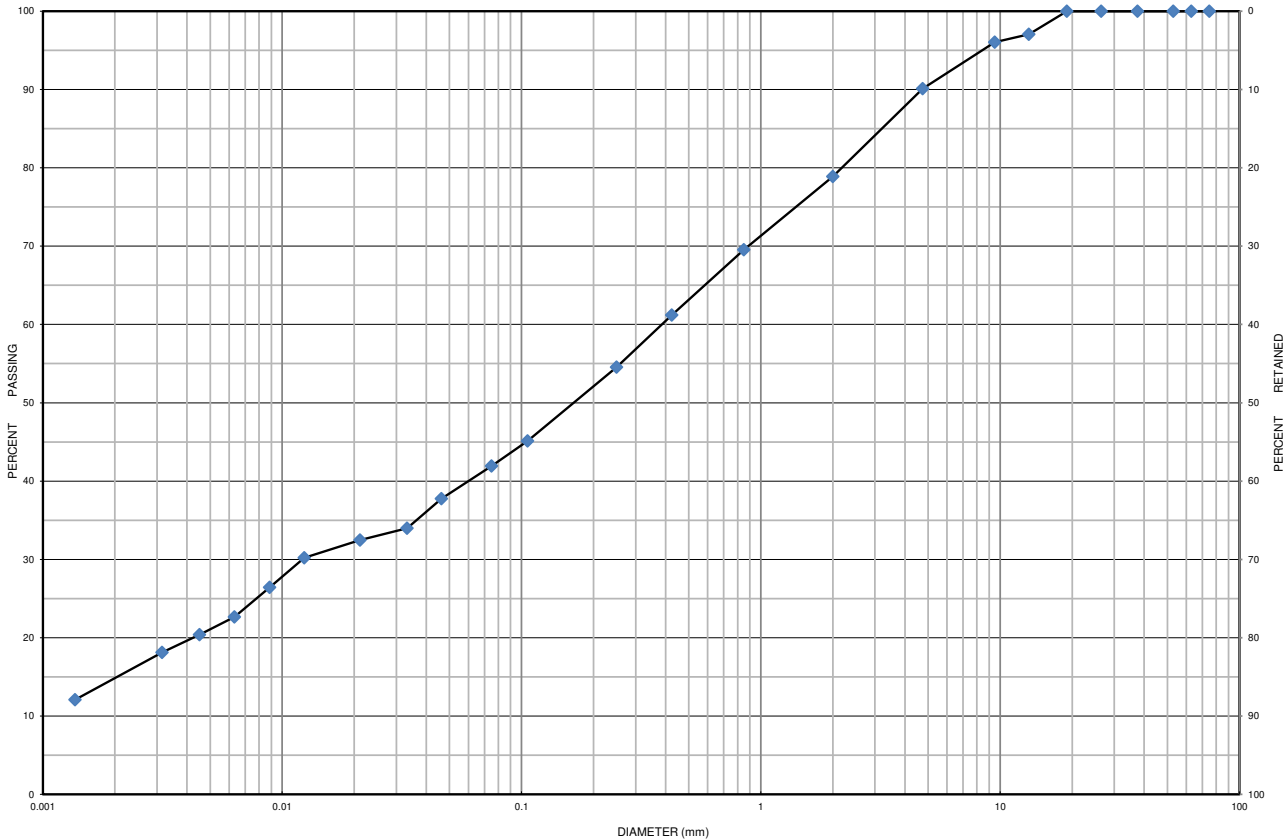
Lab Sample No: S-25-0565

Borehole No.	Sample No.	Depth	Gravel	Sand	Silt	Clay	Moisture
BH 106-25	SS 2	0.8 m to 1.4 m	10	48	27	15	11.0
Description		Classification	D ₆₀	D ₃₀	D ₁₀	C _u	C _c
Silty Clayey Sand some Gravel		SM	0.395	0.014	-	-	-

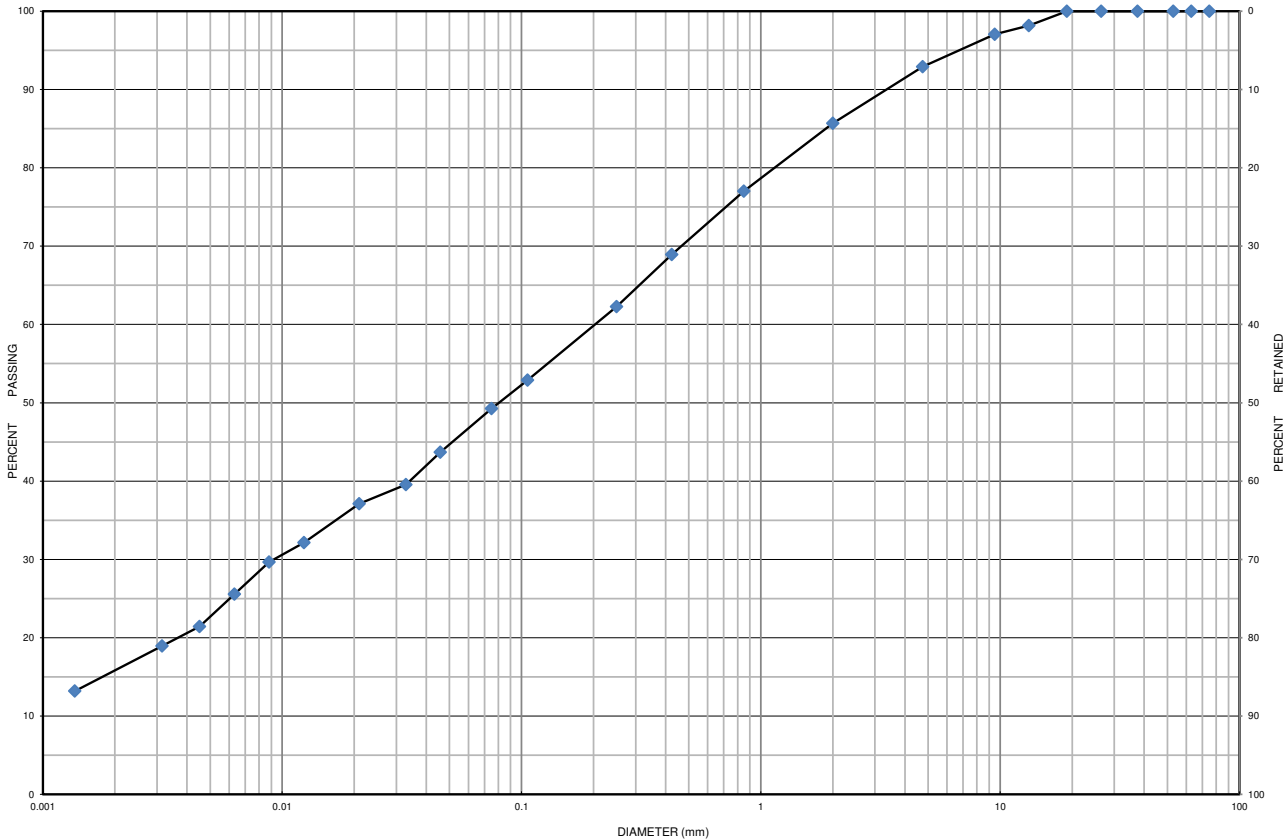
Lab Sample No: S-25-0564

Borehole No.	Sample No.	Depth	Gravel	Sand	Silt	Clay	Moisture
BH 106-25	SS 4	2.3 m to 2.9 m	7	44	33	16	11.0
Description		Classification	D ₆₀	D ₃₀	D ₁₀	C _u	C _c
Silty Clayey Sand some Gravel		SM	0.2000	0.0093	-	-	-

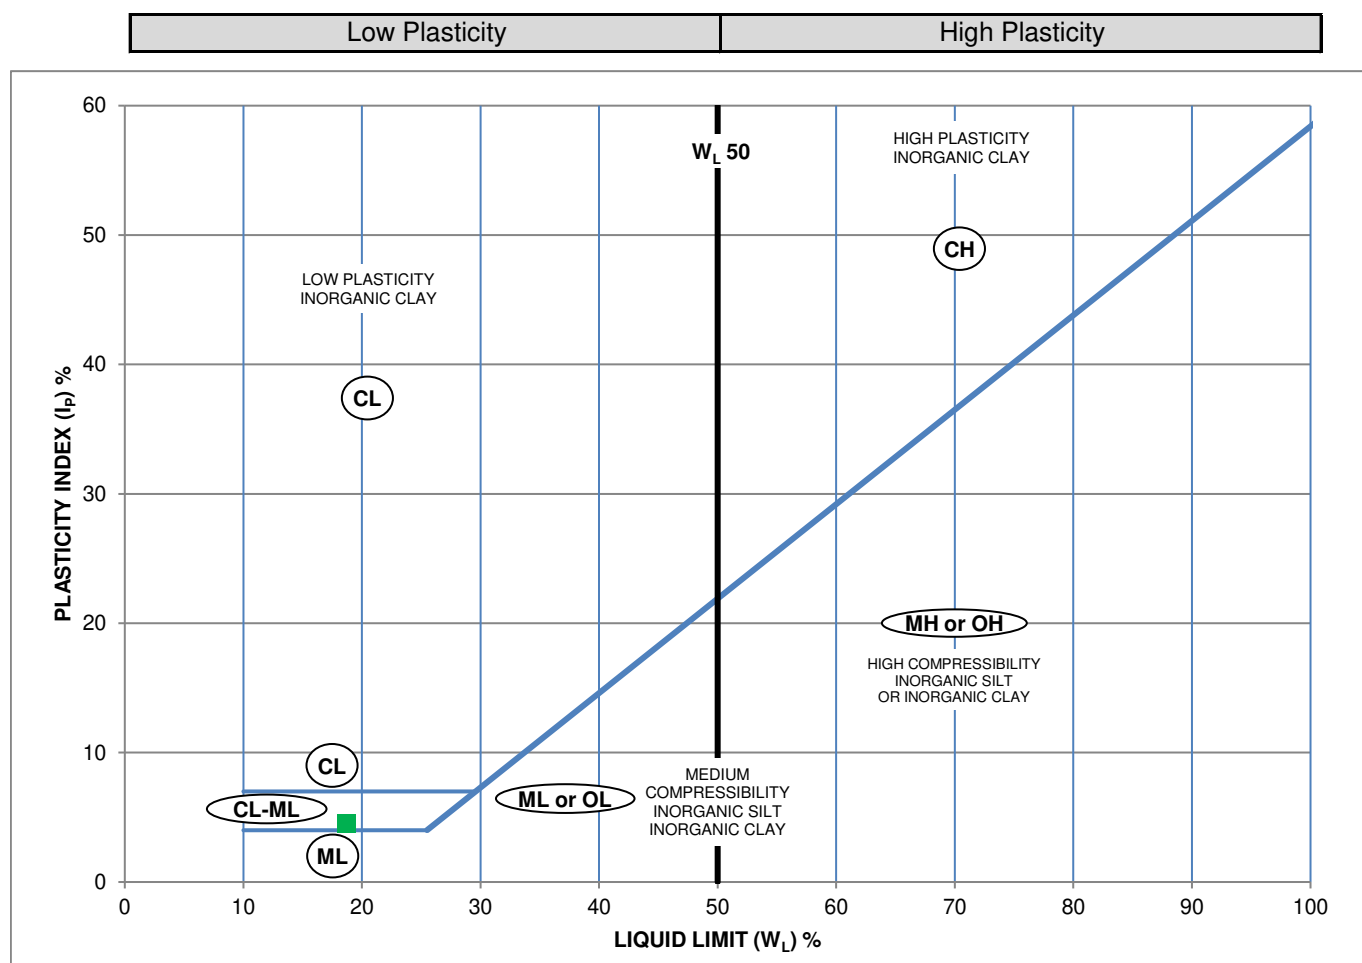
Lab Sample No: S-25-0555

Symbol	Borehole	Sample	Depth	Description
■	BH 101-25	SS 3	1.5 m to 2.1 m	CL-ML

Liquid Limit (%)	Plastic Limit	Plasticity Index (%)
18.7	14.2	4.5

Sample	Depth (mbgs)	Liquid Limit (%)	Plastic Limit (%)	Plasticity Index (%)	Moisture (%)	Classification
BH101-24 SS3	1.5 – 2.1	18.7	14.2	4.5	8.1	Low Plasticity Clayey Silt to Silty Clay
BH103-25 SS5	3.0 – 3.7	17.1	13.1	4.0	4.8	Low Plasticity Silt
BH104-25 SS4	2.3 – 2.9	18.6	12.9	5.7	9.2	Low Plasticity Clayey Silt to Silty Clay
BH105-25 SS5	3.0 – 3.7	17.7	13.2	4.5	9.2	Low Plasticity Clayey Silt to Silty Clay
