Geotechnical Investigation – Heron Gate Village Subdivision

June 2, 2025

Prepared for:
EFI Engineering

Cambium Reference: 22801-001

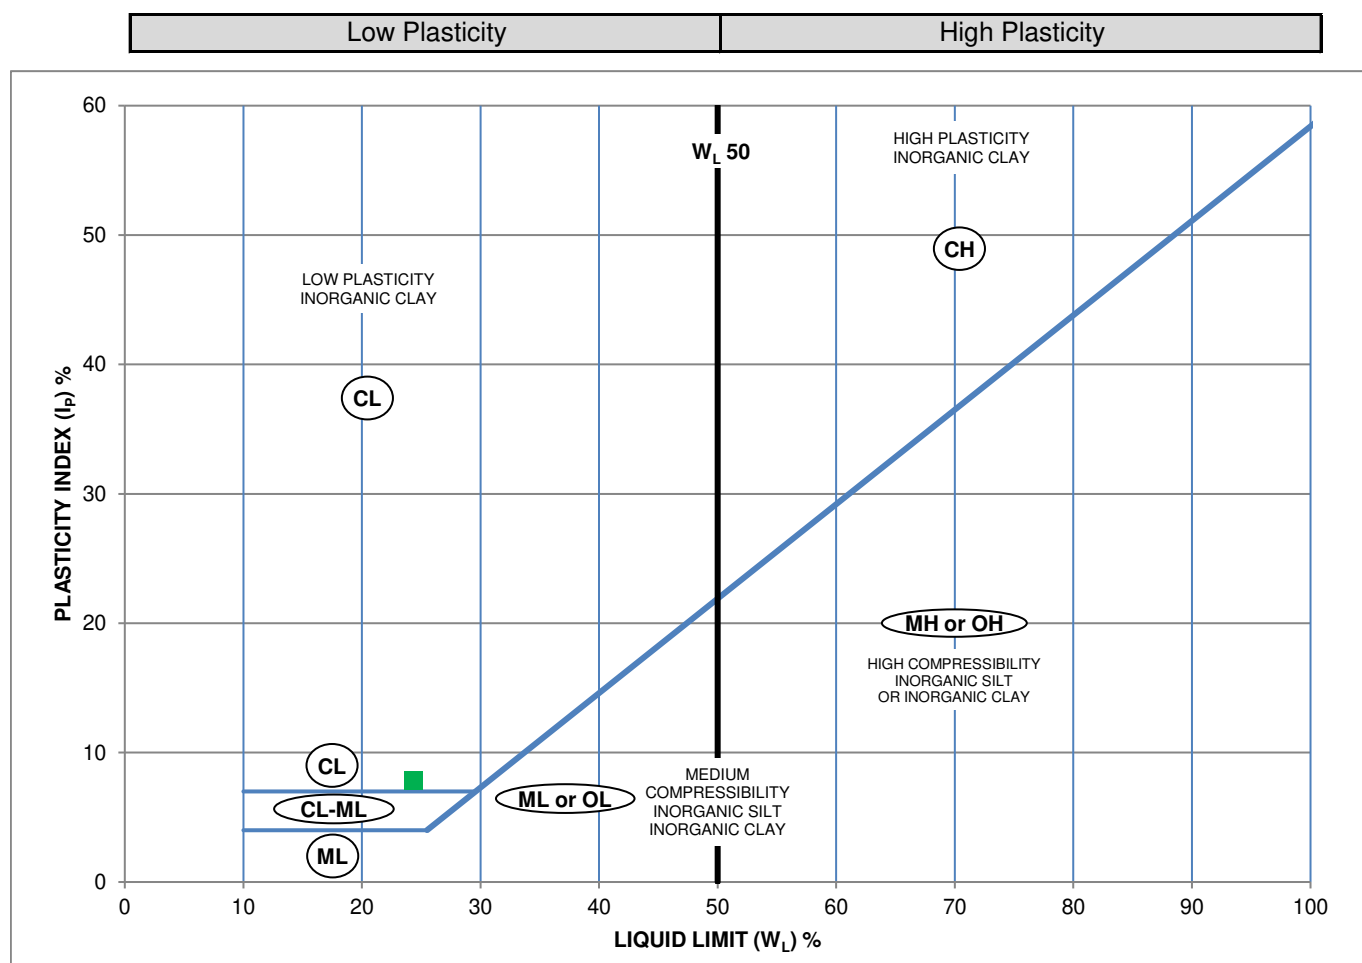
Lab Sample No: S-25-0557

Symbol	Borehole	Sample	Depth	Description
■	BH 102-25	SS 3	1.5 m to 2.1 m	Low Plasticity Clay

Liquid Limit (%)	Plastic Limit	Plasticity Index (%)
24.4	16.6	7.8

Sample	Depth (mbgs)	Liquid Limit (%)	Plastic Limit (%)	Plasticity Index (%)	Moisture (%)	Classification
BH102-25 SS3	1.5 – 2.1	24.4	16.6	7.8	11.8	Low Plasticity Clay

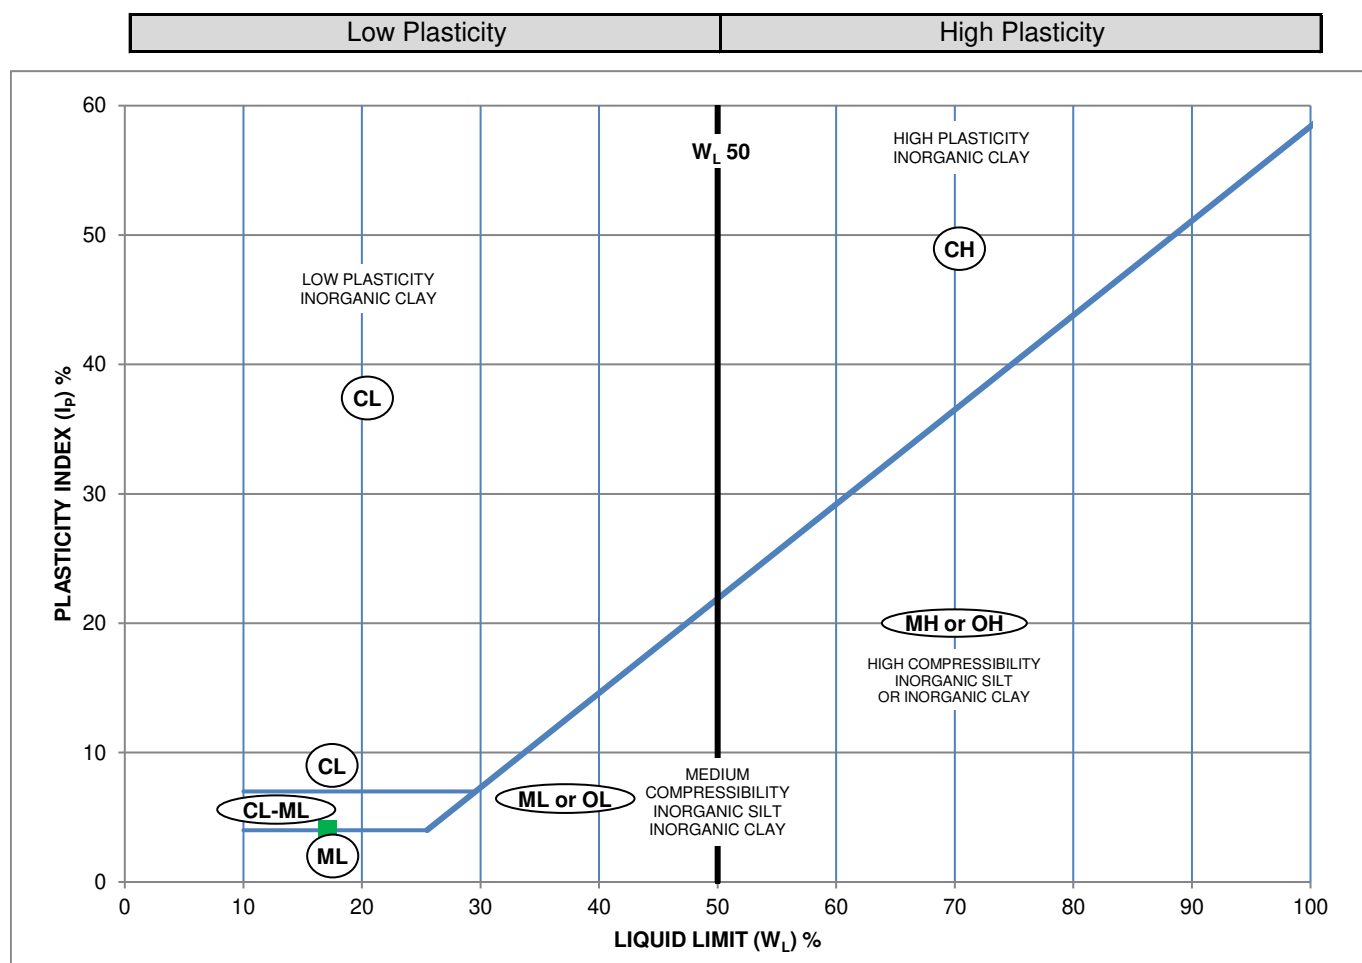
Lab Sample No: S-25-0559

Symbol	Borehole	Sample	Depth	Description
■	BH 103-25	SS 5	3 m to 3.7 m	ML

Liquid Limit (%)	Plastic Limit	Plasticity Index (%)
17.1	13.1	4.0

Sample	Depth (mbgs)	Liquid Limit (%)	Plastic Limit (%)	Plasticity Index (%)	Moisture (%)	Classification
BH101-24 SS3	1.5 – 2.1	18.7	14.2	4.5	8.1	Low Plasticity Clayey Silt to Silty Clay
BH103-25 SS5	3.0 – 3.7	17.1	13.1	4.0	4.8	Low Plasticity Silt
BH104-25 SS4	2.3 – 2.9	18.6	12.9	5.7	9.2	Low Plasticity Clayey Silt to Silty Clay
BH105-25 SS5	3.0 – 3.7	17.7	13.2	4.5	9.2	Low Plasticity Clayey Silt to Silty Clay

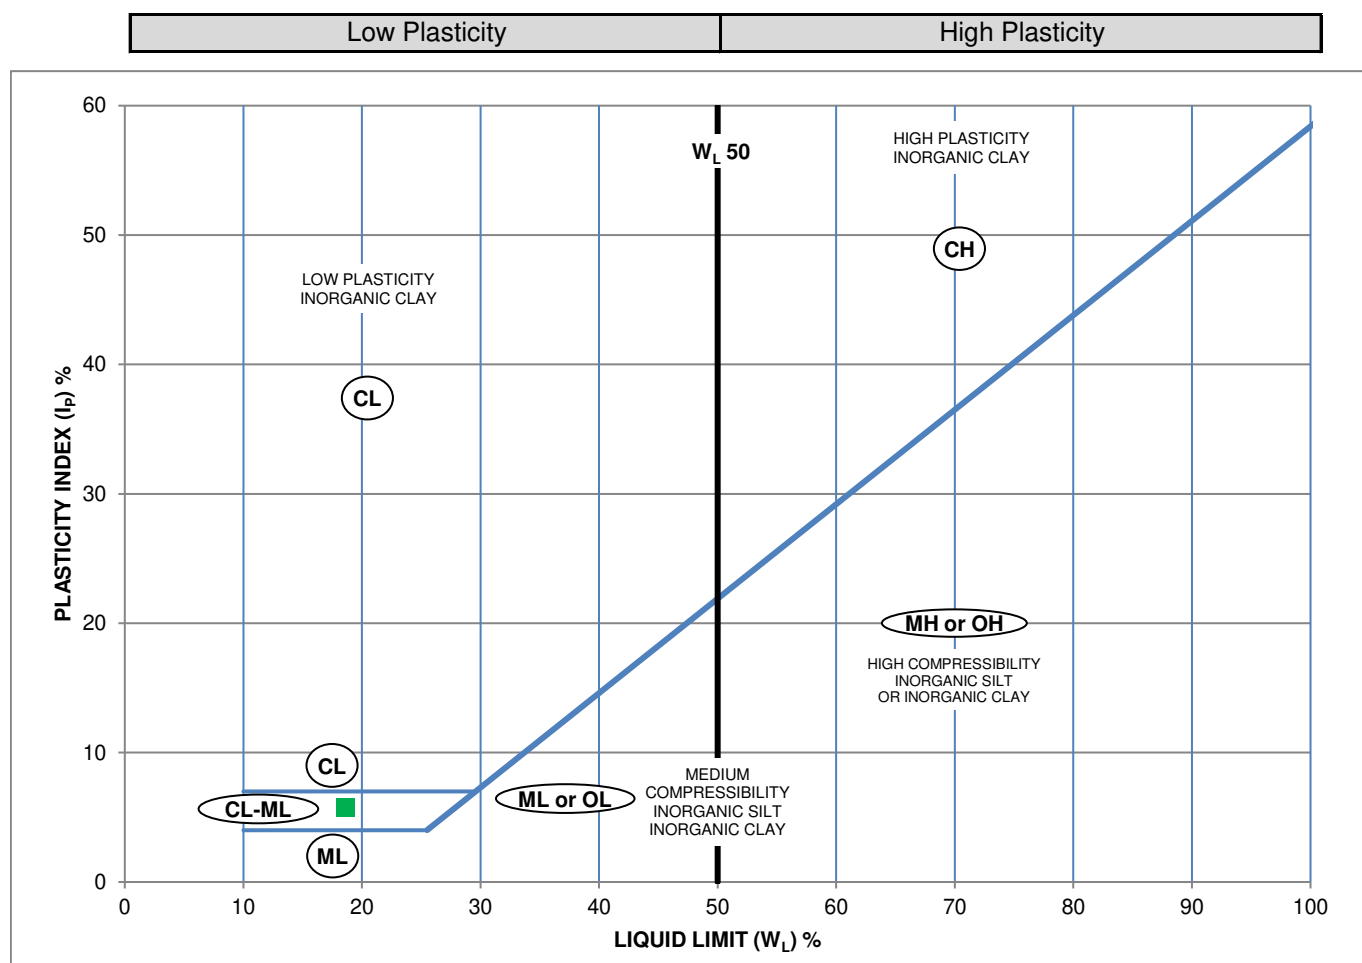
Lab Sample No: S-25-0561

Symbol	Borehole	Sample	Depth	Description
■	BH 104-25	SS 4	2.3 m to 2.9 m	CL-ML

Liquid Limit (%)	Plastic Limit	Plasticity Index (%)
18.6	12.9	5.7
