# **Phase I – Environmental Site Assessment**

4850 Bank Street  
Ottawa, Ontario

Prepared for Regional Group Ltd.

Report: PE6336-2  
September 25, 2025

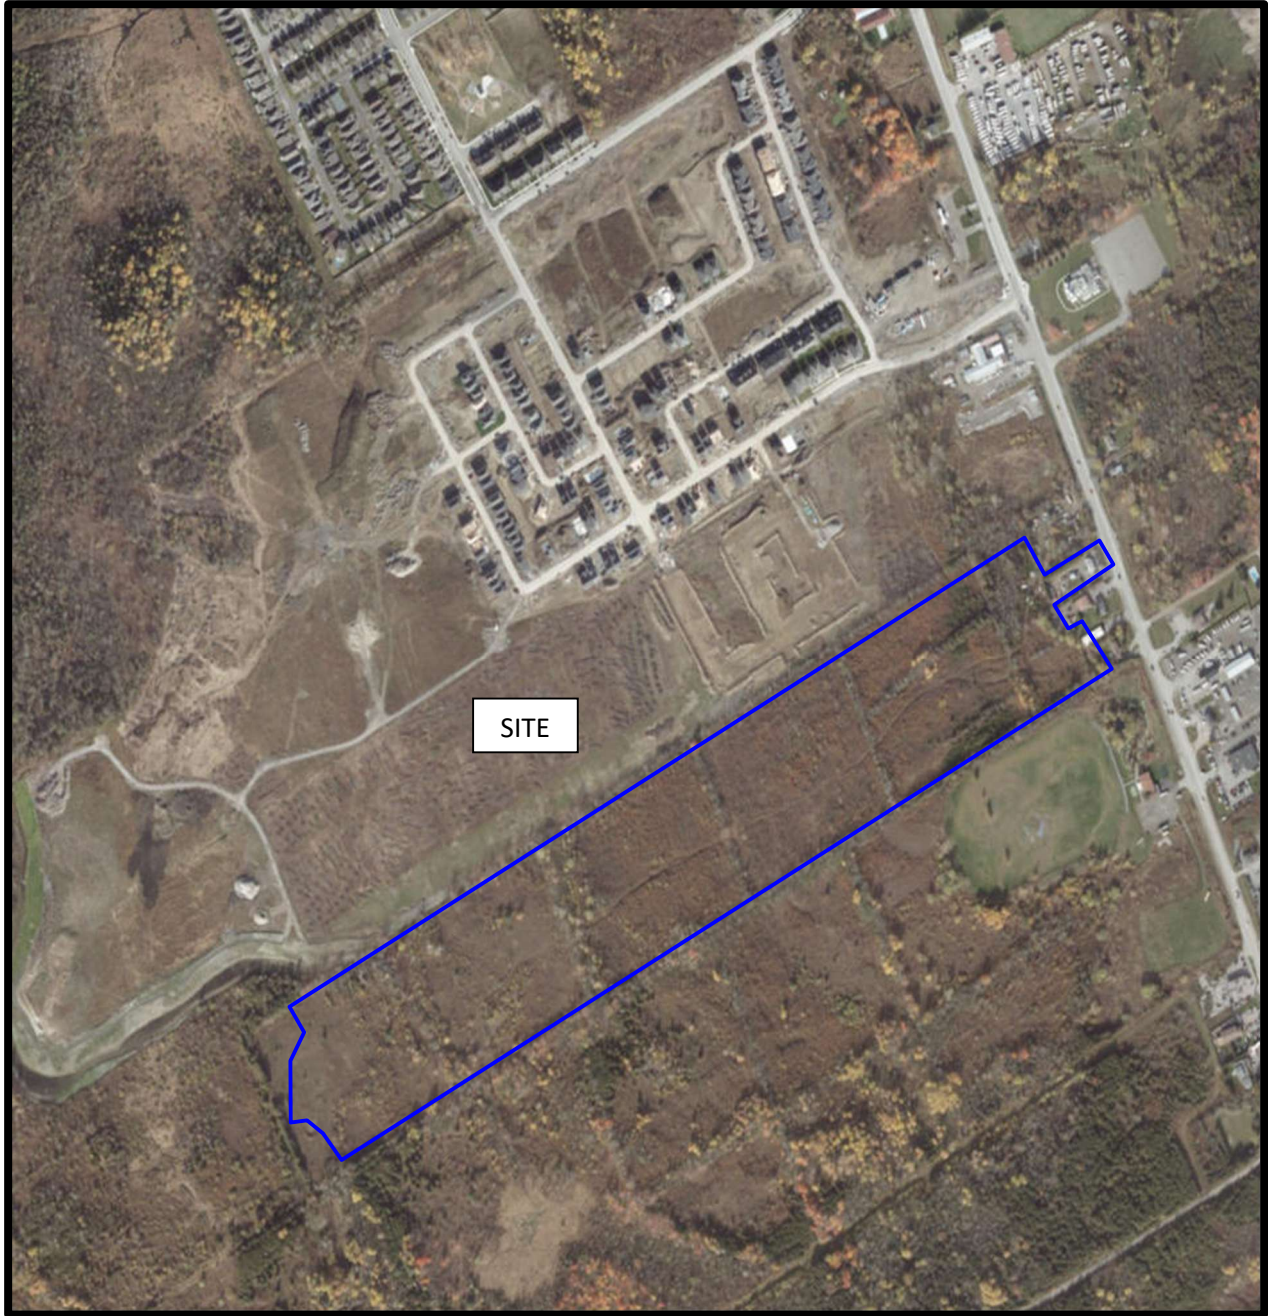
AERIAL PHOTOGRAPH  
2019

- 2019 (geoOttawa) No significant changes are apparent with respect to the Phase I Property. A residential subdivision is being developed alongside the northern edge of the Phase I Property. No other changes appear to have been made to the surrounding properties.
- 2024 (Google Earth™) No significant changes are apparent with respect to the Phase I Property. Further development of the residential subdivision can be seen to the north. The commercial building to the north has been demolished and replaced by a larger commercial building bordering Dun Skipper Drive and Bank Street.
