# A HERITAGE IMPACT ASSESSMENT 208-212 SLATER STREET, OTTAWA

APRIL 22, 2025

**Prepared By: John Stewart, Commonwealth Historic Resource Management**

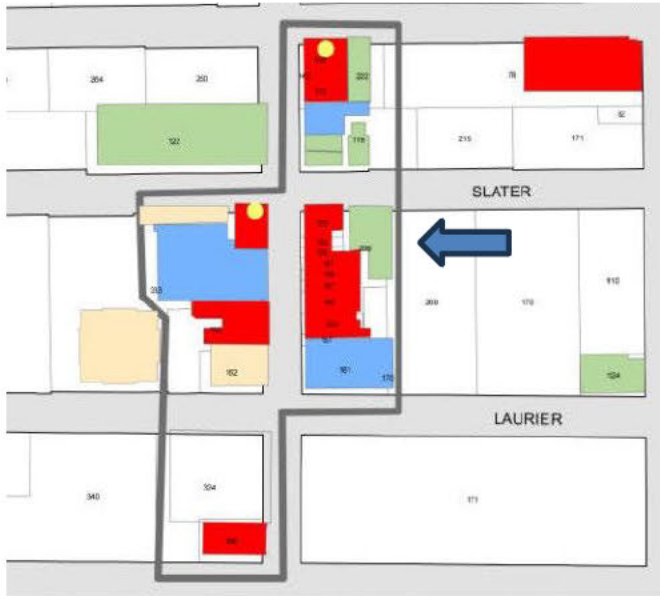
Figure 3: Bank Street Heritage Conservation District plan. Development site arrowed. After the plan was completed in 2000, 4 of the buildings within the district were demolished; specifically, the group of 4 buildings on the north side of Slater and the east side of Bank Street. Source: City of Ottawa.

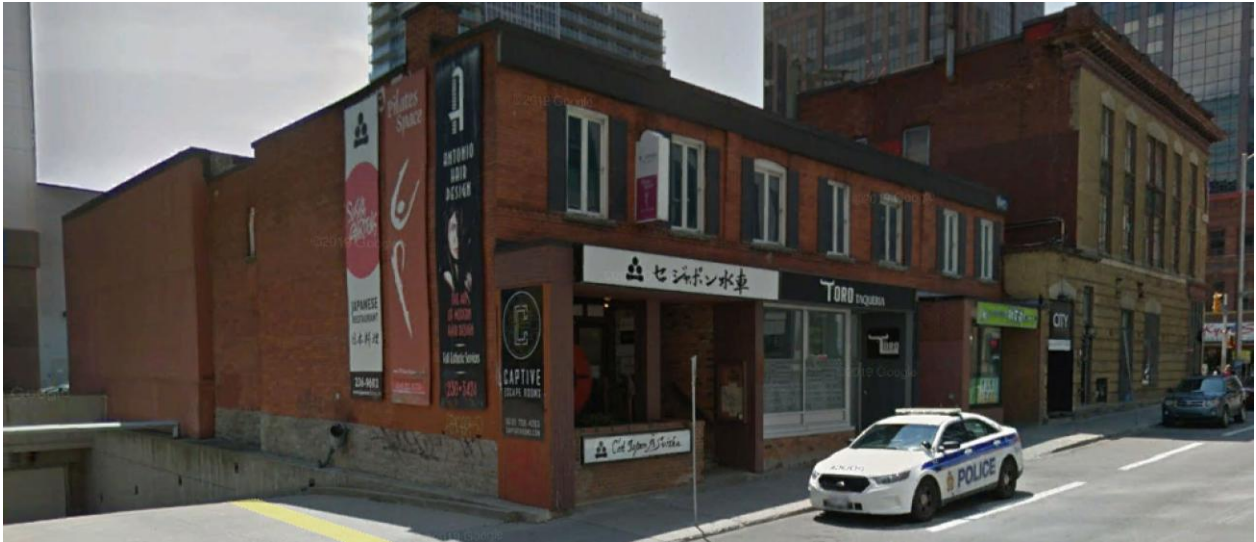
Figure 7: View looking west on Slater to the development site. Note the projecting brick walls enclosing the storefronts. Note the east wall (left) and the stone foundation walls that delimit the original built plan. The rear addition evident to the left of the photograph was completed post 1965. Source: Google Earth

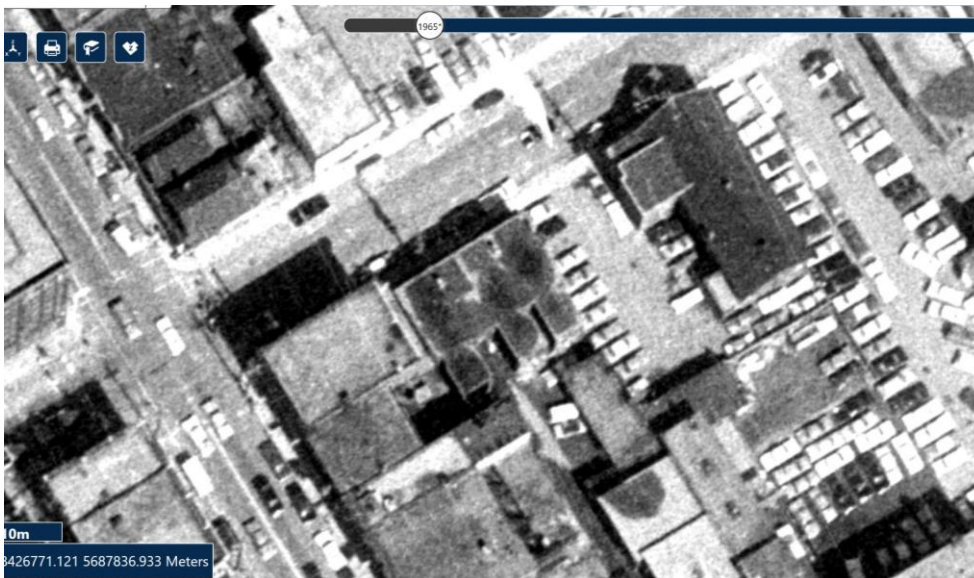
Figure 13: 1965 Aerial view of the property. The detached one-story garage remains on the site. Source: Geotowata.

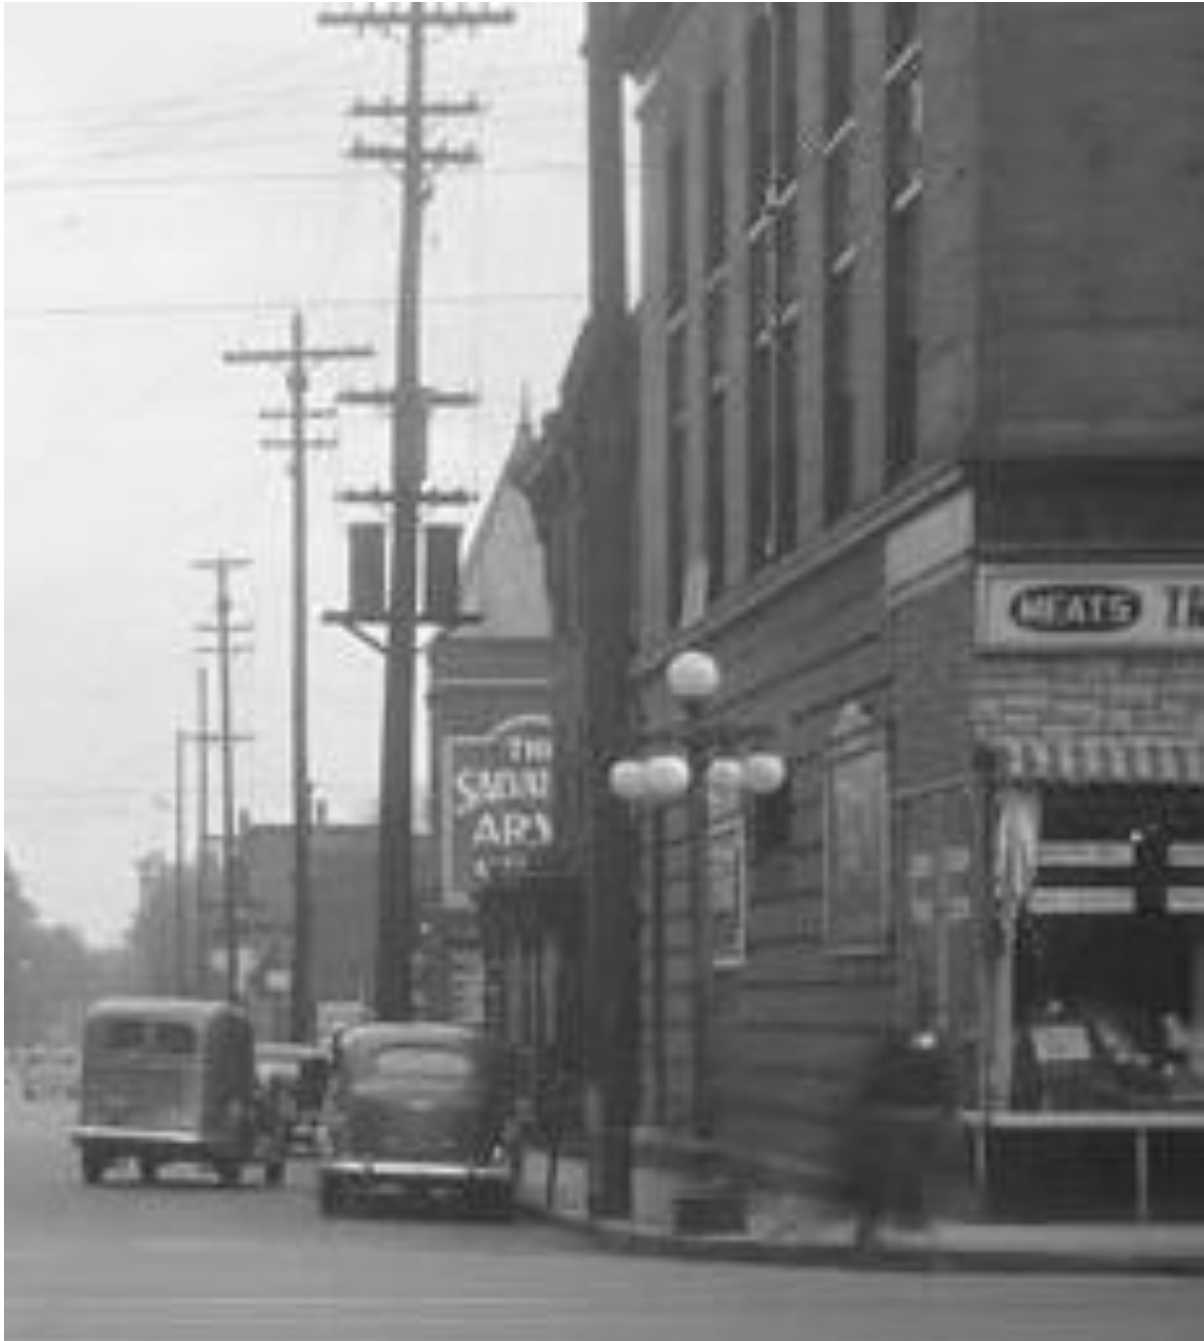
Figure 14: The blow-up of the 1938 photo provides a slightly better view of 208-212 with what appears to be two entrance porches to Units 208 and 210 enclosed with a roof structure that extends to the property line. The porches have decorative spindled columns and fret-work. The building is three storeys in height and the galvanized metal cornice reflects the articulation of the two projecting pilasters that divide the 3-bay façade with a 2:3:2 fenestration pattern. Source: Archives Canada Public Works 1938 photograph. To view on a high-resolution monitor visit <http://data2.archives.ca/e/e438/e010934846-v8.jpg>

The original design of the 3-bay façade is evident in the 1938 Public Works photo. The three bays are defined by projecting vertical pilasters; the central bay consists of three windows, and the other two flanking bays consist of two windows. The first floor is set on a raised limestone foundation with a repetitive window and door arrangement with a projecting brick clad entrance bay on unit 208 Slater with wood canopies on units 210 and 212. The second-floor brick walls are articulated with a dentilled string course extending between cast stone windowsills with gauged brick arches above the windows. The third floor was articulated in the same manner as the second floor. The metal cornice was articulated based on the 3 bay form with a shallow pedimented central section flanked by two flat cornices (Figure 14).

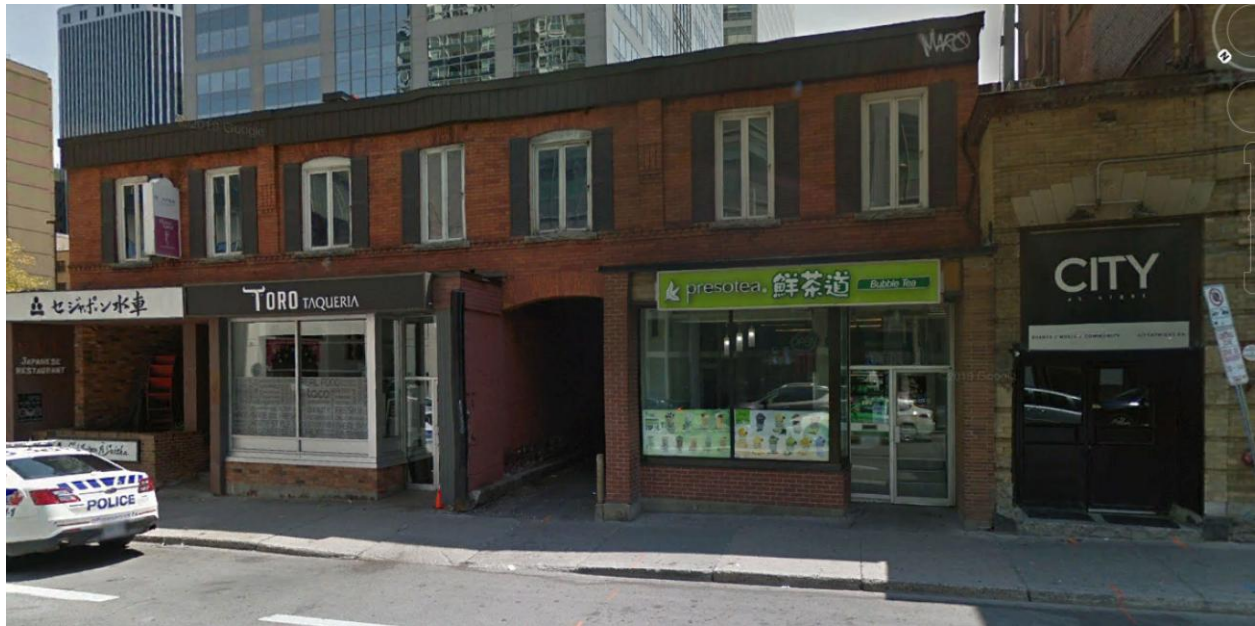
The craftsmanship in the brickwork includes a projecting string course consisting of three rows with a central dentil course at the second-floor windowsill level. The string course extends the width of the building, providing a horizontal emphasis. The two raised brick pilasters extending vertically from the second level window string course divides the façade into three bays with a 2:3:2 fenestration pattern. A decorative brick corbel course in the two pilasters consisting of 6 rows of stacked headers set on a dentil band adds visual interest. Brick work includes gauged brick arches above windows and the arched carriageway. The craftsmanship in the quarry faced coursed limestone foundation is typical of the period in which it was constructed. The building displays a moderate degree of craftsmanship in the masonry work that is typical of buildings constructed during the period.

The loss of fabric and the mid-century renovations have compromised the craftsmanship. The extensive alterations and the aggressive conversion of the ground floor to commercial use lessens its overall design value. The raised first floor now obscured is the only element of the design that **expresses its original** residential use, differentiating it from the mixed-use buildings constructed at the same time fronting onto Bank Street.

Figure 15: View of the 3-bay façade articulated with projecting pilasters that group the bays into a 2:3:2 fenestration pattern. The central bay is further articulated with a central flat headed window flanked by two wider windows with segmental brick arches. Source: Google Earth.

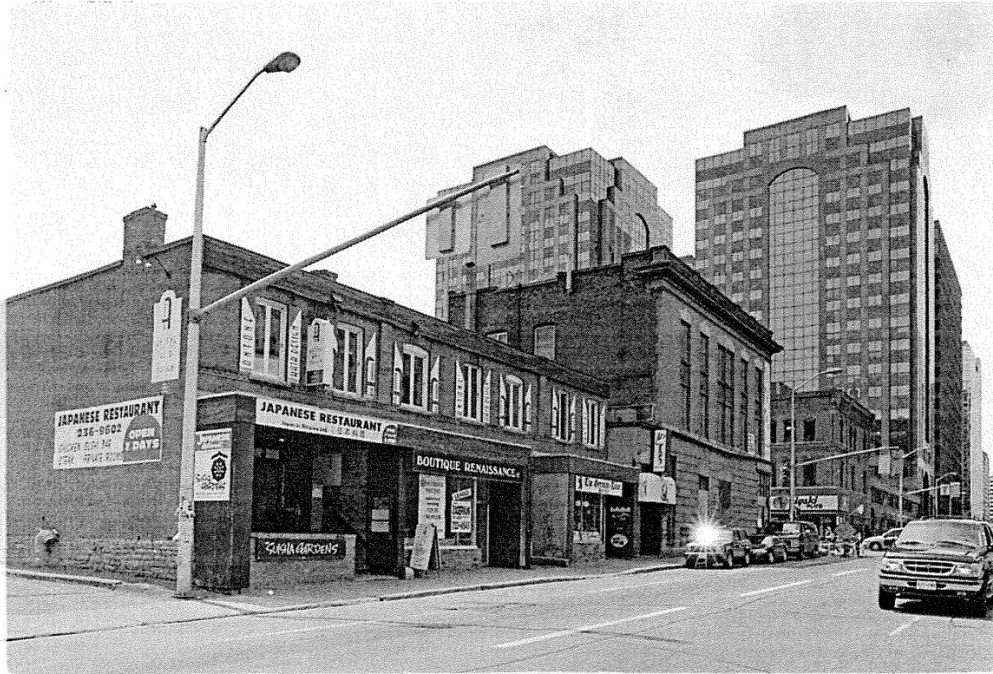
208-212 Slater St

Two-storey, seven-bay, (former) residential row. Rectangular in plan with large concrete and brick addition at the rear and a carriageway. Modern restaurant and storefront additions with offset entrances on ground floor of facade. Red brick construction on a stone foundation. Regularly spaced, rectangular (two are segmentally-arched), voussoired windows with stone sills on second storey. Dentil band below windows. Pilasters with decorative brickwork on second level. Modern, flat wood cornice at roof line. Chimney along side wall. Flat roof.

When constructed, the row was three storeys. F.I.P.s indicate that they were altered to two storeys between 1922 and 1956. Original ground floor facades have been modified with additions. Rear addition after 1956. Windows have been replaced on second storey.
