# A HERITAGE IMPACT ASSESSMENT

## 208-212 SLATER STREET, OTTAWA

APRIL 22, 2025

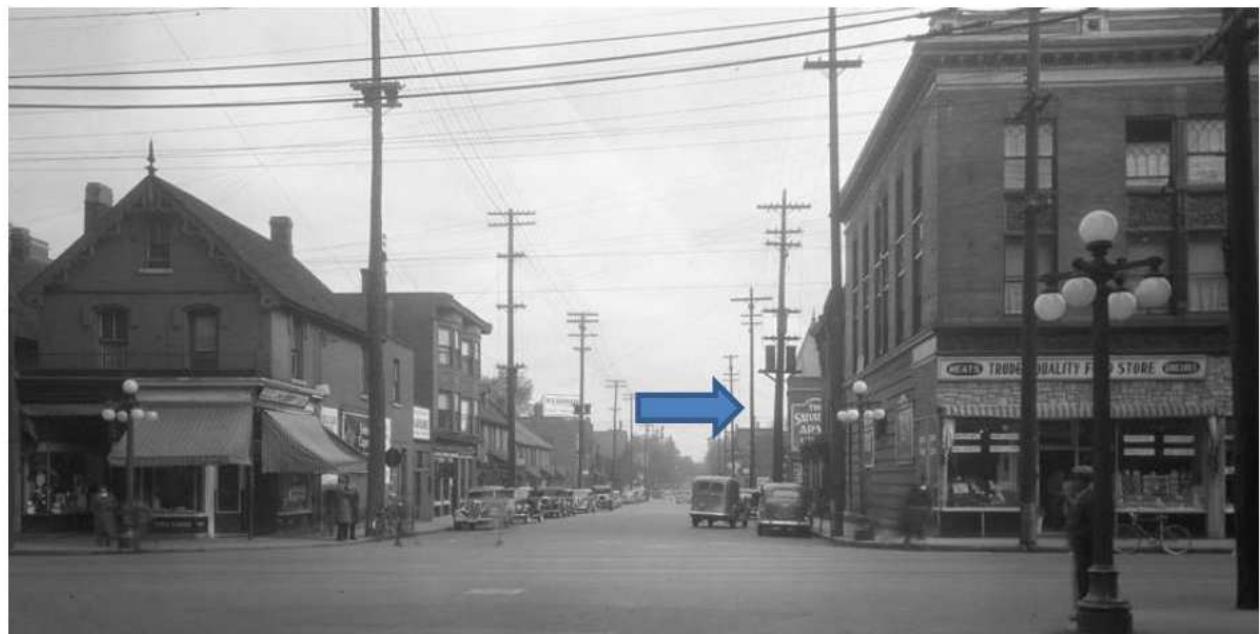
Figure 11: 1938 view looking east on Slater from the west side of Bank Street. The building is arrowed. Source: CMHC Public Works Photo Archive \ Library and Archives Canada Mikan No. 4169733

The original design of the 3-bay façade is evident in the 1938 Public Works photo. The three bays are defined by projecting vertical pilasters; the central bay consists of three windows, and the other two flanking bays consist of two windows. The first floor is set on a raised limestone foundation with a repetitive window and door arrangement with a projecting brick clad entrance bay on unit 208 Slater with wood canopies on units 210 and 212. The second-floor brick walls are articulated with a dentilled string course extending between cast stone windowsills with gauged brick arches above the windows. The third floor was articulated in the same manner as the second floor. The metal cornice was articulated based on the 3 bay form with a shallow pedimented central section flanked by two flat cornices (Figure 14).

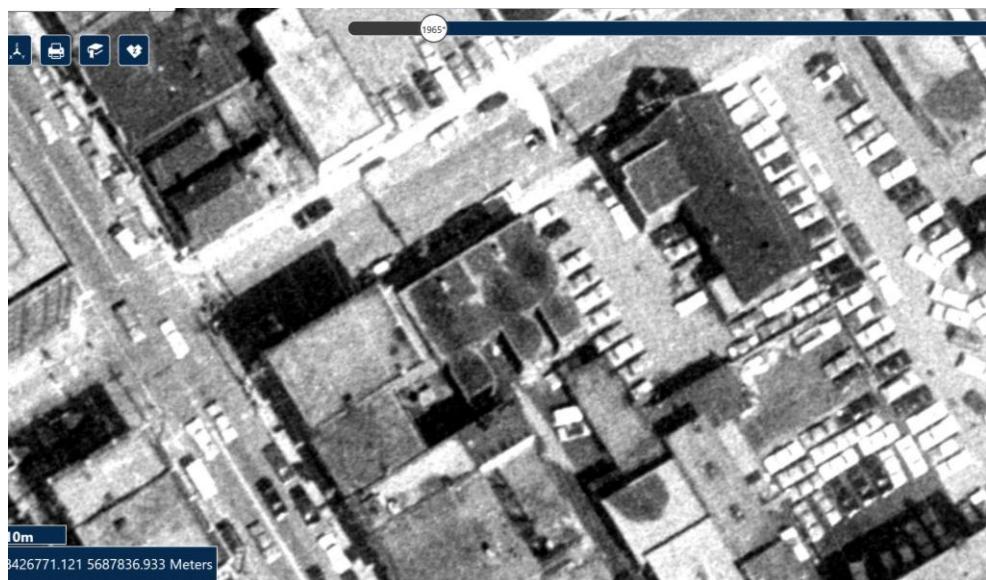
*Figure 13: 1965 Aerial view of the property. The detached one-story garage remains on the site. Source: Geotawa.*

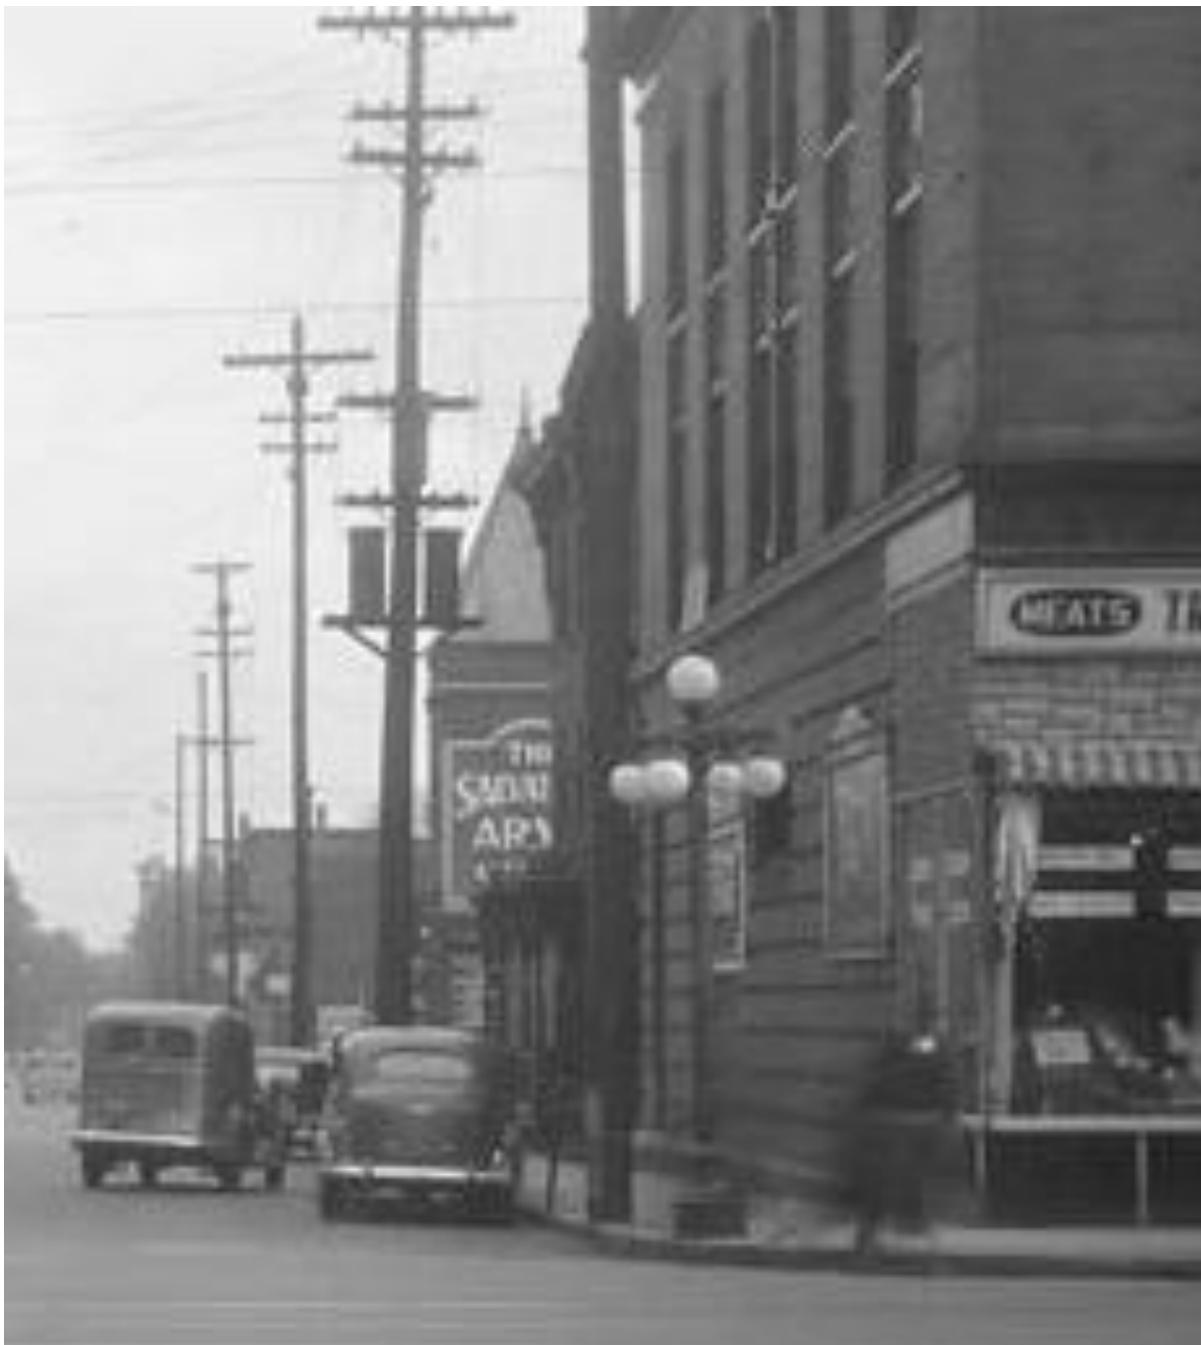
Figure 14: The blow-up of the 1938 photo provides a slightly better view of 208-212 with what appears to be two entrance porches to Units 208 and 210 enclosed with a roof structure that extends to the property line. The porches have decorative spindled columns and fret-work. The building is three storeys in height and the galvanized metal cornice reflects the articulation of the two projecting pilasters that divide the 3-bay façade with a 2:3:2 fenestration pattern. Source: Archives Canada Public Works 1938 photograph. To view on a high-resolution monitor visit <http://data2.archives.ca/e/e438/e010934846-v8.jpg>

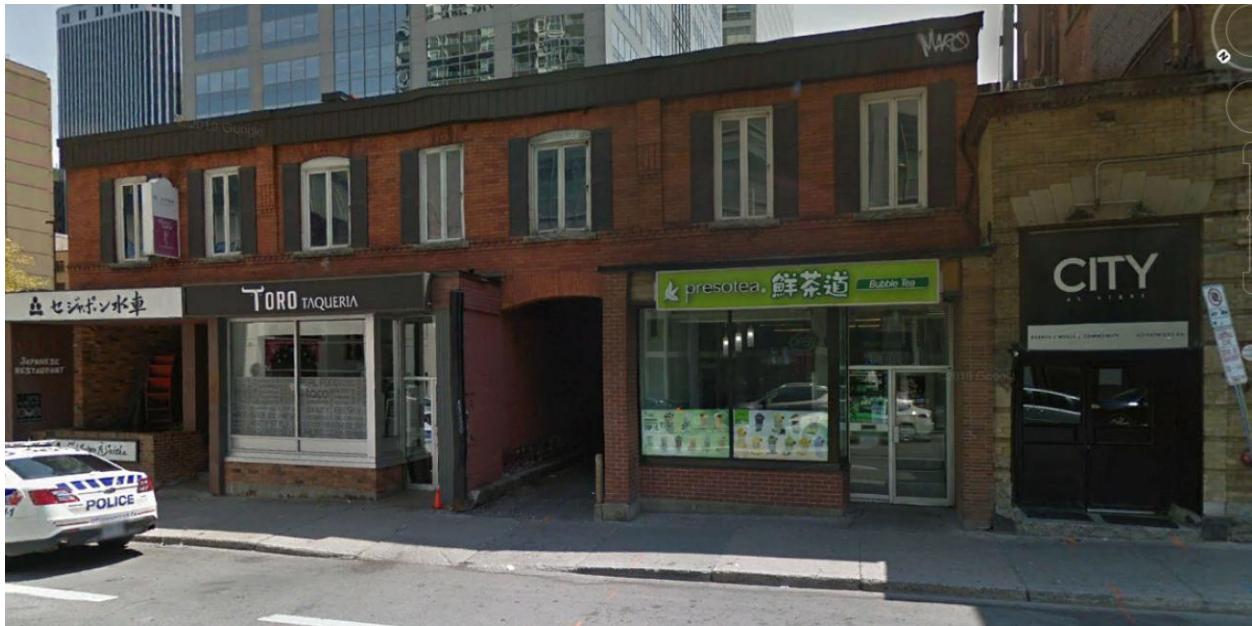
Figure 15: View of the 3-bay façade articulated with projecting pilasters that group the bays into a 2:3:2 fenestration pattern. The central bay is further articulated with a central flat headed window flanked by two wider windows with segmental brick arches. Source: Google Earth.

The craftsmanship in the brickwork includes a projecting string course consisting of three rows with a central dentil course at the second-floor windowsill level. The string course extends the width of the building, providing a horizontal emphasis. The two raised brick pilasters extending vertically from the second level window string course divides the façade into three bays with a 2:3:2 fenestration pattern. A decorative brick corbel course in the two pilasters consisting of 6 rows of stacked headers set on a dentil band adds visual interest. Brick work includes gauged brick arches above windows and the arched carriageway. The craftsmanship in the quarry faced coursed limestone foundation is typical of the period in which it was constructed. The building displays a moderate degree of craftsmanship in the masonry work that is typical of buildings constructed during the period.
