October 19 2011
File: PE2357-LET.01

Claridge Homes
2001 - 210 Gladstone Avenue
Ottawa, Ontario
K2P 0Y6

Subject: **Supplemental Phase II - Environmental Site Assessment**
Existing Commercial Property
175 Richmond Road - Ottawa

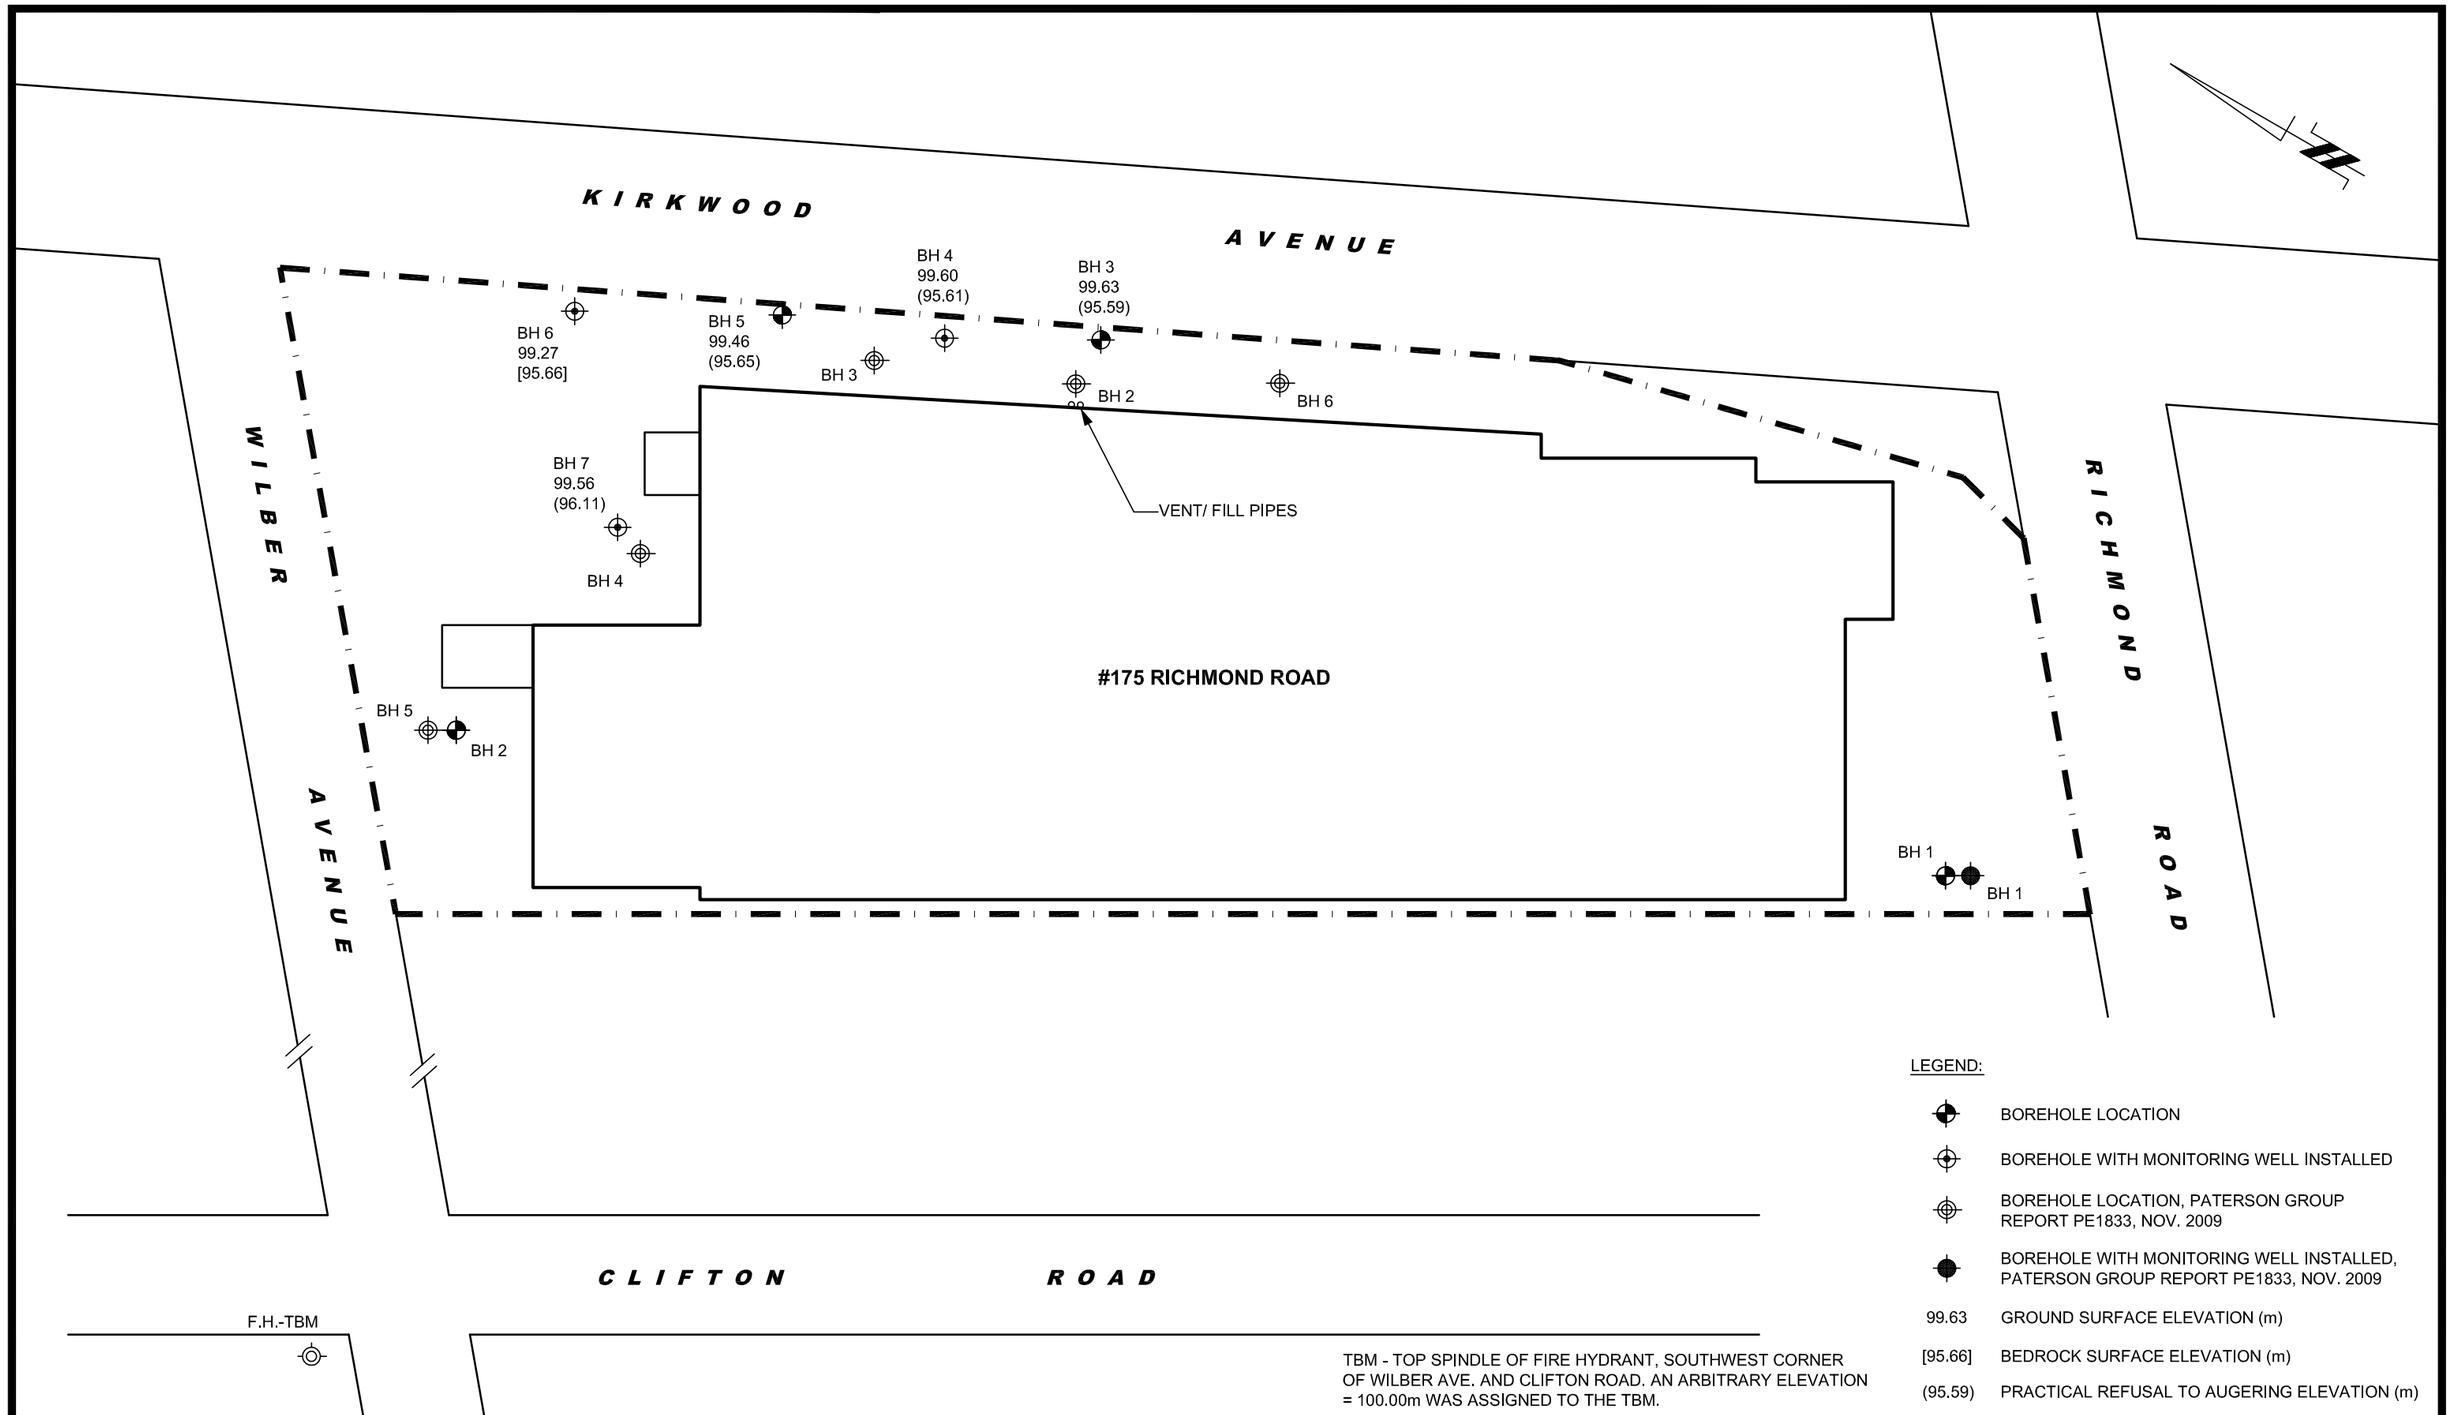
Contaminated soil and groundwater were identified in the area of the former on-site underground storage tank nest, as indicated in the attached plan. It is recommended that a soil and groundwater remediation program be conducted in this area to remove and dispose of the soil and groundwater in excess of the MOE Table 3 standards. This could be done at the time of future site redevelopment as a means of reducing costs. The impacted soil must be disposed of at an approved waste disposal facility. It is also recommended that Paterson personnel be present at the time of the removal of the impacted soil and groundwater to provide direction and to obtain confirmatory samples upon the completion of the remediation program.
