re: **Sentinel Well Groundwater Monitoring Program**
Kanata North Urban Expansion
Proposed Residential Development
March Road - Ottawa

date: October 31, 2019

file: PG3975-MEMO.01 Revision 2

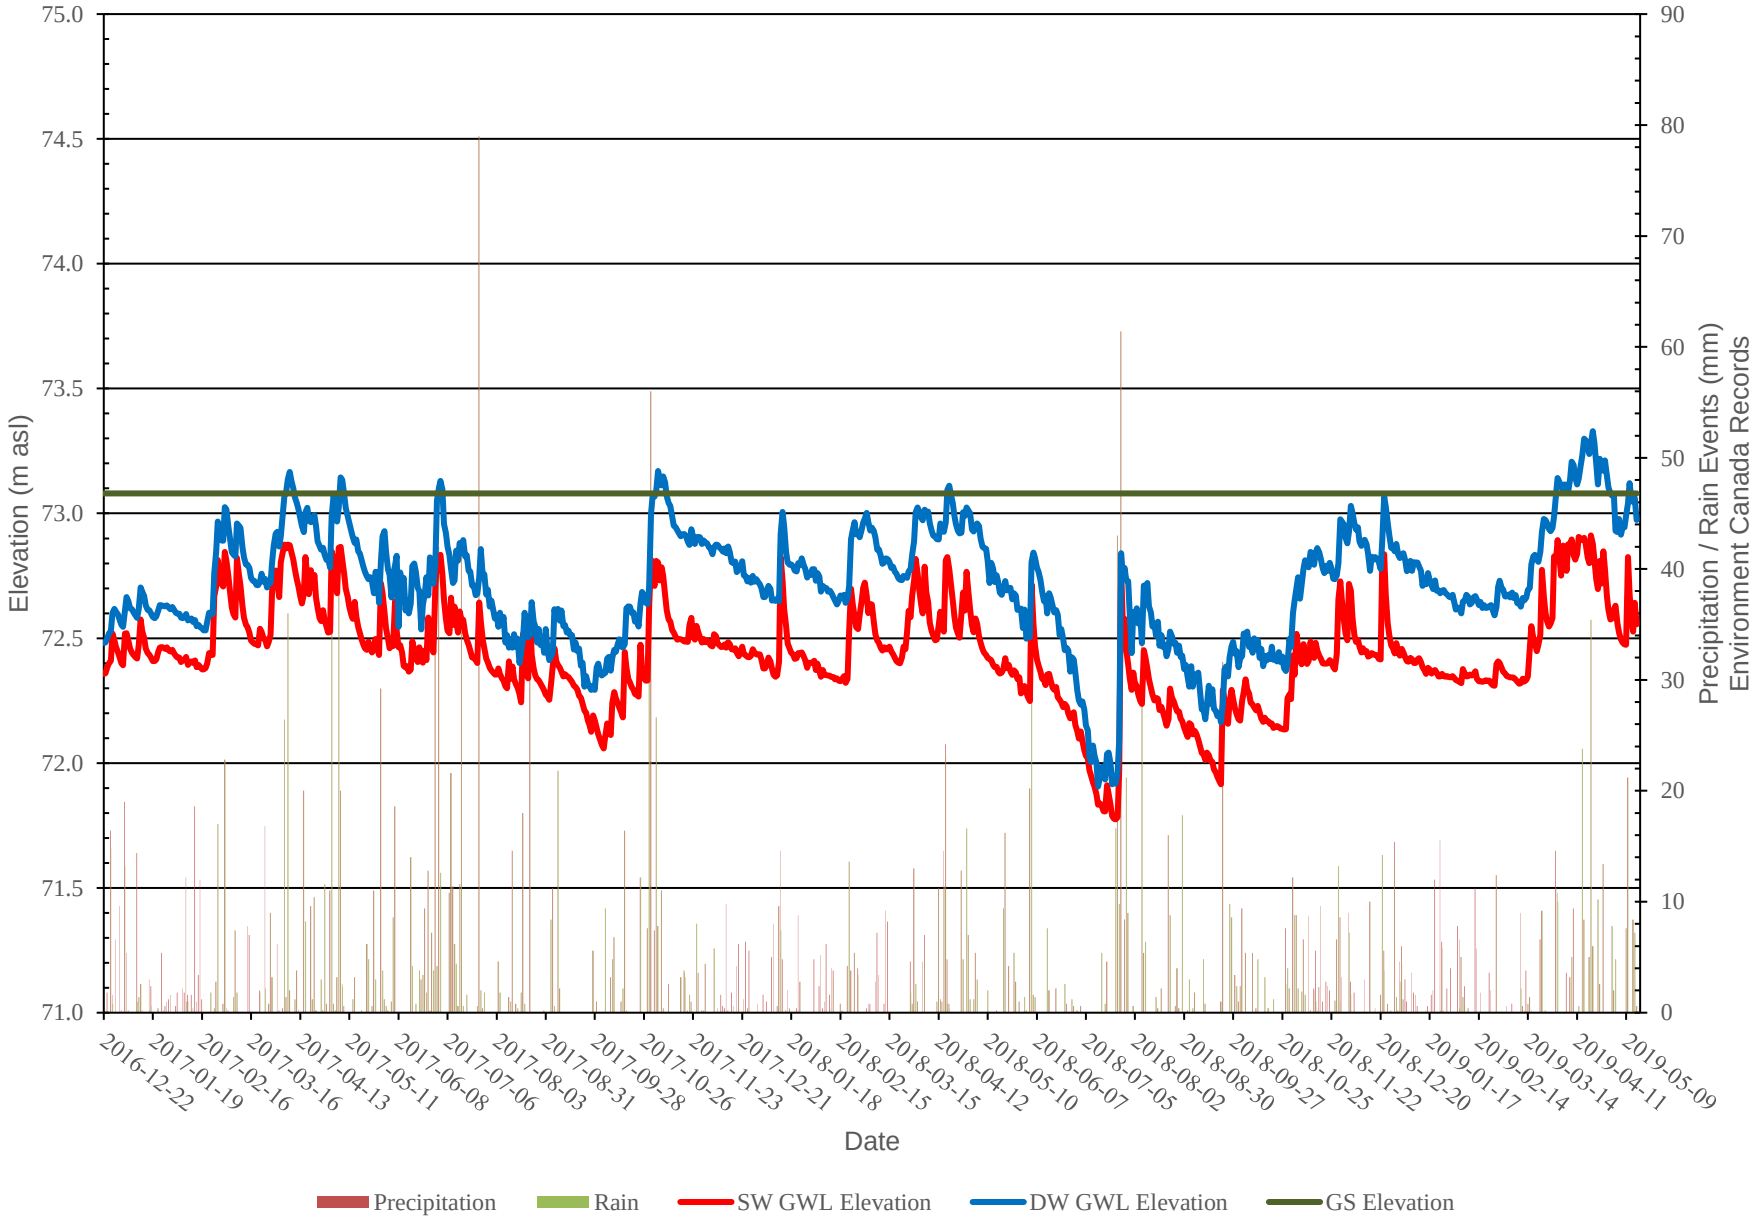
Figure 1: BH1 - Groundwater Monitoring Levels vs Precipitation Data

The data presented in Figure 1 through Figure 5 show the difference in seasonal groundwater elevation within the shallow wells at each well location vary from 1.1 to 2.3 m bgs, while the deep wells varied from 1.4 to 2.8 m bgs. The seasonal low and high groundwater elevations at each well location have been summarized in Table 2 below. Water sample results were not compared to provincial water quality guidelines or aesthetic objectives, but rather to establish baseline water quality information prior to the commencement of construction and in accordance with Paterson Report PH2223-MEMO.01.

Monitoring Well	Ground Surface Elevation	Low Groundwater Elevation	High Groundwater Elevation	Difference in Groundwater Depth
BH1-SW	73.08	71.8 m	72.9 m	1.1 m
BH1-DW	73.08	71.9 m	73.3 m	1.4 m
BH2-SW	82.95	81.0 m	83.3 m	2.3 m
BH2-DW	82.95	80.7 m	83.0 m	2.3 m
BH3-SW	88.84	85.4 m	87.7 m	2.3 m
BH3-DW	88.84	83.6 m	86.4 m	2.8 m
BH4-SW	89.34	87.3 m	89.6 m	2.3 m
BH4-DW	89.34	88.2 m	90.5 m	2.3 m
BH5-SW	84.22	82.0 m	84.0 m	2.0 m
BH5-DW	84.22	82.4 m	85.1 m	2.7 m
