Phase I - Environmental Site Assessment

1995 Carling Avenue
Ottawa, Ontario

Claridge Homes

Report: PE4833-1

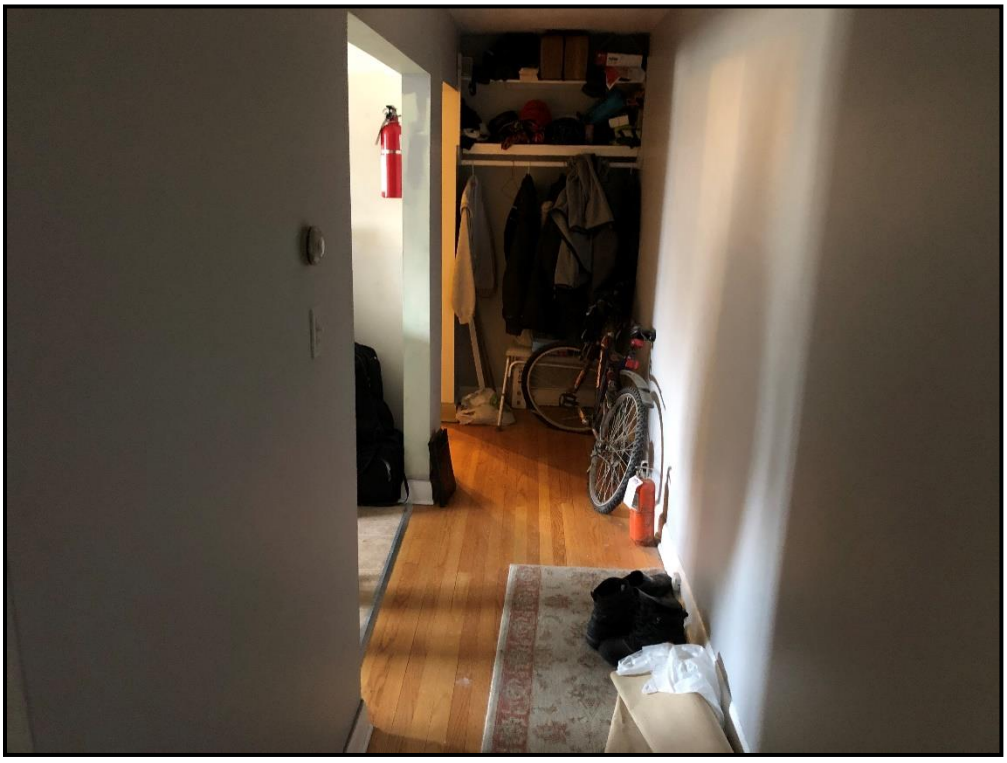
Photograph 7: Typical interior building materials consisting of hardwood and plaster walls of the Phase I buildings.
