PATERSON GROUP

Phase II – Environmental Site Assessment

134 Nelson Street

Report: PE5929-2
January 13, 2023

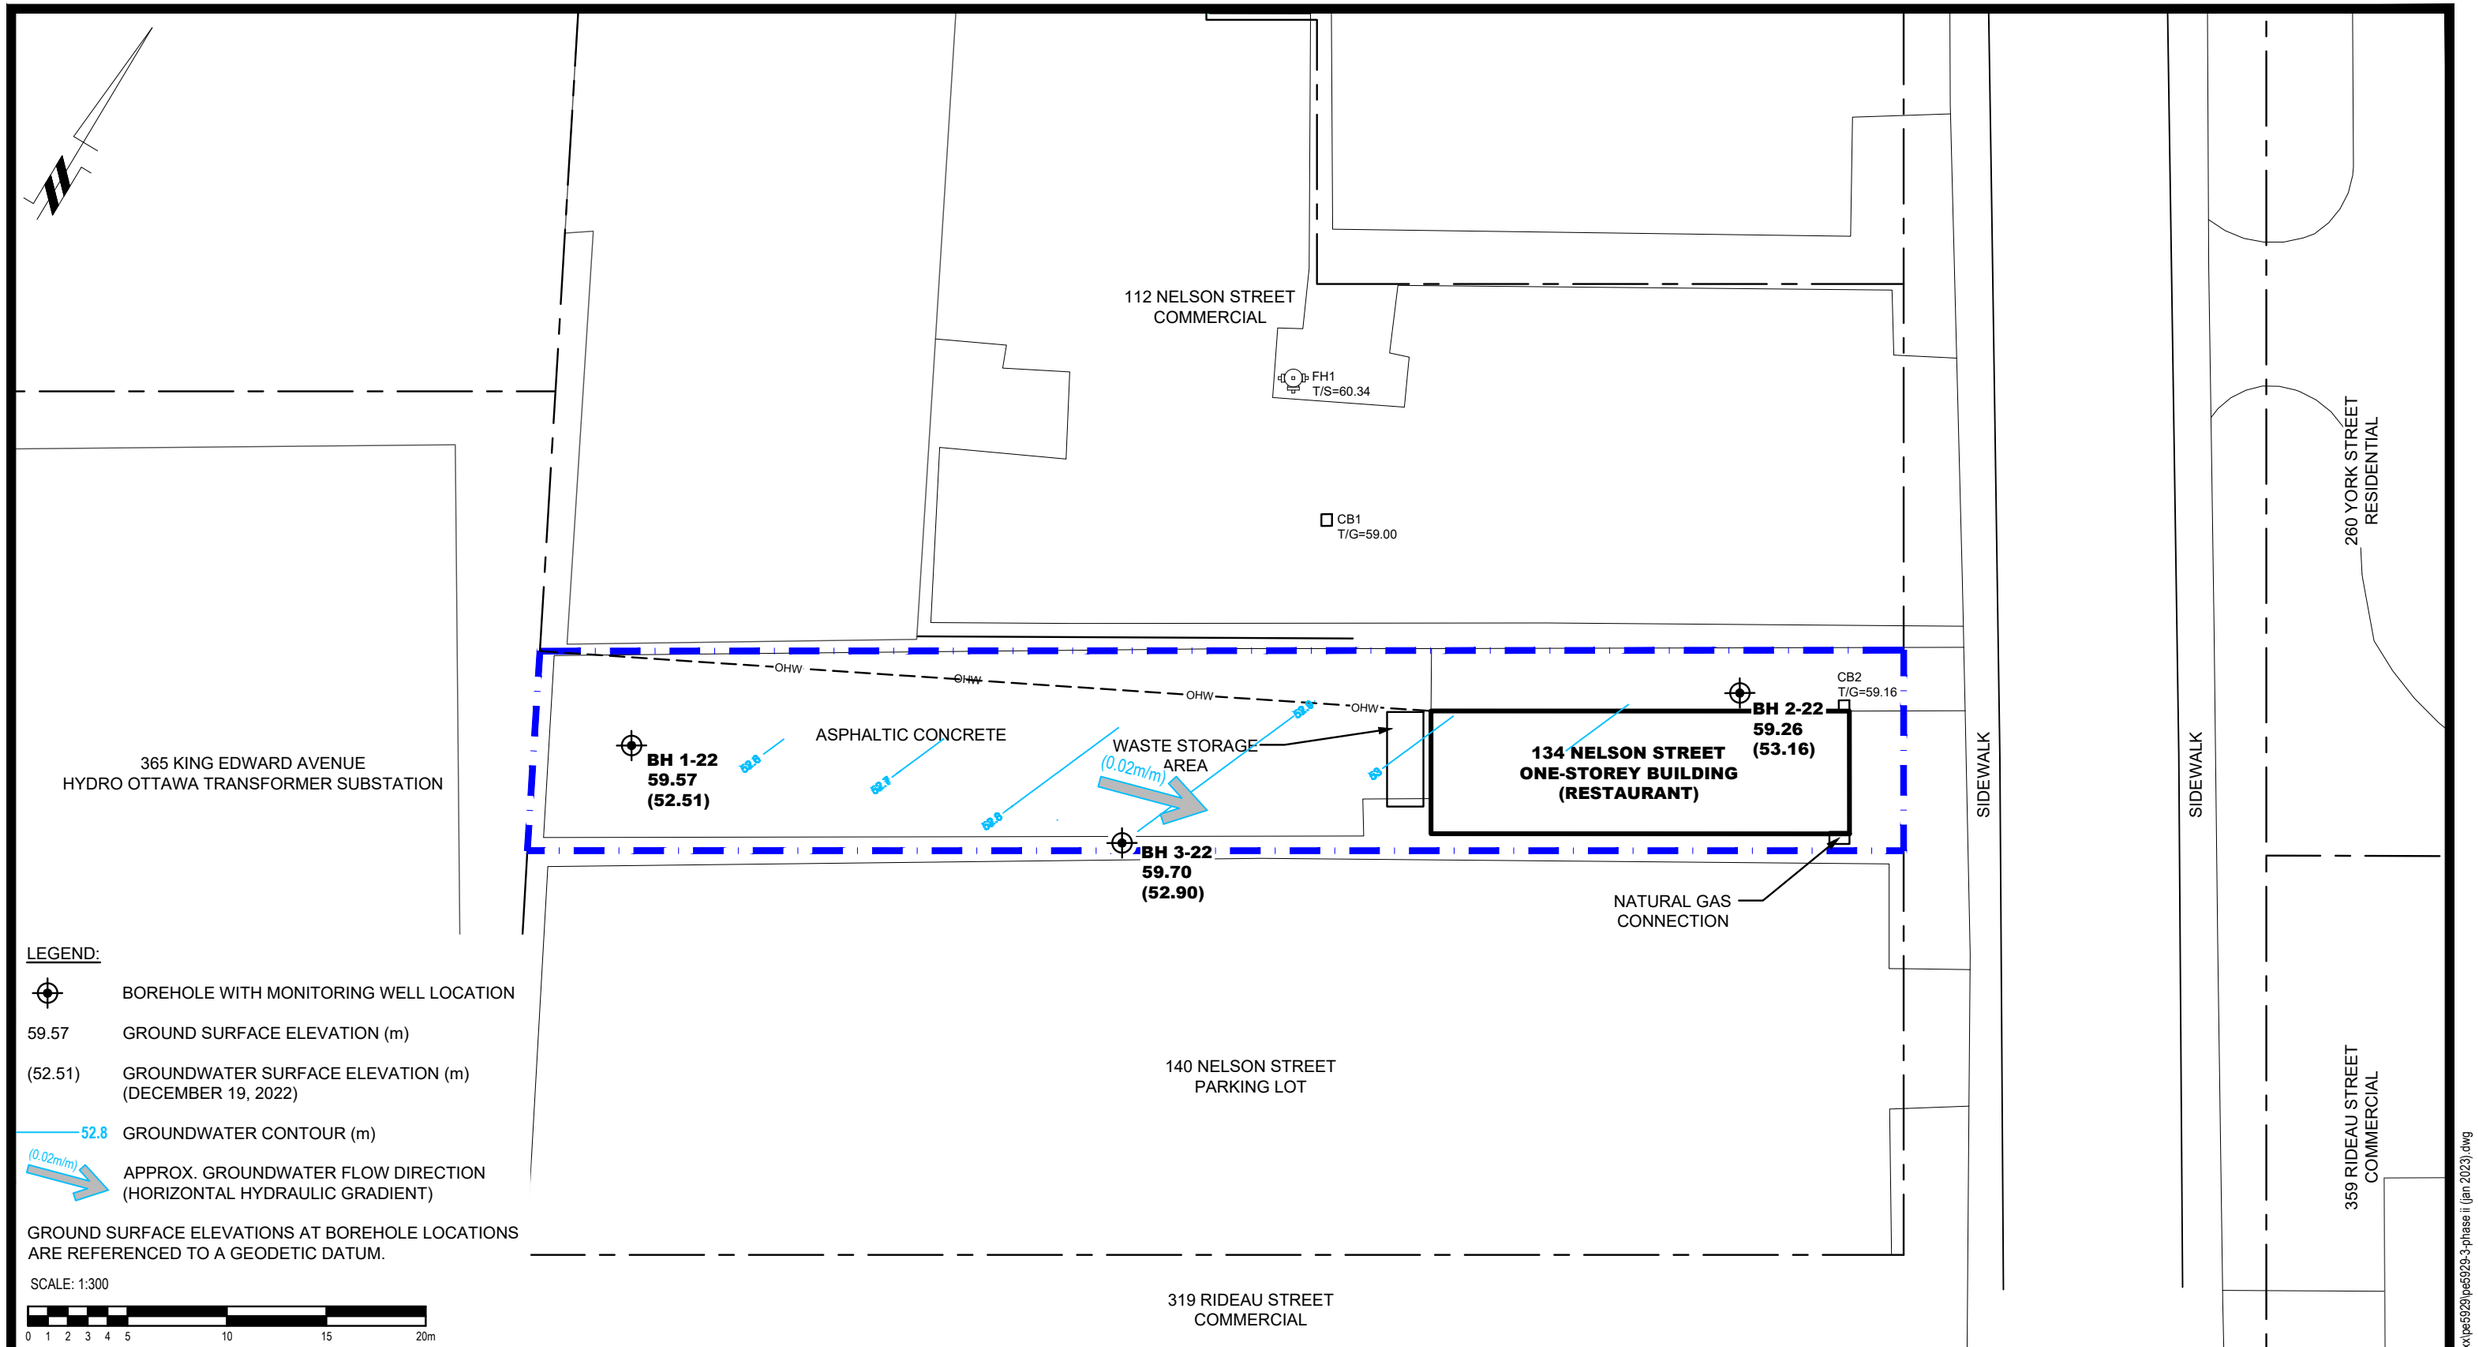
According to the mapped contour data, illustrated on Drawing PE5929-3 – Test Hole Location Plan in the appendix, the groundwater flow on the subject site was calculated to be in an easterly direction. A horizontal hydraulic gradient of approximately 0.02 m/m was also calculated as part of this assessment. It should be noted that groundwater levels are expected to fluctuate throughout the year with seasonal variations.

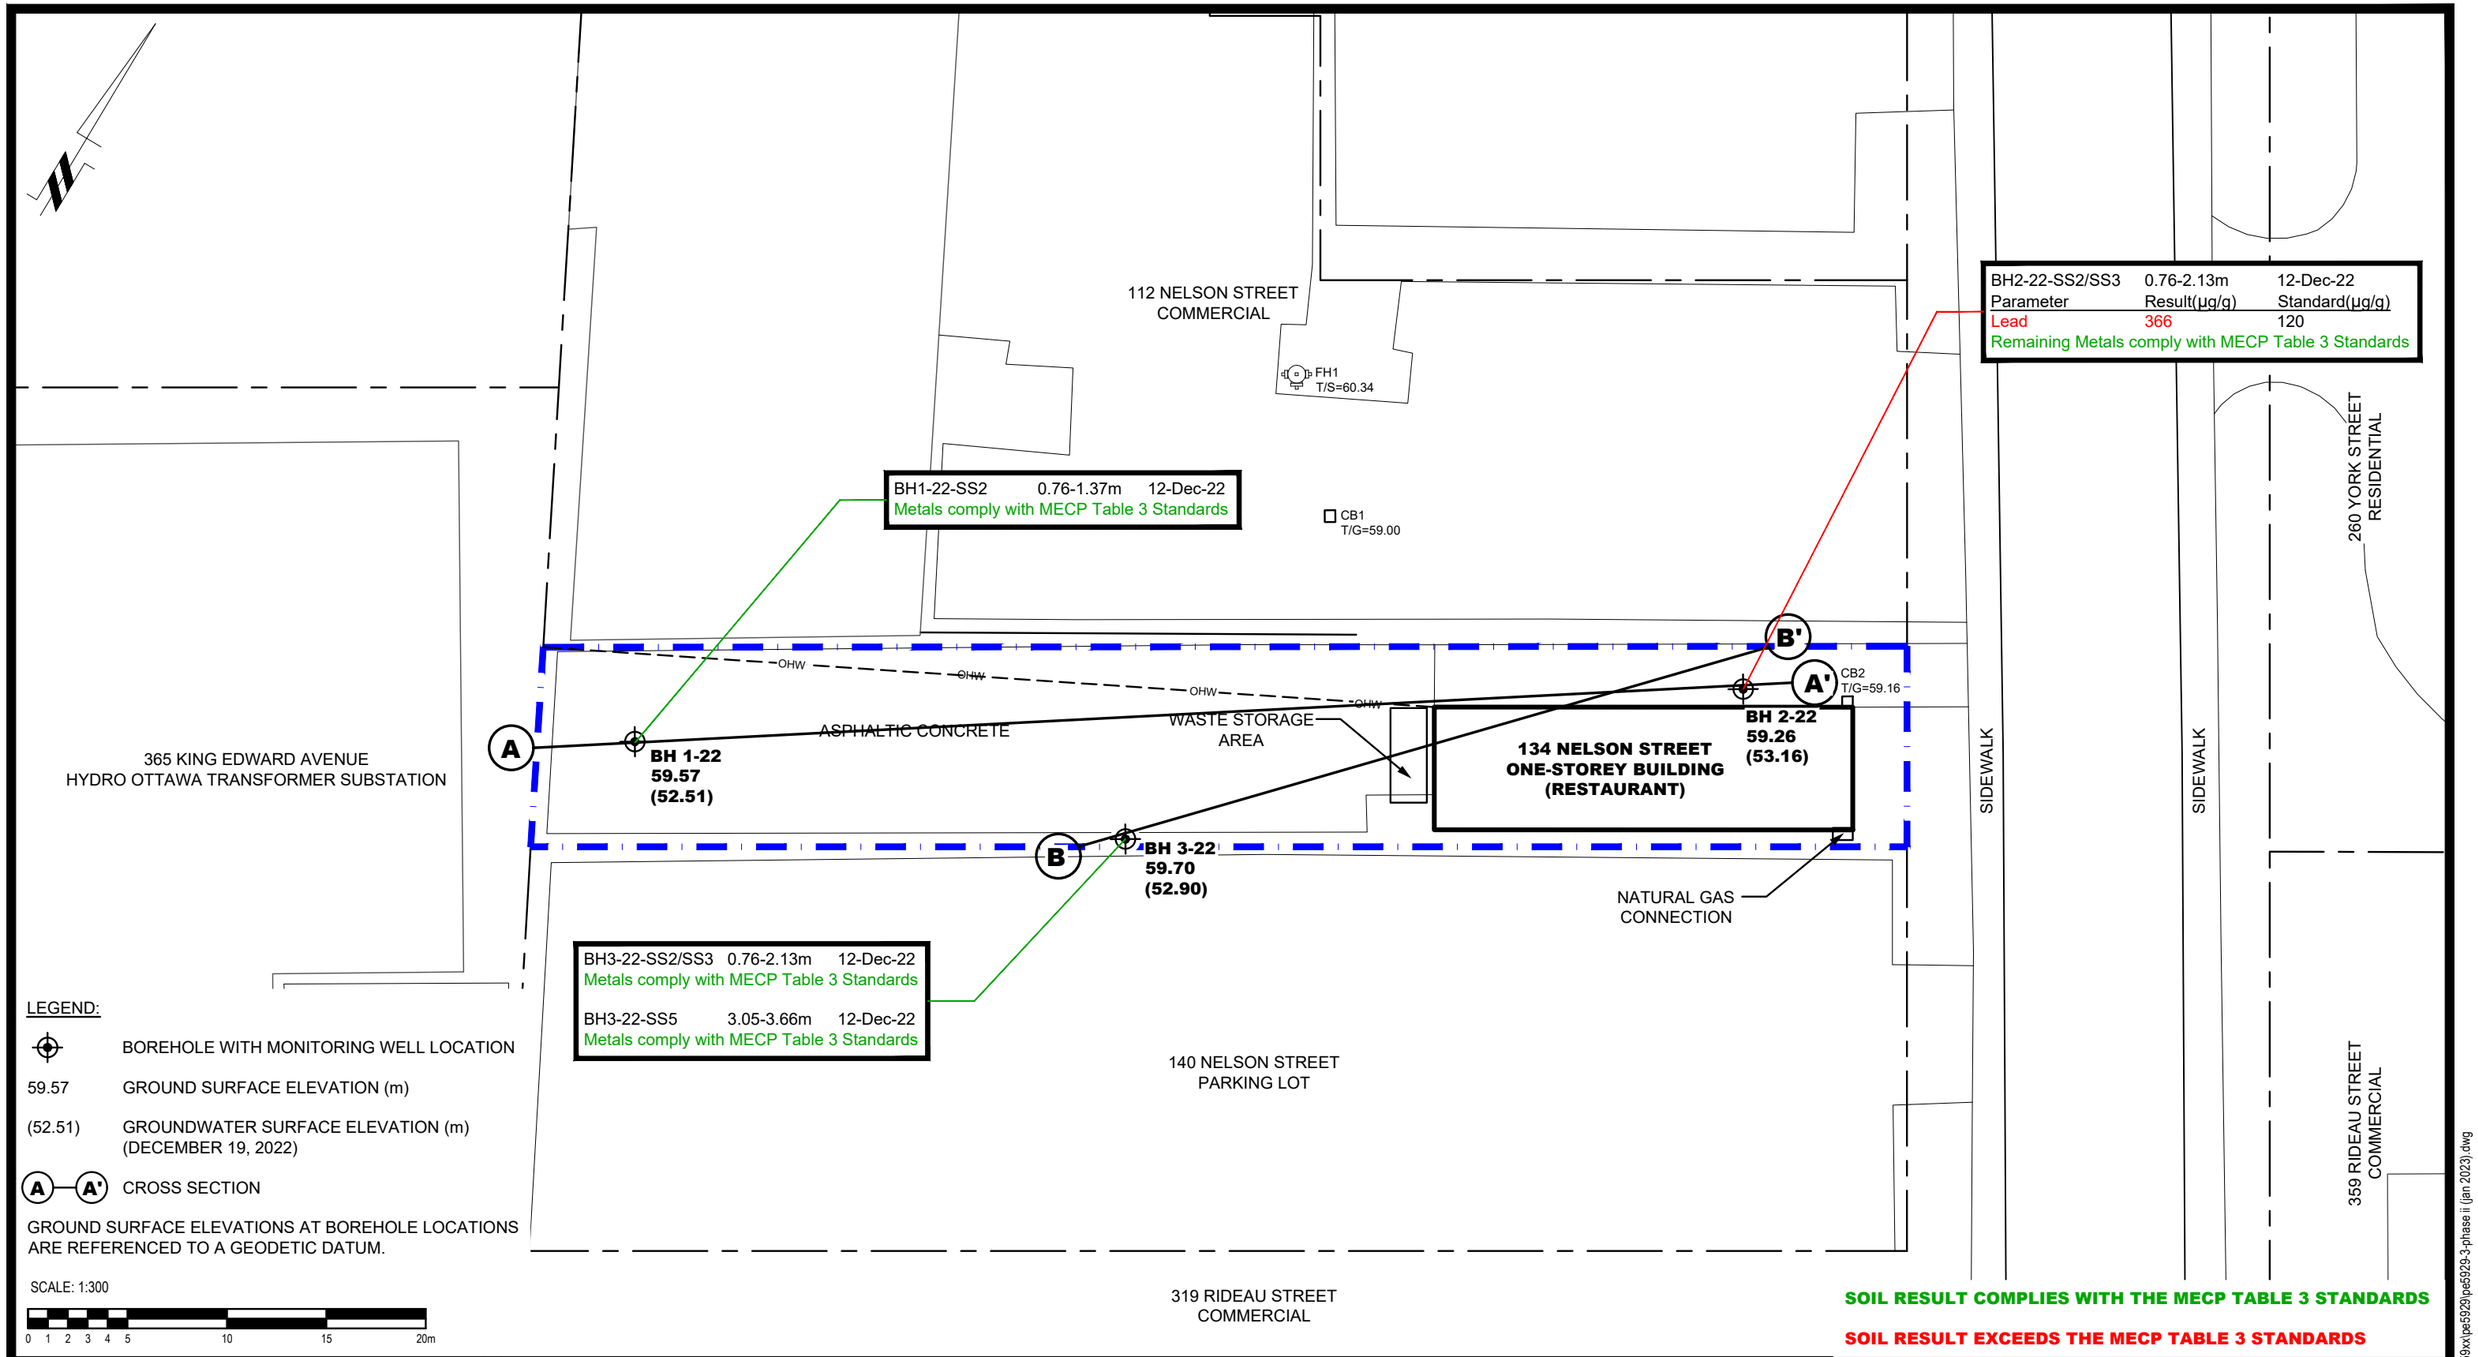
Parameter	Result(µg/g)	Standard(µg/g)
Lead	366	120

Remaining Metals comply with MECP Table 3 Standards

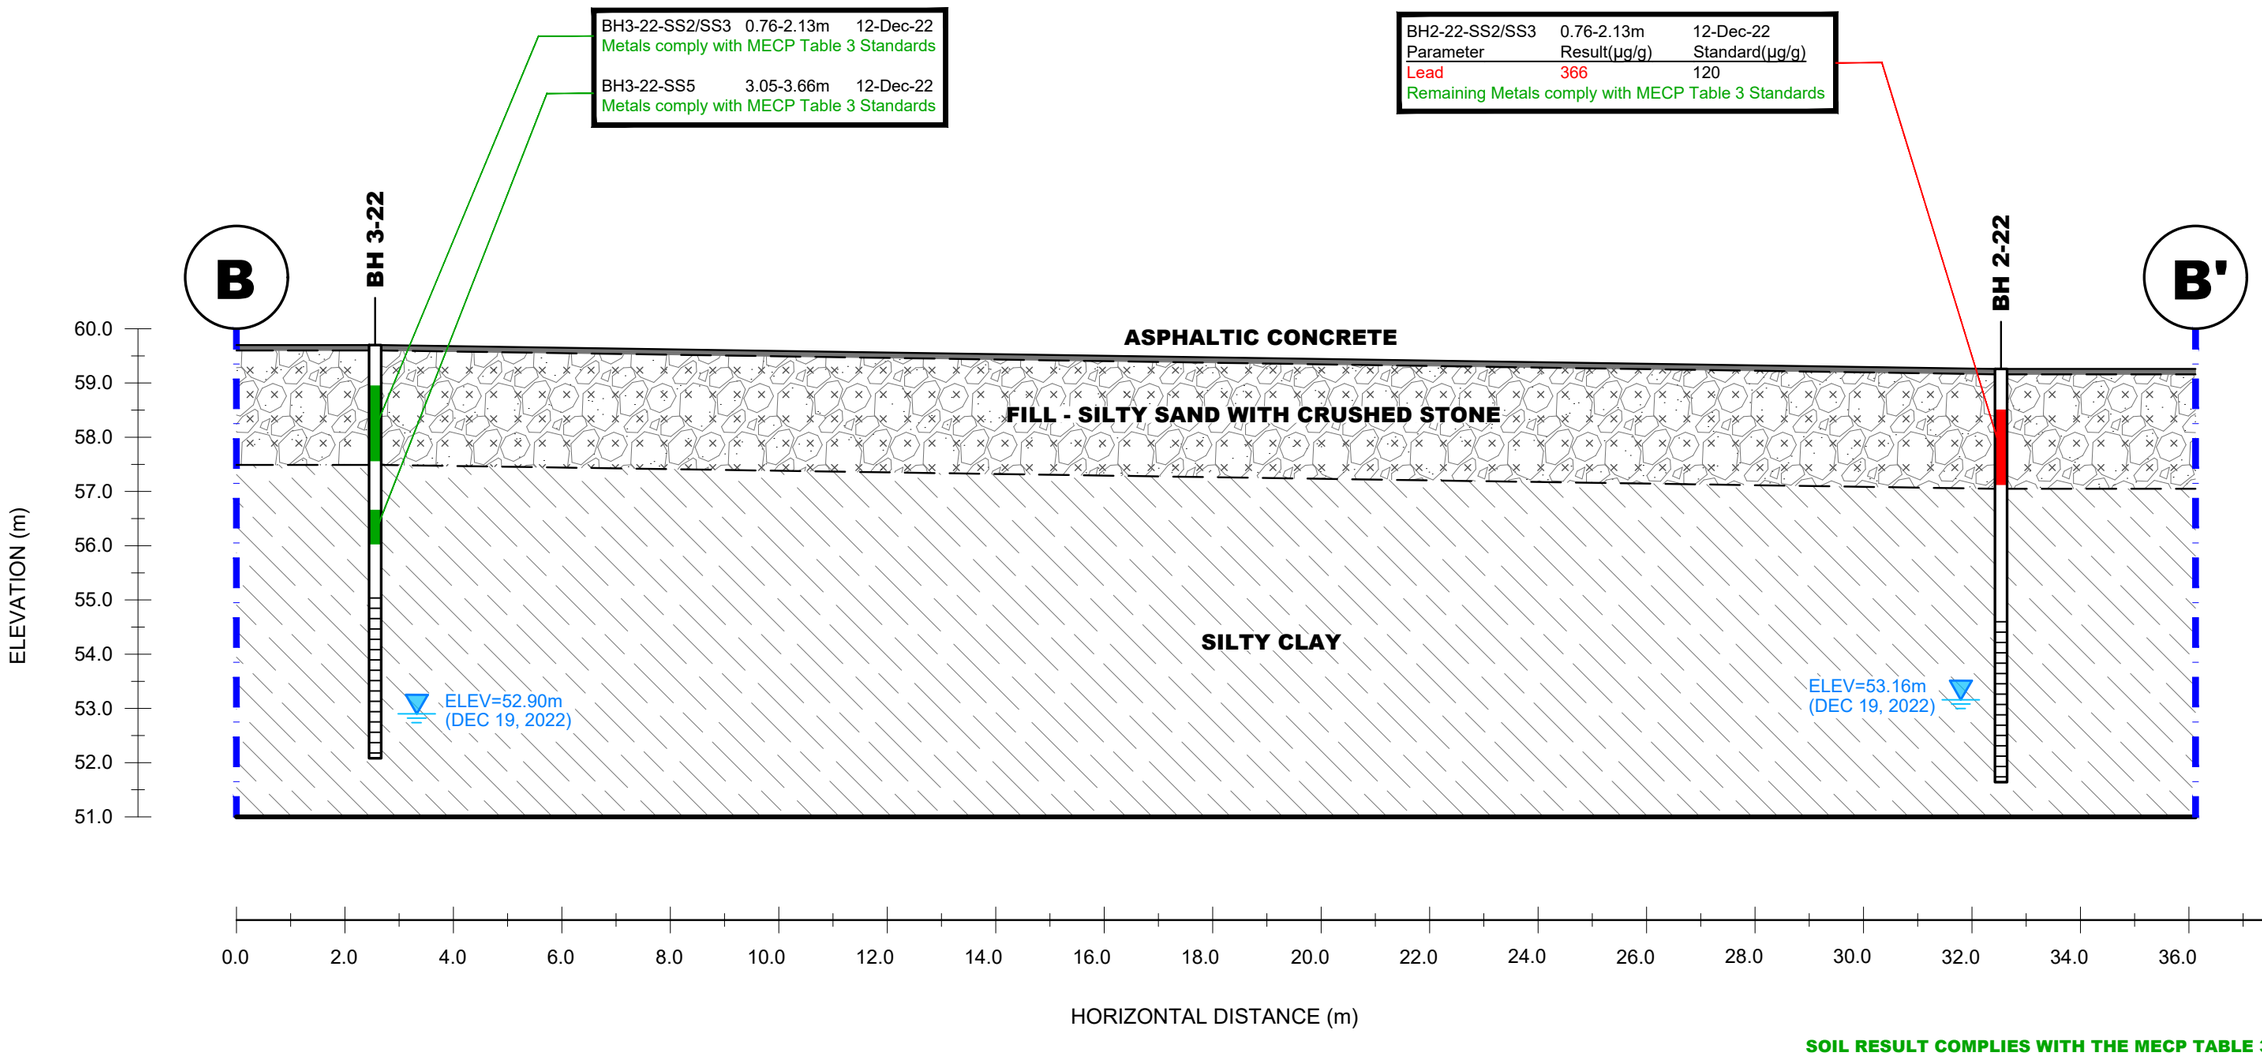
Parameter	Result(µg/g)	Standard(µg/g)
Lead	366	120

Remaining Metals comply with MECP Table 3 Standards

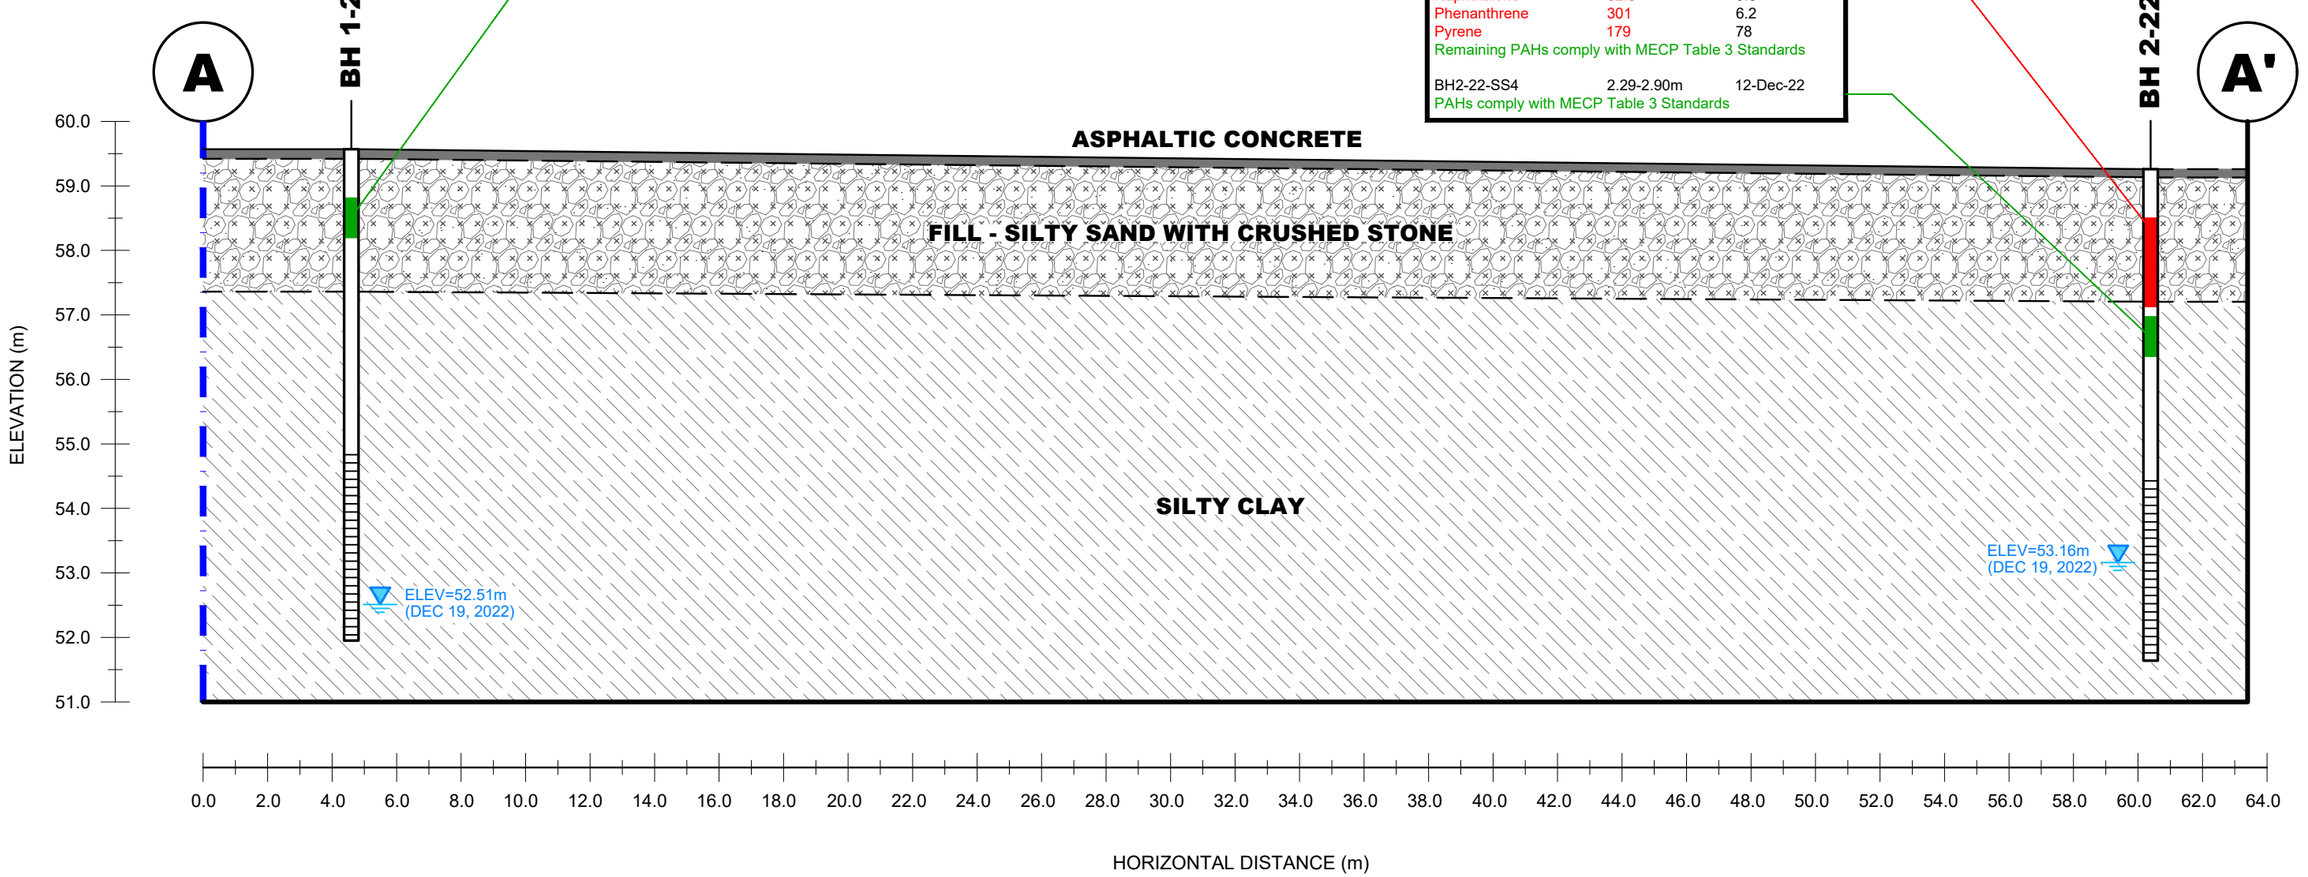
BH2-22-SS2/SS3	0.76-2.13m	12-Dec-22
Parameter	Result(µg/g)	Standard(µg/g)
Acenaphthene	27.4	7.9
Acenaphthylene	16.0	0.15
Anthracene	104	0.67
Benzo[a]anthracene	82.2	0.5
Benzo[a]pyrene	65.6	0.3
Benzo[b]fluoranthene	68.5	0.78
Benzo[g,h,i]perylene	34.3	6.6
Benzo[k]fluoranthene	36.7	0.78
Chrysene	85.4	7.0
Dibenzo[a,h]anthracene	8.69	0.1
Fluoranthene	230	0.69
Indeno[1,2,3-cd]pyrene	31.9	0.38
1-Methylnaphthalene	15.2	0.99
2-Methylnaphthalene	23.5	0.99
Methylnaphthalene(1&2)	38.7	0.99
Naphthalene	62.3	0.6
Phenanthrene	301	6.2
Pyrene	179	78
Remaining PAHs comply with MECP Table 3 Standards		
BH2-22-SS4	2.29-2.90m	12-Dec-22
PAHs comply with MECP Table 3 Standards

BH1-22-SS2 0.76-1.37m 12-Dec-2022
PAHs comply with MECP Table 3 Standards

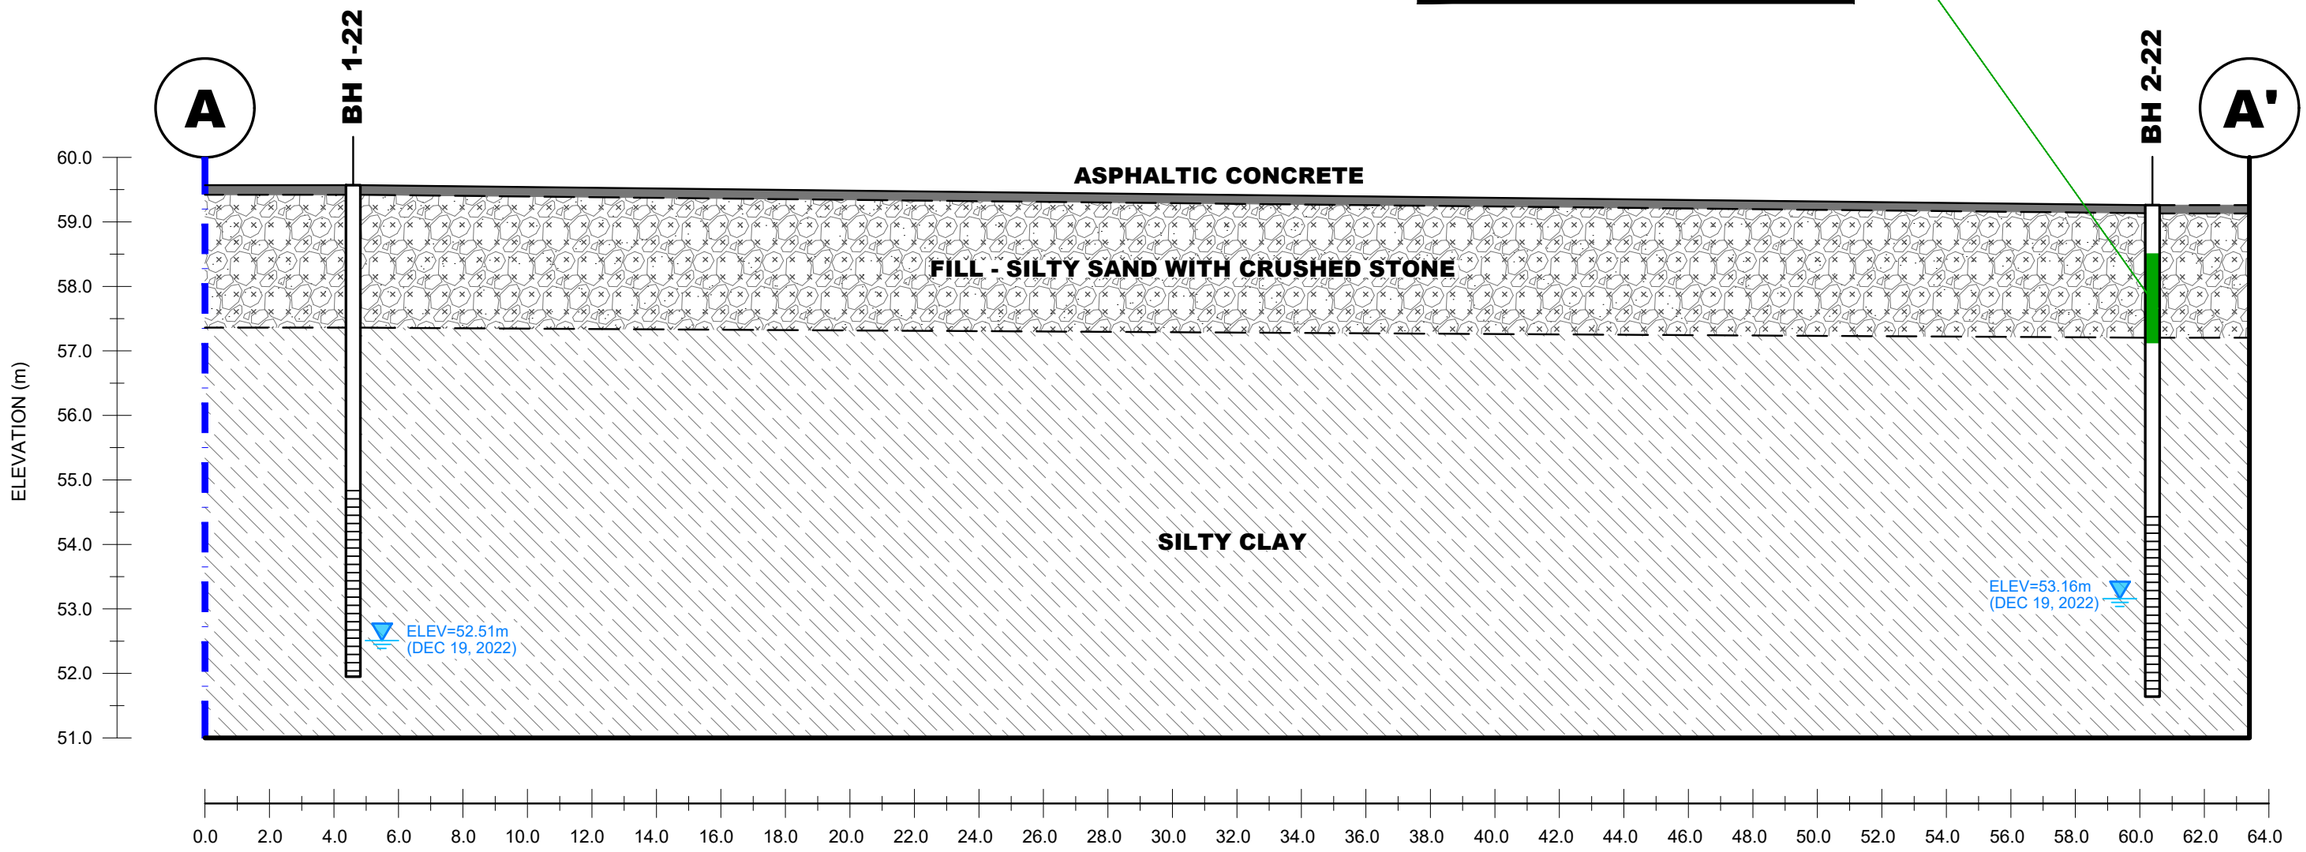
BH2-22-SS2/SS3	0.76-2.13m	12-Dec-22
Parameter	Result(uS/cm)	Standard(µS/cm)
EC	3,810	700

*EC deemed to comply with MECP Table 3 Standards (Section 49.1 of Ontario Regulation 153/04)

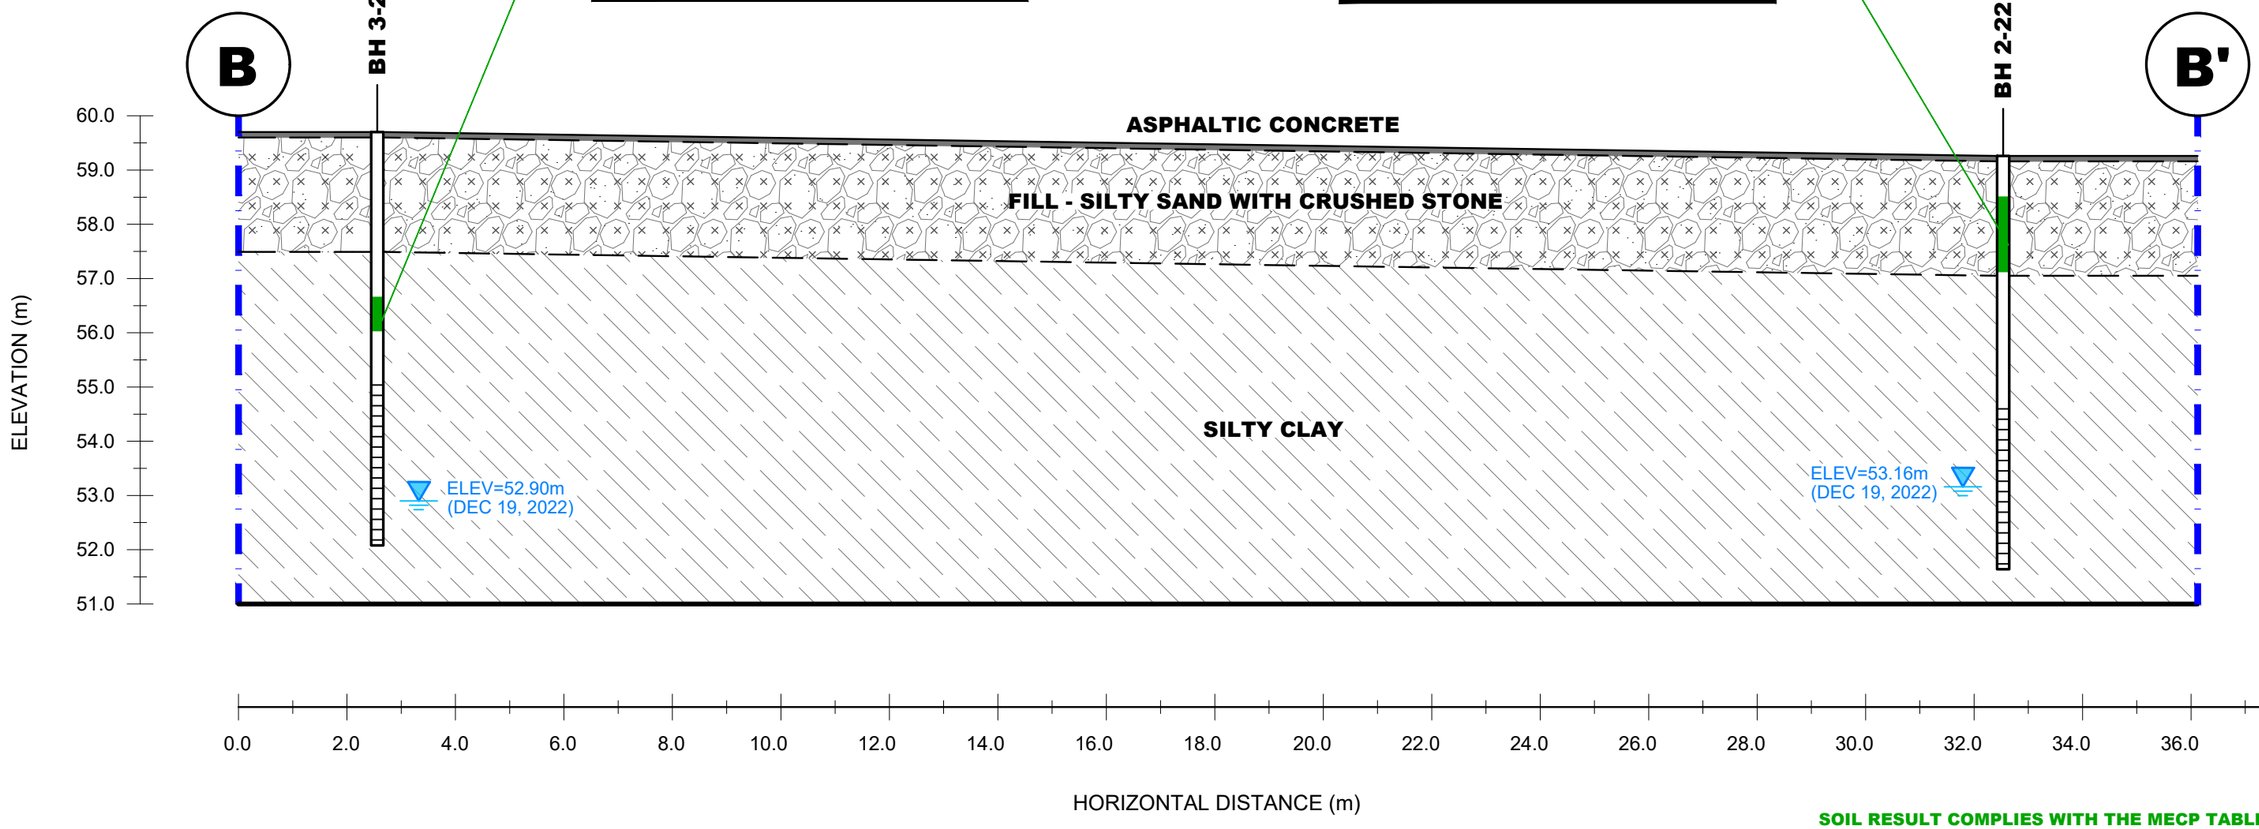
BH2-22-SS2/SS3	0.76-2.13m	12-Dec-22
Parameter	Result(uS/cm)	Standard(µS/cm)
EC	3,810	700

*EC deemed to comply with MECP Table 3 Standards (Section 49.1 of Ontario Regulation 153/04)
