Supplemental
Phase II Environmental Site Assessment

951 Gladstone Avenue and
145 Loretta Avenue North
Ottawa, Ontario

April 14, 2021

Report: PE4613-1R

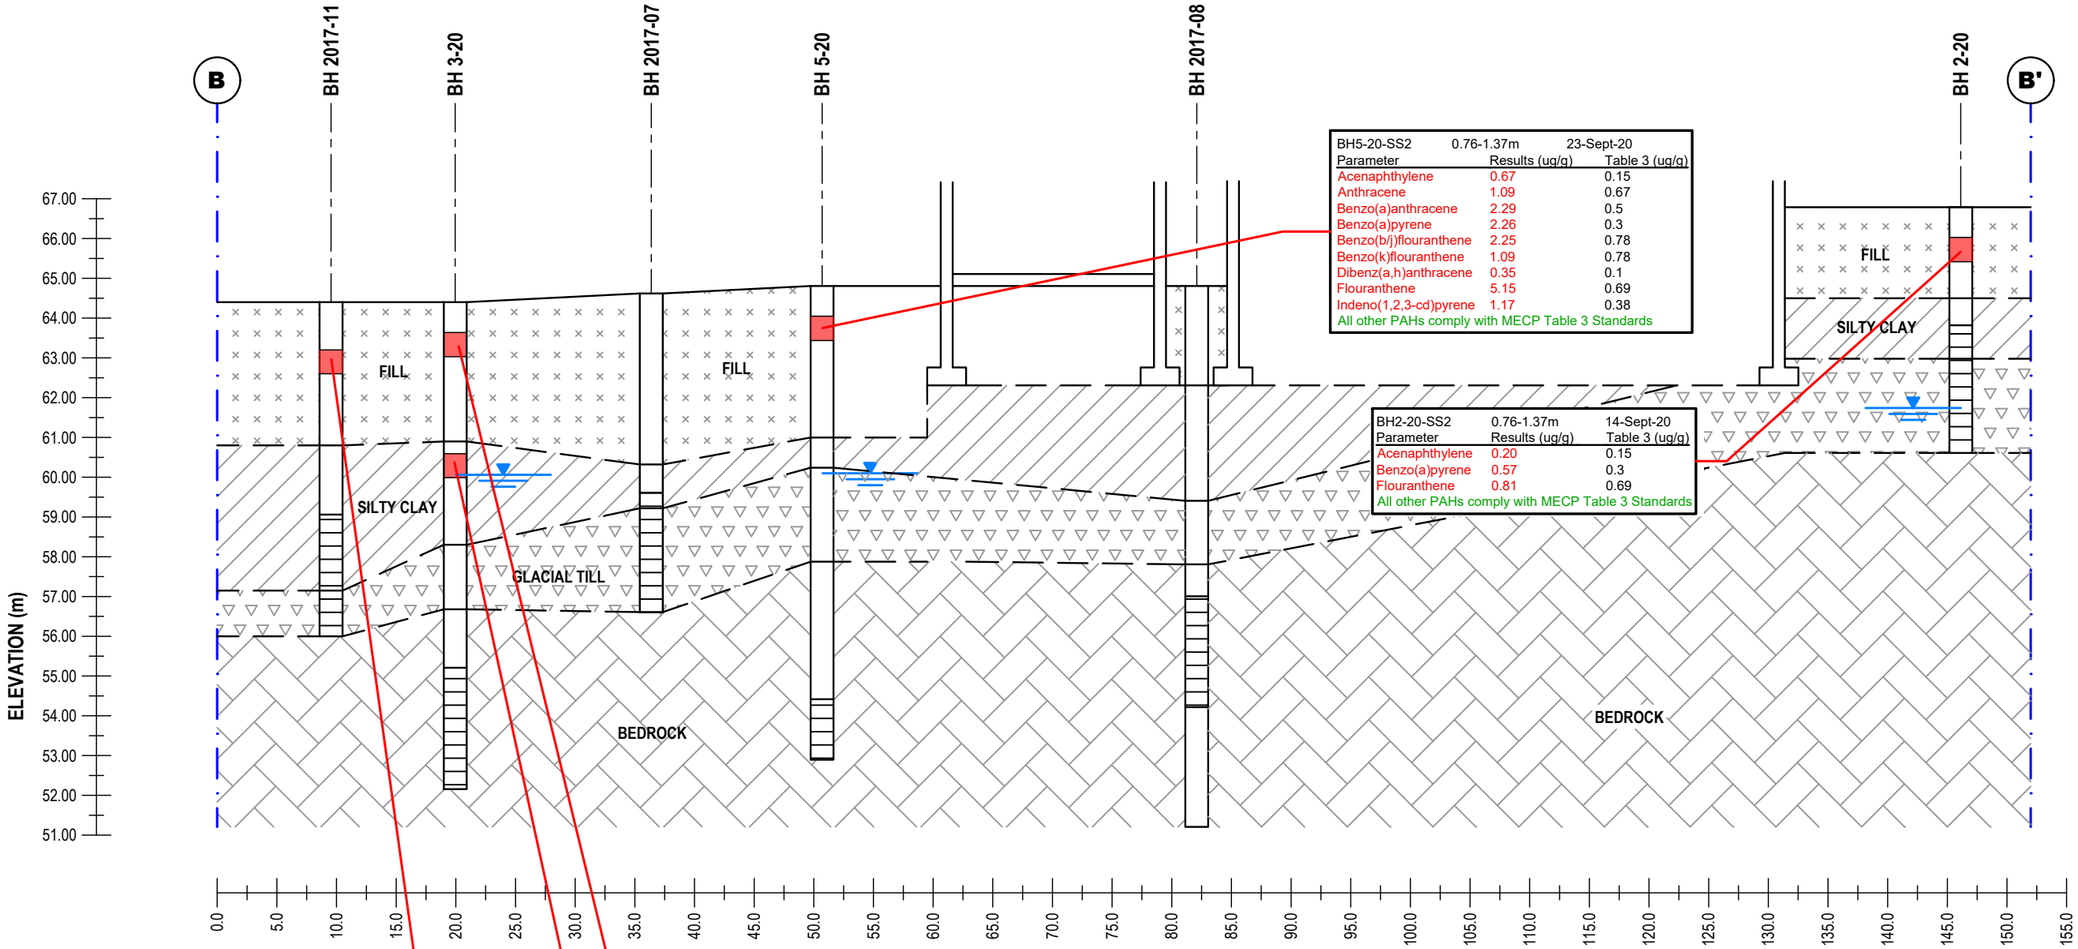
BH5-20-SS2 0.76-1.37m 23-Sept-20

Parameter	Results (ug/g)	Table 3 (ug/g)
Acenaphthylene	0.67	0.15
Anthracene	1.09	0.67
Benzo(a)anthracene	2.29	0.5
Benzo(a)pyrene	2.26	0.3
Benzo(b/j)flouranthene	2.25	0.78
Benzo(k)flouranthene	1.09	0.78
Dibenz(a,h)anthracene	0.35	0.1
Flouranthene	5.15	0.69
Indeno(1,2,3-cd)pyrene	1.17	0.38
