Geotechnical Investigation

Proposed Sortation Facility
Leikin Drive and Merivale Road Intersection
Nepean, Ontario

Medusa LP

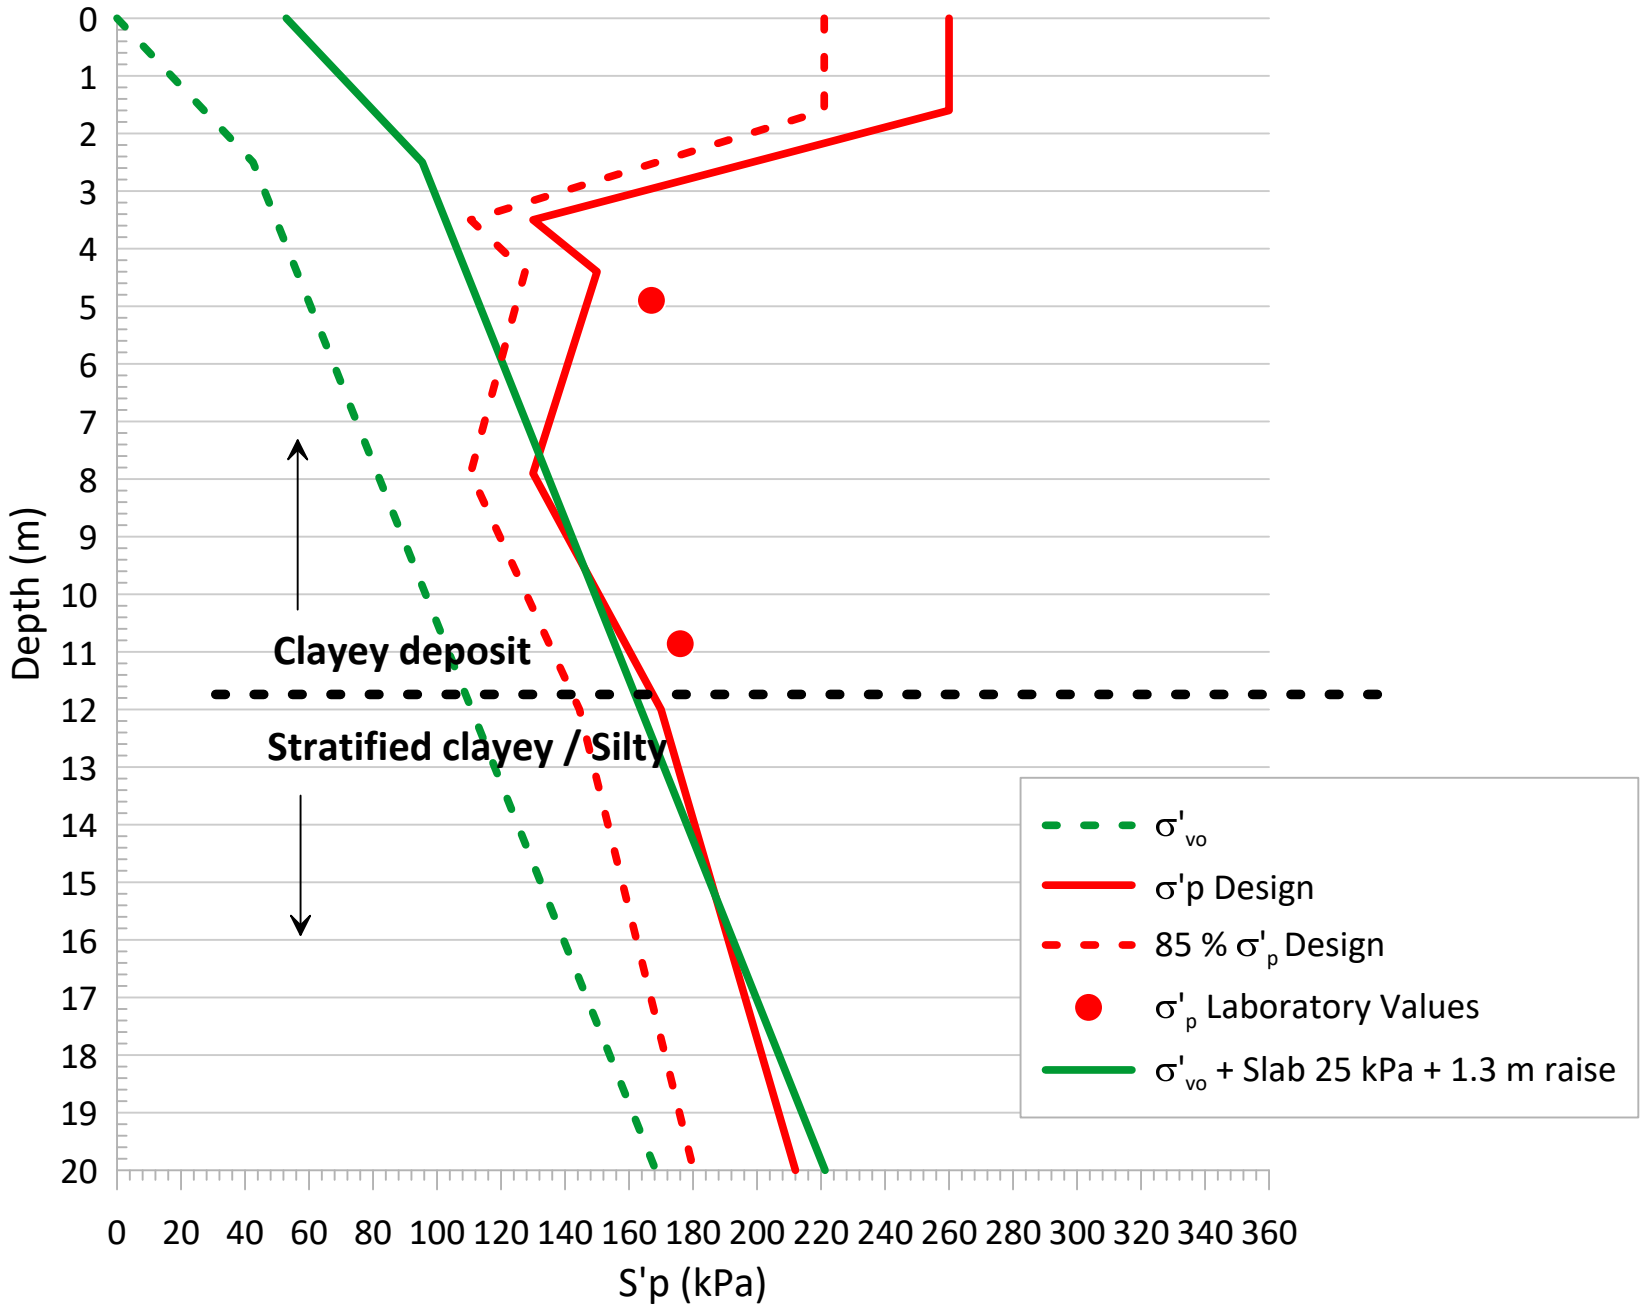
Graph D2
Preconsolidation and Load Profiles

subsequent foundation loads would render the said deposit to a normally consolidated state. This consolidation state is illustrated on Figure D2 presented in Appendix D[2].

As such, based on the proposed site development requirements, the site, in its current condition, is not suitable to support a normal slab on grade nor conventional foundations as such a construction would lead to excessive plastic settlements.

[2] This graph shows only effective stresses after site raise and slab loads. Footing loads are not considered in the graph and may move the stresses state closer to yield conditions.
